Protecting the Animas-San Juan Watersheds

Dennis McQuillan, Chief Scientist, N.M. Environment Department

Governor Martinez Directed NMED to Lead the GKM Spill Investigation And Created a Long-Term Monitoring Team

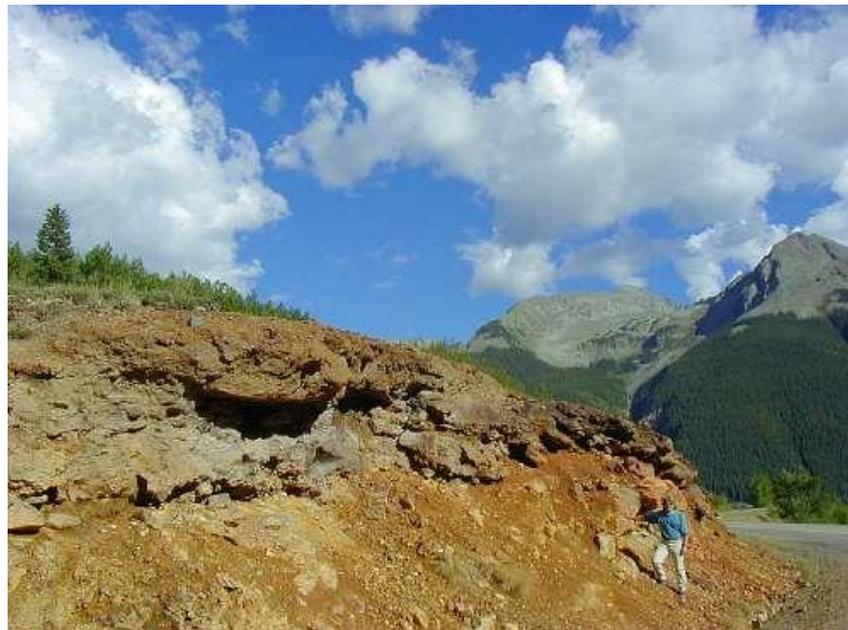
**Ferricrete deposit
in Cement Creek**

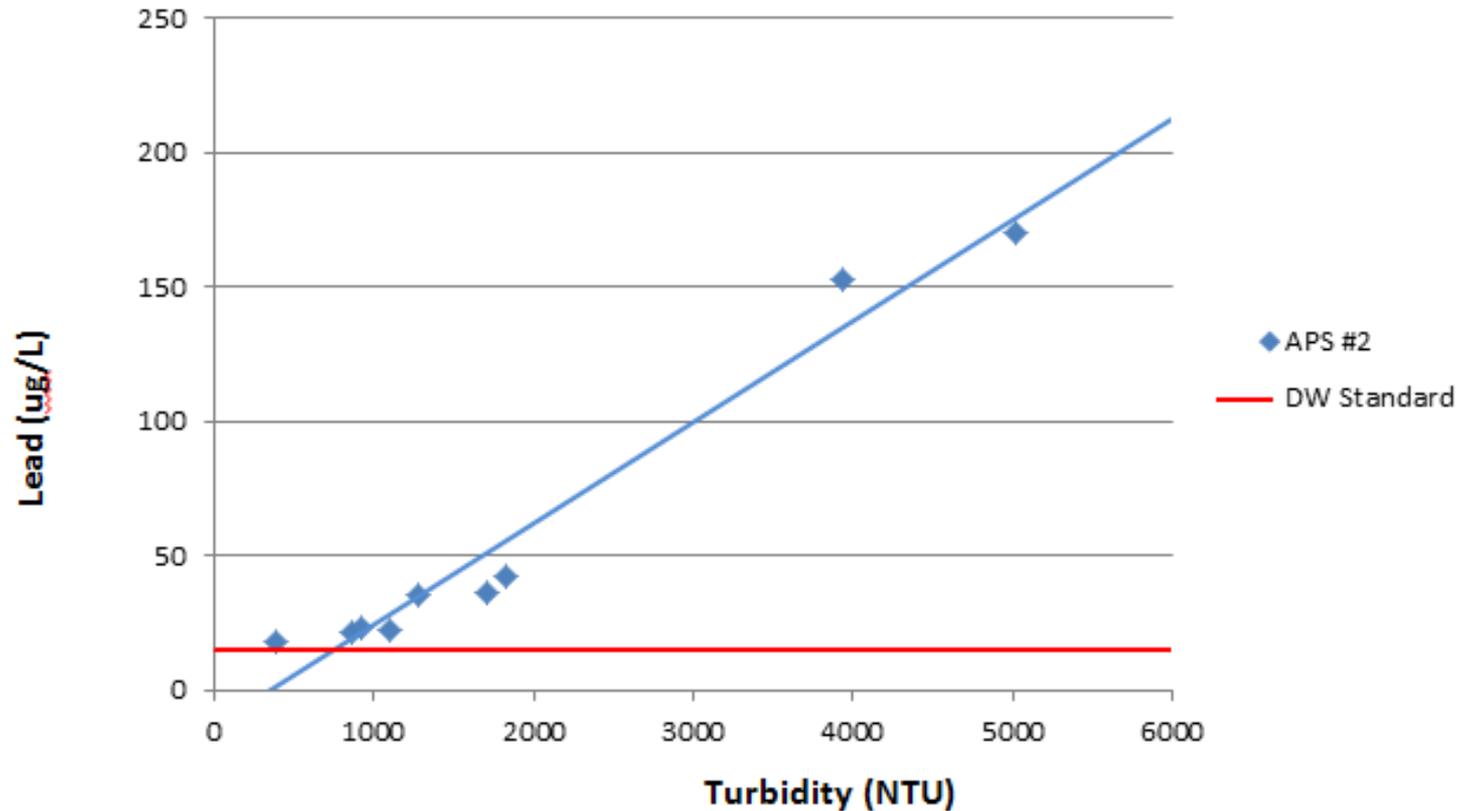
Total Lead and Turbidity in Untreated River Water

City of Farmington monitoring data

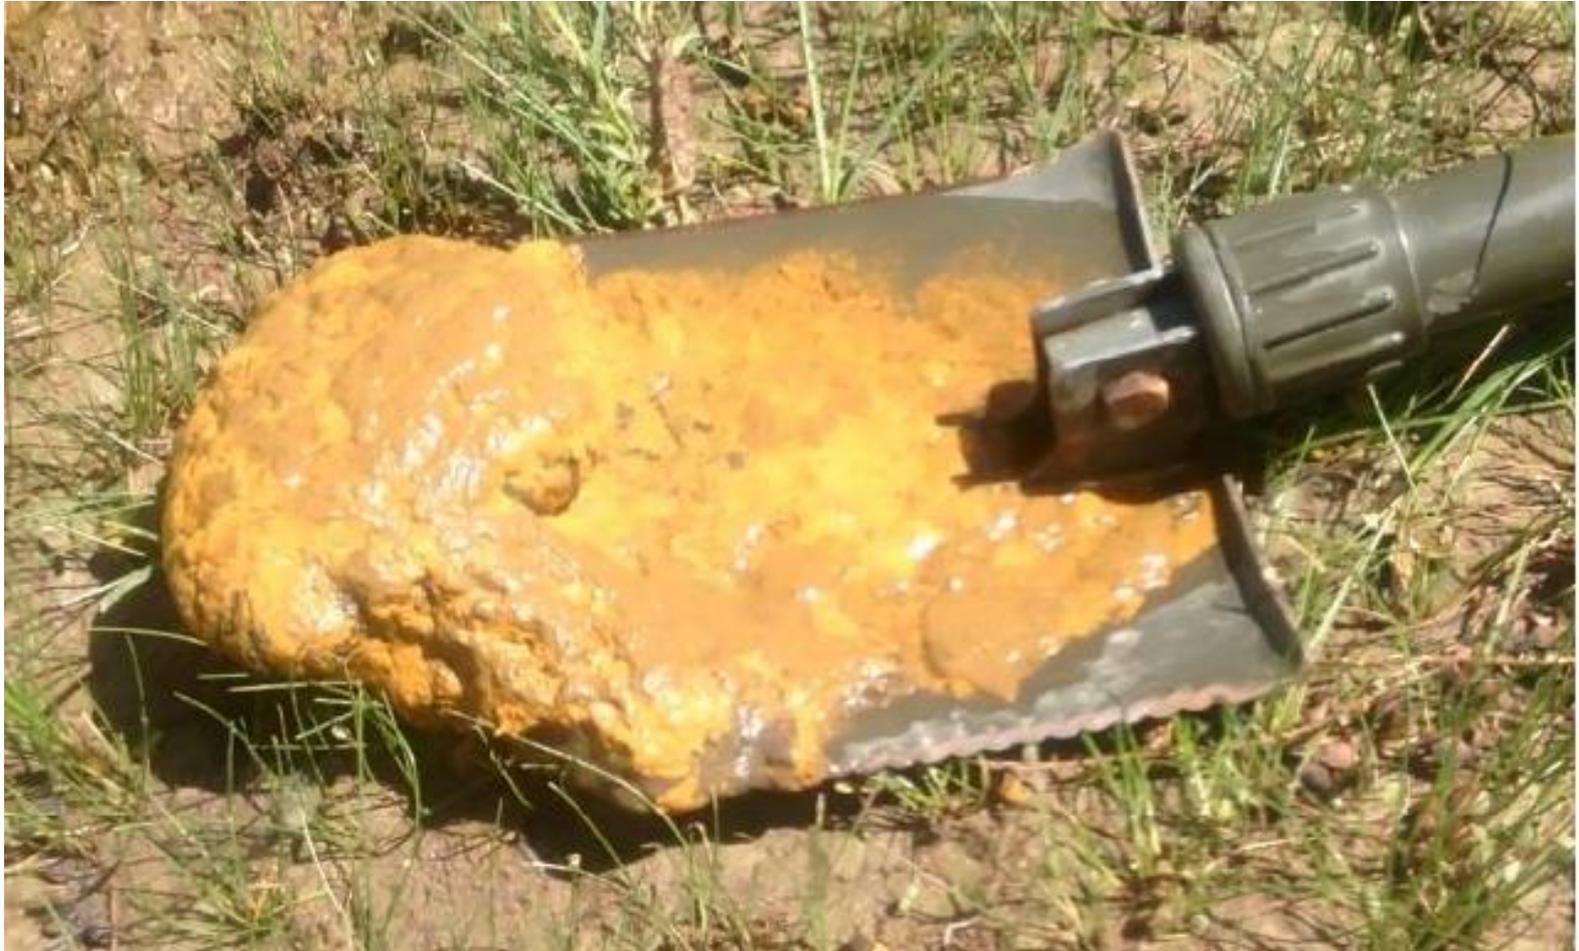
Metals are Stored in River Sediment and Re-Suspended in High-Flow Events

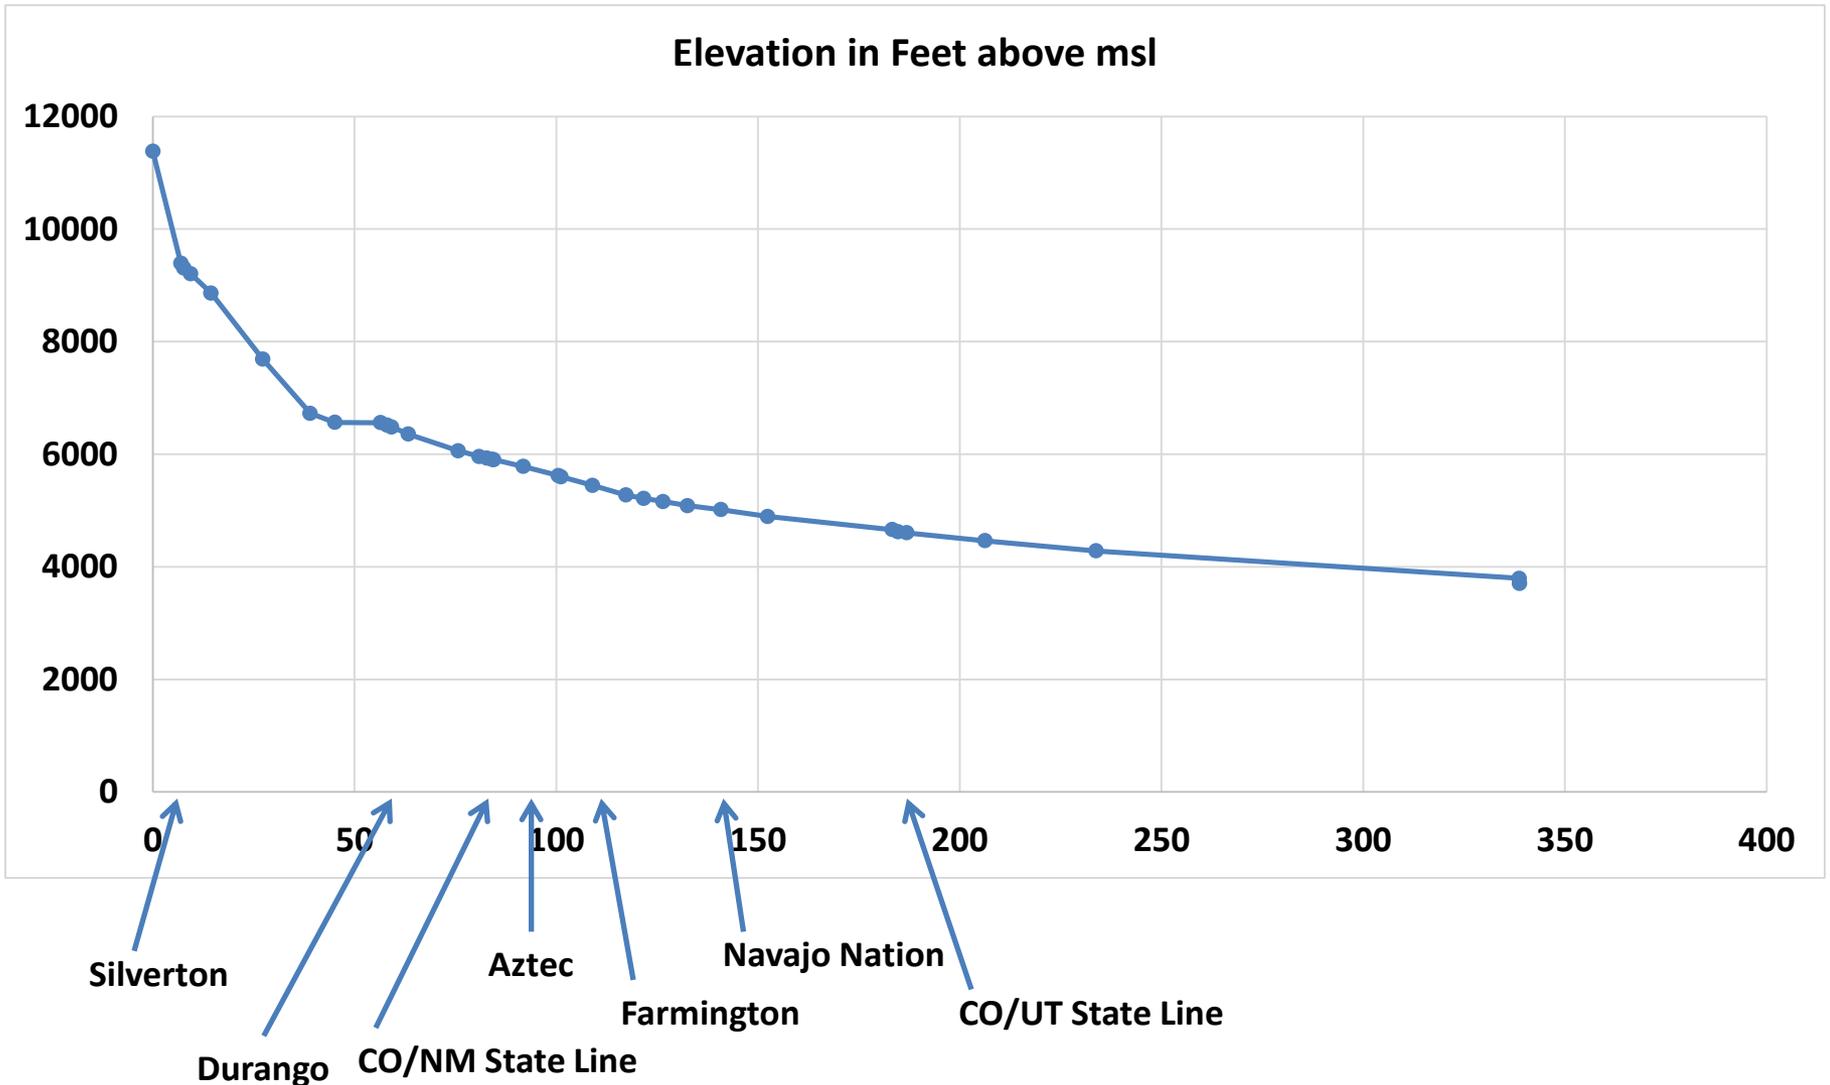
Animas/San Juan Rivers Profile

~GKM to Lake Powell~

Elevation in Feet above msl

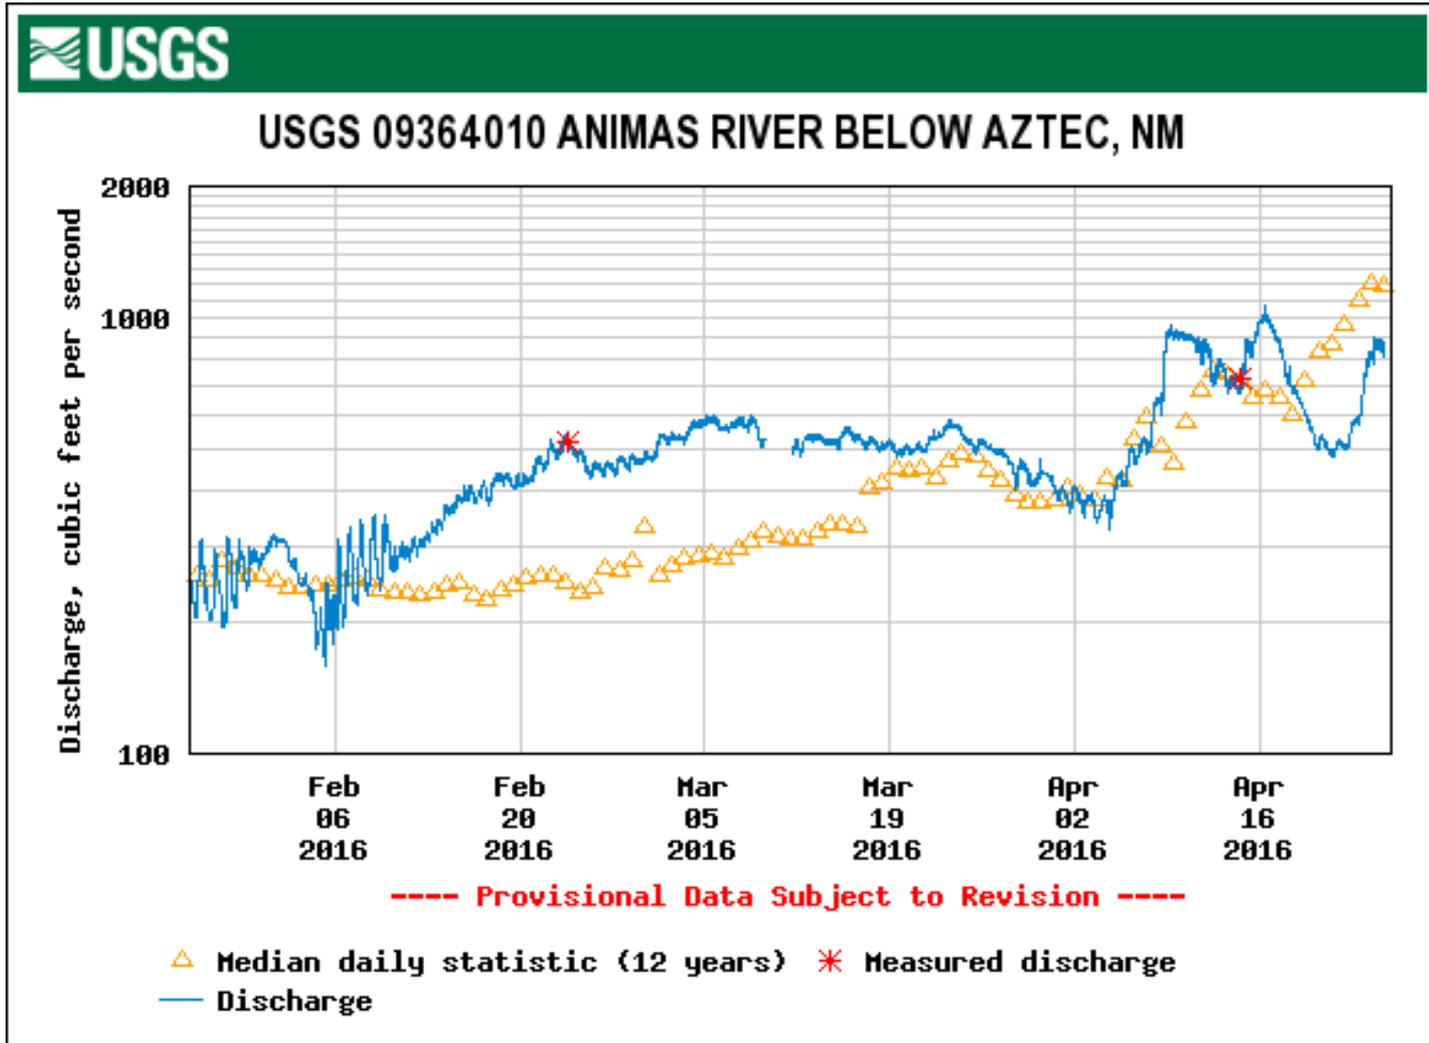
90-Day Hydrograph Animas River Below Aztec

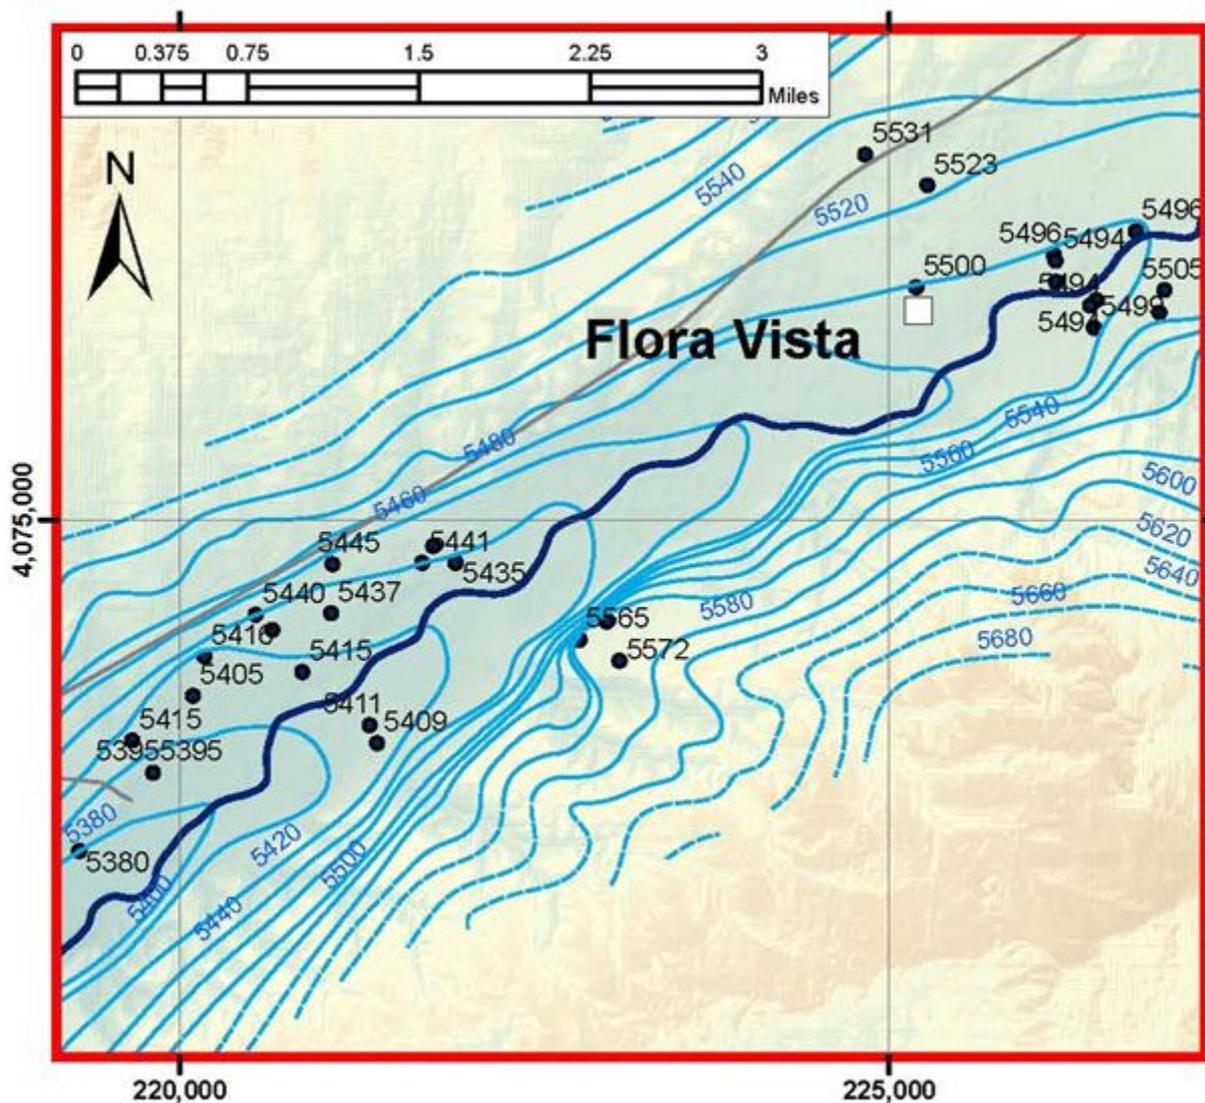
Groundwater Elevation Near Flora Vista August 2015

Animas River was gaining water from the alluvial aquifer in August.

Need to monitor aquifer-river hydraulics during spring runoff.

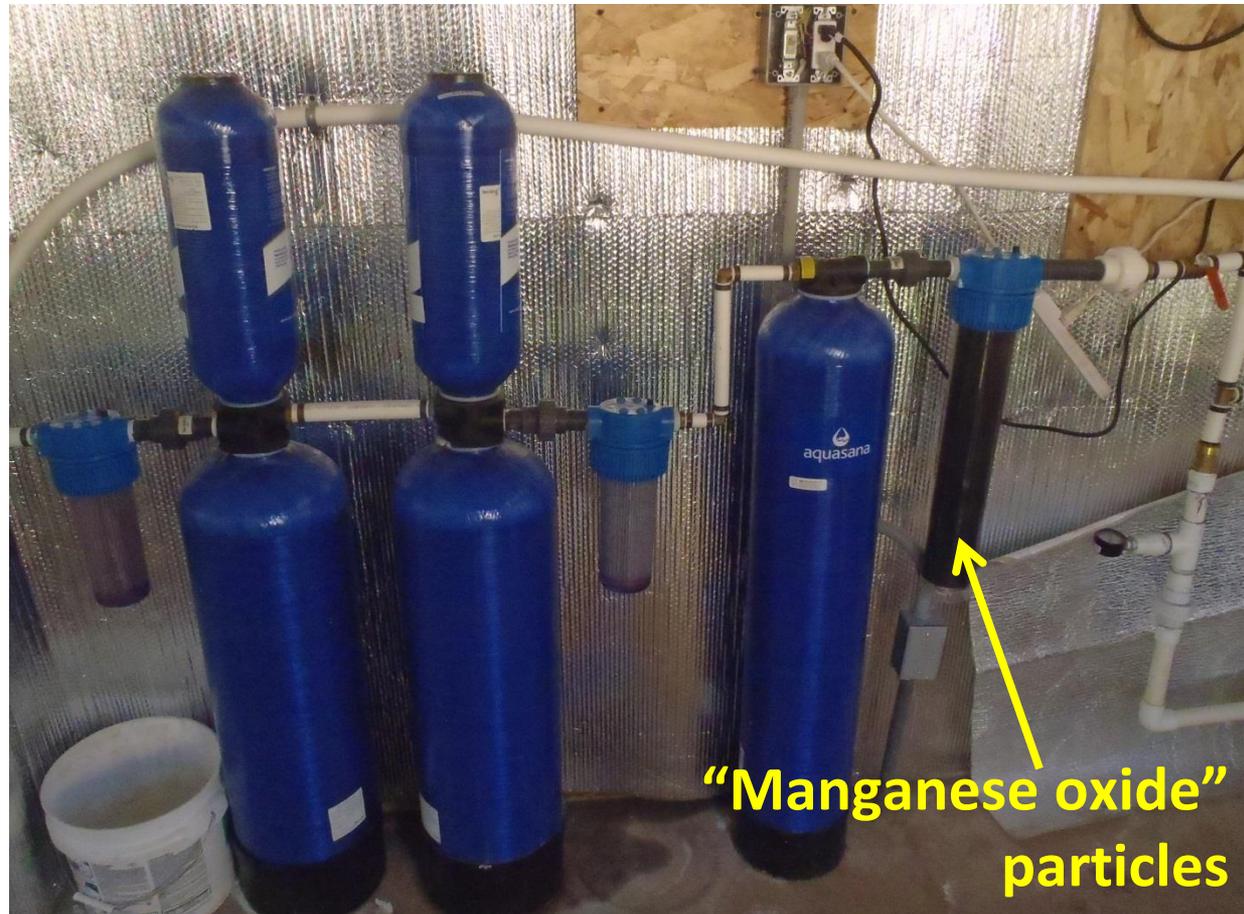
Domestic water well treatment system

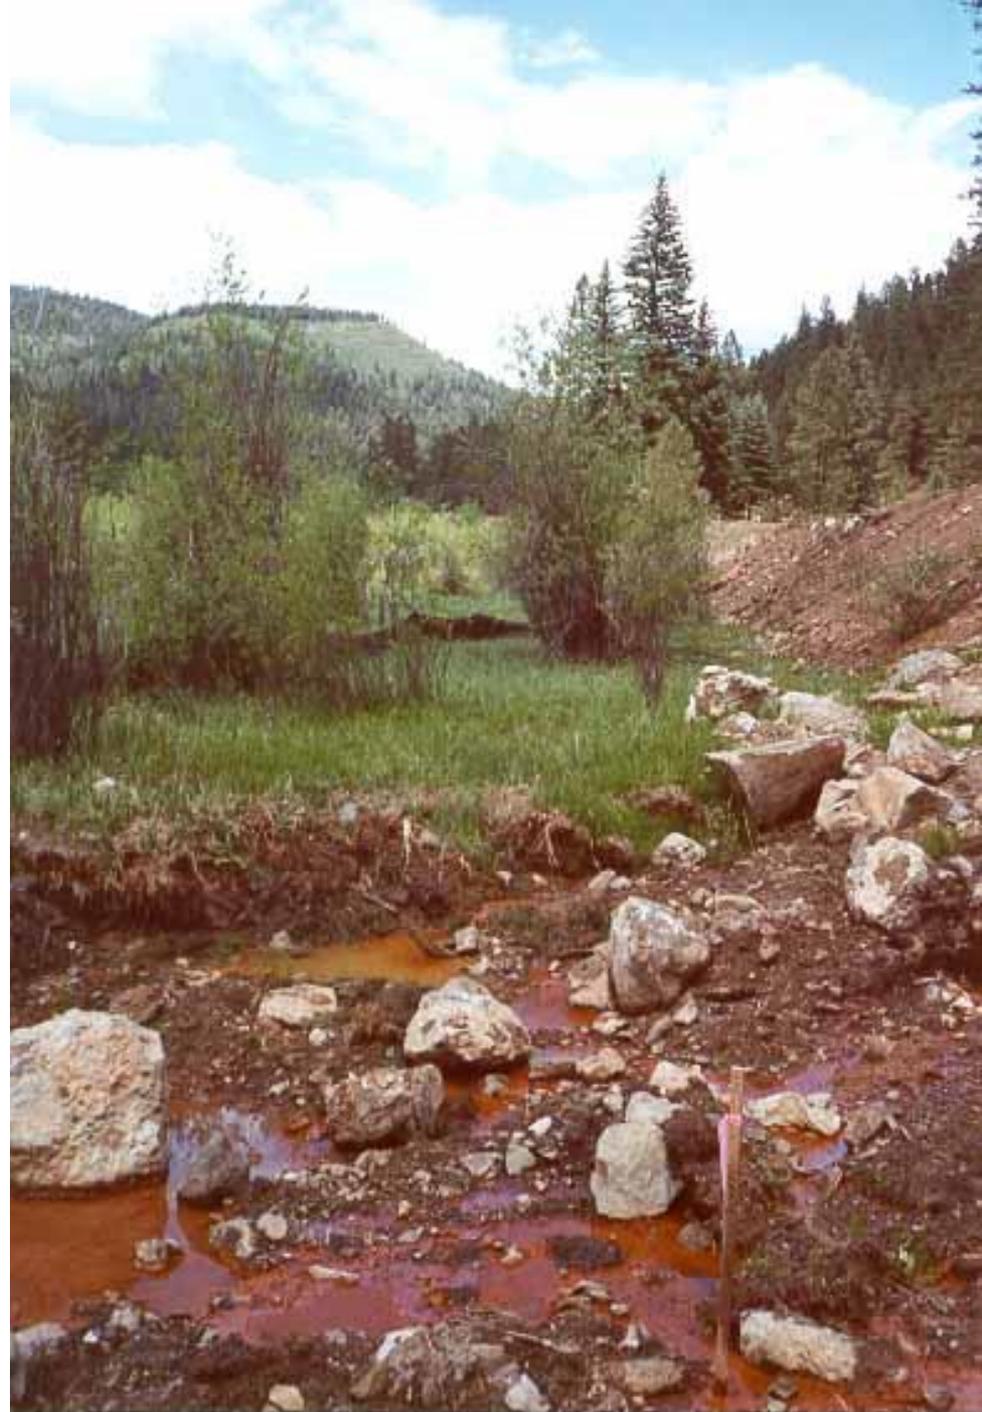
Terrero Mine in Pecos, NM Before Cleanup

- Acid rock drainage into Willow Creek
- Periodic fish kills in the Pecos River

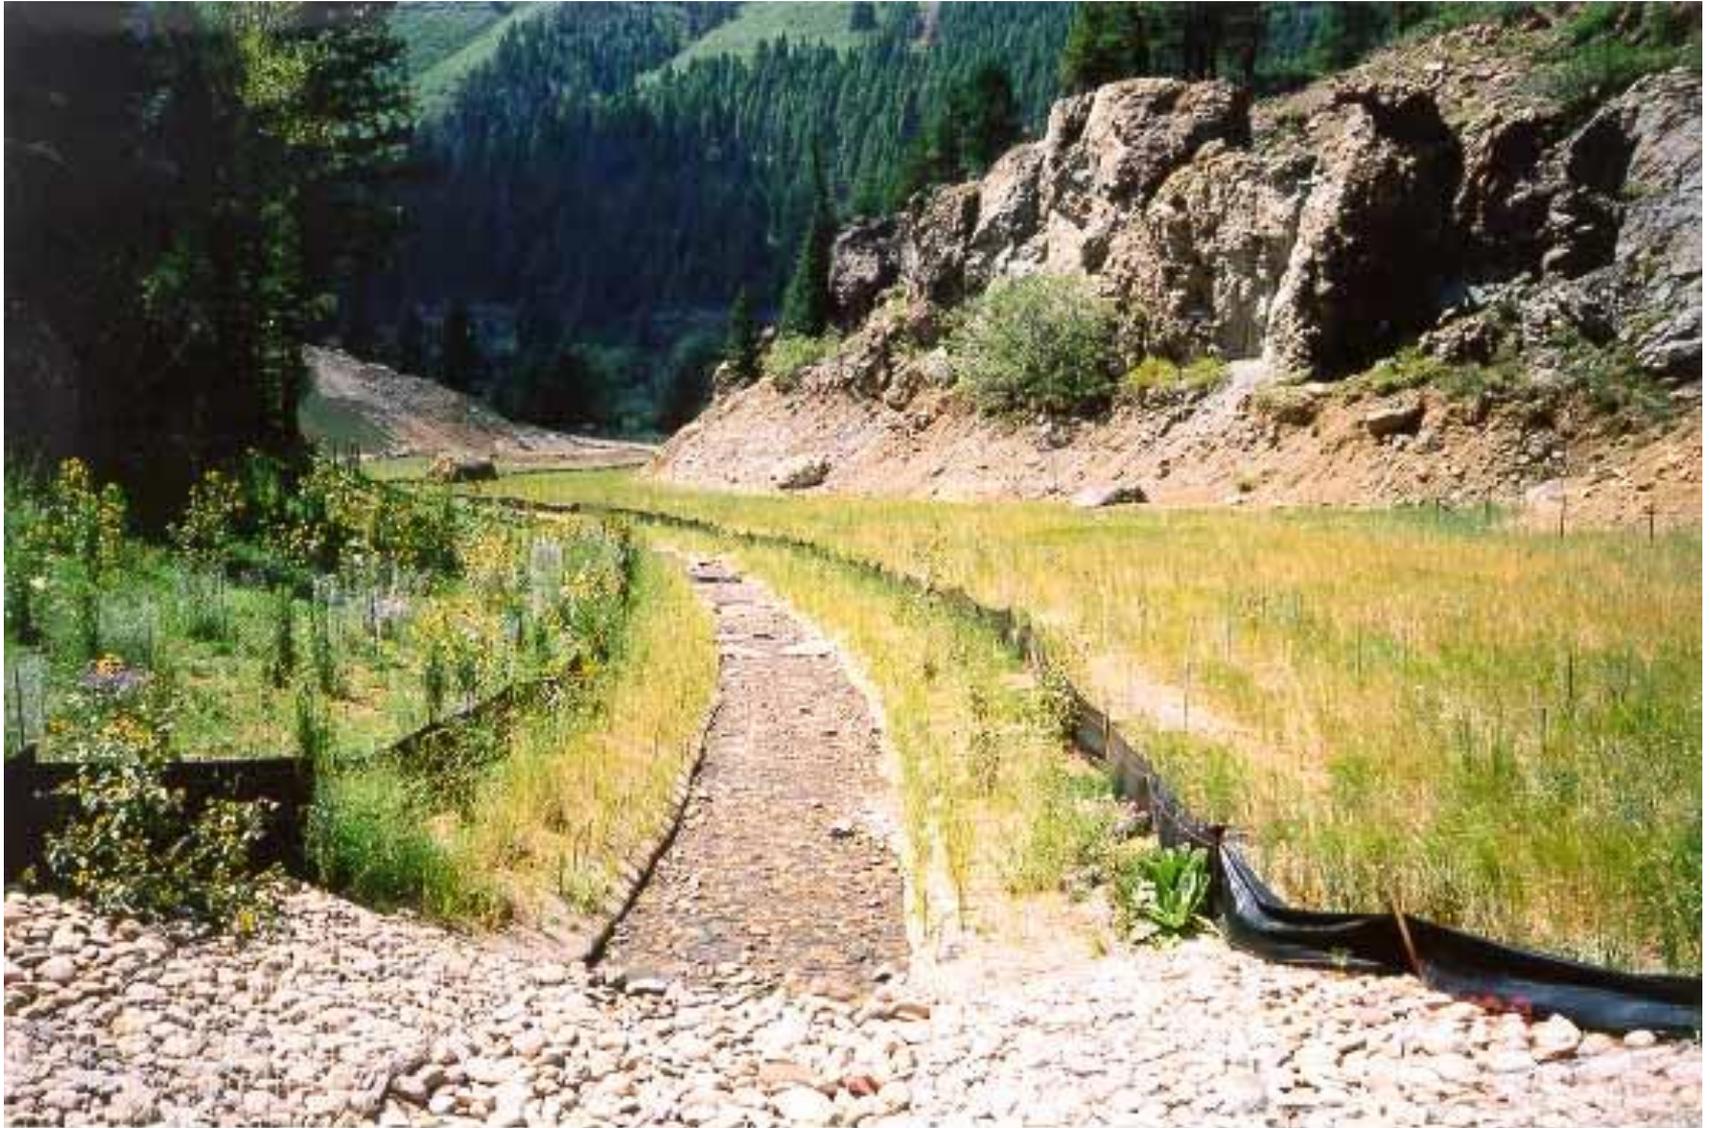
Terrero Mine After Cleanup
