CLEARING THE WATERS

A quarterly newsletter by the Surface Water Quality Bureau

Innovative Design and Restoration of Slope Wetlands in the Comanche Creek Watershed, New Mexico

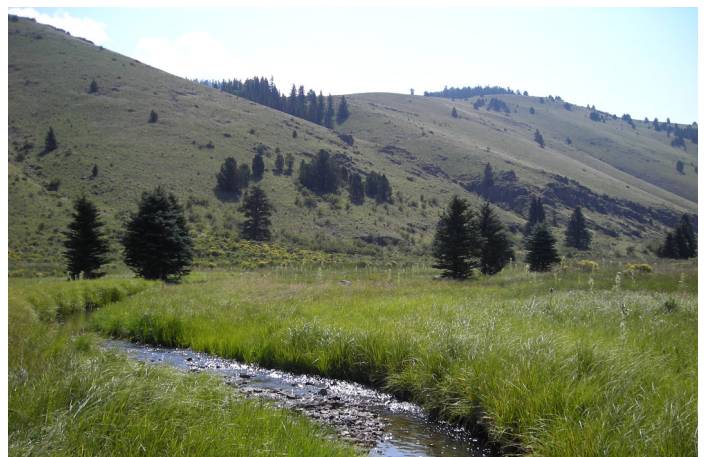
Grassy Creek (left) and Springwagon Creek (right). Volunteers building log step fall structures to arrest erosion in headcuts, preventing the slope wetlands upstream from drying. The crew boss of each crew is wearing an orange vest.

The NMED Wetlands Program worked with the Quivira Coalition and several subcontractors to characterize and restore slope wetlands. Five slope wetland areas in Northern New Mexico were surveyed. Data collected included relevant data to characterize slope wetlands hydrology, topography, soils, vegetation, and geomorphology. Common stressors that cause slope wetland decline were documented. From this characterization, novel restoration and design techniques were devised and tested in Grassy Creek. Similar companion restoration work was done in nearby Springwagon Creek to provide grant match using state restoration funds and volunteer labor. Restoration structures were made from natural materials available in the area: rocks, logs, branches, sod dug on-site, and soil excavated by hand shovel or heavy machinery.

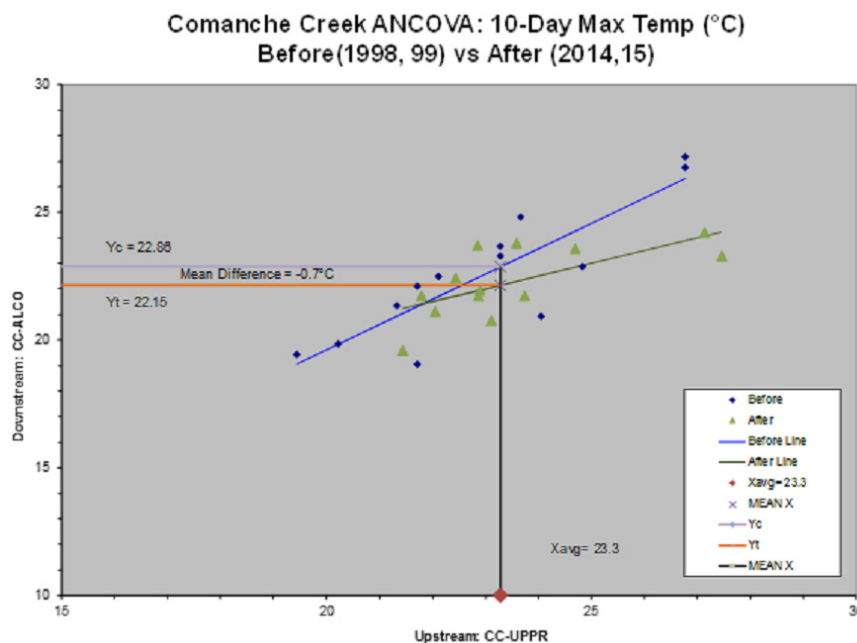
ANCOVA results show that restoration projects on Comanche Creek have decreased stream temperature.

Comanche Creek gained recognition in 2013 as a water quality success story, for improvements in sedimentation and channel morphology (See the Summer 2013 issue of Clearing the Waters: www.env.nm.gov/swqb/documents/swqbdocs/WPS/CTW/ClearingTheWaters-Summer2013.pdf). Additionally, past projects reduced temperatures in Comanche Creek. An analysis of covariance (ANCOVA) compares the relationship of stations upstream and downstream of the project reach, before and after the work was conducted, in order to isolate the effects of restoration. The projects reduced stream temperature by an average of 0.7 °C in the middle reach from Holman Creek to Little Costilla Creek, with greater effect in the higher temperature range. Although temperature has decreased, Comanche Creek does not yet meet the standard for the high quality cold water aquatic life use, which has an upper limit of 23 °C. SWQB will continue to monitor temperature on Comanche Creek to account for the lag time of vegetation growth and to capture the effect of recent and future stream and wetland restoration projects.

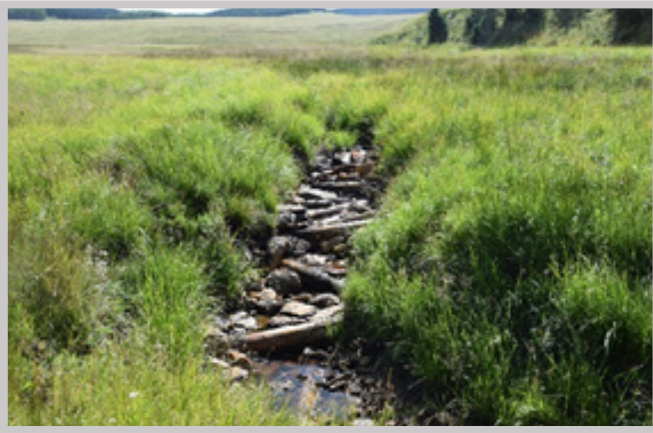
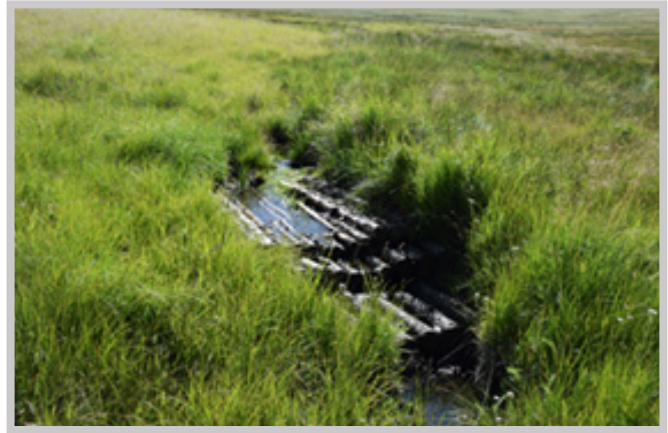
Grassy Creek. Log-rock rundown structure (left), and log step fall structure (right) in 2016, two years after installation.

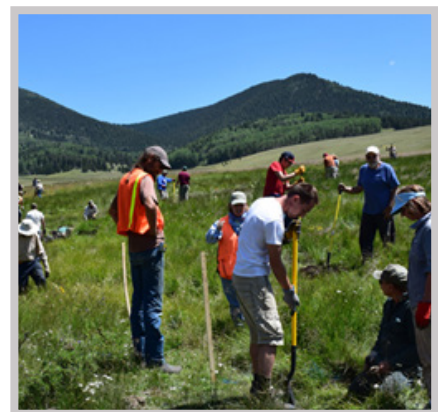
Photo on right: Volunteers digging sod for sod plugs and for chinking in stepfall structures and Zuni bowls.

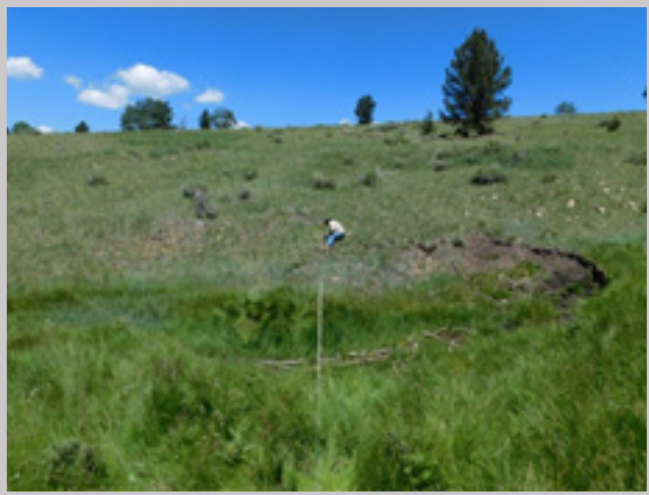
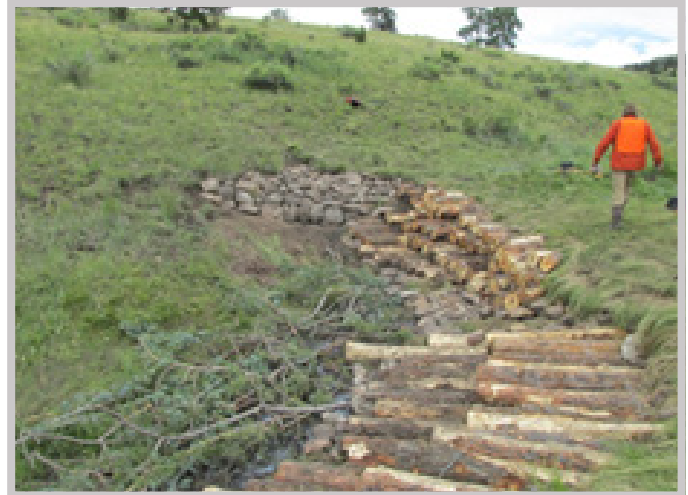
Springwagon Creek. A large headcut that was treated with a log stepfall structure. The photos were taken before and immediately after construction in 2016.
