Quality Assurance Project Plan

Bluewater Creek Riparian Improvement Project near Bluewater, New Mexico

New Mexico Environment Department

Surface Water Quality Bureau

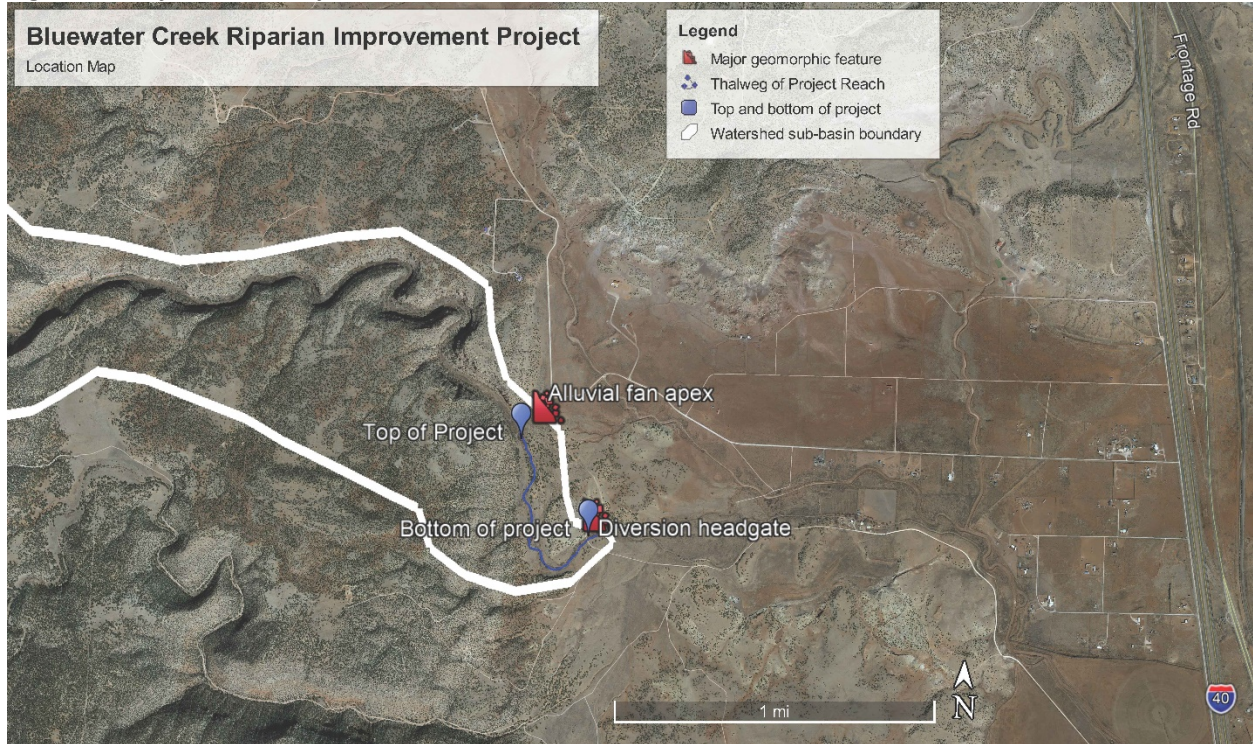
Figure 2. Project Area Map

The project reach on Bluewater Creek occurs downstream of Bluewater Lake in the foothills of the Zuni Mountains in West-Central New Mexico.

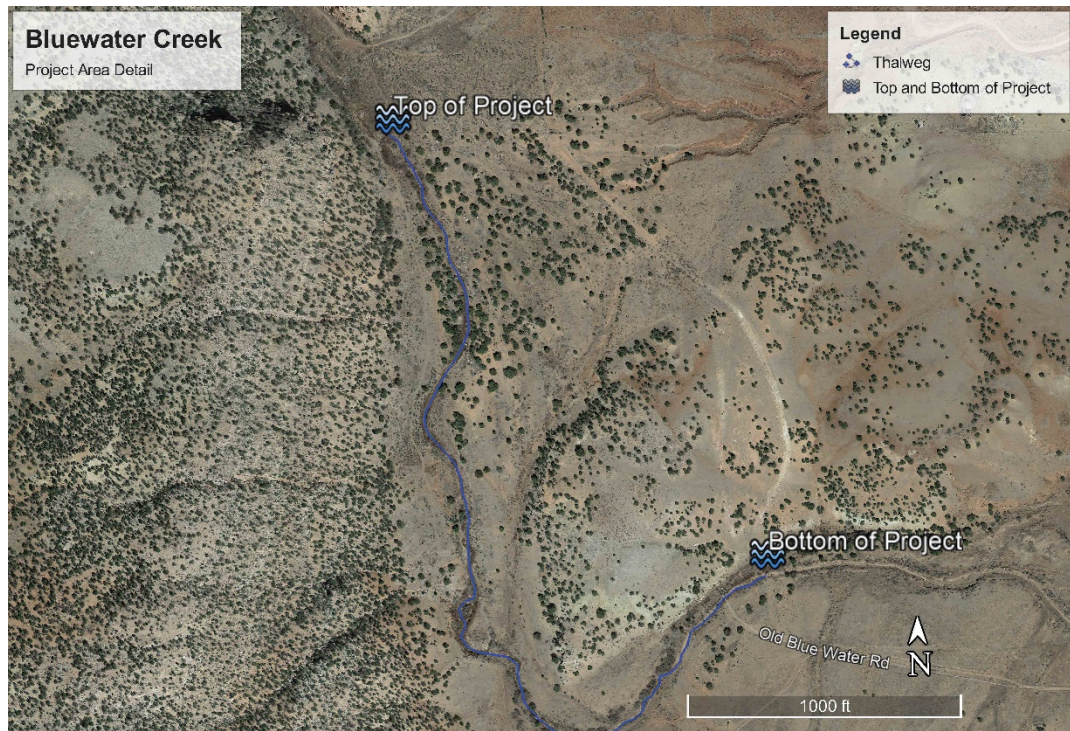
Figure 3. Project Area Detail

The Ranch boundary is located at the top of the project, and a diversion headgate provides a hard and fixed location just downstream of the bottom of the project (see Figures 1 and 2). All the proposed treatment locations will be conducted in the project area as described above using BMPs listed in Table 4. Monitoring will be developed to satisfy both CWA Sections 319 and 404 requirements. The target reach begins on the Ranch boundary just downstream from the alluvial fan apex located at 35.290252 degrees north, -108.024362 degrees west (latitude, longitude) and at the downstream end at 35.286042 degrees north, -108.020417 degrees west. Linear stream distance is approximately 0.75 miles. Waterbody attributes for the stream reach located in the project area are listed in Table 3.
