Final Report
East Fork Jemez River Innovative Wetland Restoration Using
Contour Swales, Sod Bowls and Sod Berms

Assistance Agreement No. CD#01F39601-0 (FY2018)

New Mexico Environment Department
Surface Water Quality Bureau
Wetlands Program

August 2023

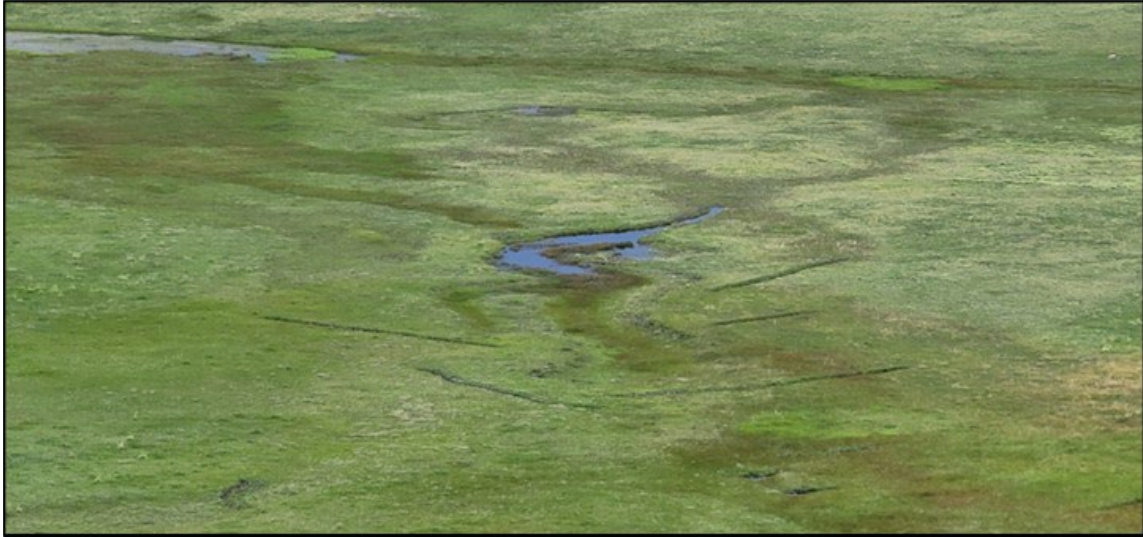
Figure 1 Plug and Pond Restoration Structures on the East Fork. The very top of the gully formation can be seen here at the bottom of the photo. Darker lines are contour swales diverting water flow away from the headcut and spreading water to surrounding areas,

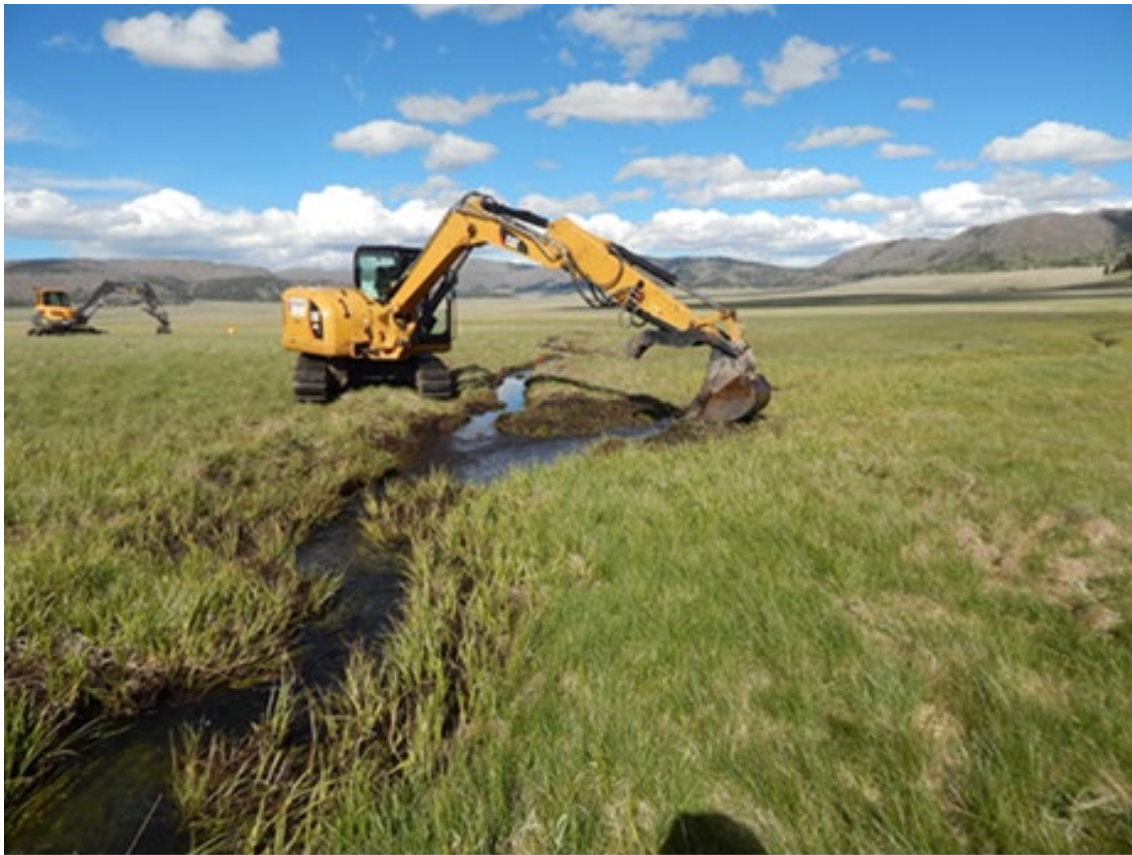
Figure 2 Subcontractor Keystone Restoration Ecology creating an excavator plug that will re-direct and spread water from the channel into historic wetlands.

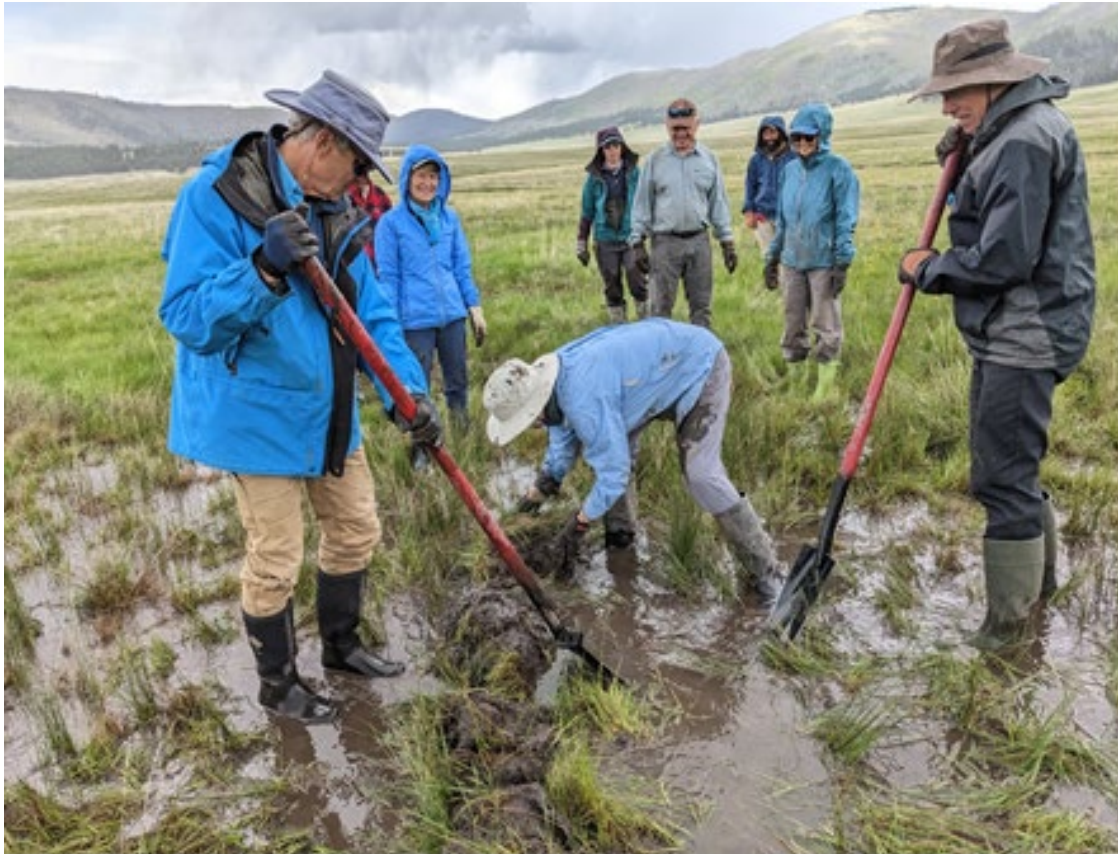
Figure 3 Volunteers for the Outdoors members building sod structures using wetland sod

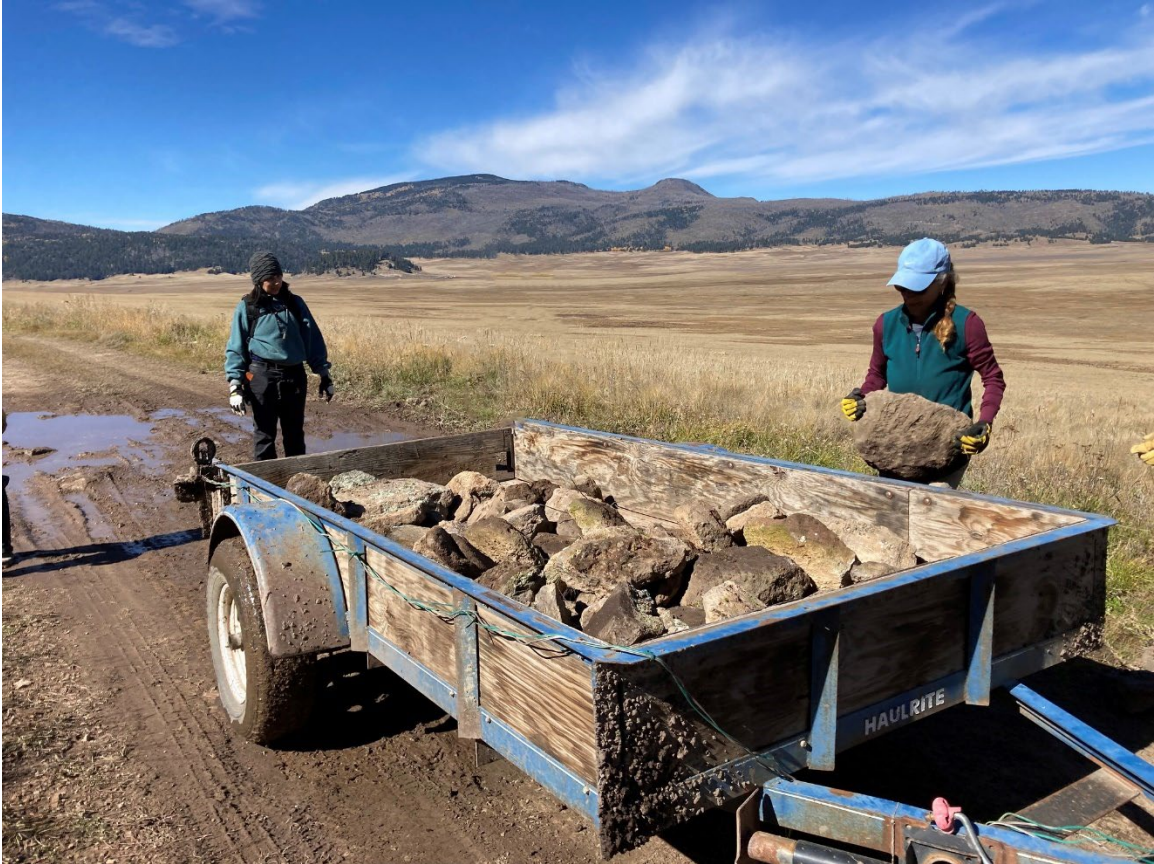
Figure 9 Volunteers collecting rock for one rock dams and for culvert inlet structure during Workshop #1.

Two wetland restoration volunteer workshops with the New Mexico Volunteers for the Outdoors (NMVFO) were held on the East Fork Restoration site on the VCNP. Workshop #1 was held on October 21, 2022, with Maryann McGraw (NMED), Steve Vrooman (KRE), and 19 NMVFO volunteers. Tasks included plugging gaps in three contour swales and repairing four excavator plugs near the East Fork of the Jemez River. Volunteers also built a culvert inlet structure to raise a pond six inches and used sod to repair six plug and pond structures up the main drainage.

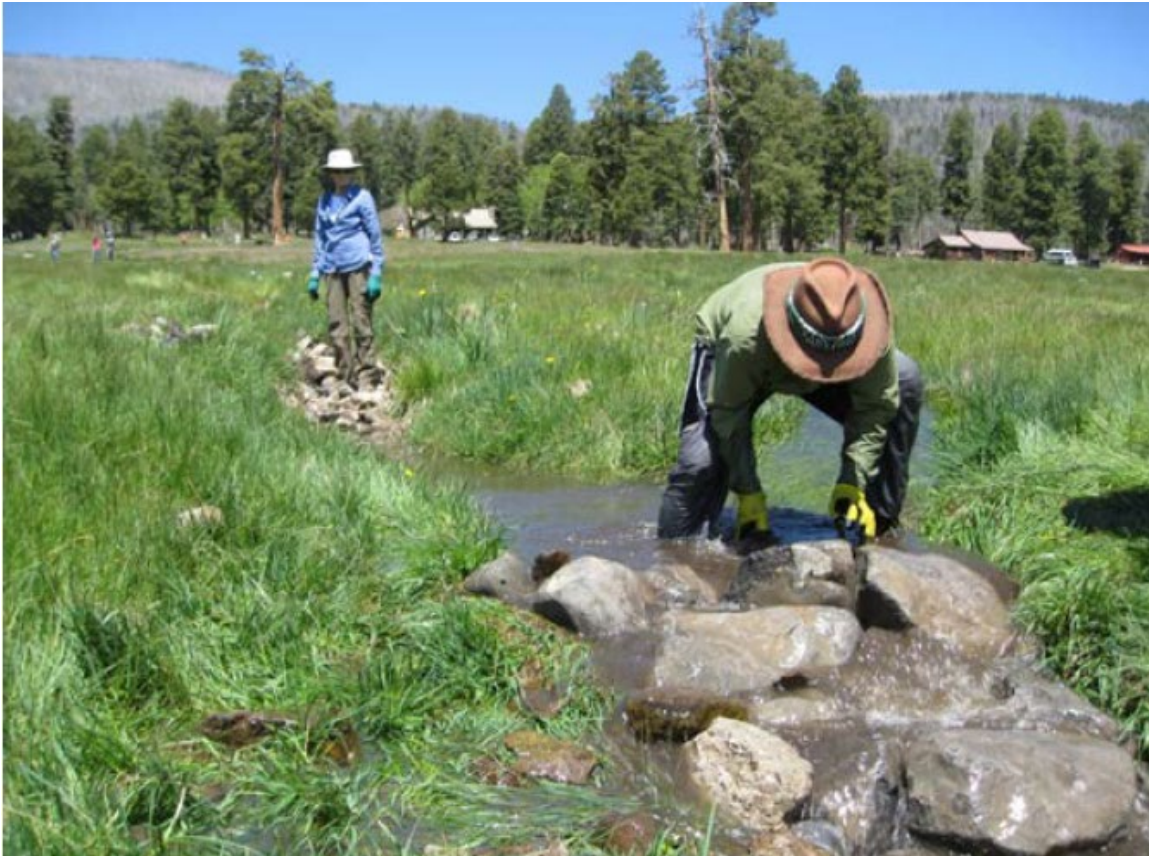
Figure 4 Albuquerque Wildlife Federation volunteers building a rock rundown structure that stabilizes the channel and spreads water into adjacent wetlands for the La Jara Creek project.

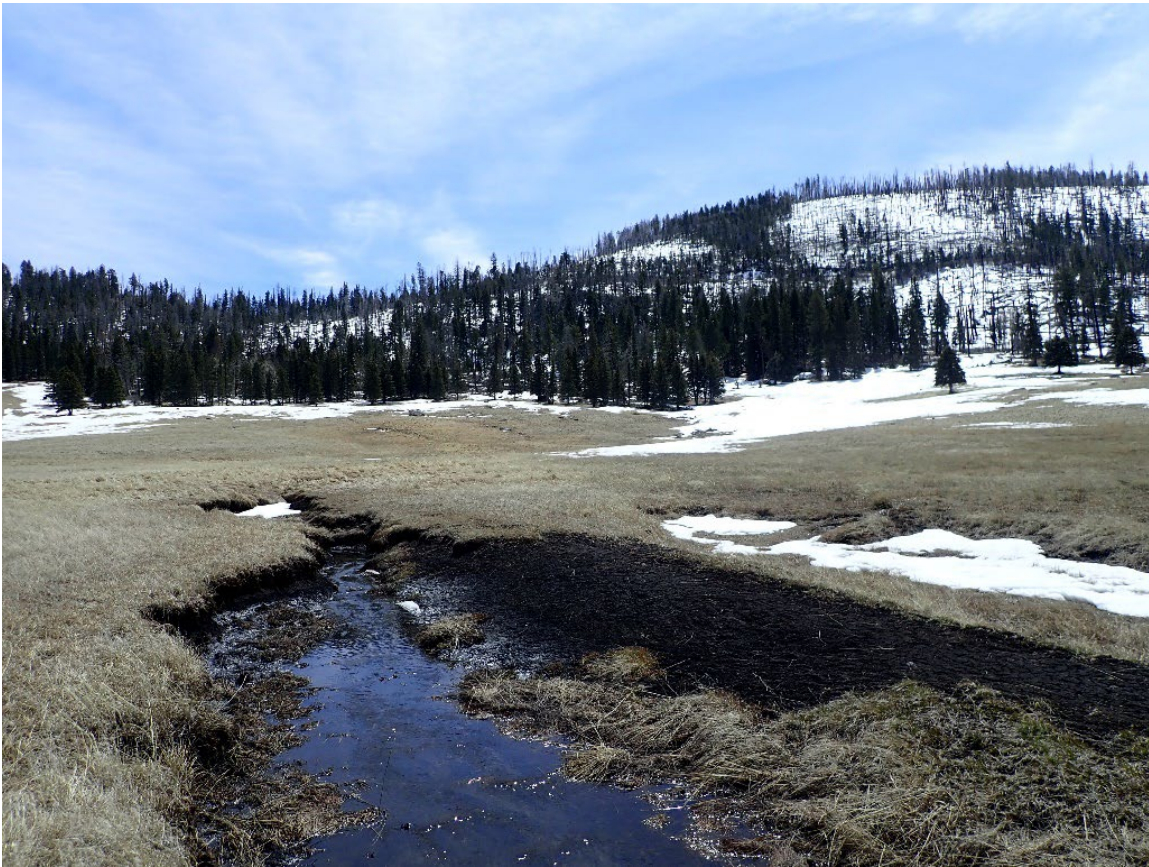
Figure 5 Photo from the draft Project Assessment and Design Report showing gullies created by a historic road that have dewatered wetlands by channelizing water.

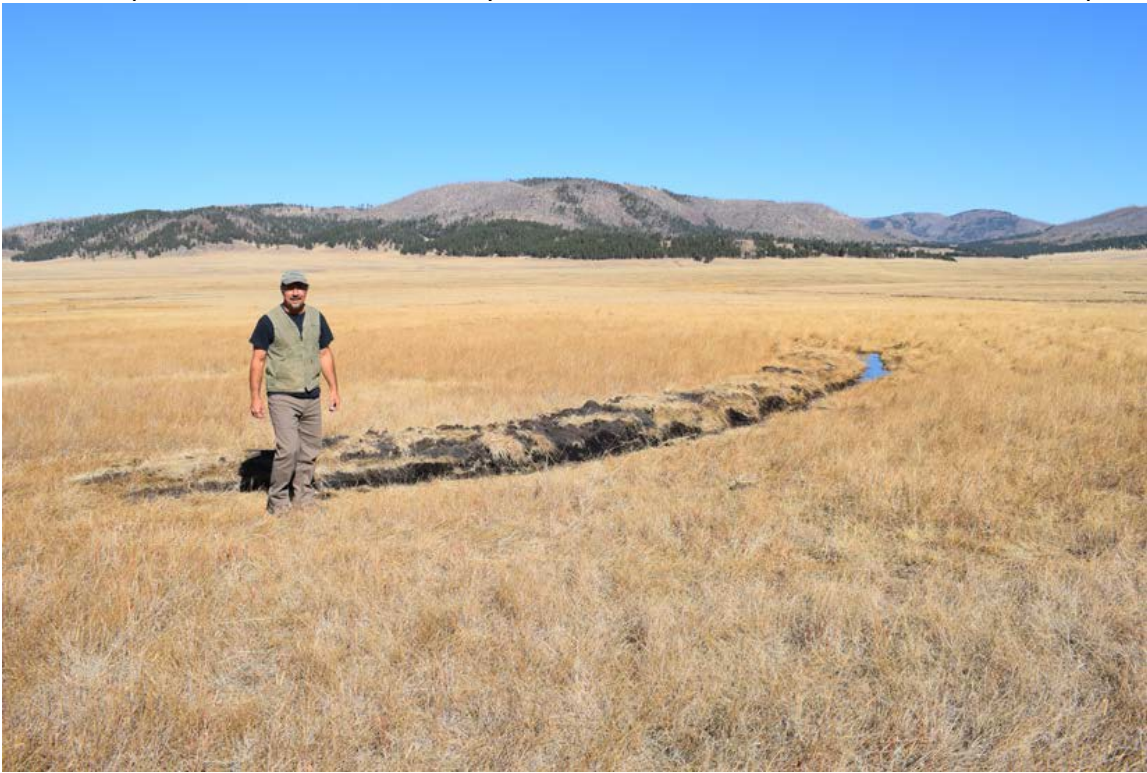
Figure 6 Subcontractor Steve Vrooman, Keystone Restoration Ecology, in front of a newly constructed contour swale that is partially filled with water.

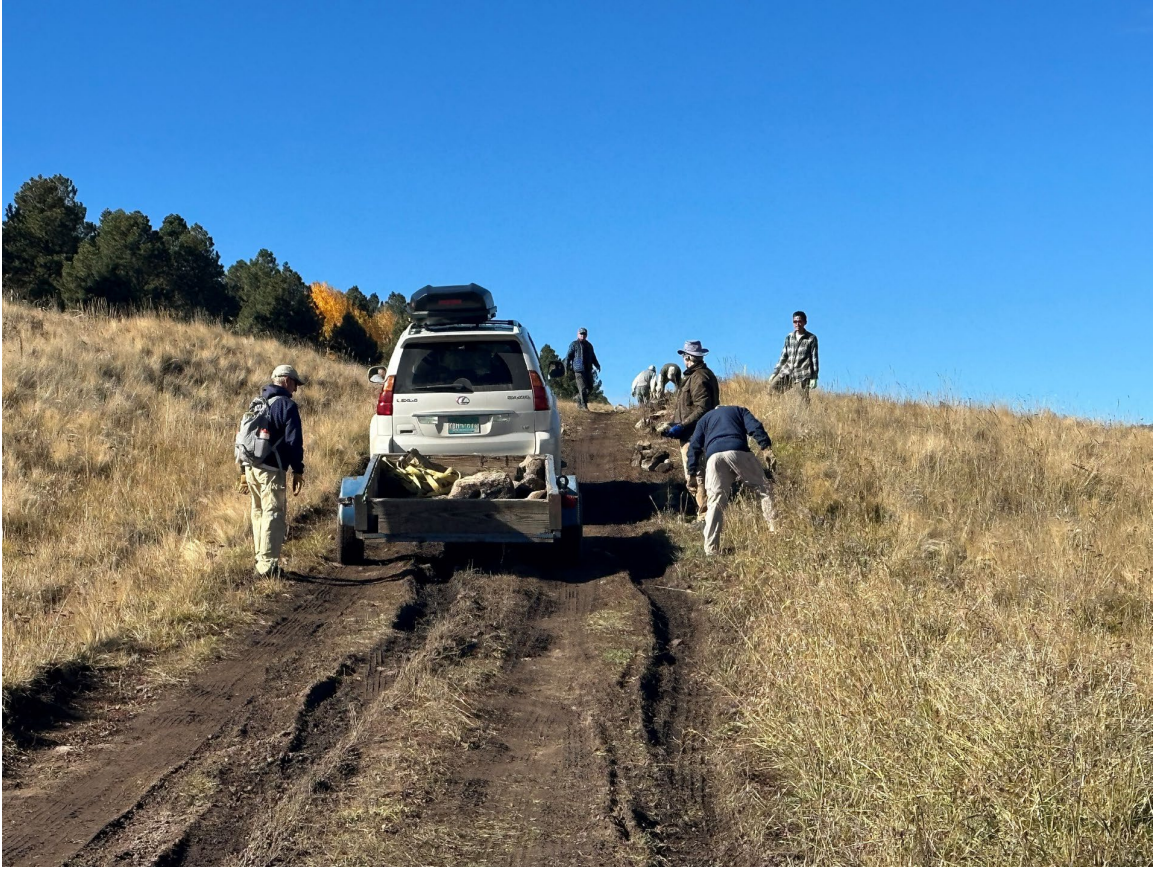
Figure 9 Volunteers for the Outdoors gather large rocks along the road for use in building and repairing restoration structures on the East Fork on October 21, 2022.

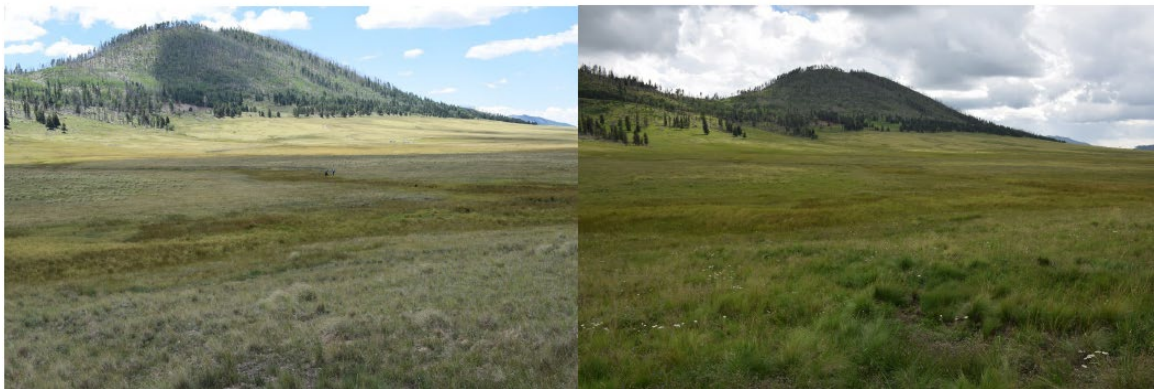
Figure 10 Example Photo point taken in August 2020 (left) and again in August 2022 (right). Because of the improvement to wetlands, the structures were nearly invisible due to plant growth and restoration of wetland land form.

blended into the landscape so well it was difficult to even see where they were located after even one growing season. This is evident in the photo-monitoring which did not pick up structures well in the photo points. Everything just looked wetter and greener across the valley bottom. This is especially important in a National Park where the native landscape is the attraction and the goal.
