**WESTERN PLAYA WETLANDS
CIBOLA AND CATRON COUNTIES, NEW MEXICO
Technical Report**

NEW MEXICO ENVIRONMENT DEPARTMENT

SURFACE WATER QUALITY BUREAU

OCTOBER 2024

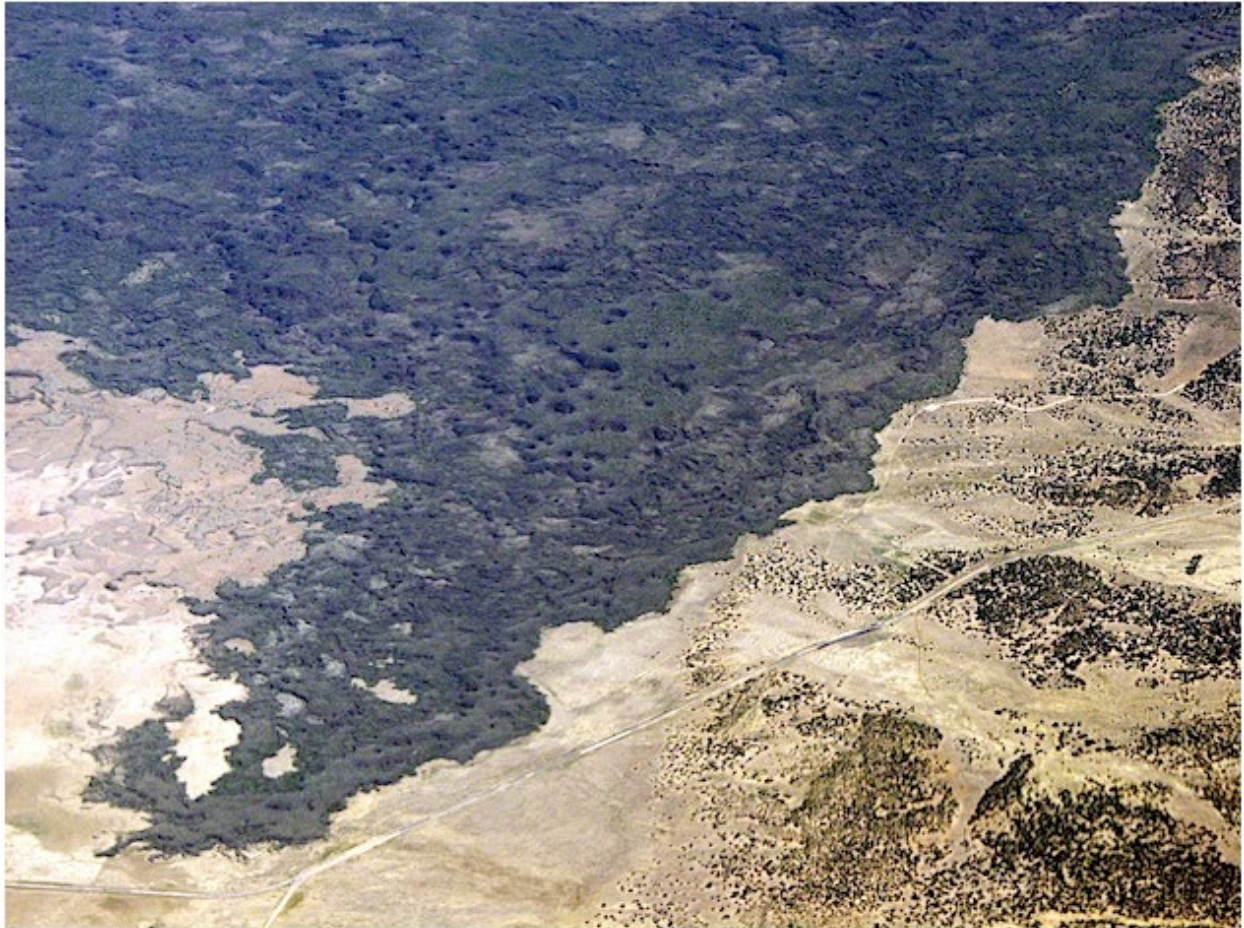
FIGURE 8 MACARTHUR LAVA FLOW, A QUATERNARY BASALT (QB) GEOLOGIC UNIT, ALONG NM 117. PHOTO L. CRUMPLER 2001.

The Zuni-Bandera volcanic field contains some of the youngest basaltic volcanism in New Mexico, including the Bandera Crater flow and McCartys flow, dated at approximately 11,00 and 3,900 years ago, respectively. The El Malpais landscape is predominantly shaped by five young basaltic lava flows: El Calderon, Twin Craters, Hoya de Cibola, Bandera, and McCartys flows (Dunbar et al. 2005). These all fall in the Quaternary Basalt (Qb) geologic unit, which are described as Basaltic to andesitic lava flows from the middle Pleistocene epoch around 126,000 years ago to the most recent flows, with flows south of Grants and west of Carrizozo mainly the more recent (NMBGMR 2003).

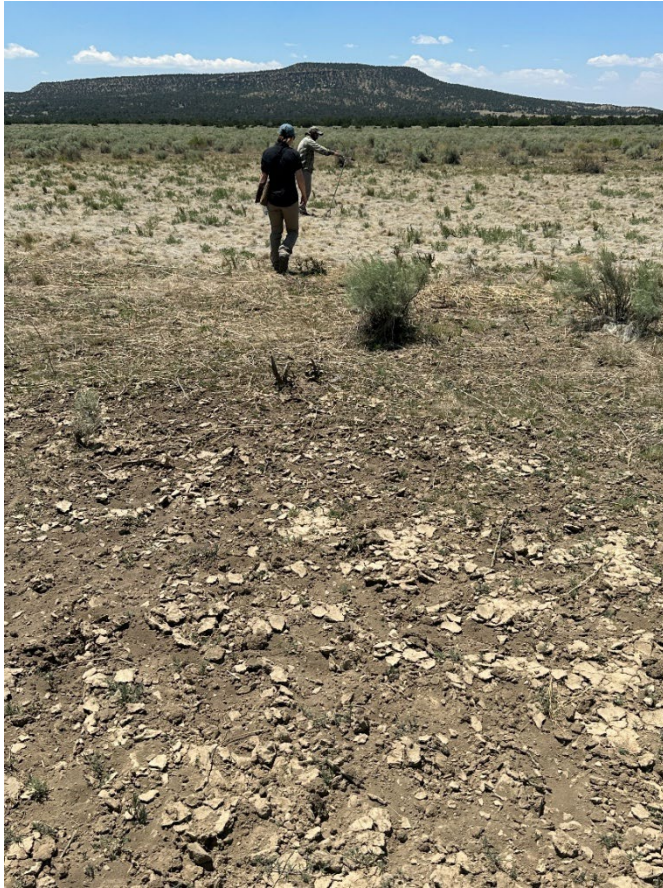
FIGURE 21 PLAYA 795, NEAR BARE CENTER AREA, WITH ANNUAL DOMINATED 2ND VEGETATION RING.

The vegetation was dominated by annual plants, though there was no prevalence or dominance of wetland species. There were three distinct rings of vegetation, with dense mat of annual grama in the center, a more sparsely vegetated 2nd ring, and a near barren 3rd ring.

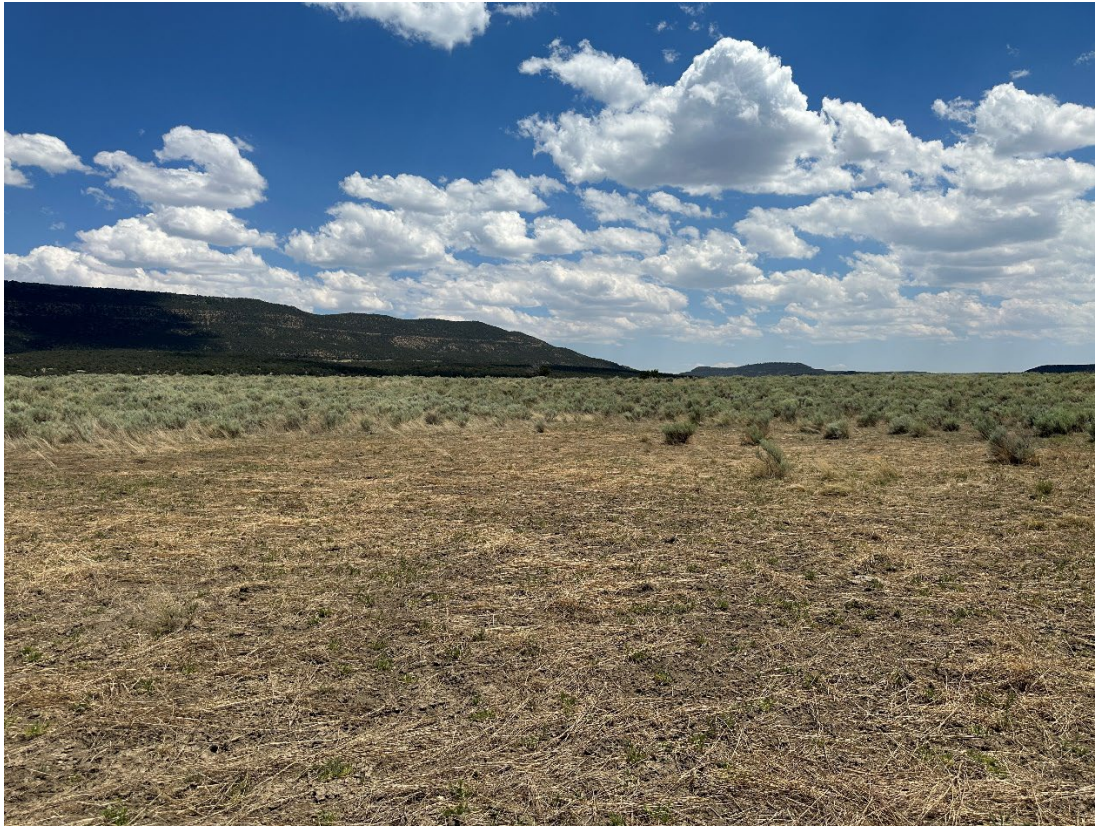
FIGURE 24 PLAYA 794 DOMINATED BY ANNUAL VEGETATION.

This location had some hairy gumweed (FACW) present but did not meet the prevalence or dominance tests for wetland hydric vegetation. There were two distinct vegetation rings in the basin.

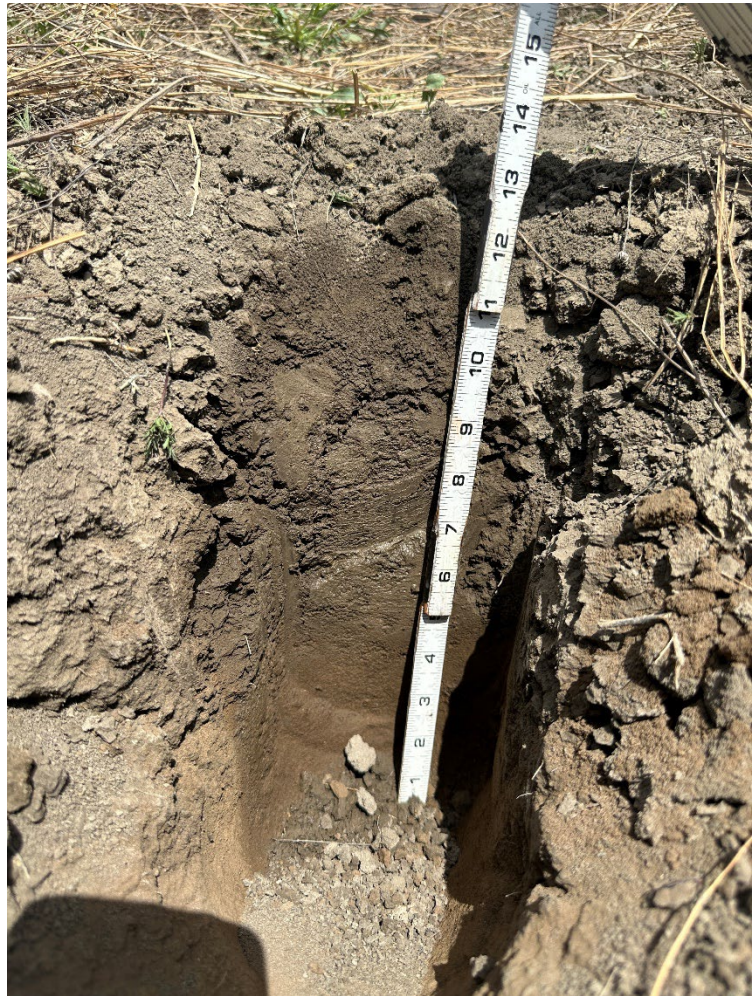
FIGURE 25 SOIL PIT PLAYA 795

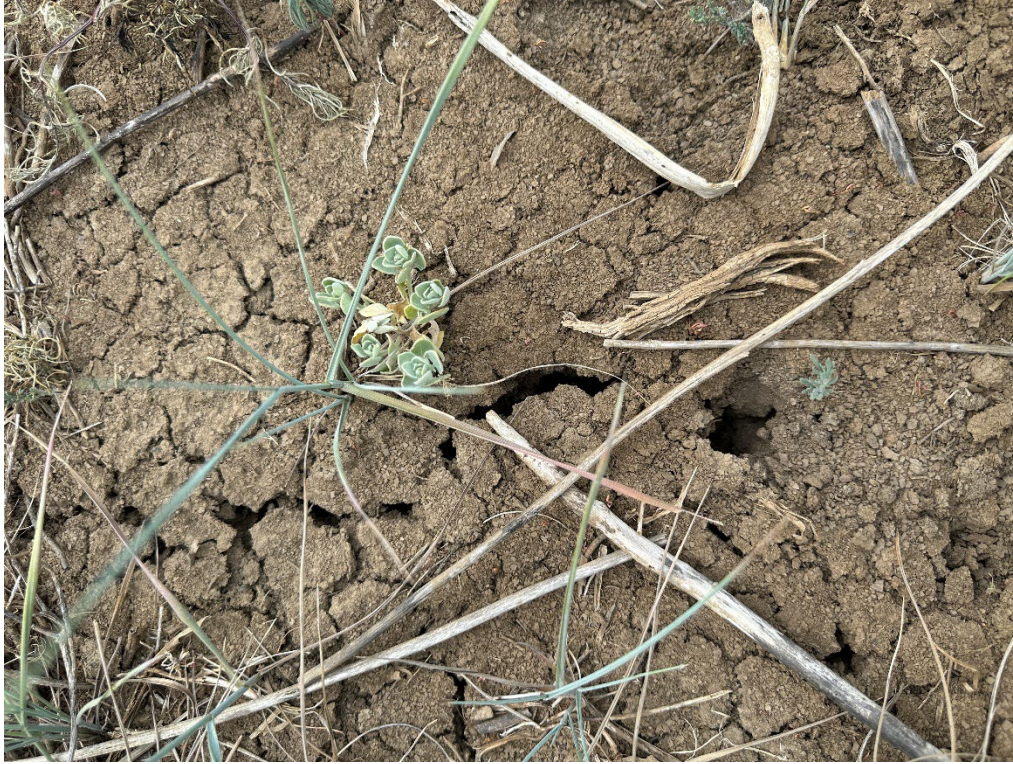
FIGURE 29 DEEP SURFACE CRACKS SHOWING MIXING OF SURFACE SANDS INTO DEEPER DRY CLAY LAYERS IN PLAYA 886.

Playa 886 had the hydrology of surface soil cracks. GSWE data shows that Playa 886 has very low recurrence in April and May, likely, and higher recurrence, <25% during the typical monsoon season through early fall. This is an infrequently flooded playa with evidence of standing surface water in only 7 of the 37 recorded years (see figures 30, 31, 32). The occurrence change data shows a strong increase in the northeast corner of the playa.

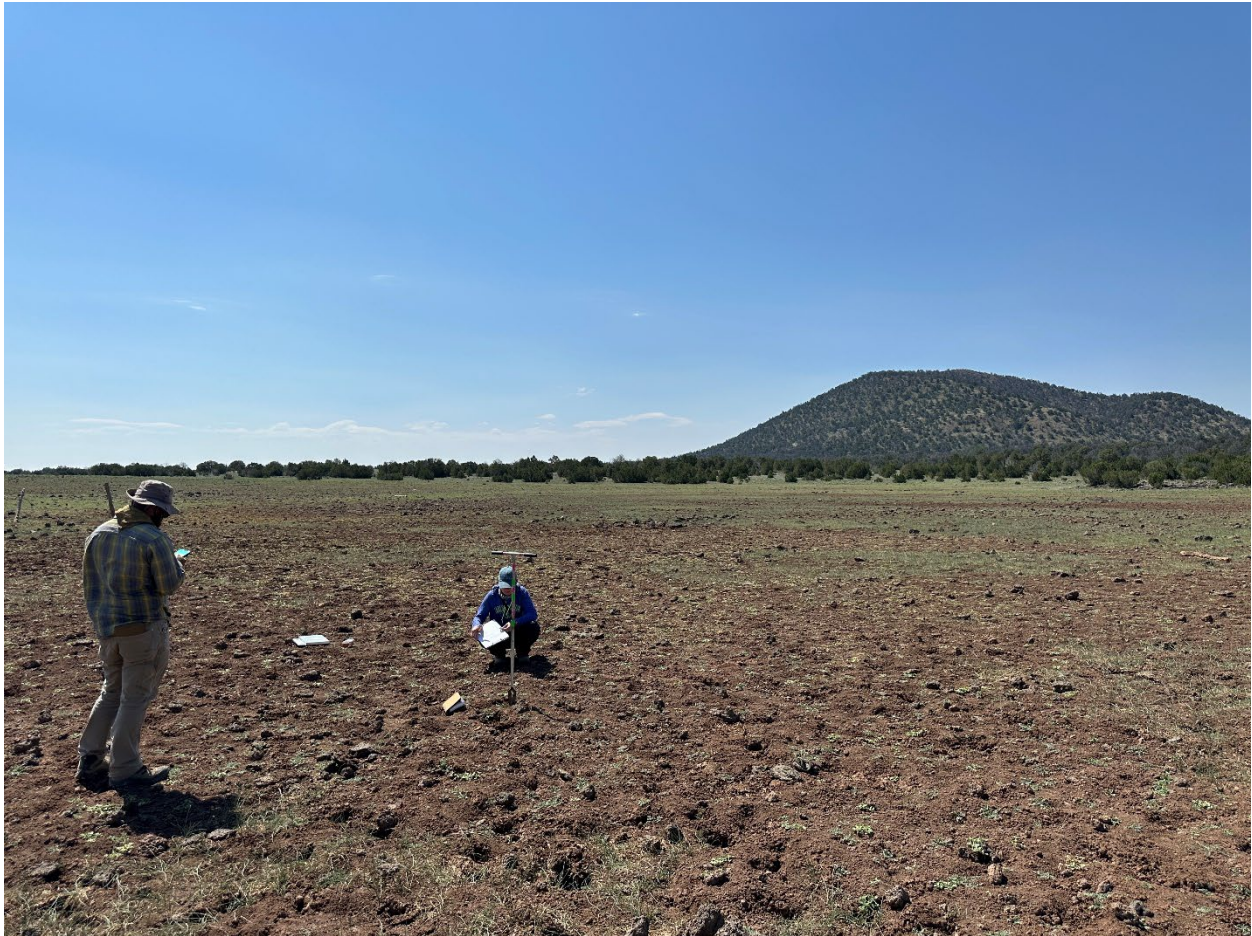
Playa 559 was directly adjacent to Cibola County Rd 42 in the El Malpais National Conservation Area managed by the BLM. This playa was very heavily trampled by cattle, with trails and deep hoof punches throughout the basin. Vegetation was cropped very low with large areas of bare soil. There was cobble sized volcanic rock throughout the basin and surrounding area.

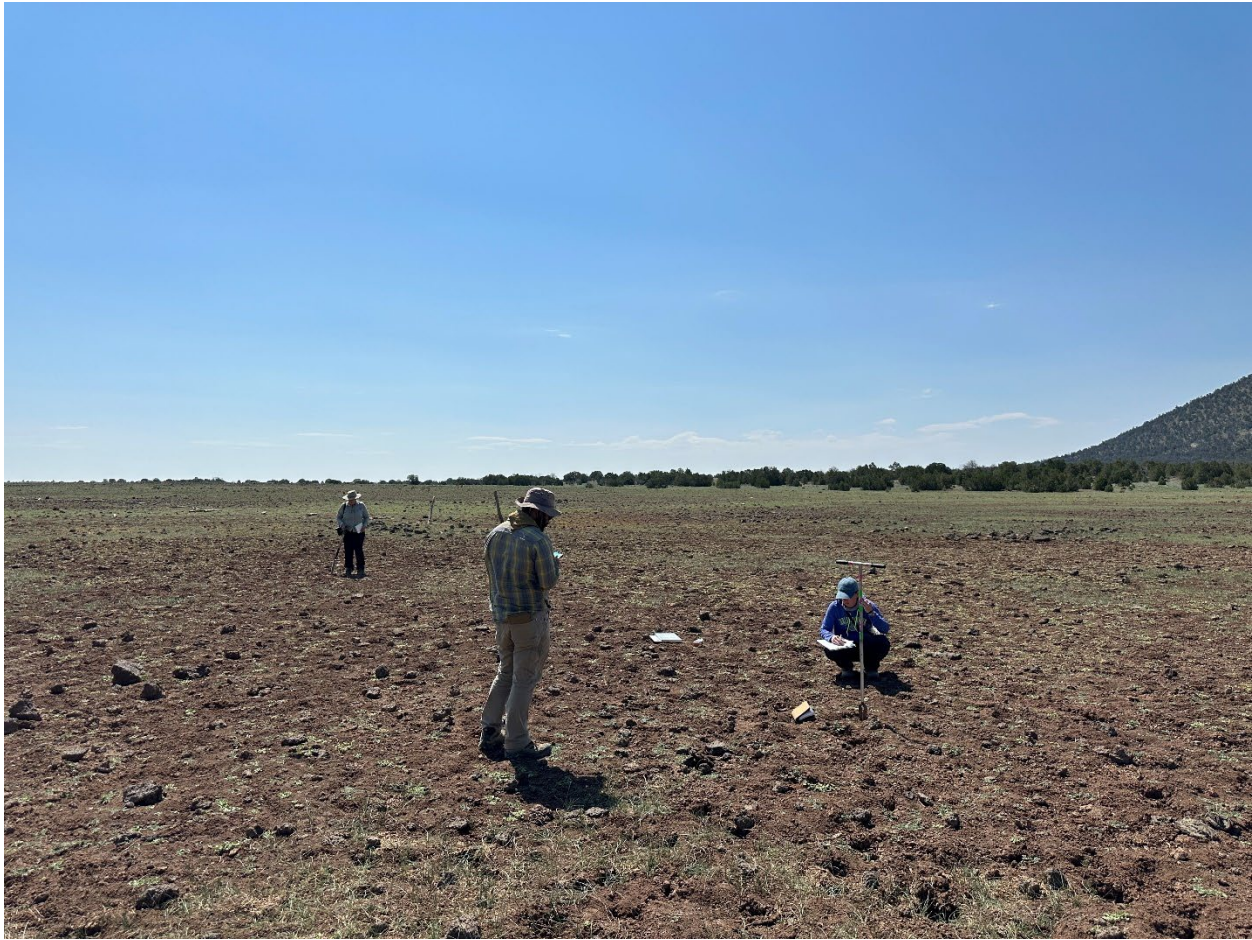
FIGURE 35 LARGELY BARE CENTER WITH LOW HEAVILY GRAZED VEGETATION, MAINLY FROGFRUIT, A PERENNIAL, FACULTATIVE WETLAND (FACW) PLANT. THERE WAS VERY LITTLE DIVERSITY, AND ALL VEGETATION WAS CROPPED TO AROUND 5CM.

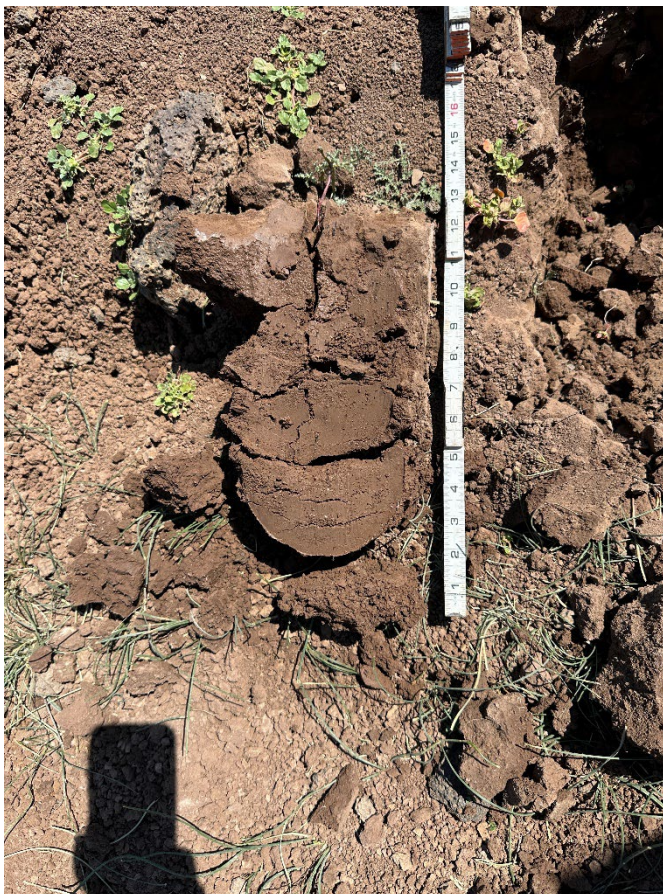
Layer 1	
1 depth (in.)	12
1 matrix color	10yr 3/2
1 matrix percent	100
1 redox color	na
1 redox percent	na
1 redox type	na
1 redox loc	na
1 texture	clay

FIGURE 36 DENSE CLAY SOILS AT PLAYA 559.

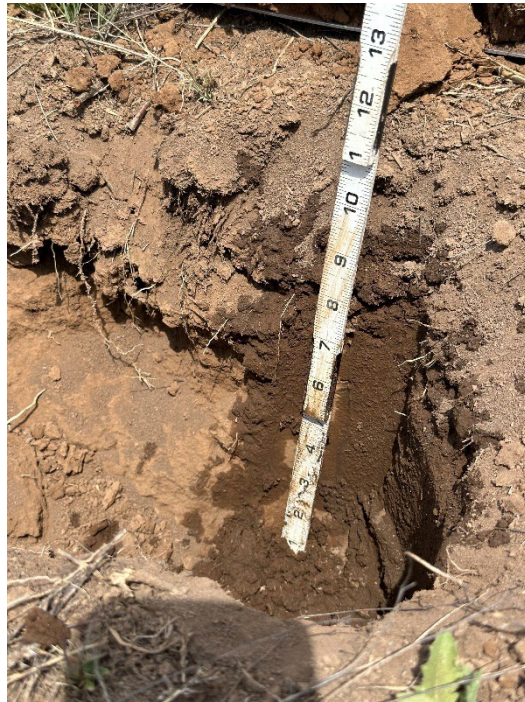
Layer 1	
1 depth (in.)	12
1 matrix color	7.5yr 4/3
1 matrix percent	100
1 redox color	na
1 redox percent	na
1 redox type	na
1 redox loc	na
1 texture	clay

FIGURE 39 PLAYA 560 SOILS, NO CLAYS IN PIT DUG IN CENTER OF LARGER BASIN.

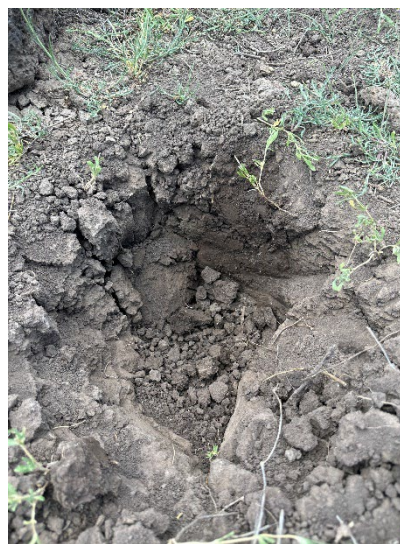
FIGURE 46 CRACKED CLAYS SOILS IN PLAYA 1004

This small basin was approximately 30 meters from County Rd 42 on a small rise. The basin was covered in cobble-to-basketball sized volcanic rock. The soils were dense clay with deep cracks.

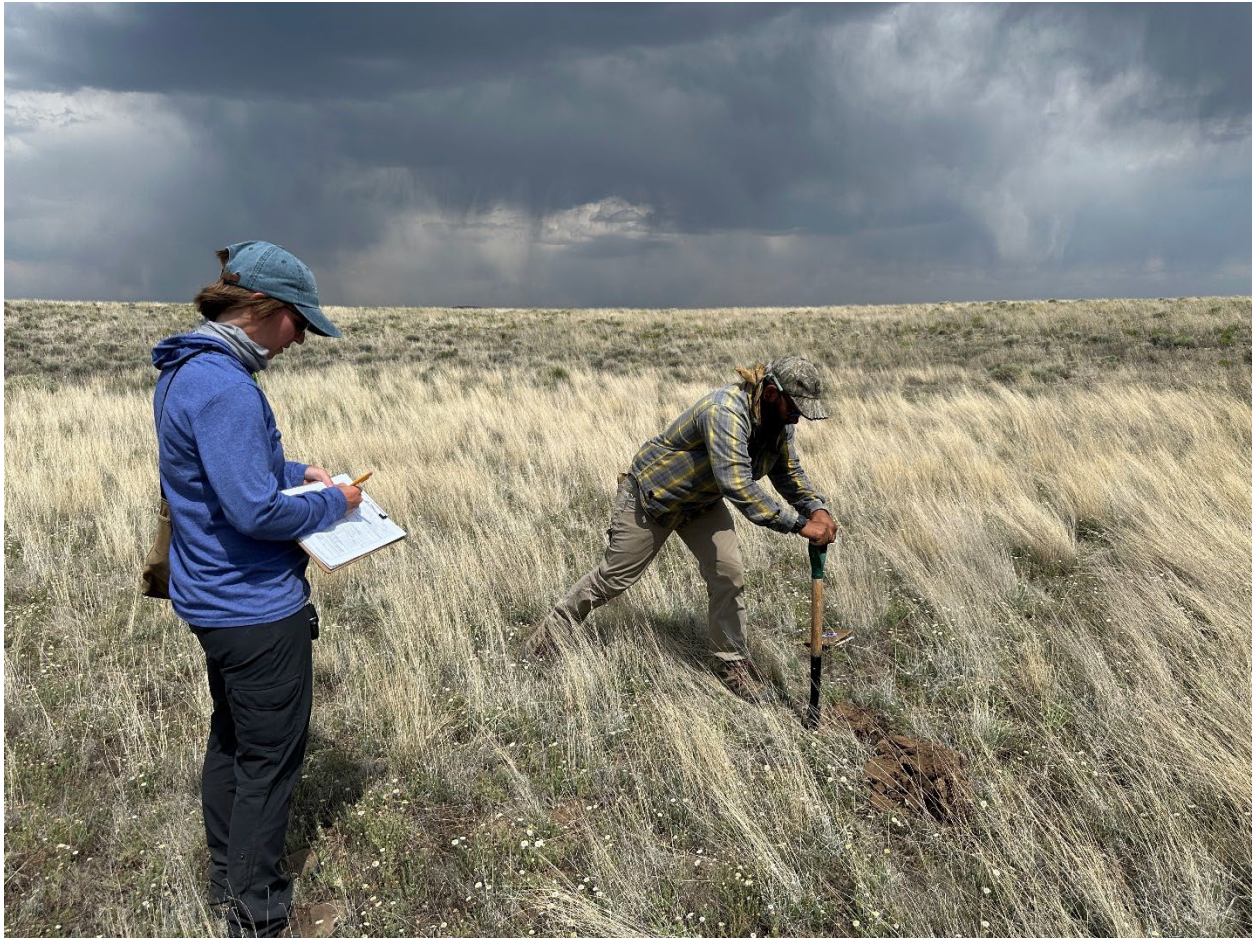
FIGURE 49 DEPRESSION 543, NOTE THAT THIS SITE WAS NOT A WETLAND.

This was one of a number of shallow depressions on the hills west of CR 42 near Playa 549. There were no wetland indicators found at this location, though it was mapped as a playa.

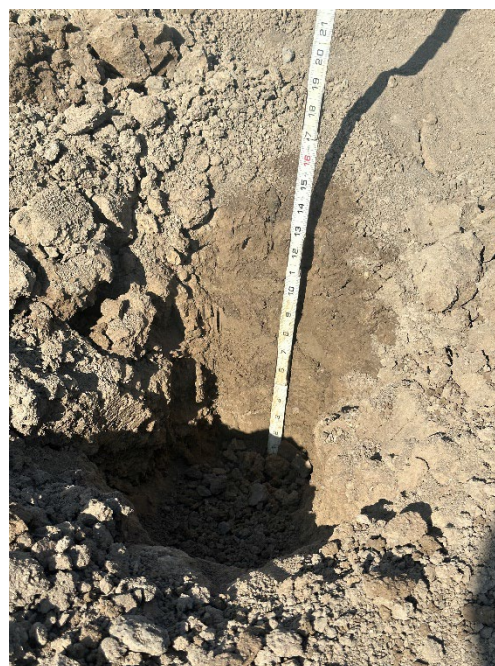
FIGURE 54 CLAY SOILS WITH DEEP CRACKS, PLAYA 950.

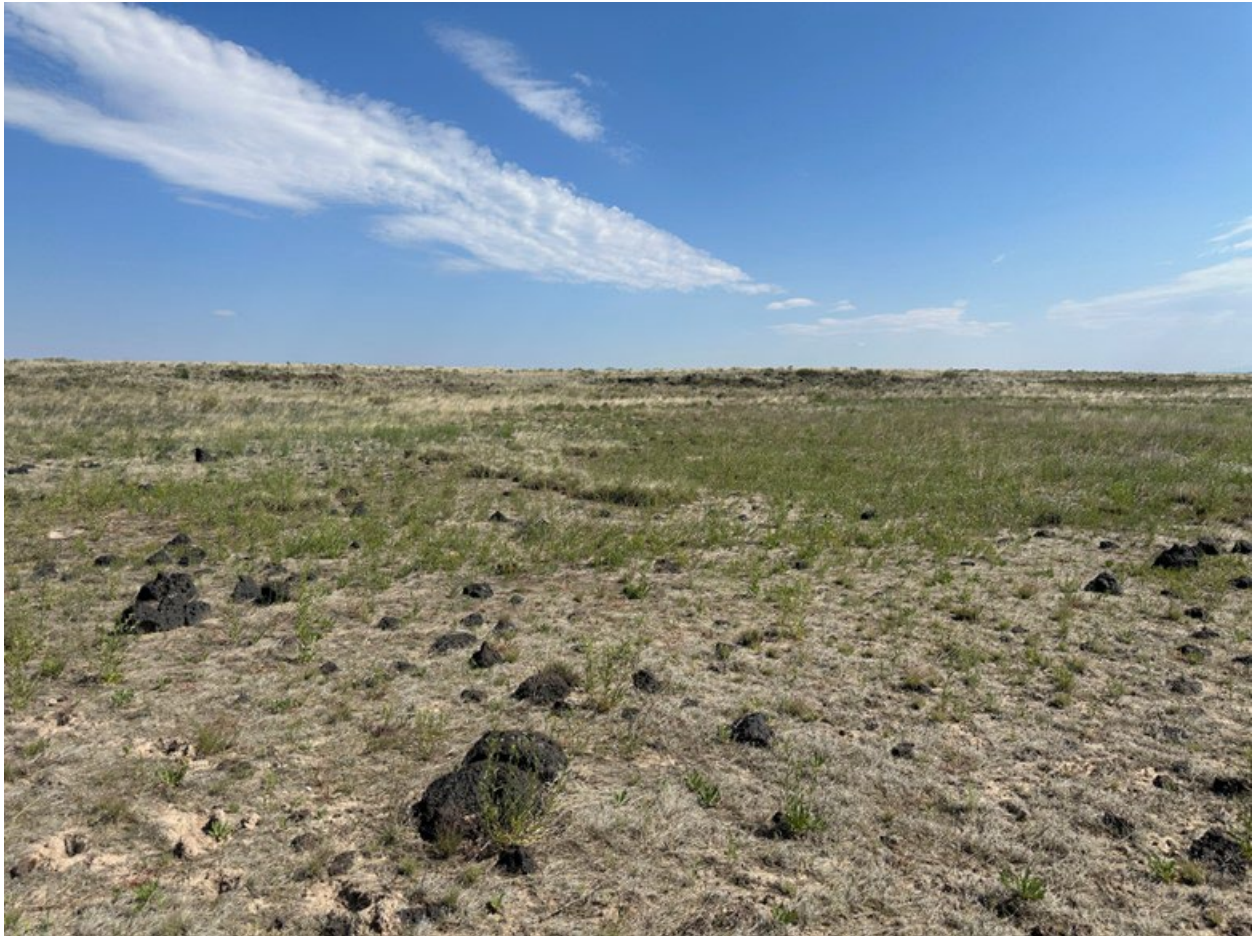
This site was near the west end of an oblong depression near NM 117 just west of Playa 950. It had two inlets that were allowing drainage and sedimentation into the basin. There were cobble-sized volcanic rocks throughout the basin and surrounding area. There were no hydric indicators present. This depression is not a wetland.

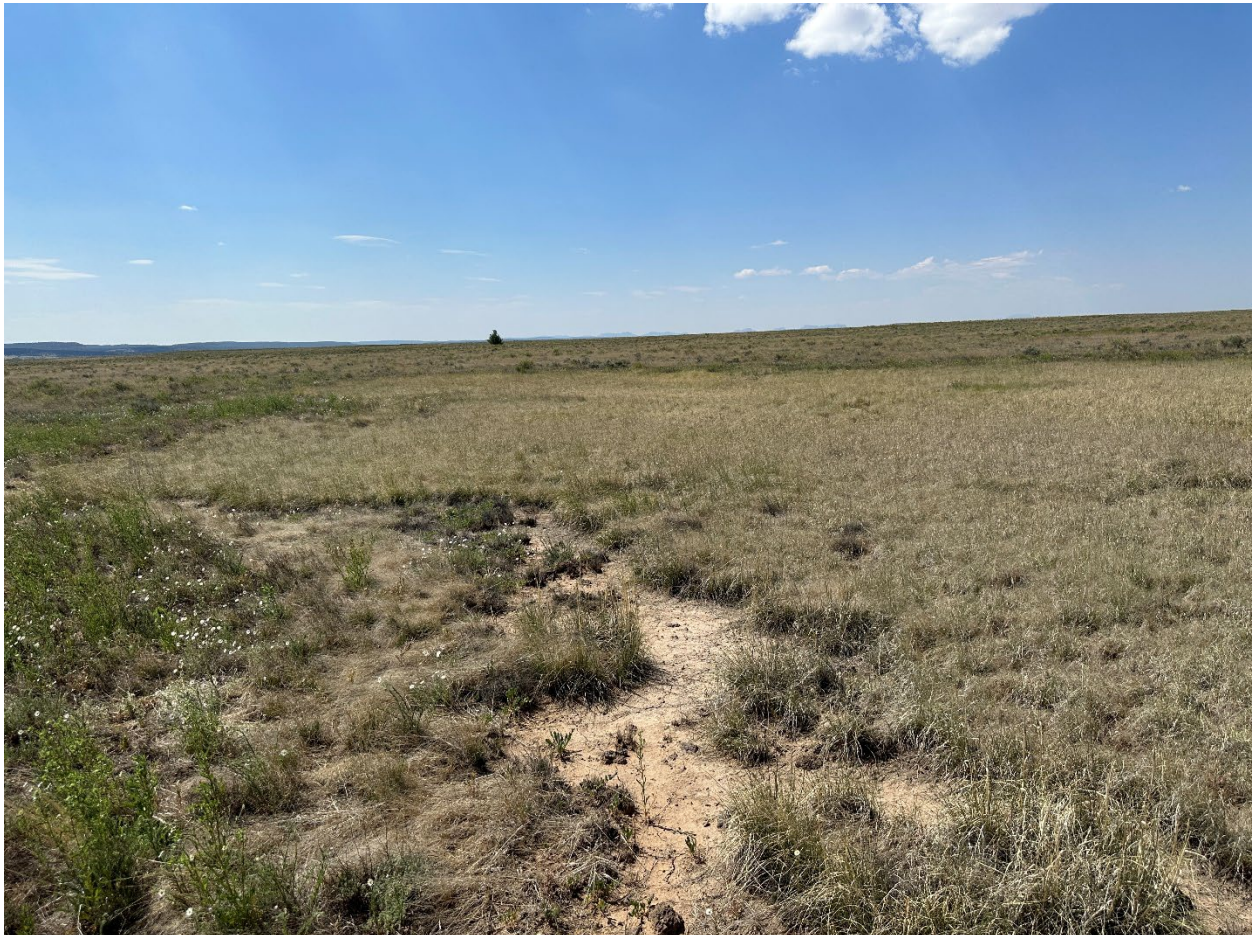
This depression is just west of depression 525 at the far west end of the same oblong basin. It was dominated by an unknown clump grass, with a ring of bare soil surrounding it. There was a shallow drainage bringing water and sedimentation to the depression. There were cobble-to-

basketball sized volcanic rocks in the basin. There were no hydric indicators present. This depression is not a wetland.

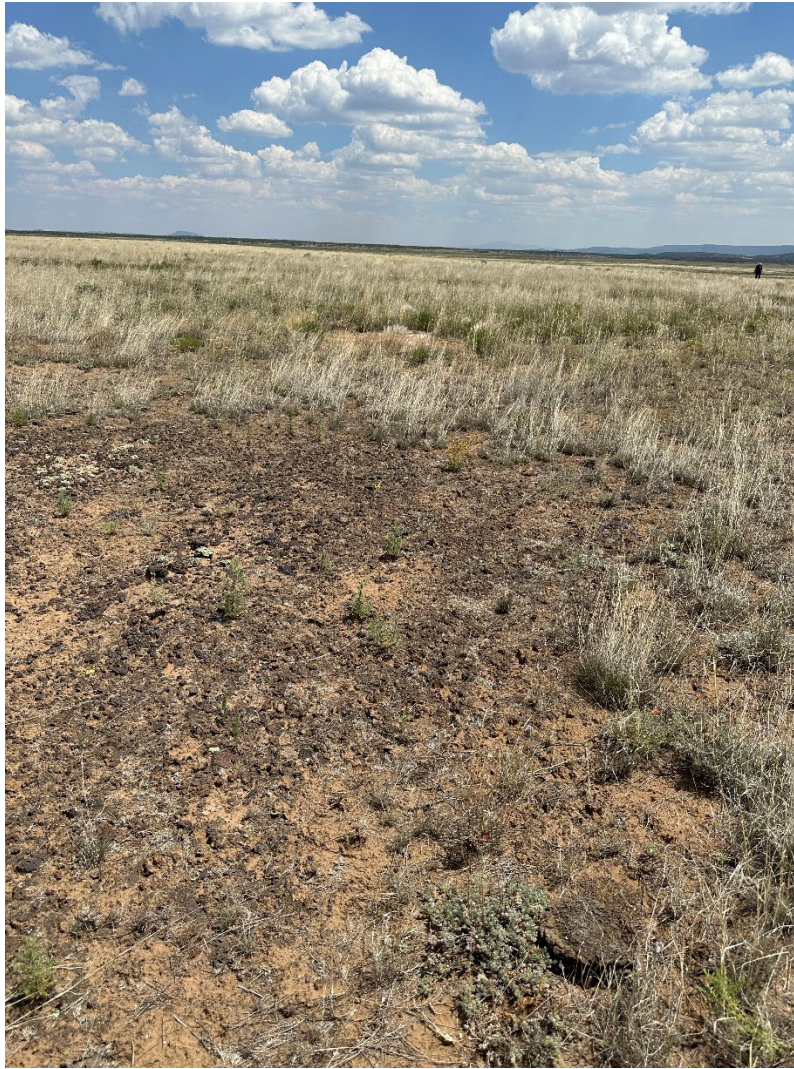
This depression was on a small hill west of the previous location. The center contained bare soil, that may have been covered in cryptobiotic soil. Volcanic gravel and cobble were present. There were no hydric indicators present. Like the previous sites this is not a wetland.

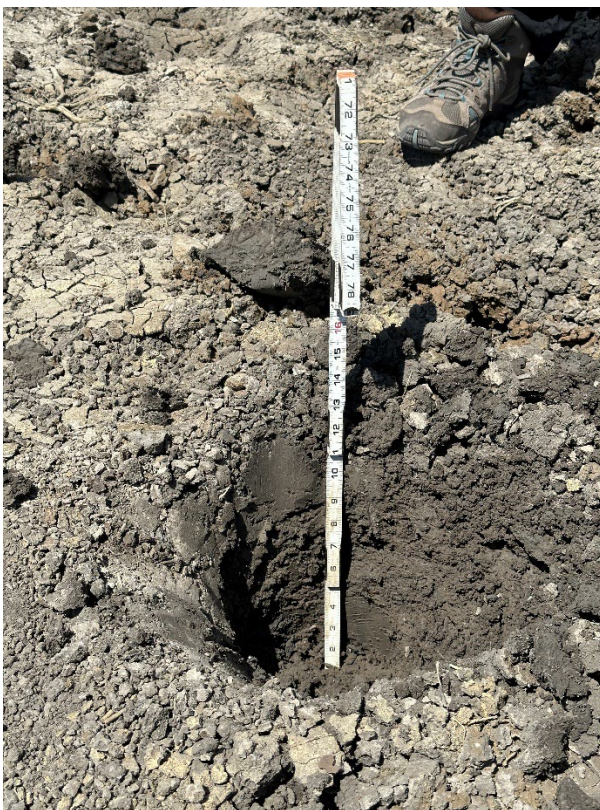
The soil sample was taken from the shore and was a heavy wet clay, that met the depleted matrix wetland soil indicator.

FIGURE 66 PLAYA 356 SOILS WITH DEPLETED MATRIX.

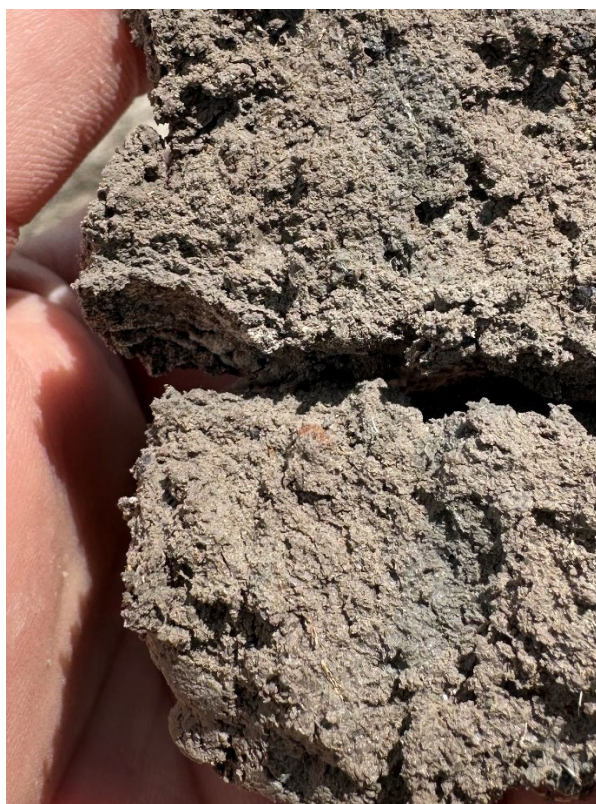
FIGURE 67 PLAYA 356 SOILS WITH REDOX FEATURES.

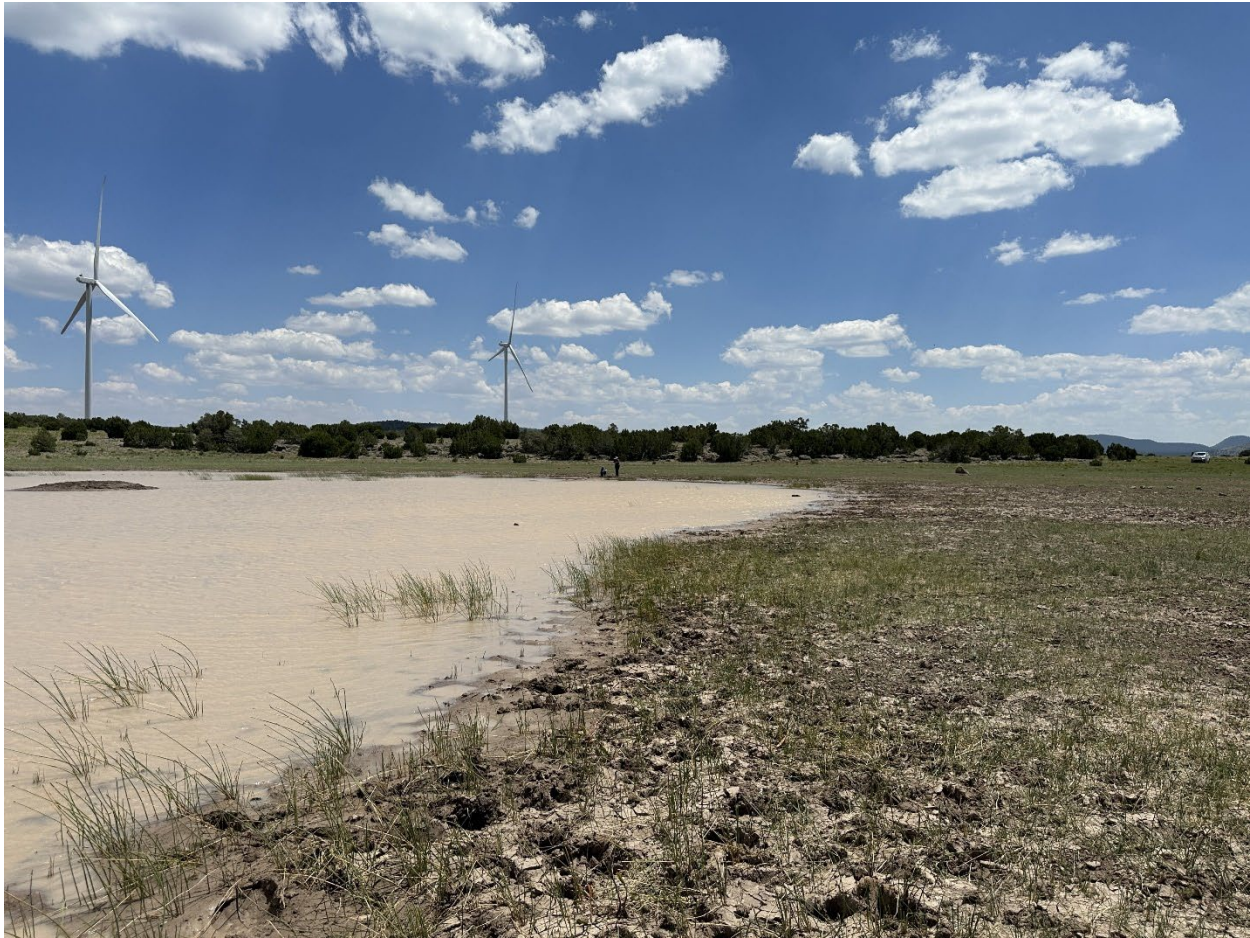
Playa 357 is noted as Jones Lake on the map and is on the edge of a large wind farm and has clearly been excavated to some extent. There were a few small volcanic rocks present. The playa basin was approximately 50% covered in standing water with very gradual sloping shores that were largely bare. The vegetation was very heavily grazed. Deep hoof punching was present throughout the area with several cattle trails throughout. The surrounding land use map (NAIP 2018) does not show the adjacent wind farm. A very shallow drainage is forming that drains into the southern end of the basin.

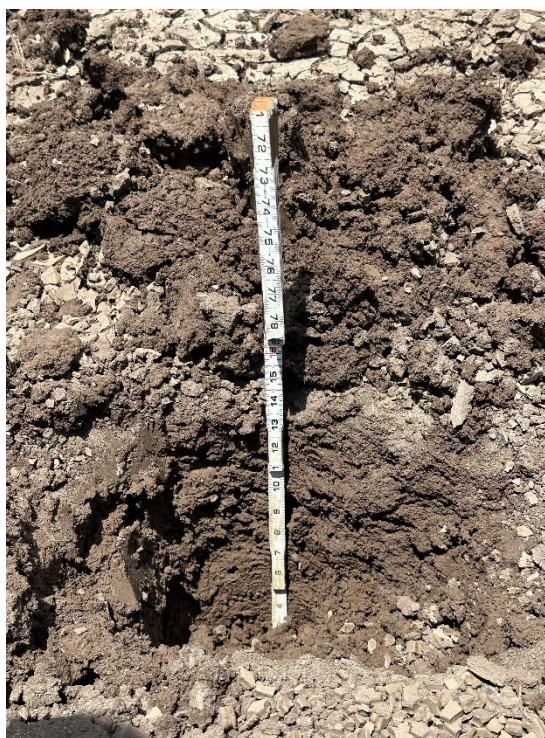
FIGURE 73 PLAYA 357 SOIL PIT FROM SOUTHERN SHORE.

A soil pit was dug on the southern shore of the playa and hydric soil was not found at that location. Hydric indicators may be found closer to the low water line.

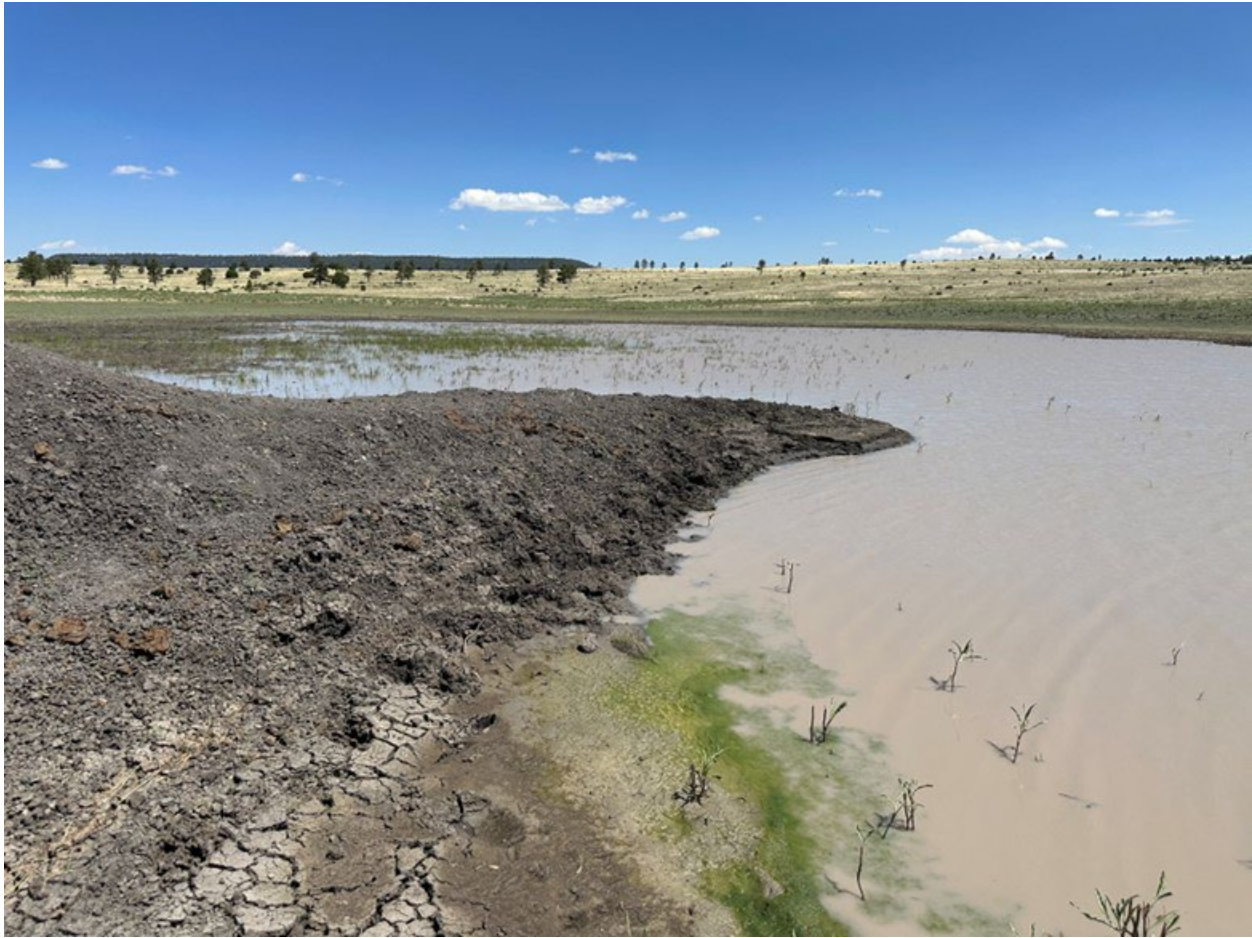
Playa 336 (Gabaldon Lake) is located in the northwest corner of the Gila National Forest. From the imagery, the excavated pit is approximately 10% of the original basin, showing extensive modification to the hydrology. The area is heavily used by cattle with deeply hoof punched soil and heavily cropped vegetation. There are defunct fences in the playa basin, numerous cattle trails, and an old road through the center of the playa. Overall, this is an extensively damaged site.

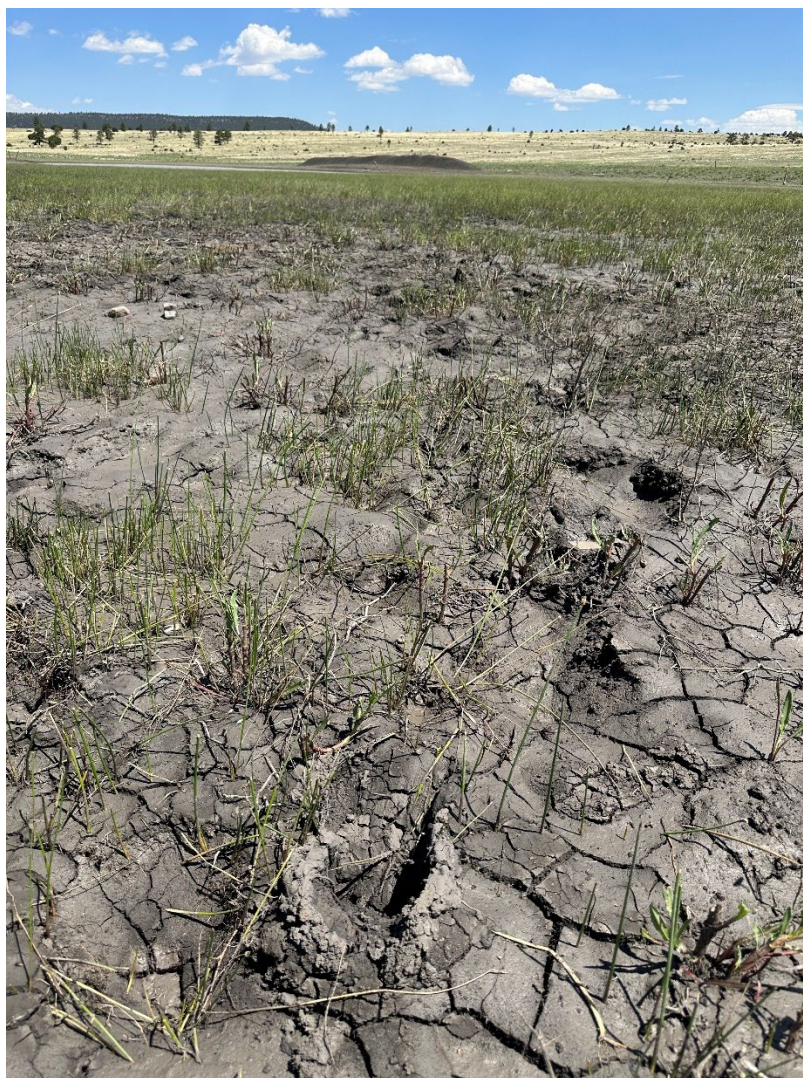
FIGURE 79 WESTERN WHEATGRASS AND DEEP HOOF PUNCHES IN THE OUTER EDGES OF THE BASIN PLAYA 336.

The site had three distinct vegetation zones with spikerush (FACW) dominating the center and 2nd ring. Western wheatgrass (FAC) covered around 40% of the outer and largest vegetation zone.

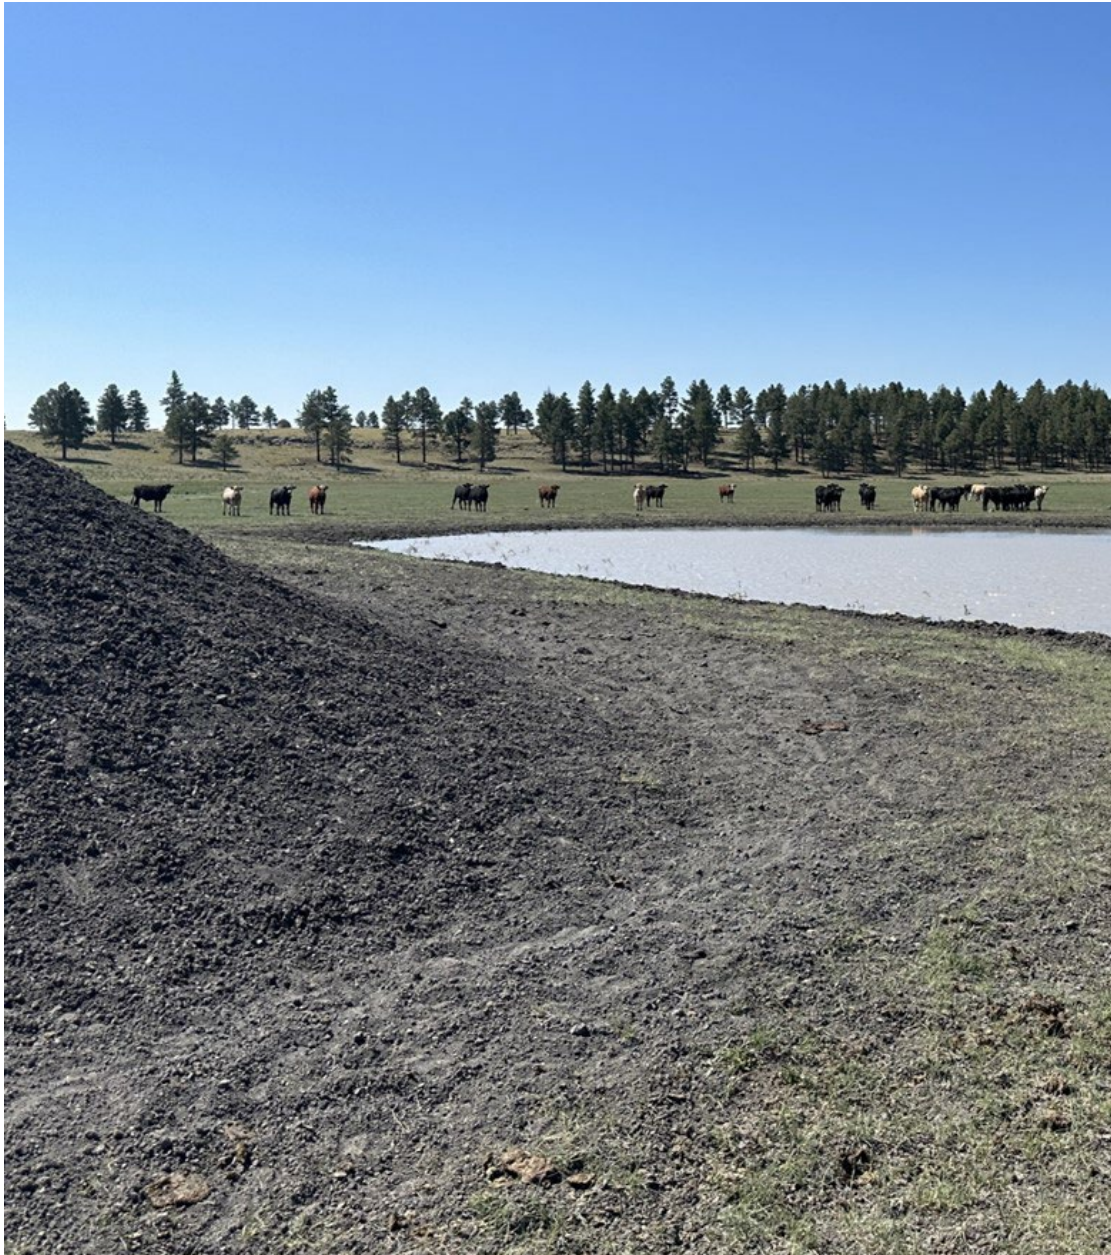
Pine Lake (Playa 353) is on Baca Mesa in the Gila National Forest just west of Gabaldon Lake. It is excavated on the northern end with spoils piles on either side of the pit, with the pit taking up less than 10% of the historic playa basin. This playa appears to be drier overall than Gabaldon. Cattle were present during the site visit, with extensive trampling, numerous trails, and heavily cropped vegetation.

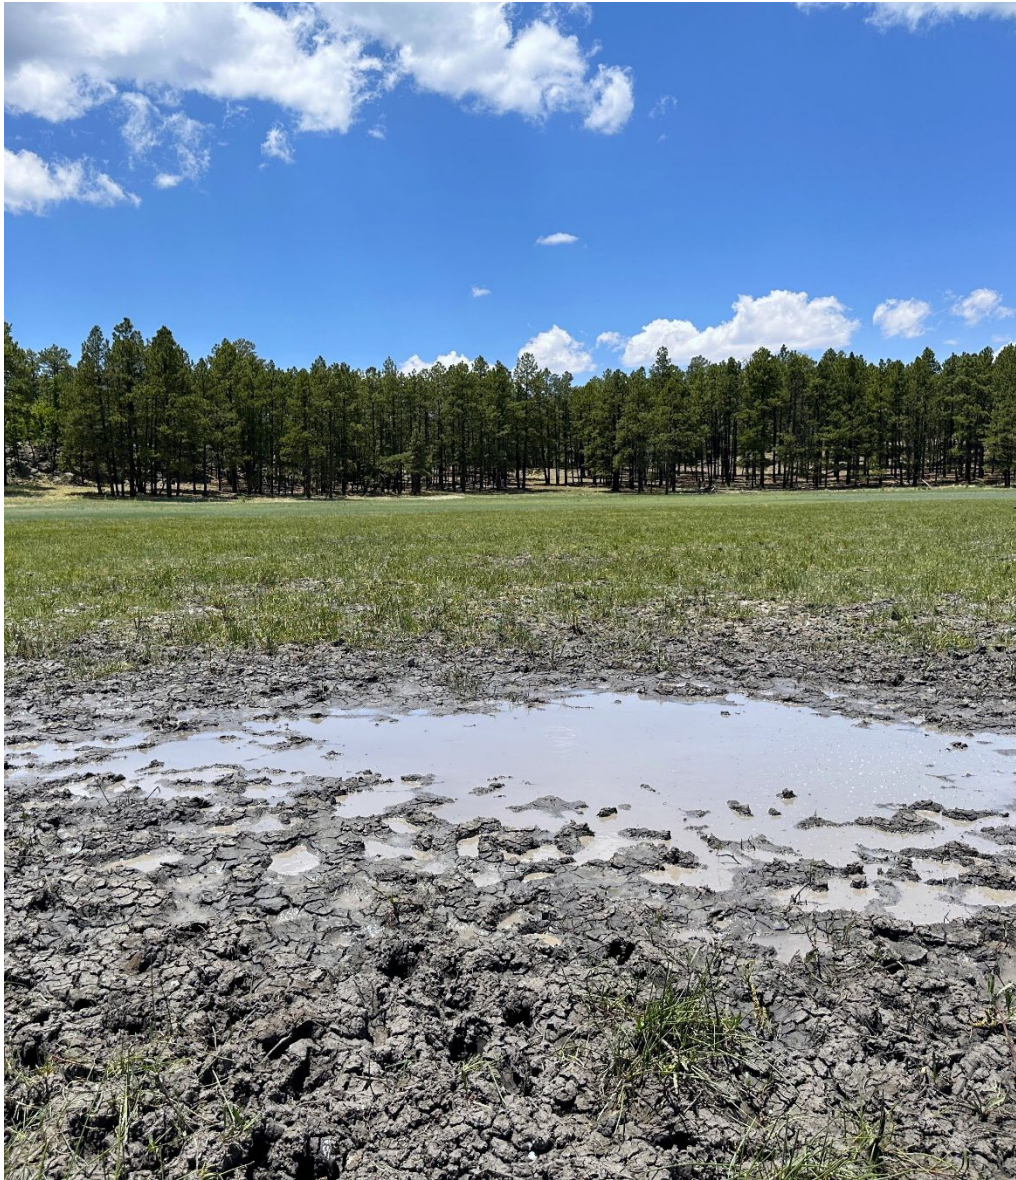
Playa 169 technically falls outside of the project area. It lies 200 meters into HUC – 8 1504004. It is just off FS Rd 93 near Playa 330. It is on a small hill west of the road surrounded by an evergreen forest. This was the only non-excavated playa on our site visit in Catron County. It did however have deep hoof punching and cropped vegetation, with numerous cattle trails.

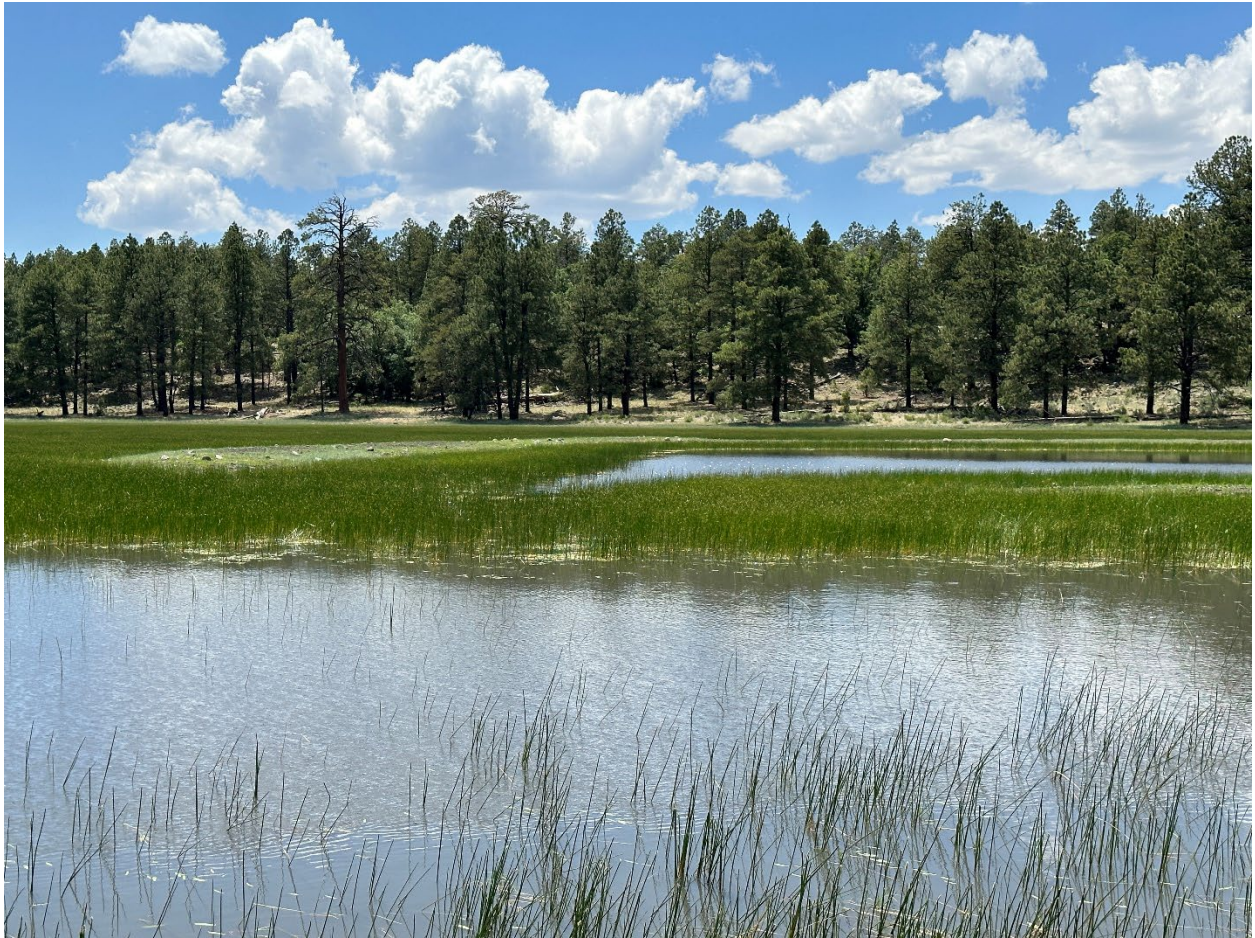
Playa 330 is a rounded triangular shaped basin off of FS Rd 132 in the Gila National Forest. The basin has two large ponds dug in it, with a berm in between. There was no evidence of cattle usage at this site.
