**WESTERN PLAYA WETLANDS
CIBOLA AND CATRON COUNTIES, NEW MEXICO
Technical Report**

NEW MEXICO ENVIRONMENT DEPARTMENT

SURFACE WATER QUALITY BUREAU

OCTOBER 2024

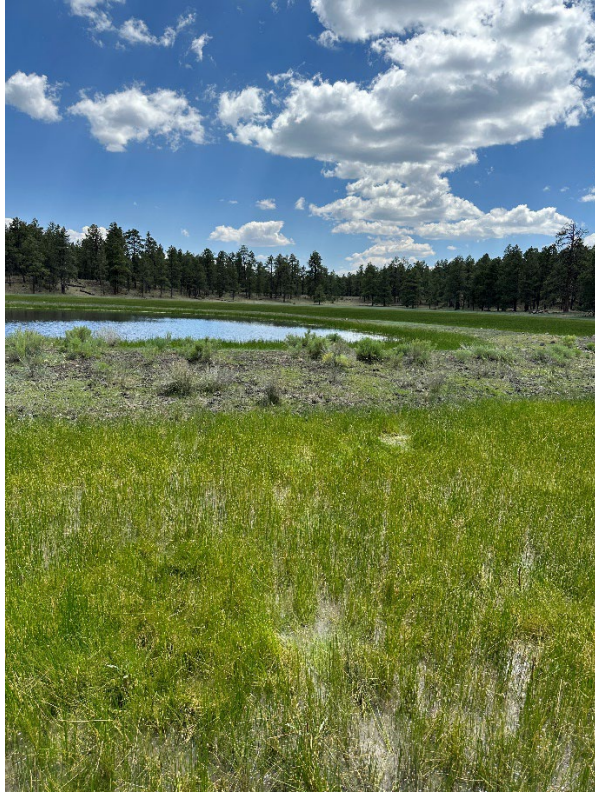
FIGURE 97 FRACTURED VEGETATION ZONES IN PLAYA 330 DUE TO PITS AND BERMS. VEGETATION ON BERMS WERE NOT NOTED.
