**Cebolla Canyon Closed Basin Watershed
Cibola County, New Mexico
Wetland Action Plan
October 2014**

**Prepared by:
Rio Puerco Alliance
3250 La Paz Lane
Santa Fe, NM 87507**

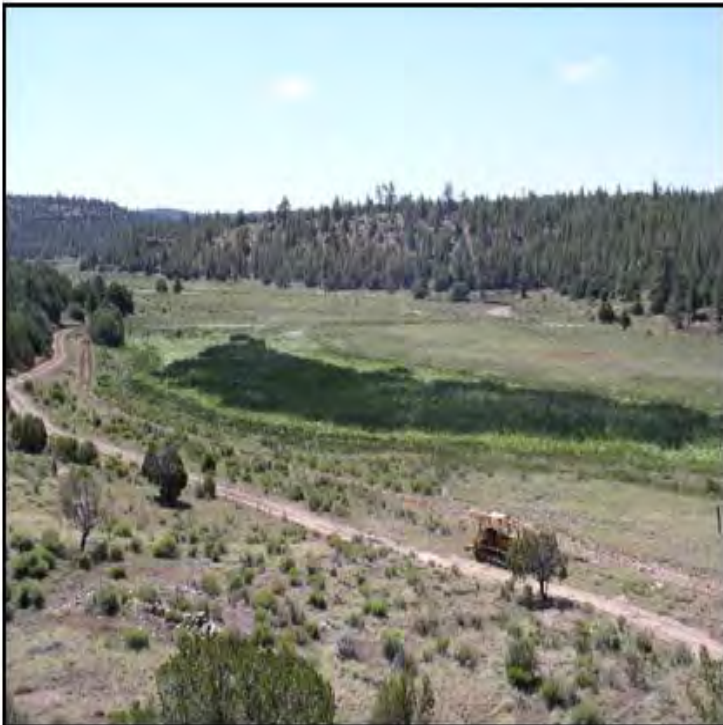
Wetland area at Cebolla Spring in 2008, restored by AWF. (See pages; photo courtesy of Gene Tatum.)

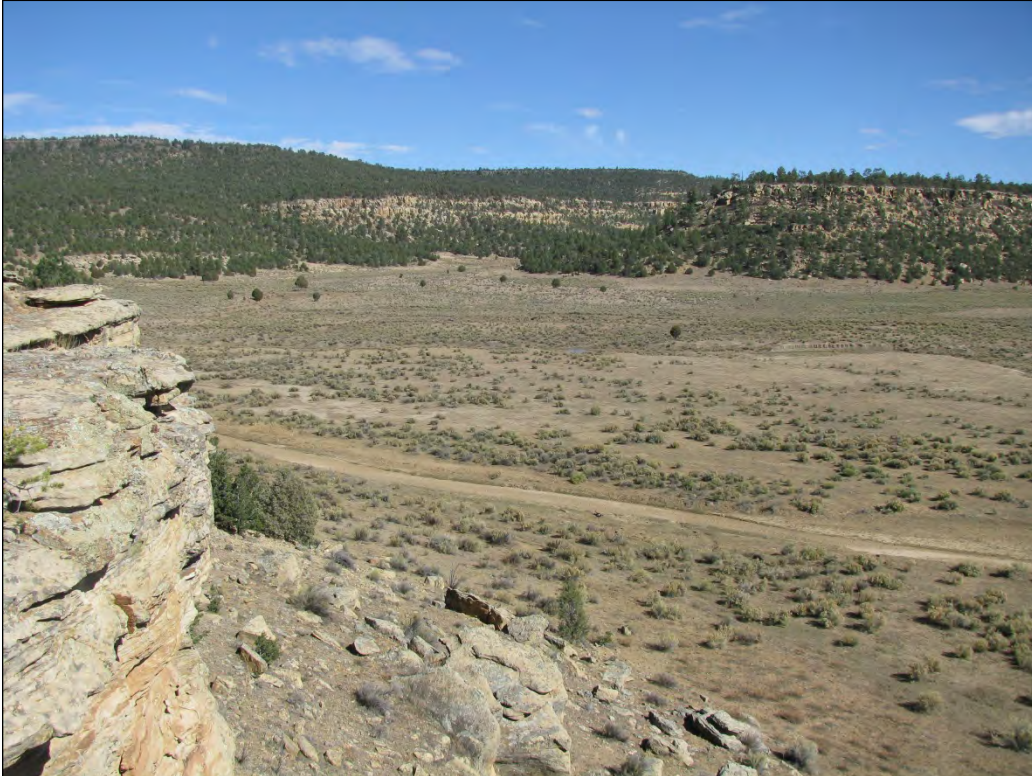
Reach 0 View downstream of Cebolla natural channel in the center with Side Valley Right #2 and 3.

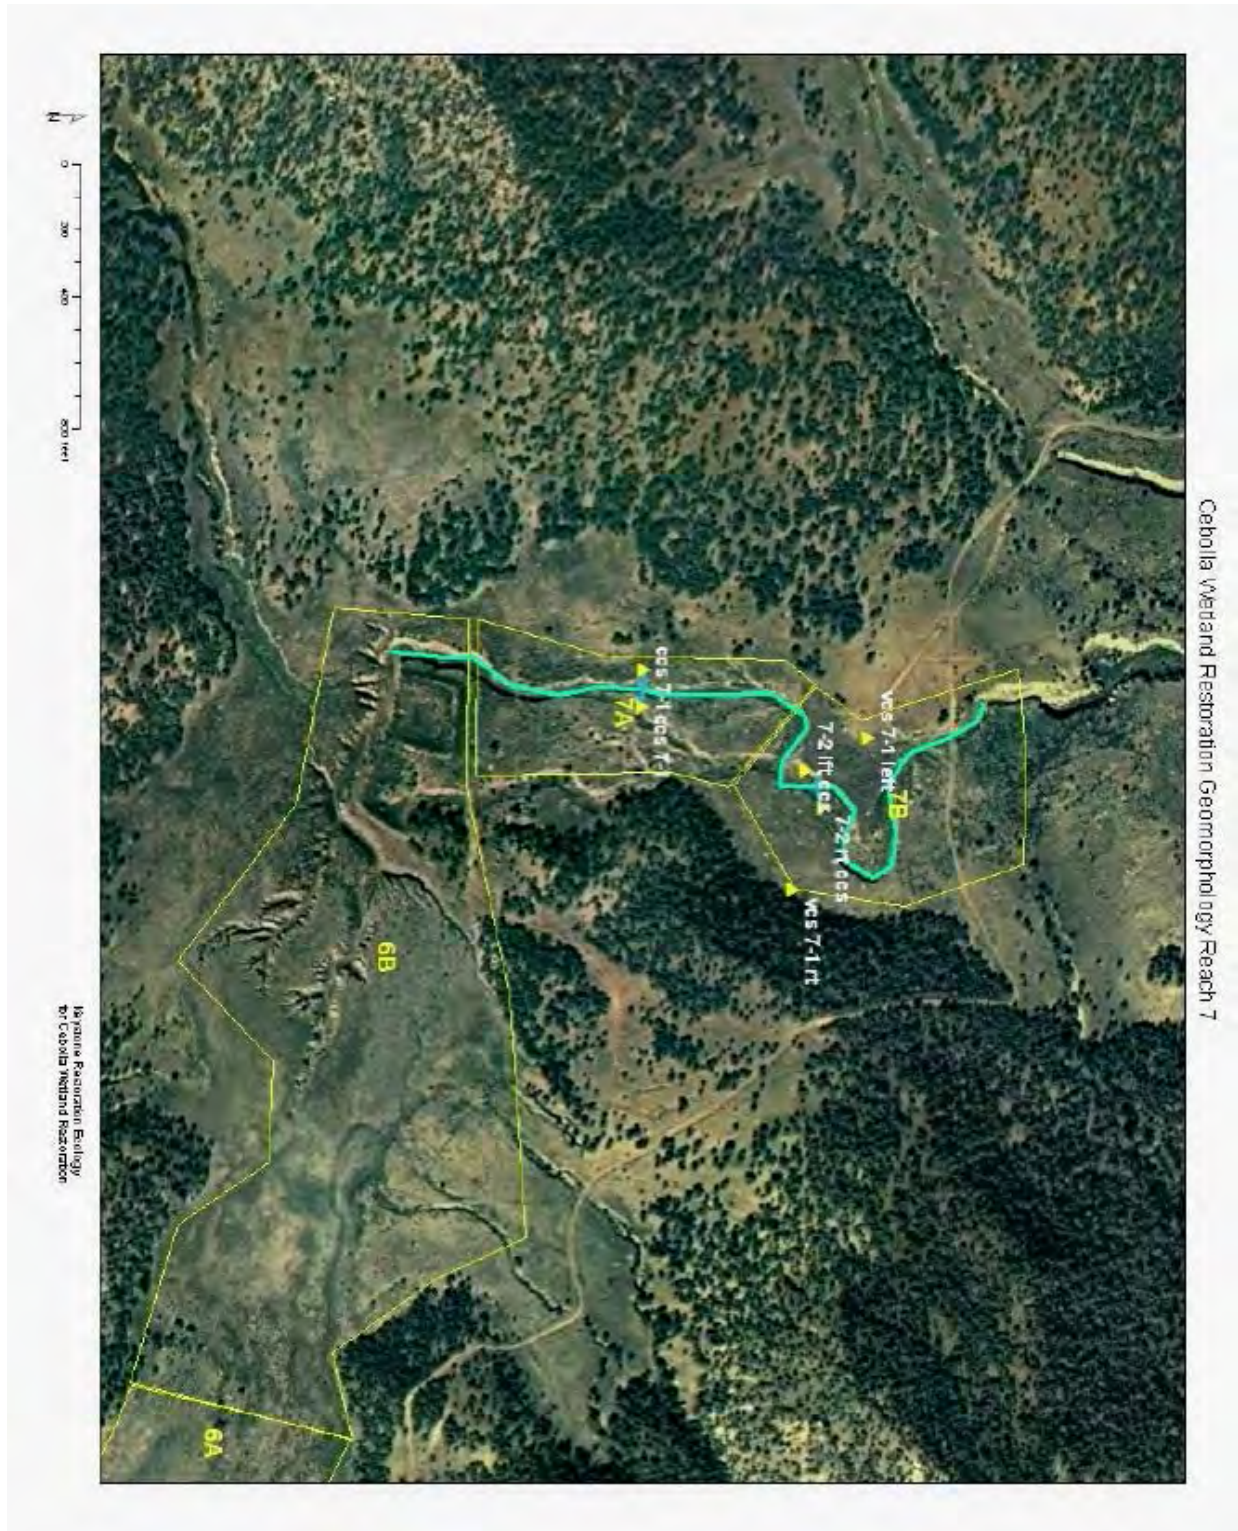
Vrooman identified Reach 7 as an area where flood debris was located and could be a good indicator of levels for a 50-year flood.

Cross section 7-1 data

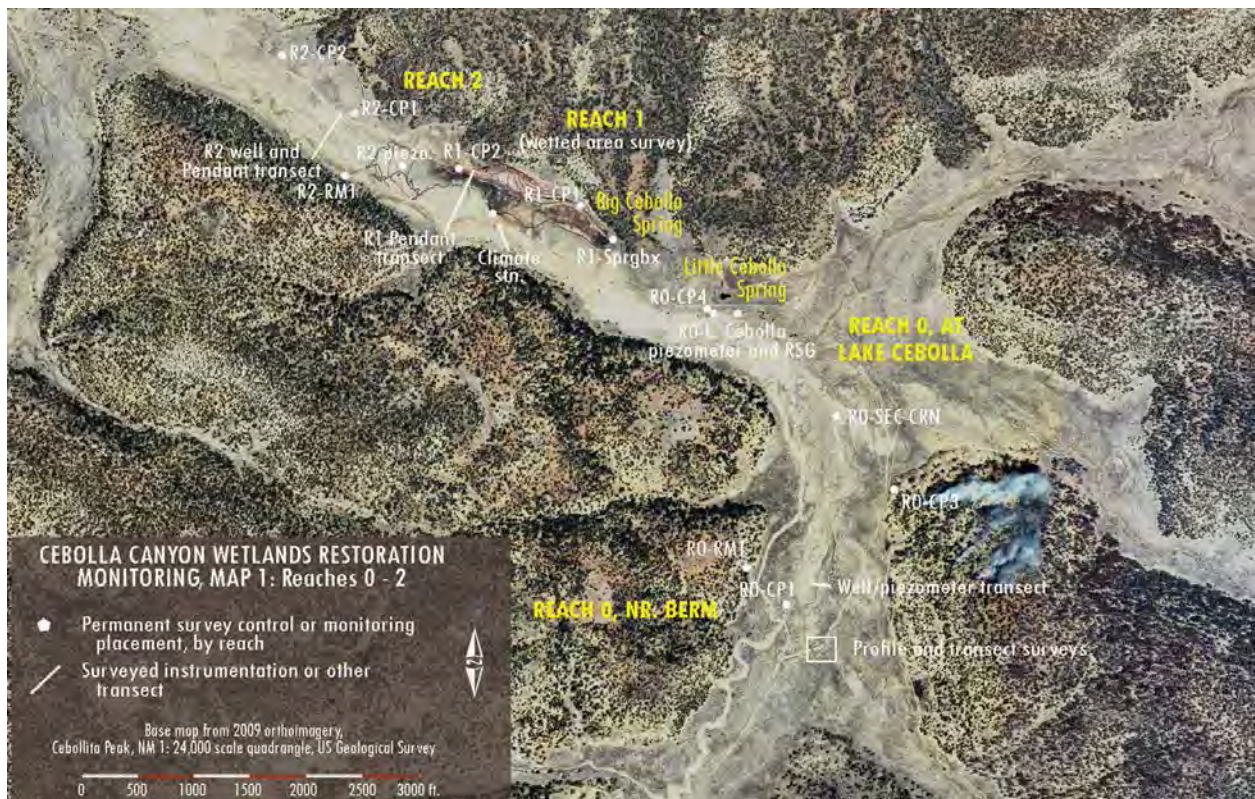
A ground monitoring system was put into place to monitor the wetland restoration effort in Cebolla Canyon, “to determine the effectiveness of restoration work on expanding the remnant wetland zones into larger areas they are believed to have historically occupied” (Soles, 2011). The majority of monitoring devices were put into place in July 2011 and the rest in October of 2011. The monitoring equipment collected ground and surface water levels and temperature at stations in reaches 0, 1 and 2 at strategic locations where restoration efforts were going to take place. The findings showed a slow increasing level of sustained moisture especially in the Cebolla Springs area (see images below). According to Soles, “there has been an overall increase in the wetted area due to land management and restoration practices, and the wetted surface area

is anticipated to increase farther, particularly down-valley, as a consequence of future restoration work” (Soles, 2011). Further data showed an increase of water depth below Cebolla Springs as well. The graph below shows Cebolla Spring’s water depth increasing subsequently giving more moisture to the area below.

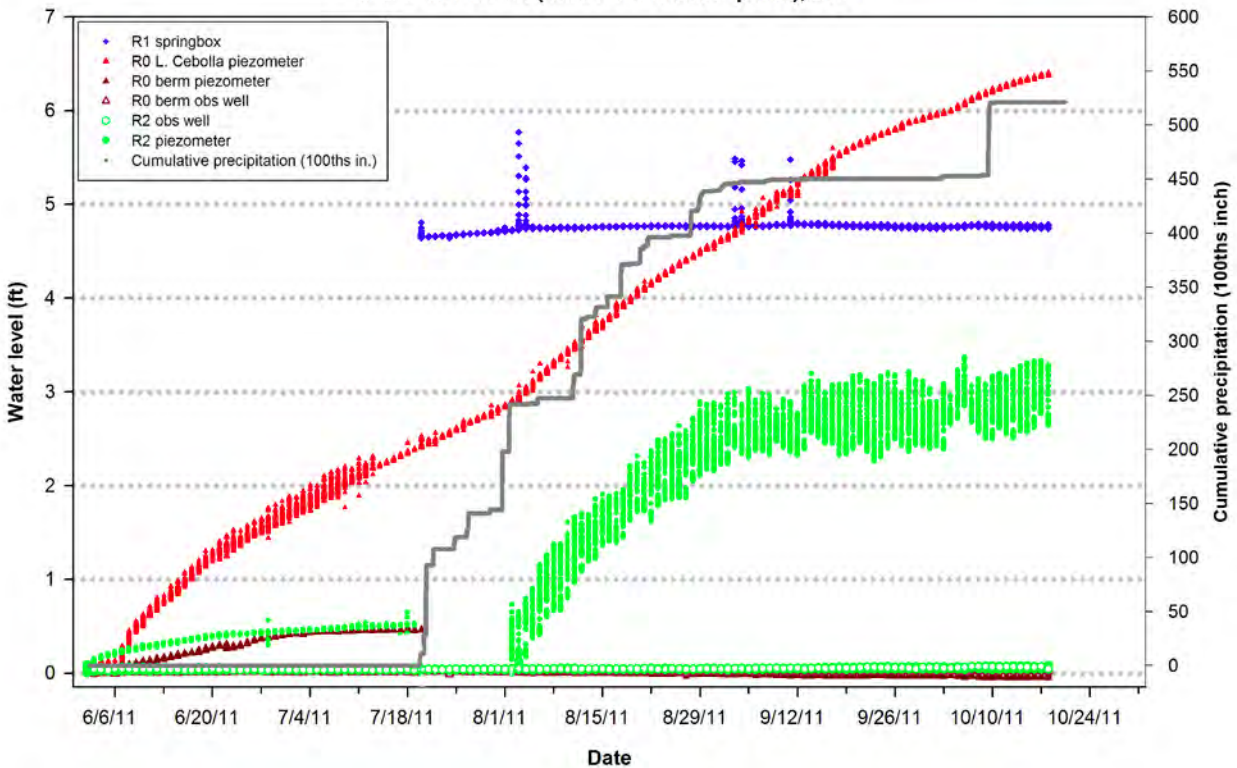
Cebolla wetlands restoration project recorded cumulative precipitation and water levels (above transducer ports), 2011

The gray line indicates moisture received during the study period. The red line indicates Cebolla Spring's moisture levels increase along the gray line. The solid green circle below is the data collection from the monitoring station below the springs. The rest of the monitoring stations seem to increase slowly or show similar levels of moisture.

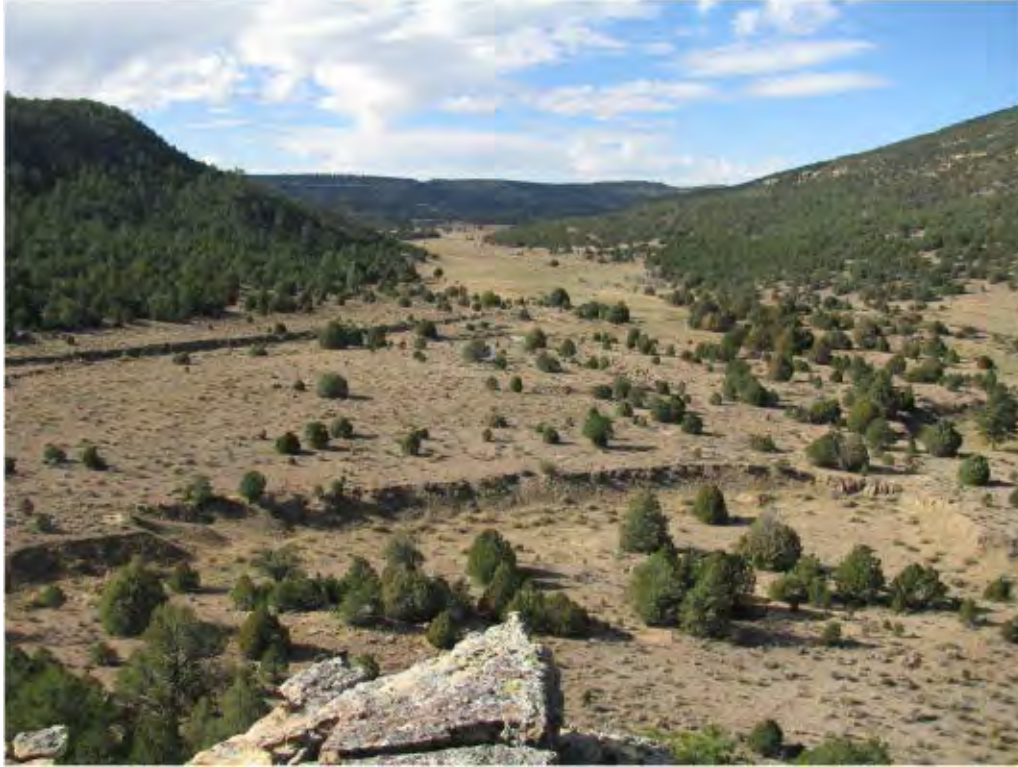
Reach 5.

The best reference area in Cebolla Canyon is located in Reach 5 because it is the least impacted area within the canyon.

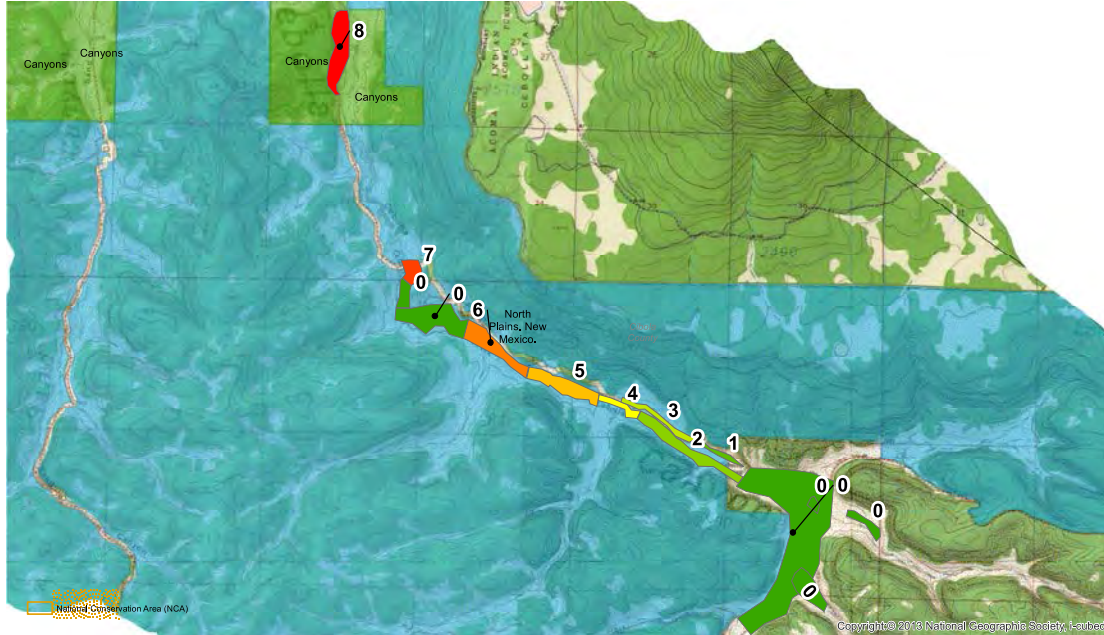
Cebolla Spring Reaches

This map is showing the different Reaches of Cebolla Canyon that have been delineated.

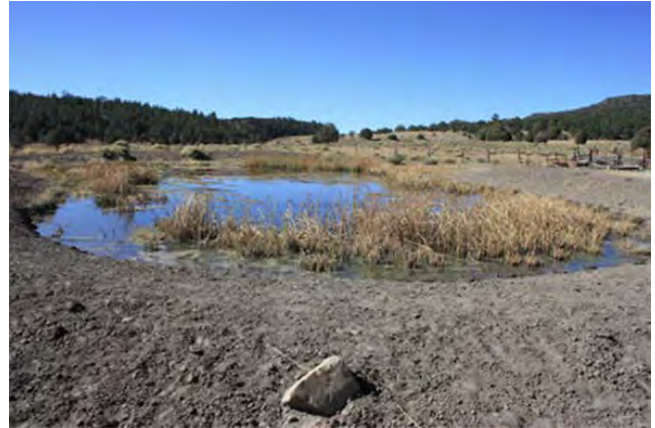
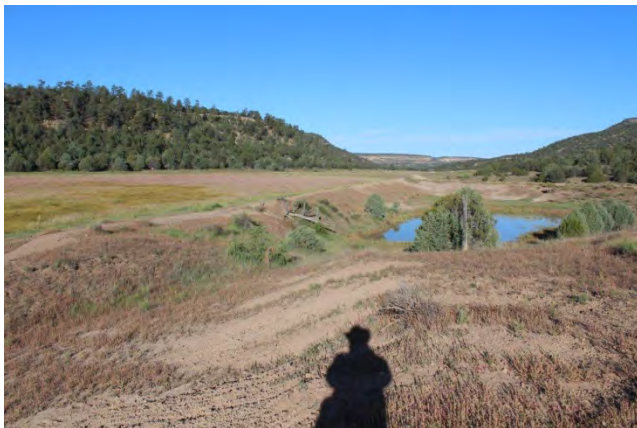
Cebolla Spring stock pond.

It is hard to say how many water impoundments there are throughout Cebolla Canyon, but within the planning area there are at least six that are highly visible. Five of these impoundments are ponds for livestock. Their physical traits vary but they are generally square or circular, relatively deep (over ten feet) and quite large. Although water pools in these installations,

the trade off for their ecological services in comparison to wetlands is minimal. They capture and cut natural flow regimes and are high traffic, low vegetative sites due to livestock use.

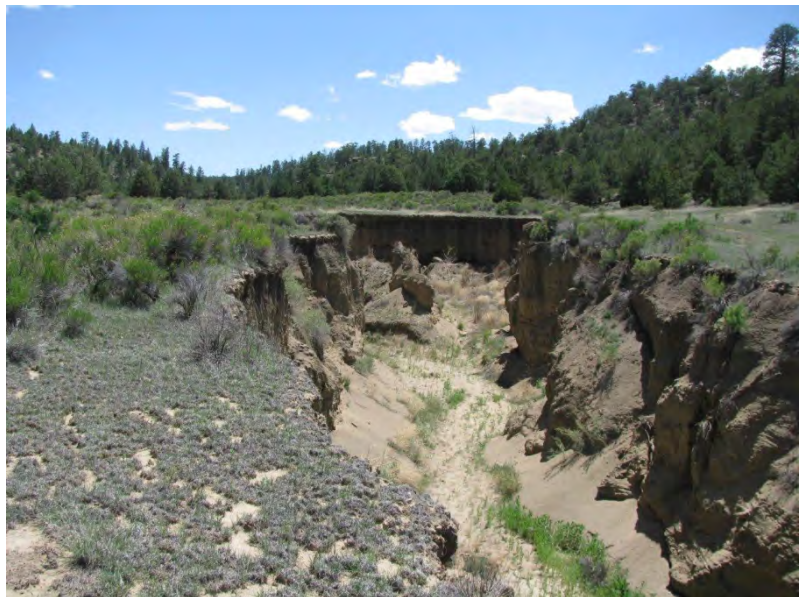
Gully in Cebolla Canyon

Roads play an important role in hydromodifications. They alter water movement across the landscape, “which can concentrate and accelerate flow and cause soil erosion and sediment deposits, gully formation and divert surface and subsurface flows causing areas

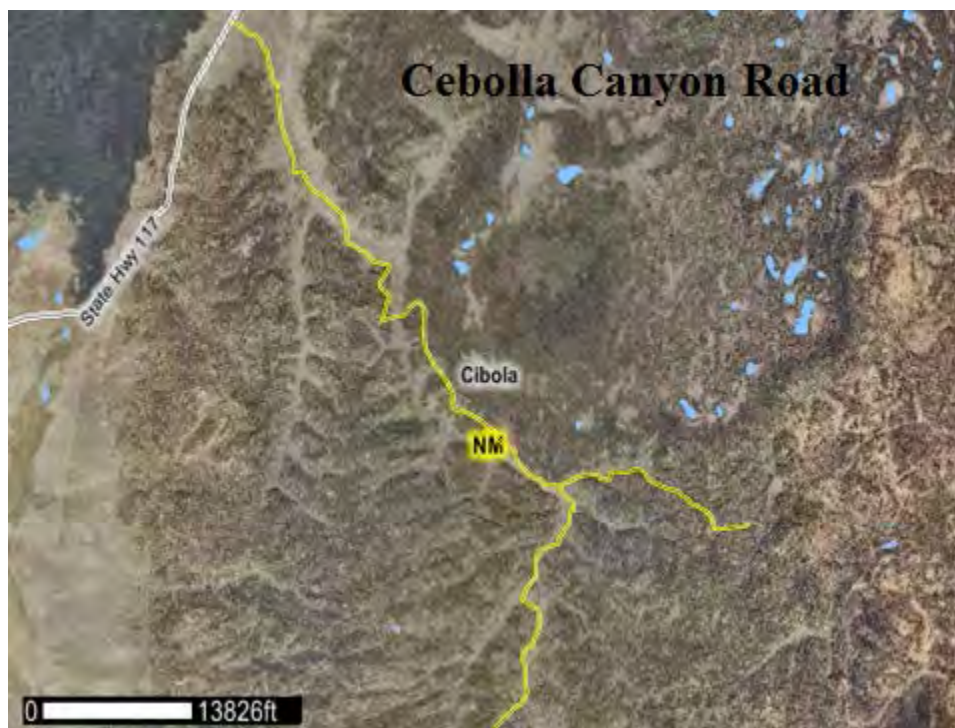
Beyond drainage and subsequent erosion from the existing road, Cebolla Creek and some of its tributaries run in old road locations. That is to say, old wagon and work roads have become the creek and tributaries. This can be seen in Reaches 4-5 near some of the Savage Ranch ruins. The water is running down an old road site and is causing rapidly expanding gullies.

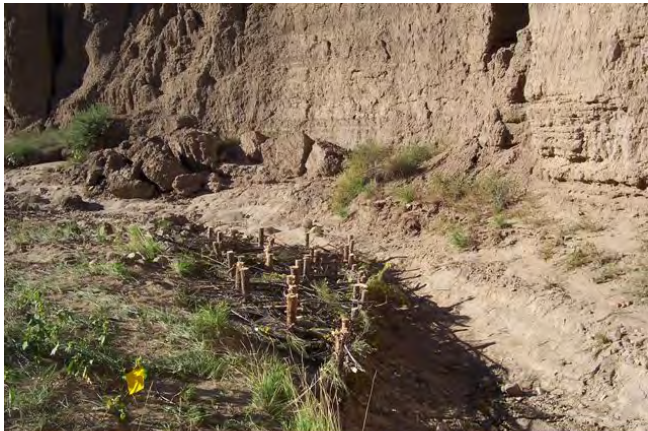
The fence was put in place mainly to keep livestock out of the springs area and allow for

vegetative growth. Although the occasional cow entered, the passive restoration technique was a success and wetland vegetation recuperated at a rapid pace. The incredible improvement showcased the importance and professional knowledge of AWF members allowing them to have access to more projects in the canyon.

At the time of the exchange, Cebolla Springs and the surrounding areas were highly degraded. According to Bill Zeedyk, former Albuquerque Wildlife Federation (AWF) chairman/restoration specialist and other witnesses there was a deep gully approximately eight feet deep that ran through the spring's area. The BLM fenced the springs sometime in the 1990s and then in 2000 asked AWF to help maintain the fence. AWF dug and placed a new cross-valley fence and then constructed a new fence downstream in 2003.

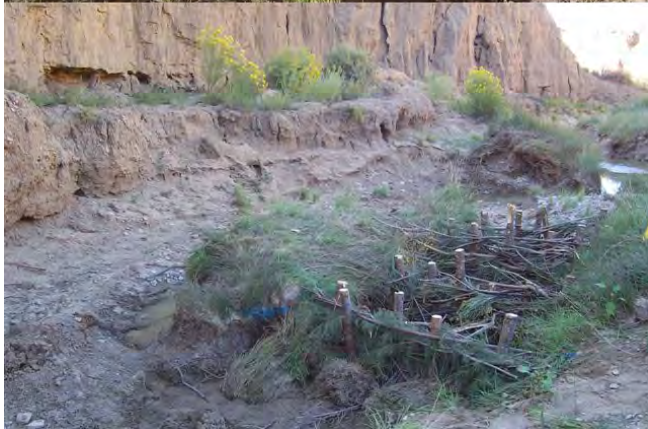
wildlife and habitat resources. See nmwildlife.org for more information.) placed *Picket baffles* AWF constructed in Reach 8 in 2010.

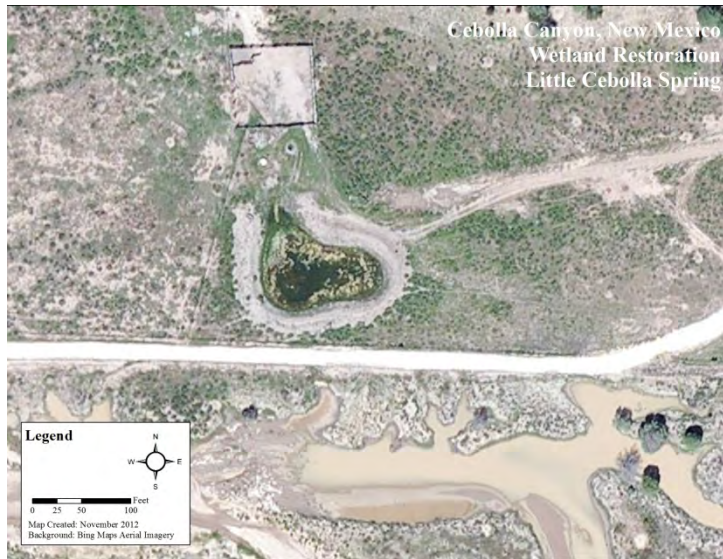
Little Cebolla Spring is a spring fed stock pond located in a small pasture and is actively used by livestock for water. There is some hydric vegetation present such as rushes and sedges. The dam, holding the pond, is low and wide and the pond is around 3 to 5 inches deep when filled. There is no obvious spillway or head-cutting.

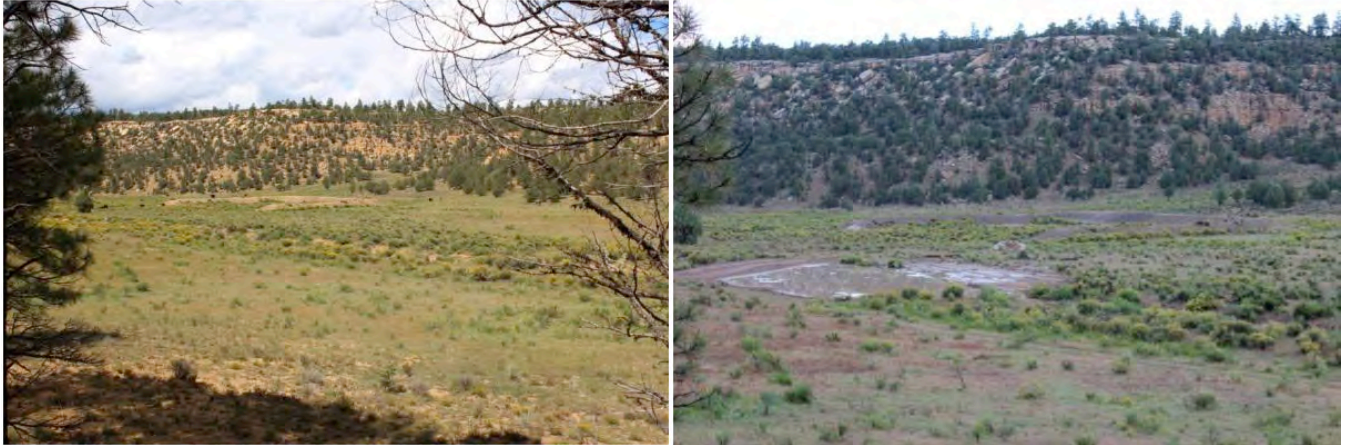
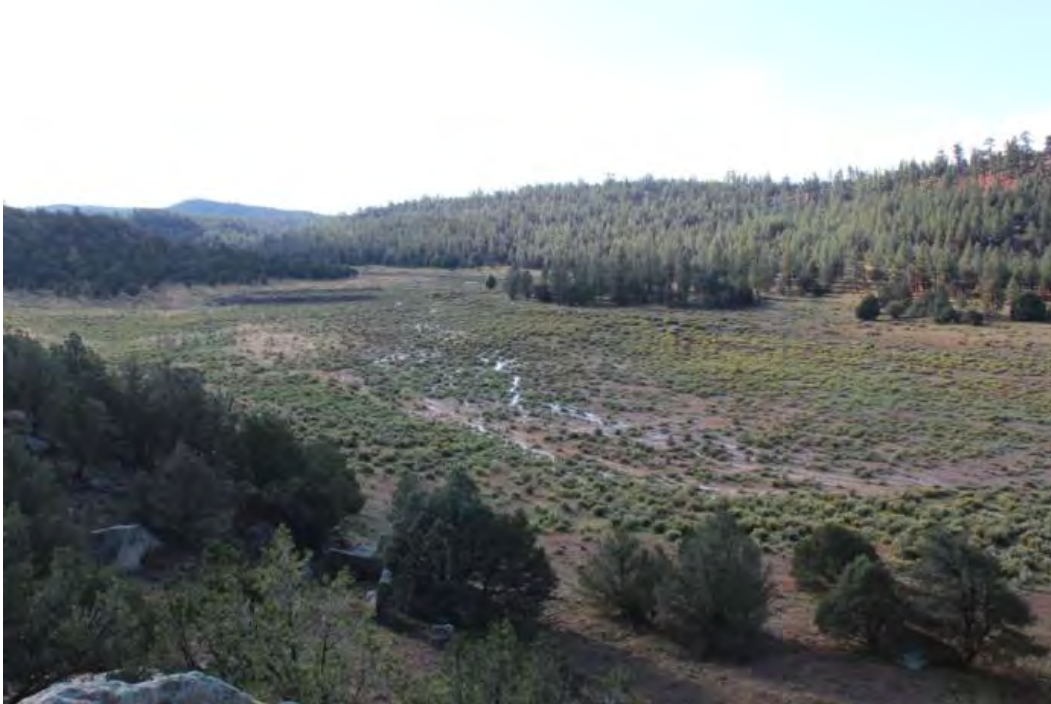
Plug and ponds are constructed from native soils and wetland sod to plug the channel. The chart above shows the plug and pond used in Reach 0. An abandoned ditch in Reach 0 was diverting water away from the valley bottom and spilling the water out into sand without any wetland potential. We used the plug and pond technique to restore water flow to the natural valley bottom with hydric soils and wetland potential.

*[Top left] Before plug and pond construction.
[Top right] Water is once again accessing the stock tank benefitting the permittee.
[Left] Water is returned to the Valley Bottom, increasing wetland potential.*

Plug and pond structures spread water over the floodplain and to create a temporary pond. These techniques have proven to restore wetlands effectively by enabling the stream to replenish the floodplain, reducing the energy of the water flow and re-watering nearby meadows. Implementation of this technique generally results in a higher water table, encourages the growth of riparian vegetation, and provides cooler water for fish and wildlife.

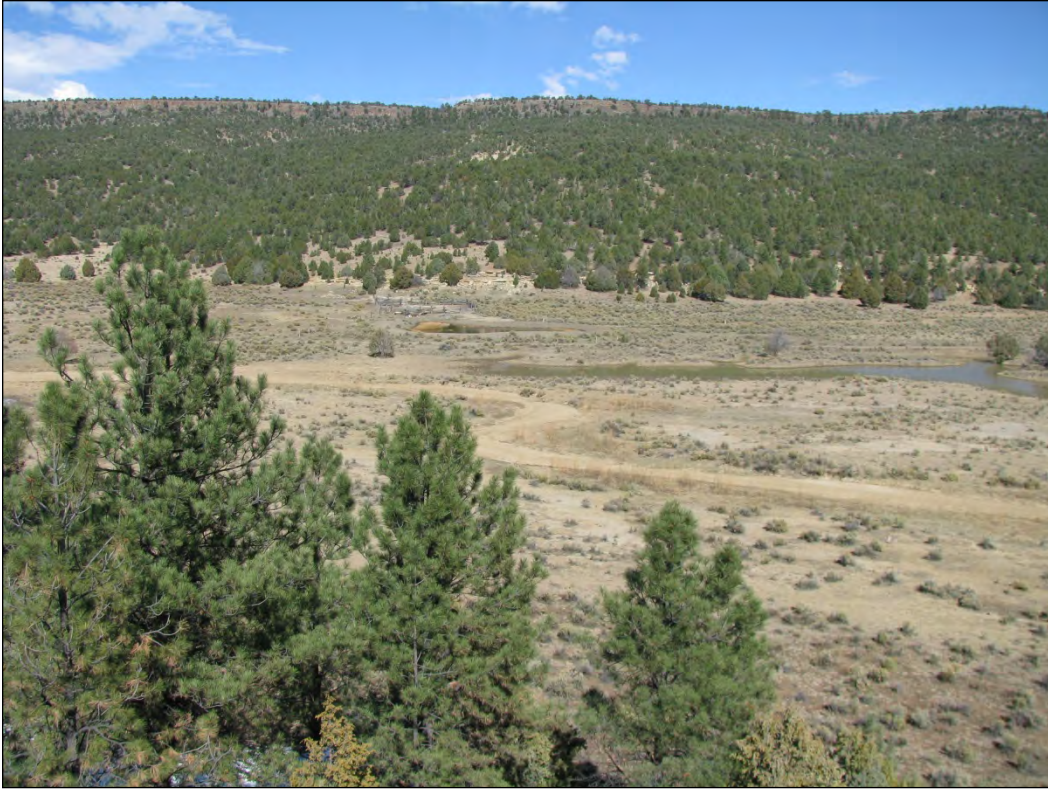
Photopoint 1 – 1 degrees – Reach 0: View of Little Cebolla Springs and Lake Cebolla as well as the sediment plug resulting from the confluence of the abandoned irrigation ditch.

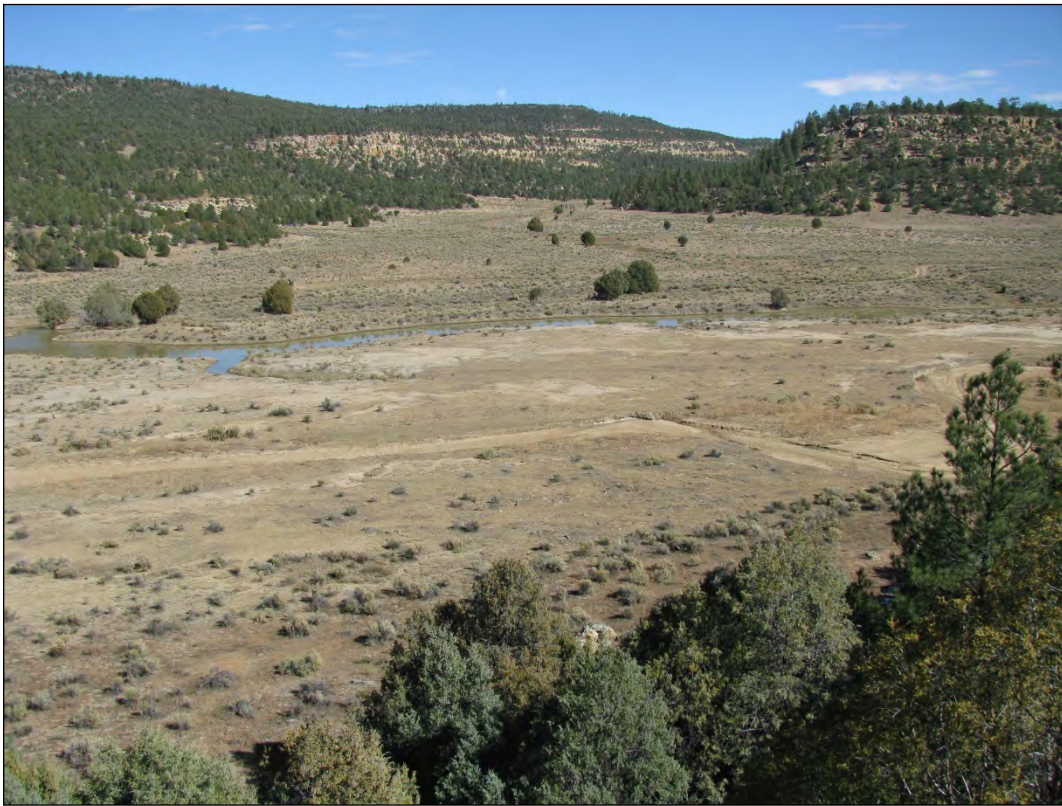
Photopoint 1 – 49 degrees – Reach 0: View of Lake Cebolla in the center with Side Valley Right #3 in the background and the abandoned irrigation ditch in the foreground.

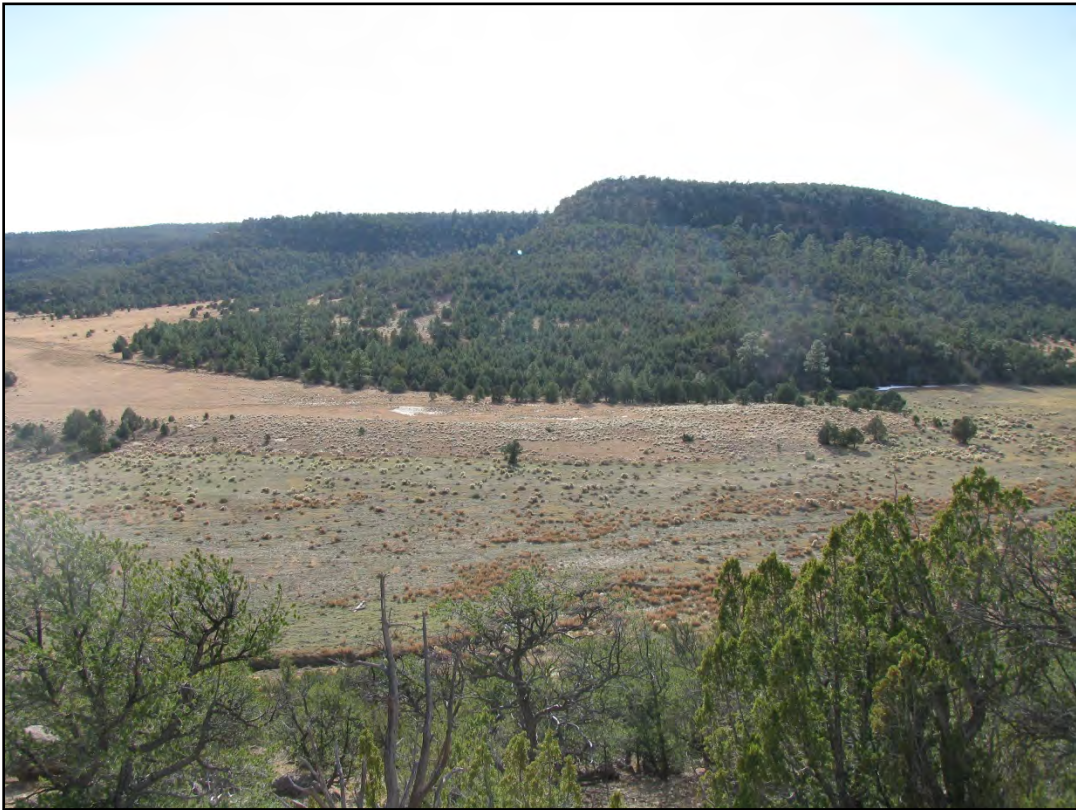
Photopoint 7 – 225 degrees – Reach 6A: View across Cebolla valley.

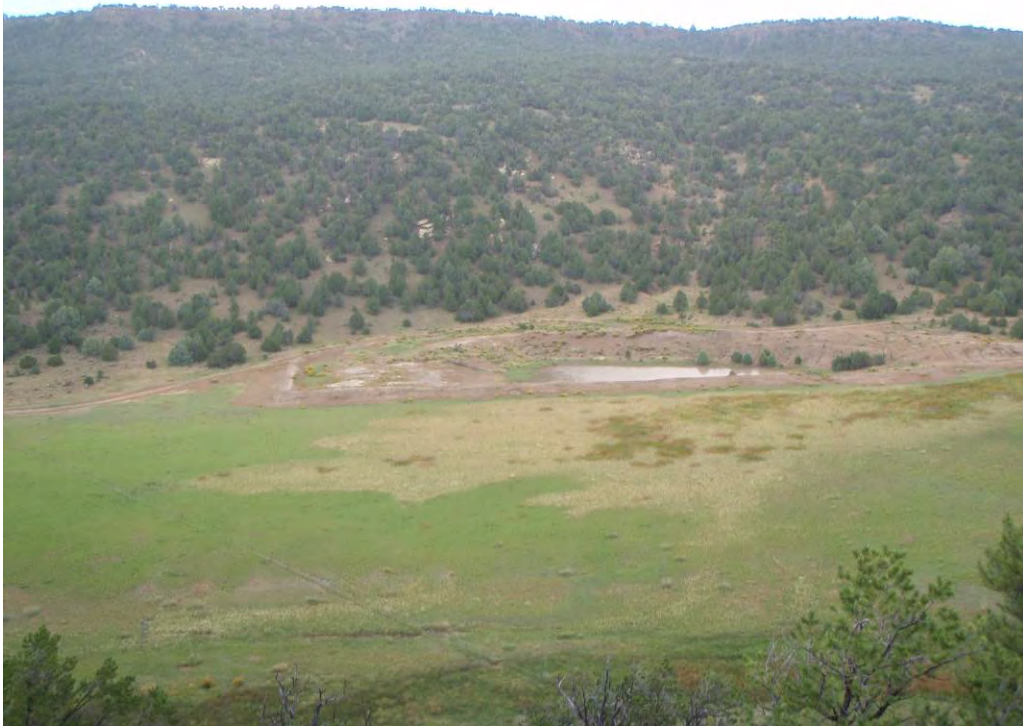
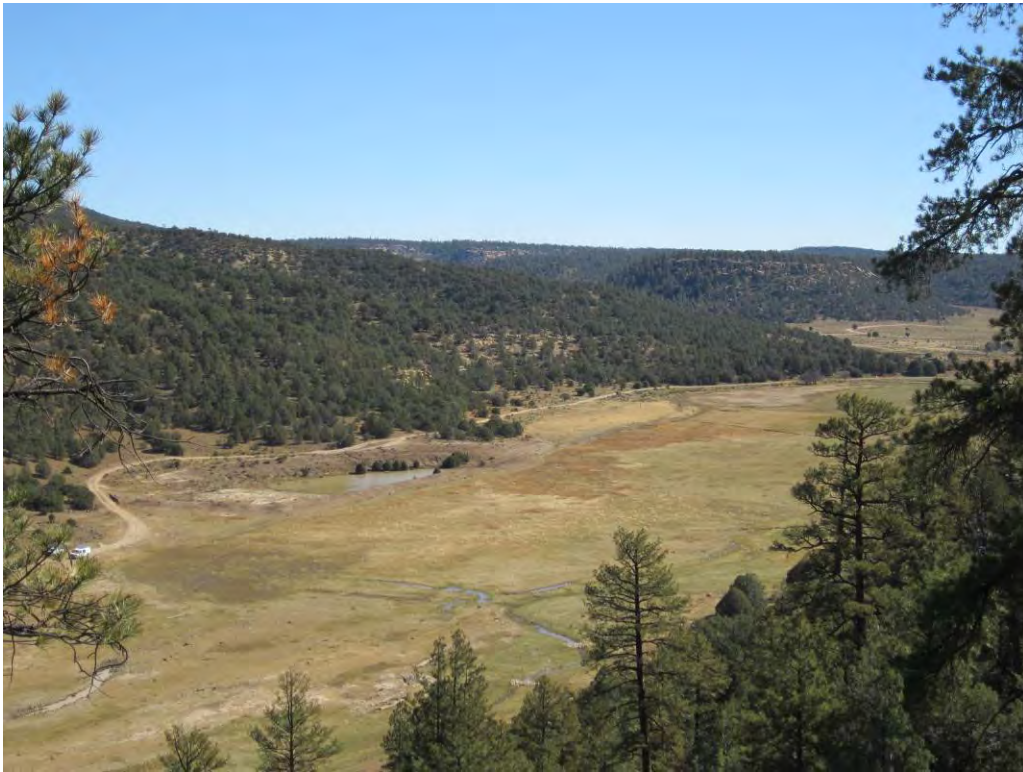
Two photos taken from different locations on the south side of Cebolla Canyon fall 2010 and fall 2013, looking at end of wetland. Upper photo has wetland ending near pond, in lower photo; wetland extends downstream 500 feet or so to bend in road and white truck to left of picture.

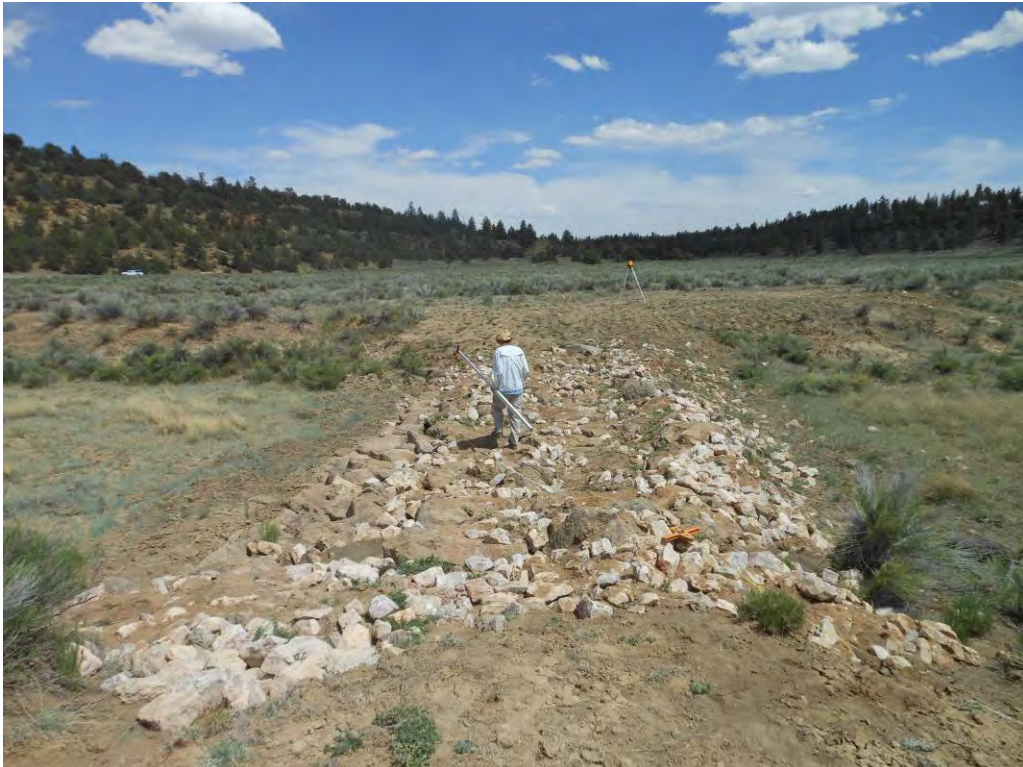
Filter Dam below Berm breach and channel reconstruction, spring 2012

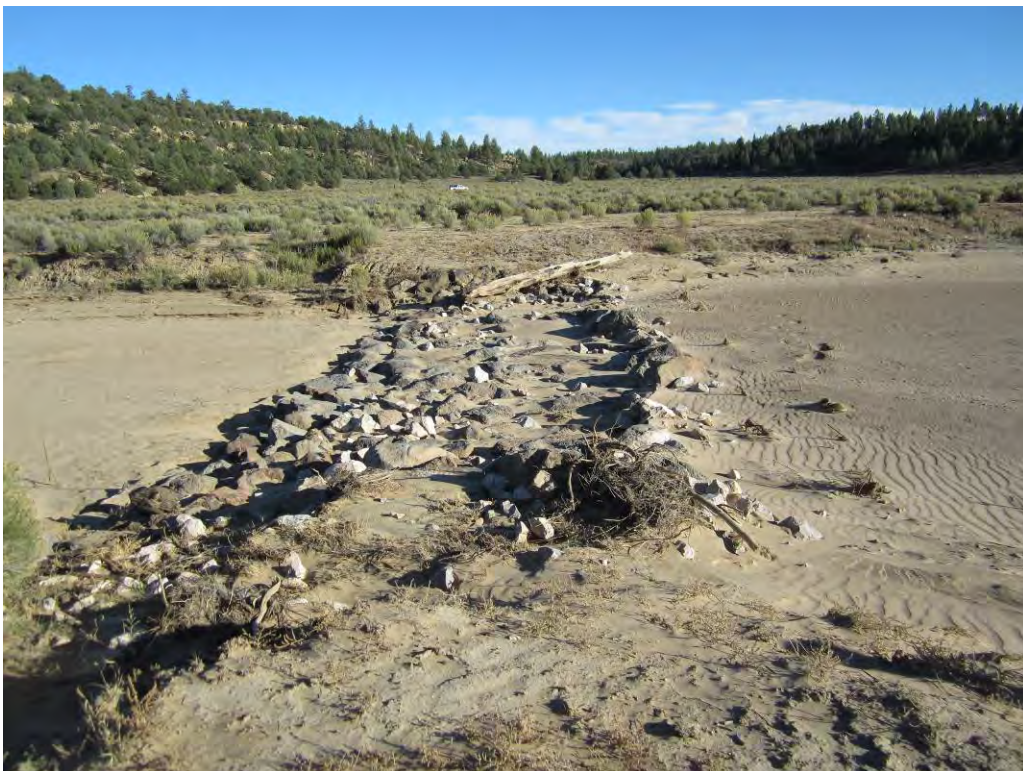
Filter Dam in October 2013, filled in with sand

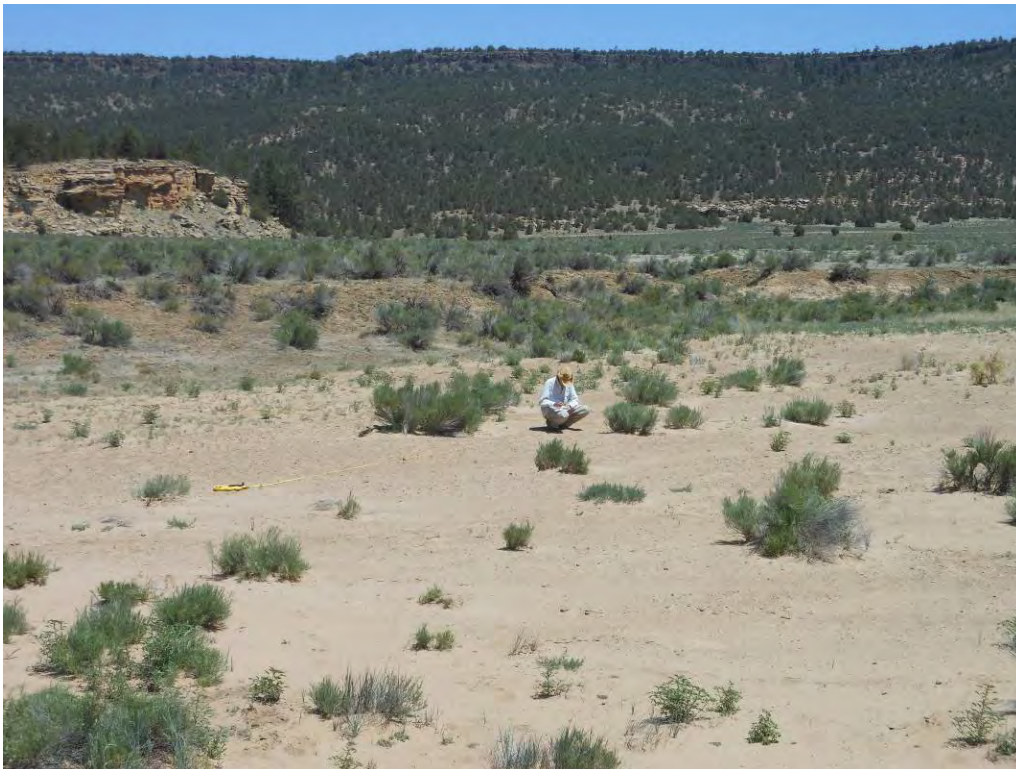
There is a large difference between 2010 and 2012, with a large decrease in the numbers of mature and juvenile rabbitbrush. This site was impacted by the berm breach, a foot of sand was deposited, and most of the existing vegetation was drowned out.

Rabbitbrush Circle 0-1, Aaron Kauffman in middle of circle, taken in 2012, some rabbitbrush remain in channel.

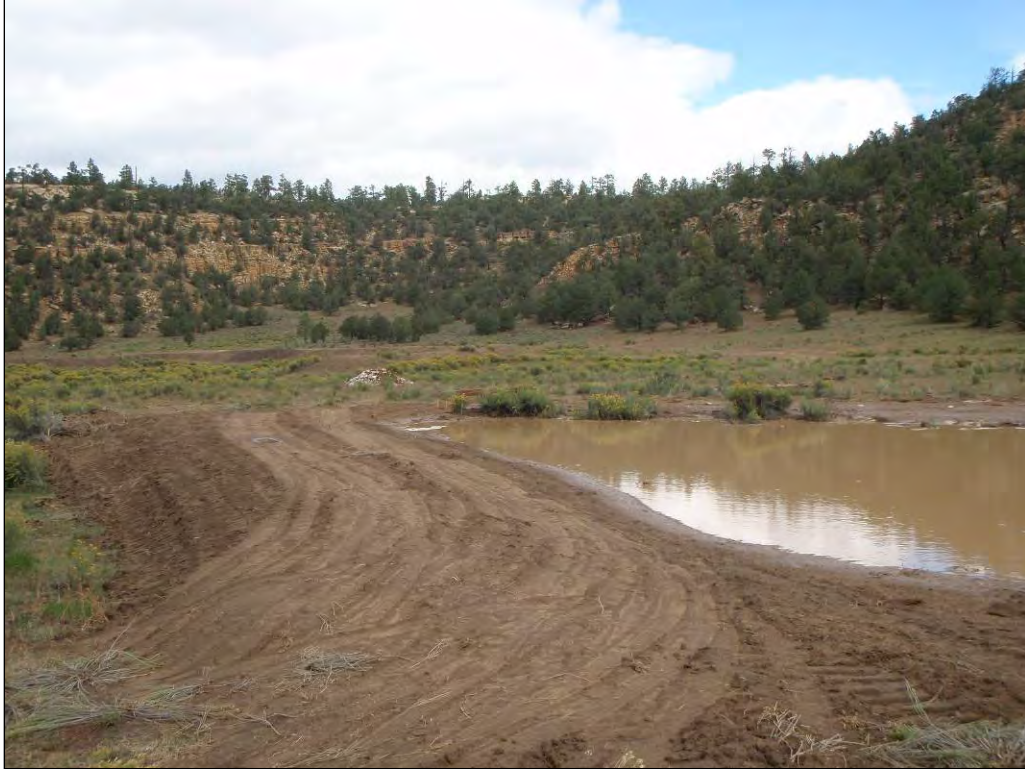
Detail of plug and pond at top of project, gully became a pond with overflow to left of picture. Pic October 2011.

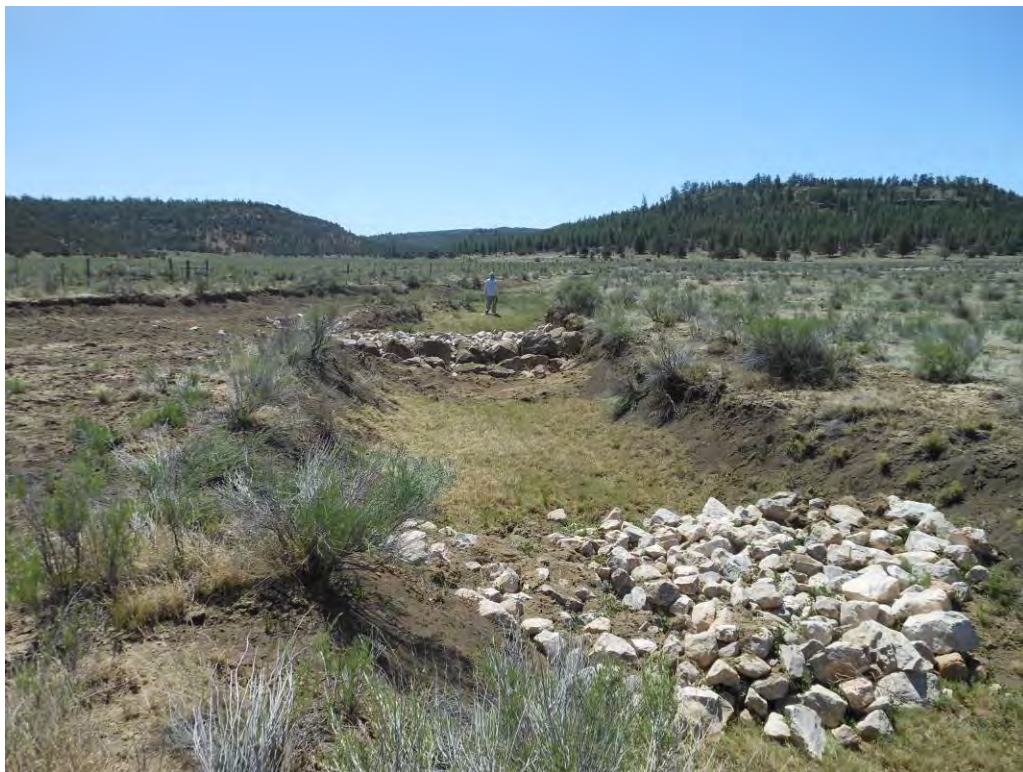
The vegetation in plot 0-3 changed somewhat due to the treatment. There was a decrease in rabbitbrush due entirely to the machine installation of the filter dam. Western wheatgrass increased its cover, probably due to the wetting of the soil. One Baltic rush was identified, this wetland plant may be invading this area. This area also is grazed heavily by the same herd of cattle as seen in Trib 0-E.

Filter dam, reach 0-N, transect is by Aaron Kauffman in top of picture

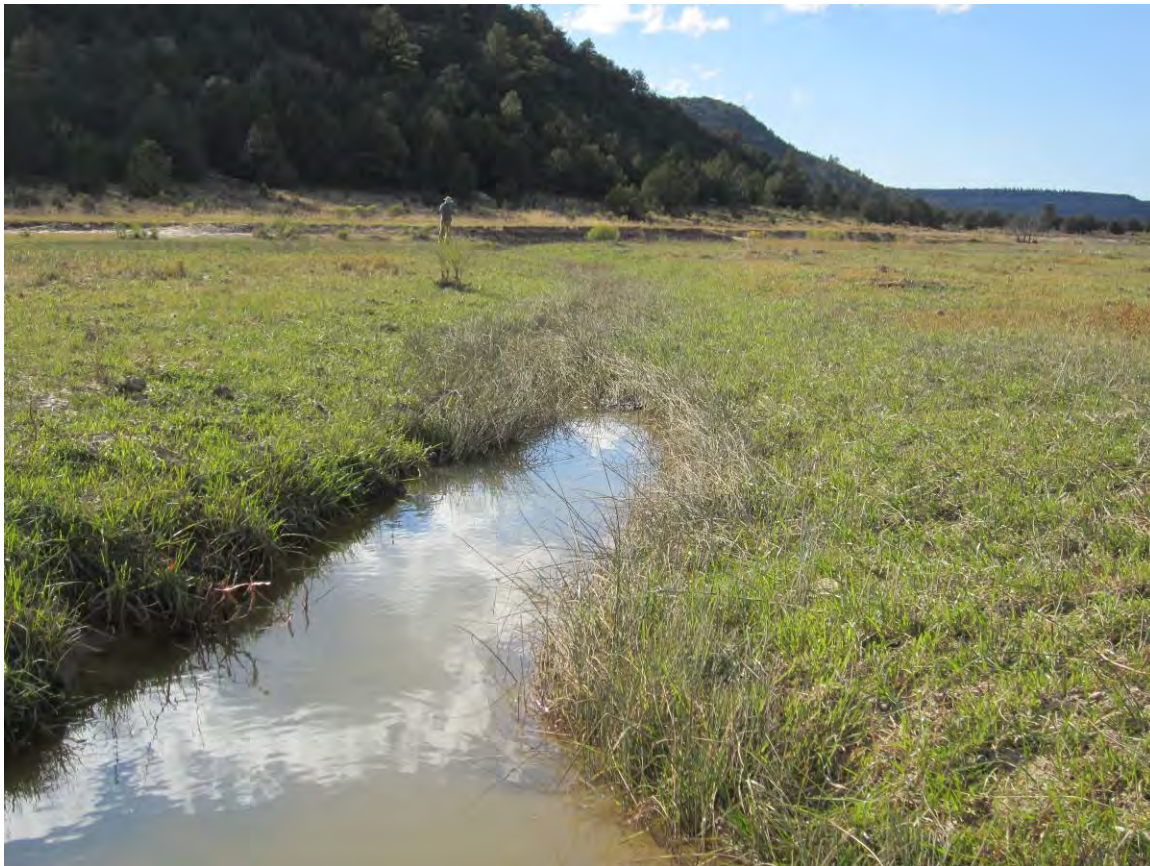
This increase was not large in area, however Baltic rush is now continuous downstream through the reach, even as a narrow fringe of vegetation along the channel. As the one rock dams installed in 2012 begin to capture sediment and raise the water table, this fringe should spread across the valley bottom and increase wetland area. This tough-rooted wetland plant will also buffer the channel from floods, and if left to grow to its natural height of 2 feet or so, capture sediment and litter from upstream, and fill the channel.

Reach 2 vegetation, Baltic Rush fringe along channel in 2013

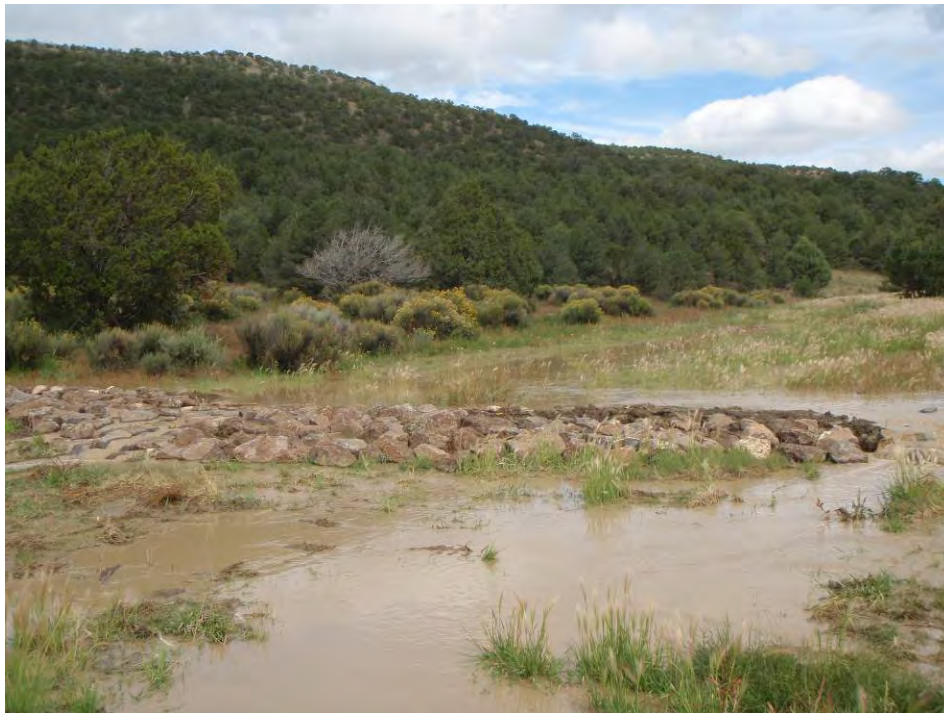
As seen in a typical alluvial fan, the middle of the fan is the highest elevation, with lower channels on both sides of the valley. The deep channel to the right of the valley is the old road, which formed a gully. This gully is filling in due to the installation of a rolling dip/one rock dam downstream from this transect.

Rolling dip road drain looking upstream at valley cross section 4-2
