**Cebolla Canyon Closed Basin Watershed
Cibola County, New Mexico
Wetland Action Plan
October 2014**

**Prepared by:
Rio Puerco Alliance
3250 La Paz Lane
Santa Fe, NM 87507**

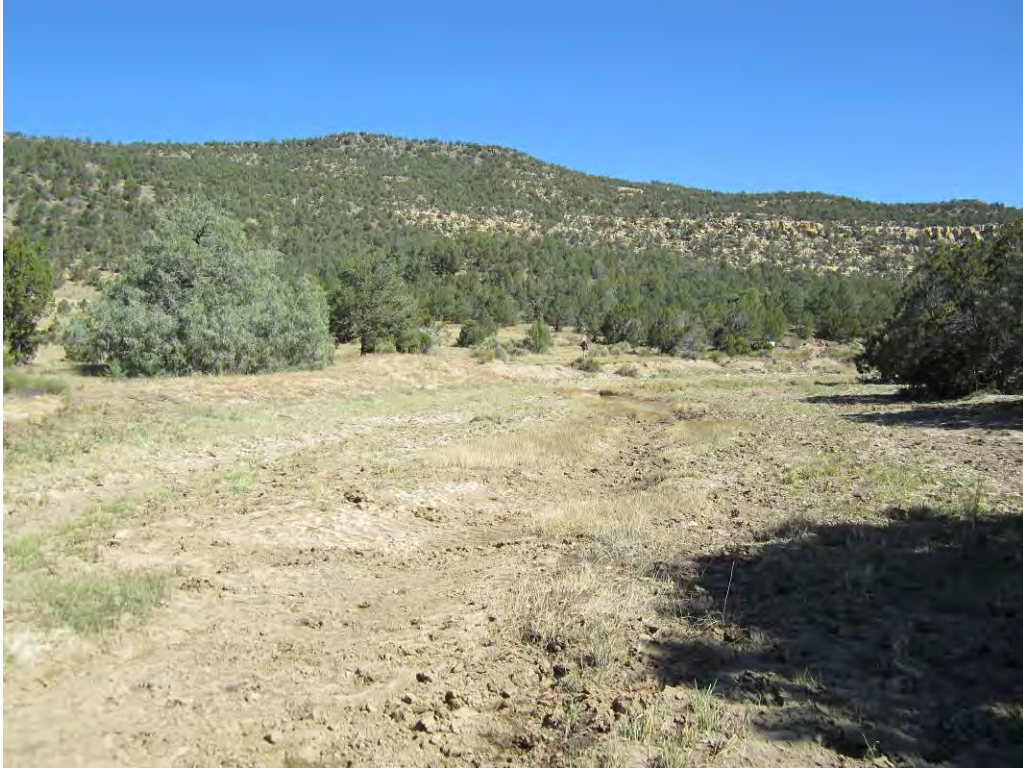
Vegetation transect 4-1 buried under new sediment

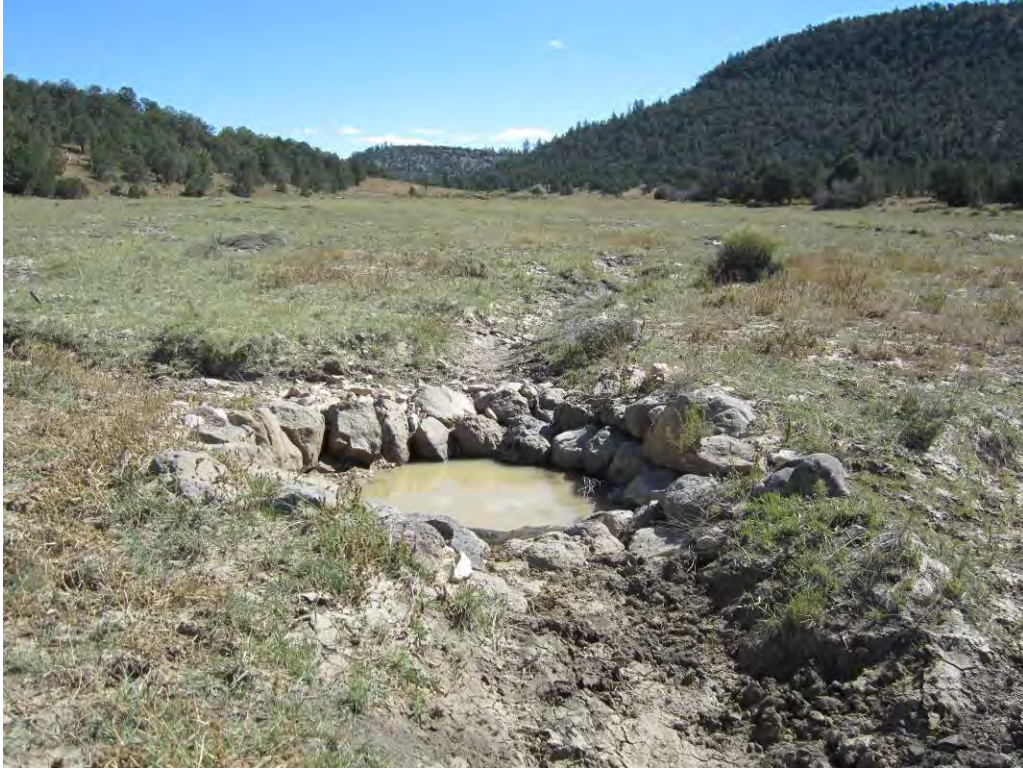
Zuni bowl to prevent gullyng upstream, upstream of vegetation transect 5-1

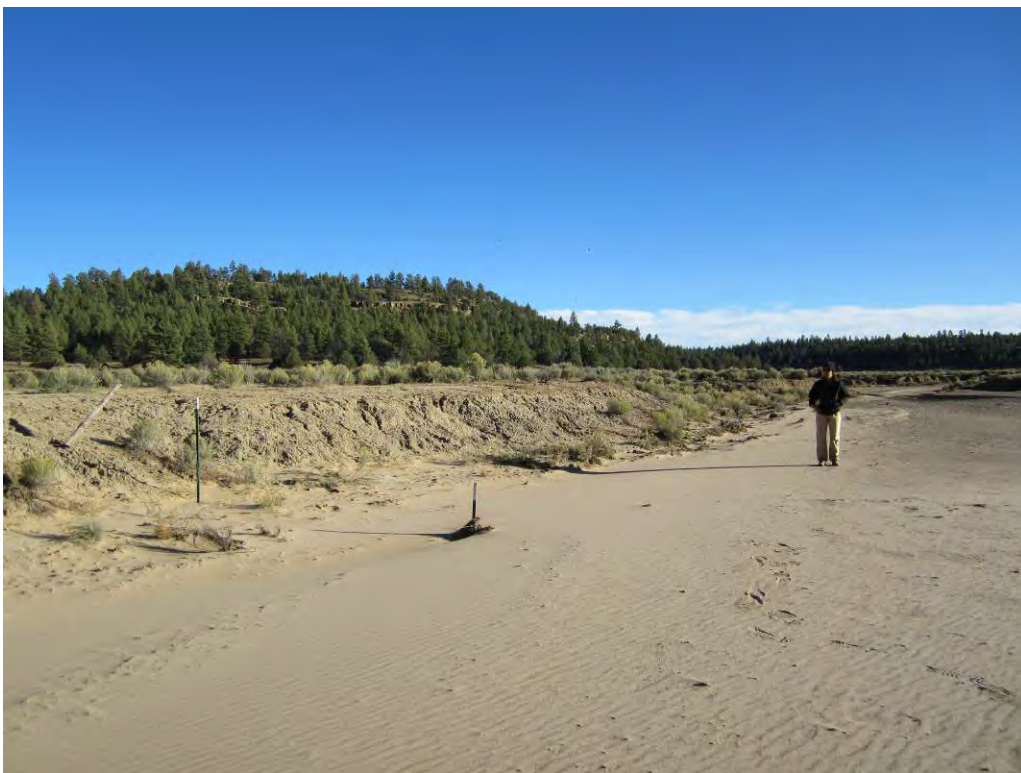
Buried exclosure fence at top of Lake Cebolla in 3 feet of sand, this channel is now only 4 feet from the former wide wetland surface of the valley and may proceed to fill in with no additional treatment, creating 10-20 acres of additional wetland area.

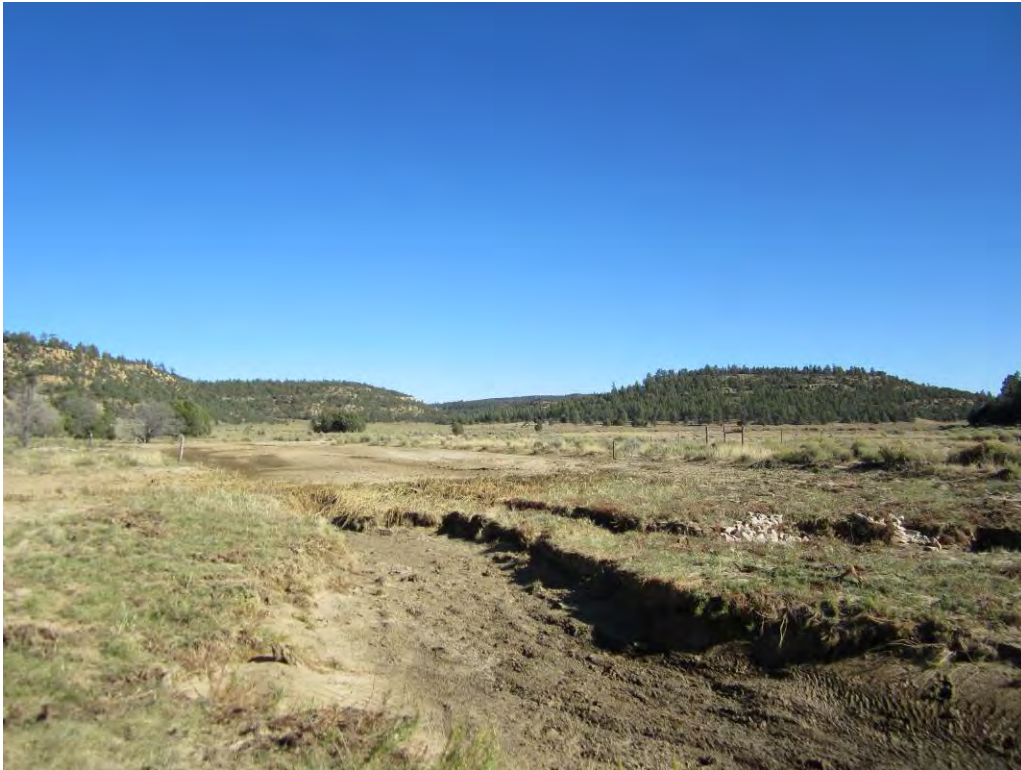
Bottom of Lake Cebolla in 2013, note channel filled in with wet sand upstream, headcut in picture should be repaired with rock, smaller flood events may fill this in with sand with no treatment. Break-away enclosure fence in middle of picture.

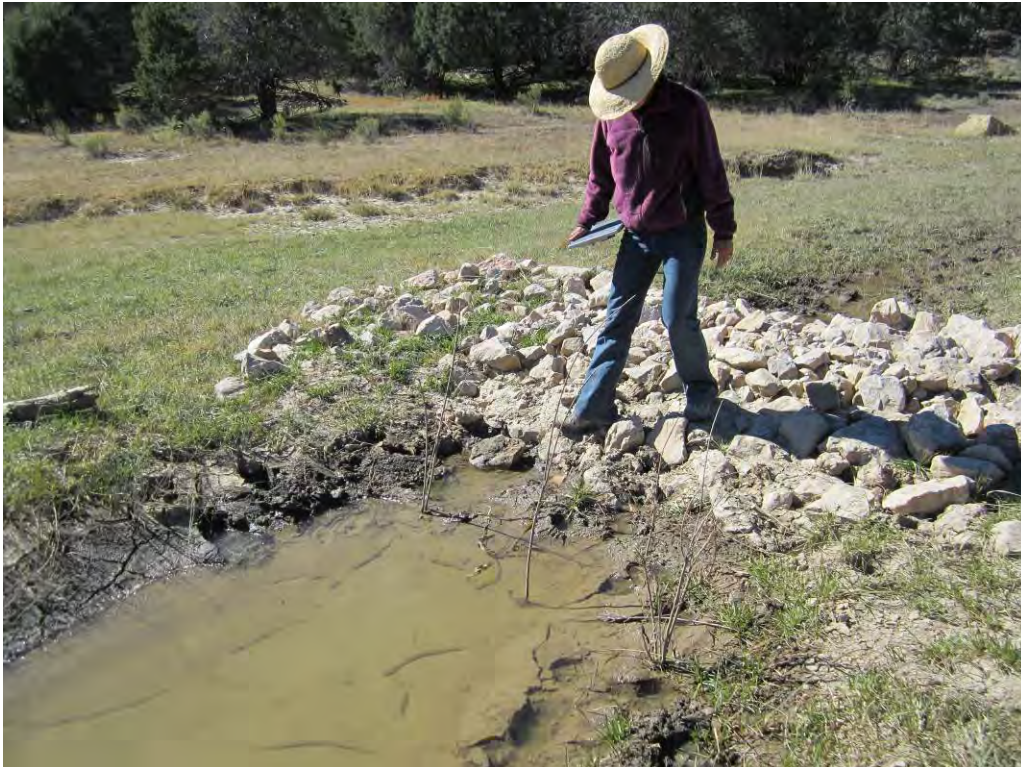
Reach 2 one rock dams should be plugged with clay and packed tight to raise the water table six inches to a foot and spread it across the floodplain.
