Re: New Mexico Department of Game and Fish; Red River State Fish Hatchery; Minor Non-Municipal Individual Permit; SIC 0921; NPDES Compliance Evaluation Inspection; NM0030147; September 11, 2019

NPDES Compliance Inspection Report

New Mexico Department of Game and Fish / Red River State Fish Hatchery
NPDES Permit No. NM0030147
Compliance Evaluation Inspection
September 11, 2019

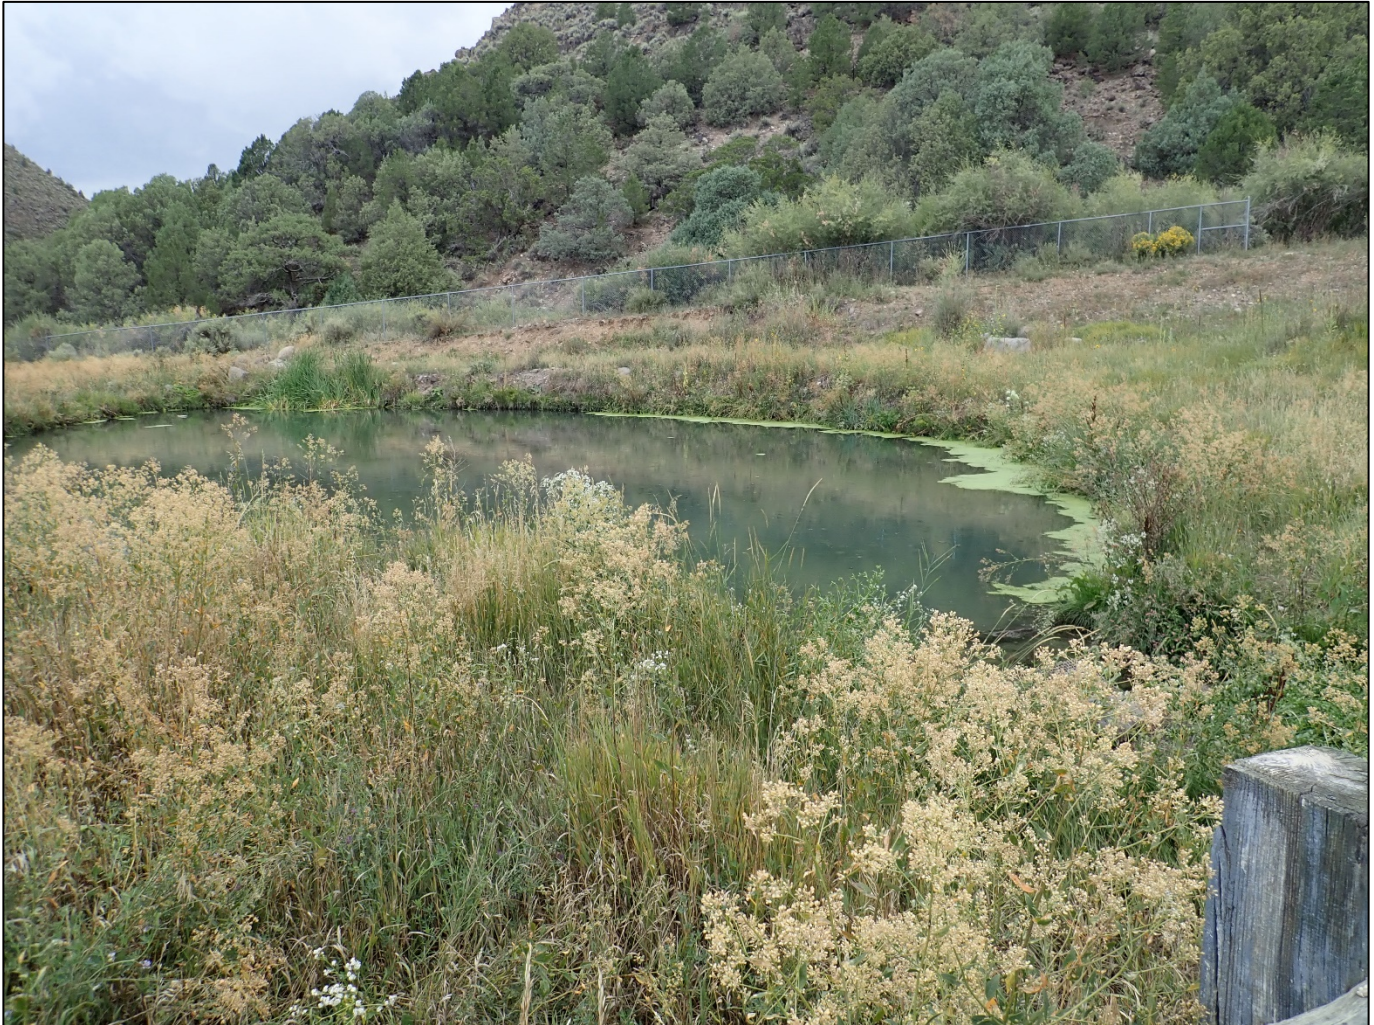
**NMED/SWQB
Official Photograph Log
Photo # 1**

- Overgrown vegetation and algal growth exist at settling ponds (off-line settling basins).
- The provided “Hatchery Management Plan” / BMP plan dated May 2, 2018 did not provide procedures for routine cleaning of the settling ponds/basins.

Photographer: Erin Shea	Date: 09/11/2019	Time: ~ 1115 hours
City/County: North of Taos and southwest of Questa / Taos County		State: New Mexico
Location: Red River State Fish Hatchery / NPDES Permit No. NM0030147		
Subject: Northern (Upper) Settling Pond had algal mat at waters edge. Vegetation around pond was overgrown.

The inspector stated that the settling ponds were overgrown with vegetation and some algal growth. Vegetation around the settling ponds is an important component to the system as these plants (mostly wetland plants) absorb nutrients from wastewater. Algae growth is inevitable due to the settling of these nutrients. The hatchery monitors the settling ponds on a regular basis and routine cleaning is scheduled every 3-5 years or when necessary. The next cleaning is scheduled for the winter of 2020.

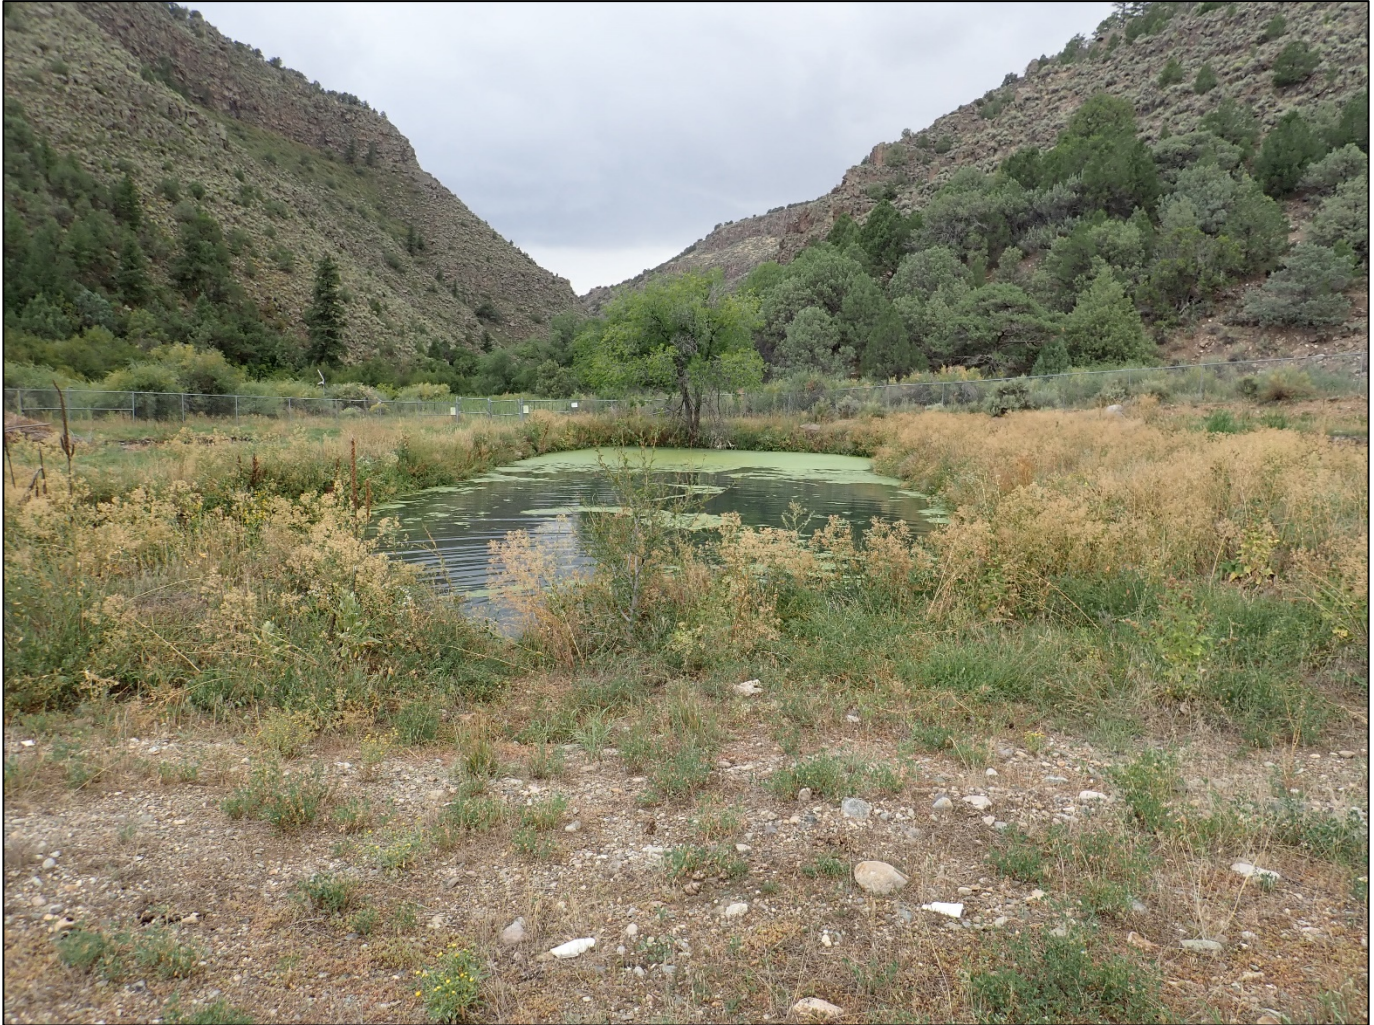
**NMED/SWQB
Official Photograph Log
Photo # 2**

Photographer: Erin Shea	Date: 09/11/2019	Time: ~ 1116 hours
City/County: North of Taos and southwest of Questa / Taos County		State: New Mexico
Location: Red River State Fish Hatchery / NPDES Permit No. NM0030147		
Subject: Southern (Lower) Settling Pond had algal mat. Vegetation around pond was overgrown.

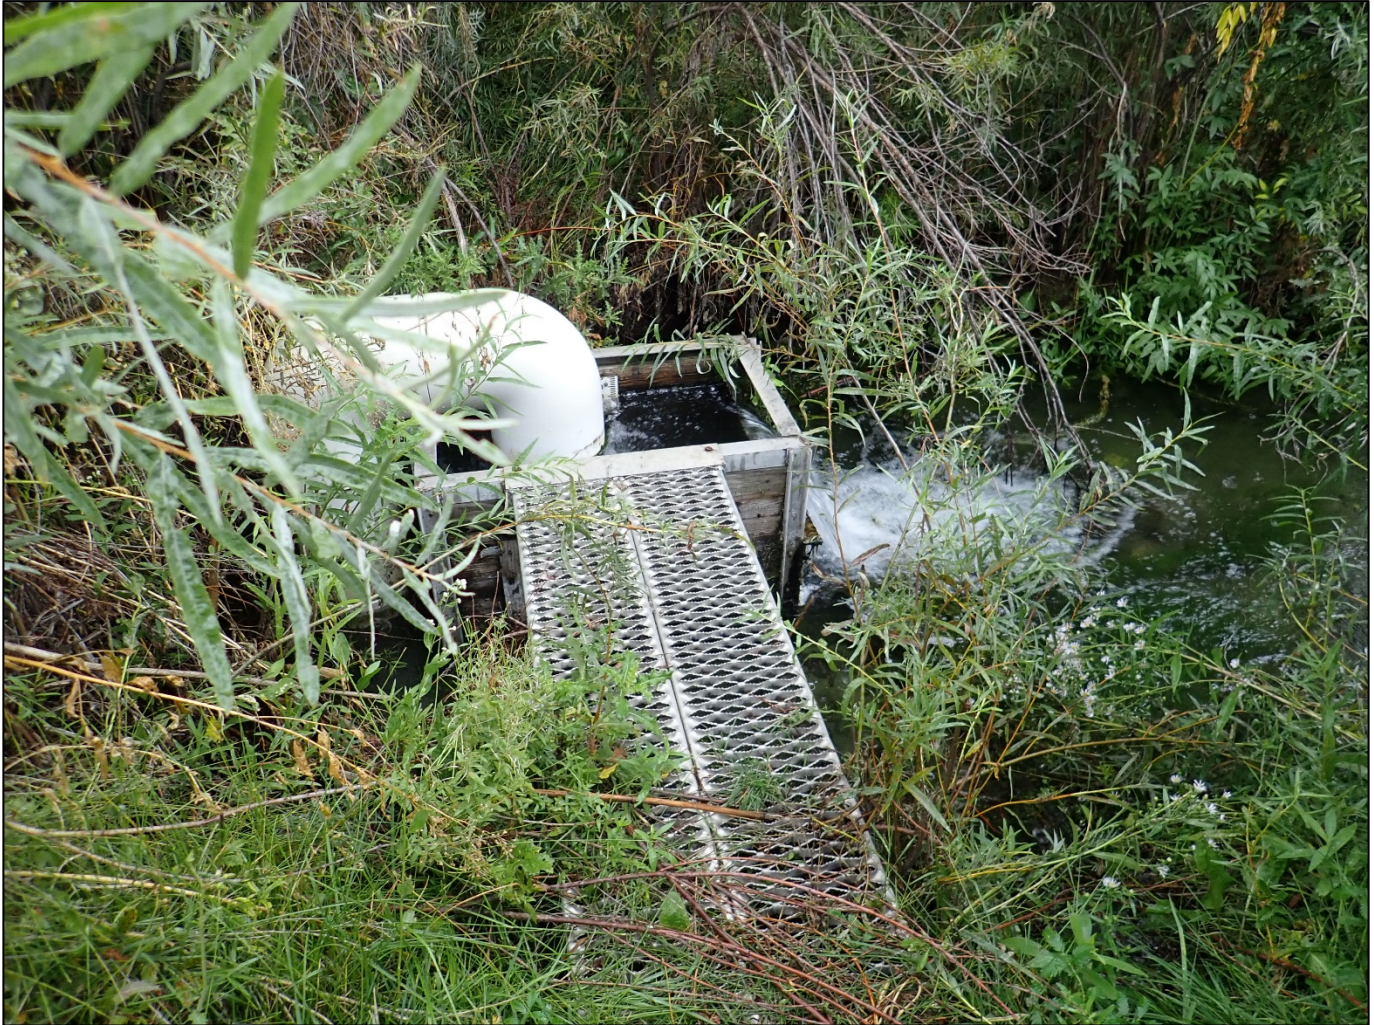
**NMED/SWQB
Official Photograph Log
Photo # 3**

Flow measurements for each outfall are taken at the beginning of the work day (approximately 0800 hours). Flow measurement “Weir Collection System” includes the raceway C weirs located before Outfall 001, and the weirs at Outfall 002 and Outfall 003. Flows at Outfall 001 were observed to be too turbulent for accurate measurement on the day of this inspection. The Permittee letter dated July 8, 2019 to EPA with copy to NMED described above normal flows at the Hatchery during the 2nd Quarter of 2019 rising near the crest of the measuring weir reducing the gap (air space) between the crest of the weir and receiving water at Outfall 002. An air gap at Outfall 002 was observed during this inspection.

Photographer: Erin Shea	Date: 09/11/2019	Time: ~ 1125 hours
City/County: North of Taos and southwest of Questa / Taos County		State: New Mexico
Location: Red River State Fish Hatchery / NPDES Permit No. NM0030147		
Subject: Outfall 002

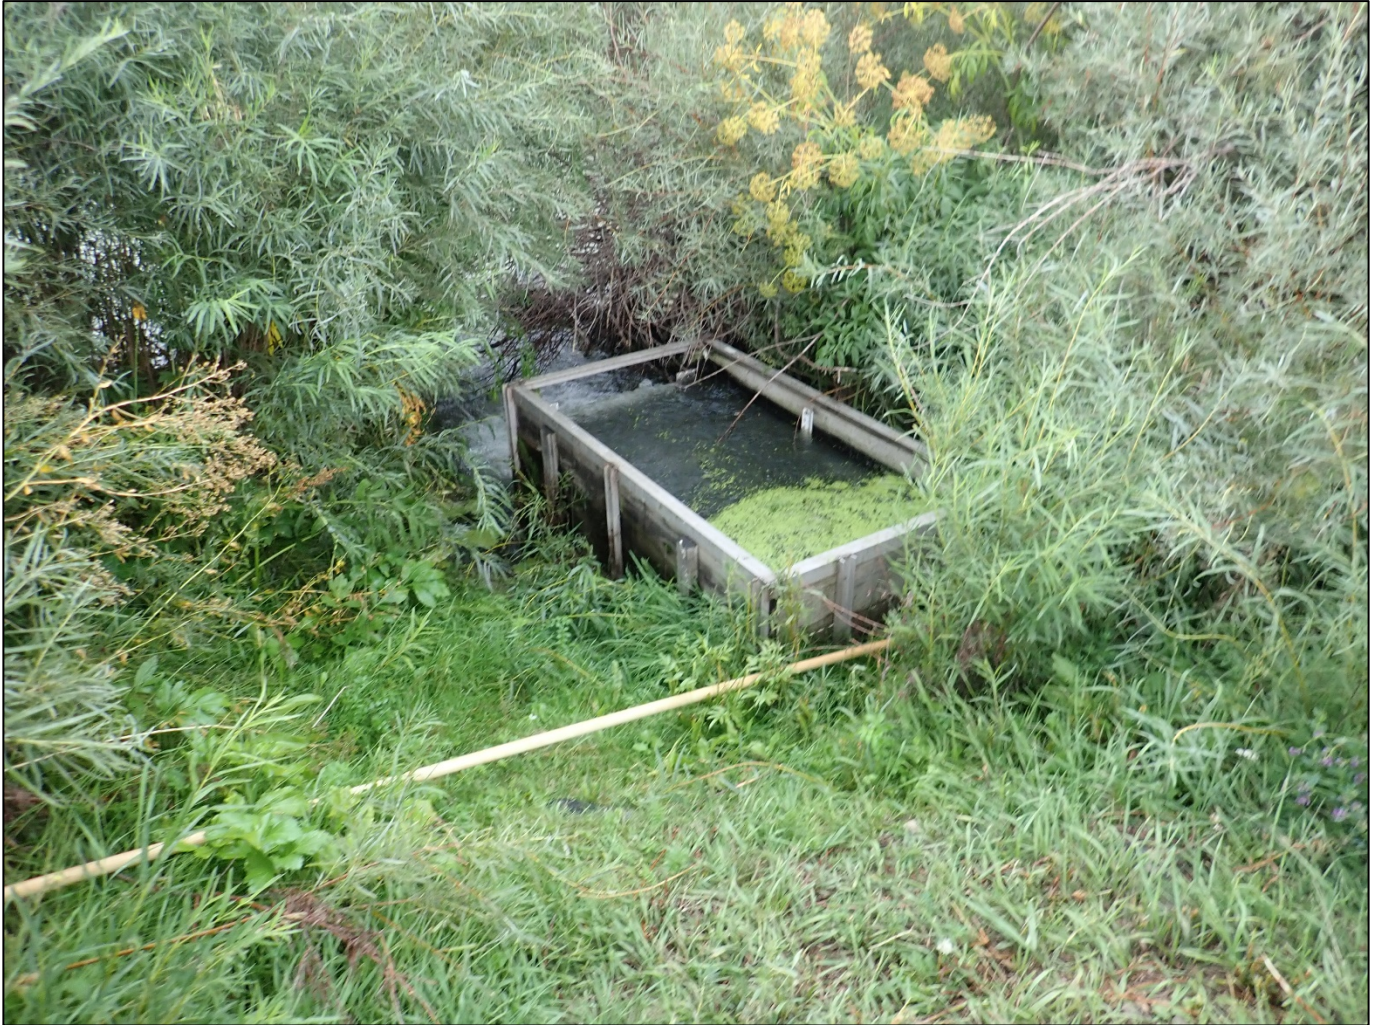
**NMED/SWQB
Official Photograph Log
Photo # 4**

Photographer: Erin Shea	Date: 09/11/2019	Time: 1126 hours
City/County: North of Taos and southwest of Questa / Taos County		State: New Mexico
Location: Red River State Fish Hatchery / NPDES Permit No. NM0030147		
Subject: Outfall 003. Weir box had vegetation.

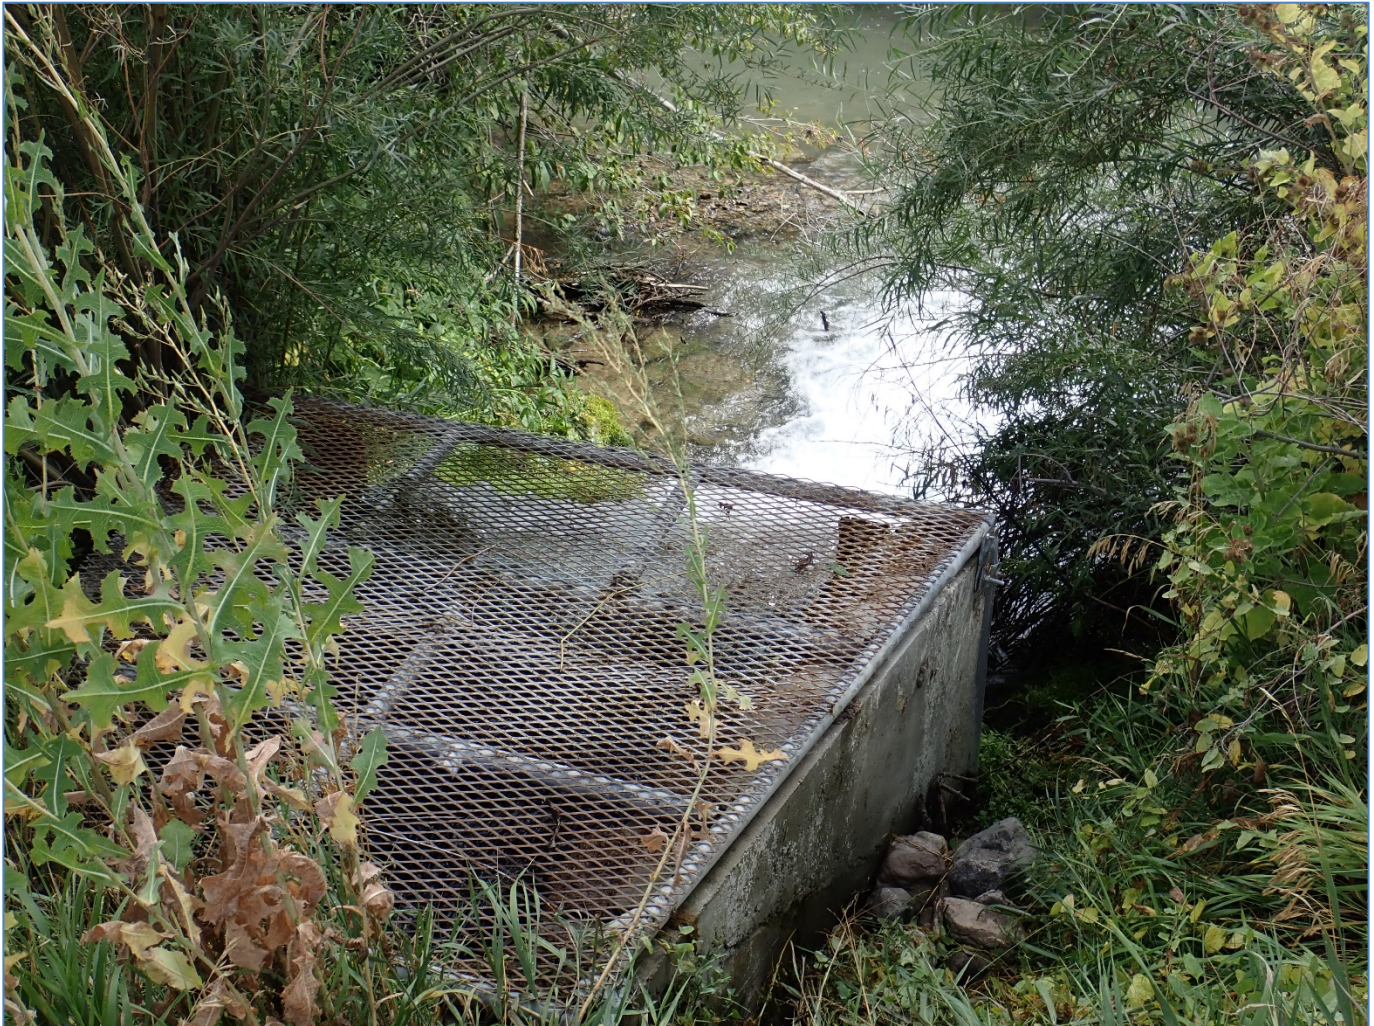
**NMED/SWQB
Official Photograph Log
Photo # 5**

Photographer: Erin Shea	Date: 09/11/2019	Time: 1332 hours
City/County: North of Taos and southwest of Questa / Taos County		State: New Mexico
Location: Red River State Fish Hatchery / NPDES Permit No. NM0030147		
Subject: Outfall 001. Concrete box at weir had some discoloration and cracking. Vegetation around the box makes inspection difficult.

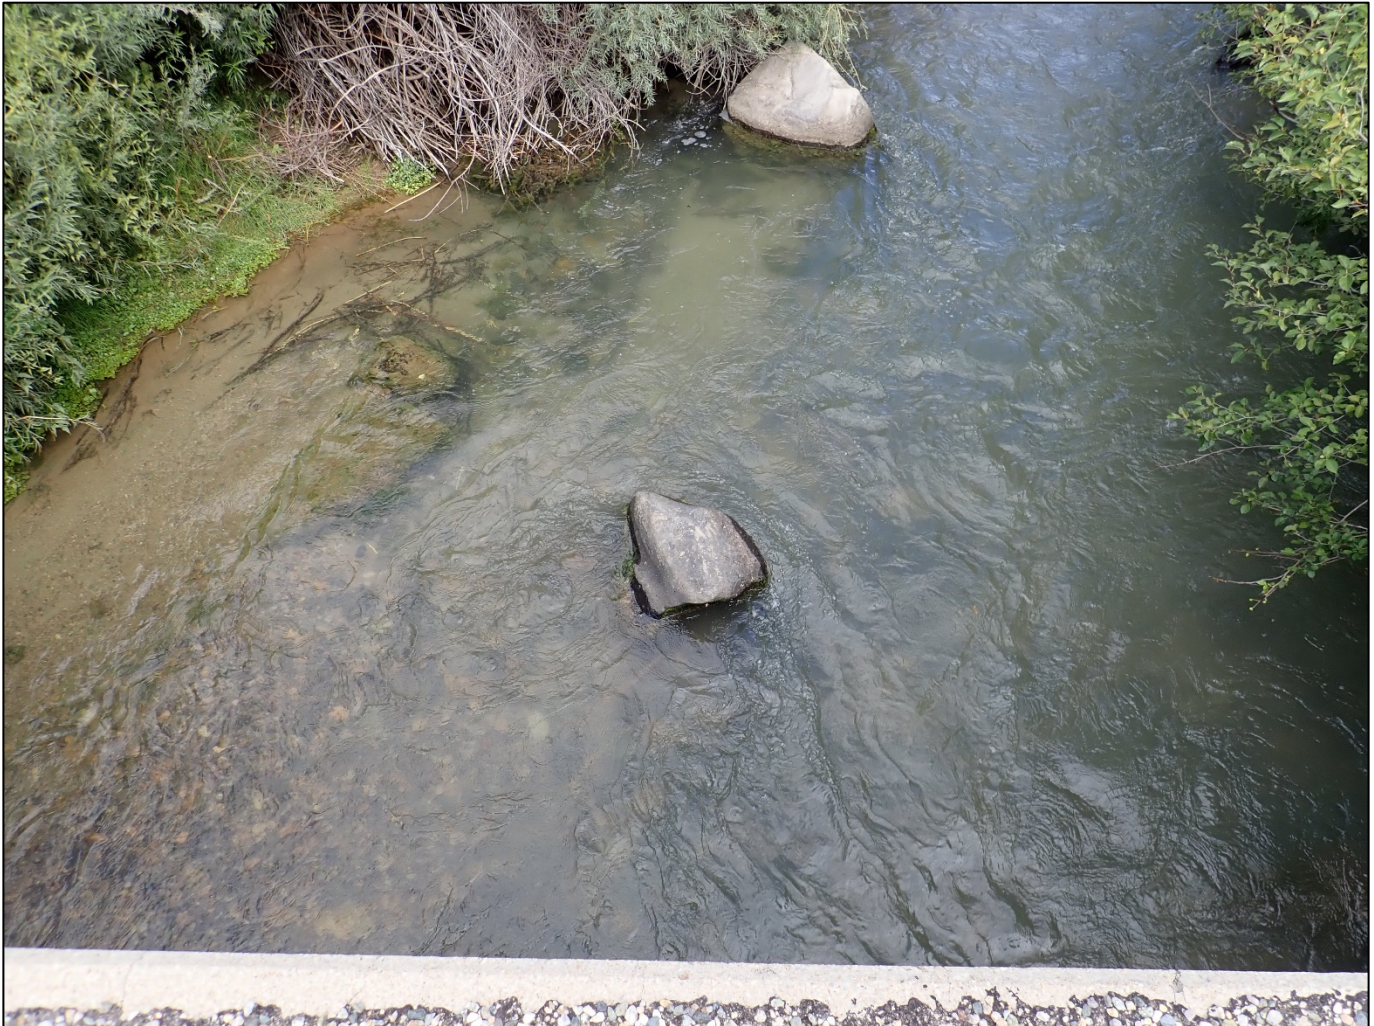
**NMED/SWQB
Official Photograph Log
Photo # 6**

RECEIVING WATER OBSERVATIONS: **Reported TRC effluent concentration exceeded permit limitation in November 2017. WET testing results of samples collected April 24, 26 and 30, 2018 passed; however, cooling preservation and holding times not met. Red River flow was slightly cloudy on day of this inspection (see Photo Log).**

Photographer: Erin Shea	Date: 09/11/2019	Time: 1345 hours
City/County: North of Taos and southwest of Questa / Taos County		State: New Mexico
Location: Red River State Fish Hatchery / NPDES Permit No. NM0030147		
Subject: Red River looking upstream from hatchery entrance bridge between Outfall 001 and Outfall 002. Receiving water was slightly cloudy.
