Sulphur Creek Watershed Wetlands Action Plan

December 2017

Los Amigos de Valles Caldera

New Mexico Environment Department Wetlands Program

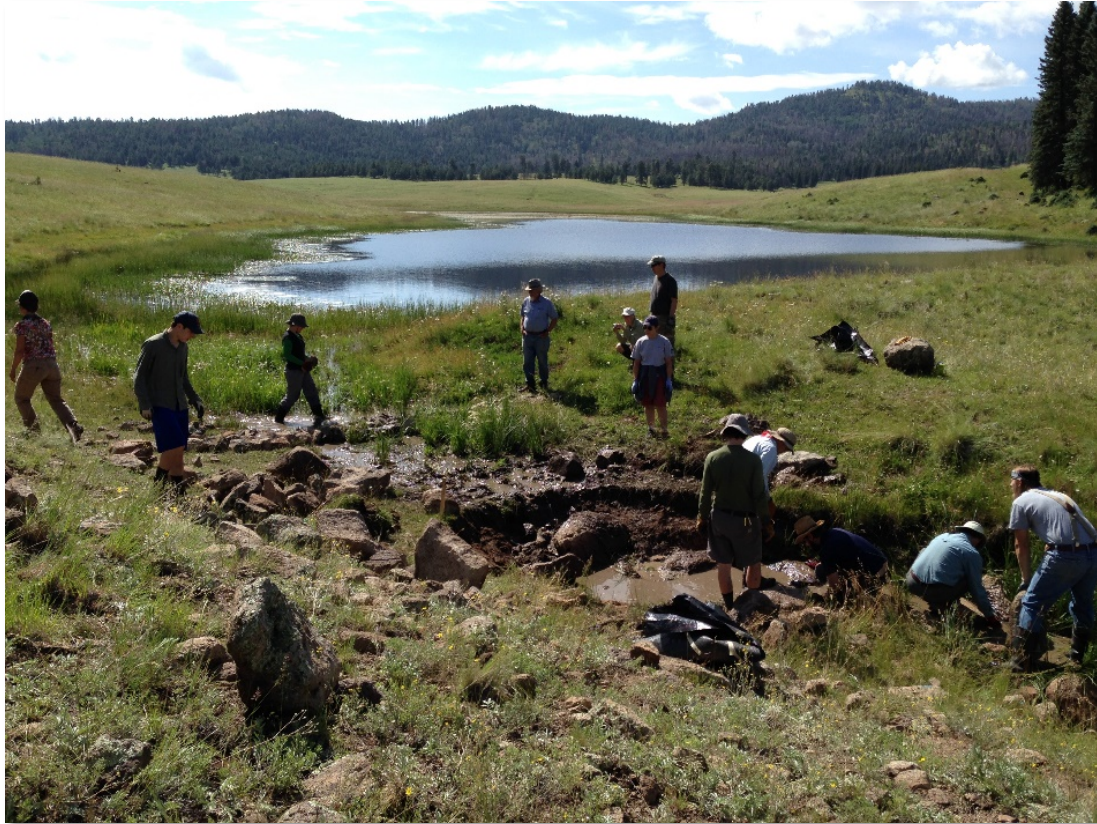
COVER PHOTO: Volunteers with Albuquerque Wildlife Federation building a series of one rock dams and zuni bowls to stop erosion below a large pond in Valle Seco. Photo courtesy of Kristina G. Fisher, 2015.

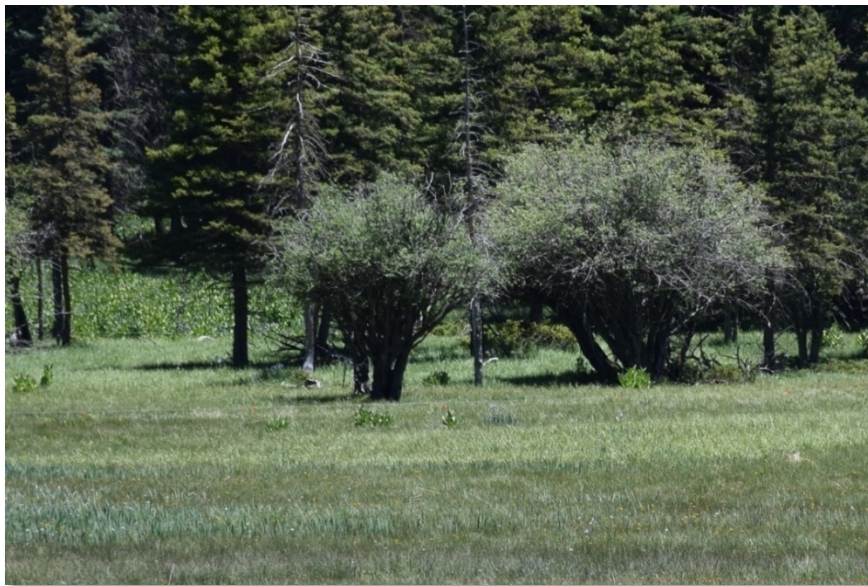
Figure 2-1. An historic willow stand in Valle Seco that shows effects of heavy browsing by elk. In 2016 a protective enclosure was built around these willows.

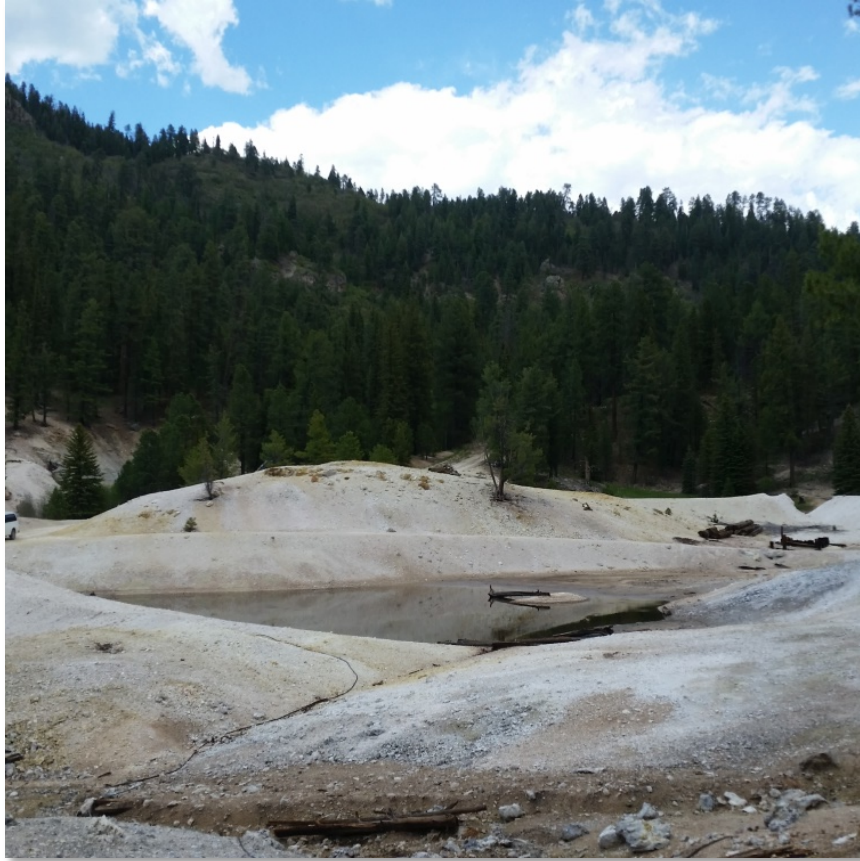
Figure 2-3. 40-acre private inholding along lower Sulphur Creek.

The Sulphur Creek headwaters and upper reaches of the watershed is public land, currently managed by VCNP, now part of National Park Service (NPS). Along lower Sulphur Creek there is a 40-acre private inholding within VCNP. This property is of interest to the NPS because of the unique geothermal and mineralized springs characteristics of this section. Elk Valley Property subdivision along lower Sulphur Creek is a residential/vacation home community with numerous private landowners. The lowest part of the watershed is public land administered by the United States Forest Service (USFS), Santa Fe National Forest, Jemez Ranger District. This WAP addresses most of the watershed that is owned and managed by the NPS.

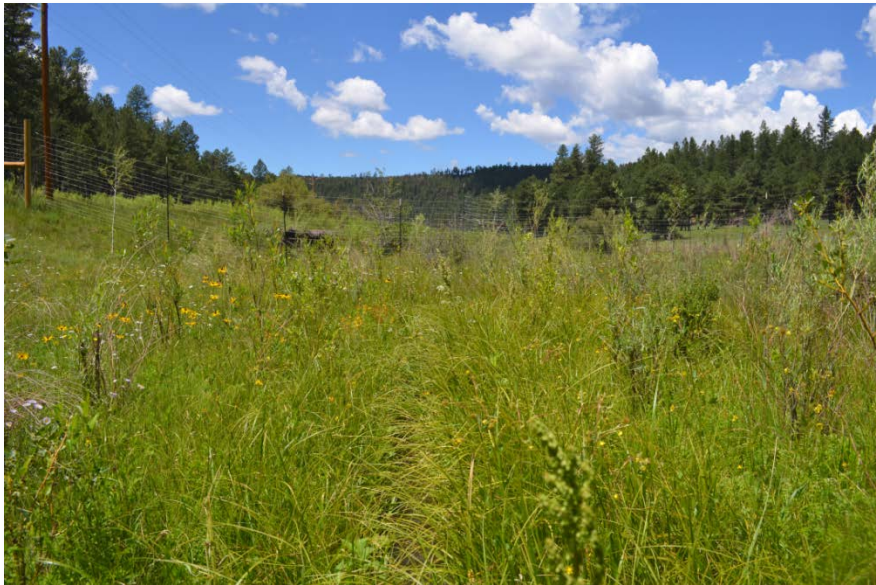
Figure 3-1. Riverine wetlands in the watershed typically consist of narrow bands along Redondo and Sulphur Creek where it is not too incised. Photo courtesy of WildEarth Guardians.

Riverine wetlands occur in floodplains and riparian corridors in association with stream channels. Dominant water sources consist of either overbank flow from the channel or from subsurface hydraulic connections between the stream channel and the wetlands. Additional water sources may consist of interflow and return flow from adjacent uplands; the occasional overland flow from adjacent uplands; from tributary inflow; and from precipitation.

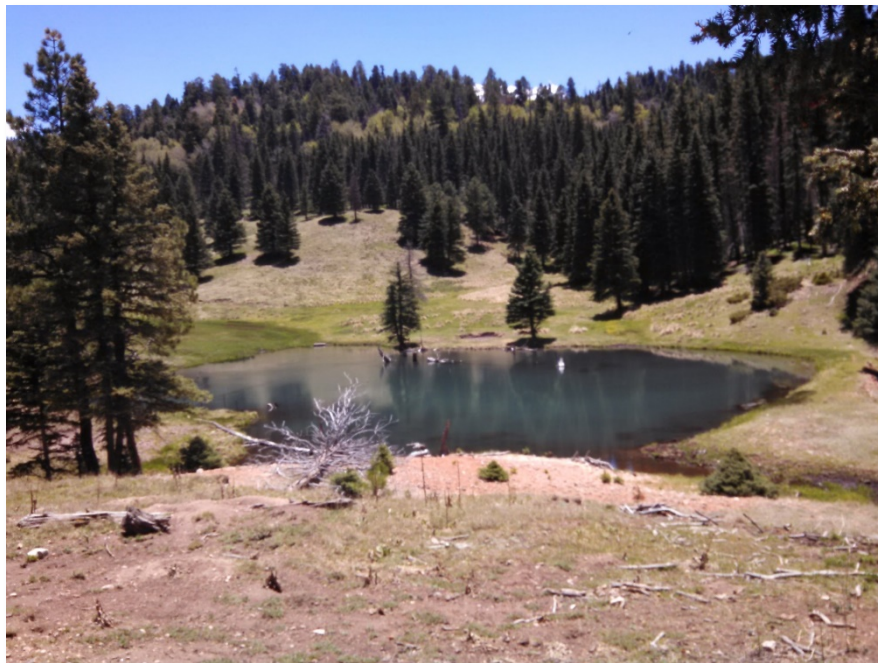
Figure 3-2. Depressional wetlands in Alamo Canyon. Depressional wetlands in the watershed occur as small historic stock ponds.

Depressional wetlands occur in topographic depressions with a closed elevation contour that allows surface water to accumulate. Precipitation, groundwater discharge, and interflow from adjacent uplands are the dominant sources of water for these wetlands. Since water normally flows from the surrounding uplands toward the center

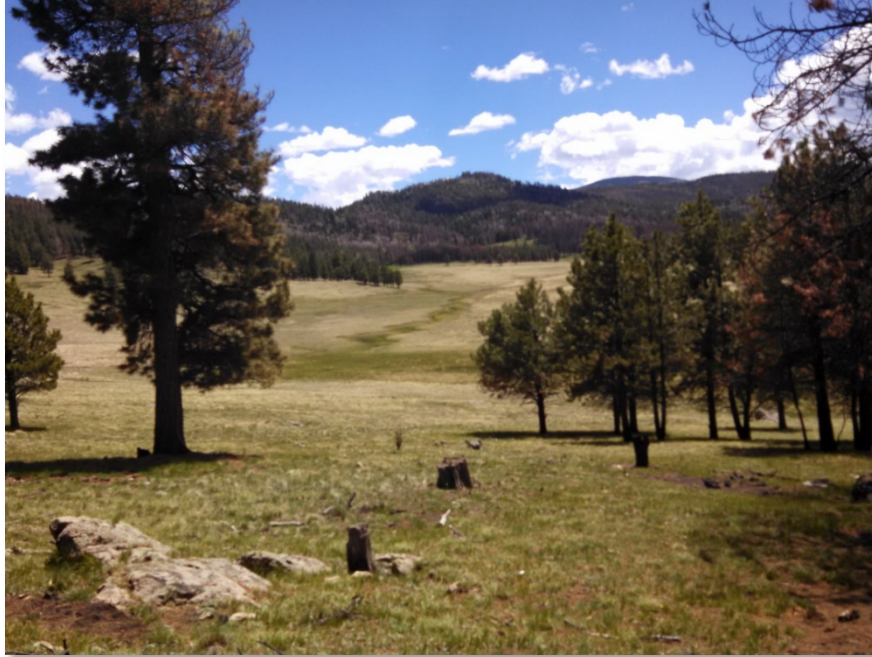
Figure 3-3. Slope wetlands in Tributary 1 of Valle Seco (2012) prior to restoration (thin ribbon of dark green in center of photo). Construction of water-spreading structures (e.g. plug and pond structures, worm ditches and media lunas) subsequently expanded the slope wetland acreage across the valley.

Slope wetlands are normally found where there is a discharge of groundwater to the surface of the land. Elevation gradients may range from steep hillsides to gentle slopes. Principal water sources are usually from the return flow of groundwater, interflow from surrounding uplands, and precipitation. If groundwater discharge is a dominant water source, slope wetlands can occur in nearly flat landscapes.

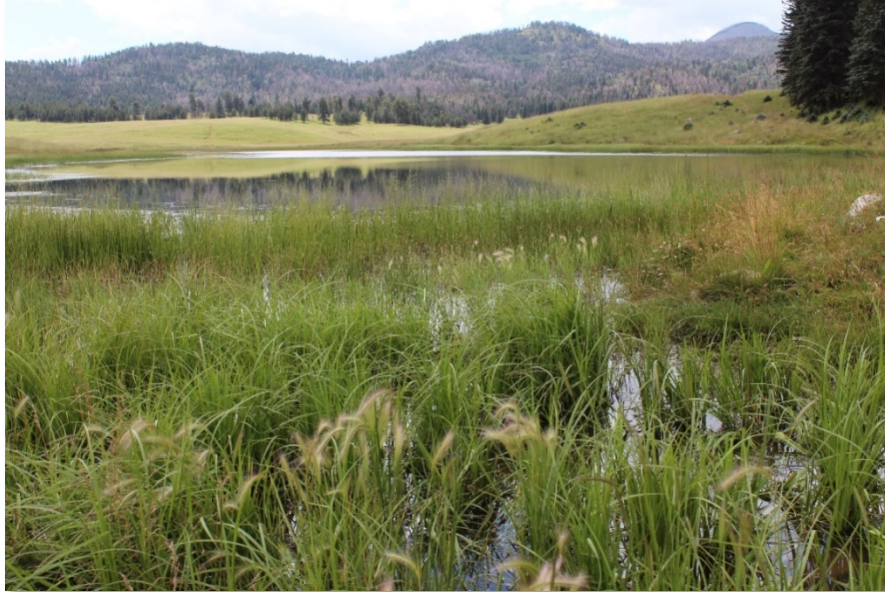
Figure 3-4. Palustrine (pond) fringe wetlands around a large stock pond in Valle Seco that is frequented by water fowl. Raising the spillway level by six inches with a one-rock dam expanded these wetlands.

Palustrine (Pond) fringe wetlands are adjacent to ponds where the water elevation of the pond maintains the water table in the wetland.

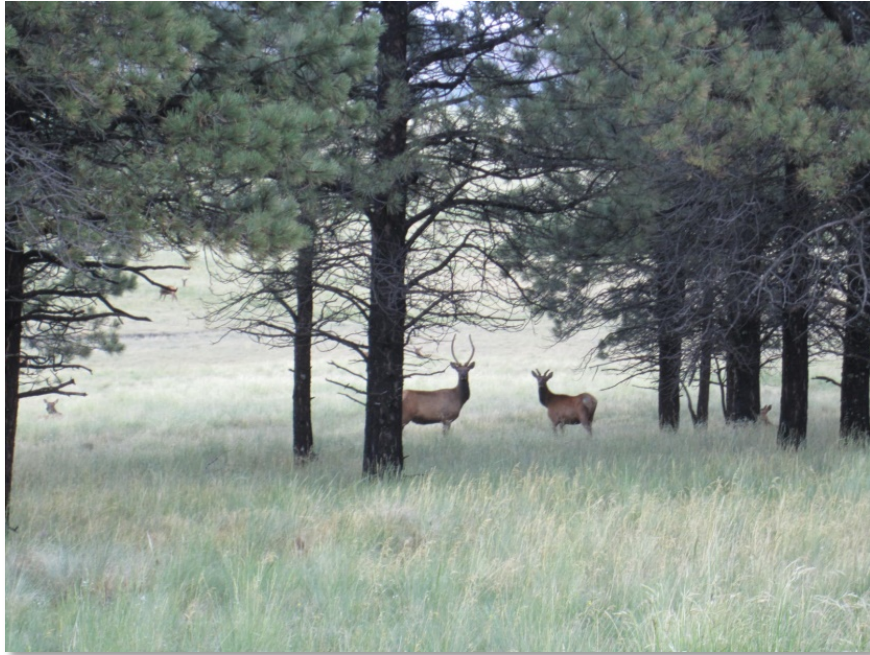
Figure 4-1. Elk grazing in the Sulphur Creek Watershed.

Large Elk herds on VCNP have also impacted wetlands by disturbing soil, wallowing and overgrazing in riparian areas. Overgrazing reduces wetland vegetation and initiates or exacerbates erosion, including the development of headcuts and pedestals in wetlands and the decimation of woody vegetation (Zeedyk et al., 2014). However, even though the elk herds are large in the Preserve, elk move more frequently than cattle do, due to predation.

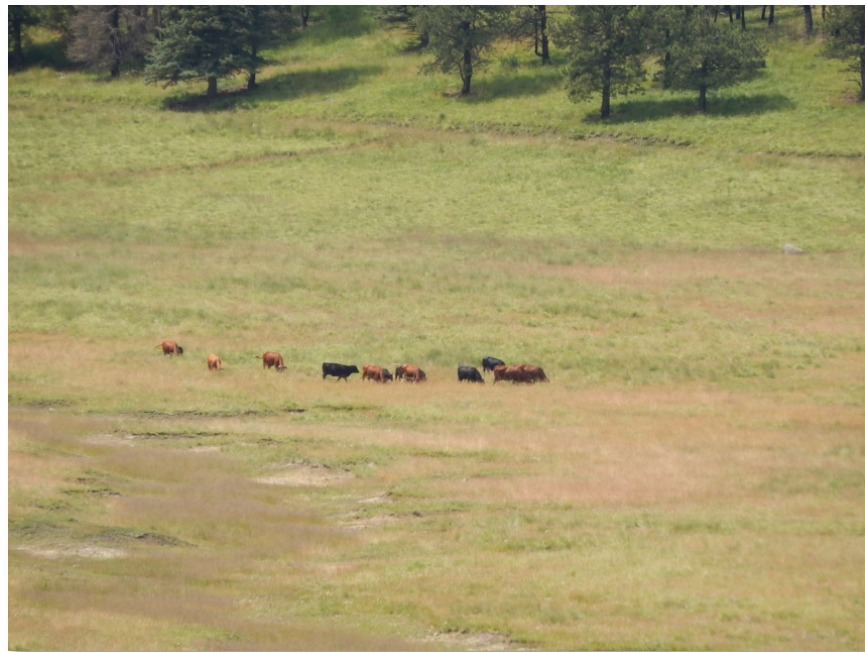
Figure 4-2. Cattle grazing in Valle Seco, July 2015.

Grazing on the Baca Ranch occurred since late in the 19th century. Sheep were grazed until about 1940, when cattle were introduced. There are about 30,000 acres of grassland on the Preserve. During the 1950-1960s, approximately 12,000 head of cattle grazed on the Baca Ranch annually. From the late 1960s through 1999 approximately 5,000-6,000 head were grazing the grasslands annually (Anchuetz and Merlan, 2007). When the Valles Caldera National Trust took over management of the Preserve in 2000, livestock grazing continued as part of the experimental management policy but with reduced numbers. Approximately 700 head of cattle grazed each year between 2000 and 2016. Currently, cattle grazing is not permitted in the Sulphur Creek Watershed. This is a recent development (2016) and the wetlands are now just starting to recover from historic grazing effects. (personal communication, Jorge Silva-Bañuelos, Superintendent VCNP, 2017)

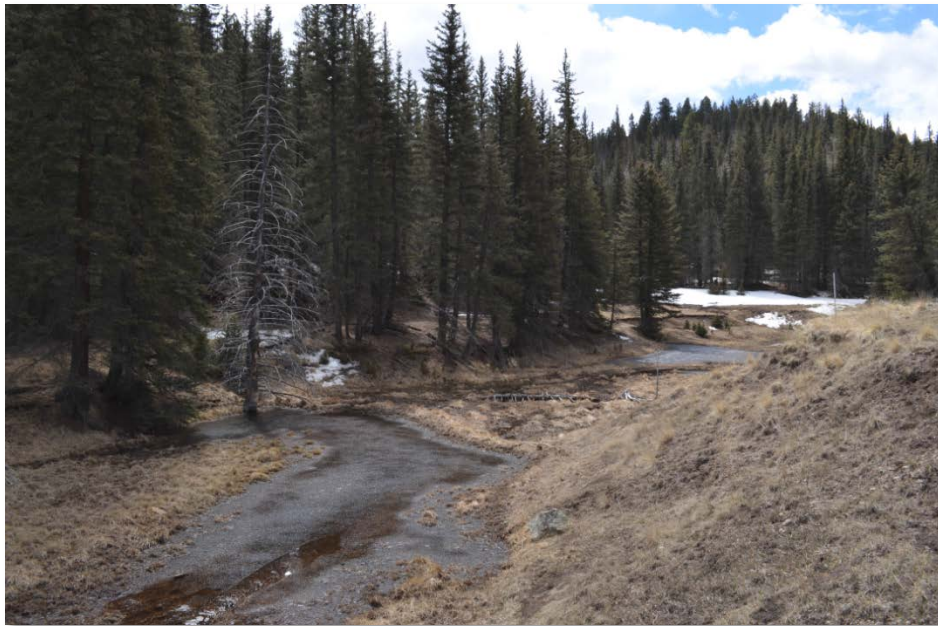
Figure 4-3. In this April 2013 photo, historic beaver activity is visible along lower Sulphur Creek where old beaver dams appear as berms across the creek valley. Photo courtesy of WildEarth Guardians.

Beavers were present historically in the Valles Caldera area as indicated by a 2006 survey (Sperry et al., 2006). Beaver trapping was an historic economic activity that decimated beaver populations. In Sulphur Creek, there are intact beaver dams, beaver-gnawed stumps and downed trees, but beaver are no longer present in the watershed. Beaver dams provide many benefits including: improving water quality, storing surface water and ground water, reducing downstream flood impacts and providing habitat to diverse terrestrial, avian and aquatic species. There is a strong correlation between the presence of beavers and the health and abundance of wetlands; conversely, wetlands areas can become degraded as the water table drops after beaver dams are removed from an area. The extirpation of beavers from the Sulphur Creek Watershed indicates the loss of these ecosystem services.

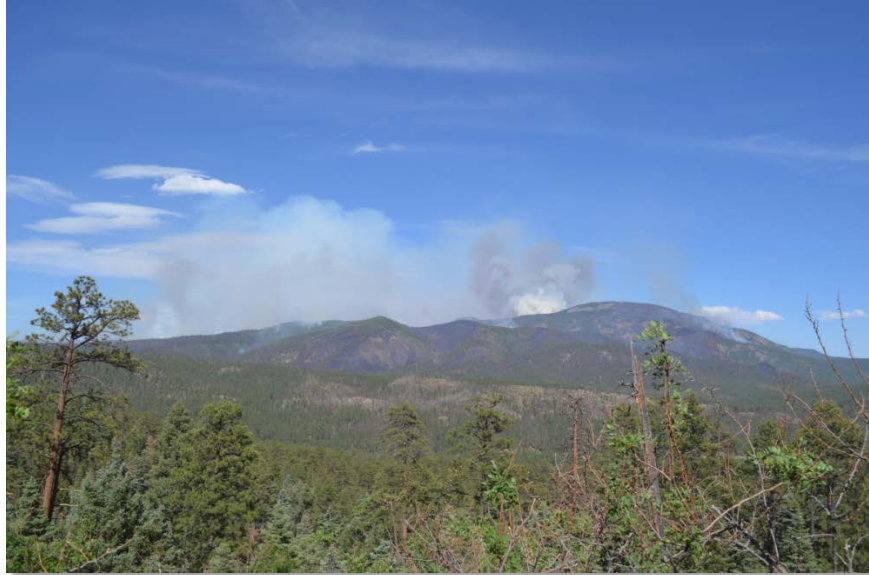
Figure 4-5. Thompson Ridge Fire, June 11, 2013 burning on Redondo Peak. Photo courtesy of WildEarth Guardians.

Wildfires can cause water quality impairments, particularly turbidity, sedimentation, and temperature impacts. The Thompson Ridge fire occurred in June 2013. The fire was human-caused and burned 23,965 acres of grass, ponderosa and mixed conifer within the fire perimeter (InciWeb, July 3, 2013).

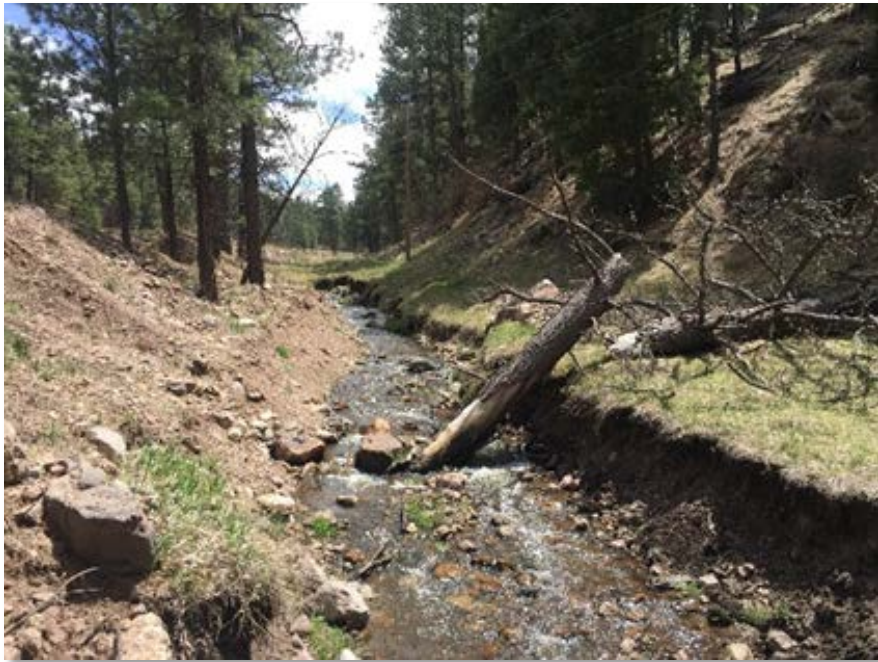
Figure 4-6. Scour along Redondo Creek that occurred from post-fire flooding after the Thompson Ridge fire. Photo courtesy of WildEarth Guardians.

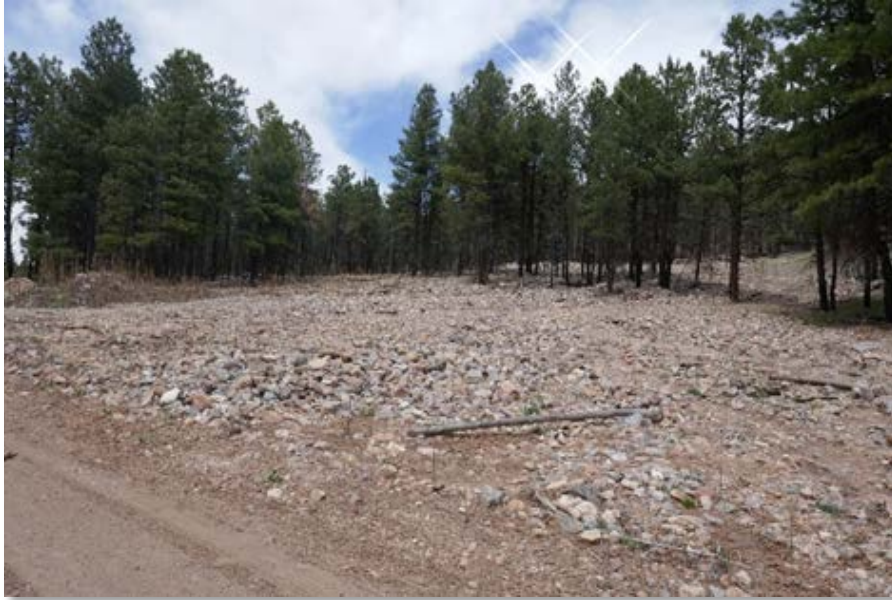
Figure 4-7. Sediment deposition along Redondo Creek after the Thompson Ridge fire. Photo courtesy of WildEarth Guardians.

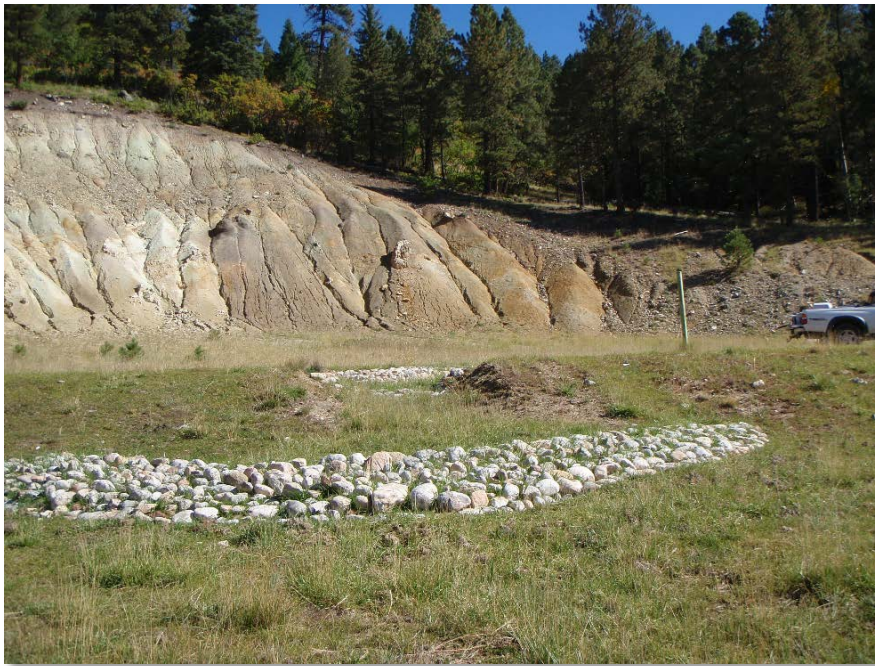
Figure 5-1. Media luna on the main well pad in Alamo Canyon, 2010. Photo courtesy of Steve Vrooman.

In 2007-2008, Los Amigos conducted an innovative wetlands restoration project in Alamo Canyon. Geothermal exploration conducted in the past created steep, eroding slopes due to road development and well pads that were depositing sediment to the valley. This was the first project that Los Amigos and NMED applied innovative structures used to control erosion, reverse headcutting and gullying and protect and restore wetlands including fens. See Figure 5-1. The restoration design was created by Zeedyk Ecological Consulting. Table 5-1 summarizes the structures built.

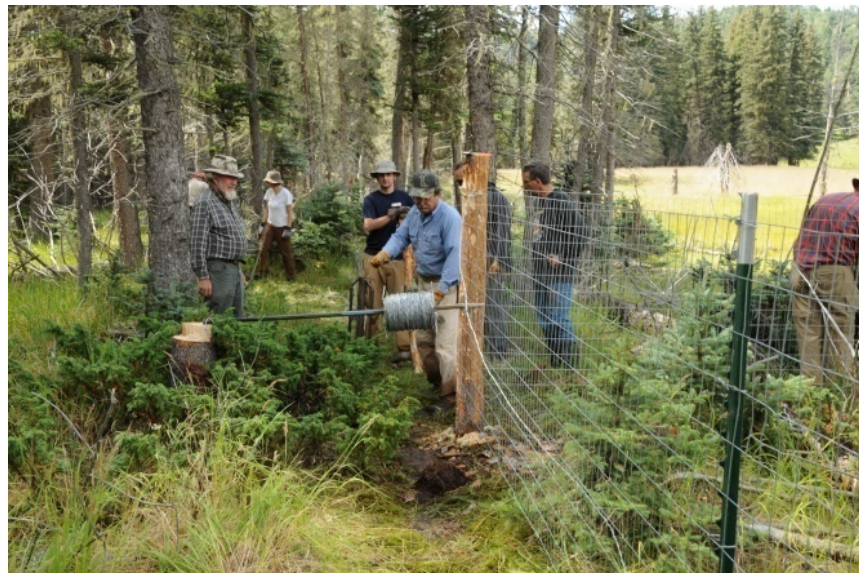
Figure 5-2. Los Amigos de Valles Caldera volunteers installing fence to protect Bog birch.

The project included construction of exclosures by volunteers to protect habitat for the rare Bog birch (*Betula pumila*); 35 people participated in this endeavor. See Figures 5-2 and 5-3. The project was funded by federal CWA Section 104(b) (3) Wetlands Program Development funds.

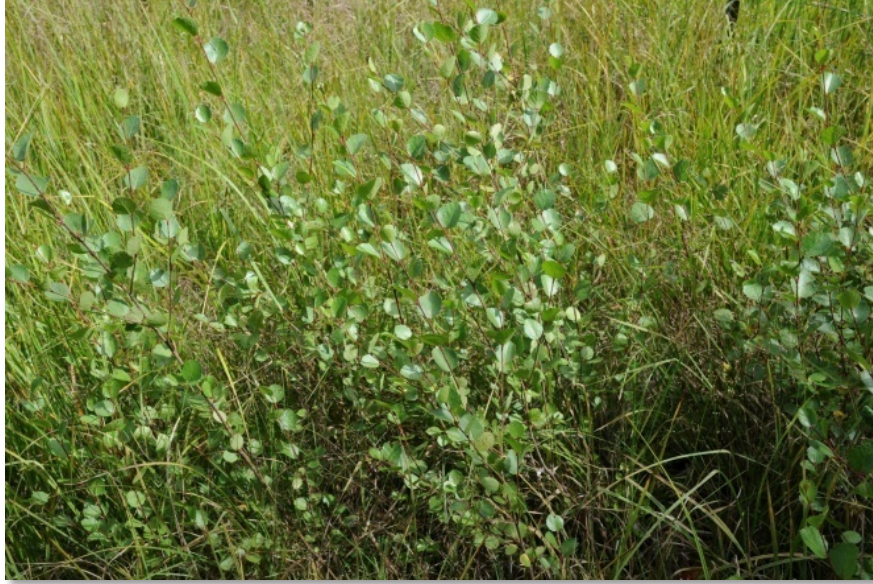
Figure 5-3. Regeneration of Bog birch.

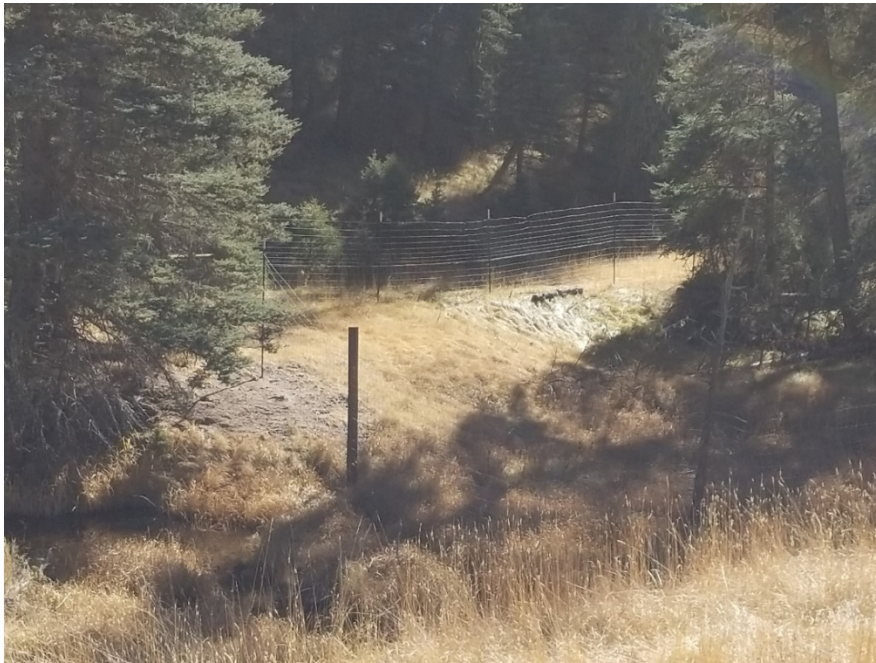
Figure 5-4. Elk exclosure along Sulphur Creek below Alamo Canyon.

In 2012-2013, WildEarth Guardians constructed elk exclosures and planted woody vegetation species along Sulphur Creek downstream of Alamo Canyon. At this location, there are intact (but unoccupied) beaver ponds. The project was funded by the State of New Mexico River Ecosystem Restoration Initiative (RERI).

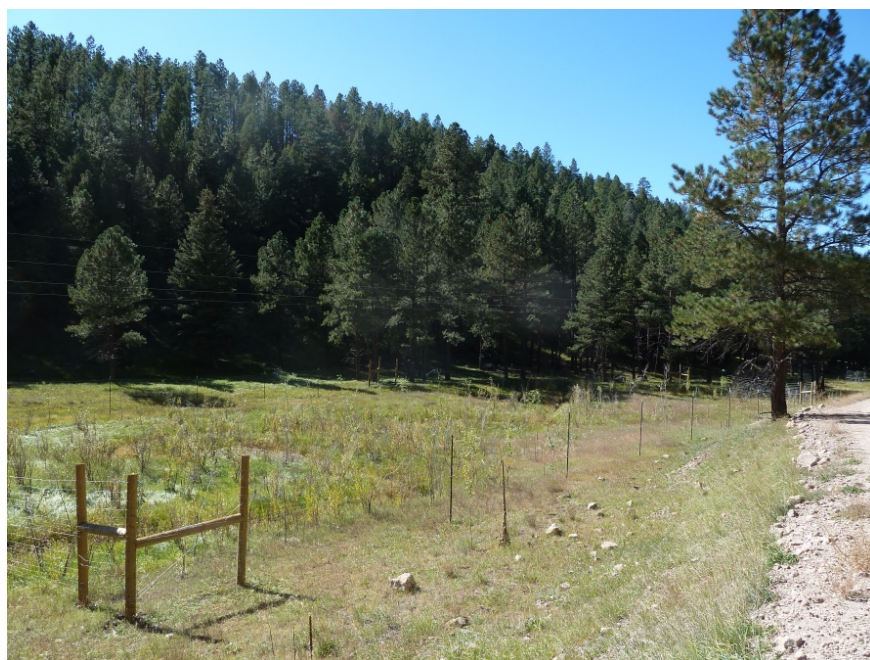
Figure 5-5. Elk exclosure along Redondo Creek.

In 2010-2013, WildEarth Guardians constructed elk exclosures and planted woody vegetation species along two miles of Redondo Creek. Fifteen large exclosures and several small exclosures were constructed; 15,000 willows, 600 cottonwoods, and 500 riparian forage species were planted. The project sustained moderate damage following large flows post-Thompson Ridge Fire, including altering the channel and its streambanks, causing planted vegetation to be washed away, and damaging the exclosures. The project was funded by State of New Mexico RERI funds.

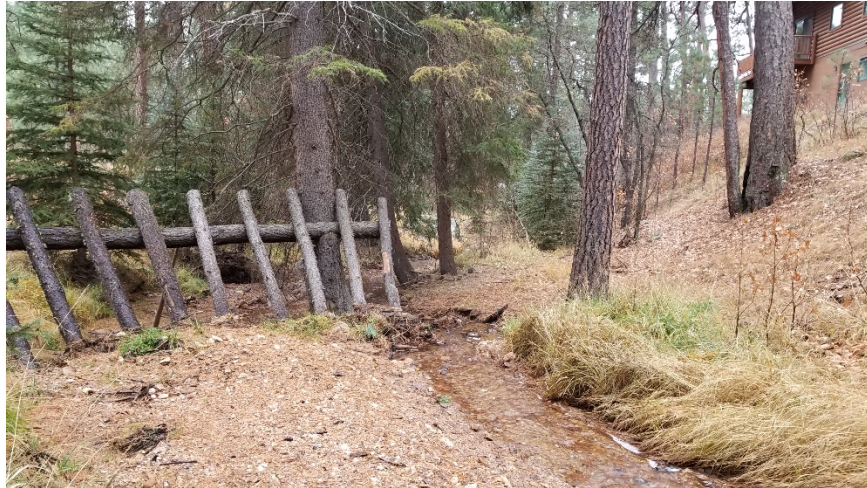
Figure 5-6. Trash rack built by the BAER Team to catch debris along lower Sulphur Creek after the Thompson Ridge Fire. Photo courtesy of Jim Counce.

Post-Thompson Ridge Fire BAER treatments were completed by July 13, 2013 and included cutting and removing burned trees near roads and buildings throughout the burned area including the historic cabins in VCNP. The trees were anchored into place to serve as barriers to redirect flood waters and debris away from the cabins. Debris was removed from creeks, streams, roads and arroyos. This wildfire occurred before the expected monsoon and floods carrying ash, sediment and debris would be hazardous. Scheduled aerial rehabilitation operations dropped seed over specified areas above homes in the Sulphur Creek area. The seed mix included annual barley. Water control features were placed on roads and trails to minimize damage and log trash racks were installed in Sulphur Creek to catch post-fire debris (InciWeb, July 31, 2013).

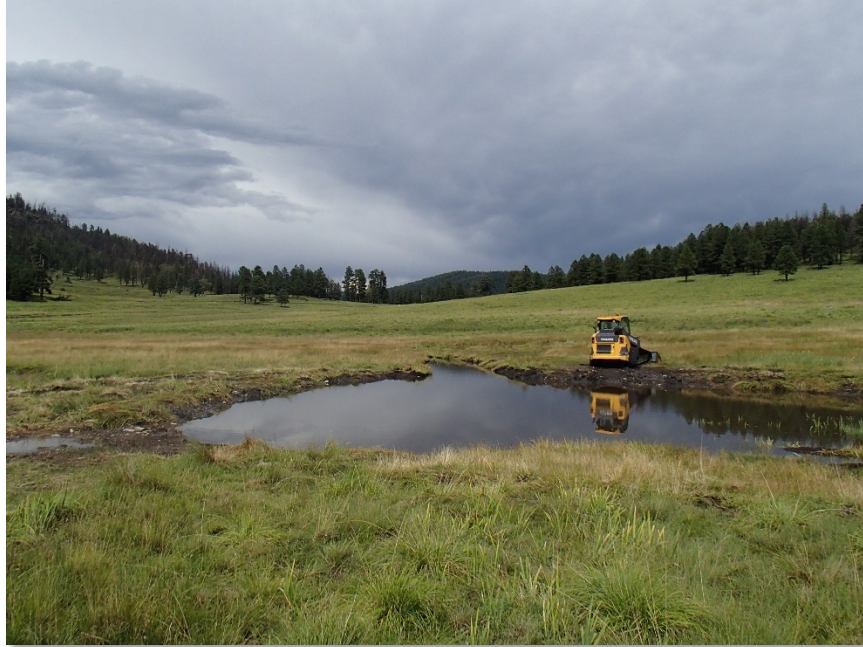
Figure 5-9. Plug and pond treatment in Valle Seco just after construction. Photo courtesy of Steve Vrooman, 2016.

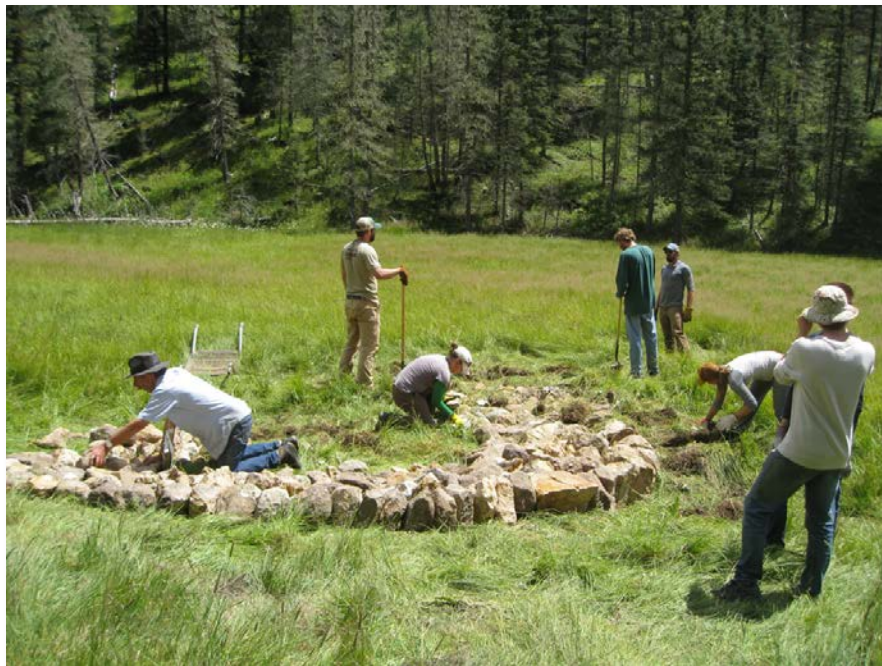
Figure 5-10. Volunteers building a media luna along Sulphur Creek. Photo courtesy of Albuquerque Wildlife Federation.
