Upper Pecos Watershed Wetland Action Plan

Submitted by the Upper Pecos Watershed Association

New Mexico Environment Department

Contract ID # 13-667-5000-005

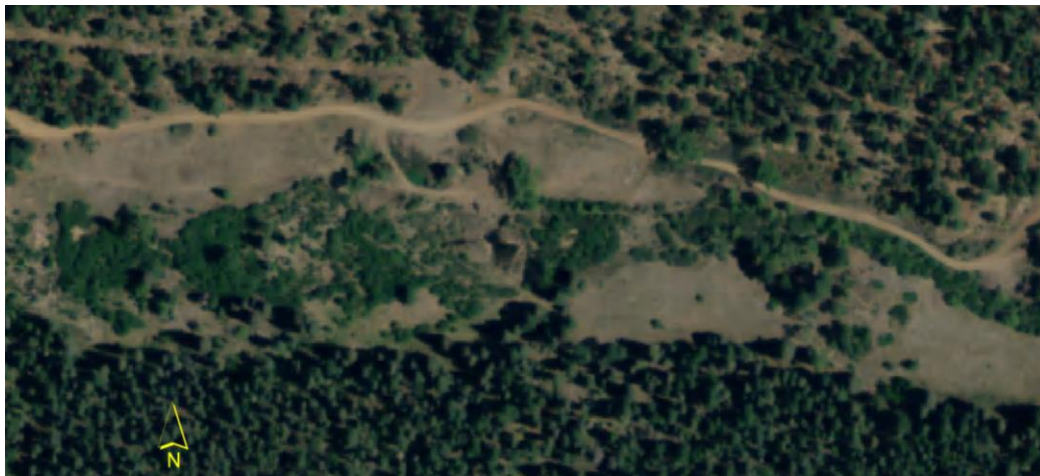
Figure 8. Dalton Canyon repeat photography from 1935 (top) 1996 (middle) and 2011 (bottom). Note open, braided floodplain and hill slopes in 1935, large flood beaver ponds in 1996, and lack of open water in 2011.

The Soil Conservation Service began aerial photography within the watershed in the 1930s. Individual images are available from the Earth Data Analysis Center (<http://edac.unm.edu/>) in Albuquerque for small a fee. These early aerial photographs, combined with ground based repeat photography, create a picture of the watershed not readily obtained from written reports or other sources. Comparing historic photographs to recent images, a trend emerges of reduced wetland and mountain meadow acreage with a concomitant increase in coniferous species. The confluence of Bull and Cow Creek (Figure 6) is a good example of this trend. The following pages show similar trends at the Pecos NHP, and Dalton Canyon (Figures 7 and 8).

◆ *Dalton Canyon Beaver Ponds.* Dalton Canyon historically supported a population of beavers who maintained a series of ponds. (Figure 8, page 20). Aerial photograph analysis has shown that in the past 15 years the ponds have gradually diminished. Site visits in May 2013 demonstrated that there is little recent beaver activity in the vicinity of the ponds or further downstream.

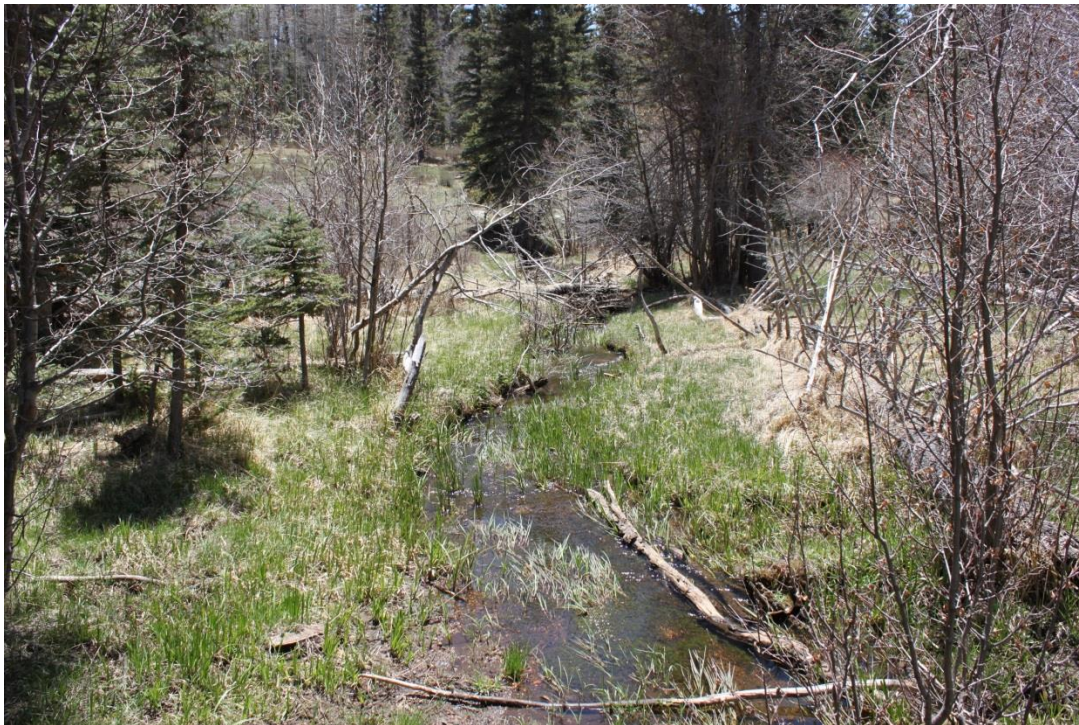
Figure 10. Riverine wetland type in excellent condition along upper Bull Creek.

Riverine wetlands occur in floodplains and riparian corridors in association with stream channels. Dominant water sources are overbank flow from the channel or subsurface hydraulic connections between the stream channel and wetlands. Additional water sources may be interflow and return flow from adjacent uplands, occasional overland flow from adjacent uplands, tributary inflow, and precipitation.

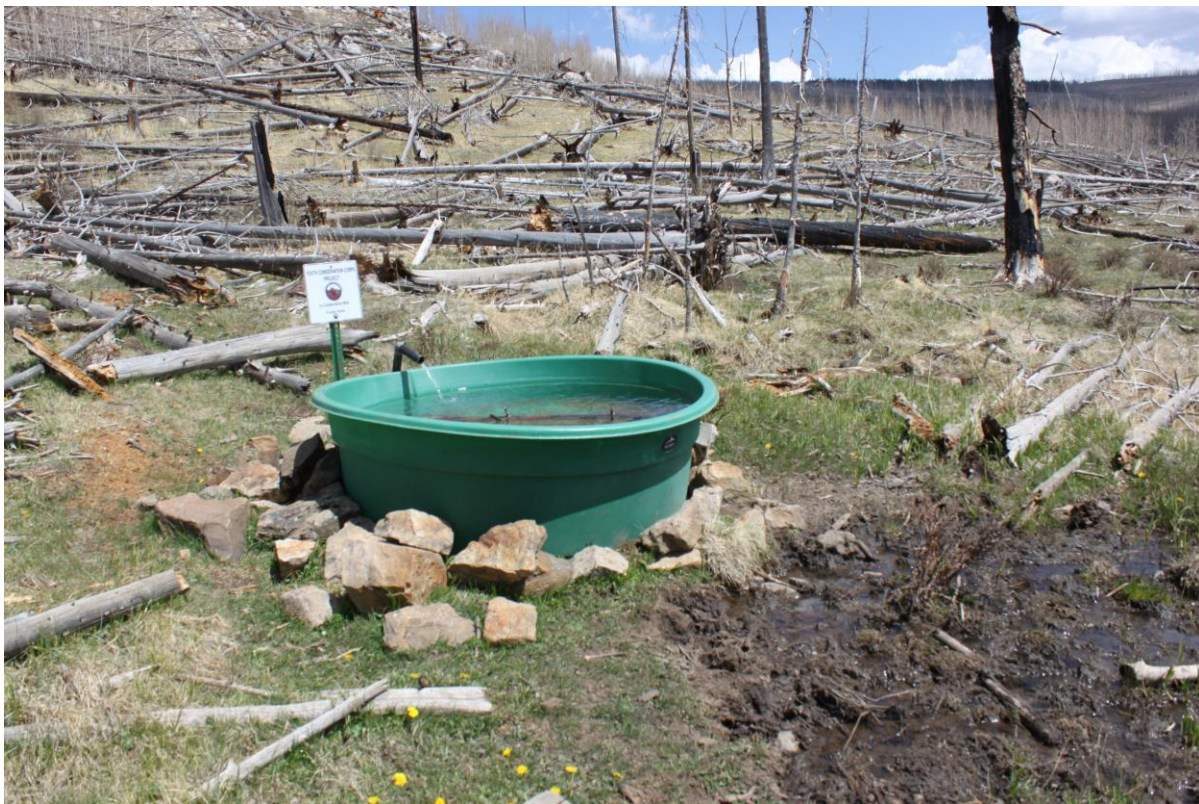
Figure 11. Slope wetland type being piped into a livestock-wildlife tank. Wetland is at high elevation within 2000 Viveash fire.

Slope wetlands are normally found where there is a discharge of groundwater to the land surface. Elevation gradients may range from steep hillsides to gentle slopes. Principal water sources are usually groundwater return flow, interflow from surrounding uplands and precipitation. Slope wetlands can occur in nearly flat landscapes if groundwater discharge is a dominant water source. They lose water primarily by saturation subsurface, surface flows and by evaporation. Springs are an example of slope wetlands in New Mexico.

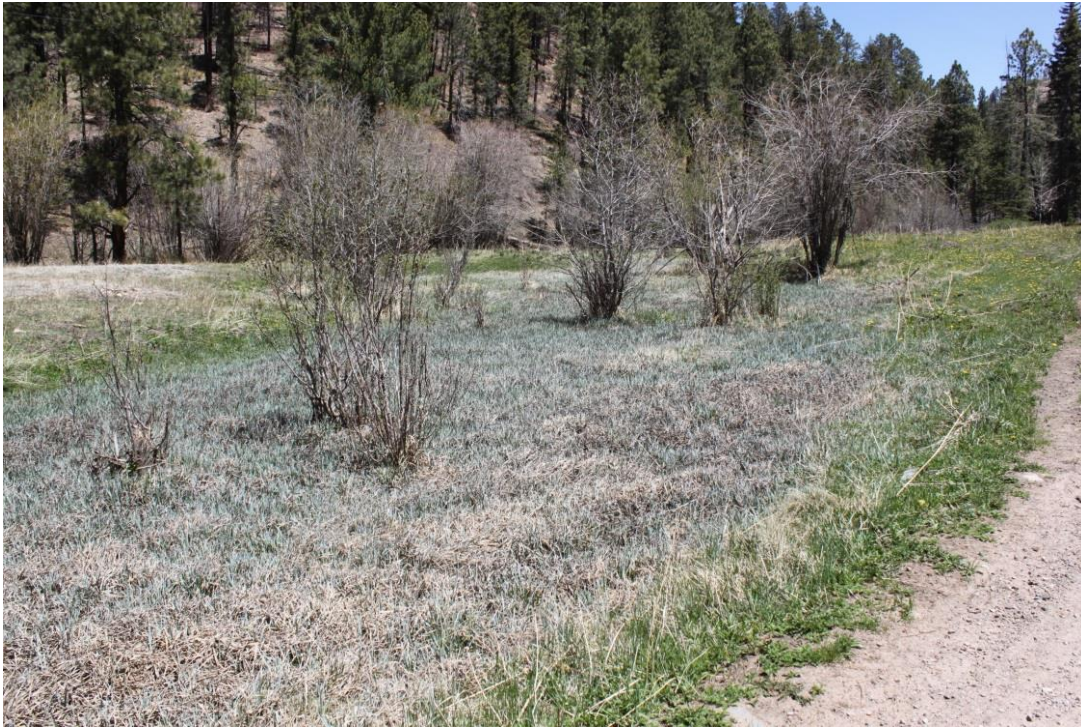
Figure 12. PEM1B wetland type at mid elevation near Cow Creek.

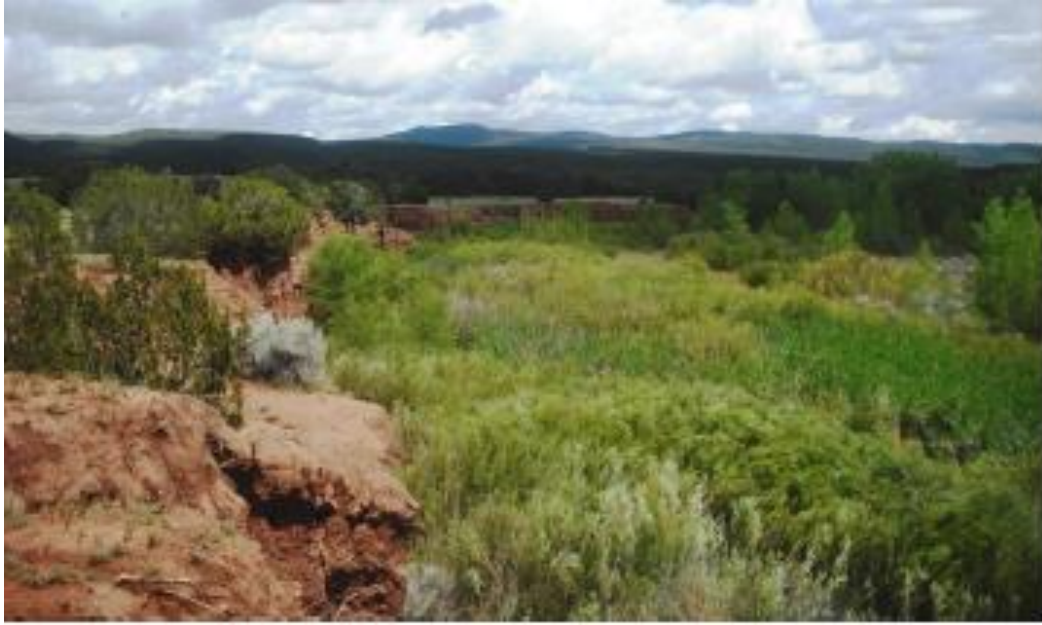
Figure 13. Restored low-elevation willow dominated wetland along lower Glorieta Creek within Pecos National Historic Park. Photo credit: Joel Wagner, National Park Service.

Palustrine Scrub-Shrub Broad leaved Deciduous Temporarily Flooded/Saturated. These are willow and alder-dominated wetlands. They typically are found in river drainages and creek bottoms, but may be found occasionally in isolated wetlands not connected to flowing surface water. These wetlands serve a vital hydrologic function along streams by slowing floodwaters, preventing stream bank erosion, cooling the water via shading and contributing leaf litter to the water which serves as food for aquatic invertebrates. They are also prime habitat for migratory song-birds that use the dense vegetation for nesting and foraging.

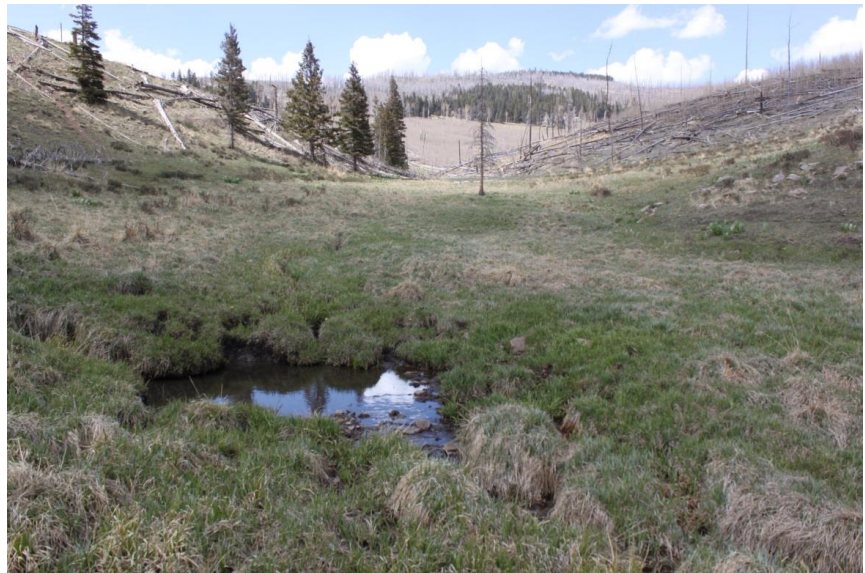
Palustrine Emergent Persistent Seasonally Flooded. This wetland type is generally wetter and less common than the PEM1B/A type, although they share similar vegetation characteristics. This type is wetter for longer periods of time during the growing season. This wetland type is often found at the head of small creeks and serves as the “source” for the water. *Figure 14. PEM1C wetland type near 10,000 feet*

The wetland serves to absorb the snowmelt each spring and gradually release it downstream during the spring and summer.

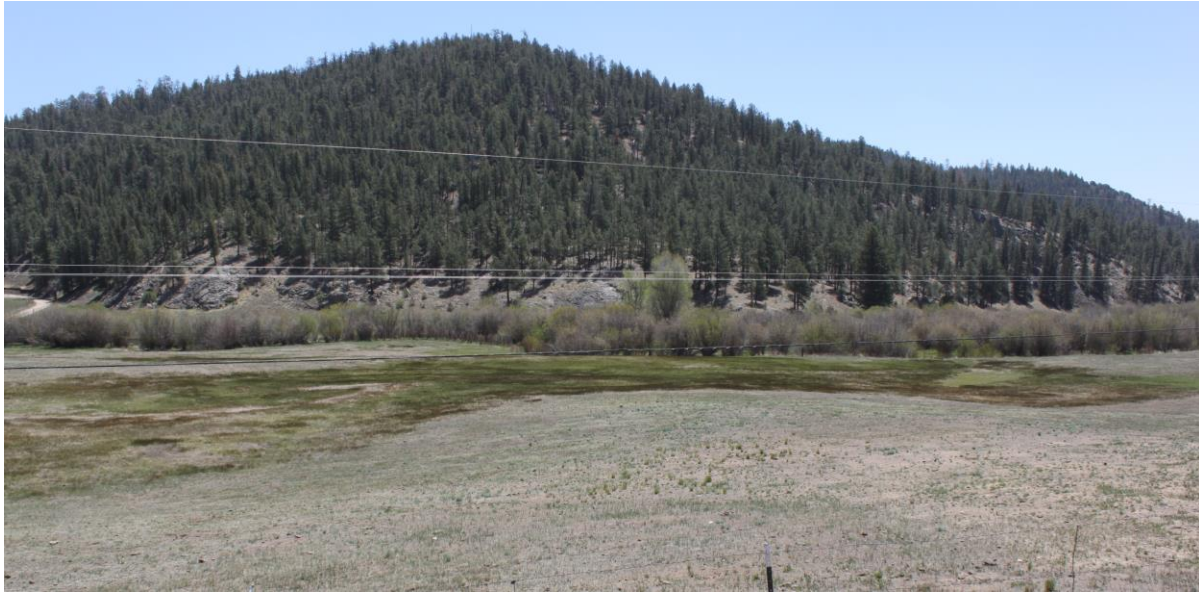
Figure 15. PEM1C wetland type along Cow Creek. Note dark green vegetation denoting persistent saturation and wetland vegetation

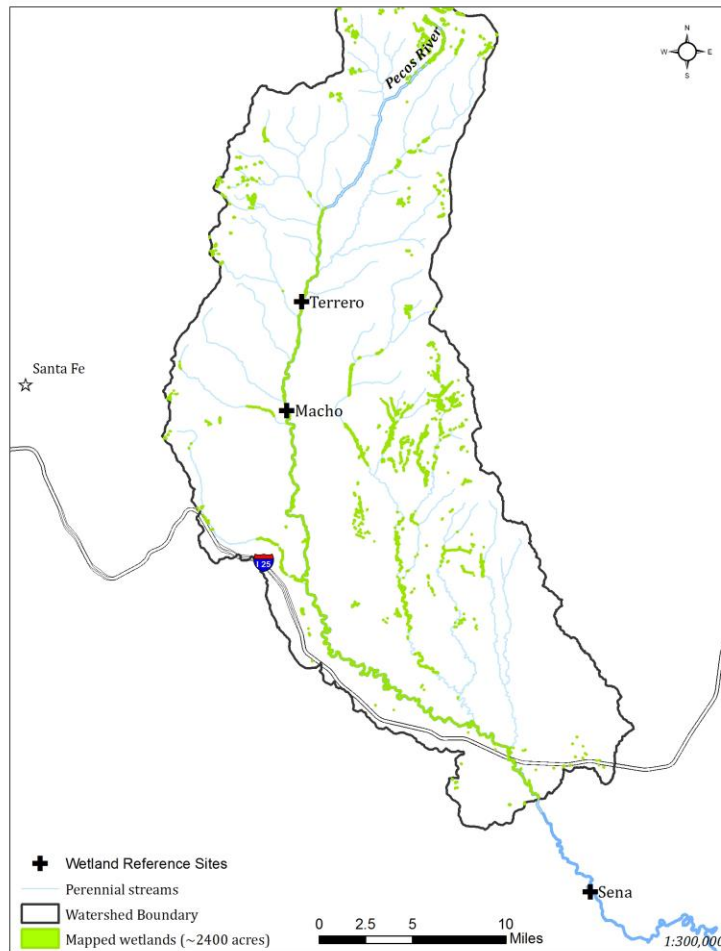
Figure 16. Location of NMHP wetland reference sites.

The uppermost reference site is just north of the Tererro general store. It was graded B+; “Overall, direct impacts are minimal and wetland communities are in good condition.”

Moving downstream, the next reference site is near El Macho. This site was grade B and described as “Overall, wetland communities are undisturbed, diverse, and well-developed. The hydrologic regime of the site is affected by upstream mine activity, the highway, and irrigation diversions. Finally, the Sena site lies just outside of the defined limits of the upper Pecos watershed boundary, but it does, nevertheless, give insight into the condition of the lower portion of the watershed. Sena was rated C+; “Impacts to this site are fairly extensive and affect community condition. Threats to this site include Russian olive encroachment and further fragmentation from agriculture.” These three wetland reference sites show a trend toward decreasing wetland condition moving down the watershed as human development and pressures on the river increase and accumulate. These three wetland sites have not been reevaluated since their original inventory in 1998 (Esteban Muldavin, personal communication).

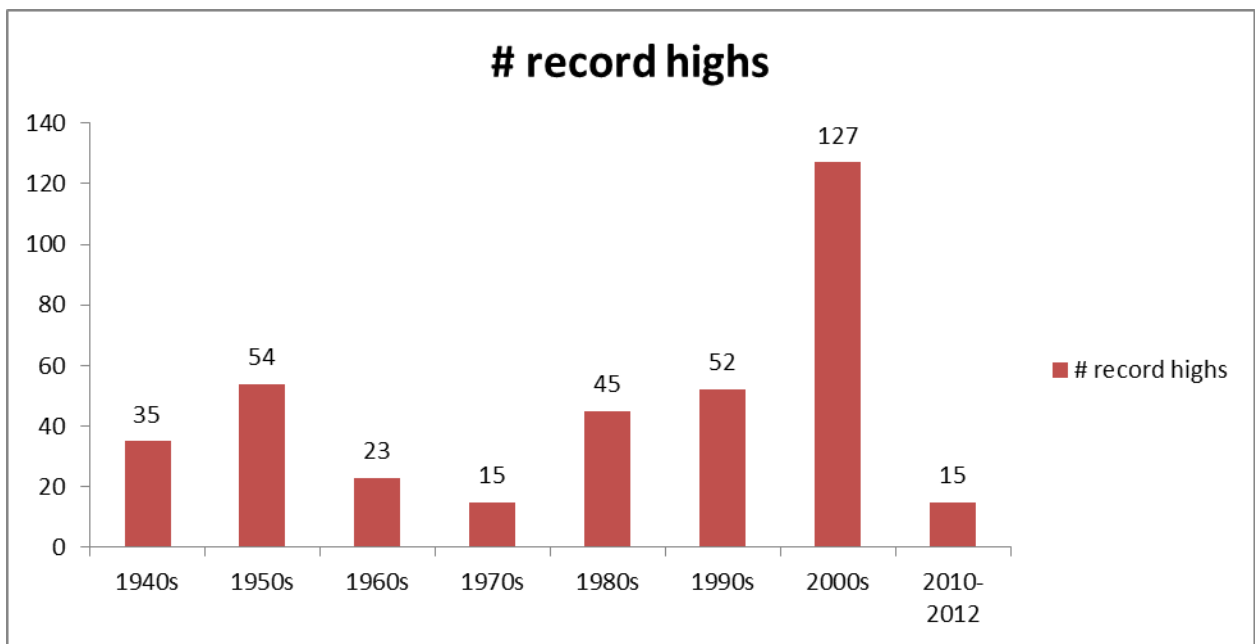
Figure 17. Distribution of record high temperatures by decade from the Pecos weather station. Data source: Western Region Climate Center.

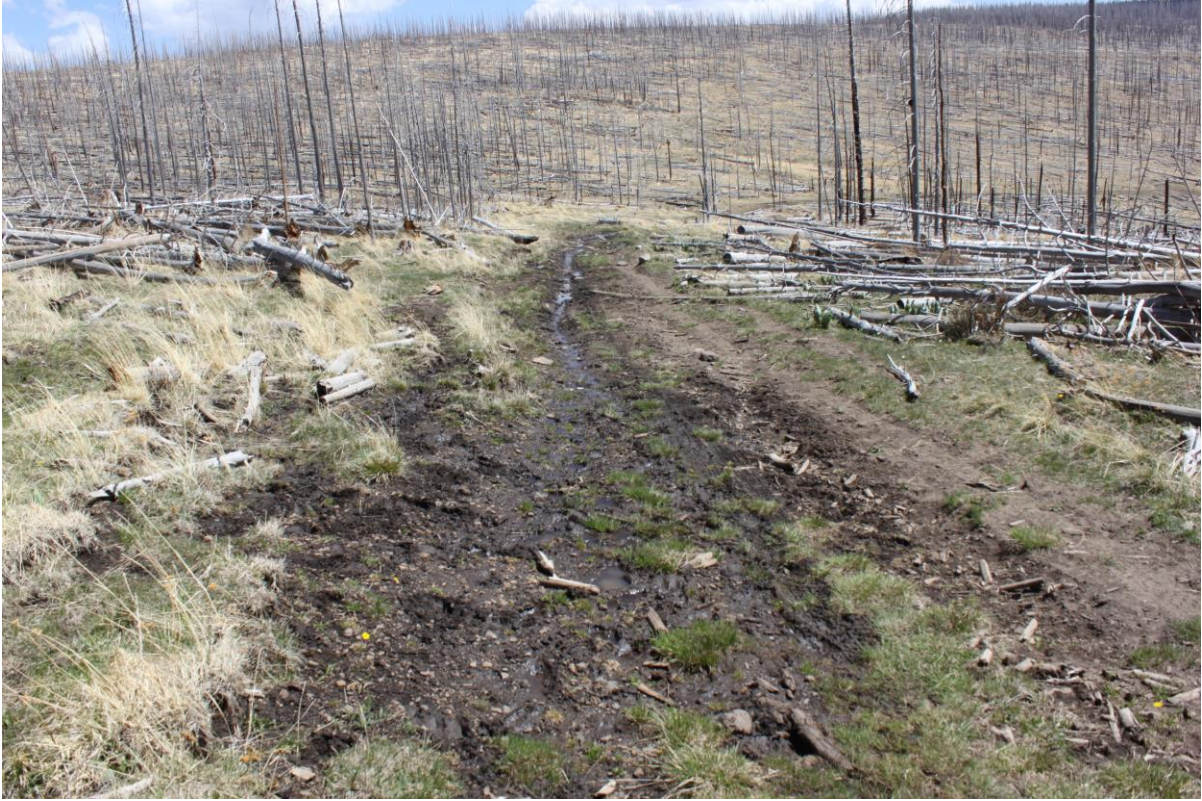
Figure 18. Slope type wetland at high elevation wetland with poorly sited road cutting bisecting the water flow.

Roads and trails should be built to avoid wet areas whenever possible. Road cutting through wet areas, particularly on hill slopes, can intercept surface and groundwater moving downslope (Figure 18). Water caught on the road is conveyed down the road, gathering velocity. If it

cannot be suitably discharged into an open sink or depression, the water will often form its own outlet causing head cutting and erosion at the outlet, as well as downstream.

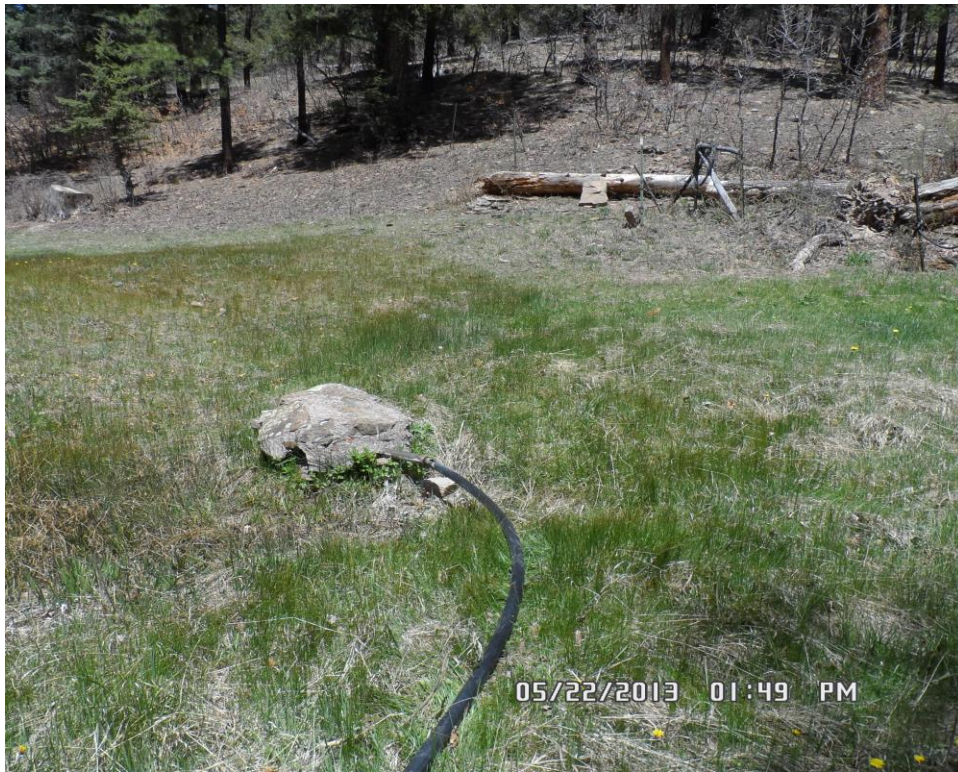
Figure 19. Surface water spring and associated wetland near Grass Mountain Summer Homes. This spring serves as a household water supply for many residents.

is a small concrete collection box and a pipe to move the water to the road. Currently, the wetland is in good condition, but there is dispersed camping nearby and reports of ORV trespass through the wetland. This project would require simple pipe fencing to prevent damage to the spring and collection point.

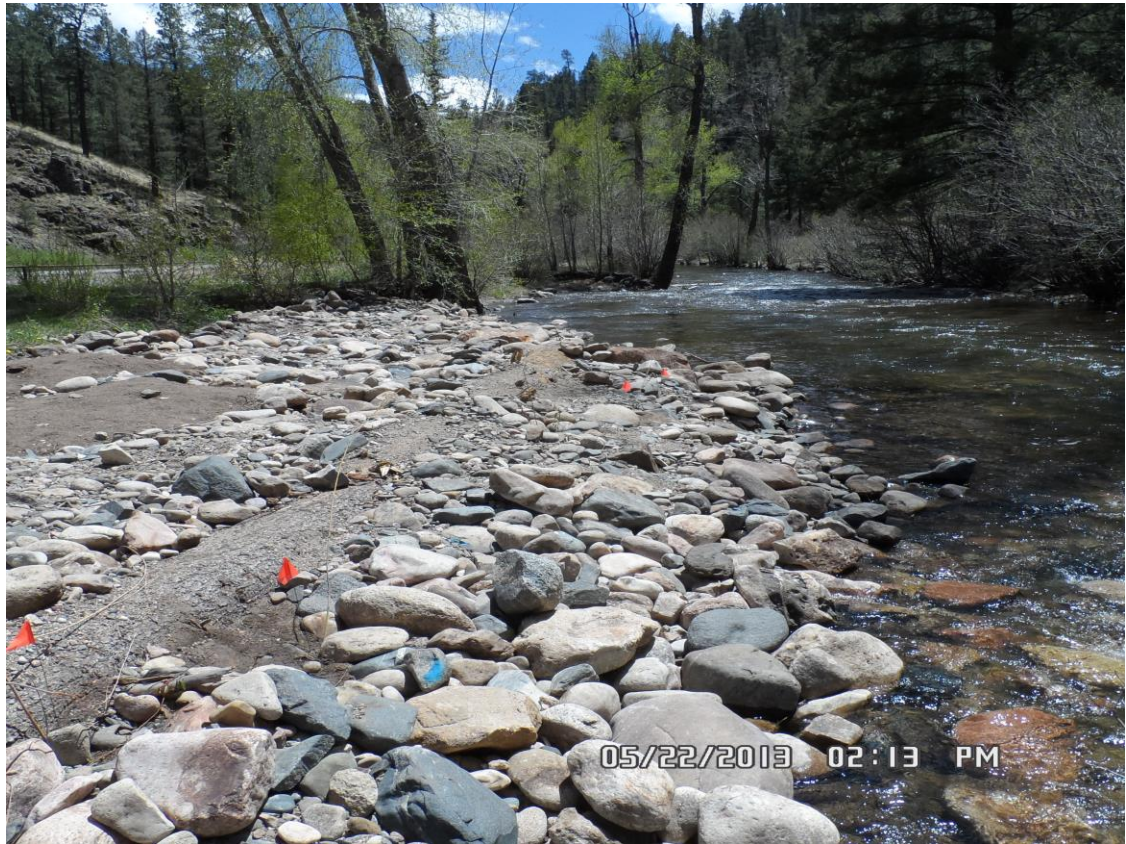
Figure 20. Streambank and riparian habitat improvement along the Pecos River near the Rio Mora confluence. Stream was narrowed, creating a wider planting zone for riparian vegetation.
