## NEW MEXICO ENVIRONMENT DEPARTMENT

Re: Major Municipal; SIC 4952; Compliance Evaluation Inspection; Farmington Wastewater Treatment Plant; NPDES Permit No. NM0020583; August 13, 2014

### NPDES Compliance Inspection Report

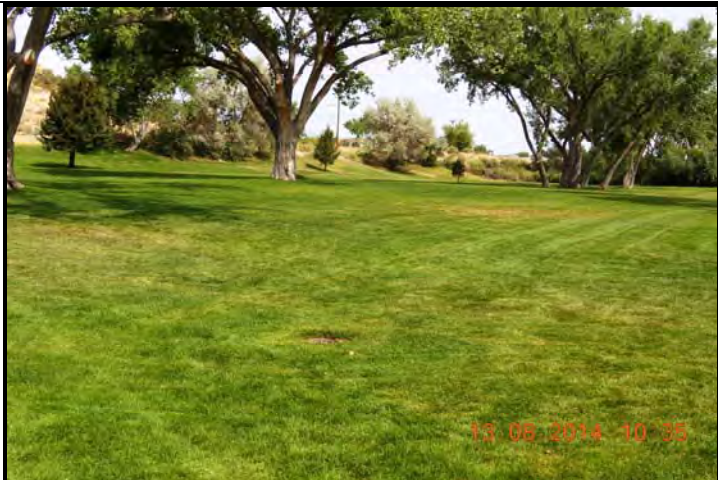
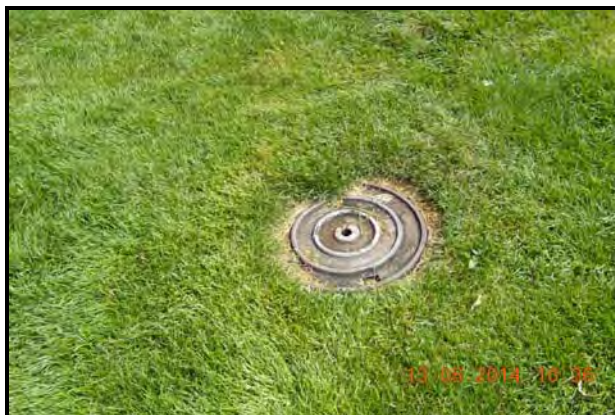
NMED/SWQB  
Official Photograph Log  
Photo # 3 and 4

Location: Kiwanis Park

Subject: Sewer Overflow 8 June 2014 area has been cleaned, disinfected and is free of debris.

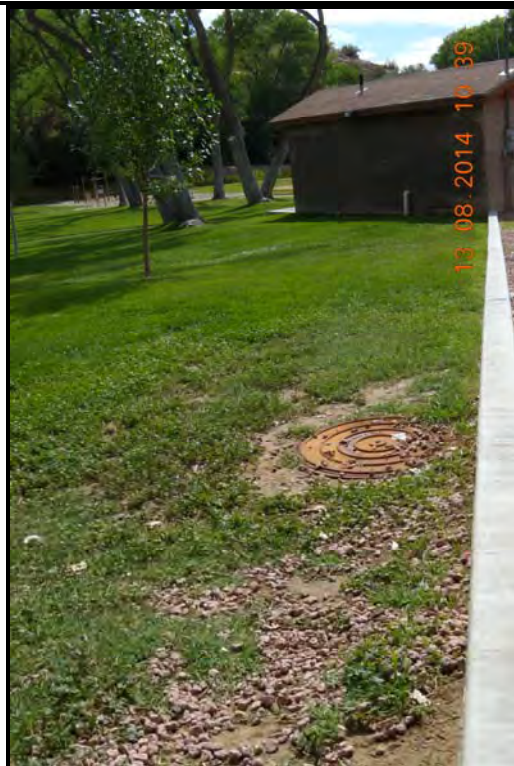
NMED/SWQB  
Official Photograph Log  
Photo #5

Location: Kiwanis Park

Subject: Sewer Overflow 8 June 2014 area has been cleaned, disinfected and is free of debris.

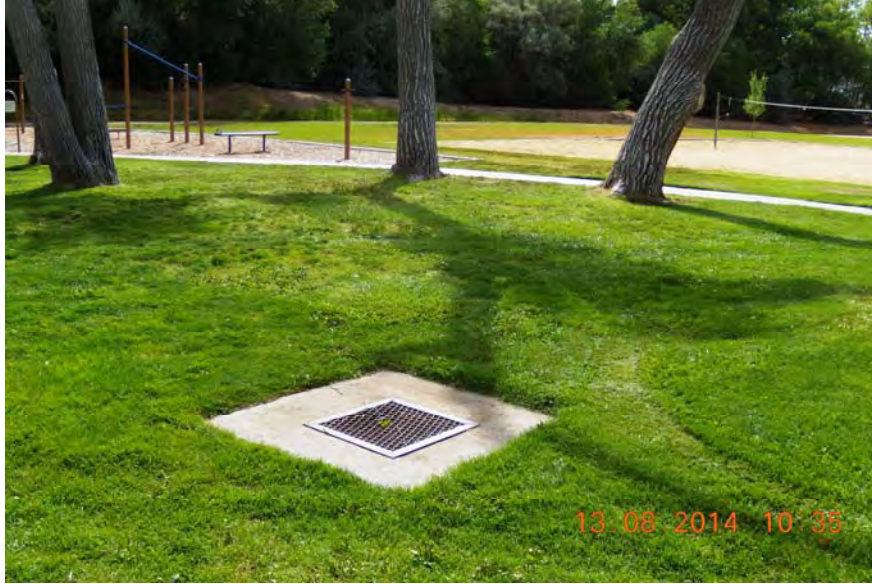
NMED/SWQB  
Official Photograph Log  
Photo #6

Location: Kiwanis Park

Subject: Storm water drain that flows to the San Juan River. A sewer overflow 8 June 2014. The sewer overflow did reach the storm drain and possible to the River. At the time of the inspection the area was clean and clear of debris.

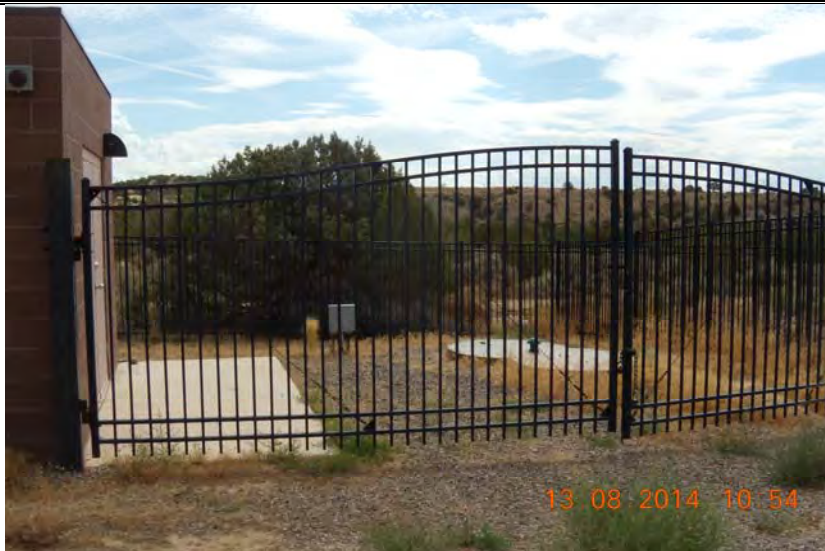
NMED/SWQB  
Official Photograph Log  
Photo # 7

Location: Farmington Country Club

Subject: The Farmington Country Club, a privately owned and operated community has a lift station inside the development gates. There have been complaints from residents in the area in past years that sewer overflows occurred frequently at the lift station. At the time of this inspection, the area was clear of sewage debris and the lift station appeared to be functioning properly.

(b) The Farmington Country Club, a privately owned and operated community has a lift station inside the development gates. There have been complaints from residents in the area in past years that sewer overflows occurred frequently at the lift station. At the time of this inspection, the area was clear of sewage debris and the lift station appeared to be functioning properly. According to City of Farmington representatives, the causes for this lift station failures are large volumes of adult diapers, rags and towels.

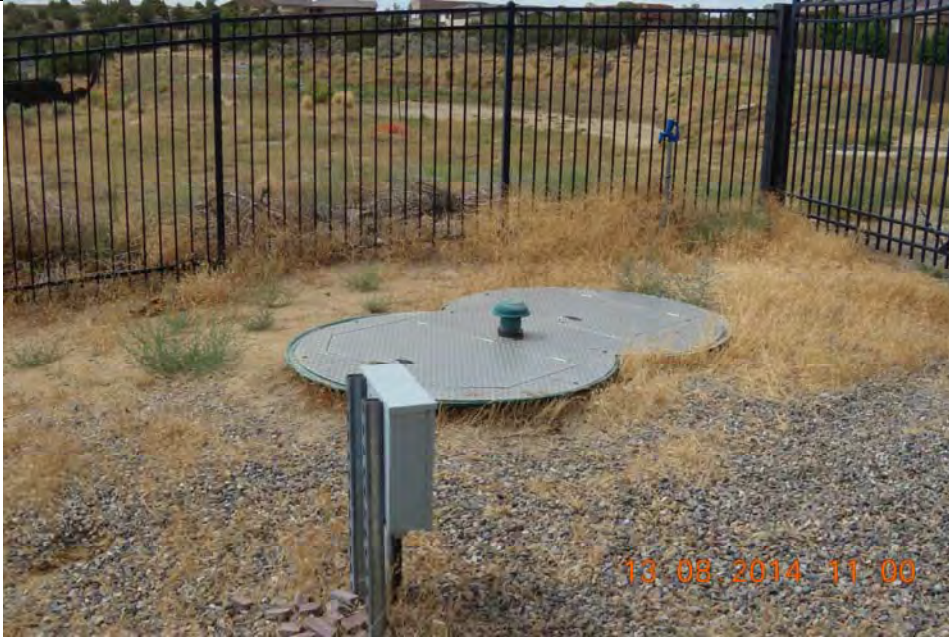
NMED/SWQB  
Official Photograph Log  
Photo # 8

Location: Farmington Country Club

Subject: The Farmington Country Club, a privately owned and operated community has a lift station inside the development gates. There have been complaints from residents in the area in past years that sewer overflows occurred frequently at the lift station. At the time of this inspection, the area was clear of sewage debris and the lift station appeared to be functioning properly.

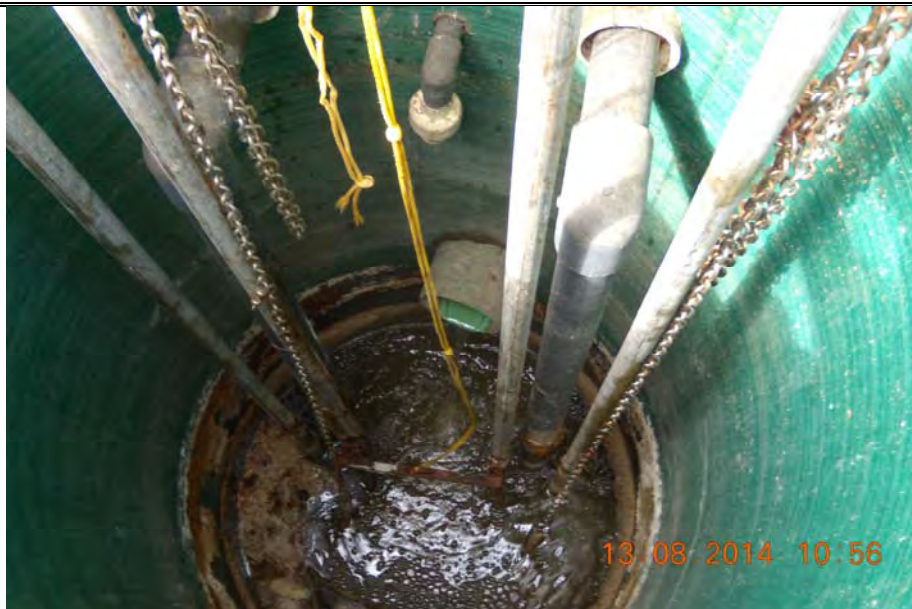
NMED/SWQB  
Official Photograph Log  
Photo # 9

Subject: Farmington Country Club Wet Well

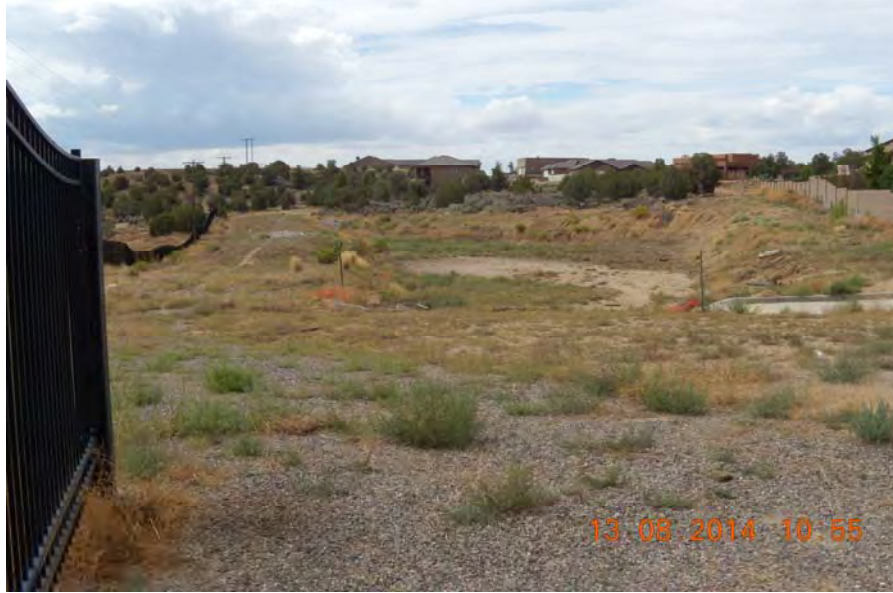
NMED/SWQB  
Official Photograph Log  
Photo # 10

Location: Farmington Country Club

Subject: The Farmington Country Club, a privately owned and operated community has a lift station inside the development gates. There have been complaints from residents in the area in past years that sewer overflows occurred frequently at the lift station. At the time of this inspection, the area was clear of sewage debris and the lift station appeared to be functioning properly.

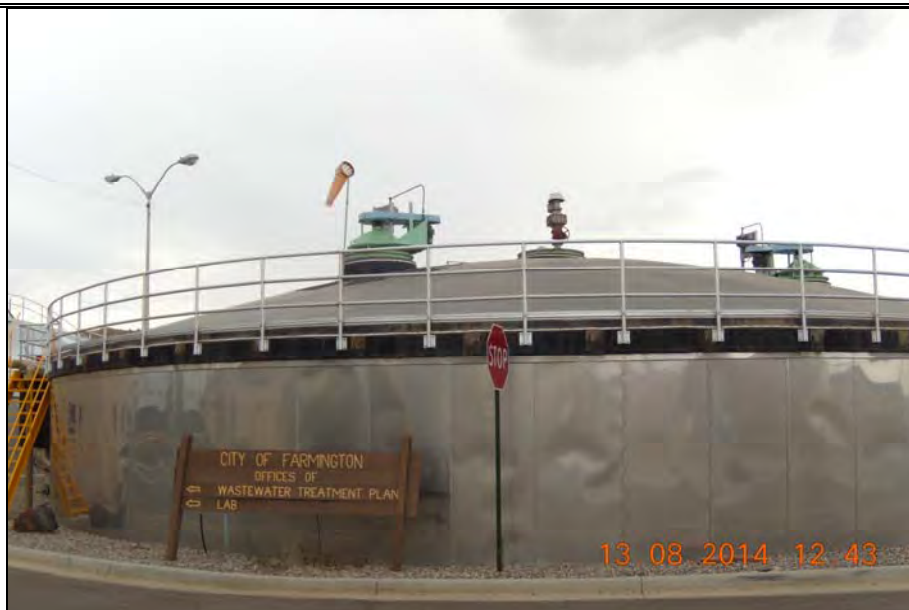
NMED/SWQB  
Official Photograph Log  
Photo # 11

Location: Farmington Wastewater Treatment Plant

Subject: Sludge Digester

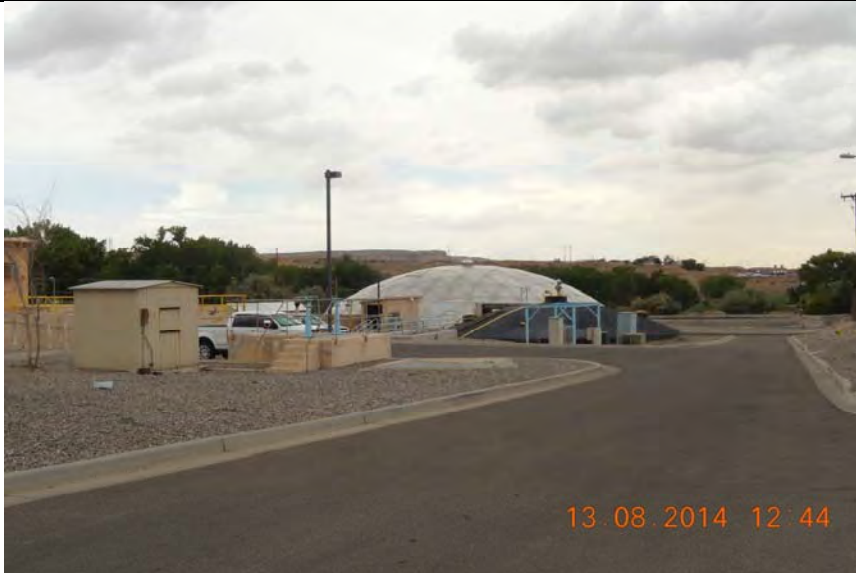
NMED/SWQB  
Official Photograph Log  
Photo # 12

Location: Farmington Wastewater Treatment Plant

Subject: Covered trickling filter in the distance. The treatment plant was bermed and contained any run off on site.

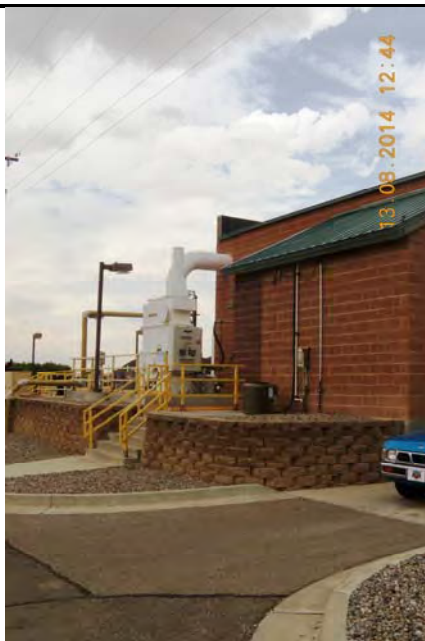
NMED/SWQB  
Official Photograph Log  
Photo # 13

Subject: Headworks air scrubber.

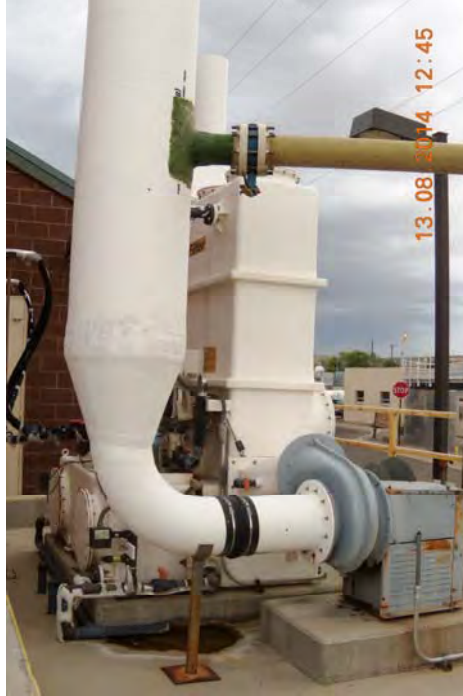
NMED/SWQB  
Official Photograph Log  
Photo # 14

Subject: Headworks biological and water suspended media air scrubber is scheduled for replacement in the next year.

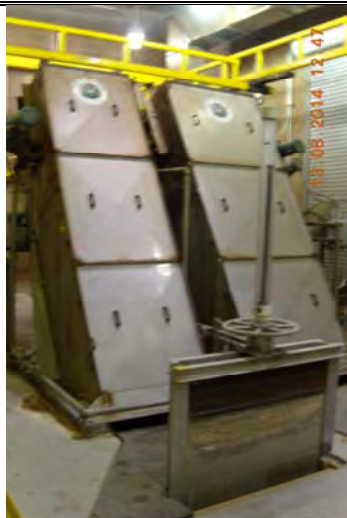
NMED/SWQB  
Official Photograph Log  
Photo # 15

Subject: Headworks parallel enclosed bar screens. The influent is split evenly through these units.

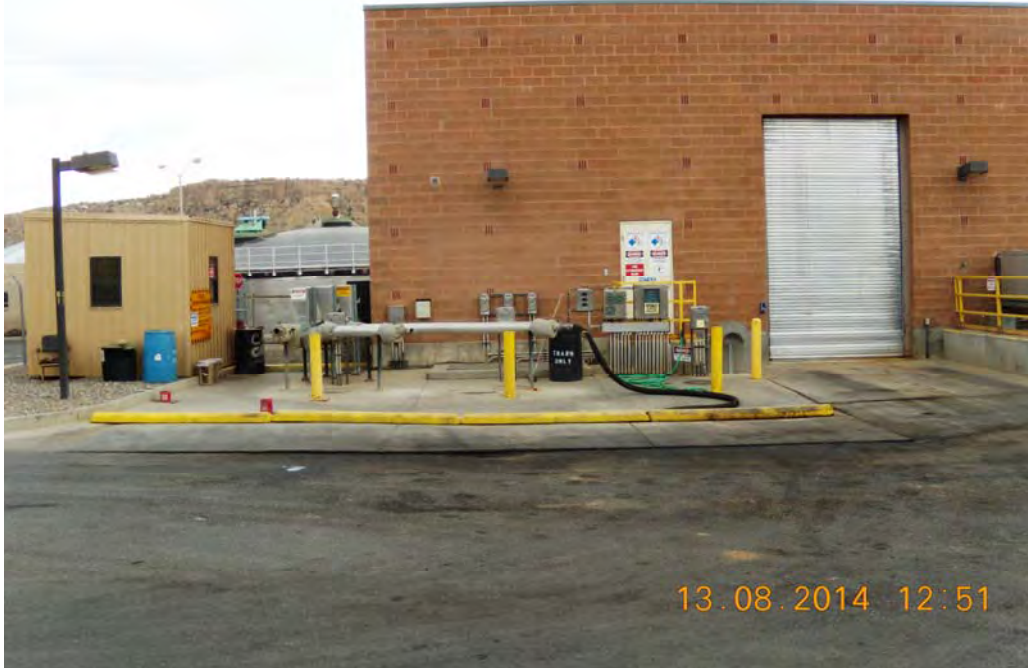
NMED/SWQB  
Official Photograph Log  
Photo # 16

Subject: Septage Receiving Station is bermed so there is no run off from the site. It is attended by an operator during business hours.

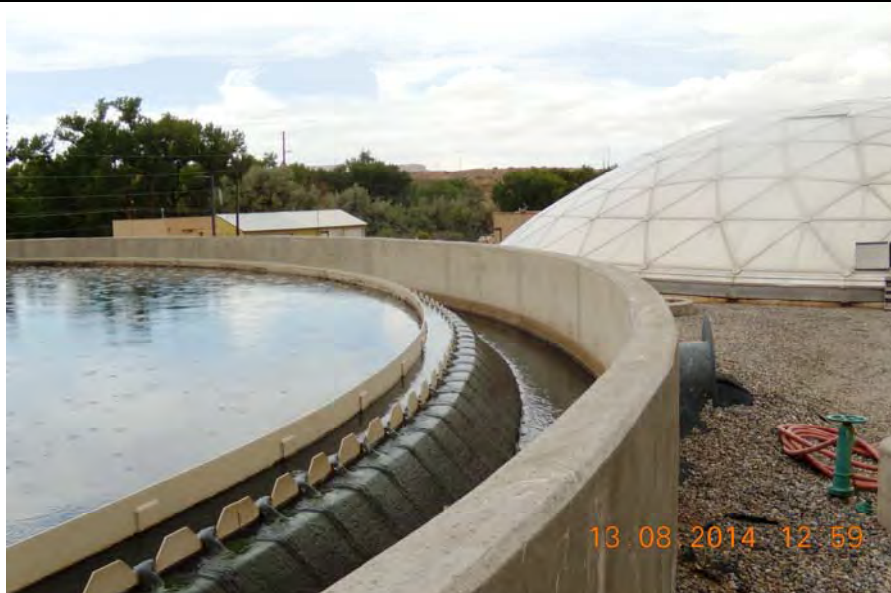
NMED/SWQB  
Official Photograph Log  
Photo # 17

Subject: Primary Clarifier weirs were level and short circuiting was not observed.

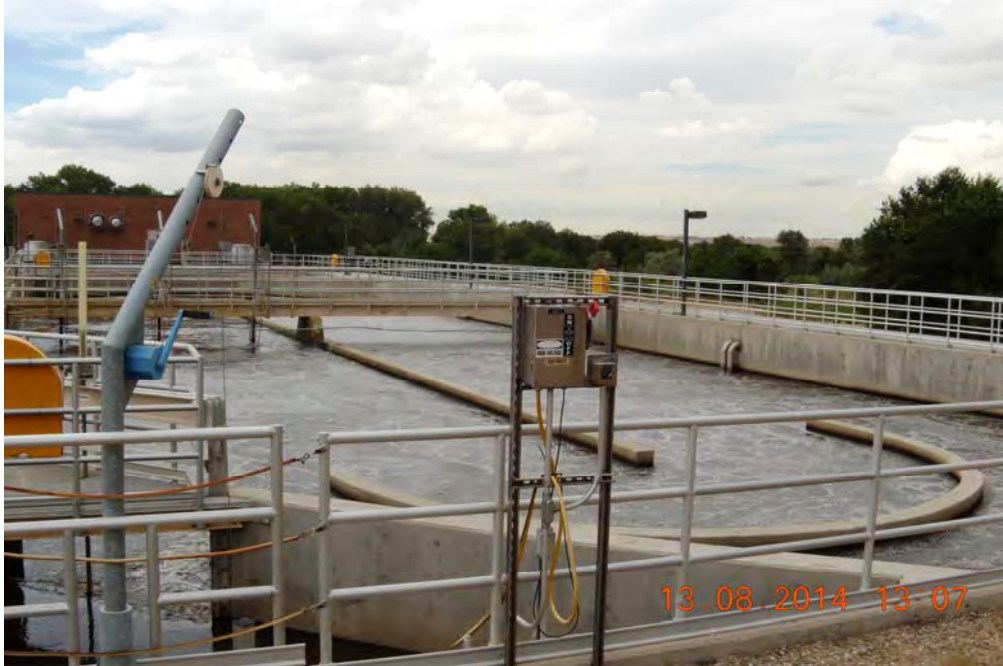
NMED/SWQB  
Official Photograph Log  
Photo # 18

Subject: Medium Rate Activated Sludge (MRAS) system.

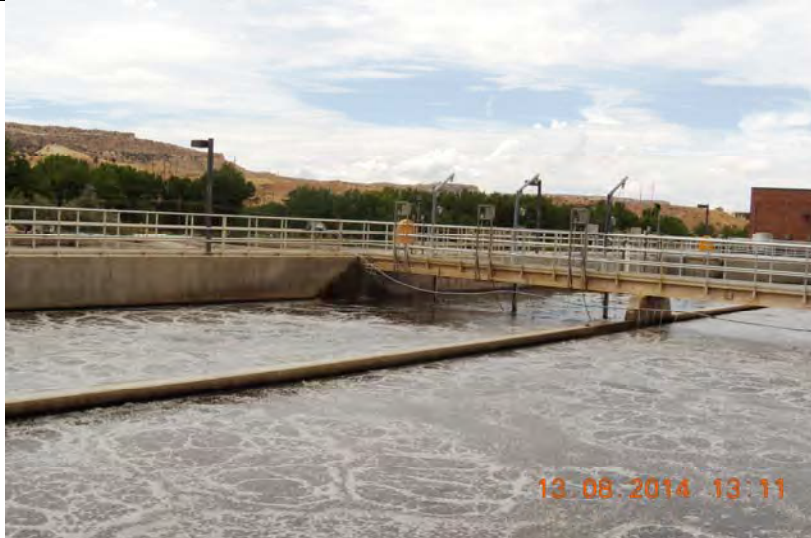
NMED/SWQB  
Official Photograph Log  
Photo # 19

Subject: Medium Rate Activated Sludge (MRAS) system. The anoxic zone is only approximately 20 feet wide under the bridge, limiting the effectiveness of Nitrogen removal.

Although this non-aerated zone could technically be considered an anoxic zone, the main purpose is to have an air free zone prior to mixing. Air bubbles would inhibit mixer performance. Because the treatment facility is still partially using the fixed film process, trickling filters, it is important to run the suspended growth in aeration mode only to reduce effluent ammonia in order to reduce the possibility of failing the permit-mandated biomonitoring test due to ammonia toxicity. The current NPDES permit does not have nitrogen limits. The City does have plans in the next phase of expansion to add valving to isolate aeration zones which will enable denitrification to occur should it be required.

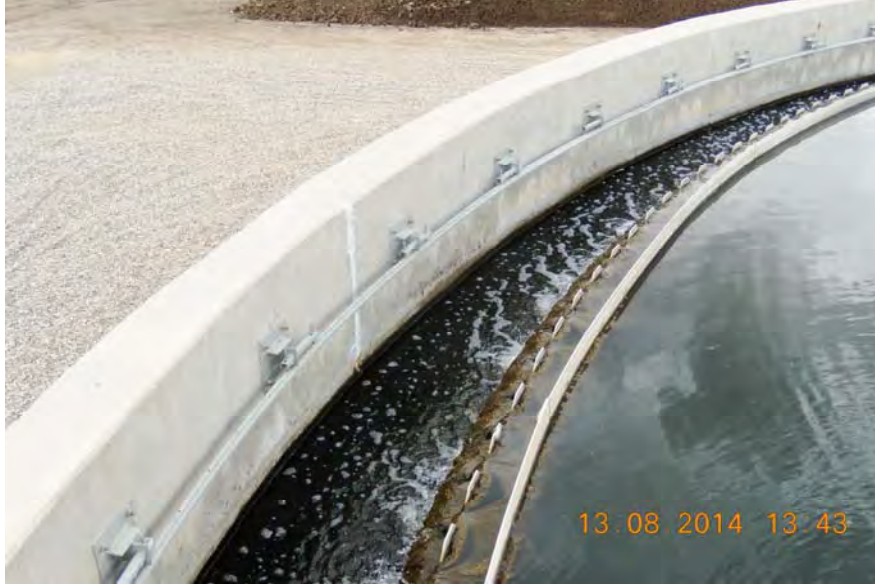
NMED/SWQB  
Official Photograph Log  
Photo # 20

Subject: Secondary Clarifier for the MRAS system had excessive amounts of algae in the weirs.

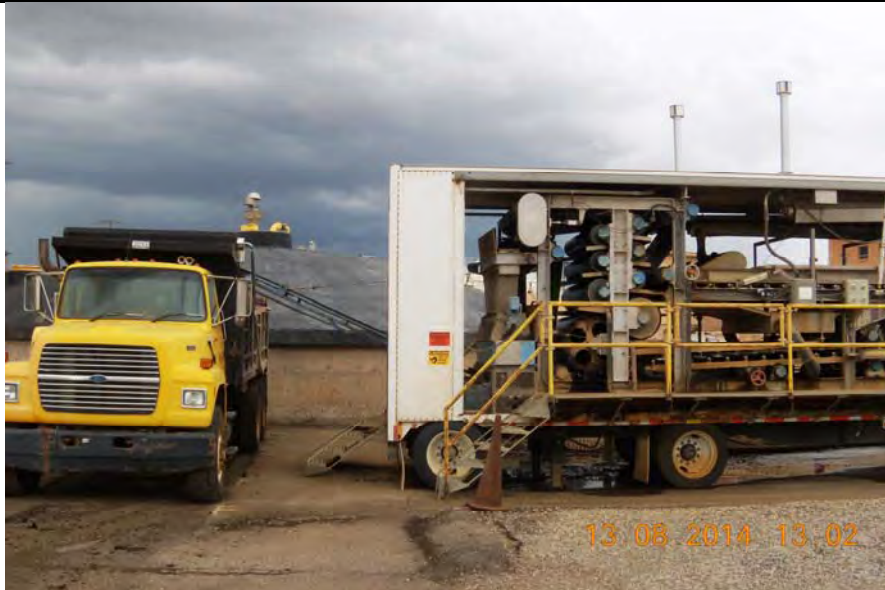
NMED/SWQB  
Official Photograph Log  
Photo # 21

Subject: The sludge belt press is in operation daily, as solids are wasted from the digester.

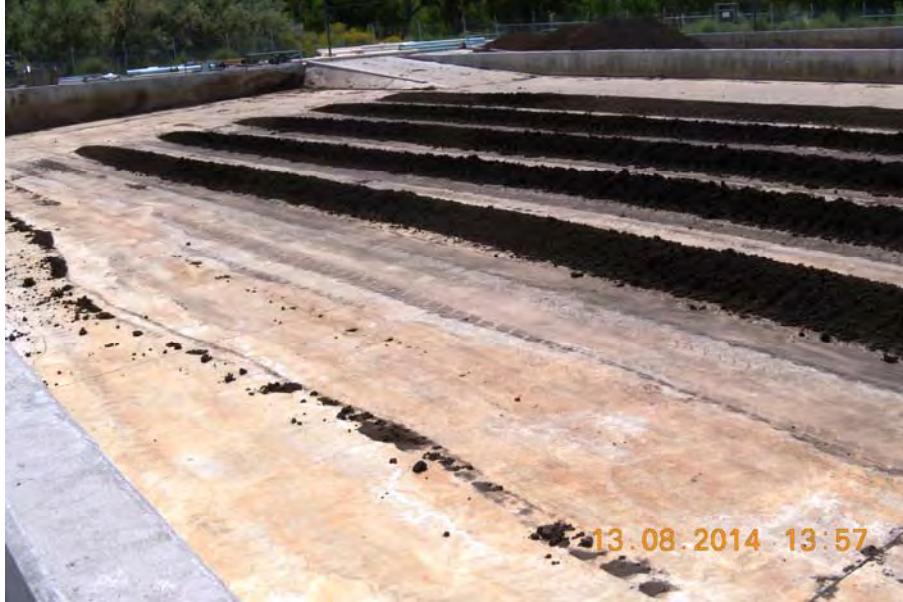
NMED/SWQB  
Official Photograph Log  
Photo # 22

Subject: Sludge Drying Beds. Solids are disposed of at the County Landfill and at the Landfill in Bondad, Colorado.

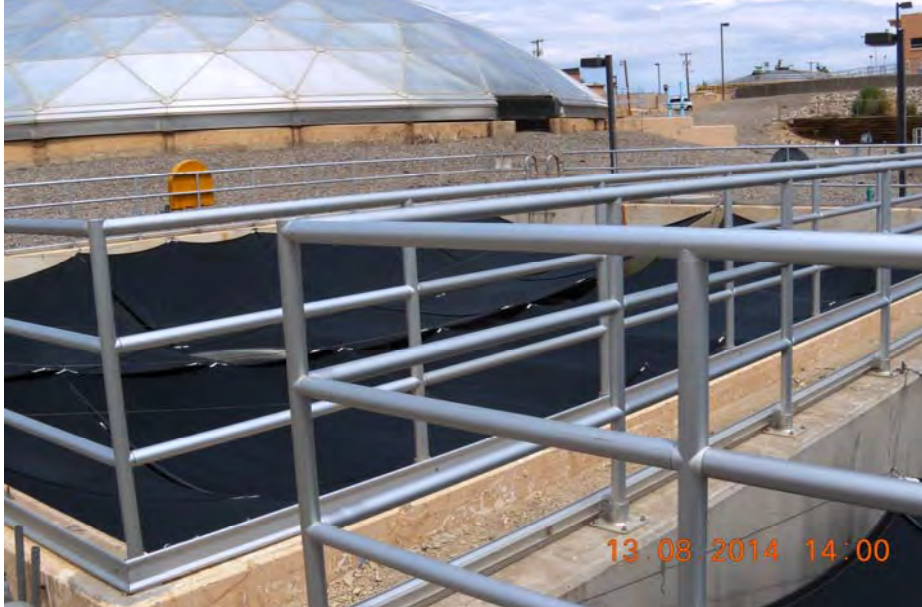
NMED/SWQB  
Official Photograph Log  
Photo # 23

Subject: Chlorine contact chambers are cover with cloth tarps to prevent excessive algae growth in the basins.

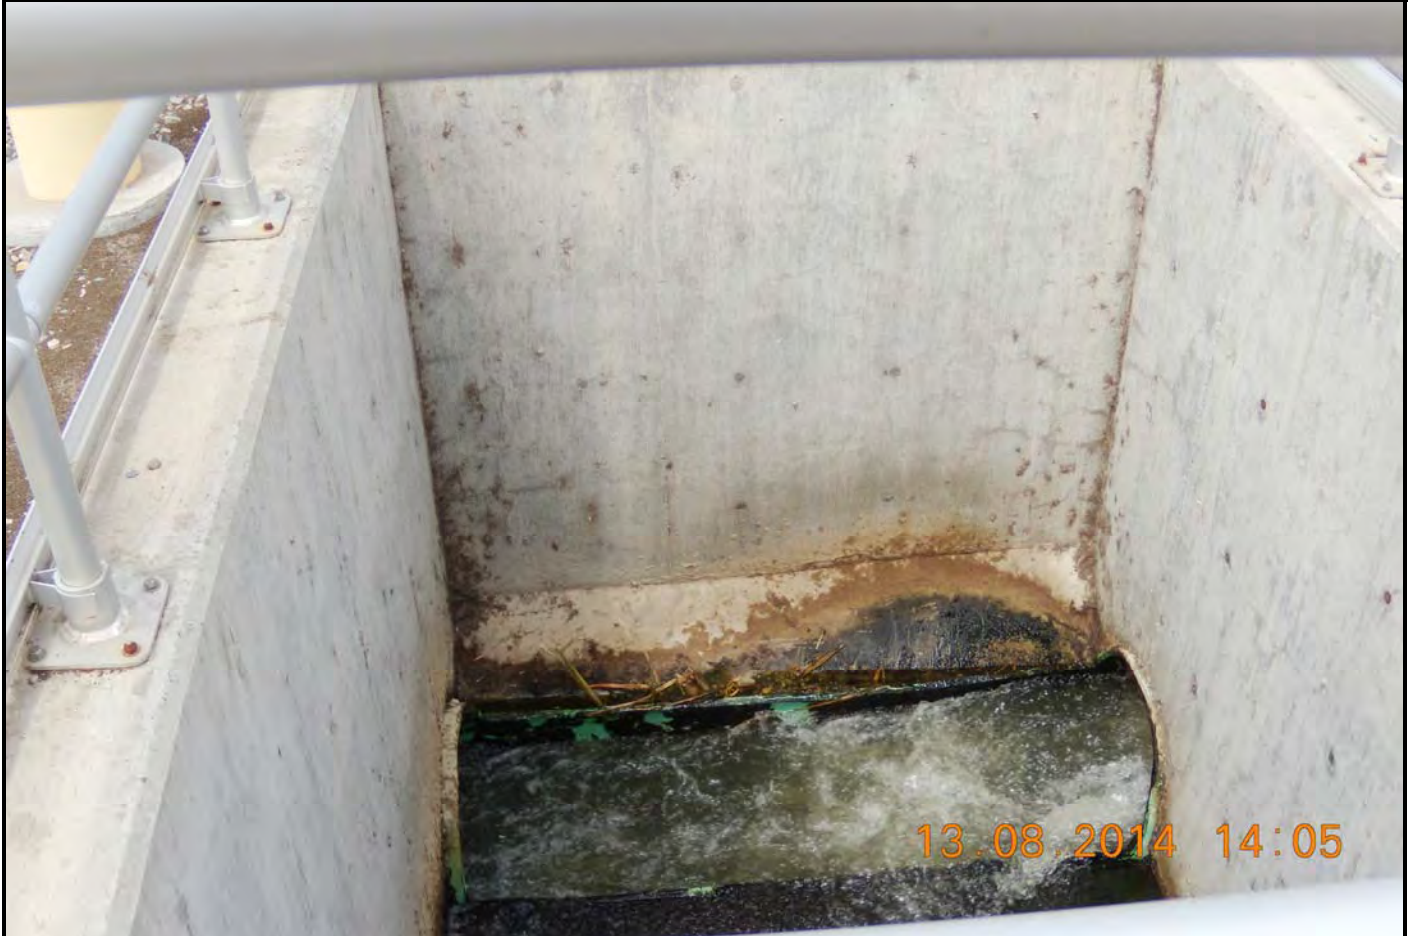
Subject: Effluent from the WWTP is sent to the San Juan River.
