Re: El Paso Electric, Rio Grande Station; Minor; Individual Permit; SIC 3511; NPDES Compliance Evaluation Inspection; NM0000108; December 2, 2014

NPDES Compliance Inspection Report

**NMED/SWQB
Official Photograph Log**

EPE Rio Grande Station CEI Report
NM0000108
Appendix A

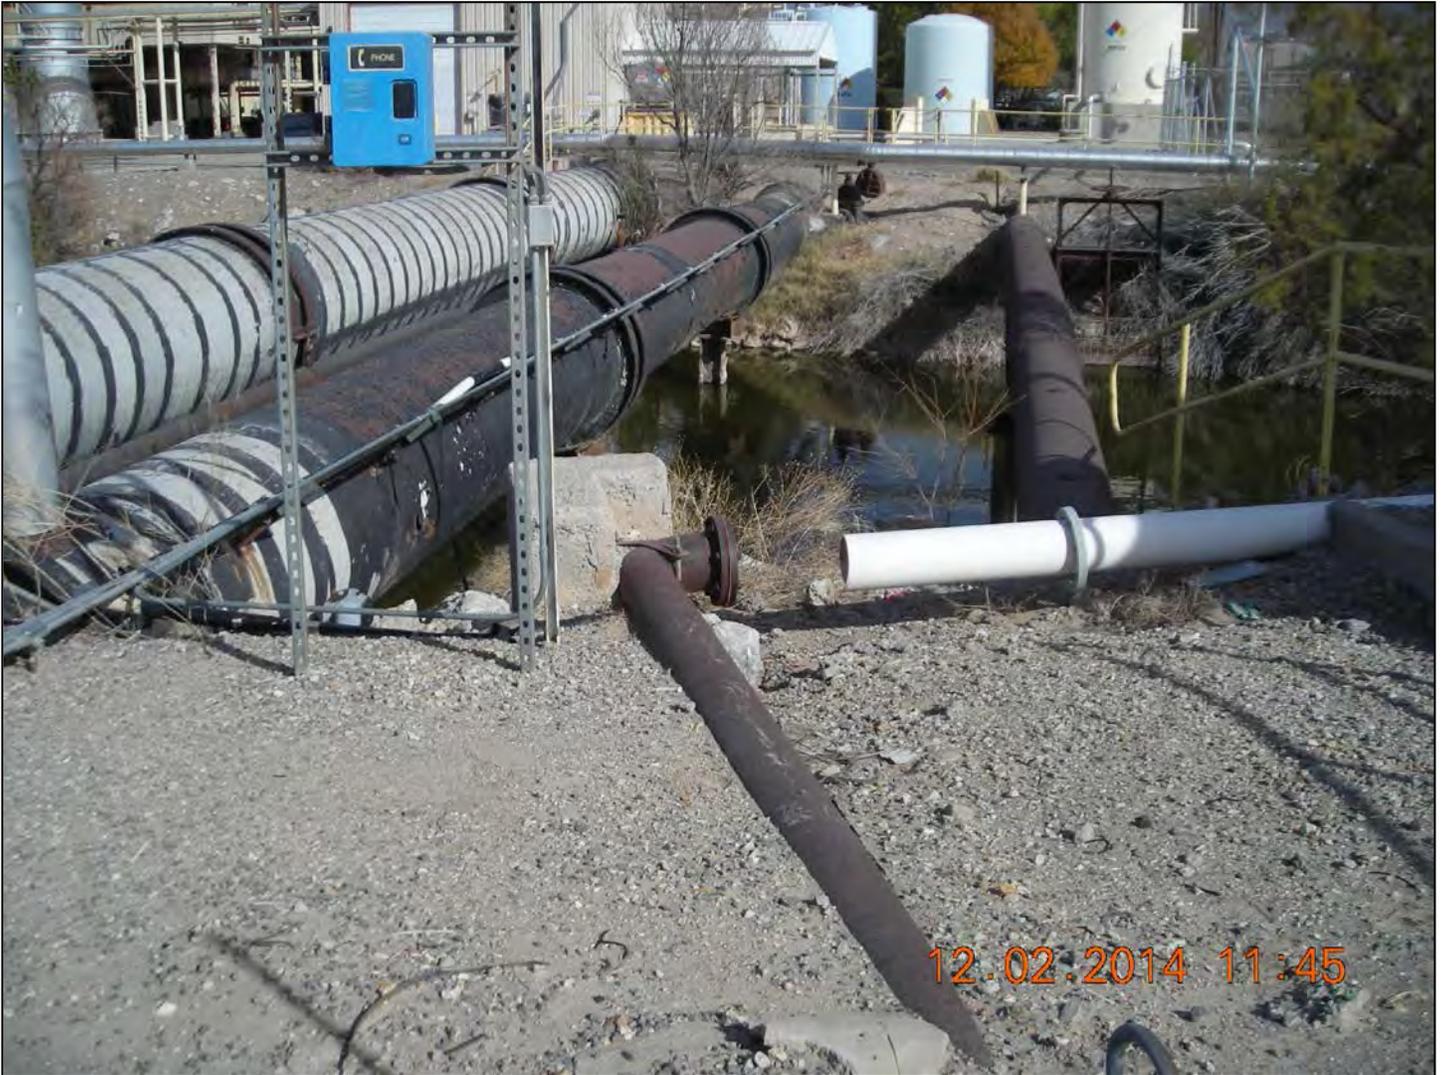
Photo #1:

Photographer:	Sarah Holcomb	Date	12-2-2014	Time	1045 hours*
Location:	El Paso Electric – Rio Grande Station, Sunland Park, Dona Ana County, NM				
Subject:	Disconnected PVC pipe that leads to Outfall 001. This outfall has been out of service since May 2010.

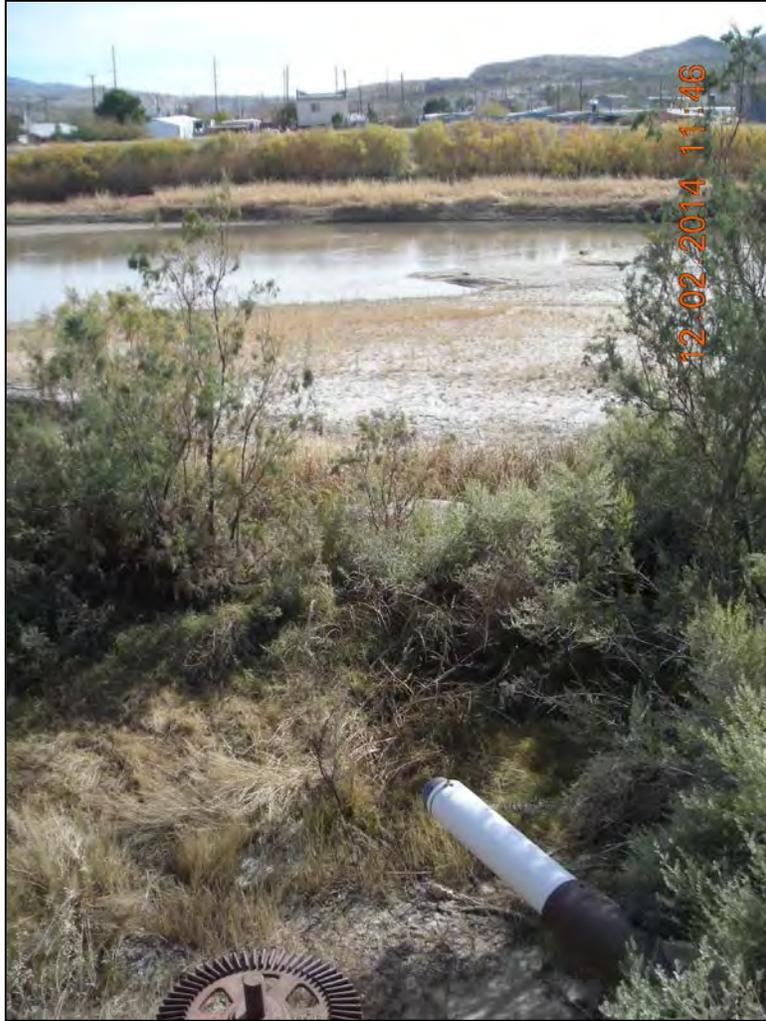
Photo #2:

Photographer:	Sarah Holcomb	Date	12-2-2014	Time	1046 hours*
Location:	El Paso Electric – Rio Grande Station, Sunland Park, Dona Ana County, NM				
Subject:	Outfall 001 – Rio Grande in the background.

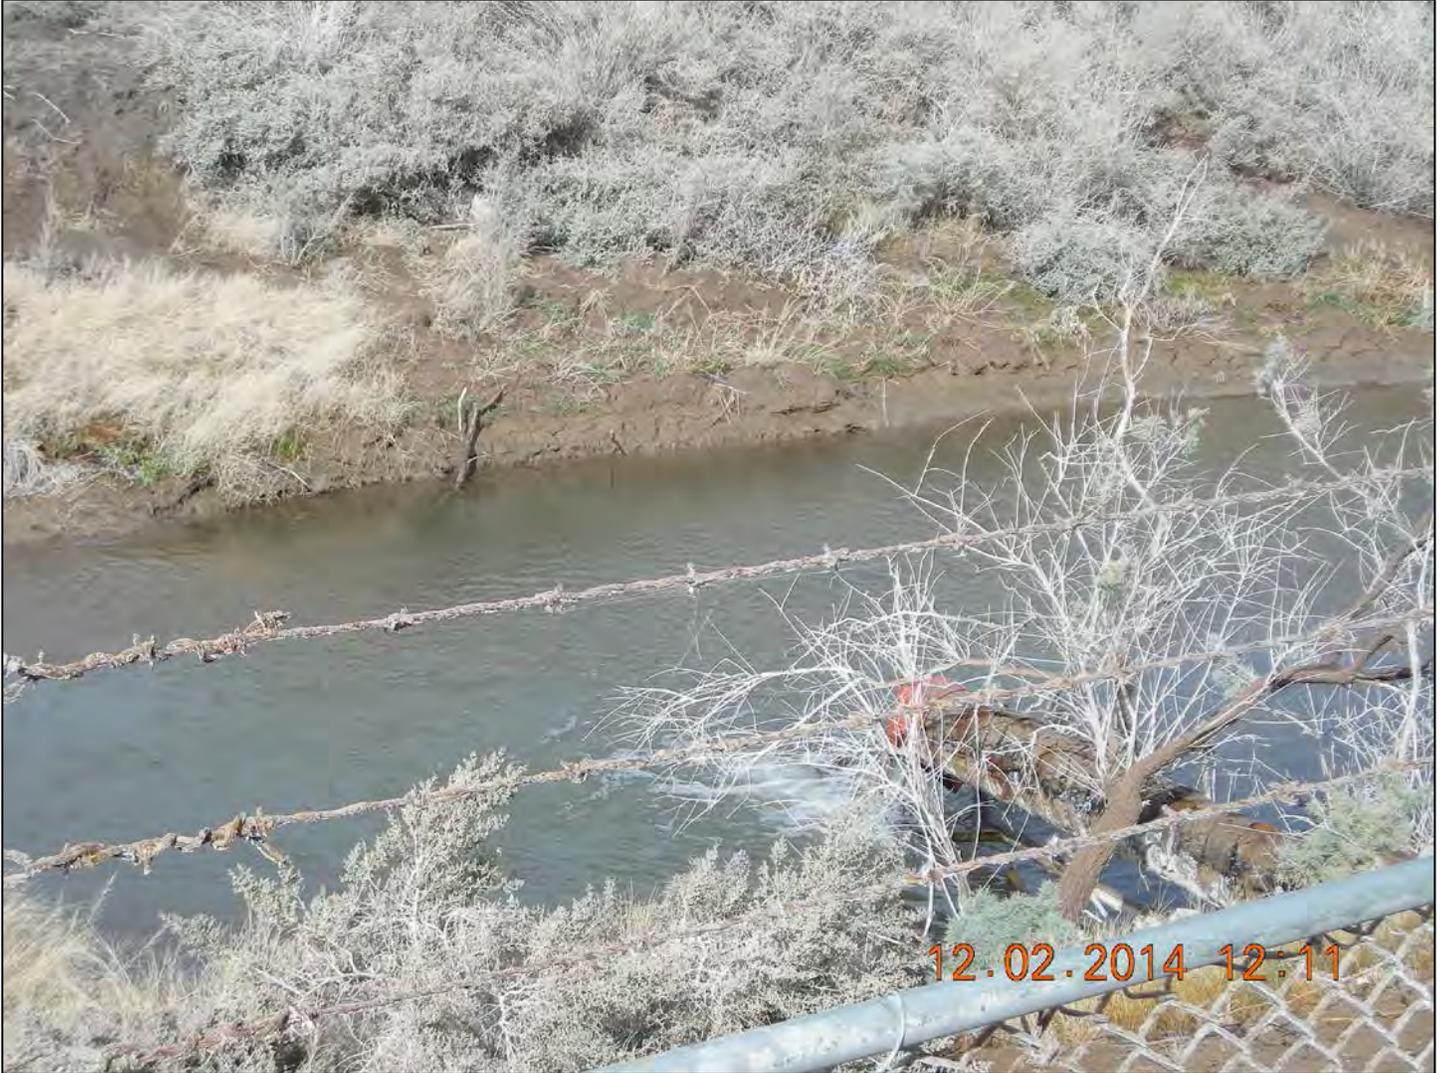
Photo #3:

Photographer:	Sarah Holcomb	Date	12-2-2014	Time	1111 hours*
Location:	El Paso Electric – Rio Grande Station, Sunland Park, Dona Ana County, NM				
Subject:	Outfall 002 to Montoya Arroyo, thence to the Rio Grande.

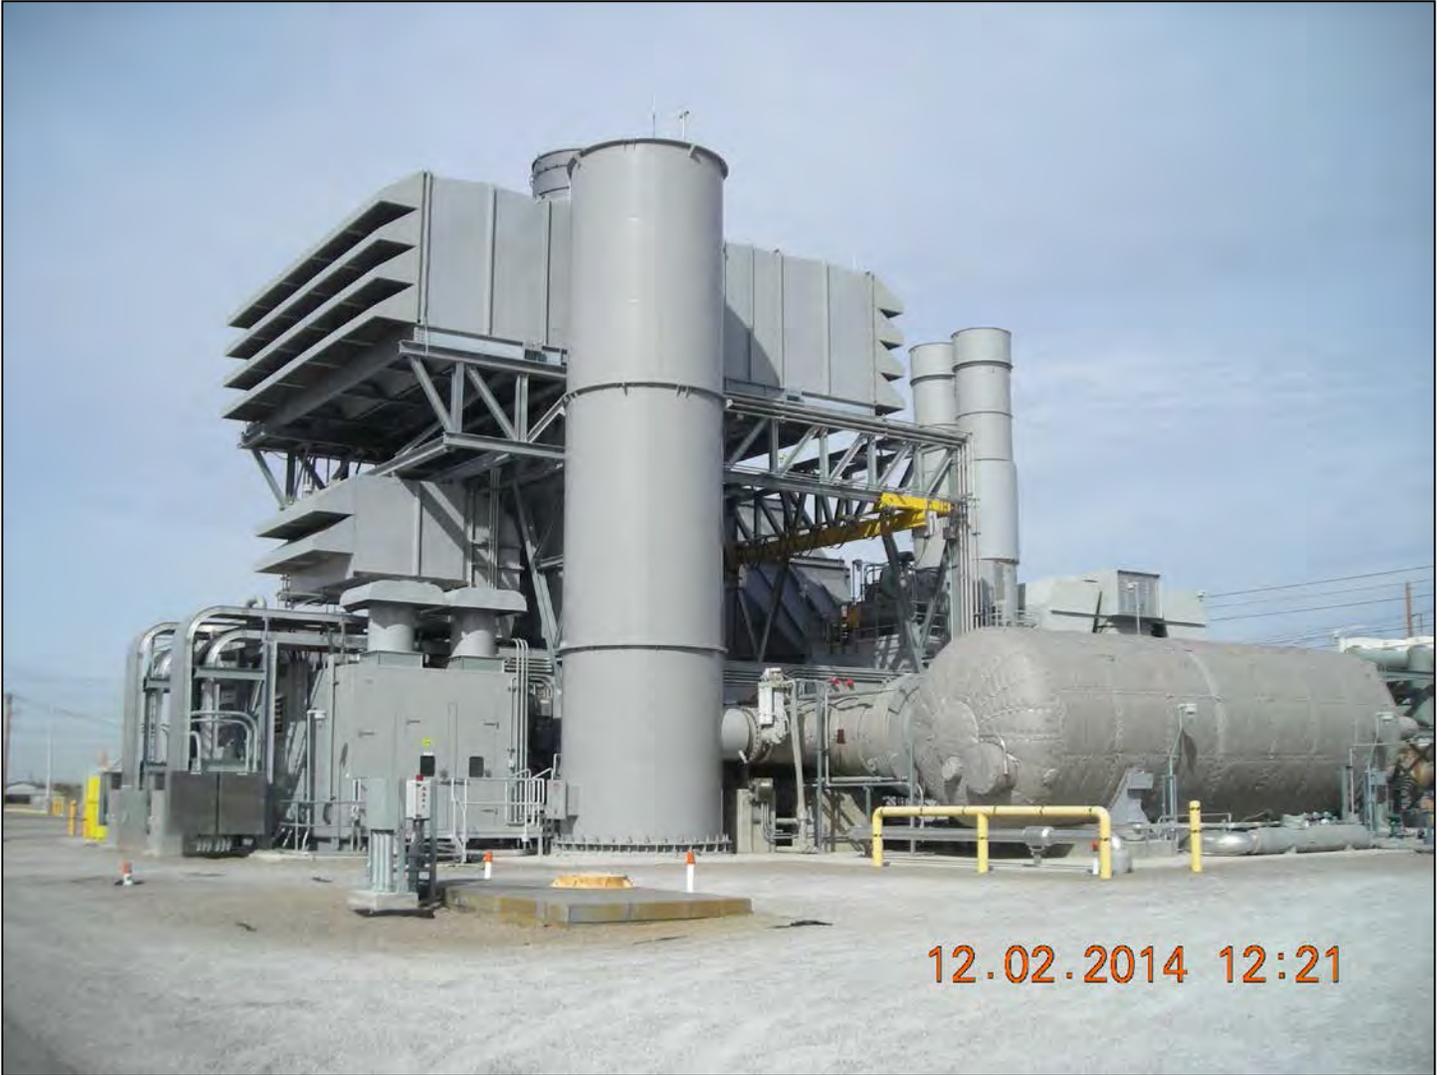
Photo #4:

Photographer:	Sarah Holcomb	Date	12-2-2014	Time	1121 hours*
Location:	El Paso Electric – Rio Grande Station, Sunland Park, Dona Ana County, NM				
Subject:	New Unit 9 – installed and operational as of May 2013.

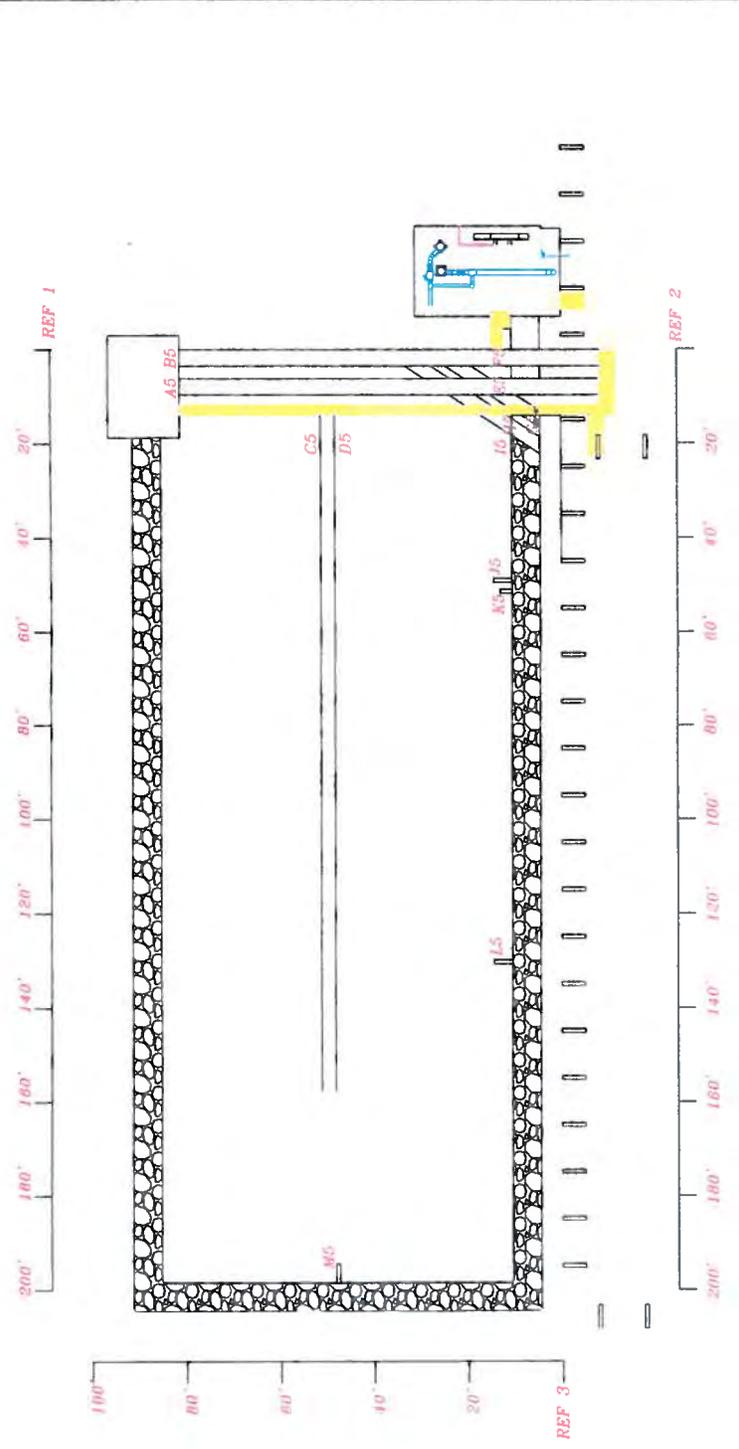
EL PASO ELECTRIC COMPANY RIO GRANDE PLANT		TITLE: UPPER CANAL - SECTION 1	
PROJECT NO.	DWG NO.	SCALE	SHEET
A	D90929.001	NTS	4 of 4
APPROVAL:	JJ	REV:	0

Pipe No.	Pipe Type	Pipe Identification	Status	Purpose	Normal Daily Flow (GPD)	Emergency/Non Routine Flow
Upper Canal - Section 1						
A5	4" Steel Pipe	Unit 8 Cooling Tower Circulation Supply Pipe - Drain 5 ft West of Ref 1 - 81 ft North of Ref 3 Located Under the Circulation Line	Active	Drain for Maintenance	0	Non-Routine
B5	4" Steel Pipe	Unit 8 Cooling Tower Circulation Return Pipe - Drain 3 ft West of Ref 1 - 81 ft North of Ref 3 Located Under the Circulation Line	Active	Drain for Maintenance	0	Non-Routine
C5	2" Sch40 PVC Pipe	Upper Canal Chlorination Pipe 14 ft West of Ref 1 - 52 ft North of Ref 3 Isolation Valve Located adjacent to the Pedestrian Bridge	Active	Upper Canal Chlorination Recirculation	200 GPM	Routine
D5	2" Sch40 PVC Pipe	Upper Canal Aeration Pipe 14 ft West of Ref 1 - 48 ft North of Ref 3 Isolation Valve Located adjacent to the Pedestrian Bridge	Active	Upper Canal Aeration Recirculation	200 GPM	Routine

E5	4" Steel Pipe	Unit 8 Cooling Tower Circulation Supply Pipe - Drain 5 ft West of Ref 1 - 12 ft North of Ref 3 Located Under the Circulation Line	Active	Drain for Maintenance	0	Non-Routine
F5	4" Steel Pipe	Unit 8 Cooling Tower Circulation Return Pipe - Drain 3 ft West of Ref 1 - 12 ft North of Ref 3 Located Under the Circulation Line	Active	Drain for Maintenance	0	Non-Routine
G5	12" PVC pipe	Unit 8 Cooling Tower - Overflow Pipe 14 ft West of Ref 1 - 7 ft North of Ref 3	Active	Overflow	0	Routine
I15	4" Steel Pipe	Unit 7 Cooling Tower Circulation Return Pipe - Drain 16 ft West of Ref 1 - 7 ft North of Ref 3 Located Under the Circulation Line	Active	Drain for Maintenance	0	Non-Routine
I5	4" Steel Pipe	Unit 7 Cooling Tower Circulation Supply Pipe - Drain 20 ft West of Ref 1 - 7 ft North of Ref 3 Located Under the Circulation Line	Active	Drain for Maintenance	0	Non-Routine
J5	12" Steel Pipe	Unit 7 Cooling Tower - Ground Diversion Pipe 20 ft West of Ref 1 - 11 ft North of Ref 3	Active	Divert Stormwater/Overflow	0	Routine

K5	2" Sch40 PVC Pipe	Unit 7 Cooling Tower - Acid Day Day Drain 24 ft West of Ref 1 - 11ft North of Ref 3 Out of Service	Inactive	Drain	0	Non-Routine			
I.5	12" Steel Pipe	Unit 7 Cooling Tower - Overflow Pipe 200 ft West of Ref 1 - 11ft North of Ref 3	Active	Overflow	0	Routine			
M5	6" Steel Pipe	Rio Grande Plant Fire Main - Drain 24 ft West of Ref 1 - 48 ft North of Ref 3	Inactive	Drain for Maintenance	0	Non-Routine

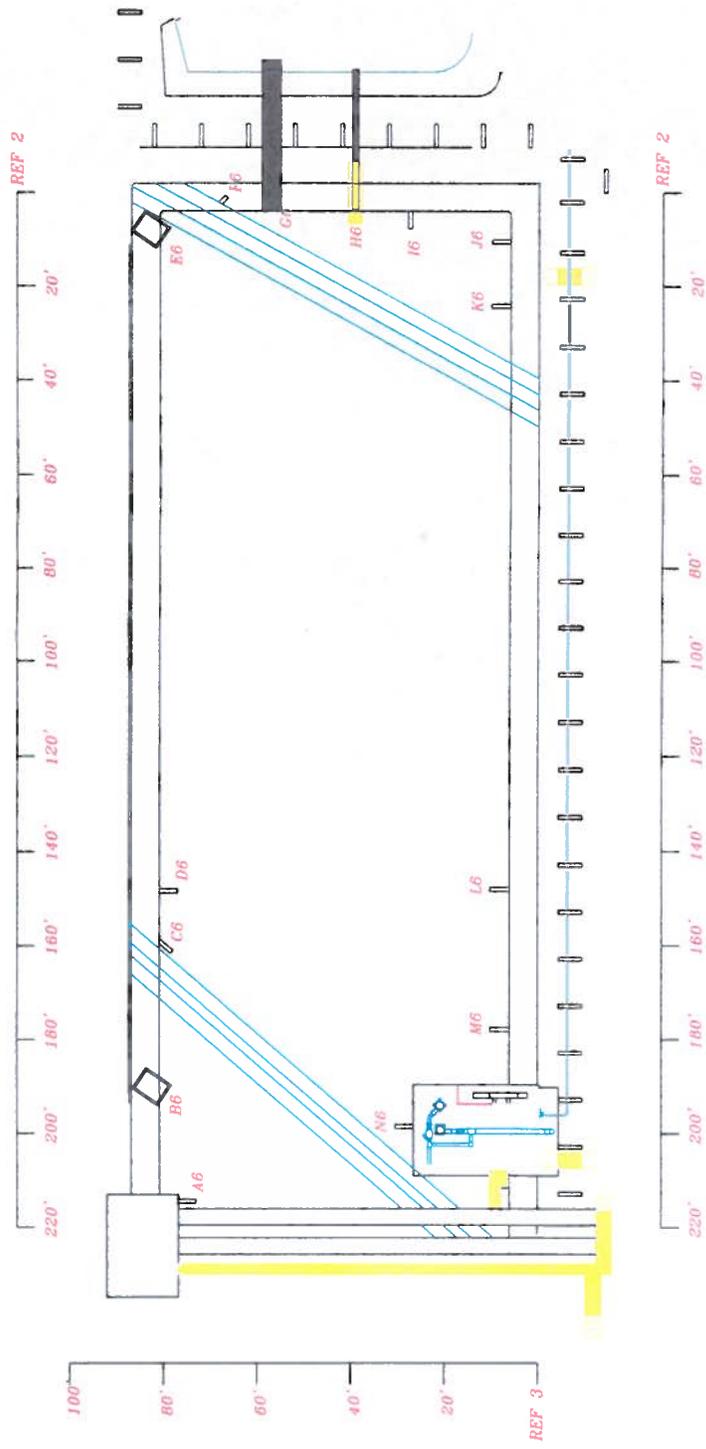
PROJECT NO.		DRAWING NO.		SHEET	
APPROVAL: JJJ		050929.001		4 of 4	
SCALE: NTS		REV: D		DATE	
TITLE: UPPER CANAL - SECTION 2		EL PASO ELECTRIC COMPANY RIO GRANDE PLANT

Pipe No.	Pipe Type	Pipe Identification	Status	Purpose	Normal Daily Flow (GPD)	Emergency/Non Routine Flow
Upper Canal - Section 2						
A6	2" SCH80 PVC Pipe	Unit 8 Cooling Tower Circulation Supply Pipe - Drain 215 ft West of Ref 1 - 81 ft North of Ref 3 Located Adjacent to Unit 8 Circulation Line	Active	Drain for Maintenance	0	Non-Routine
B6	12" Steel Pipe	Unit 8 Boiler - Oil Separator Drain 190 ft West of Ref 1 - 80 ft North of Ref 3	Active	Capture Blowdown Water	200 GPM	Routine
C6	2" Sch80 PVC Pipe	Unit 8 Circulating Line - Priming Line 160 West of Ref 1 - 80 ft North of Ref 3 Isolation Valve Located adjacent to Circulating Water Line	Active	Pime Circulating Water Line	0	Non-Routine
D6	2" Sch40 PVC Pipe	Drain from the Amertap Building 145 ft West of Ref 1 - 80 ft North of Ref 3 Out of Service	Inactive	Drain for Maintenance	0	Non-Routine
E6	10" Steel Pipe	Unit 7 Boiler - Oil Separator Drain 10 ft West of Ref 1 - 80 ft North of Ref 3	Active	Capture Blowdown Water	200 GPM	Routine

F6	2" Steel Pipe	Unit 8 Cooling Tower Circulation Return Pipe - Drain 3 ft West of Ref 1 - 170 ft North of Ref 3 Located Under the Circulation Line	Active	Drain for Maintenance	0	Non-Routine
G6	48" Concrete Pipe	Equalizing Pipe between Sections 2 & 3 Upper Canal 10 ft West of Ref 1 - 60 ft North of Ref 3	Active	Equalize Water levels Upper Canal	0	Routine
I16	20" Carbon Steel Pipe	Equalizing Pipe between Decisions 2 & 3 Upper Canal 10 ft West of Ref 1 - 40 ft North of Ref 3 Out of Service	Inactive	Equalize Water levels Upper Canal	0	Non-Routine
J6	2" Steel Pipe	Service Water Supply to Plant - Drain Valve 10 ft West of Ref 1 - 25 ft North of Ref 3	Active	Drain for Maintenance	0	Non-Routine
J6	2" Sch40 PVC Pipe	FireMain Drain Line 15 ft West of Ref 2 - 10 ft North of Ref 3 Out of Service	Inactive	Drain for Maintenance	0	Non-Routine

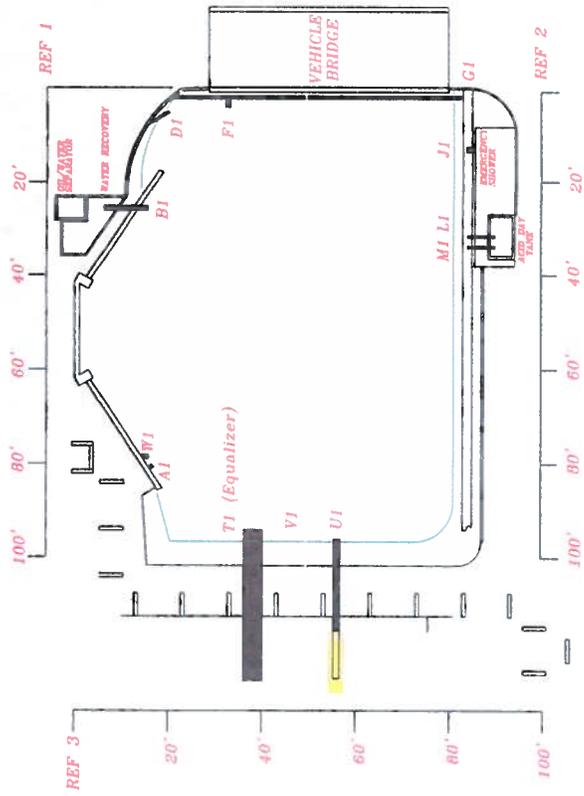
EL PASO ELECTRIC COMPANY RID GRANDE PLANT	
	TITLE: UPPER CANAL - SECTION 3	
PRODUCT NO.	SIZE / FROM NO.	DATE NO.
APPROVAL: JJJ	A	090929.001
	SCALE: NTS	SHEET: 4 of 4
		REV: 0

Pipe No.	Pipe Type	Pipe Identification	Status	Purpose	Normal Daily Flow (GPD)	Emergency/Non Routine Flow
Upper Canal Drains - SECTION 3						
A1	3" Carbon Steel Pipe	Warehouse Drain 81.5 ft west of Ref 1 protruding over sloped wall of intake Out of Service	InActive		1	
B1	10" Carbon Steel Pipe	Unit # 6.7.8 Boiler Blowdown & #6 Floors. outlet from oil trap 15.5 ft west of Ref 1. opens from intake wall (Currently used on Emergency Case Basts)	Active	Capture Blowdown Water	0	175 GPM (Loss of recovery Pumps)
D1	6" Carbon Steel Pipe	Old Fire Line connection (cut off. not used) 3.5 ft west of Ref 1 (Out of Service)	InActive		0	
F1	6" Carbon Steel Pipe	Fire Main 2" Drain Valve adjacent to PIV-8A 2.5 ft west of Ref 1, 20 ft south of Ref 1 at the black bridge	Active	Fire Main Drain	0	10,000 Gallons Drain entire Fire Main
G1	24" Carbon Steel Pipe	Old Circulation Line 85' South of Ref 3 - Running Parallel to the Canal (Out of Service)	InActive	Old Circulation Line	0

J1	1" Carbon Steel Pipe	Water Supply & Drain from Safety Shower 12 ft West of Ref 2. above ground. south side of Lower Canal 1" Pipe capped off. Emerg Shower drains to Middle Canal	Active	Emergency Shower (Circulation of water Thru the Emergency Shower)	5	
L1	2" Sch80 PVC	Acid Day Tank Drain 25 ft west of Ref 2. aboveground. south side of Middle Canal	Active	Acid Tank Cleaning Acid Day Tank	0	
M1	2" Sch80 to Sch40 PVC	Acid Feed Line to Lower Canal from Acid Mixing Chamber 27.5 ft west of Ref 2. aboveground, south side of Lower Canal	Active	Addition of Acid to Upper Canal	0	3000 Gallons 5 GPM for 8 Hrs
T1	48" Concrete Pipe	Equalizing Pipe between Decitions 2 & 3 Upper Canal 38 ft south of Ref 3, Protrudes from berm between canals	Active	Equalize Water Levels Upper Canal	0	
U1	20" Carbon Steel Pipe	Equalizing Pipe between Decitions 2 & 3 Upper Canal 56 ft south of Ref 3, protrudes from berm between canals Out of Service	InActive

V1	4" SCH80 PVC Pipe	Chlorination Line 50 ft South of Ref 3. Crosses the Middle Canal along the Bottom	Active	Chlorinate Upper Canal Section 3	0

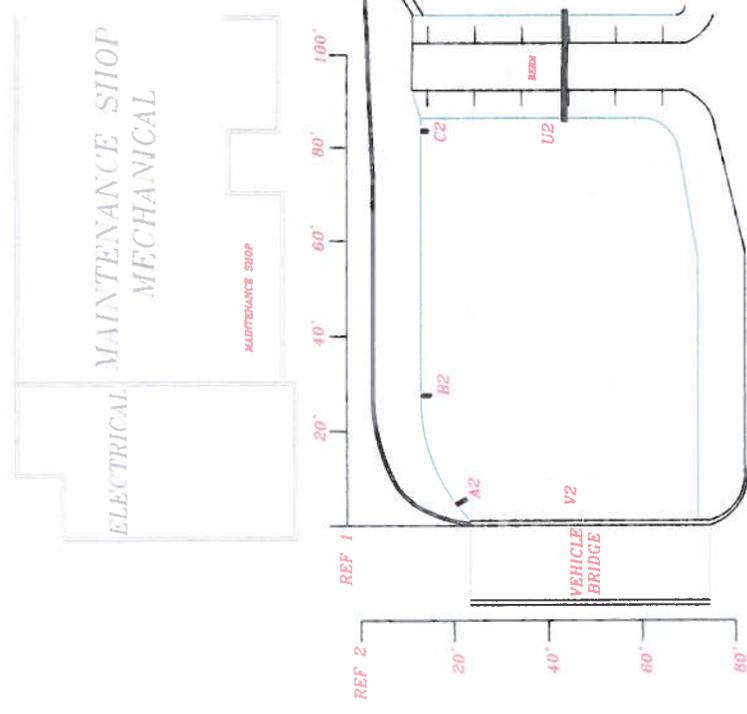
EL PASO ELECTRIC COMPANY RIO GRANDE PLANT	
PROJECT NO.		TITLE: UPPER CANAL - SECTION 4	
APPROVAL: J.J.		SIZE / FROM NO. A	DWG NO. 090929.001
SCALE: N.T.S.		SHEET: 4 of 4

Pipe No.	Pipe Type	Pipe Identification	Status	Purpose	Normal Daily Flow (GPD)	Emergency/Non Routine Flow
Upper Canal Drains - SECTION 4						
A2	10" Cast Iron Pipe	Outlet from #5 DWT Drain, & #5 Unit Floor Drains 5 ft East of Ref 1, at traffic bridge, 6 ft below top of bank	Active	Floor Drain	0	
B2	8" Sch40 PVC Pipe	Maintenance Shop Roof Runoff & Ladies Room Floor Drains 28 ft East of Ref 1, 4 ft below top of north bank	Active	Storm/Floor Drain	0	
C2	8" Carbon Steel Pipe	Floor Drain on South side of Maintenance shop 84 ft East of Ref 1, 1.5 ft below top of north bank	Active	Storm Drain	0	
U2	8" Carbon Steel Pipe	Equalizing Pipe between Middle & Lower Canal 43 ft South of Ref 2, protrudes from berm between canals	Active	Overflow	0	
V2	4" SCH80 PVC Pipe	Middle Canal Chlorination Line 47 ft South of Ref 2, crosses the Middle Canal along the Bottom	Active	Chlorinate Middle Canal Upper Canal/Middle Canal	0

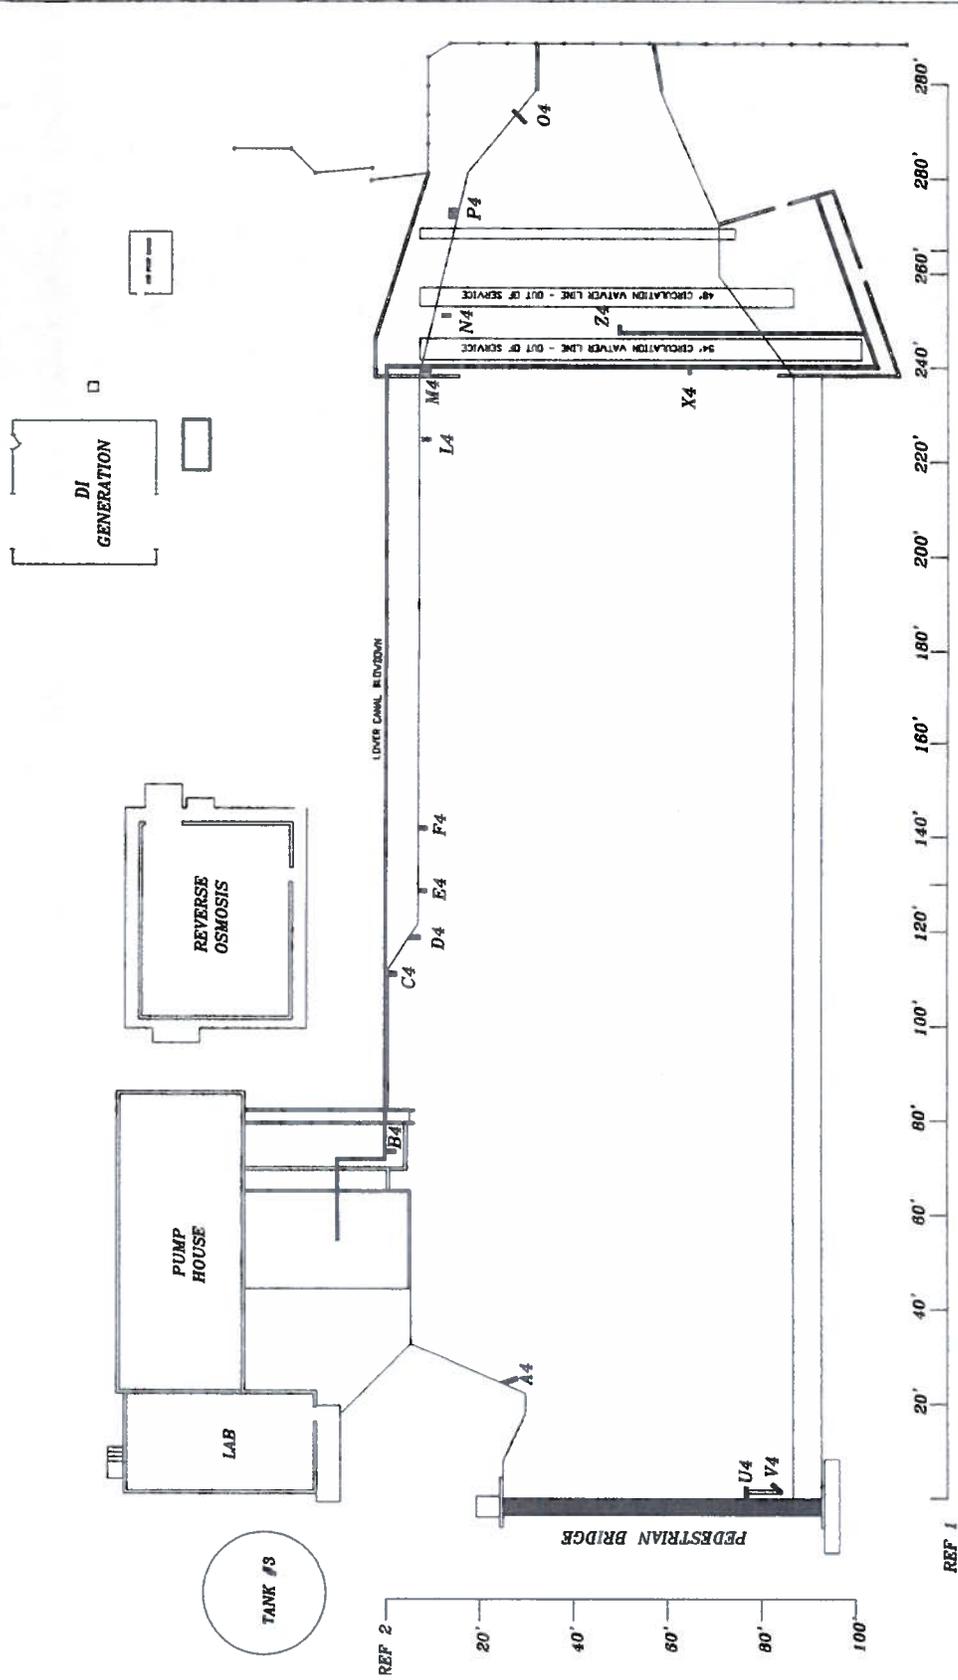
EL PASO ELECTRIC COMPANY RIO GRANDE PLANT	
TITLE: LOWER CANAL - SECTION 2			
PROJECT NO.	SCALE	NTS	SHEET: 4 of 4
SIZE / FOCUS NO.	A		
REV	0		
ORD NO.	090929.001

Pipe No.	Pipe Type	Pipe Identification	Status	Purpose	Normal Daily Flow (GPD)	Emergency/Non Routine Flow
LOWER CANAL DRAINS - SECTION 2						
A4	4" Carbon Steel Pipe	Well Water Supply to RO Unit 24 ft east of Ref 1, 5 ft below top of north bank	Inactive	Well Water Supply to RO Drain Line	0	
B4	1/4" Tygon Tube	Double Valve (1/2") connected to 6" Flange 74 ft east of Ref 1, protrudes from pipe laying on top of berm	Active	Sample Line (used for sampling PH/CL of water discharged to the river)	0	
C4	7-1/2" Cast Iron Pipe	#1 Boiler Blowdown Flashback 110 ft east of Ref 1, 6 ft below top of north bank <i>Out of Service</i>	In/Active		N/A	
D4	3" Carbon Steel Pipe	City Water Blowoff at Inlet to R.O. 110 ft east of Ref 1, laying on top of berm <i>Valve Removed and Line Removed</i>	In/Active	Piping Drain	0	
E4	1" Stainless Steel Pipe	City Water Heater at Inlet to R.O. 129 ft east of Ref 1, laying on top of berm <i>Normally Closed - Capped</i> <i>City Water re-routed to RO Waste Sump</i>	Inactive	Piping Drain (Used only in Cold Weather)	0

F4	6" Carbon Steel Pipe	Outlet of R.O. Roof Gutter Drain 142 ft east of Ref 1, 2 ft below top of north bank	Active	Storm Drain	0	
L4	3" Sch40 PVC Pipe	Unknown source, not in use 224 ft east of Ref 1, 6 ft below top of north bank <i>Out of Service</i>	Inactive		N/A	
M4	3" Sch80 PVC Pipe	Old R.O. Building Floor Drain Outlet 240 ft east of Ref 1, 7 ft below top of north bank <i>Connection to Lower Canal Cut off</i>	Inactive	Waste Sump Overflow	0	45 GPM
N4	8" Carbon Steel Pipe with Flanged End	Obsolete Well Water Line 250 ft east of Ref 1, runs from south between C.T. Supply lines <i>Out of Service - Flanged off</i>	Inactive	Old Service Water Line??	N/A	
O4	8" Carbon Steel Pipe	City Water Supply Header Blowdown Line	In/Active	Piping Drain	0

295 ft east of Ref 1, supported over top of north bank <i>Valve Removed & Outlet Flanged</i>				
P4	54" Cast Iron Gate Valve	Opens equalizing line between lower canal and front canal 270 ft east of Ref 1, 6 feet below top of north bank <i>Out of Service</i>	InActive		N/A	
X4	4" Carbon Steel Pipe	Lower Canal Recirculation - Blowdown 65 ft south of Ref 2, 240 ft east of Ref 1 <i>Normally Open - Recirculation Line</i>	Active	Recirculation	N/A	
Z4	6" Carbon Steel Pipe	Lower Canal Recirculation - Blowdown 50 ft south of Ref 2, 248 ft East of Ref 1 <i>Normally Open - Recirculation Line</i>	Active	Recirculation	N/A	
V4	2" Carbon Steel Pipe	Fire Main Connection 83 ft south of Ref 2, South East side of Pedestrian Bridge <i>Valve Removed and Outlet Flanged</i>	InActive	Fire Main Connection	0	
U4	6" Carbon Steel Pipe	Fire Main Drain 76 ft south of Ref 2, South East side of Pedestrian Bridge <i>Valve Removed and Outlet Flanged</i>	InActive	Fire Main Drain	0
