Re: GCC Rio Grande, Inc.; Tijeras Plant; Minor; SIC 3241; NPDES Compliance Evaluation Inspection; NM0000116; March 18 & 19, 2015

NPDES Compliance Inspection Report

**GCC Rio Grande, Inc. - Tijeras Plant
Compliance Evaluation Inspection
NPDES Permit No. NM0000116
March 18 and 19, 2015**

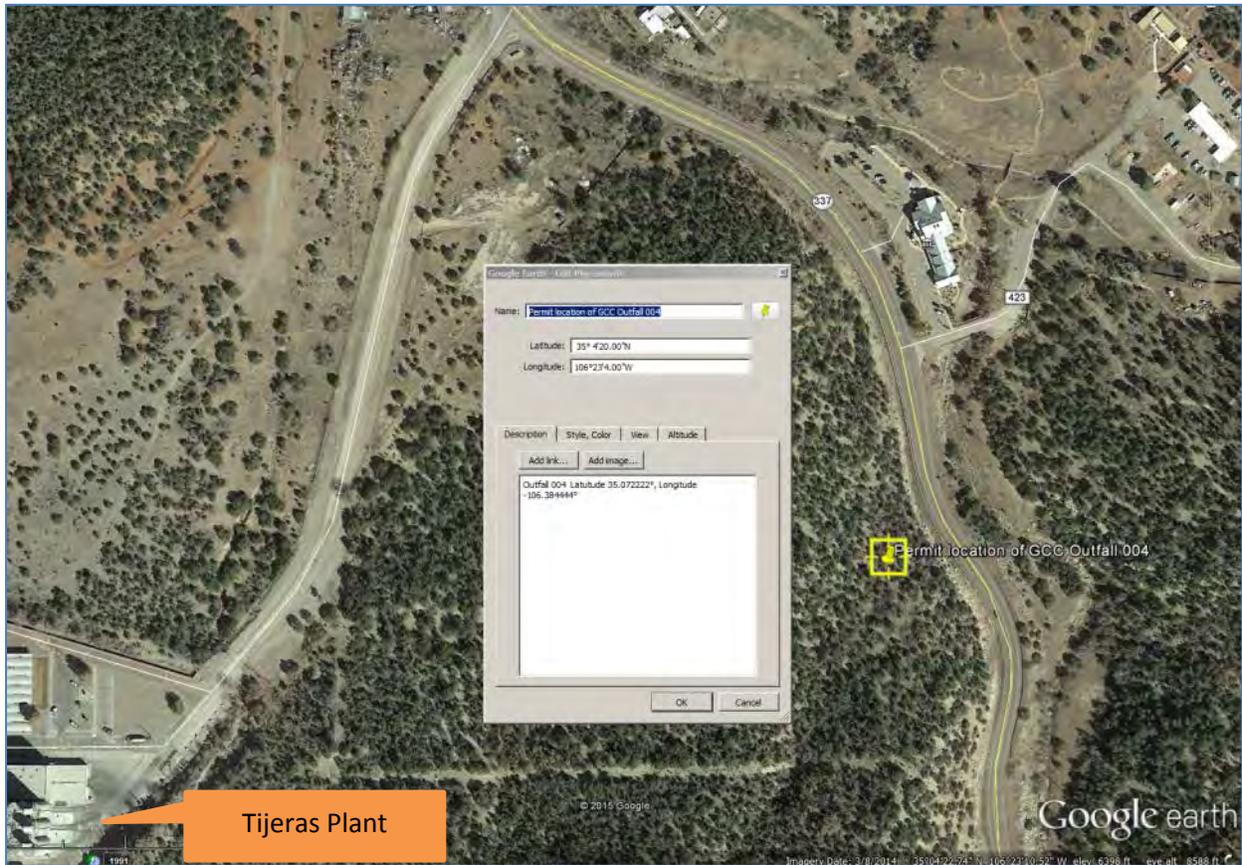
Figure 4: Permit Location for Authorized Outfall 004

The cover or title page of the Permit provides the following information for the location of Outfall 004:

Outfall 004: Latitude: 35° 04' 20", Longitude: 106° 23' 04"

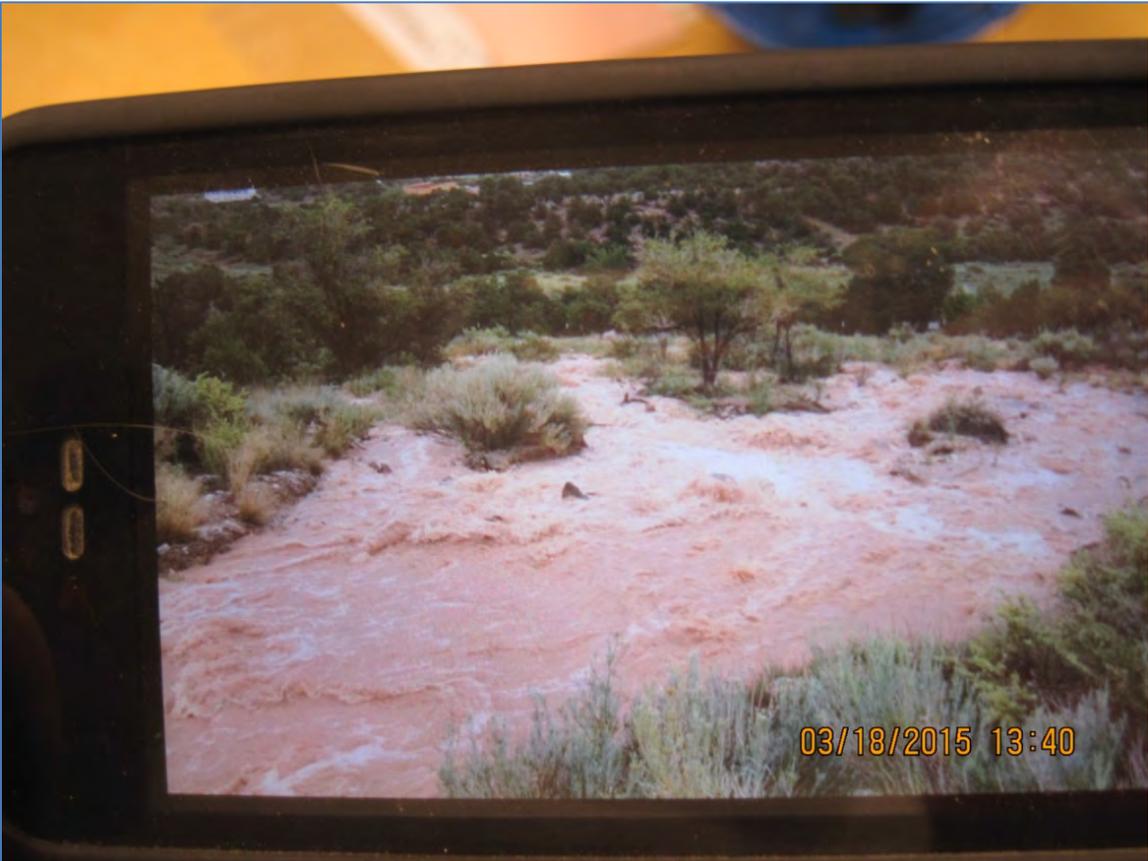
NMED/SWQB Official Photograph Log Photo # 1		
Photographer: Erin S. Trujillo	Date: 03/18/2015	Time: 1340 hours
City/County: Tijeras / Bernalillo County		State: New Mexico
Location: GCC Rio Grande, Inc. / Tijeras Plant		
Subject: Photograph of permittee representative cell phone video of Outfall 001 discharge (Wednesday, August 13, 2014 at 4:35:47 pm). The discharge in the video appears highly turbid and brown in color. Permittee representatives stated that the discharge continued for approximately 2 hours.

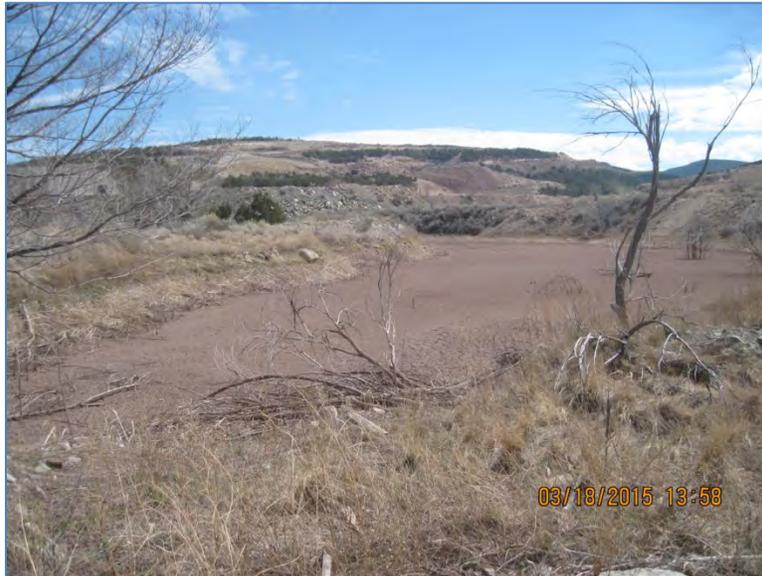
NMED/SWQB Official Photograph Log Photo # 2		
Photographer: Erin S. Trujillo	Date: 03/18/2015	Time: 1358 hours
City/County: Tijeras / Bernalillo County		State: New Mexico
Location: GCC Rio Grande, Inc. / Tijeras Plant		
Subject: Looking south-southeast, Quarry #1 pond from overflow low area near Outfall 001. Mining areas (active & reclaimed) in background

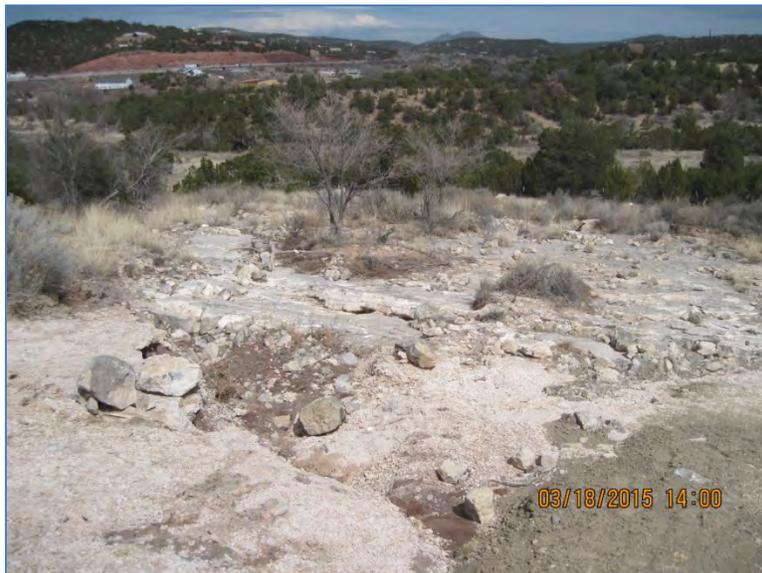
NMED/SWQB Official Photograph Log Photo # 3		
Photographer: Erin S. Trujillo	Date: 03/18/2015	Time: 1400 hours
City/County: Tijeras / Bernalillo County		State: New Mexico
Location: GCC Rio Grande, Inc. / Tijeras Plant		
Subject: Looking north, limestone bedrock at Outfall 001 (see Photo #1).

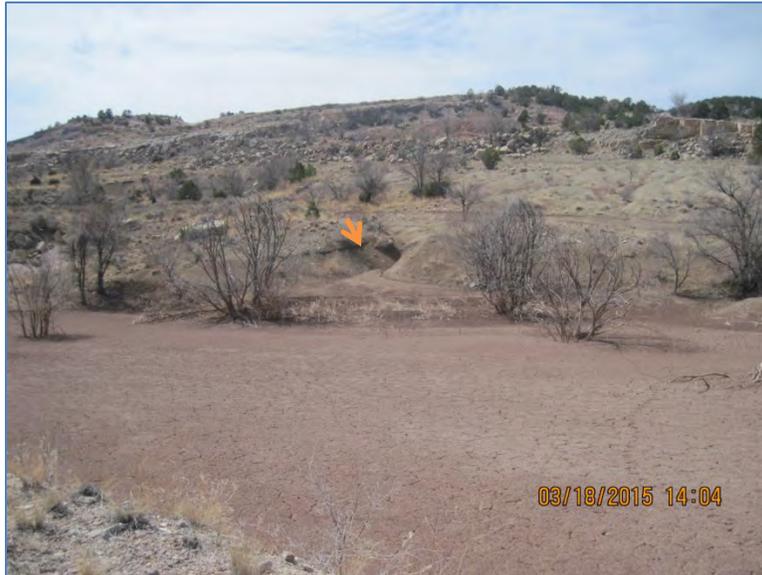
NMED/SWQB Official Photograph Log Photo # 4		
Photographer: Erin S. Trujillo	Date: 03/18/2015	Time: 1404 hours
City/County: Tijeras / Bernalillo County		State: New Mexico
Location: GCC Rio Grande, Inc. / Tijeras Plant		
Subject: Looking generally west at Quarry Pond #001, arrow points to channel that enters pond.

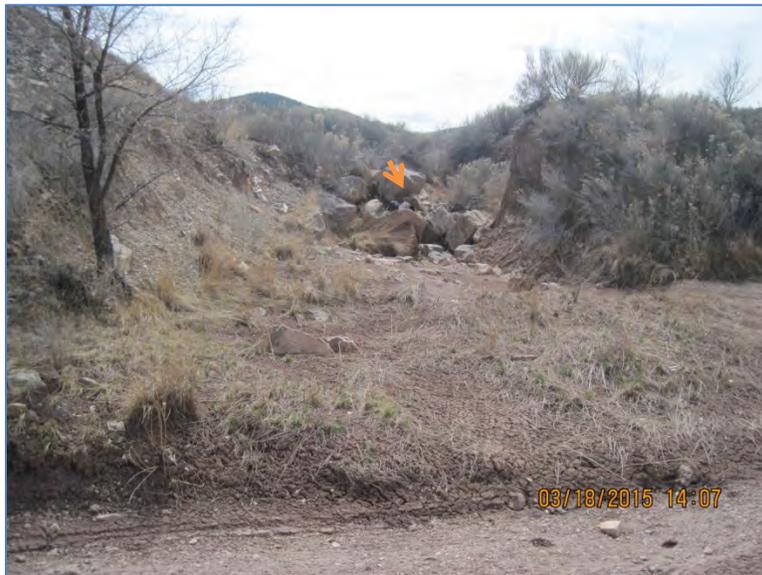
NMED/SWQB Official Photograph Log Photo # 5		
Photographer: Erin S. Trujillo	Date: 03/18/2015	Time: 1407 hours
City/County: Tijeras / Bernalillo County		State: New Mexico
Location: GCC Rio Grande, Inc. / Tijeras Plant		
Subject: Arrow points to rock in channel opening between "Frog Pond" and southeast corner Quarry #1 pond.

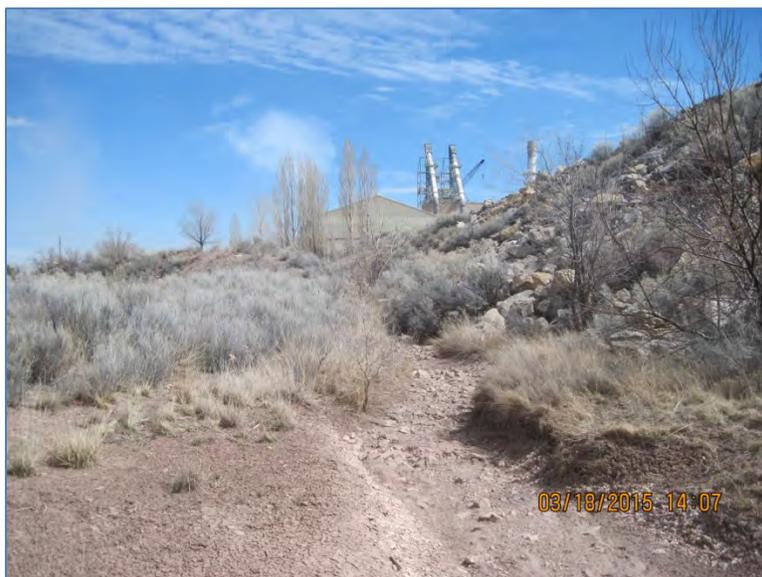
NMED/SWQB Official Photograph Log Photo # 6		
Photographer: Erin S. Trujillo	Date: 03/18/2015	Time: 1407 hours
City/County: Tijeras / Bernalillo County		State: New Mexico
Location: GCC Rio Grande, Inc. / Tijeras Plant		
Subject: Channel between plant process and storm water pipe outlet (next photo) and Quarry #1 pond.

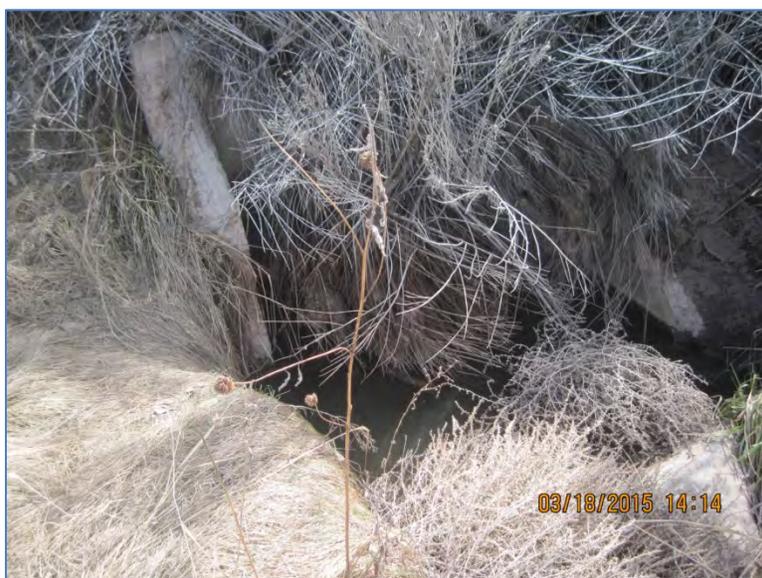
NMED/SWQB Official Photograph Log Photo # 7		
Photographer: Erin S. Trujillo	Date: 03/18/2015	Time: 1414 hours
City/County: Tijeras / Bernalillo County		State: New Mexico
Location: GCC Rio Grande, Inc. / Tijeras Plant		
Subject: Plant process water and stormwater pipe outlet. Pounded water below outlet did not continue to channel shown in previous photo.

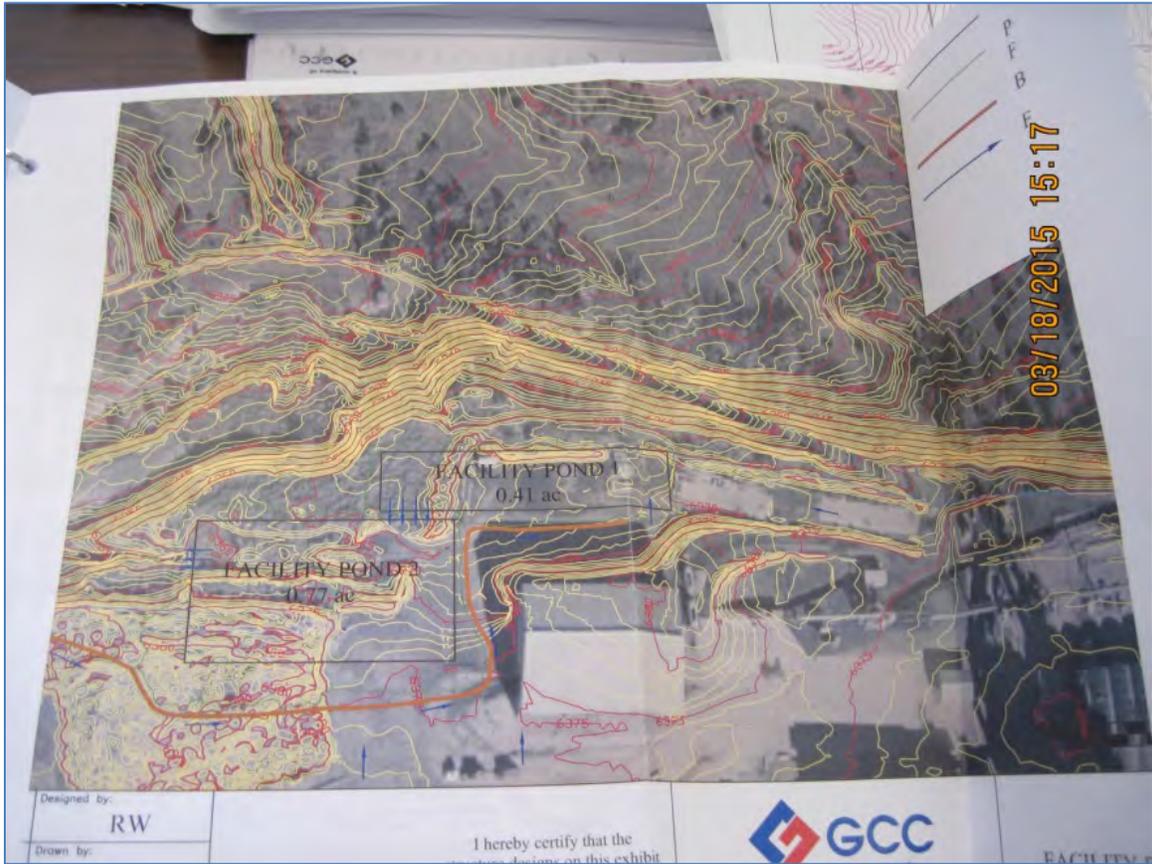
NMED/SWQB Official Photograph Log Photo # 8		
Photographer: Erin S. Trujillo	Date: 03/18/2015	Time: 1517 hours
City/County: Tijeras / Bernalillo County	State: New Mexico	
Location: GCC Rio Grande, Inc. / Tijeras Plant		
Subject: Drawing showing location of proposed facility ponds north and west of the coal building at the plant.
