**Re: Los Alamos County - Los Alamos Wastewater Treatment Facility; Major; Municipal;  
SIC 4952; NPDES Compliance Evaluation Inspection; NM0020141; November 8, 2013**

### NPDES Compliance Inspection Report

Los Alamos County - Los Alamos Wastewater Treatment Facility  
NPDES Permit Number NM0020141  
Compliance Evaluation Inspection  
November 8, 2013  
Page 1 of 6

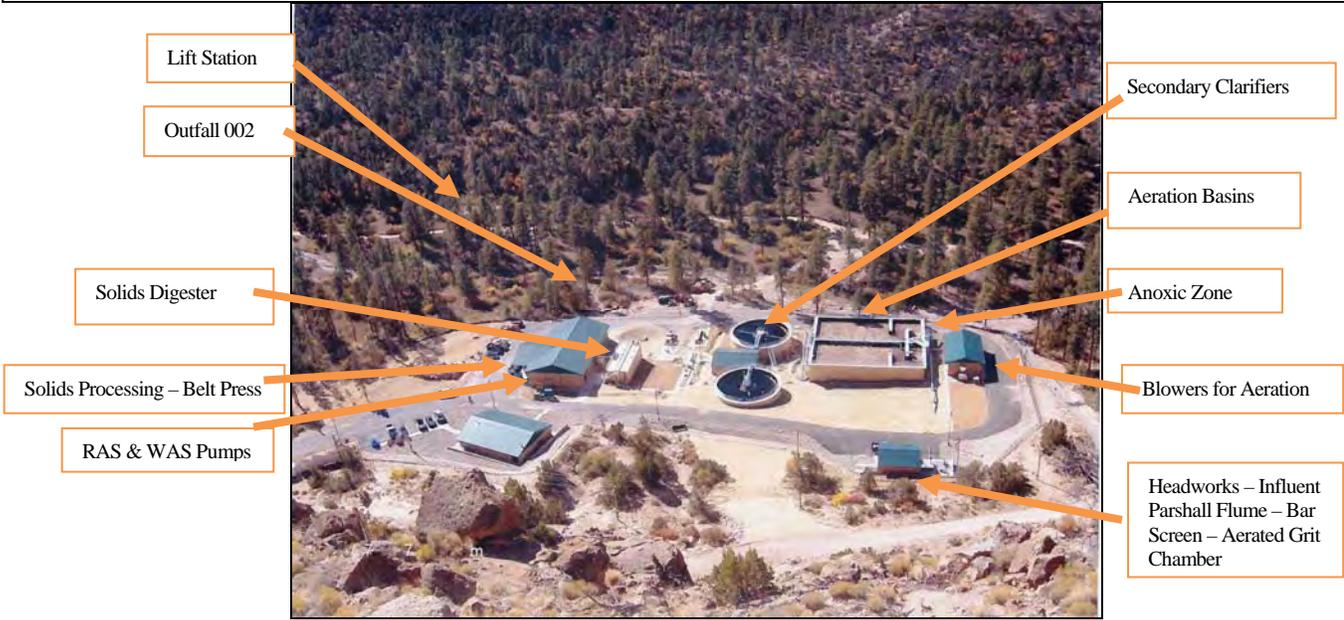
**NMED/SWQB  
Official Photograph Log  
Photo # 1**

Photographer: Los Alamos County Record	Date: Unknown	Time: Unknown
City/County: Los Alamos / Los Alamos		State: New Mexico
Location: Los Alamos County – Los Alamos Wastewater Treatment Facility		
Subject: Hill side view of the new WWTP

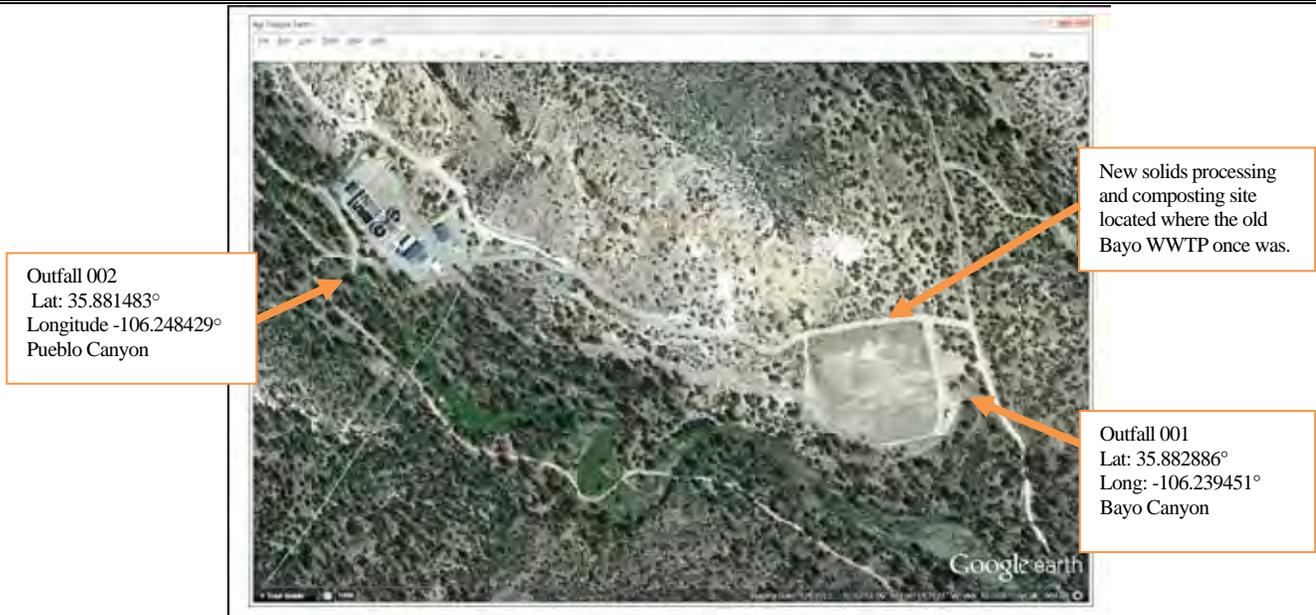
**NMED/SWQB  
Official Photograph Log  
Photo # 2**

Photographer: Google Earth	Date: May 4, 2012	Time: Unknown
City/County: Los Alamos / Los Alamos		State: New Mexico
Location: Los Alamos County – Los Alamos Wastewater Treatment Facility		
Subject: 1. Location of the New WWTP and Outfall 002 to Pueblo Canyon. 2. The location of the Old Bayo WWTP is being converted to a solids and compost processing facility. 3. The location of the old outfall 001 at Bayo Canyon.

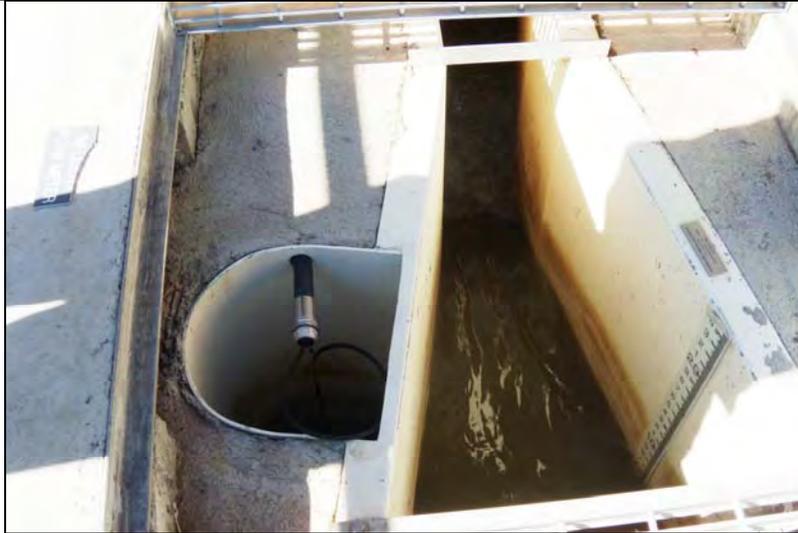
NMED/SWQB  
Official Photograph Log  
Photo # 3

Subject: Influent Parshall Flume – staff gauge and pressure sensor – transducer flow meter that provides totalize flow values.

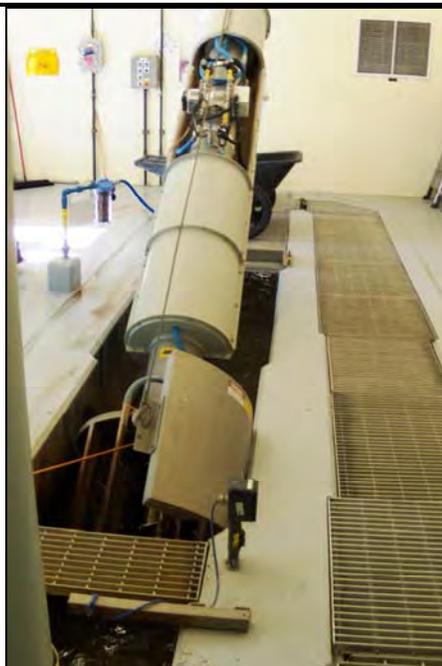
NMED/SWQB  
Official Photograph Log  
Photo # 4

Subject: Grinder – screw pump for influent solids removal.

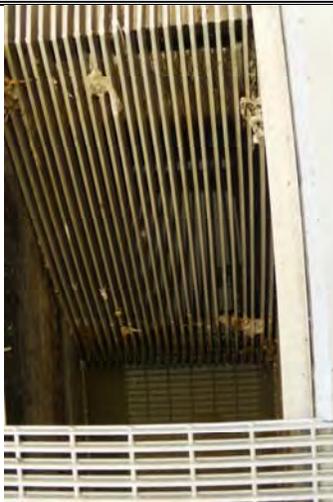
**NMED/SWQB  
Official Photograph Log  
Photo # 5**

Subject: Influent manual bar screen for back up.

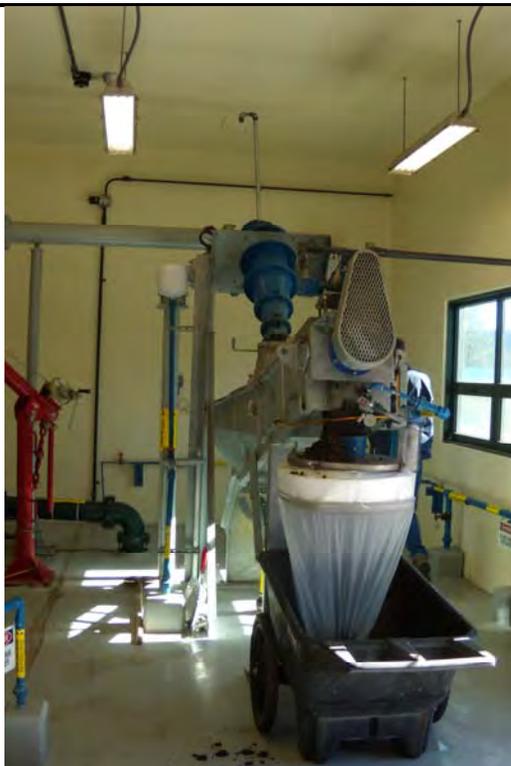
**NMED/SWQB  
Official Photograph Log  
Photo # 6**

Subject: Influent screens – large solids are bagged for disposal at the land fill after meeting the paint filter test.

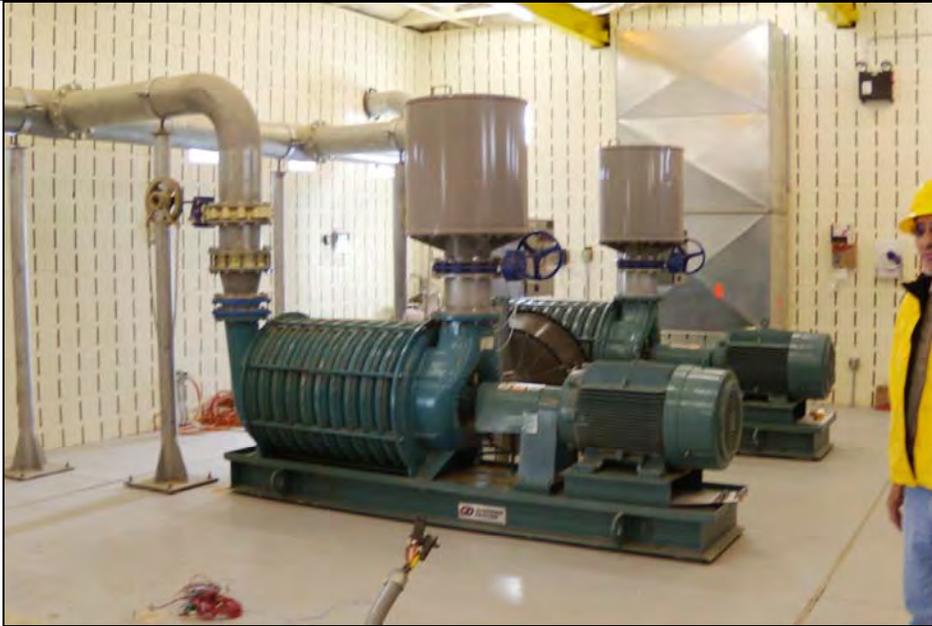
NMED/SWQB  
Official Photograph Log  
Photo # 7

Subject: Blower Motors – variable speed – a third motor is onsite and another backup was on order at the time of the inspection. Even at the lowest setting these blower are too powerful for one train.

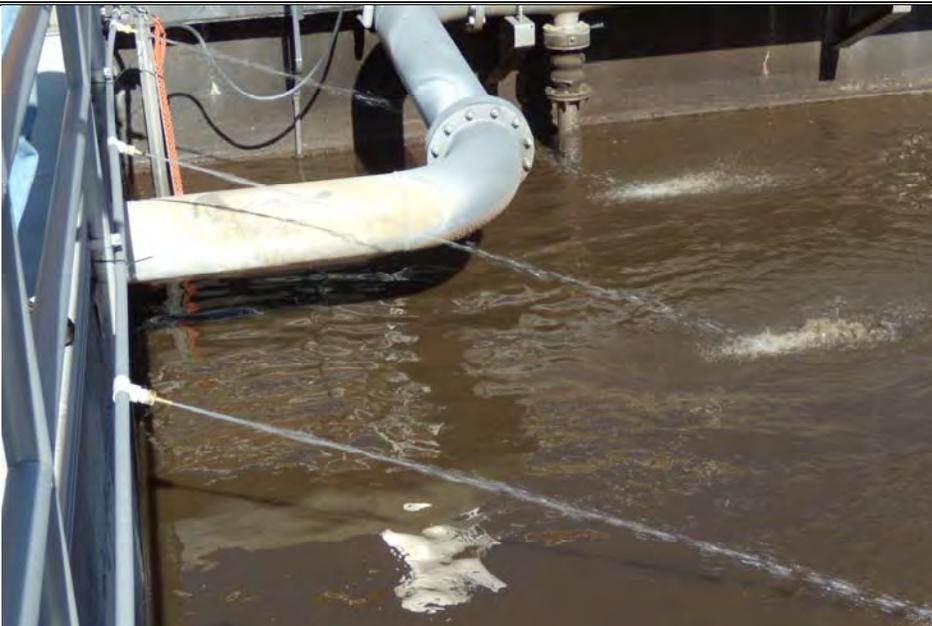
NMED/SWQB  
Official Photograph Log  
Photo # 8

Subject: Anoxic Zone – Dissolved Oxygen reading are 0.00 mg/L

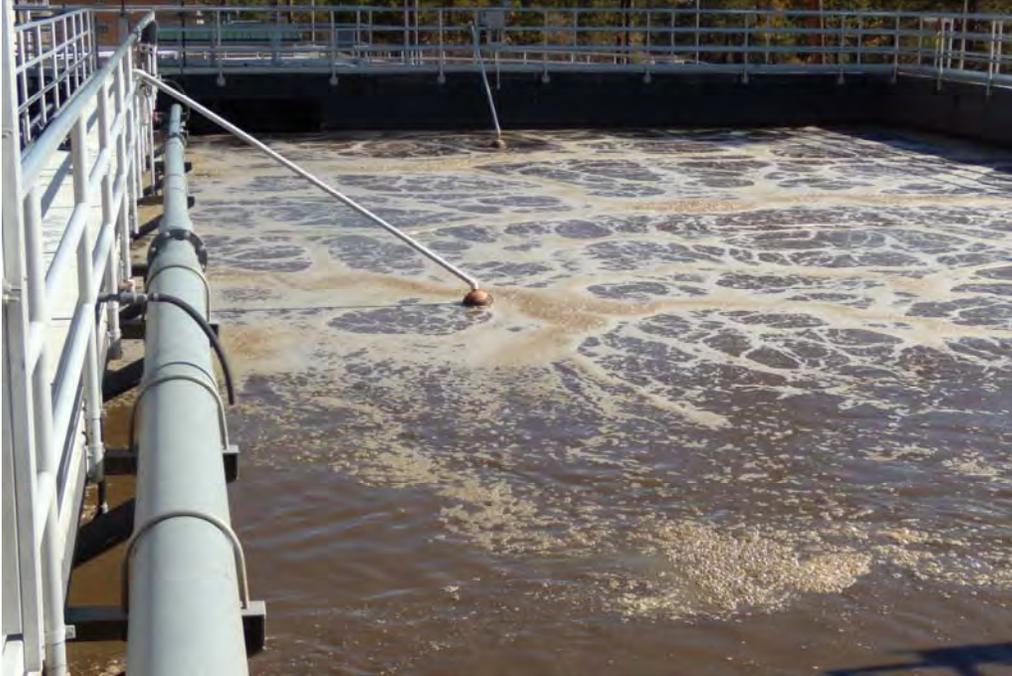
NMED/SWQB  
Official Photograph Log  
Photo # 9

Subject: Aeration Basin – Dissolved Oxygen ranges up to 104 mg/L – Mixed Liquor Suspended Solids (MLSS) ranges from 1800 to 2800 mg/L

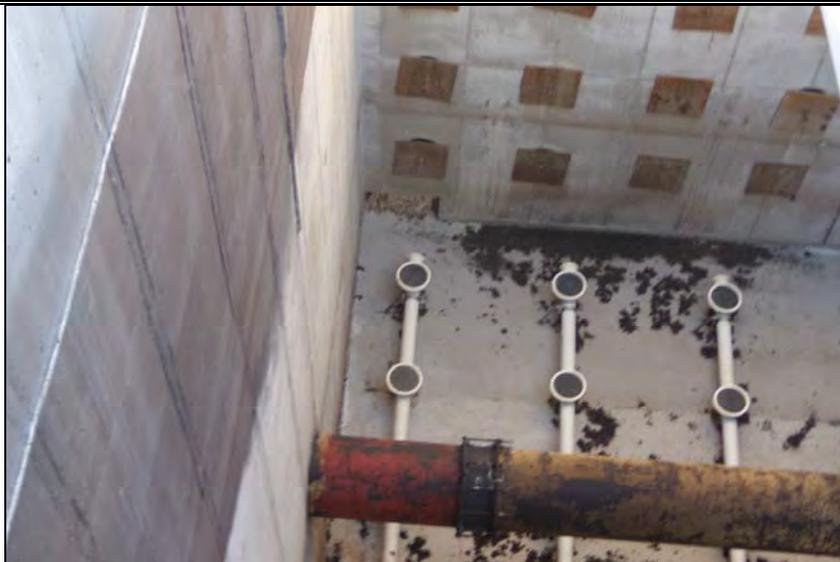
NMED/SWQB  
Official Photograph Log  
Photo # 10

Subject: One treatment train was on line at the time of the inspection due to the volume of the influent. The photo below shows air diffusers in the offline basin. The depth is 22 feet deep.

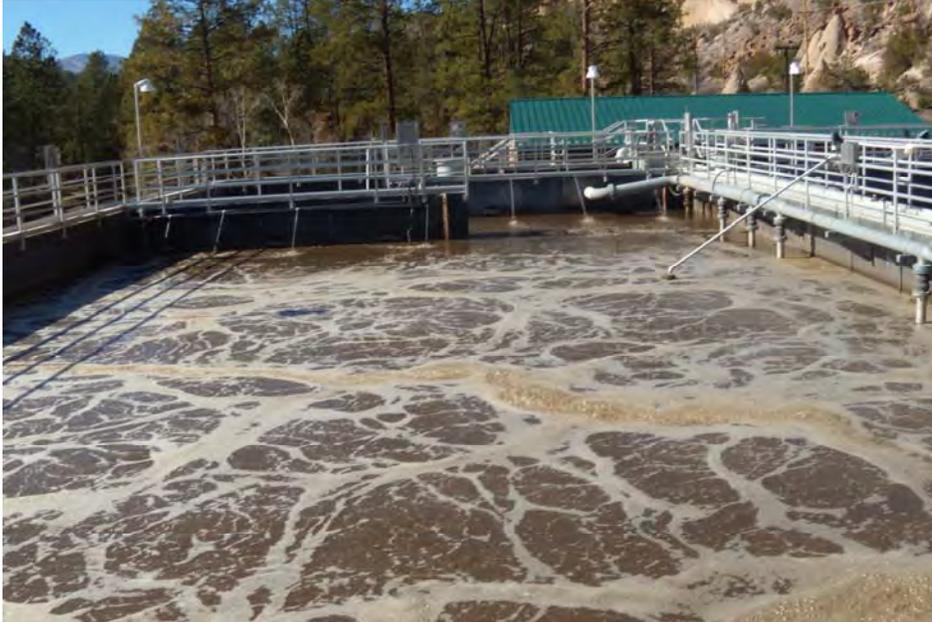
NMED/SWQB  
Official Photograph Log  
Photo # 11

Subject: Aeration Basin – another view.

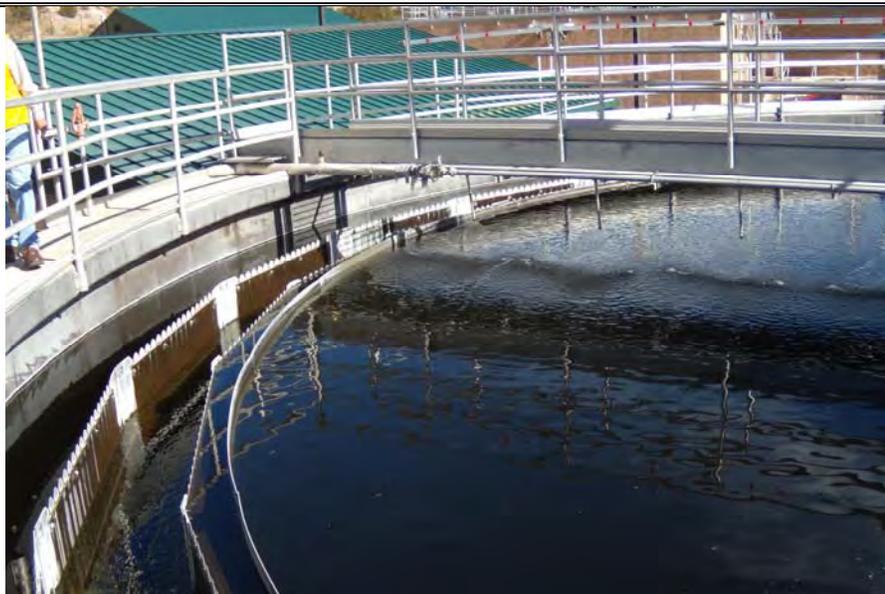
NMED/SWQB  
Official Photograph Log  
Photo # 12

Subject: Secondary Clarifier – Both clarifiers were on line and running parallel at the time of the inspection. Sludge Blanket is 1.5 deep feet at mid basin. Wasting is done 1/week due to the cost of sludge hauling to Rio Rancho solid waste facility, while the new composting site is being built.

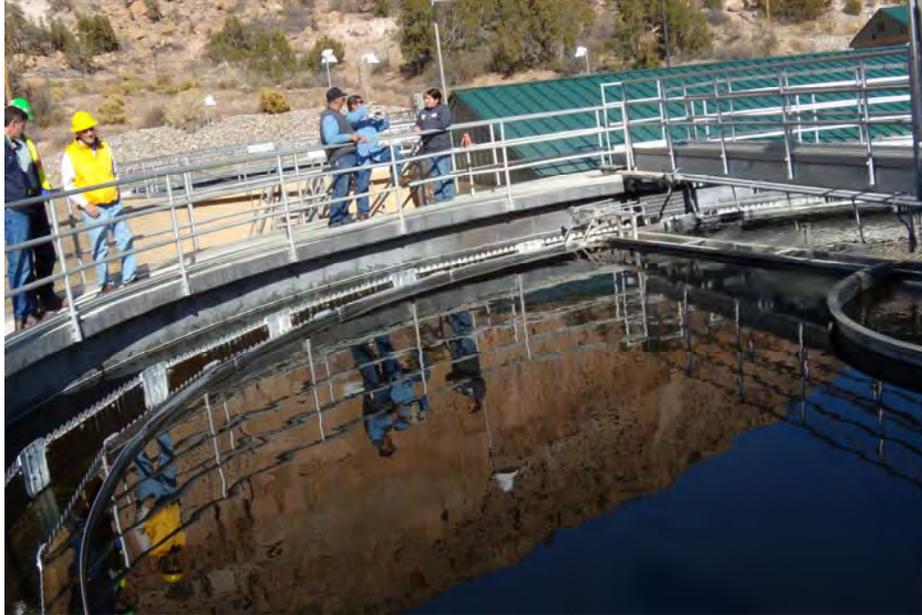
NMED/SWQB  
Official Photograph Log  
Photo # 13

Subject: Clarifier and weirs appear to be level with very little to no short circuiting.

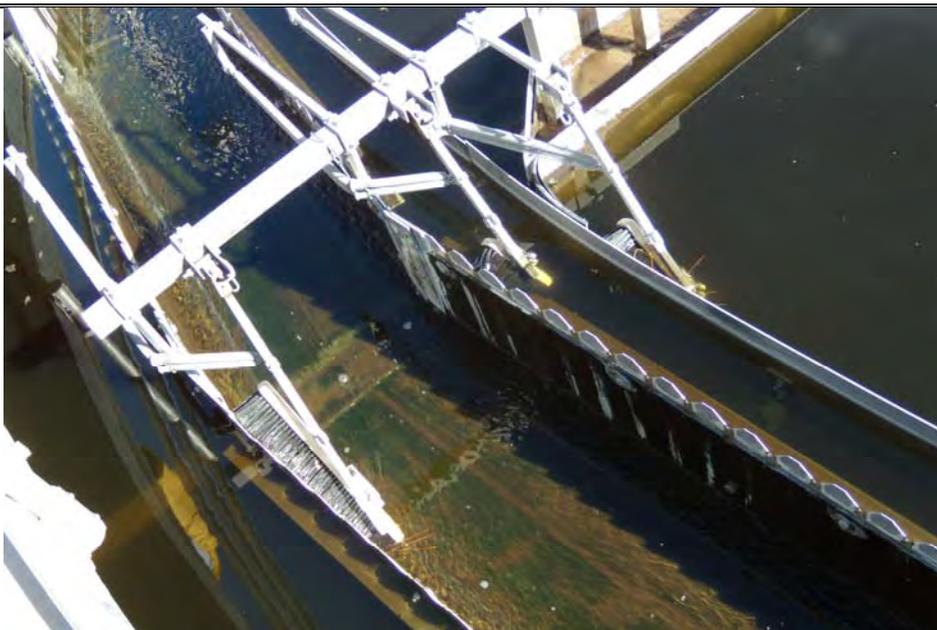
NMED/SWQB  
Official Photograph Log  
Photo # 14

Subject: Clarifier weir troughs are scrubbed mechanically w/ brushes to keep algae growth and accumulation at a minimum.

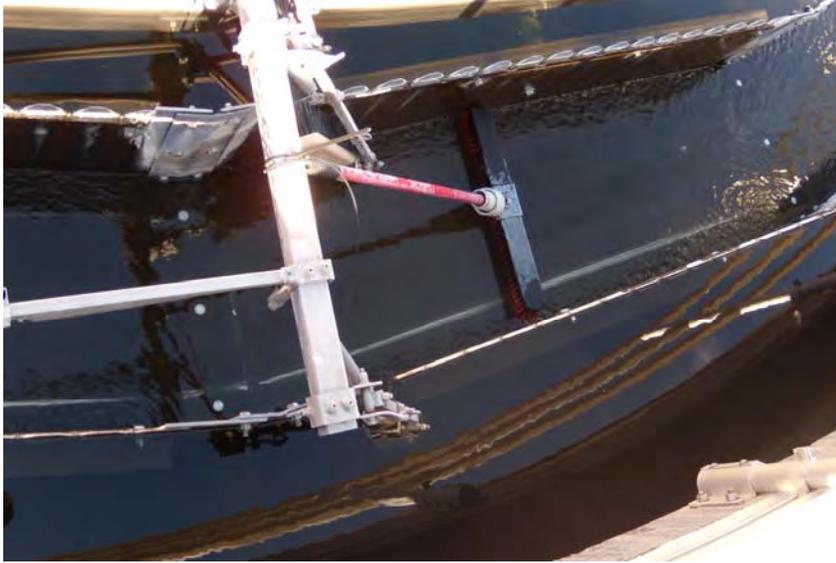
NMED/SWQB  
Official Photograph Log  
Photo # 15

Subject: Clarifier weir troughs are scrubbed mechanically w/ brushes to keep algae growth and accumulation at a minimum. A push broom was fastened by operators to the rotating arm to clean the trough floor.

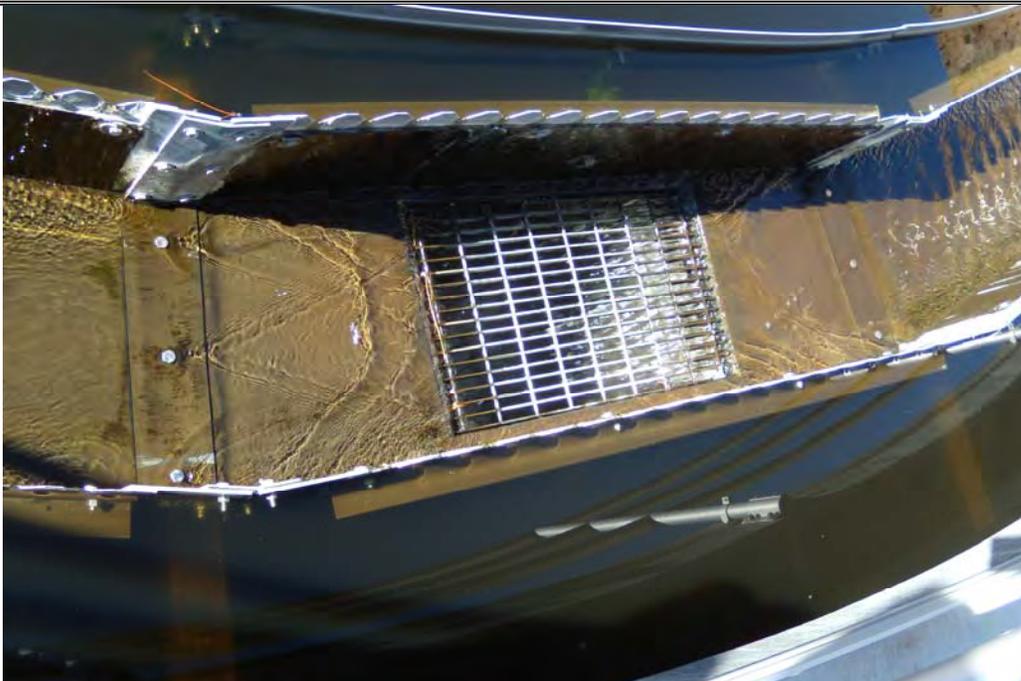
NMED/SWQB  
Official Photograph Log  
Photo # 16

Subject: Effluent leaving the clarifier is clear and free of floating solids.

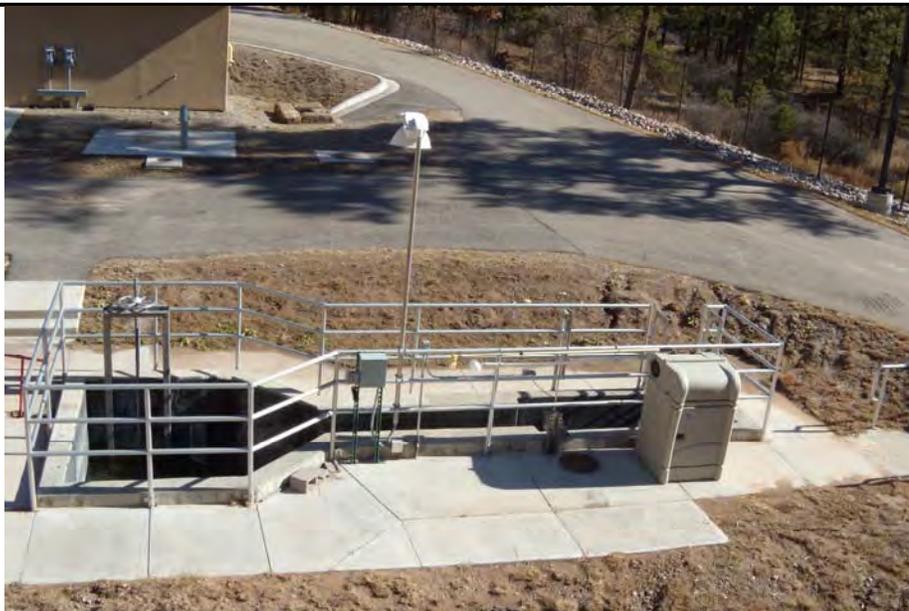
NMED/SWQB  
Official Photograph Log  
Photo # 17

Subject: Effluent Parshall flume following the Ultraviolet Disinfection Units. Note the ISCO auto sampler located at the end of the treatment works for collection of samples for analysis.

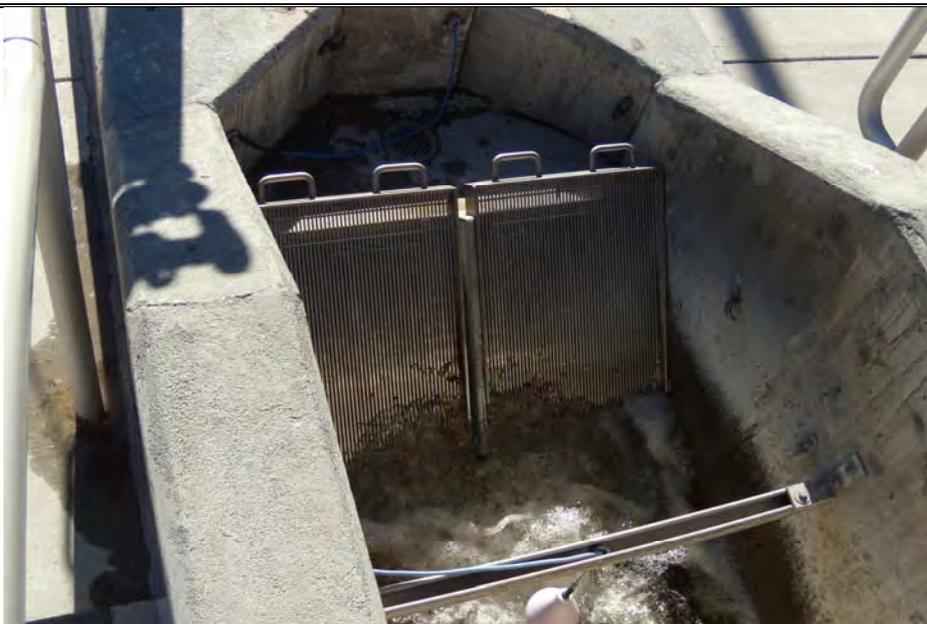
NMED/SWQB  
Official Photograph Log  
Photo # 18

Subject: Fine screen in place prior to the Ultraviolet (UV) Disinfection Chamber collects any solids that may have made it through the other treatment units. This protects the UV lights, improves disinfection and effluent quality.

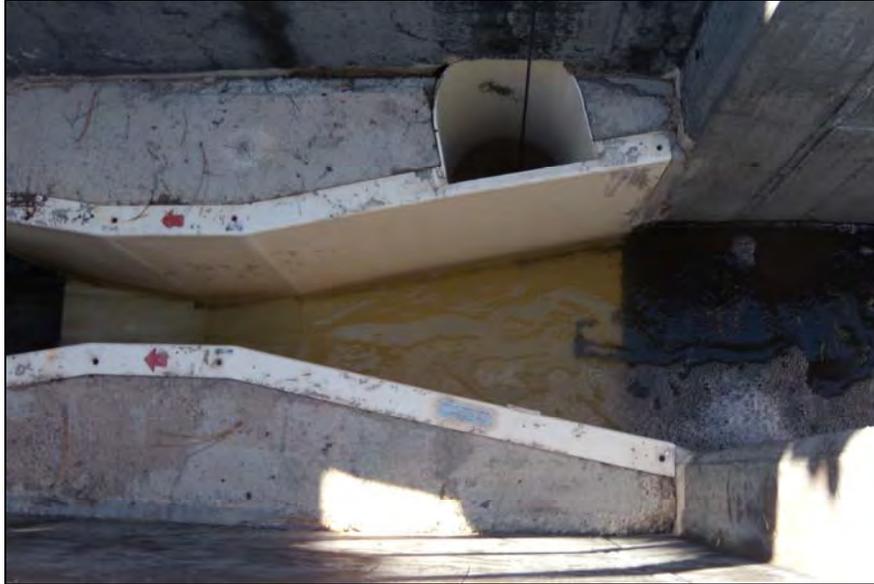
NMED/SWQB  
Official Photograph Log  
Photo # 19

Subject: Effluent Parshall Flume – flow measurement and sampling location.

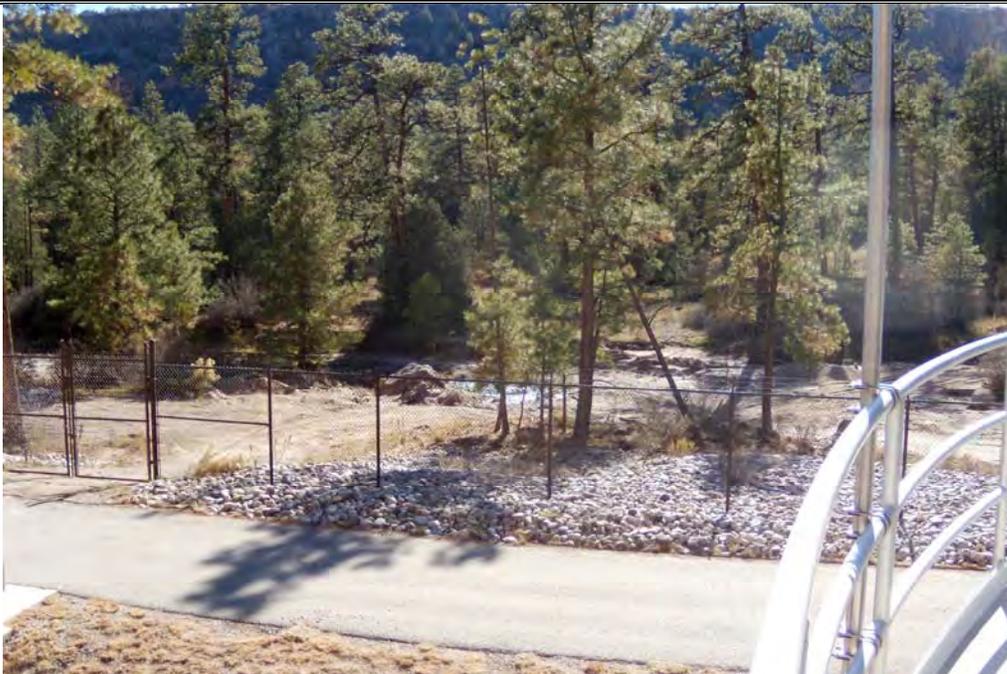
NMED/SWQB  
Official Photograph Log  
Photo # 20

Subject: From the final flow measurement the effluent travels approximately 300 feet through an underground 18 inch pipe to the final discharge point.

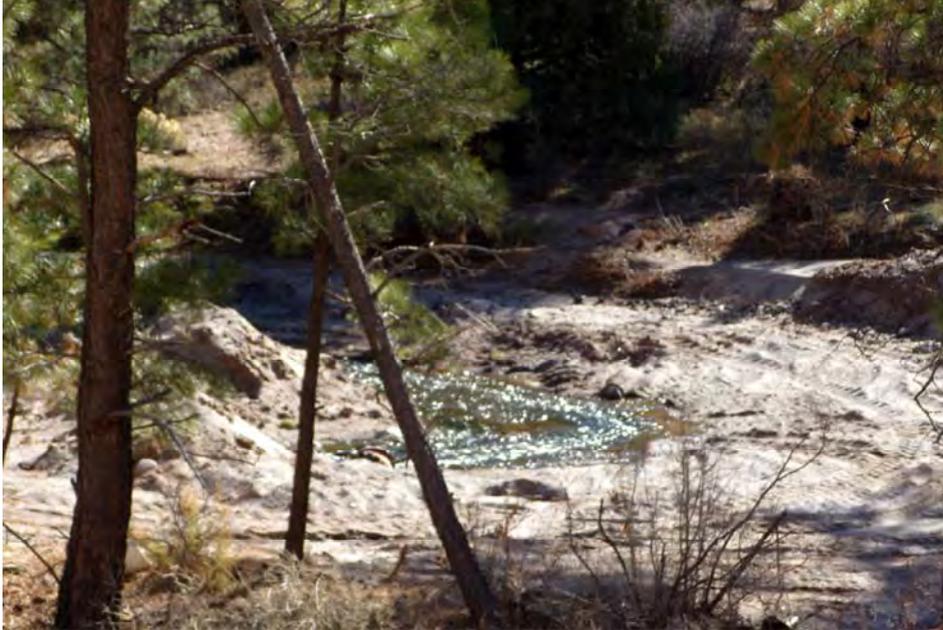
NMED/SWQB  
Official Photograph Log  
Photo # 21

Subject: Final Discharge point to Pueblo Canyon.

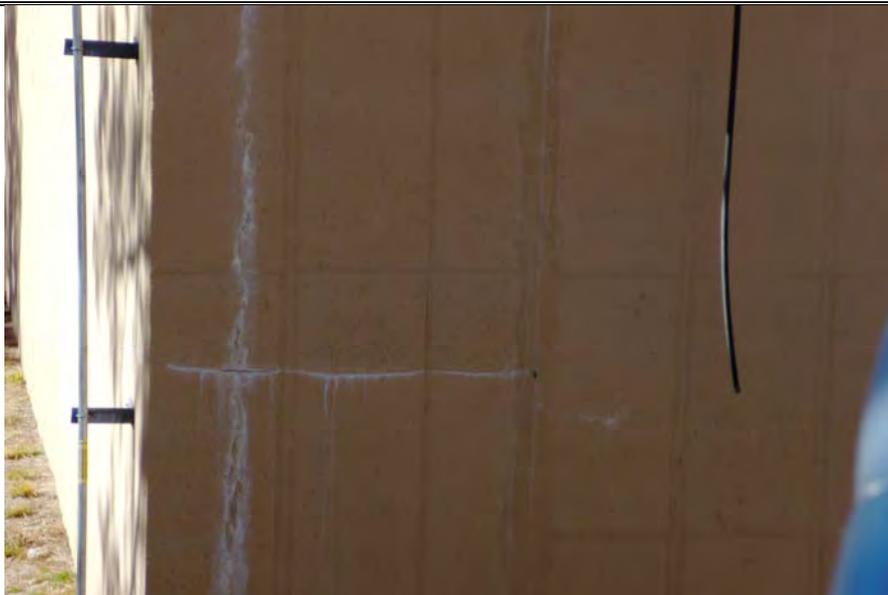
NMED/SWQB  
Official Photograph Log  
Photo # 22

Subject: Noted on the wall of the aeration basins are some sealed joints that show staining. These areas of the basin should be watched as time goes by as cracking and leaking could develop.

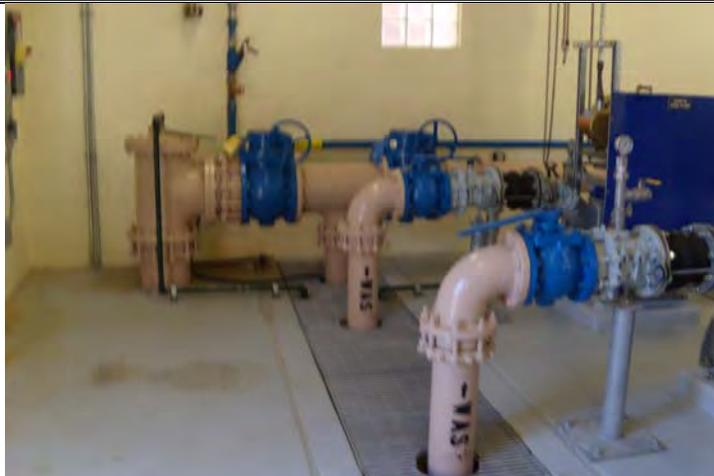
NMED/SWQB  
Official Photograph Log  
Photo # 23

Subject: Waste Activated Sludge (WAS) and Return Activated Sludge (RAS) lines and pumps.

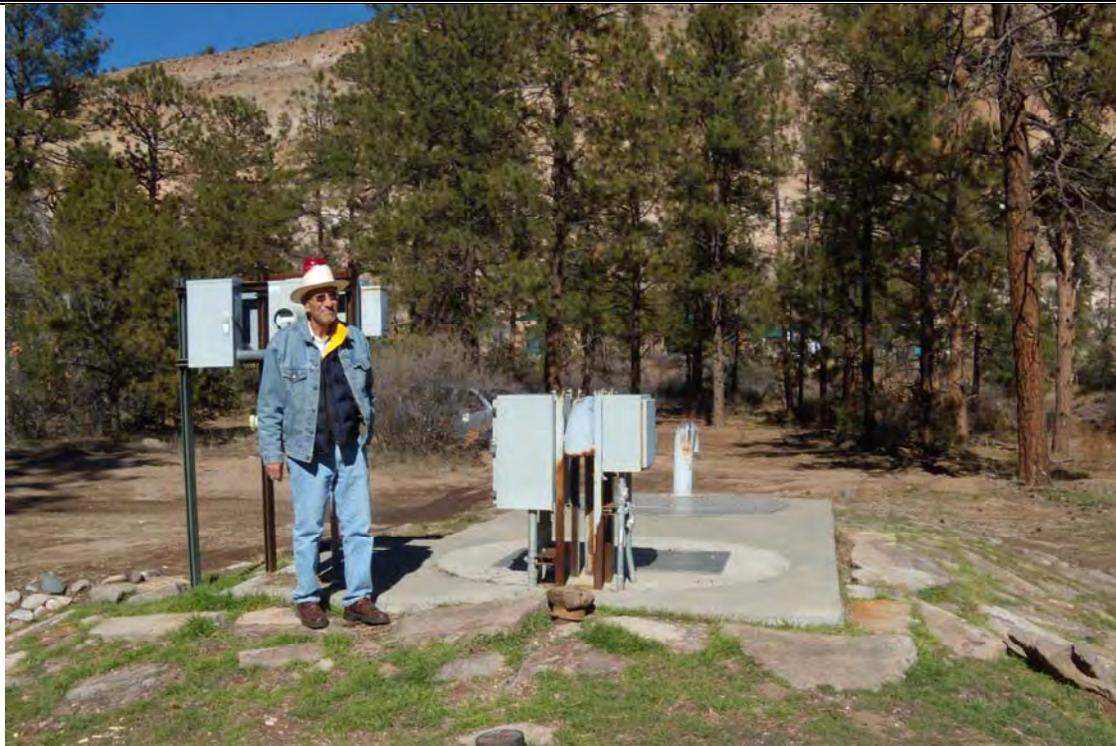
NMED/SWQB  
Official Photograph Log  
Photo # 24

Subject: Final lift station before the WWTP. This lift station overflowed during the week of September 9, 2013 when New Mexico and the Western United States experienced massive rain fall and flooding. Los Alamos County received up to 10 inches of rain in a single day. – The area has since been cleaned and disinfected by plant operators.

There are 17 lift stations throughout the collection system. Only a few of these have alarms call-out devices to notify operators if there is an overflow or power failure. The other lift stations have flashing lights and citizens in the area call into the utilities department when there is a problem. These lift stations are also checked by operators on a regular basis. According to facility representative the County is in the process of rehabilitating these lift stations – a few each year. When the lift station is upgraded so is the alarm system. It is advisable for the permittee to consider these upgrades as a high priority.

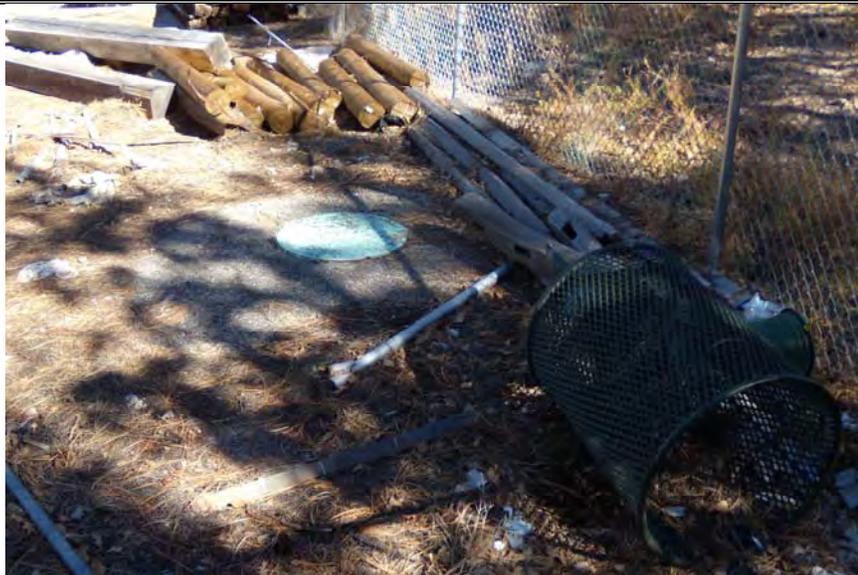
NMED/SWQB  
Official Photograph Log  
Photo # 25

Subject: Man hole near Canyon Road and above Acid Canyon overflowed an unknown amount of wastewater mixed with rain water during the week of September 9, 2013 when New Mexico and the Western United States experienced massive rain fall and flooding. Los Alamos County received up to 10 inches of rain in a single day. – The area has since been cleaned and disinfected by plant operators.

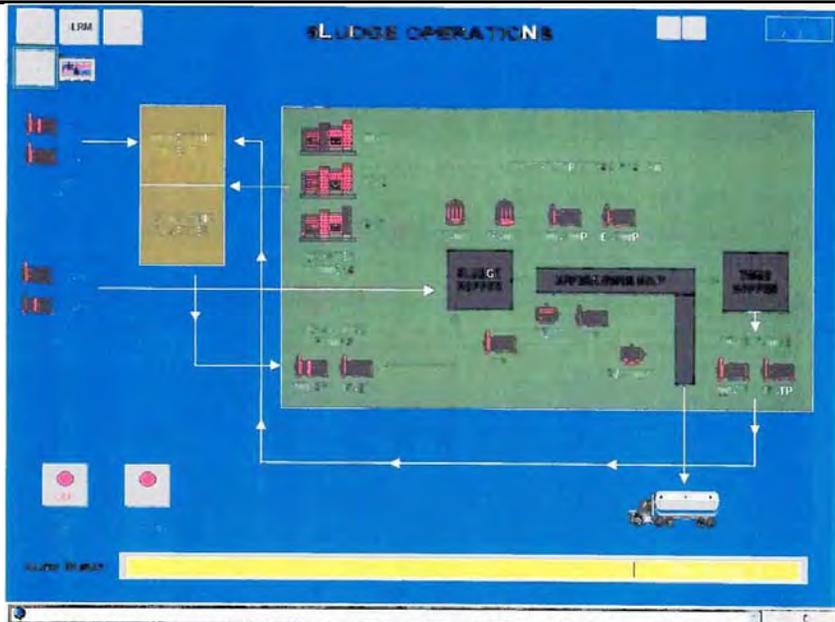
NMED/SWQB  
Official Photograph Log  
Photo # 26

Subject: SCADA computerized operational system for the WWTP and Solids Processing – Screen Print

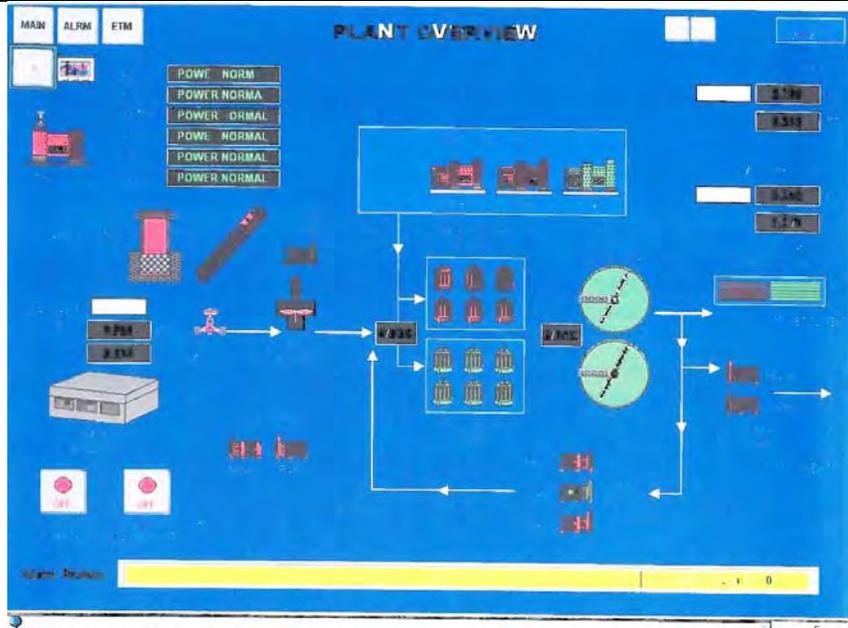
NMED/SWQB  
Official Photograph Log  
Photo # 27

Subject: SCADA computerized operational system for the WWTP and Solids Processing – Screen Print

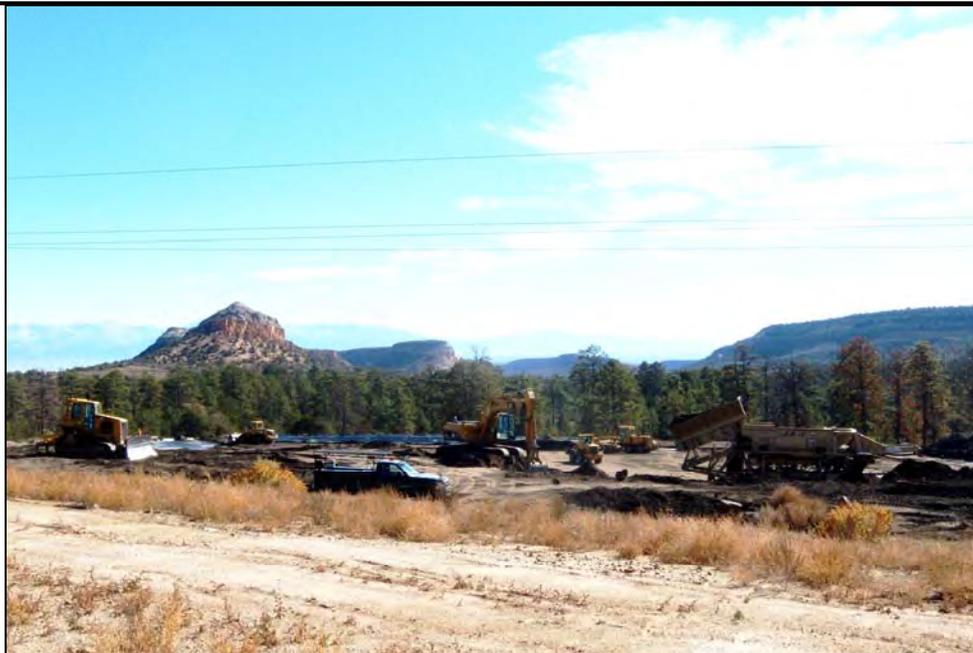
NMED/SWQB  
Official Photograph Log  
Photo # 28

Subject: Location of the old Bayo WWTP – Now being converted to a Solids processing and composting facility.

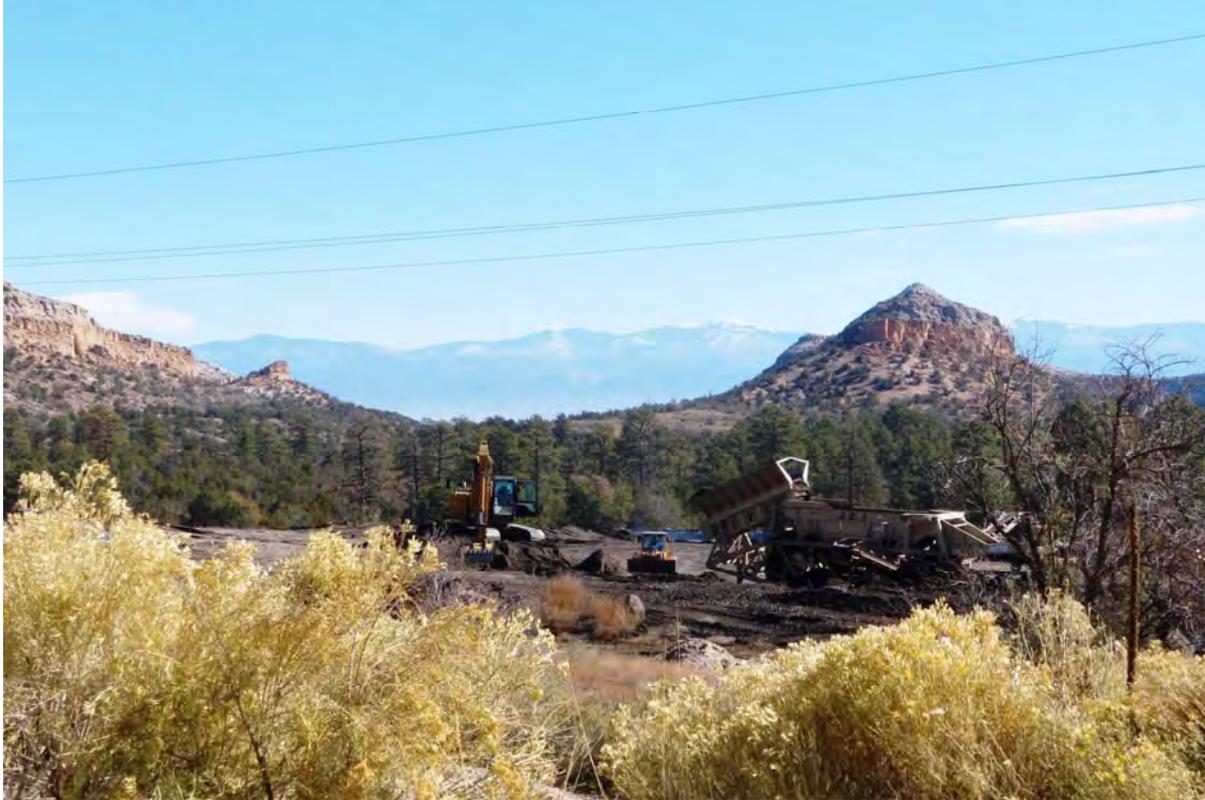
**NMED/SWQB  
Official Photograph Log  
Photo # 29**

Subject: Location of the old Bayo WWTP – Now being converted to a Solids processing and composting facility.
