Re: Truth or Consequences Wastewater Treatment Plant; Major Municipal; SIC 4952; NPDES Compliance Evaluation Inspection; NM0020681; May 12, 2016

Further Explanations
Truth or Consequences Wastewater Treatment Plant NPDES Permit No. NM0020681
Inspection Date: May 12, 2016

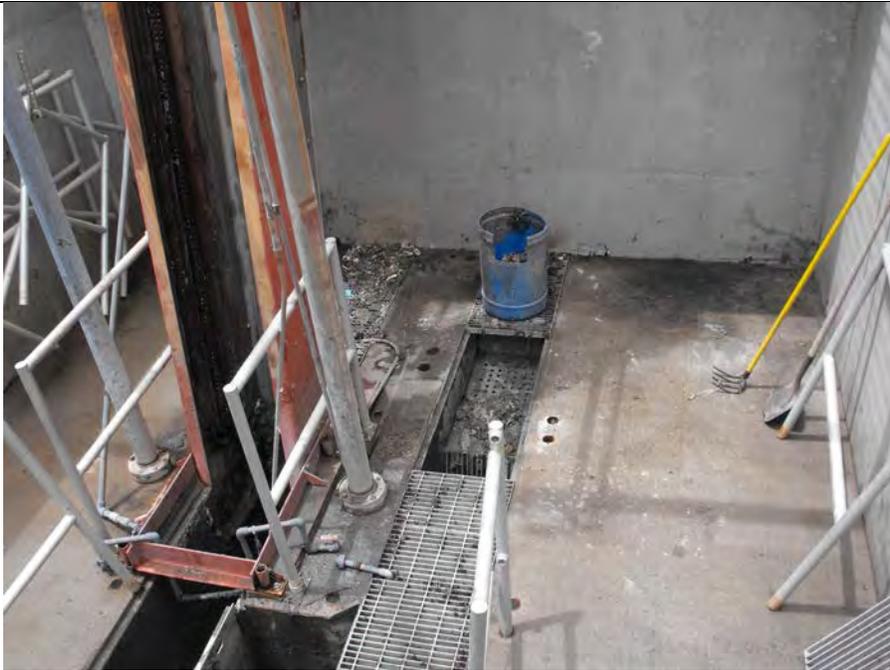
NMED/SWQB
Official Photograph Log
Photo # 2

- The automated bar screen (photo 2) and grit separator are both being bypassed due to equipment issues.
- The facility has a lined emergency overflow pond (photo 3). The liner appeared to have some damage near the inflow pipe and may not contain all fluids if used for emergency overflow before it is replaced as part of Phase 2B upgrades.
- Many teeth on the clarifier weirs are broken (photo 5) allowing some floatables to get past the system. The teeth had been replaced two years ago and are planned to be replaced with fiberglass teeth.
- March 13, 2016 the headworks VFD stopped operating and the SCADA system did not alarm, resulting in a sewage back up out of a manhole. The spill did not reach a watercourse and was cleaned up and reported.

Subject: manual bar screen

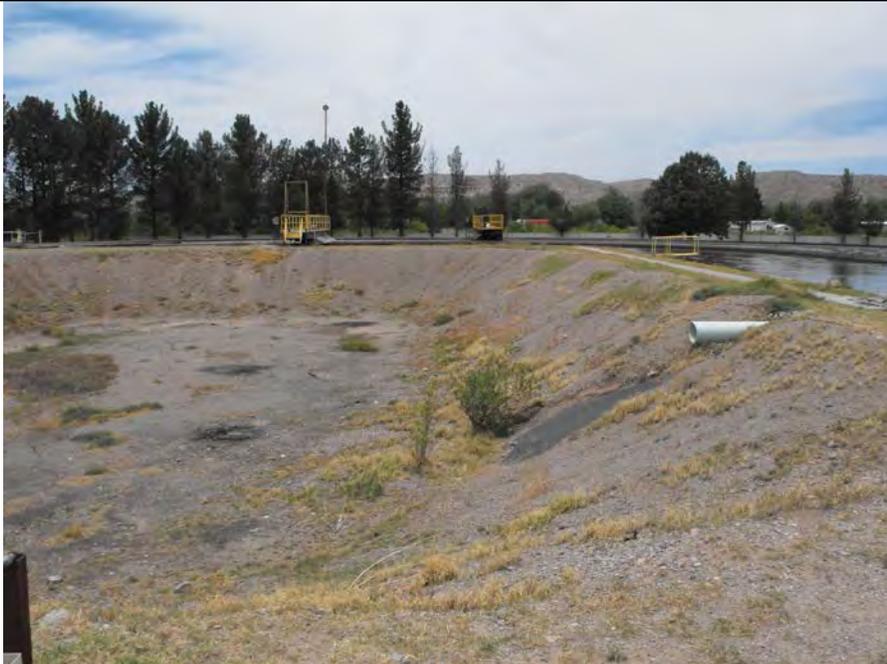
NMED/SWQB
Official Photograph Log
Photo #3

Subject: Emergency overflow pond, gravel missing near outfall pipe (hole not visible in this photo) and possible damage in other areas.

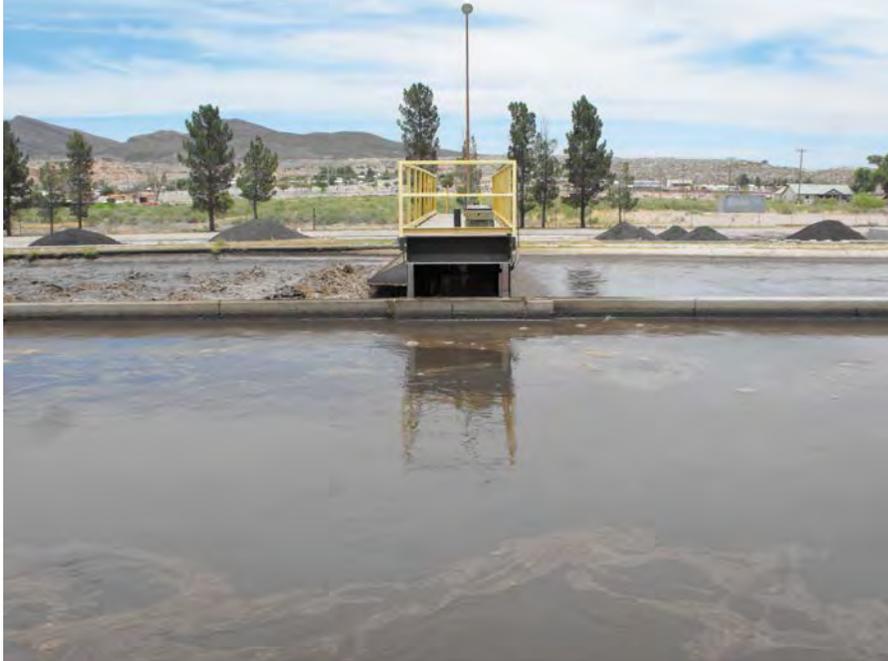
NMED/SWQB
Official Photograph Log
Photo #4

Wastewater from the grit chamber gravity flows into a racetrack type extended aeration basin equipped with three surface power brush rotors that are used for aeration. A scum trough in the aeration basin collects excess foam that is sent directly to the foam drying beds, until landfill disposal occurs.

Subject: Rotors in oxidation oval

The planned Phase I Construction scheduled to begin this month include: renovating the headworks, influent flow meter, VFD, and mechanical bar screen; replacing the power brush rotors in the aeration basin with bubble diffusers; upgrading to an ultraviolet light disinfection system; incorporating a belt filter press to dry solids; and upgrading the SCADA system. Phase 2A will replace the circular clarifiers, phase 2B will replace the digester basin, and rehabilitate the oxidation oval and emergency overflow pond.

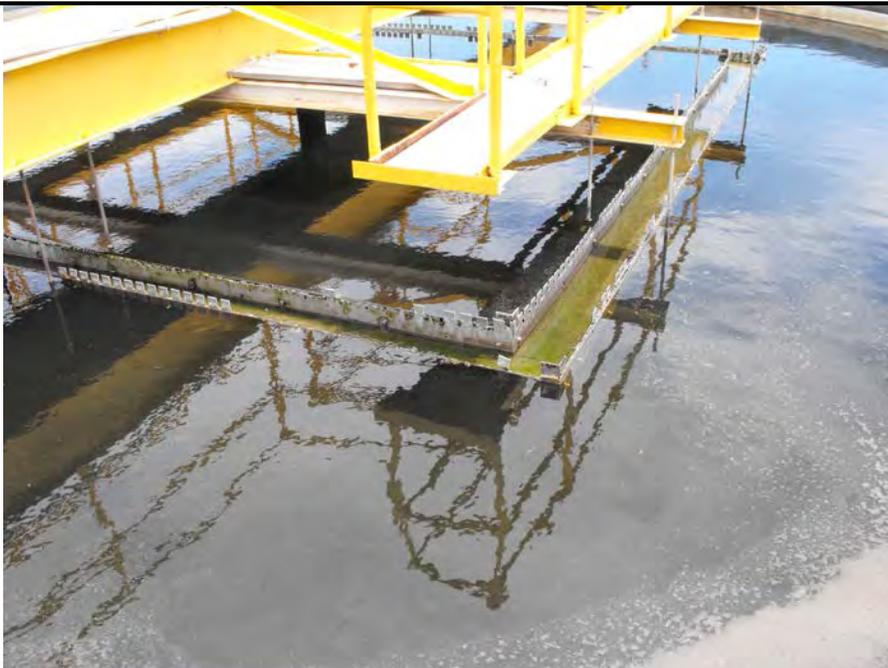
NMED/SWQB
Official Photograph Log
Photo # 5

Subject: broken teeth on clarifier

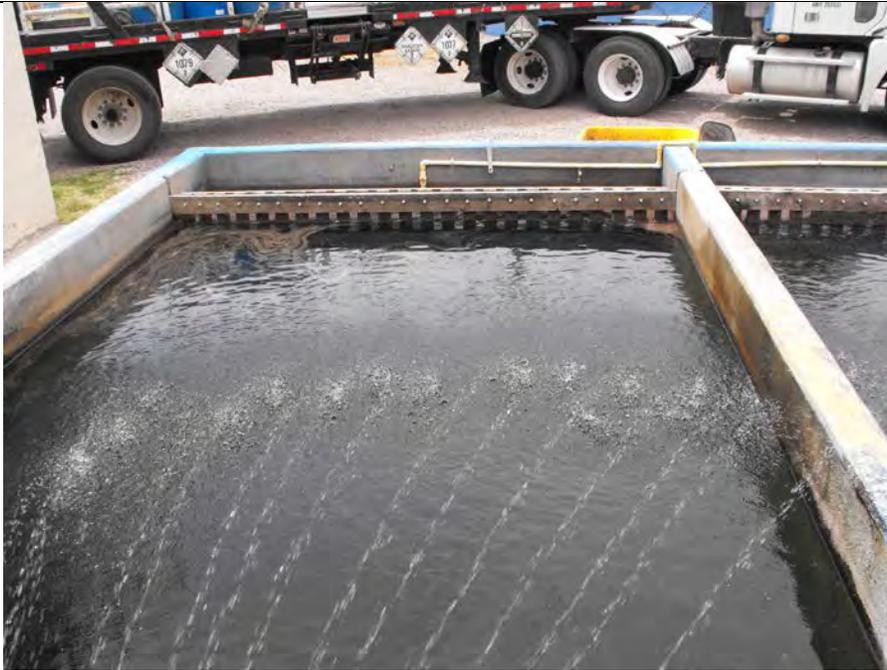
NMED/SWQB
Official Photograph Log
Photo # 6

The effluent enters a chlorine contact chamber that consists of two parallel rectangular concrete basins. There is approximately 45 minutes of contact time in each basin. The plant uses water to spray down their contact chamber in order to keep the scum down. Disinfected wastewater is dechlorinated with sulfur dioxide gas in a basin following the chlorine chamber. Both gas tanks for chlorine and sulfur dioxide are equipped with an automatic switchover device to ensure there are no lapses in chemical feed, quantities are set to uniform rates.

Subject: chlorine contact chamber

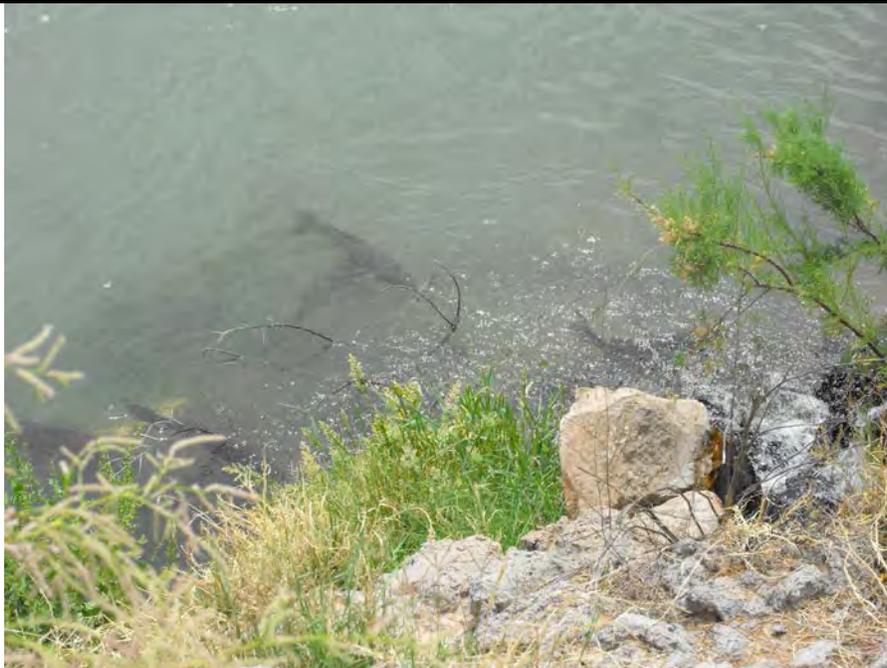
NMED/SWQB
Official Photograph Log
Photo # 7

RECEIVING WATER OBSERVATIONS: Carp were gathering at the outfall.

Subject: Fish in river at outfall 001
