**Re: City of Tucumcari Waste Water Treatment Plant; Major; Municipal; SIC 4952; NPDES Compliance Evaluation Inspection; NPDES Permit NM0020711; July 21, 2014**

### NPDES Compliance Inspection Report

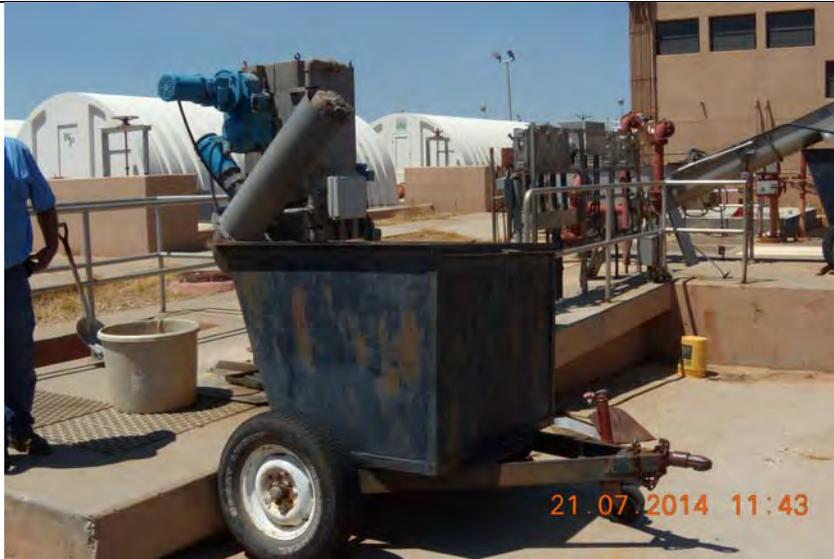
Subject: Headworks grit removal.

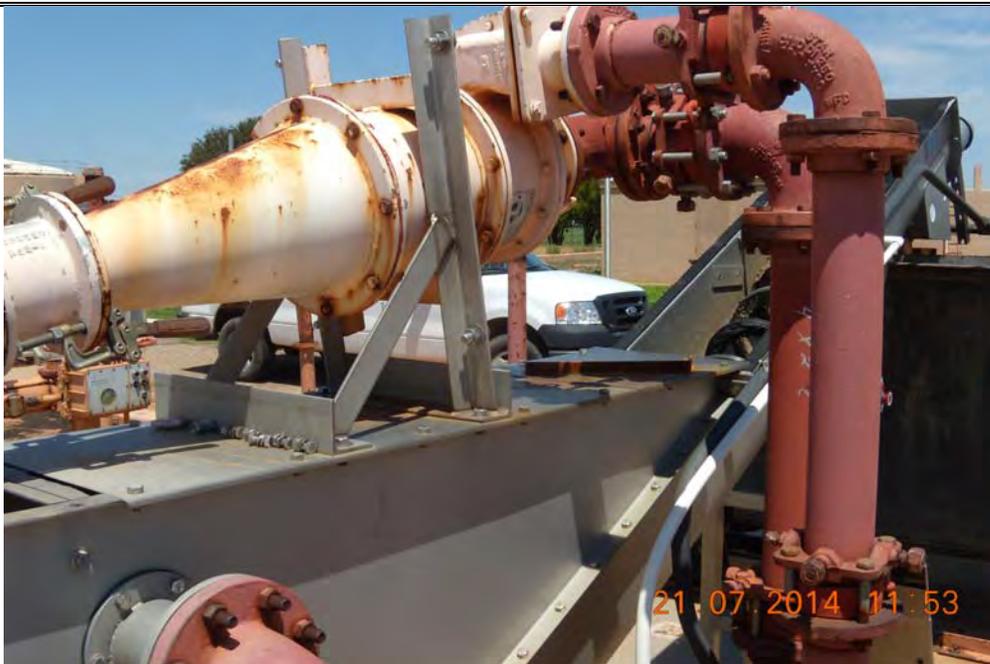
NMED/SWQB  
Official Photograph Log  
Photo # 2

Subject: Headworks large solids removal system.

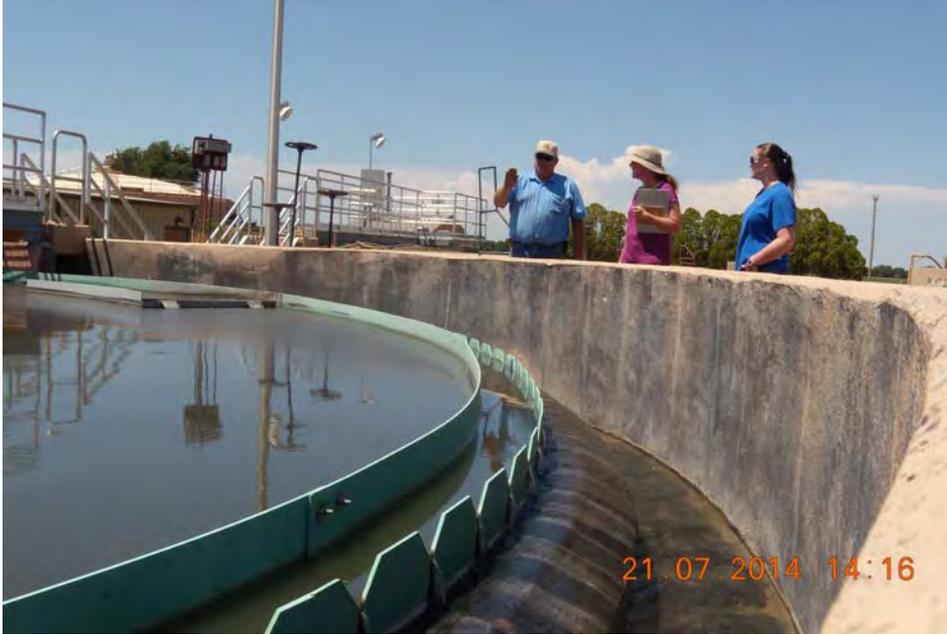
NMED/SWQB  
Official Photograph Log  
Photo #3

Subject: Primary Clarifier Weirs were level and no short circuiting was observed.

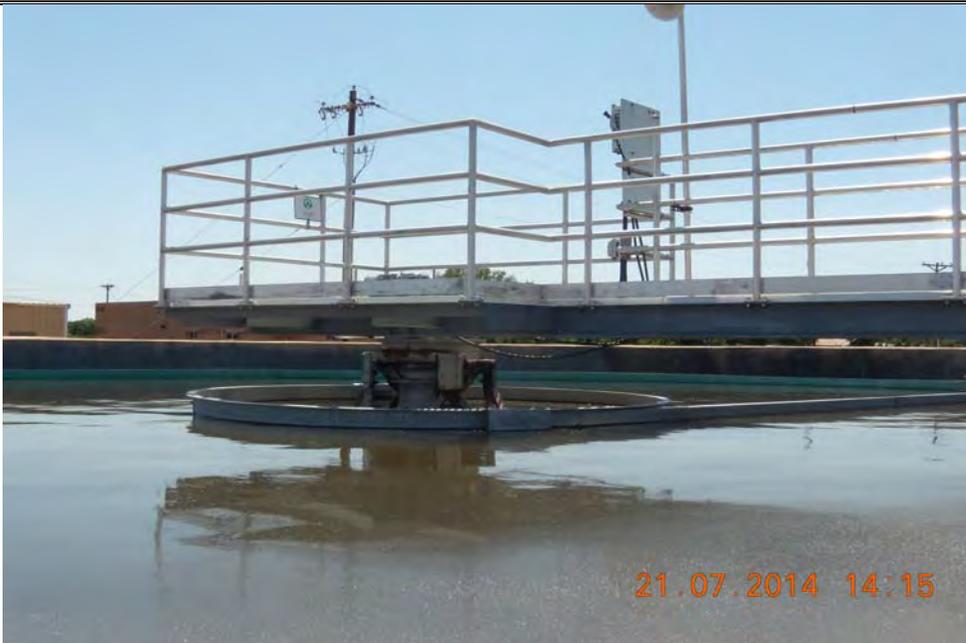
NMED/SWQB  
Official Photograph Log  
Photo #4

Subject: Primary Clarifier has a coating of white milk products floating on the surface.

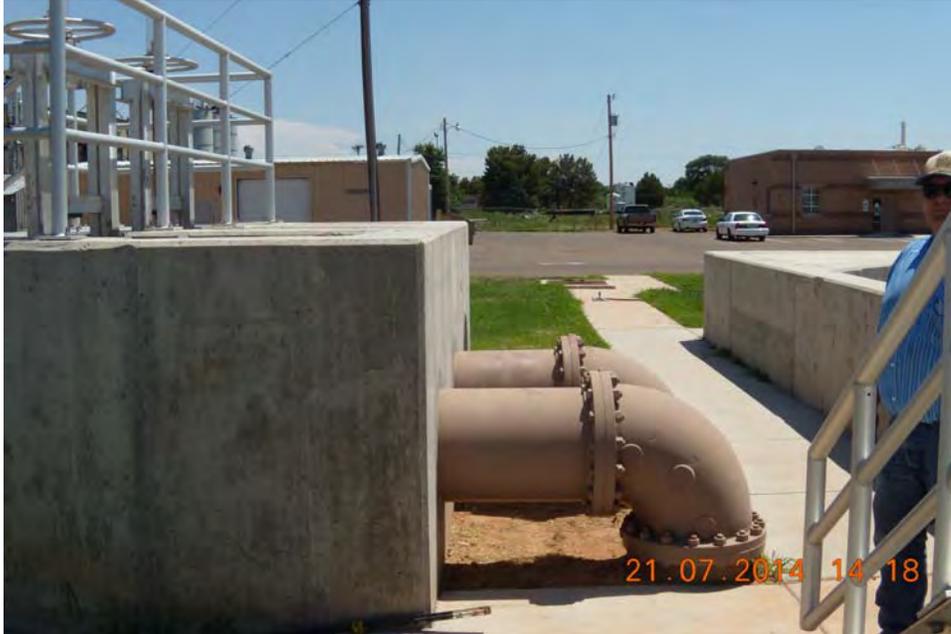
NMED/SWQB  
Official Photograph Log  
Photo # 5

Subject: Past the primary clarifiers - a splitter box allows the flow to be sent to the two basins for Medium Rate Activated Sludge (MRAS) treatment.

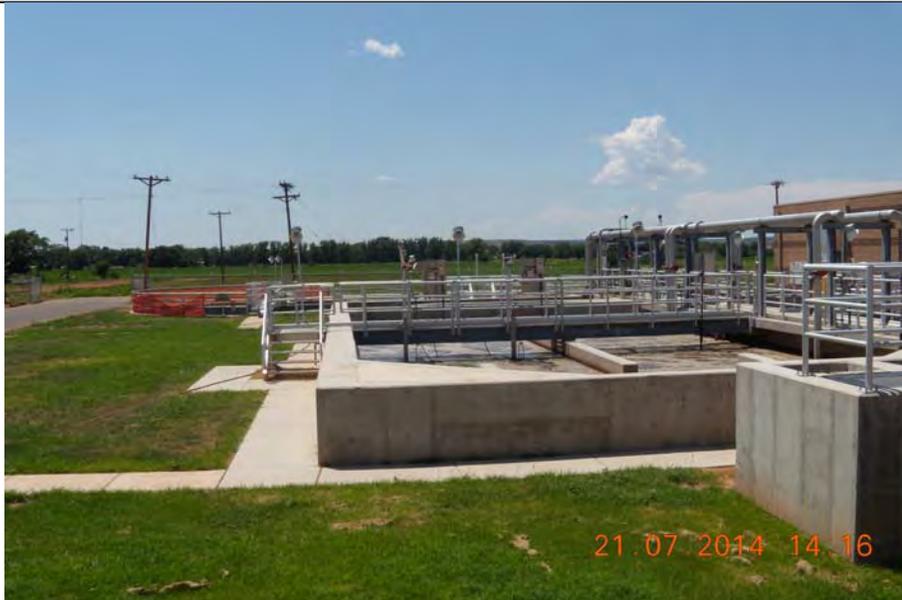
NMED/SWQB  
Official Photograph Log  
Photo # 6

Subject: Medium Rate Activated Sludge (MRAS) treatment – aeration basin. The south unit is in operation.

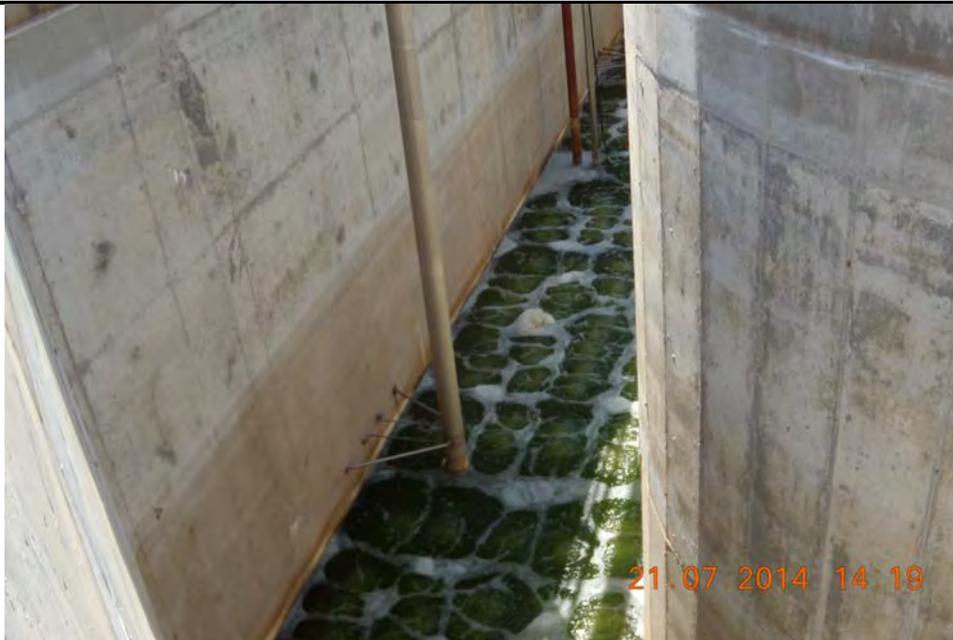
NMED/SWQB  
Official Photograph Log  
Photo # 7

Subject: Medium Rate Activated Sludge (MRAS) treatment – aeration basin. The north unit is not in operation because the volume of wastewater does not necessitate its use. A small amount of treated effluent is kept in the basins to protect the treatment works. The bubble patterns seen show the air diffusers locations.

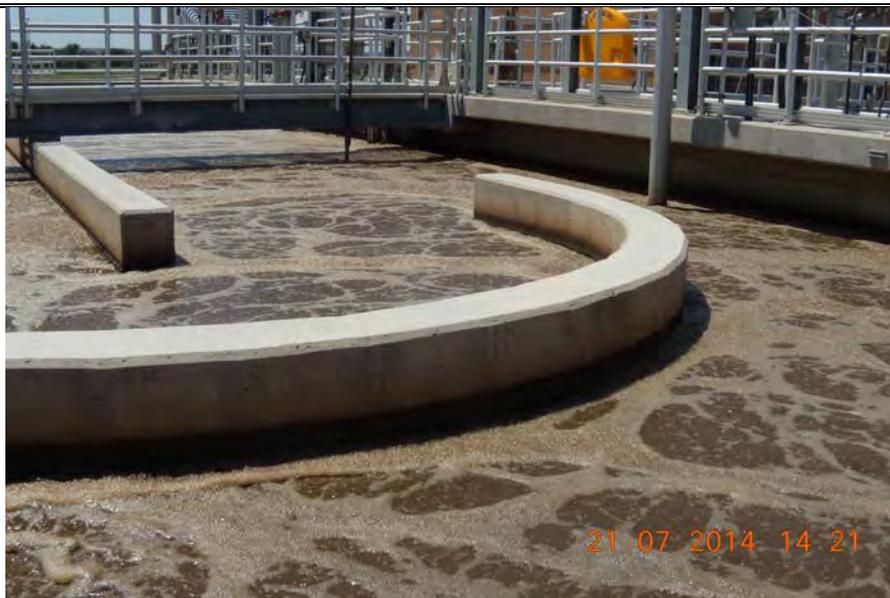
NMED/SWQB  
Official Photograph Log  
Photo # 8

Subject: Medium Rate Activated Sludge (MRAS) treatment – aeration basin.

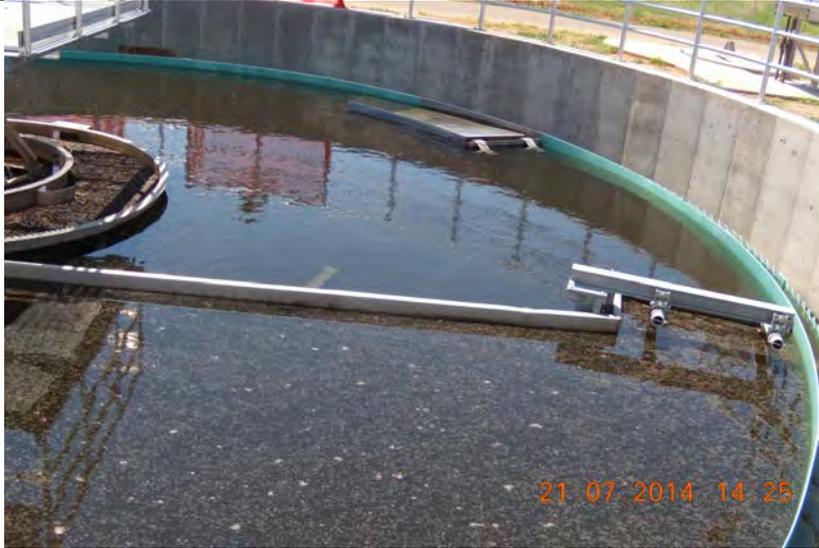
NMED/SWQB  
Official Photograph Log  
Photo # 9

Subject: Secondary Clarifier. There is an excessive amount of floating cheese waste products in the basin. The scraper arm does capture most so it is not being discharged.

5. Cheese Factory - The permittee is advised, that this additional influent waste stream to the WWTP should be monitored closely. They are required in the permit to reject any waste that could potentially cause harm to or interfere with the treatment process. It is advisable for the city to adopt local limits for the collection system and industrial contributors. Additionally a sanitary sewer survey of contributors could also assist in protecting the function of the WWTP and the effectiveness of the treatment process.

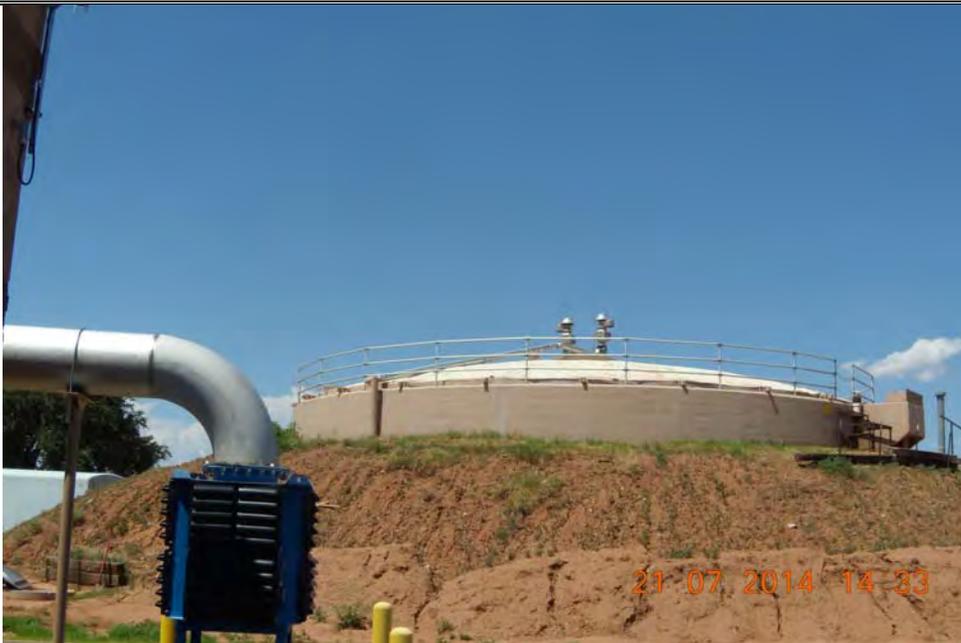
NMED/SWQB  
Official Photograph Log  
Photo # 10

Subject: The anaerobic sludge digester. Repairs have been made to the original unit, including converting the floating roof to a fixed roof. Also repairs to the concrete have been made.

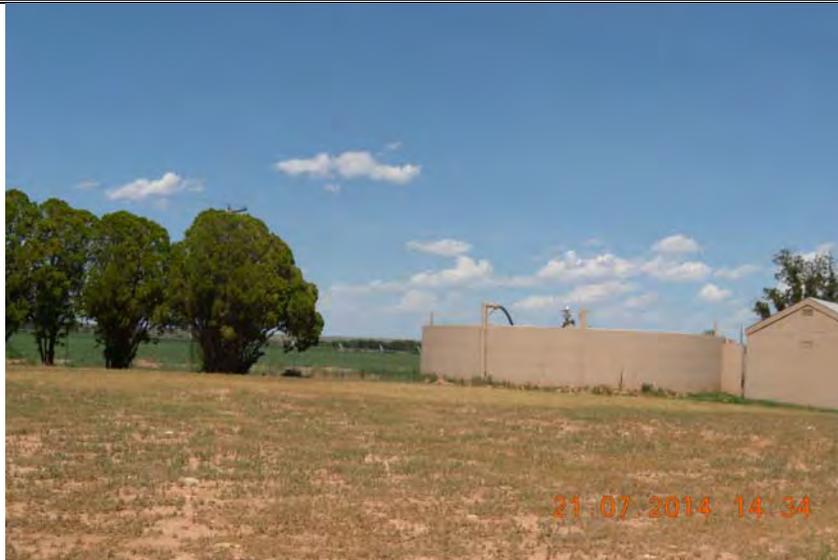
NMED/SWQB  
Official Photograph Log  
Photo # 11

Subject: Aerobic solids digestion follows the anaerobic sludge digester.

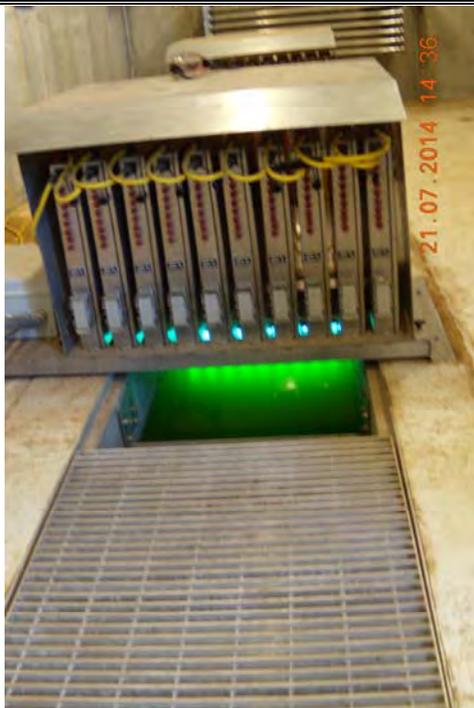
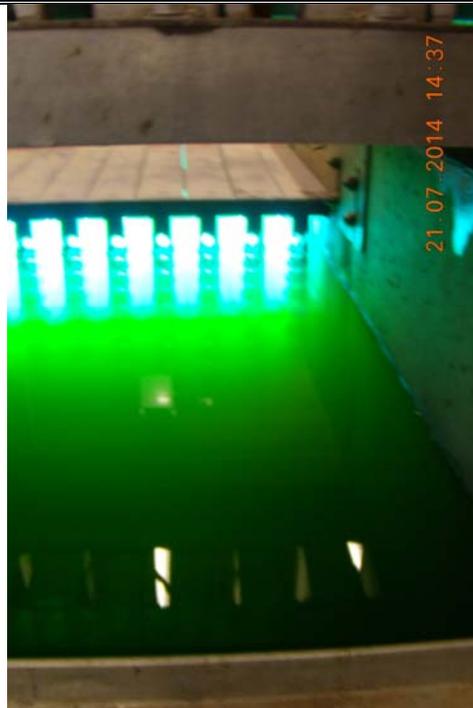
NMED/SWQB  
Official Photograph Log  
Photo # 12 & 13

Subject: Ultraviolet Disinfection Units. Chlorine is no longer the primary disinfection treatment process. There are two banks of 10 cartridges each.

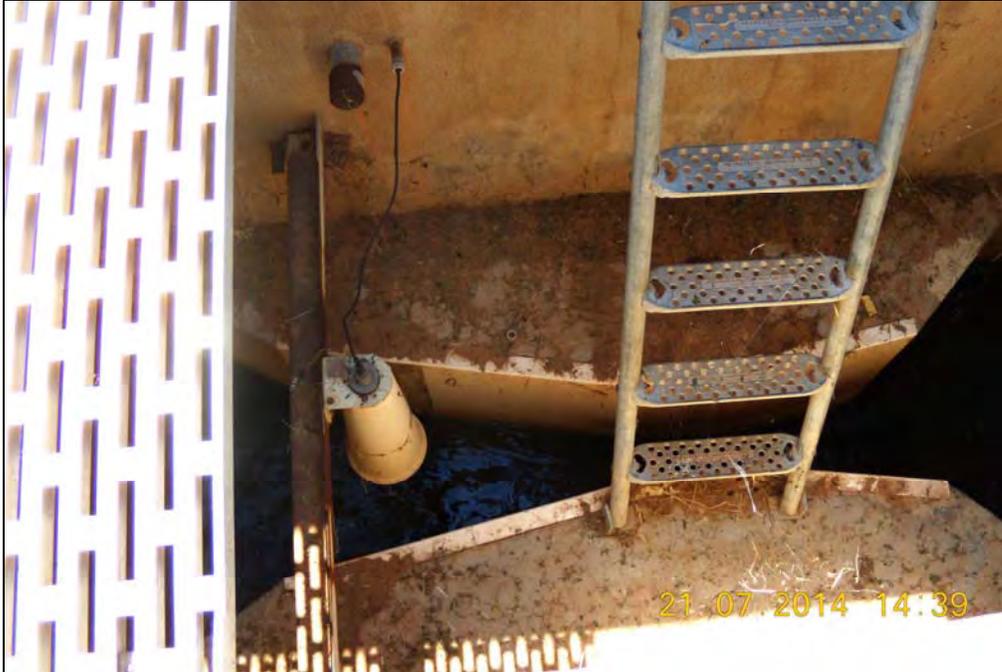
NMED/SWQB  
Official Photograph Log  
Photo # 14

1. Flow Measurement –The effluent Parshall Flume does not have an affixed staff gauge. Operators are using a hand held ruler to take backup flow readings. The ultrasonic meter is checked monthly against the hand held ruler. It is advisable for the permittee to work with an engineer to install a fixed staff gauge and to develop conversions from the depth of the head to million gallons per day. This finding is also noted in the section above for Operation and Maintenance.

Subject: Effluent flow meter. There is not an affixed staff gauge that is readable. Operators use a metal ruler to take readings as a backup check to the primary sensor.

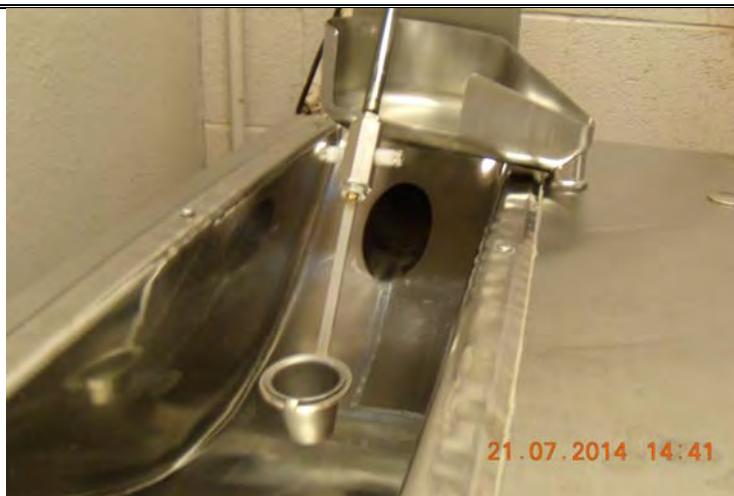
NMED/SWQB  
Official Photograph Log  
Photo # 15

Subject: Effluent Sample location is at the Parshall flume. Flow weighted and grab samples are taken.

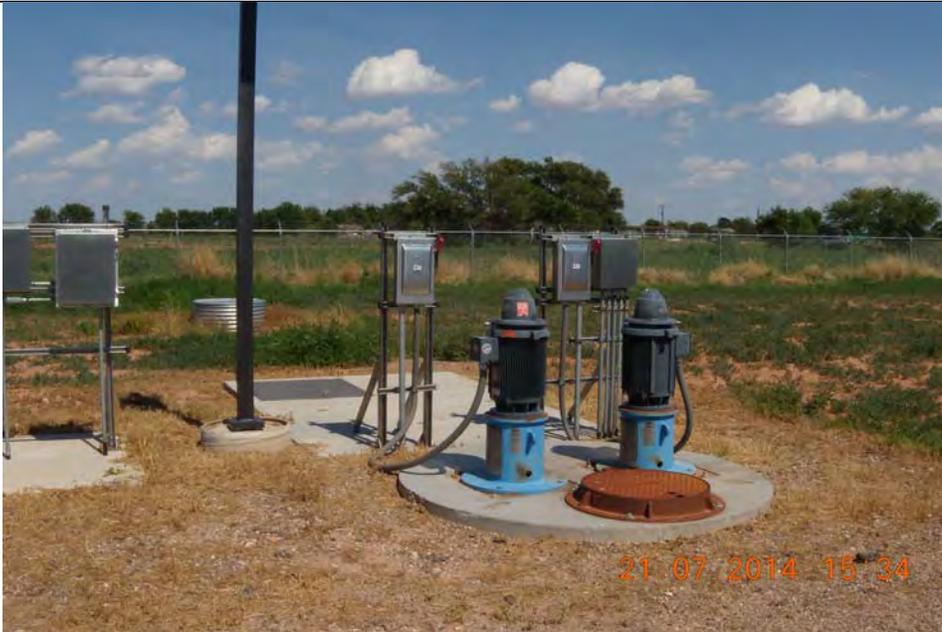
NMED/SWQB  
Official Photograph Log  
Photo # 18

Subject: Dual reuse pumps send treated effluent to the New Mexico State Research Center approximately 2 miles east of the WWTP.

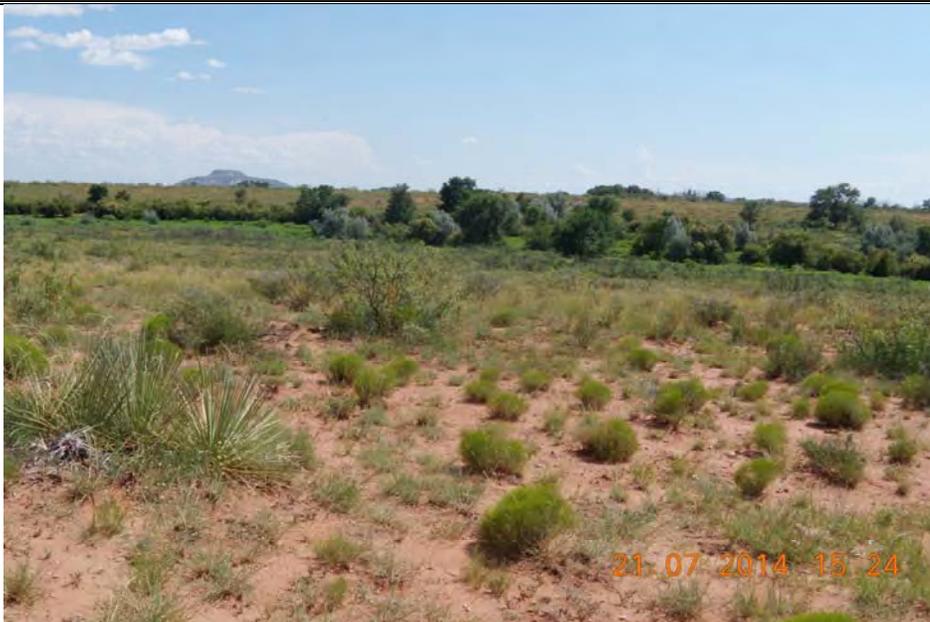
Location: Breen's Pond below Tucumcari WWTP

Subject: Tributary to Breen's Pond has riparian vegetation, distinctly different from the surround upland.

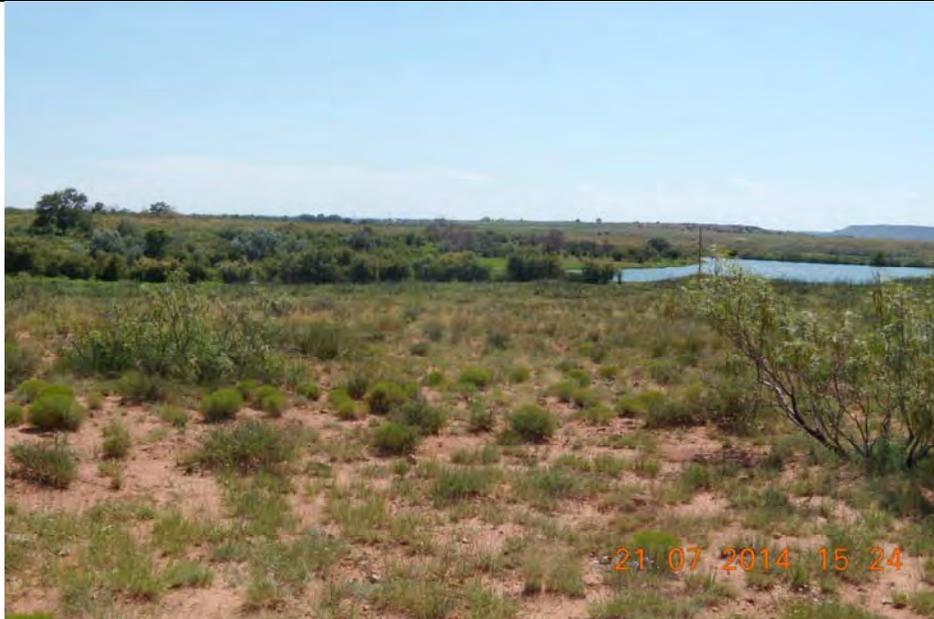
Location: Breen's Pond below Tucumcari WWTP

Subject: Tributary to Breen's Pond has riparian vegetation, distinctive from the upland and surrounding area.

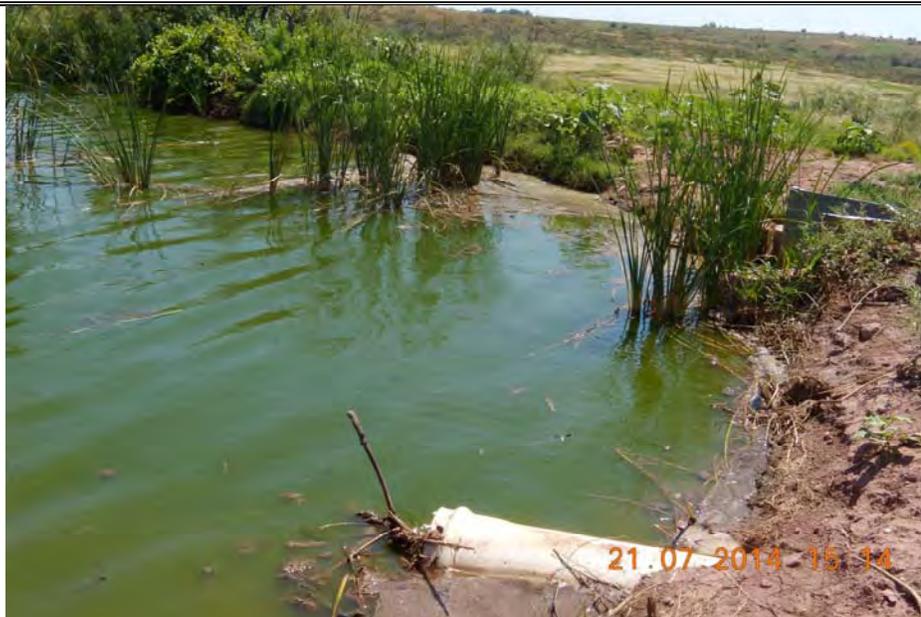
NMED/SWQB  
Official Photograph Log  
Photo # 21

Subject: Breen's Pond – the receiving water for the effluent from the Tucumcari WWTP. The outfall location to No Name Creek and the white piping is for diversion to irrigation.

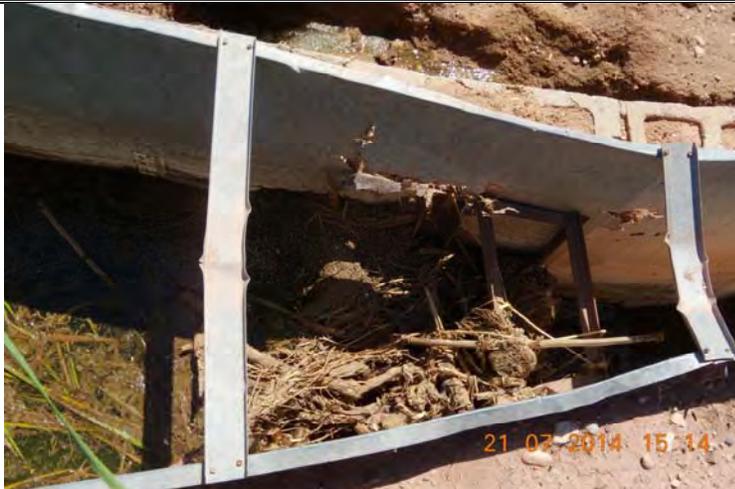
NMED/SWQB  
Official Photograph Log  
Photo # 22

Subject: Breen's Pond outfall Parshall Flume. A barrier was put into the flume to reduce discharge volumes and debris is also caught behind the barrier.

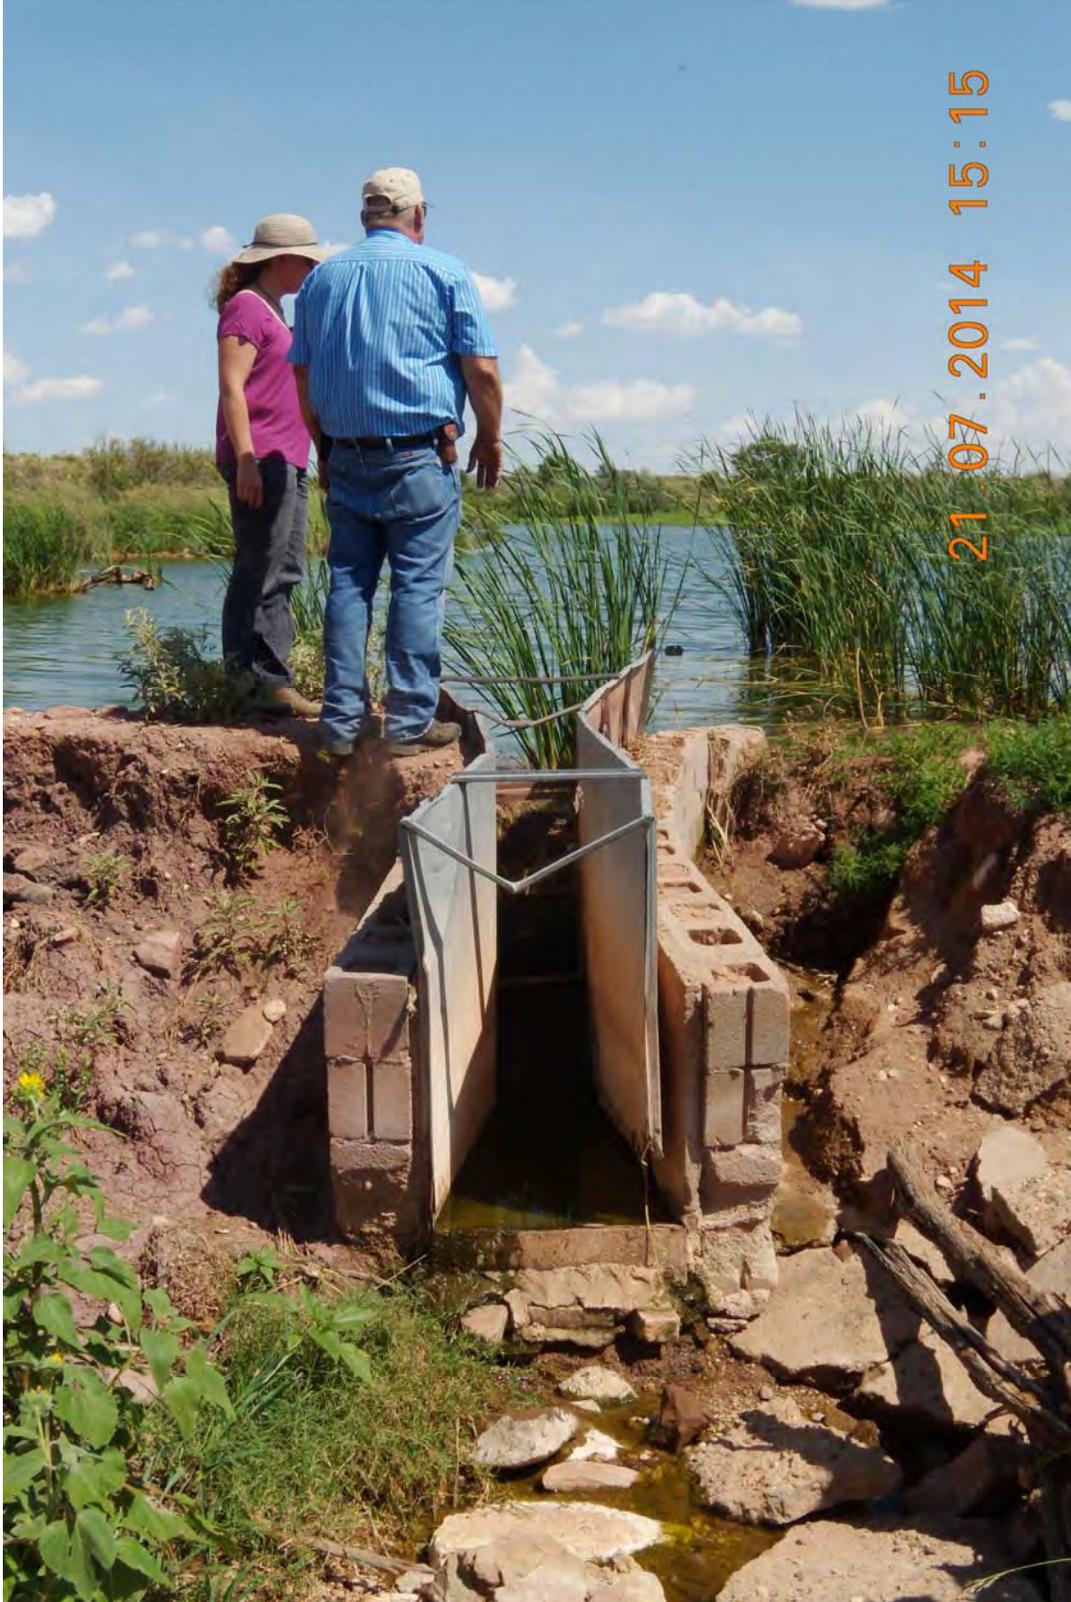
Location: Breen's Pond below Tucumcari WWTP

Subject: Breen's Pond outfall Parshall flume.

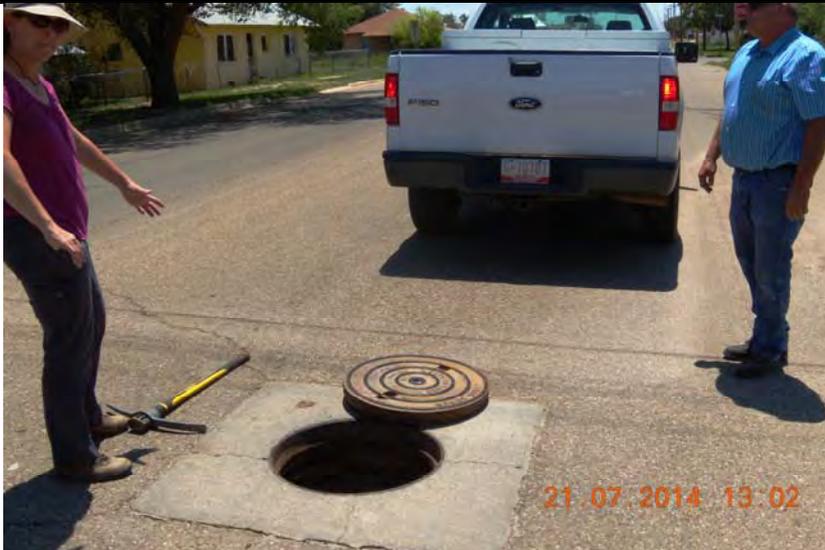
Location: Tucumcari, New Mexico, Rock Island Street

Subject: Manhole to the Tucumcari collection system below the Tucumcari Mountain Cheese Company.

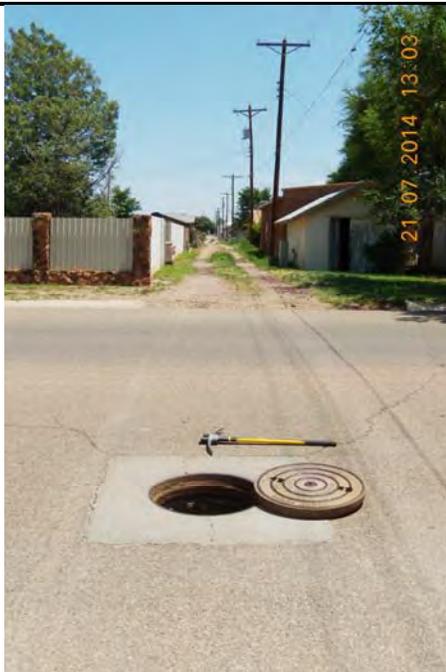
Location: Tucumcari, New Mexico, Rock Island Street

Subject: Manhole to the Tucumcari collection system below the Tucumcari Mountain Cheese Factory. The factory is two blocks up the alley way.

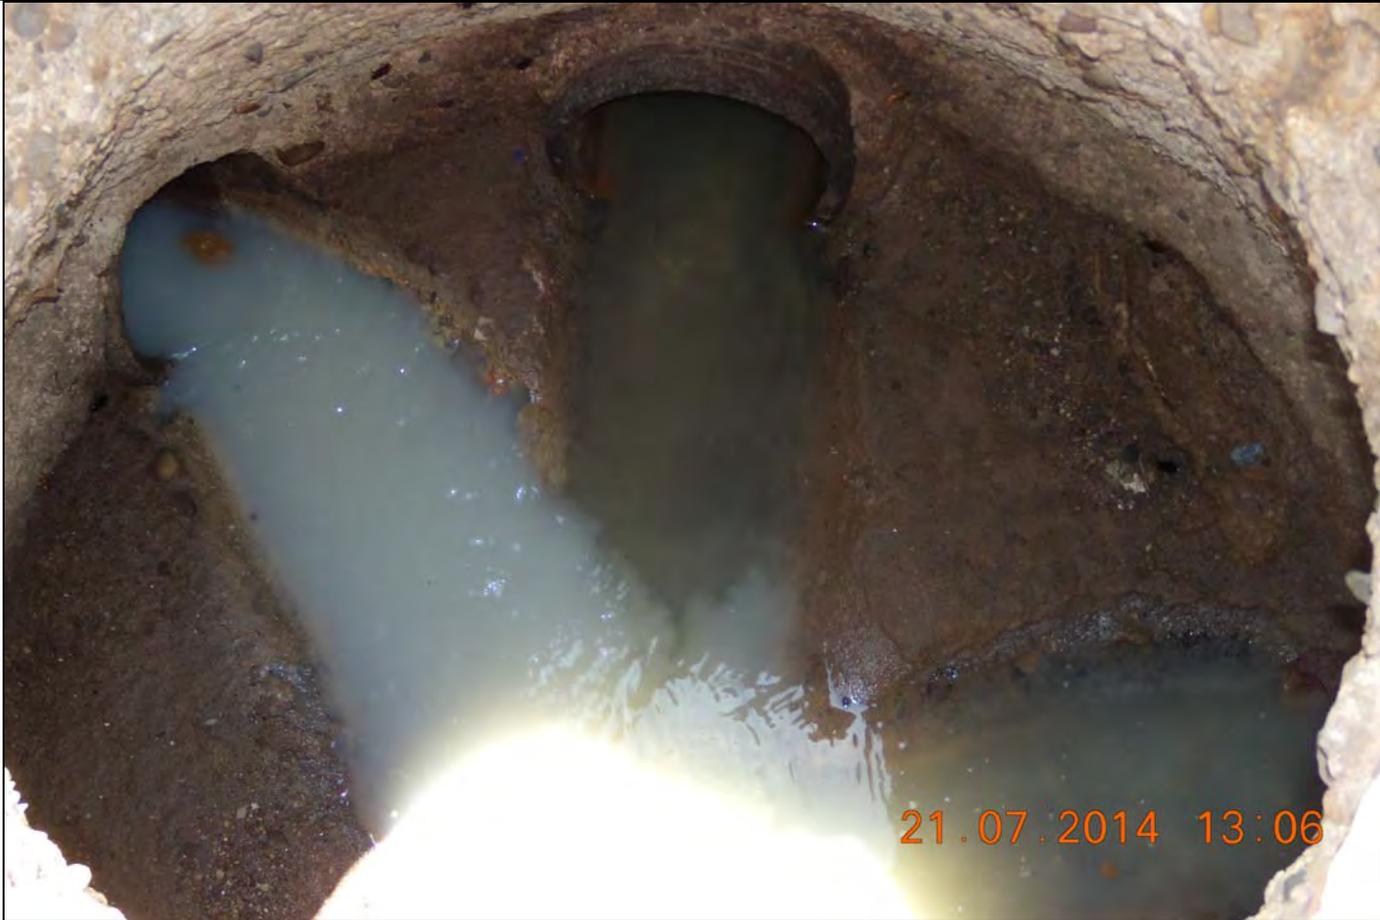
NMED/SWQB  
Official Photograph Log  
Photo # 27

Subject: Manhole to the Tucumcari collection system below the Tucumcari Mountain Cheese Factory. The waste from the factory on the left is white with mild by products. It is mixing with the domestic waste coming from residences.

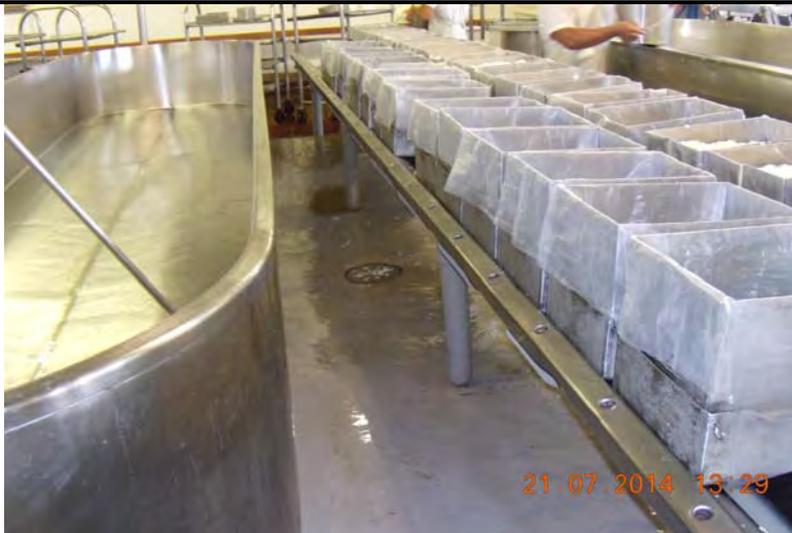
NMED/SWQB  
Official Photograph Log  
Photo # 29

Subject: Floor drain in the factory that goes to the City of Tucumcari WWTP collection system and eventually to the WWTP

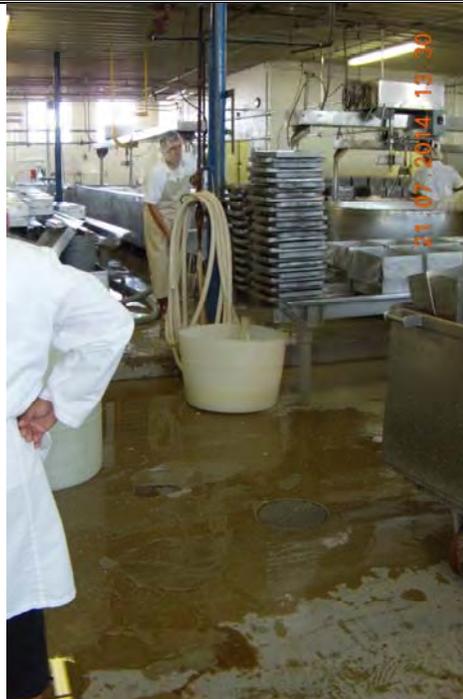
NMED/SWQB  
Official Photograph Log  
Photo # 30

Subject: Floor drain in the factory that goes to the City of Tucumcari WWTP collection system and eventually to the WWTP

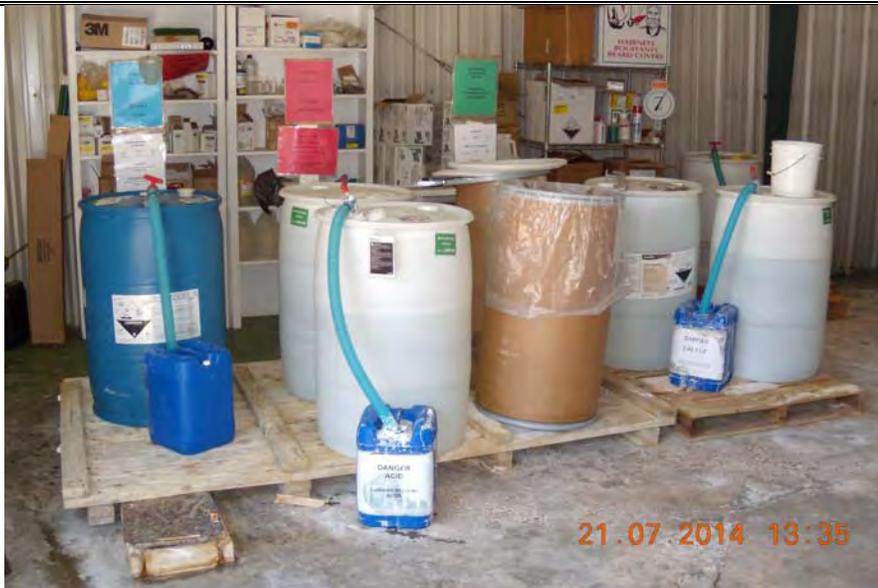
NMED/SWQB  
Official Photograph Log  
Photo # 31

Subject: Acid Chemical storage and use in an area with open floor drains that go to the City of Tucumcari WWTP collection system and eventually to the WWTP.

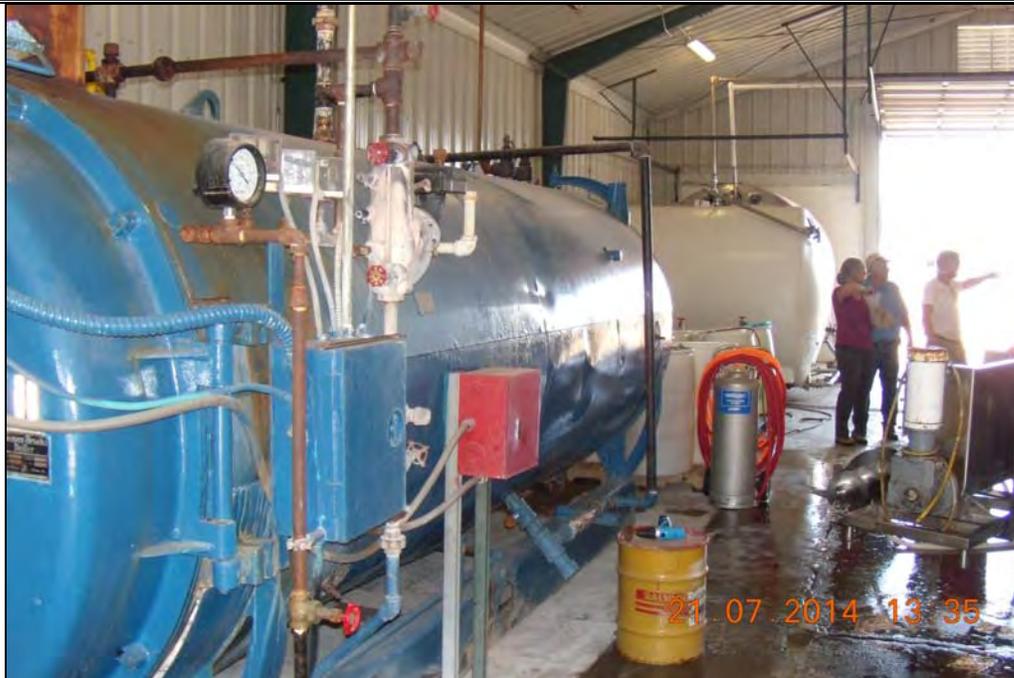
Location: Tucumcari Mountain Cheese Factory

Subject: Pasteurizing System.

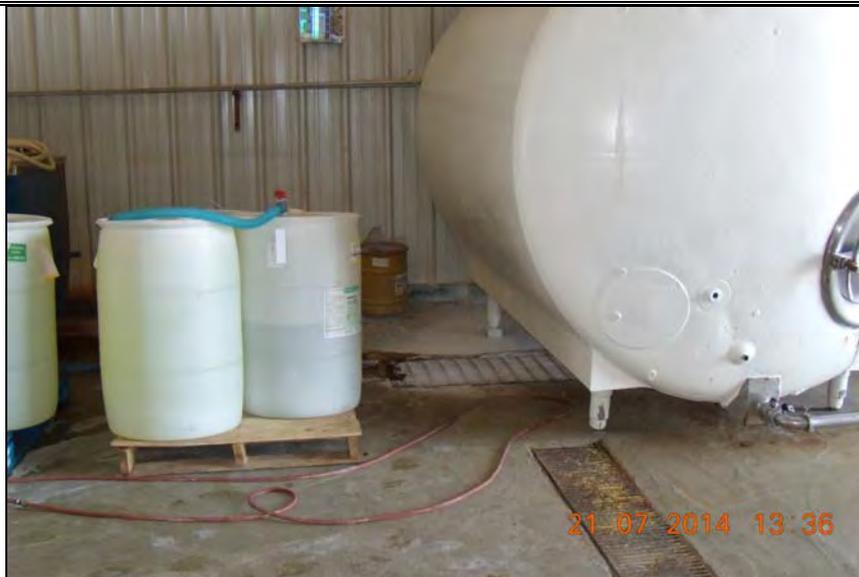
NMED/SWQB  
Official Photograph Log  
Photo # 33

Subject: Chemical storage near the pasteurizing system. A floor drain is near the stored drums, that goes to the City of Tucumcari WWTP collection system and eventually to the WWTP.

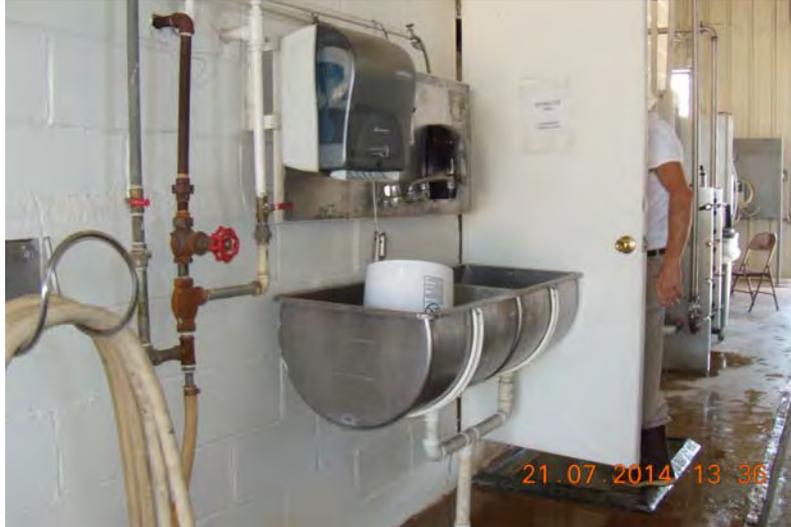
NMED/SWQB  
Official Photograph Log  
Photo # 34

Subject: Sink and drain that goes to the City of Tucumcari WWTP collection system and eventually to the WWTP.

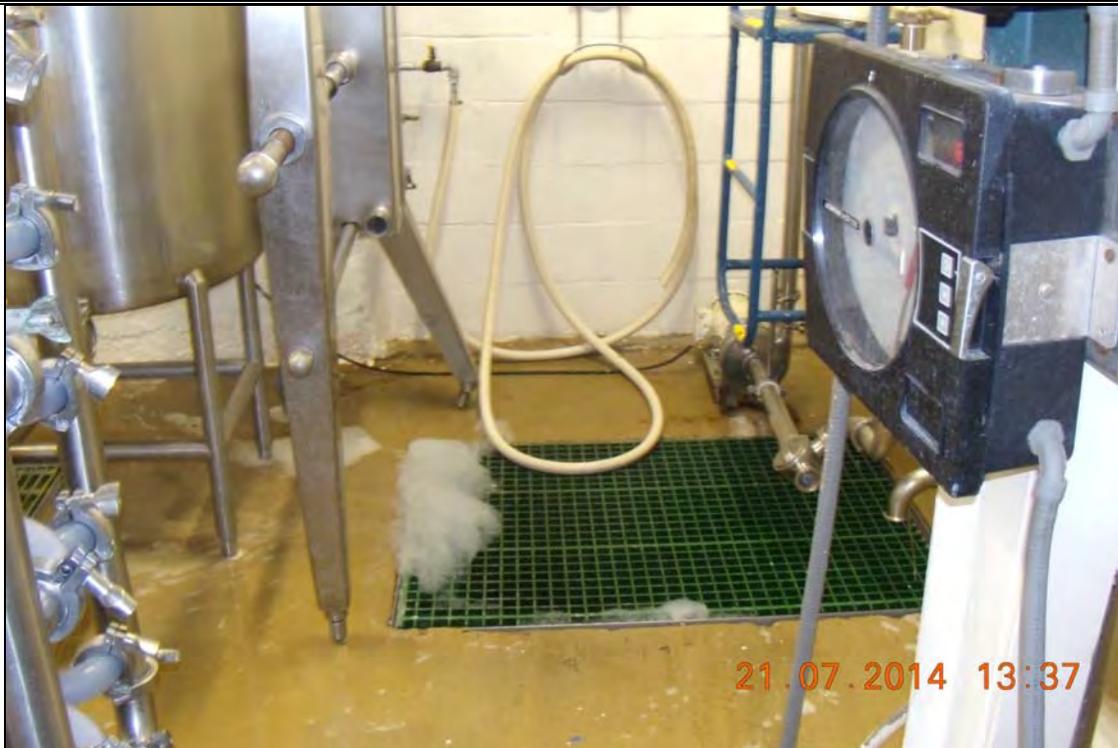
Location: Tucumcari Mountain Cheese Factory

Subject: Drain in the factory that goes to the City of Tucumcari WWTP collection system and eventually to the WWTP

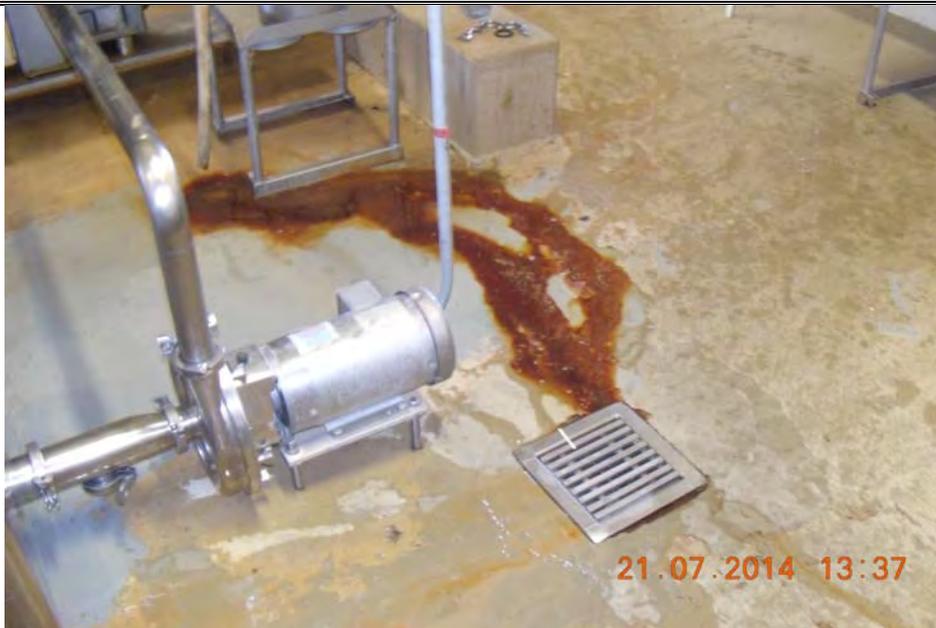
Location: Tucumcari Mountain Cheese Factory

Subject: Drain in the factory that goes to the City of Tucumcari WWTP collection system and eventually to the WWTP.

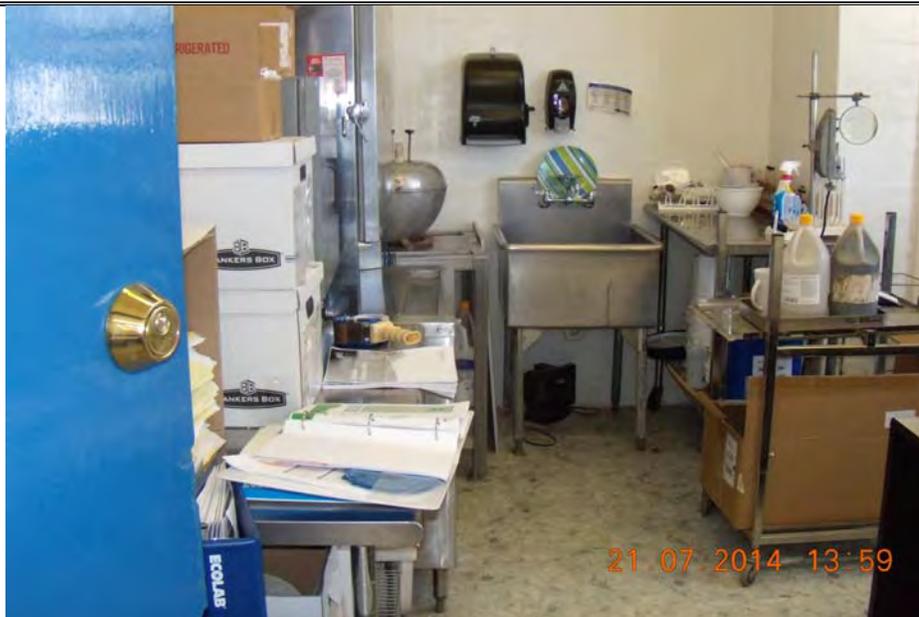
Location: Tucumcari Mountain Cheese Factory

Subject: Sink and drain. Cleaning supplies are stored on the shelf to the right of the sink.

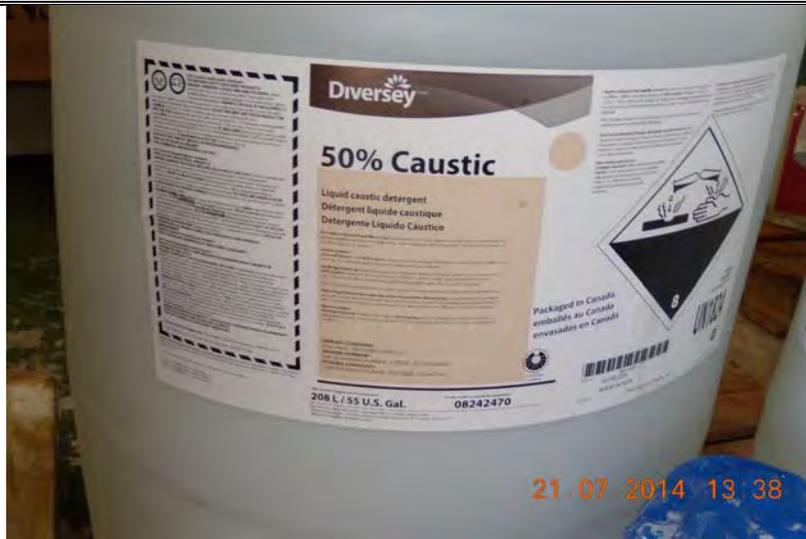
NMED/SWQB  
Official Photograph Log  
Photo # 38

Subject: Caustic solution used in cleaning processes in the factory. The used chemicals are sent down the drain and eventually to the WWTP.

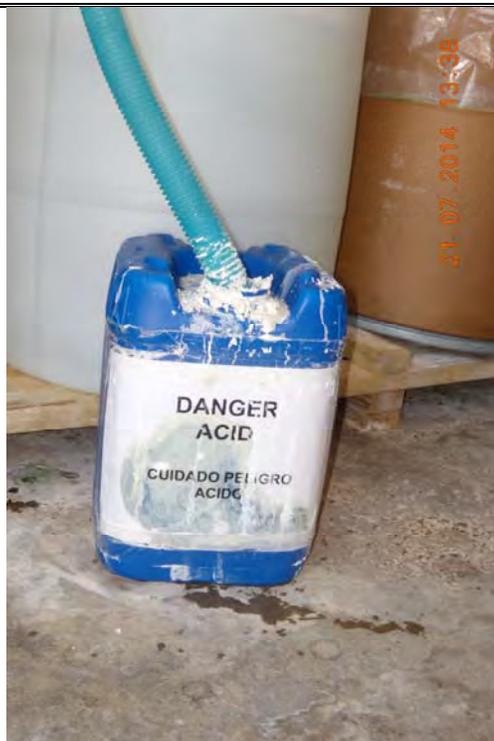
Location: Tucumcari Mountain Cheese Factory

Subject: The used chemicals are sent down the drain and eventually to the WWTP.

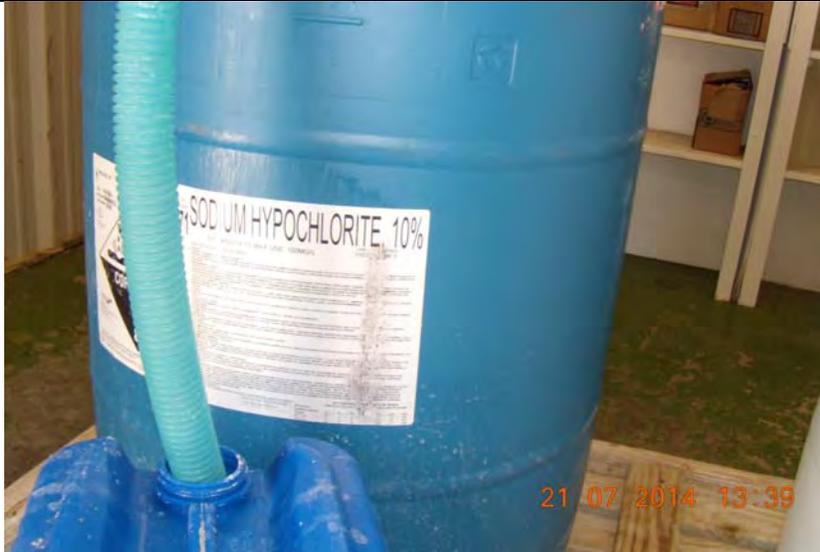
Location: Tucumcari Mountain Cheese Factory

Subject: The used chemicals are sent down the drain and eventually to the WWTP.

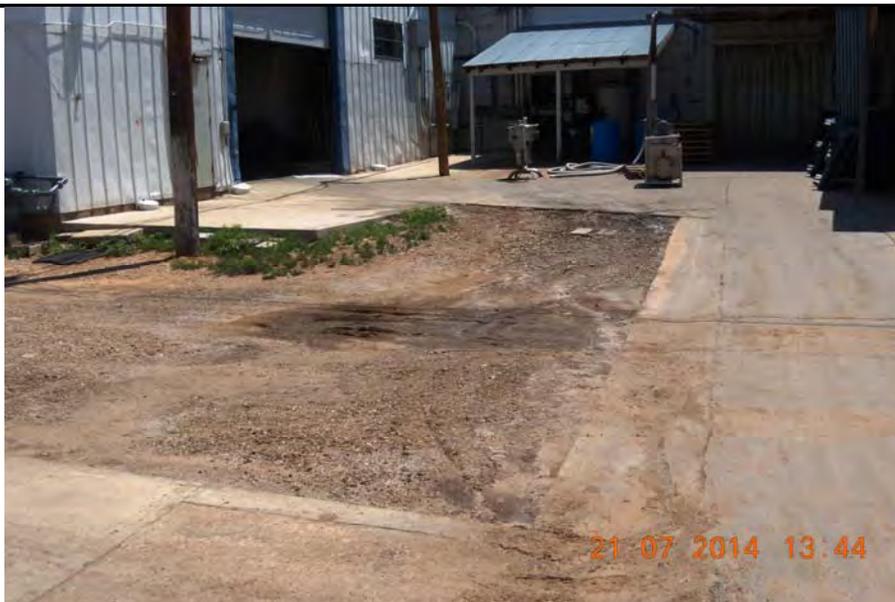
NMED/SWQB  
Official Photograph Log  
Photo # 41

Subject: Alley drainage area from factory. The wet areas were a result of heavy rain fall. There is a potential for some drainage from the factory site to mix with rain water in this location.
