**Re: City of Tucumcari Waste Water Treatment Plant; Major; Municipal; SIC 4952; NPDES Compliance Evaluation Inspection; NPDES Permit NM0020711; July 21, 2014**

### NPDES Compliance Inspection Report

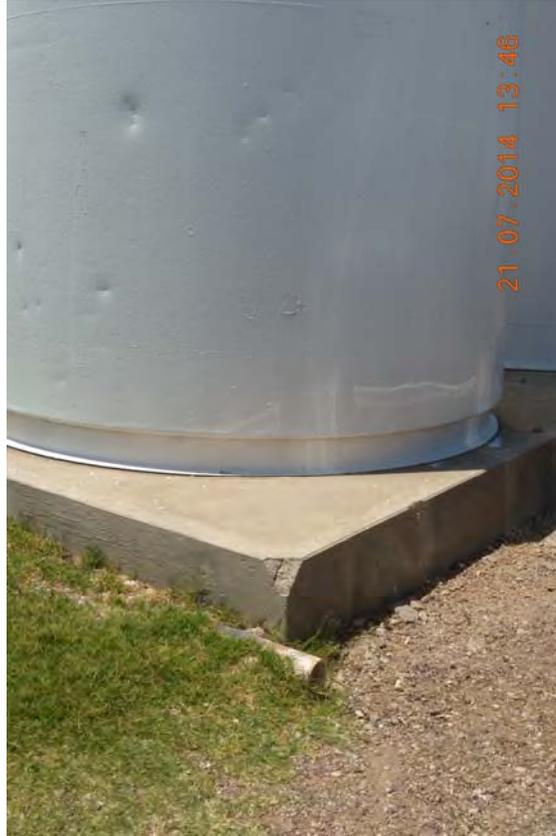
Location: Tucumcari Mountain Cheese Factory

Subject: Storm water drain on property.
