Re: Major Municipal; SIC 4952; Compliance Evaluation Inspection; Bloomfield Wastewater Treatment Plant; NPDES Permit No. NM0020770; August 14, 2014

### NPDES Compliance Inspection Report

City of Bloomfield WWTP  
NPDES Permit Number NM0020770  
Compliance Evaluation Inspection  
14 August 2014  
Page 1 of 5

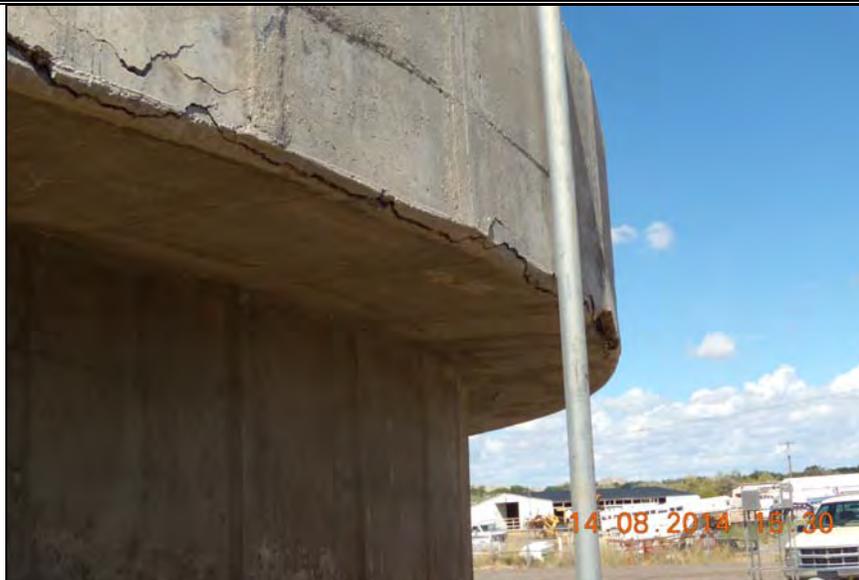
MED/SWQB  
Official Photograph Log  
Photo # 1

Subject: Concrete cracking on the outside of a secondary clarifier is indicative of the condition throughout the WWTP.

4. Concrete cracks - This WWTP was built in 1978. New head works were built and put on line approximately 6 years ago. Throughout the WWTP there are indications of failing concrete, including cracks throughout all the treatment units including the secondary clarifiers. Inside the basins the concrete is pitted and crumbling from the many years of exposure to the caustic wastewater. Structural rebar is visible through the deteriorating treatment units. Metal parts and water works are showing signs of rusting throughout. The facility has contracted with a concrete specialist to evaluate the condition. **(This is a repeat finding)**

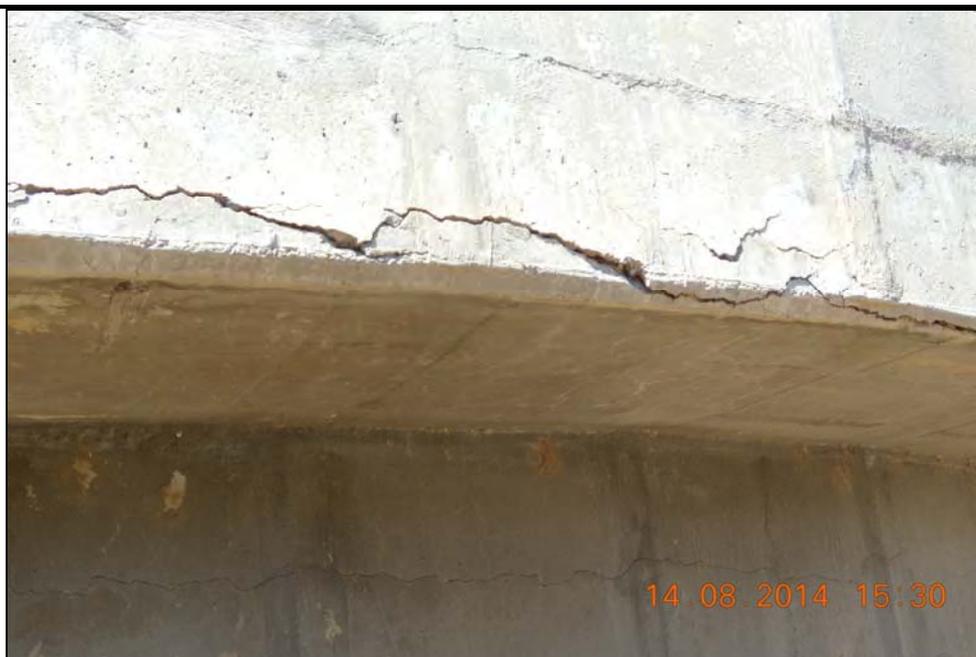
NMED/SWQB  
Official Photograph Log  
Photo # 2

Subject: More concrete cracking on the outside of a secondary clarifier is indicative of the condition throughout the WWTP.

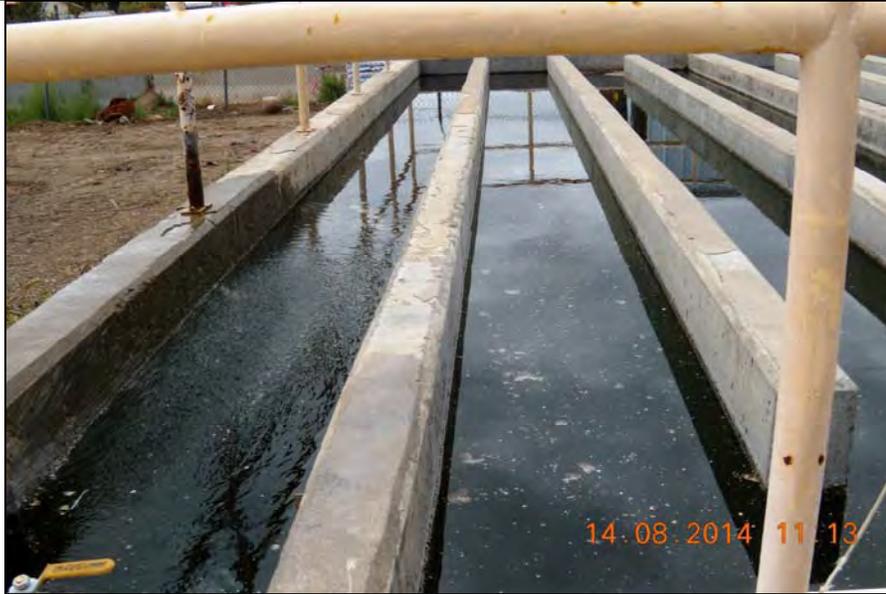
NMED/SWQB  
Official Photograph Log  
Photo # 3

Subject: The chlorine contact chamber has floating solids and suspended solids entering the treatment unit from the secondary clarifiers.

7. Chlorine Contact Chamber - The serpentine chlorine contact chambers were very turbid. Floating solids were observed in the chamber. Operators have installed a surface baffle to catch floating solids before they reach the effluent discharge point. However because floating solids are visible throughout the water column, the surface baffles are only partially effective at removing all of it. **(This is a repeat finding)**

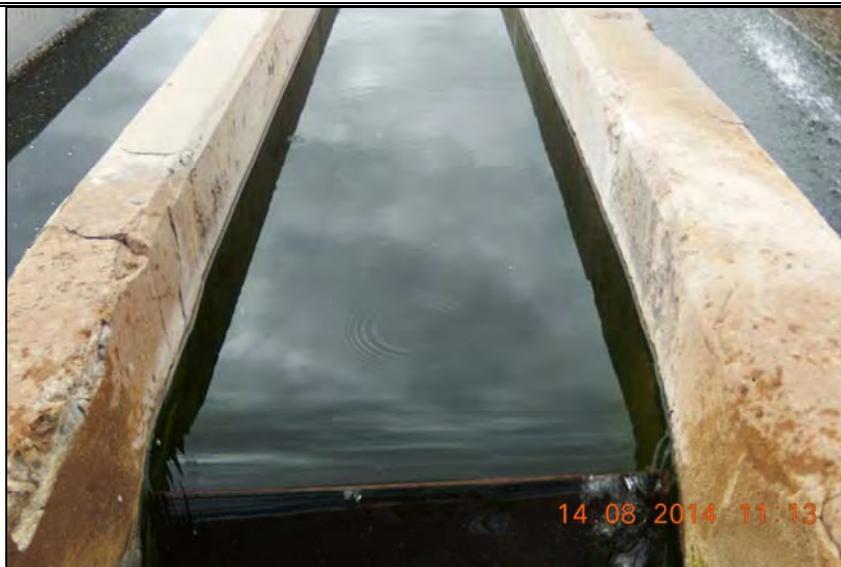
NMED/SWQB  
Official Photograph Log  
Photo # 4

Subject: The chlorine contact chamber has surface baffles in place to capture some of the floating solids before being sent to de-chlorination and to the outfall. However suspended solids are noted throughout the water column. It is suggested additional screening be installed and the sweeper arms of the secondary clarifiers be adjusted to capture more solids.

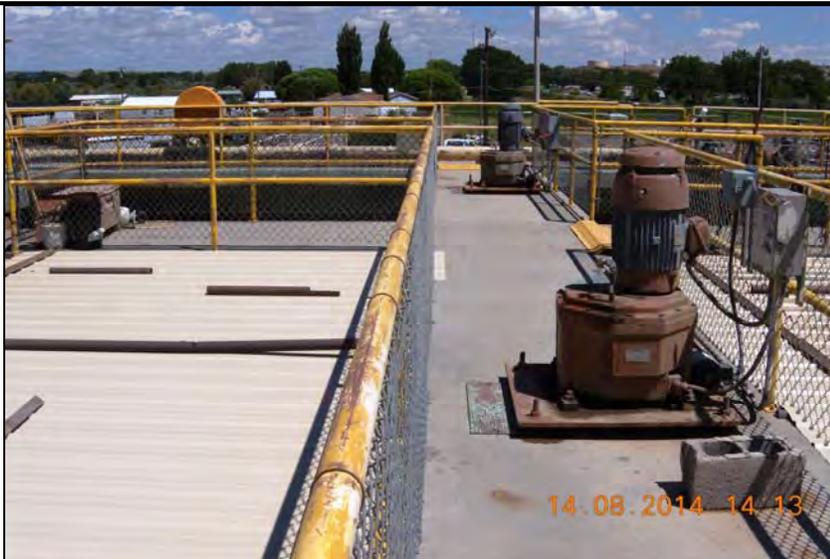
NMED/SWQB  
Official Photograph Log  
Photo # 6

Subject: Motors for the mixers in the aeration basins are very old and worn. Oil leaks are noted around each of the motors.

5. Aging treatment units and obsolete treatment units - The motors for the aeration basin paddle aerators are heavily worn, rusting and leaking oil. **(This is a repeat finding)**

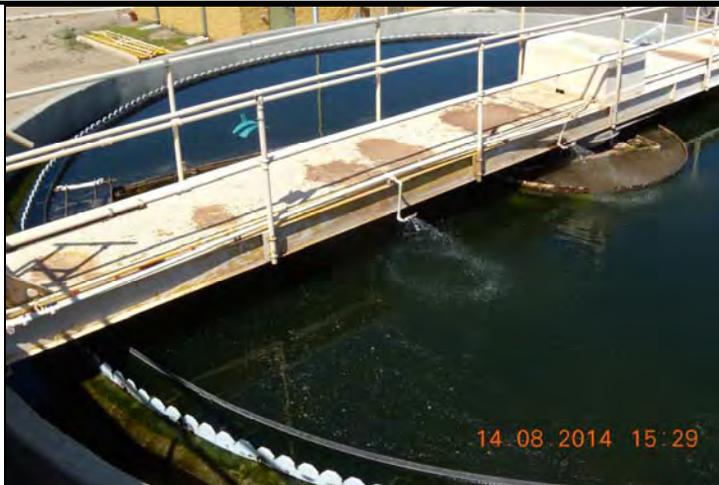
NMED/SWQB  
Official Photograph Log  
Photo # 7

Subject: Secondary Clarifier, a small amount of algae is noted at the base of the weirs though not excessive. The sweeper arm of the clarifier is actually pushing some of the floating solids over the weirs and to the chlorine contact chamber.

3. Secondary Clarifiers -The surface skimmer is worn and is not aligned correctly. It is pushing floating solids over the weirs and to the chlorine contact chamber.

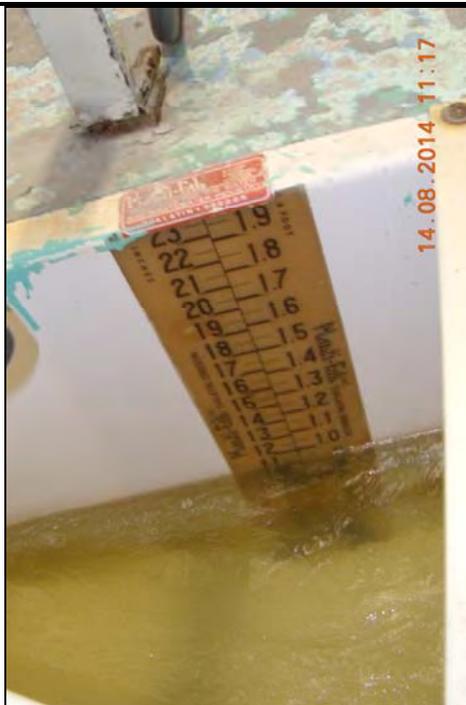
NMED/SWQB  
Official Photograph Log  
Photo # 8

Subject: Effluent at the Parshall Flume and staff gauge has a deeper greenish colored tint than is typically present for a conventional activated sludge treatment plant, based on the observations of the inspector.

6. Effluent color was slightly turbid green - The effluent color was indicative of ineffective treatment throughout the WWTP. The color of the effluent was similar to what is commonly found in trickling filter processes. Activated sludge sewage treatment should be able to produce a much more clear effluent than was observed at this facility. **(This is a repeat finding)**

1. The effluent from the WWTP was slightly turbid green-brown at the time of the inspection. There were small amounts of floating solids noted in the chlorine contact chamber and in the effluent at the Parshall Flume. The presence of floating solids is reason for the "Marginal" rating.
2. There were no effluent exceedences reported for the last 12 months.
