Re: **Major Municipal; SIC 4952; NPDES Compliance Evaluation; Village of Taos Ski Valley Wastewater Treatment Plant; NM0022101; July 22, 2014**

Village of Taos Ski Valley
Wastewater Treatment Plant
Compliance Evaluation Inspection
NPDES Permit Number NM0022101

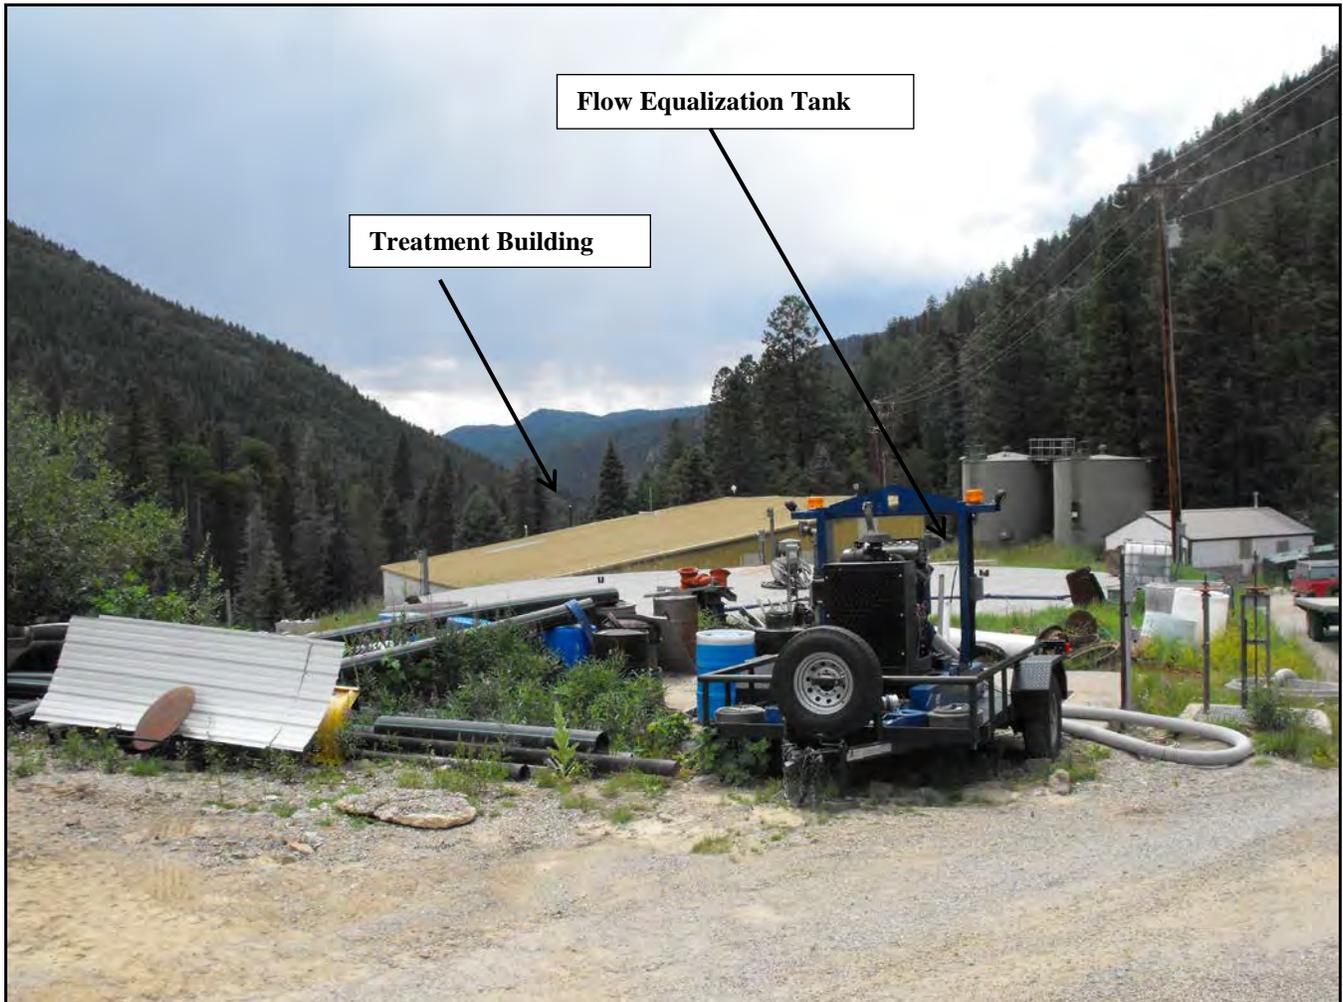
Photo # 1

Photographer: Daniel Valenta	Date: 7/22/2014	Time: 1458 hours
City/County: Village of Taos Ski Valley/Taos County		
Location: Twining Wastewater Treatment Plant, 36 Ocean Blvd, Village of Taos Ski Valley, 87525		
Subject: Village of Taos Ski Valley Waste Water Treatment Facility

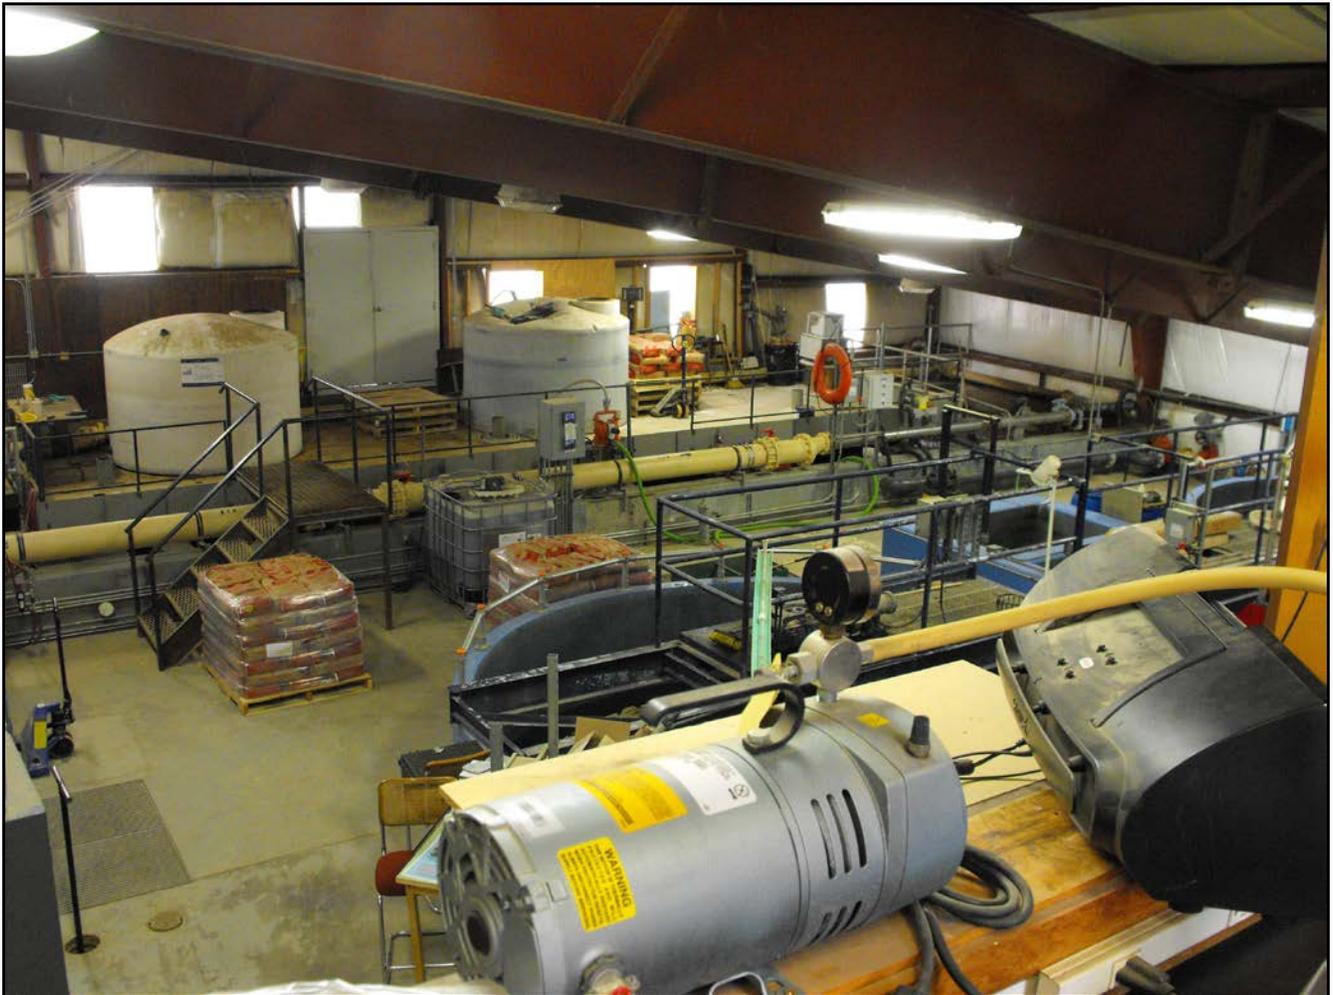
Photo # 2

Photographer: Daniel Valenta	Date: 7/22/2014	Time: 1542 hours
City/County: Village of Taos Ski Valley/Taos County		
Location: Twining Wastewater Treatment Plant, 36 Ocean Blvd, Village of Taos Ski Valley, 87525		
Subject: Inside treatment building of Village of Taos Ski Valley Waste Water Treatment Facility

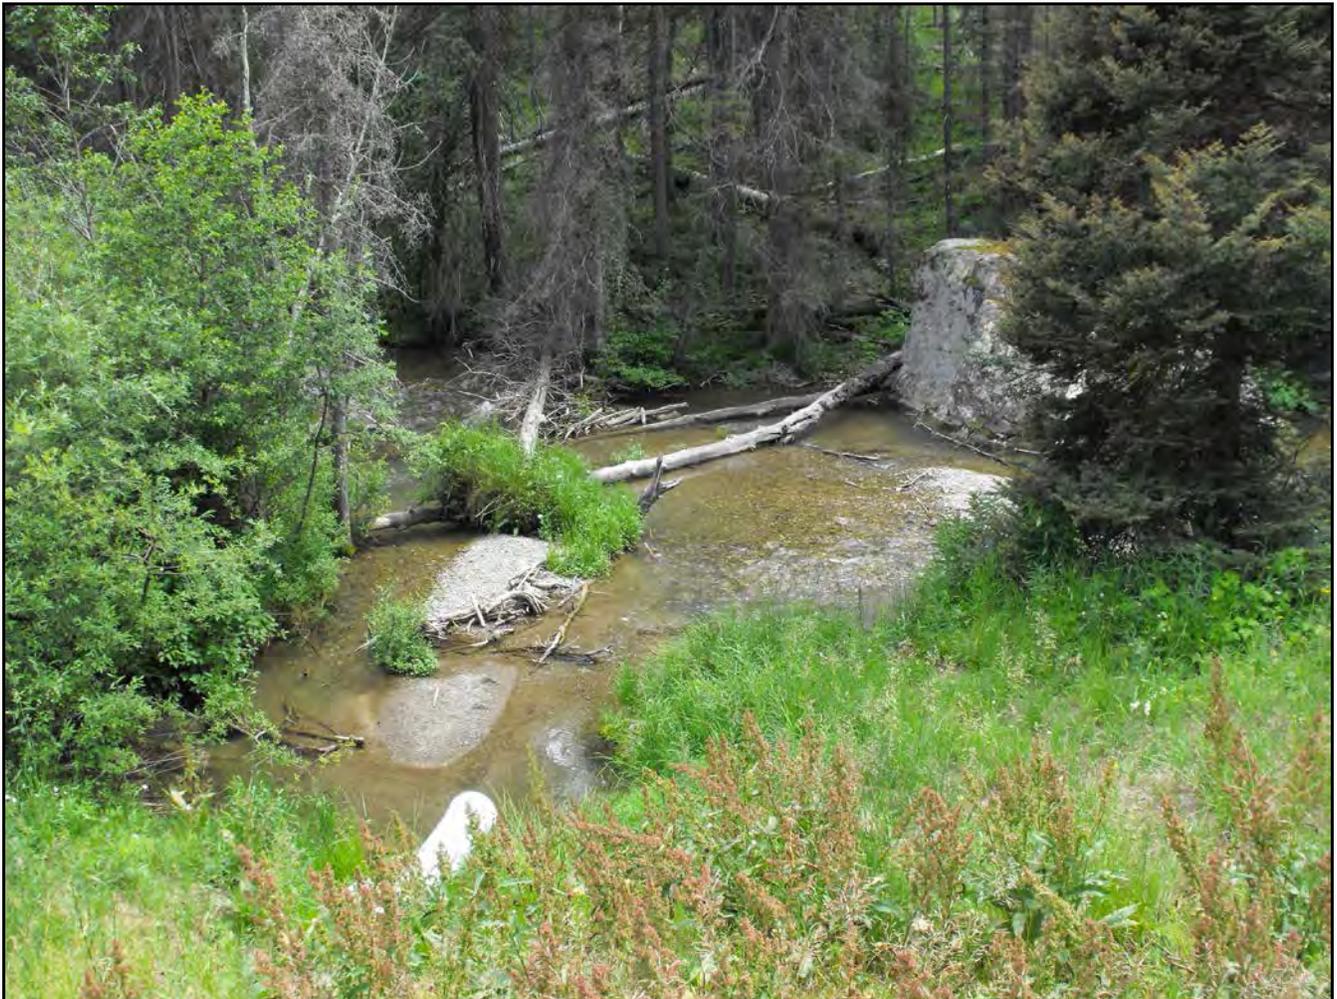
Photo # 2

Photographer: Daniel Valenta	Date: 7/22/2014	Time: 1506 hours
City/County: Village of Taos Ski Valley/Taos County		
Location: Twining Wastewater Treatment Plant, 36 Ocean Blvd, Village of Taos Ski Valley, 87525		
Subject: Outfall of treatment facility to Rio Honda.
