**NEW MEXICO
ENVIRONMENT DEPARTMENT**

Re: Major Municipal, SIC 4952, NPDES Pretreatment Compliance Inspection, Southside Water Reclamation Facility, NM0022250, October 3, 2011

Pretreatment Compliance Inspection (PCI) Report

Name of the Municipality: Albuquerque Bernalillo County Water Utility Authority (ABCWUA) Southside Water Reclamation Facility

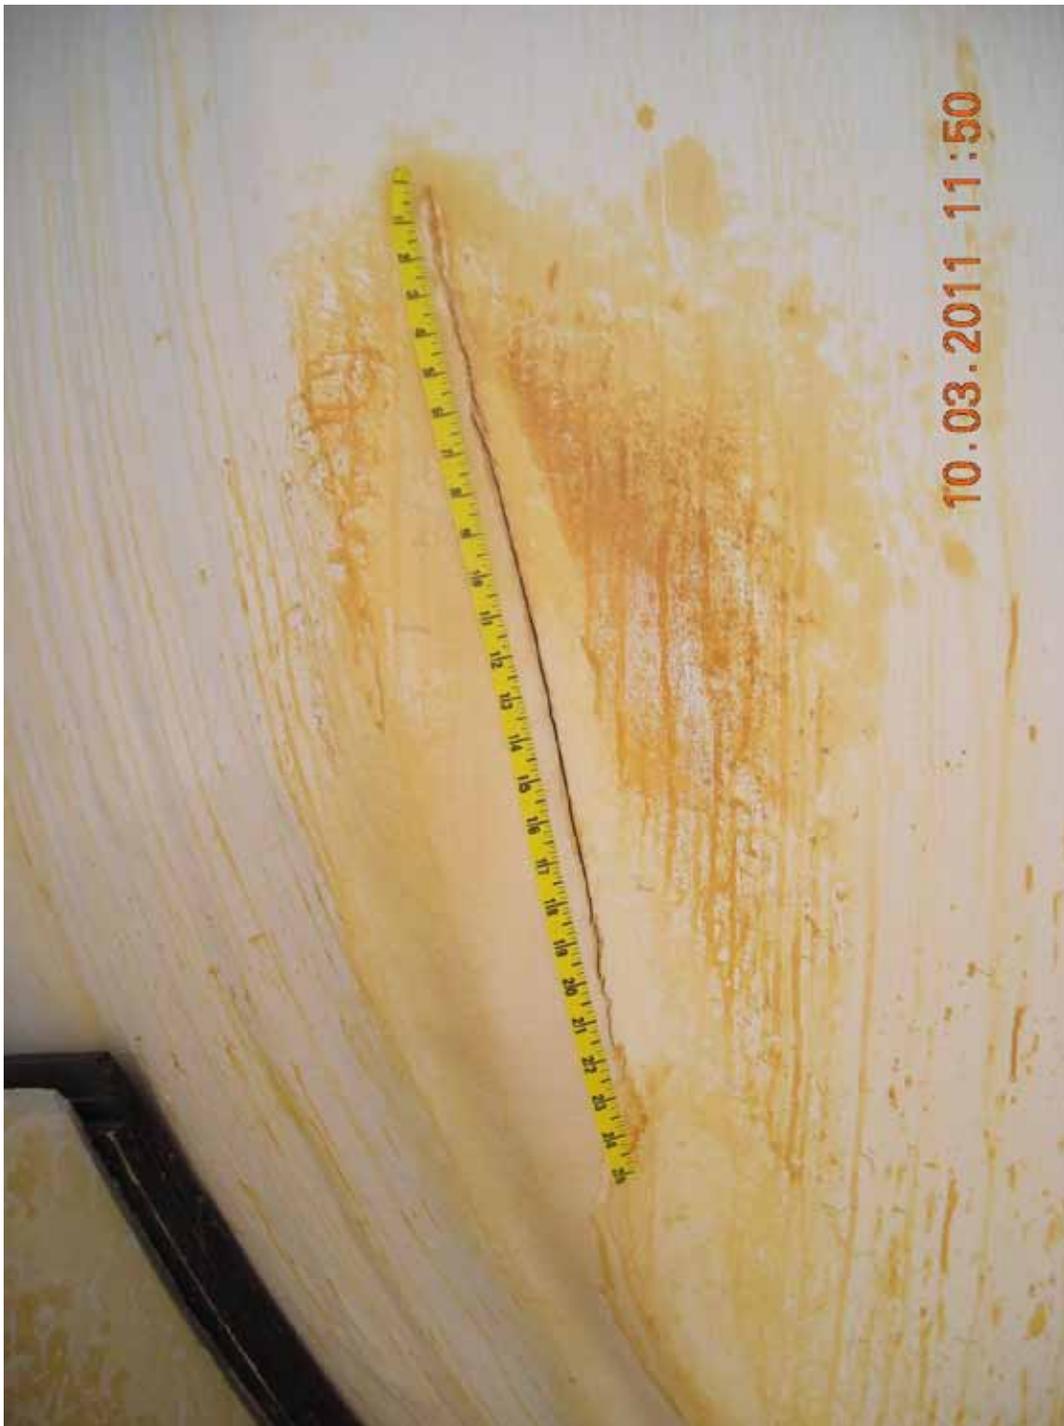
NMED/SWQB
Official Photograph Log
Photo # 1

On September 10th, a tank at Station 70 cracked and ruptured. The leak was not discovered until Monday morning the 12th when Groendyke (the company that delivers the ferric chloride) staff showed up at the facility to deliver railcars full of ferric chloride. The Groendyke staff notified ABCWUA staff, who then showed up on site about an hour later.

The independent inspectors that ABCWUA brought in to investigate the tank rupture were not able to come to a conclusion about why the tank ruptured. The tanks are fiberglass, and coated with a material to discourage disintegration by the sun – all the tanks are exposed to the elements. ABCWUA staff indicated that no tank inspections had been performed on the tanks since Station 70 was placed into service in 2004.

Photographer: Sarah Holcomb	Date: 10-3-2011	Time: 1150 hours
City/County: Albuquerque/Bernalillo County		
Location: Station 70, near Paseo del Norte and Edith Blvd., in Albuquerque		
Subject: Damaged ferric chloride tank which resulted in an approximate 44,000 gallon discharge of ferric chloride to the sanitary sewer.

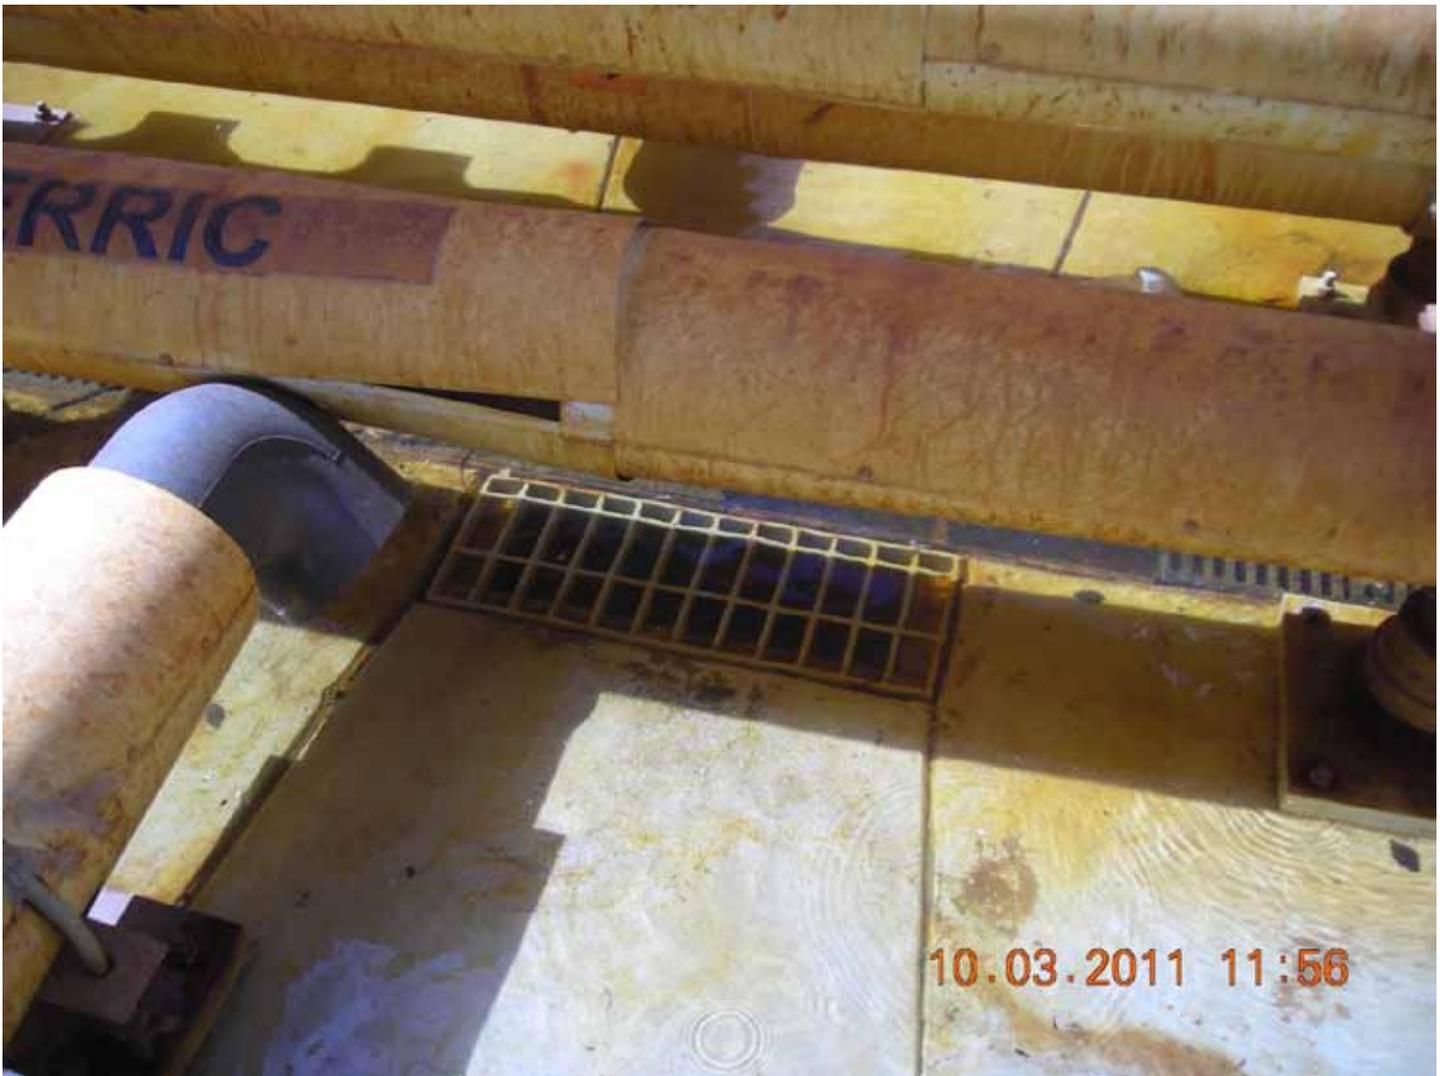
NMED/SWQB
Official Photograph Log
Photo # 2

The ferric chloride storage facility ("Station 70") is set up so that four 20,000 gallon capacity tanks of ferric chloride are on the east side of the facility, and four 20,000 gallon capacity tanks of ferrous chloride are on the west side of the facility. The tanks are surrounded by a concrete block wall, with no roof. In the floor of the facility is a grated floor drain that is connected directly to the sanitary sewer. The ferric tanks (on the water side) are run in parallel ("floating"), so when the tank cracked, the tank was pressurized by the remaining three tanks. The crack in the tank was 24 inches, and stopped about three feet from the bottom of the tank. (Please see Photo #1). On September 10th, these tanks had approximately 17,000 gallons of ferric chloride each.

Photographer: Sarah Holcomb	Date: 10-3-2011	Time: 1156 hours
City/County: Albuquerque/Bernalillo County		
Location: Station 70, near Paseo del Norte and Edith Blvd., in Albuquerque		
Subject: Floor drain which leads directly to the sanitary sewer from Station 70. Water on the floor of facility at the time of the inspection was from a hose that had been running on the floor of the facility.

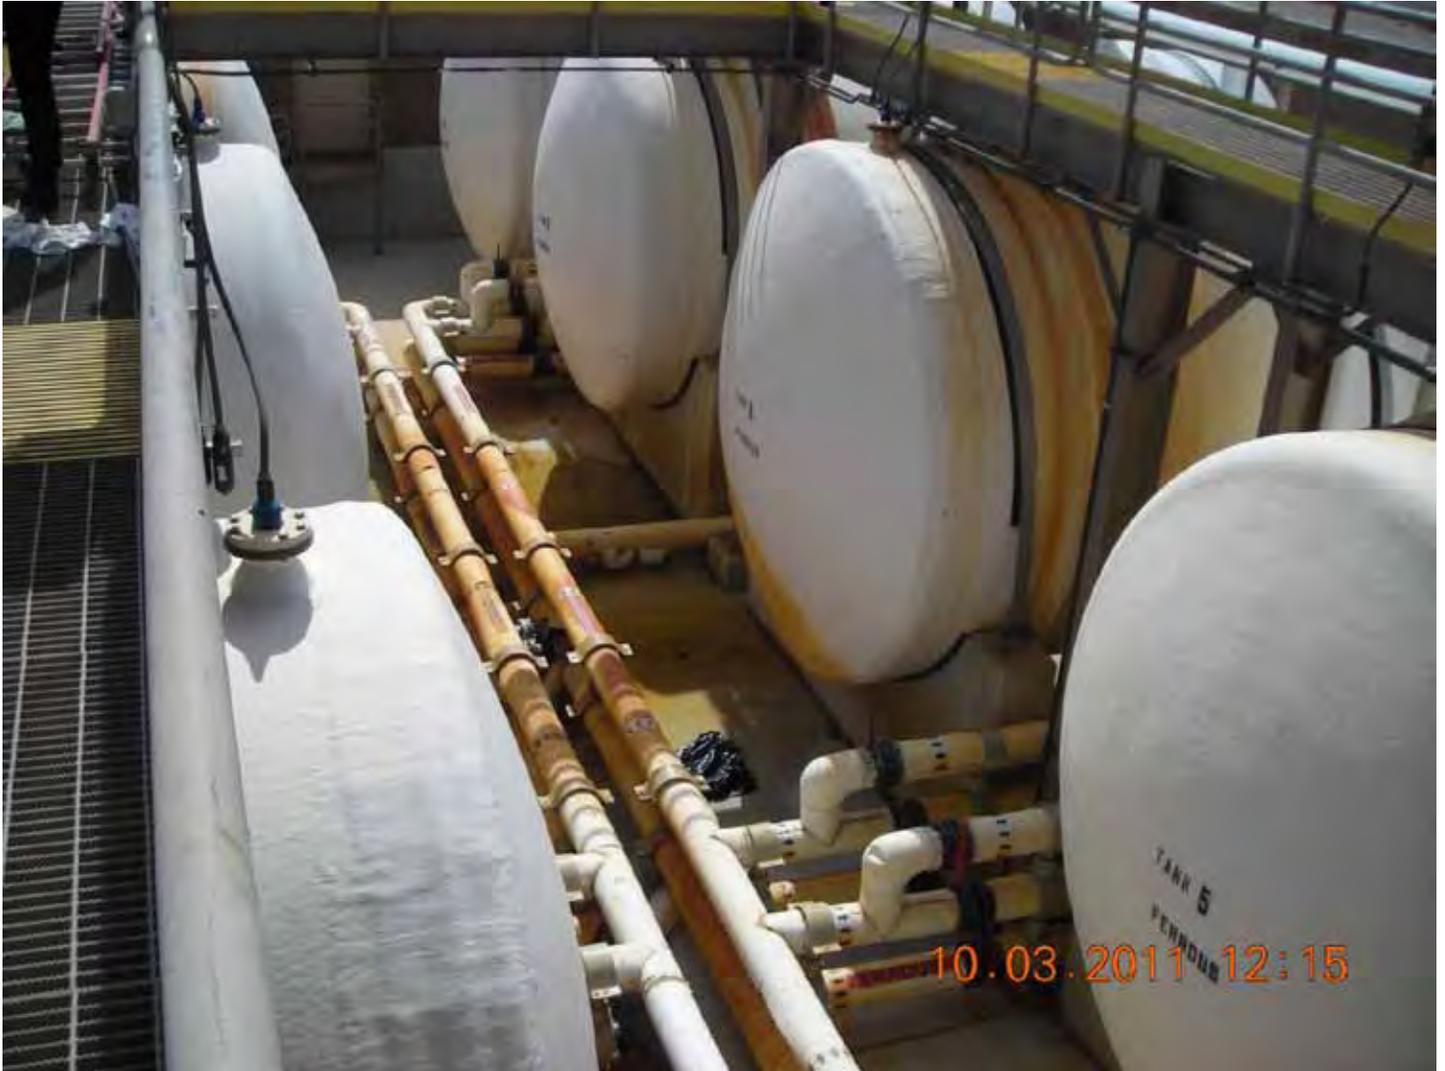
NMED/SWQB
Official Photograph Log
Photo # 3

Photographer: Sarah Holcomb	Date: 10-3-2011	Time: 1215 hours
City/County: Albuquerque/Bernalillo County		
Location: Station 70, near Paseo del Norte and Edith Blvd., in Albuquerque		
Subject: Aerial view of Station 70 set-up.

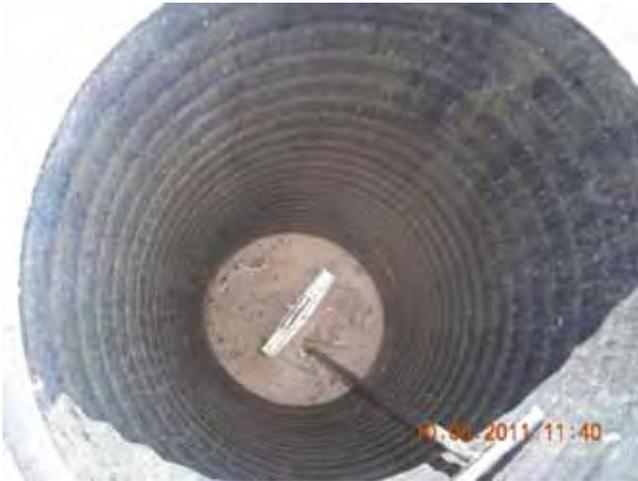
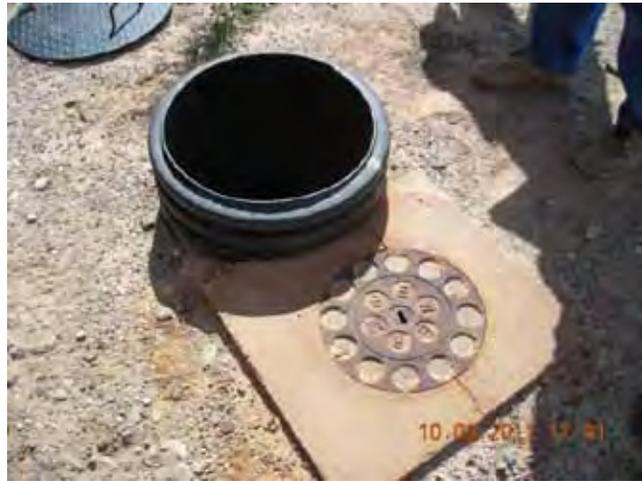
NMED/SWQB
Official Photograph Log
Photo # 4

The pretreatment program never considered Station 70 a potential threat, so it had not been permitted as of the date of this inspection. The valve to the sanitary sewer has been shut off since this incident. According to pretreatment staff, the water employees did not notify pretreatment staff of the discharge. Pretreatment staff found out that the plant was experiencing issues Monday morning from observations of the primary clarifiers and sent staff out into the field to sample at manholes and identify the source of the discharge. By Monday evening, pretreatment staff had narrowed down the discharge to Station 70. At that point, the pH in the manhole downstream of Station 70 was at 1.5 S.U. pH levels all the way down to the plant had not risen above 3.0 S.U.

Photographer: Sarah Holcomb	Date: 10-3-2011	Time: 1140/1141 hours
City/County: Albuquerque/Bernalillo County		
Location: Station 70, near Paseo del Norte and Edith Blvd., in Albuquerque		
Subject: Valve located outside the containment walls of Station 70 that must be opened to discharge anything to the sanitary sewer.
