NEW MEXICO
ENVIRONMENT DEPARTMENT

Re: Major Municipal; SIC 4952; Compliance Evaluation Inspection; Artesia Wastewater Treatment Plant;
NPDES Permit No. NM0022268; January 23, 2013

NPDES Compliance Inspection Report

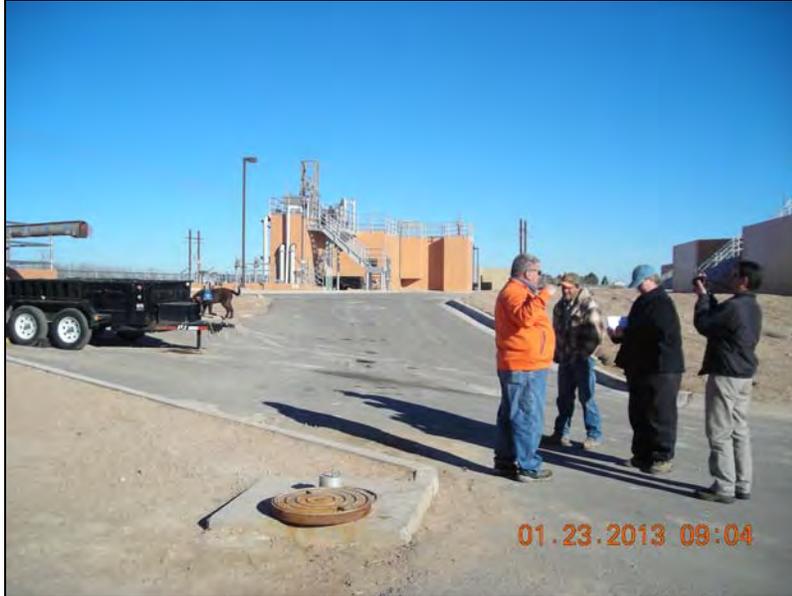
NMED/SWQB
Official Photograph Log
Photo # 3

Subject: The treatment unit in the background consists of Flygt pumps to lift influent to a second bar screen, influent flow measurement and grit removal system.

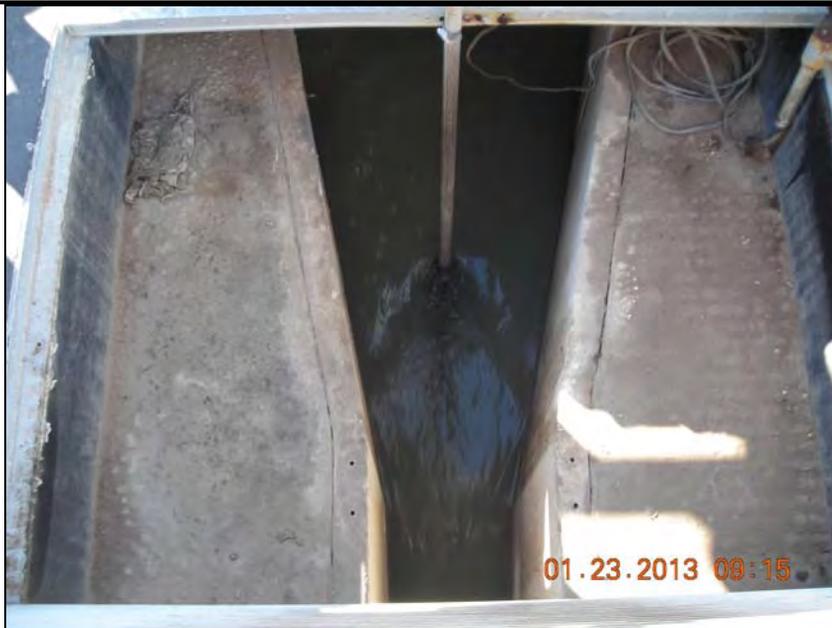
NMED/SWQB
Official Photograph Log
Photo # 4

Subject: Influent Parshall Flume with a Drexelbrook pressure sensor. The influent flow is somewhat turbulent.

somewhat turbulent and does not have a steady laminar flow as it enters the Parshall flume flow measurement device. Following is a rectangular aerated grit removal chamber. The solids removed from the screens and from the grit chamber are dried and after passing the paint filter test, disposed of at the county landfill between Carlsbad and Hobbs, New Mexico. The treatment plant is monitored with a SCADA control system. An alarm call out system is in place with the Operators phone numbers programmed in. The facility has a backup diesel generator for power that is exercised weekly.

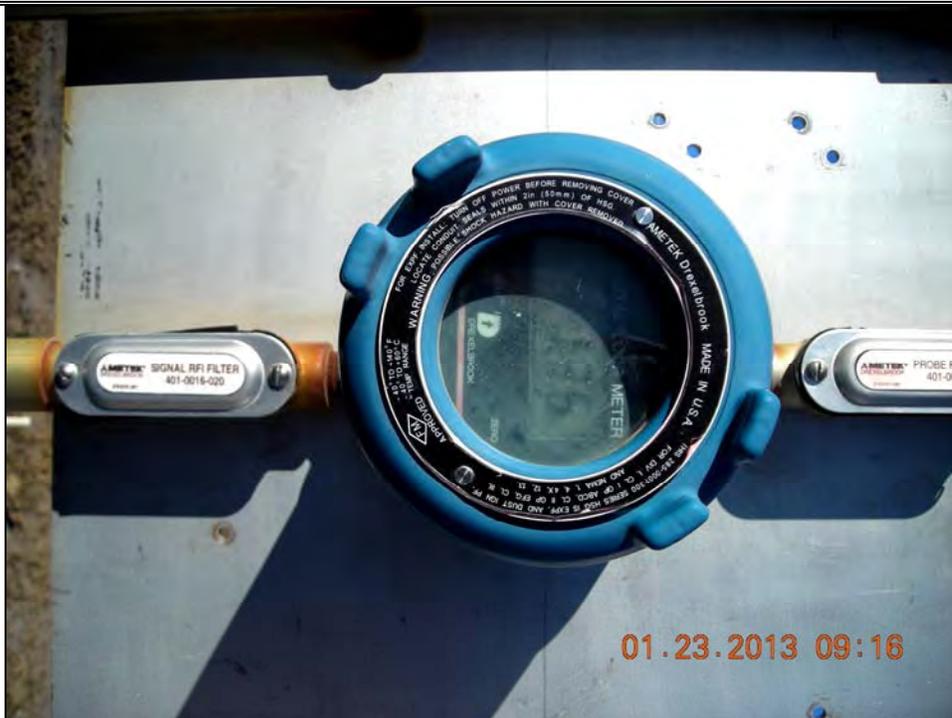
NMED/SWQB
Official Photograph Log
Photo # 5

Subject: Influent Flow Meter - Drexelbrook pressure measurement system, readout meter.

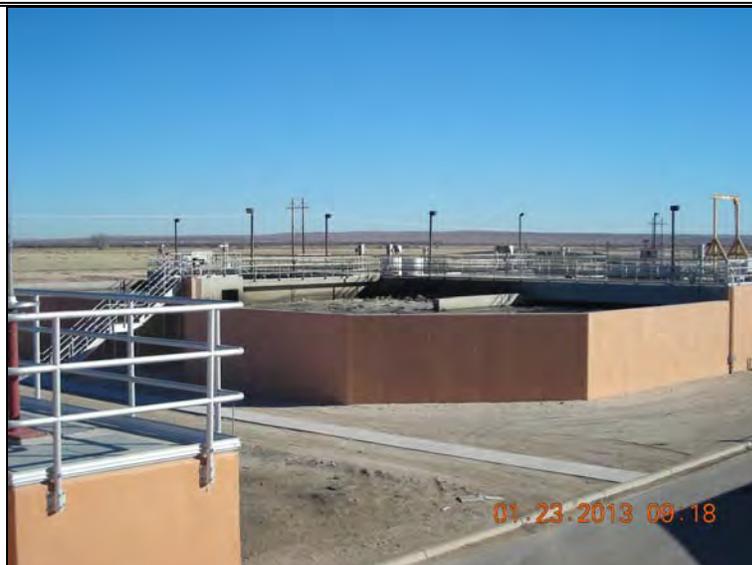
NMED/SWQB
Official Photograph Log
Photo # 6

Subject: North Oxidation Ditches, view from the influent grit chamber.

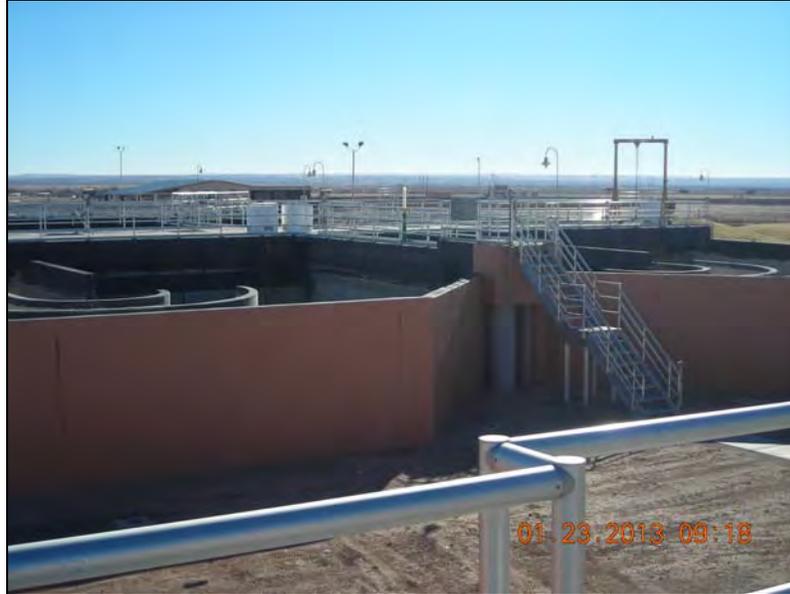
NMED/SWQB
Official Photograph Log
Photo # 7

Subject: South Oxidation Ditches that were offline at the time of the inspection.

The south oxidation ditch units were not in operation and were dry. Because of the duplicate units, the WWTP design capacity is actually double that of the NPDES permitted 1.3 MGD capacity that is used to calculate effluent loading. The increased capacity is available for the use if the WWTP were to receive higher volumes of sewage for treatment. In that even, changes to the NPDES permit may be required.

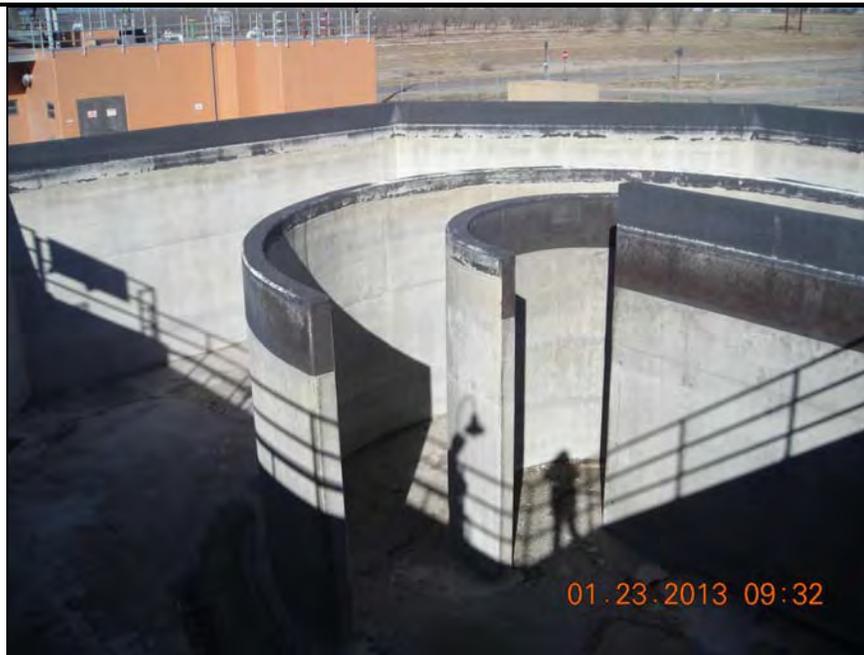
NMED/SWQB
Official Photograph Log
Photo # 8

Subject: Empty treatment units of the south oxidation ditches.

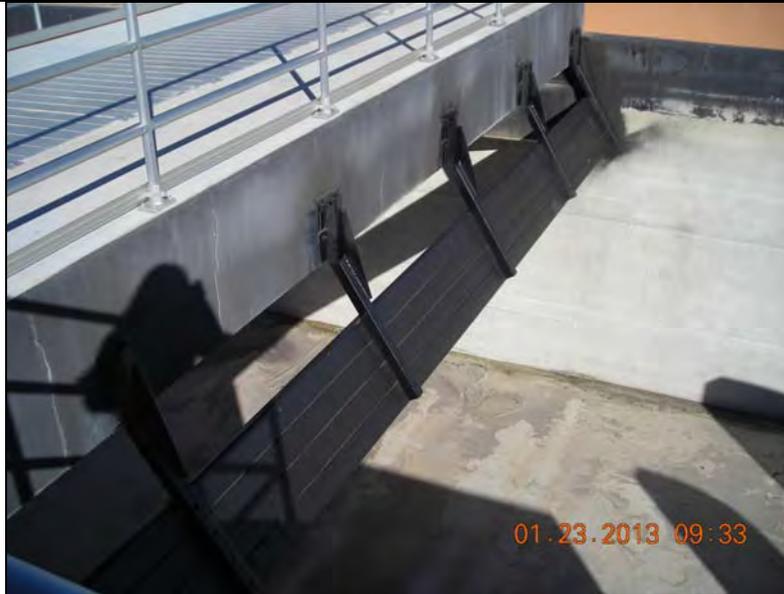
NMED/SWQB
Official Photograph Log
Photo # 9

Subject: Baffling and hydraulic arm of the empty oxidation ditches.

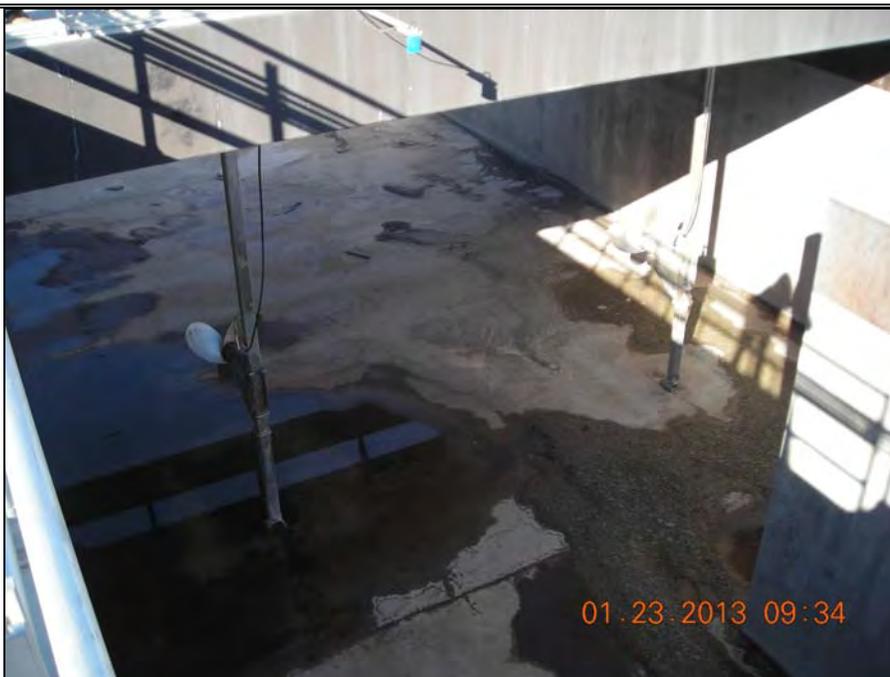
NMED/SWQB
Official Photograph Log
Photo # 10

Subject: Subsurface mixers in the empty oxidation ditches. These are set at approximately 8 feet deep.

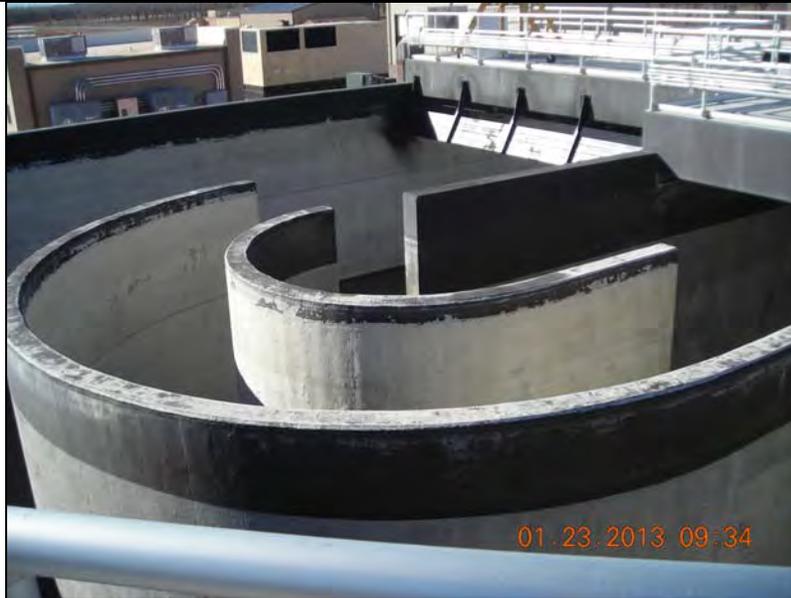
NMED/SWQB
Official Photograph Log
Photo # 11

Subject: another view of the empty oxidation ditch and unit configuration.

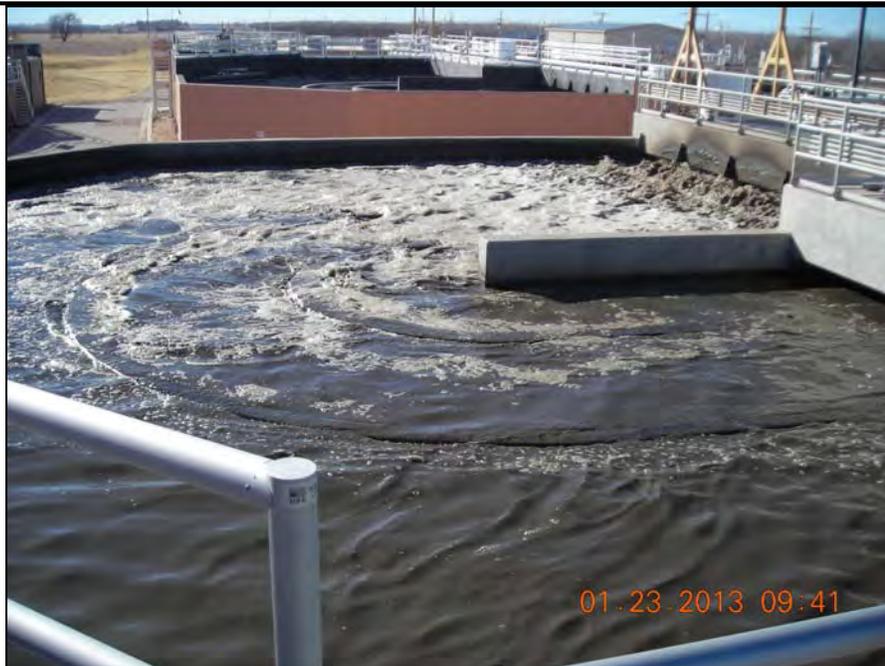
NMED/SWQB
Official Photograph Log
Photo # 12

Subject: Oxidation ditch in use. The ditch is hydraulically overloaded as can be seen by the high water level and nearly submerged treatment unit walls. In the back the brush aerators are in operation. . Note the extremely dark grey color that is atypical for domestic activated sludge. This is an indication that inadequate biological activity is occurring to properly treat domestic waste.

4. Flock shearing was noted in the oxidation ditch. This is an indication of interference with the optimal activated sludge process. The cause is not specifically identified in this report, however this condition is consistent with an interference occurring from unknown substances in the influent and improper mixing.

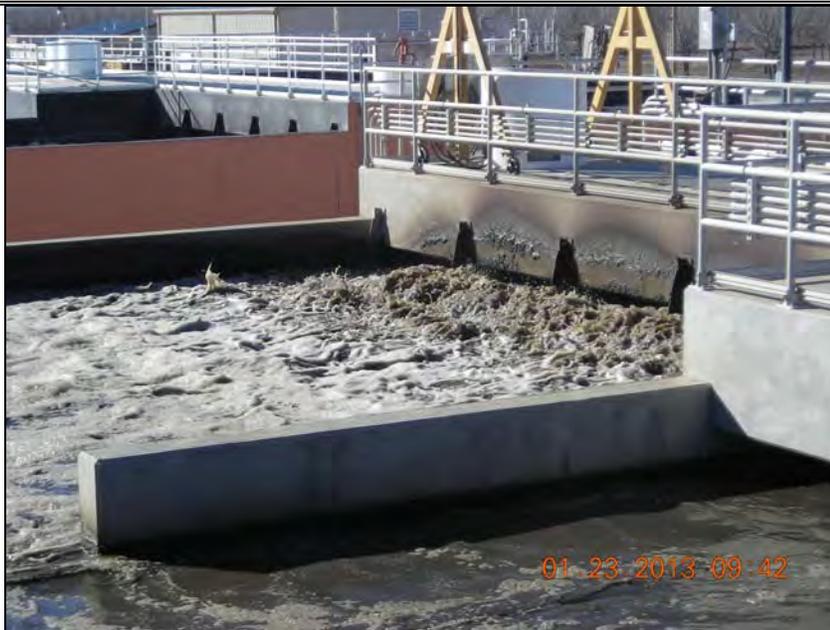
NMED/SWQB
Official Photograph Log
Photo # 13

Subject: Oxidation ditch in use. The ditch is hydraulically overloaded as can be seen by the high water level and nearly submerged treatment unit walls. In the back the brush aerators are in operation. Note the extremely dark grey color that is atypical for domestic activated sludge. This is an indication that inadequate biological activity is occurring to properly treat domestic waste.

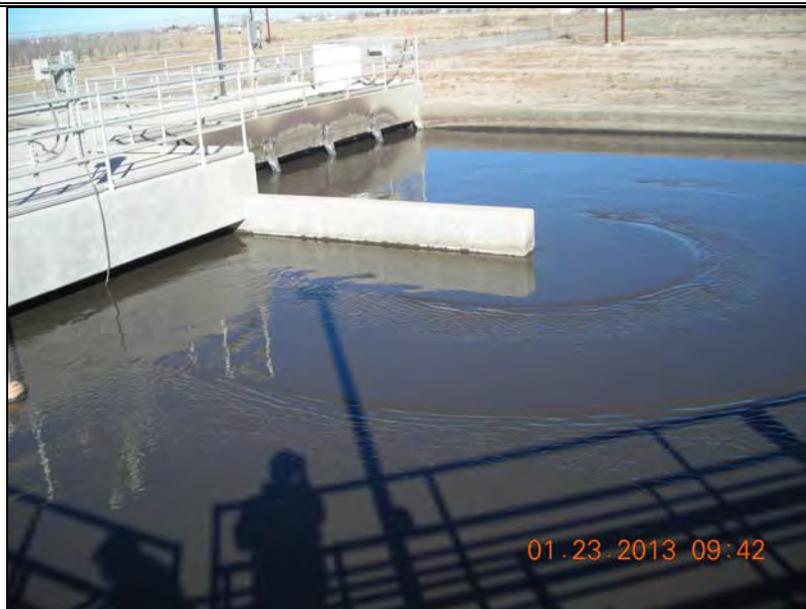
NMED/SWQB
Official Photograph Log
Photo # 14

Subject: Oxidation ditch in the anaerobic phase.

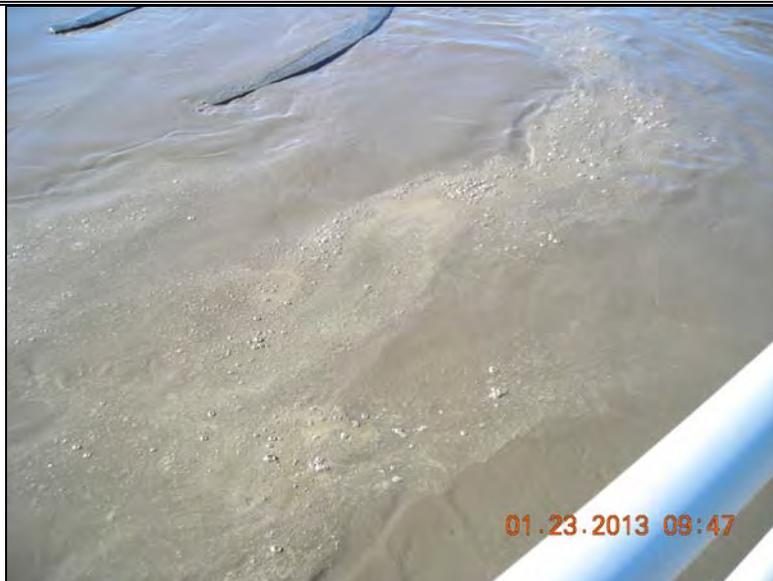
NMED/SWQB
Official Photograph Log
Photo # 15

Subject: Oxidation ditch in the anaerobic phase.

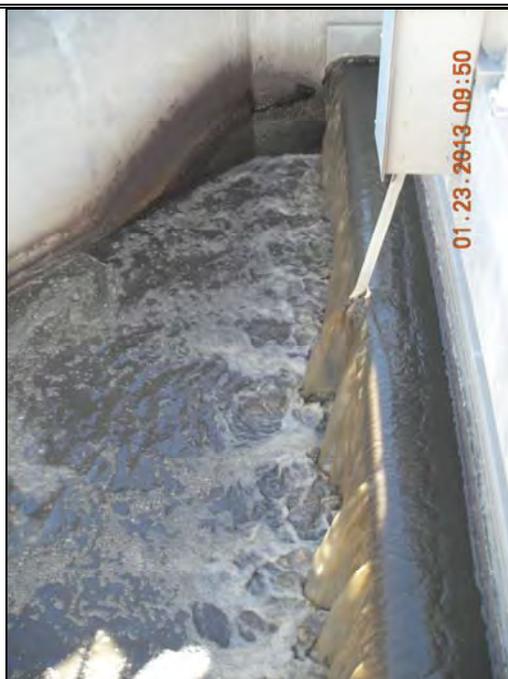
NMED/SWQB
Official Photograph Log
Photo # 16

Subject: Decant from the oxidation ditch to the secondary clarifier.

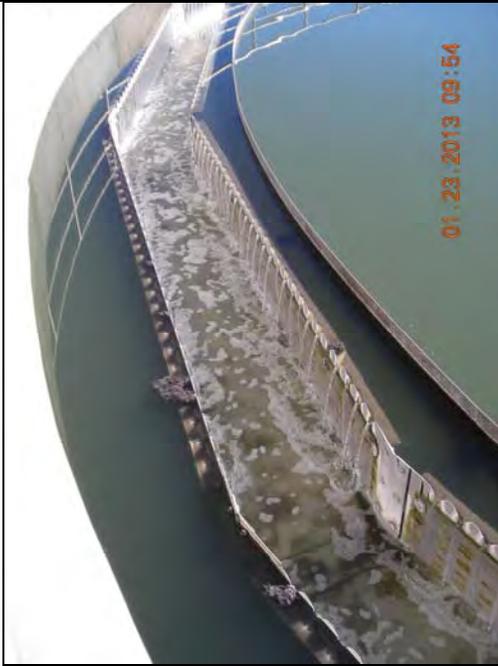
6. The secondary clarifier was opaque and grey green in color. This is atypical for the quality of the wastewater at this stage of the treatment process. It is also noted that some floating solids and pinfloc were in the basin, and being sent with the decant to the next treatment process, ultraviolet disinfection.

NMED/SWQB Official Photograph Log Photo # 17		
Photographer: S. Holcomb	Date: : January 23, 2013	Time: 0954 hours
City/County: Artesia/ Eddy County		State: New Mexico
Location: Artesia WWTP		
Subject: Secondary Clarifier. Note the very turbid opaque grey green color. Also note the floating solids, indicating very old solids in the sludge blanket.

The solids in the oxydation ditch were being held longer than they should be because of the very dilute influent. This is not an optimal condition for an activated sludge treatment process.

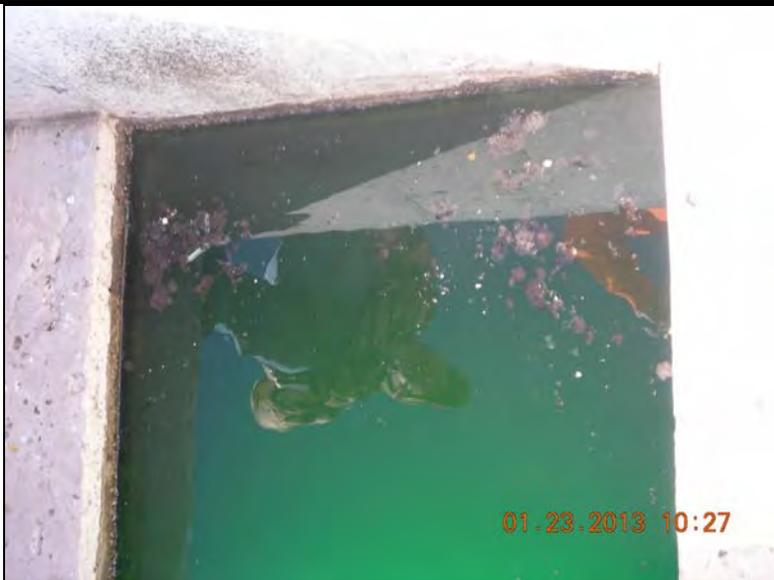
NMED/SWQB Official Photograph Log Photo # 18		
Photographer: S. Holcomb	Date: : January 23, 2013	Time: 1027
City/County: Artesia/ Eddy County		State: New Mexico
Location: Artesia WWTP		
Subject: Water entering the Ultraviolet Disinfection System. Note the floating solids and the opaque grey green color. The UV lights cannot adequately penetrate the water for effective disinfection.

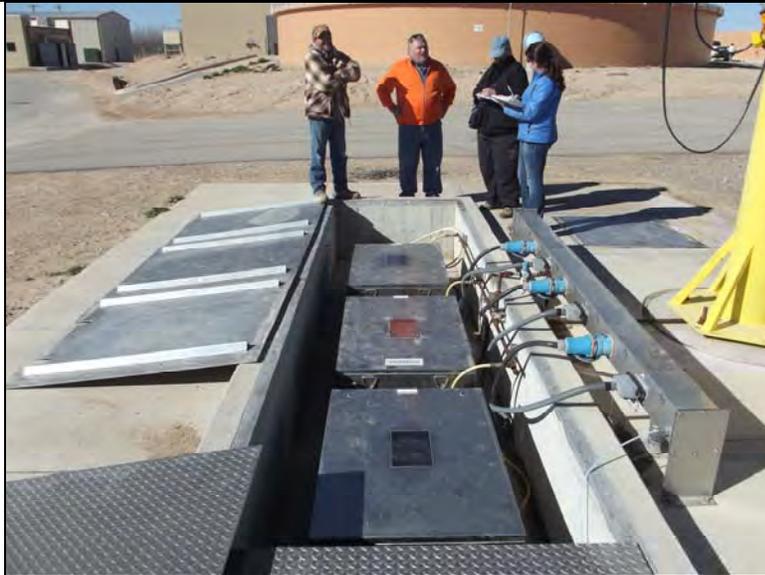
NMED/SWQB
Official Photograph Log
Photo # 19

Subject: Ultra Violet Disinfection System consisting of three sequential banks of lights.

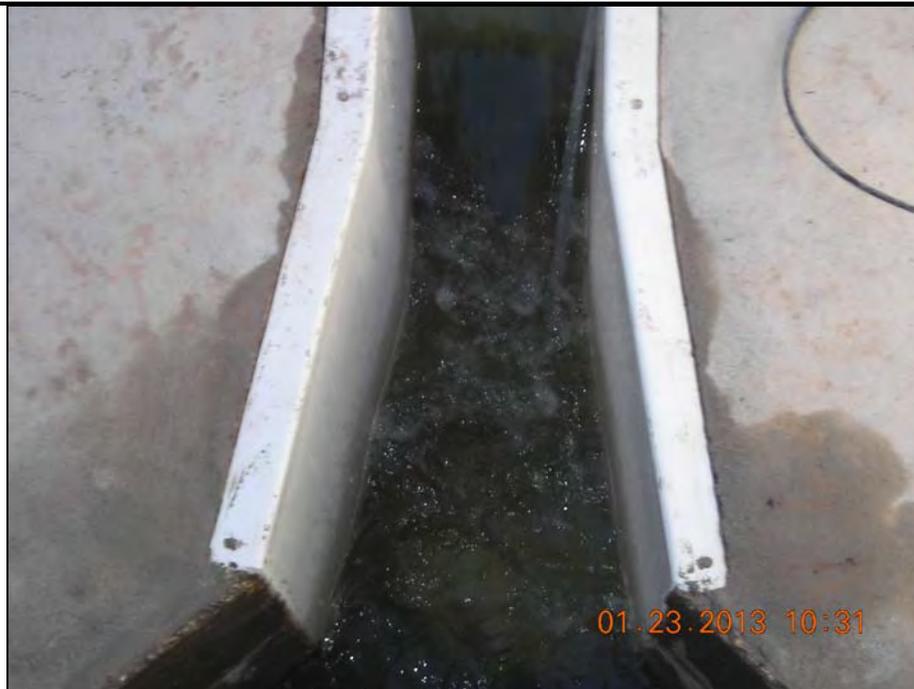
NMED/SWQB
Official Photograph Log
Photo # 20

1. Effluent Flow meter is improperly installed. The meter cannot be used for flow measurements. Influent flow is being used for reporting.

Subject: Effluent Parshall Flume – Turbulent flow is a result of an improperly installed channel. The effluent flow meter cannot be used and cannot be reported on the NPDES permit or on the NMED Ground Water Discharge Permit.

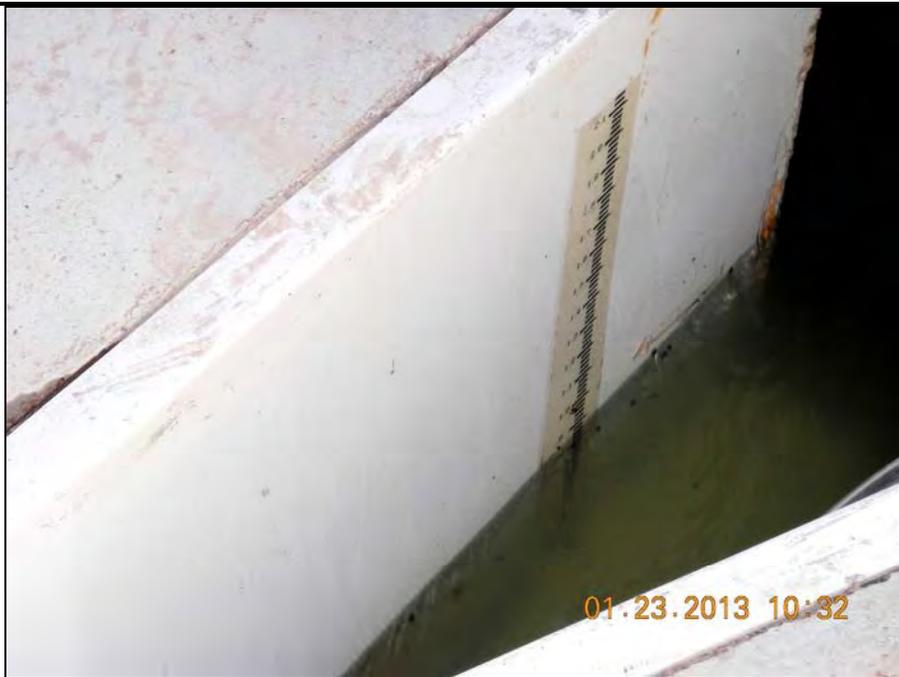
NMED/SWQB
Official Photograph Log
Photo # 21

1. On the day of the inspection, floating solids were noted in the discharge.
2. On the day of the inspection, effluent exceedences occurred for E. coli bacteria. The sample was reported to be TNTC.

Subject: staff gauge at the effluent flow channel. Flows from this meter are inaccurate and cannot be used for permit reporting. Floating Solids and turbid water were observed.

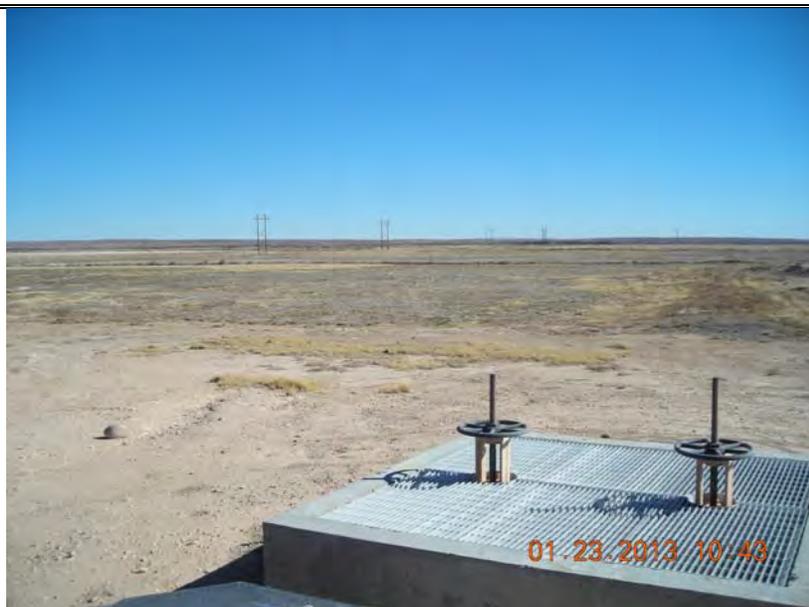
NMED/SWQB
Official Photograph Log
Photo # 22

Subject: Effluent well – splitter location. Flow can be sent either to the Pecos River or to the reuse holding pond.

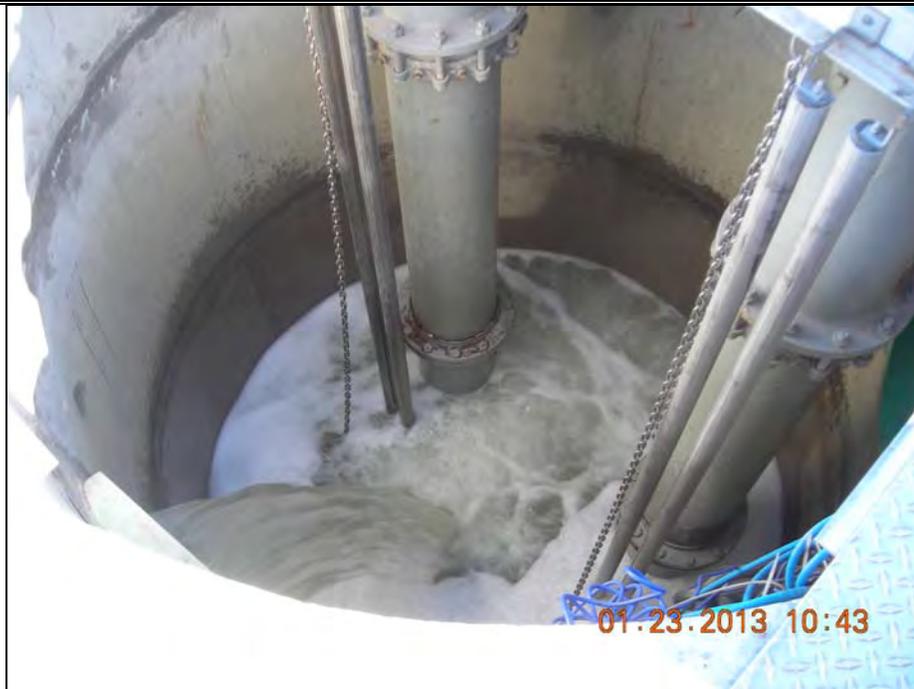
NMED/SWQB
Official Photograph Log
Photo # 23

Subject: Effluent well – splitter location. Flow can be sent either to the Pecos River or to the Reuse holding pond.

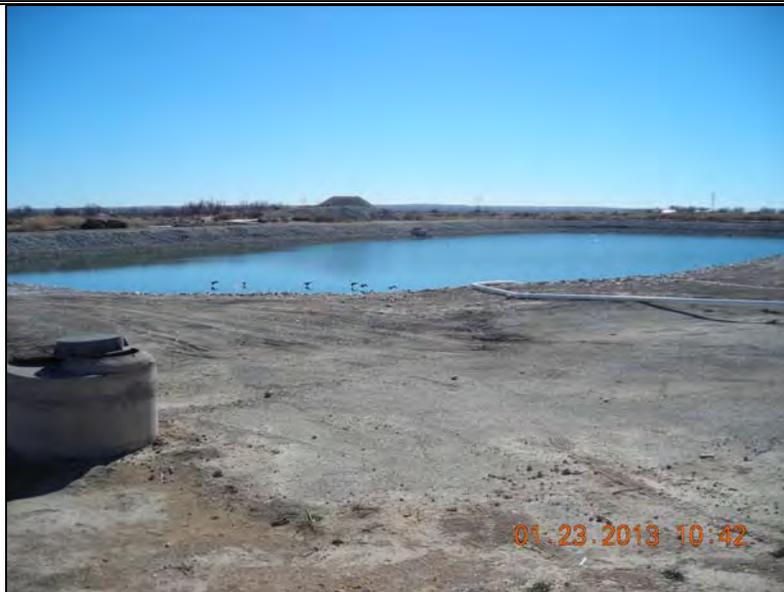
NMED/SWQB
Official Photograph Log
Photo # 24

Subject: Effluent Reuse holding pond.

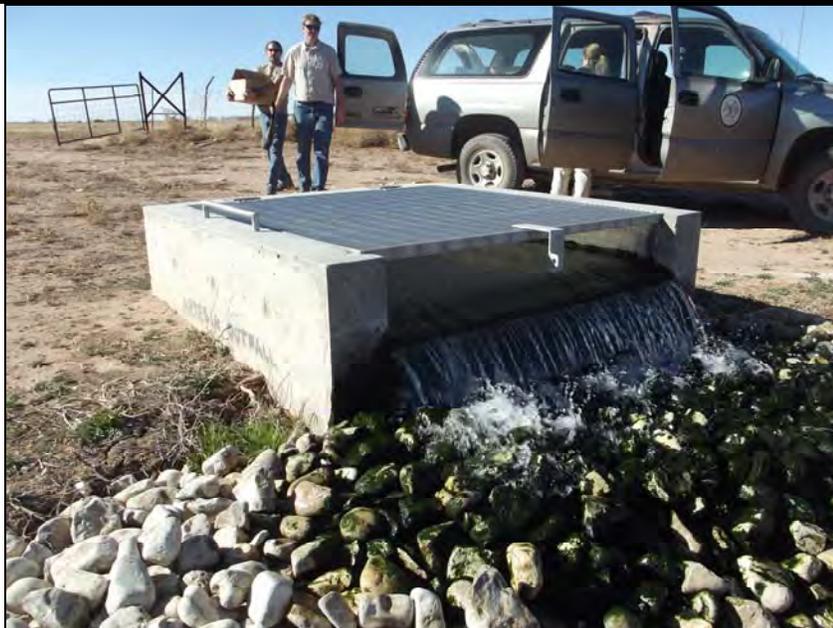
NMED/SWQB
Official Photograph Log
Photo # 25

Subject: Outfall to the Pecos River from the Artesia WWTP. Note the rough rocks lining the bank for stabilization and to assist in re-aerating the effluent as it enters the river.

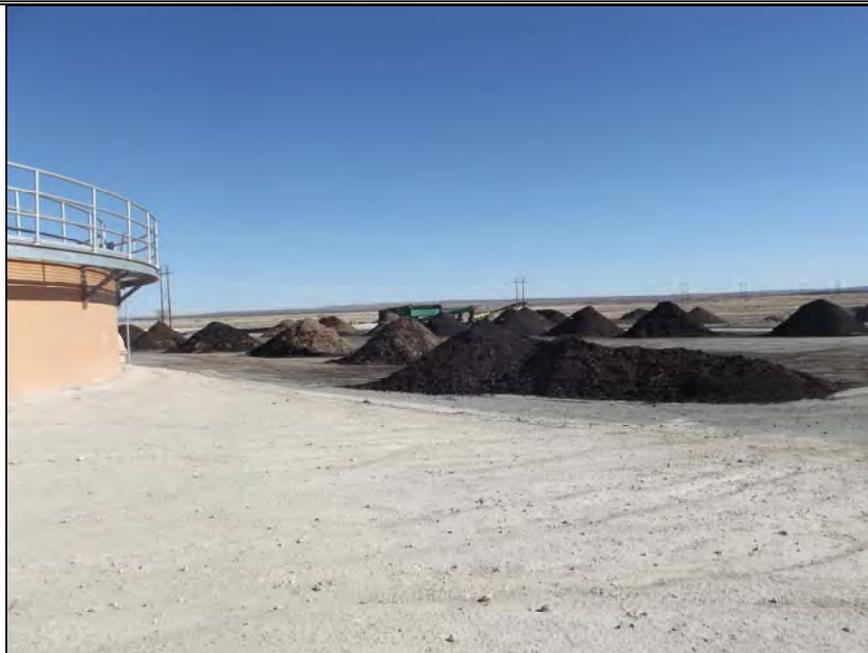
NMED/SWQB
Official Photograph Log
Photo # 26

Subject: Sludge processing, Piles have been mixed with mulch for composting. The piles are warmed in the sun and biologically for pathogen reduction.

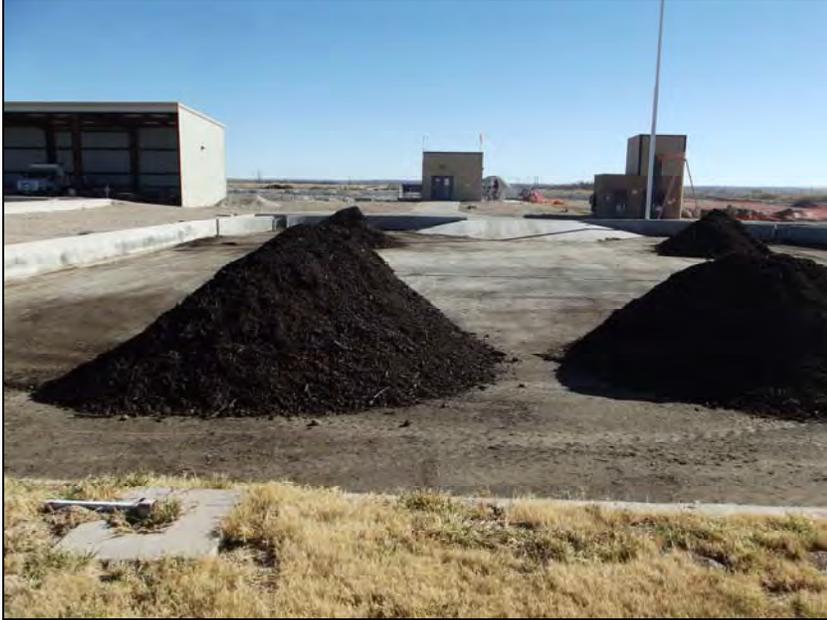
NMED/SWQB
Official Photograph Log
Photo # 27

Subject: Sludge processing, Piles have been mixed with mulch for composting. The piles are warmed in the sun and biologically for pathogen reduction.

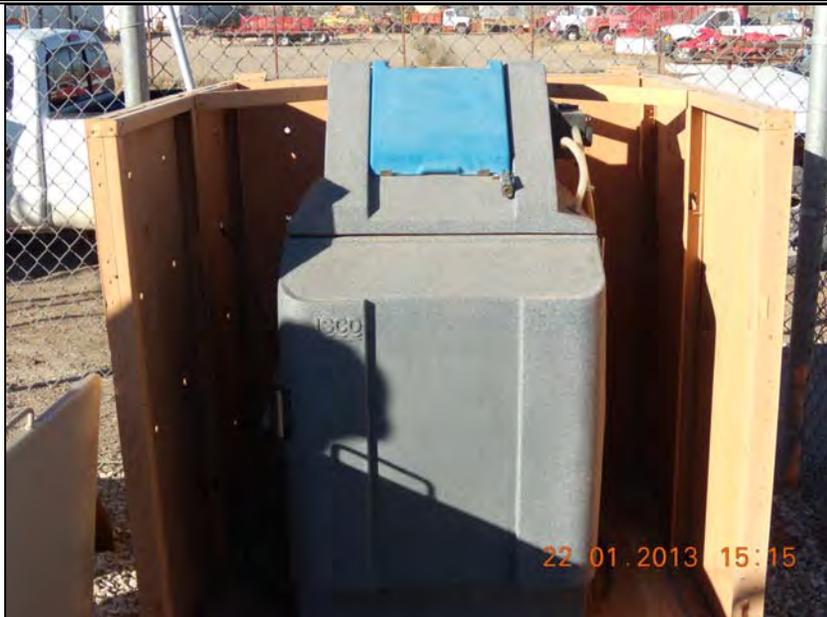
NMED/SWQB
Official Photograph Log
Photo # 28

Subject: Isco compositing sampler at the Navajo Refinery, processed water point where it enters the City of Artesia collection system for wastewater.

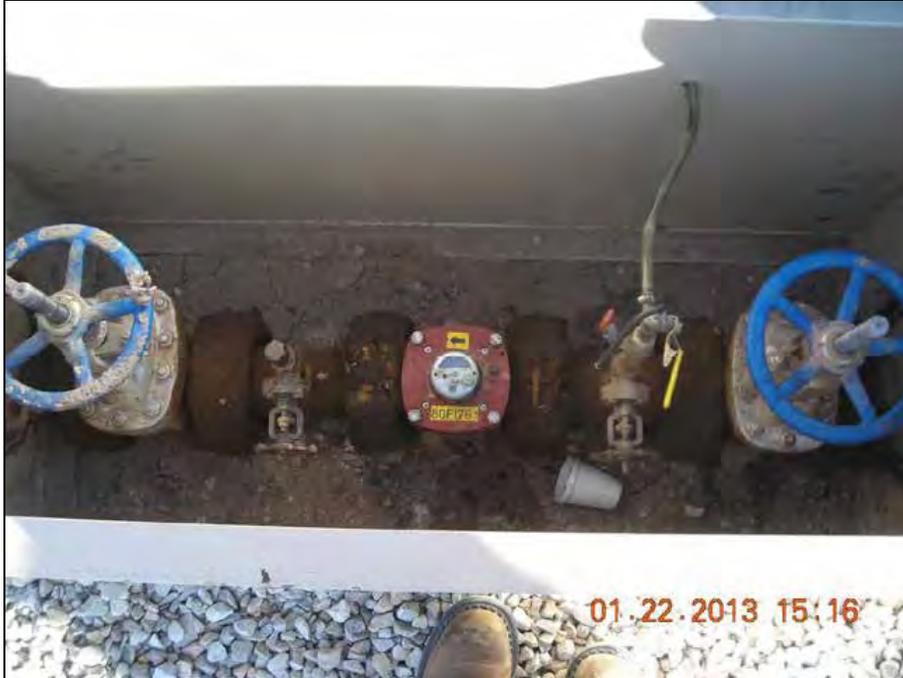
NMED/SWQB
Official Photograph Log
Photo # 29

Subject: Carlon H-400 effluent meter installed at the city-only access point from Navajo to the City of Artesia sewer line.
