**Re: Chevron Mining, Inc. (CMI), Questa Mine; Major Individual Permit; SIC 1061; NPDES Compliance Evaluation Inspection (CEI); NM0022306; September 23 & 24, 2014**  
**Revised**

**Chevron Mining, Inc. (CMI) - Questa Mine - NM0022306  
NPDES Compliance Evaluation Inspection (CEI) Report**

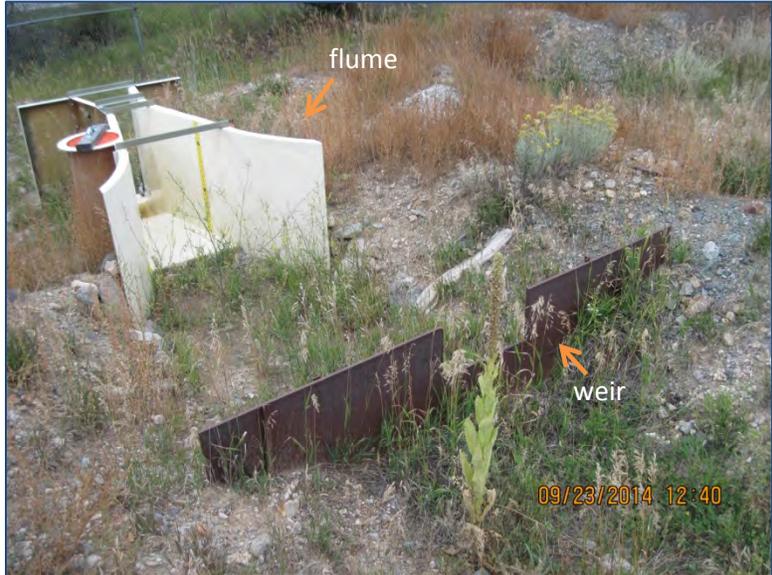
<b>NMED/SWQB</b> <b>Official Photograph Log</b> <b>Photo # 1</b>		
Photographer: Erin S. Trujillo	Date: 09/23/2014	Time: 1240 hours
City/County: East of Questa / Taos County		State: New Mexico
Location: CMI Questa Mine, Mill Area - Monitoring and Measurement Location for Outfall 005		
Subject: Looking south-southeast, arrows point to weir and flume at monitoring and measurement location for Outfall 005. Weir was upgradient of the flume for Outfall 005. A channel for flow was not well defined in this area.

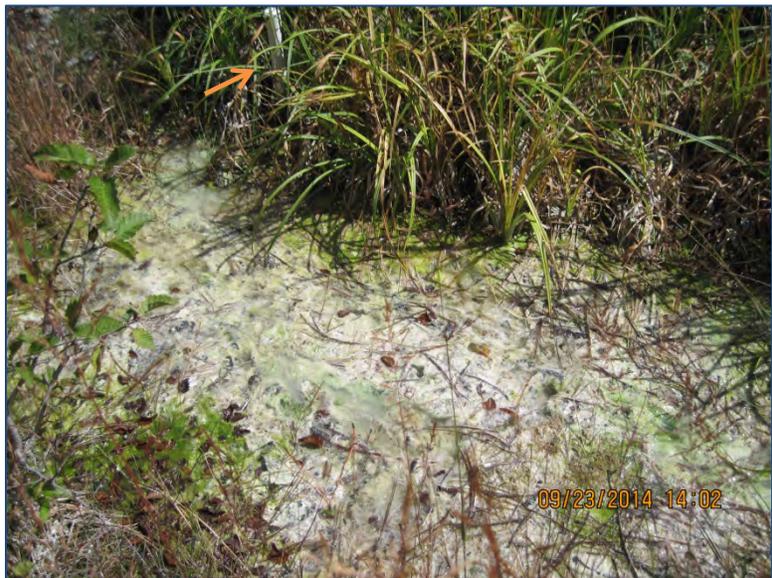
<b>NMED/SWQB</b> <b>Official Photograph Log</b> <b>Photo # 2</b>		
Photographer: Erin S. Trujillo	Date: 09/23/2014	Time: 1402 hours
City/County: East of Questa / Taos County		State: New Mexico
Location: CMI Questa Mine, Spring 39 Seepage Interception System Area		
Subject: Visible white precipitate and surface water at Spring 39 Seepage Interception System. Arrow points to PVC pipe for interception system.

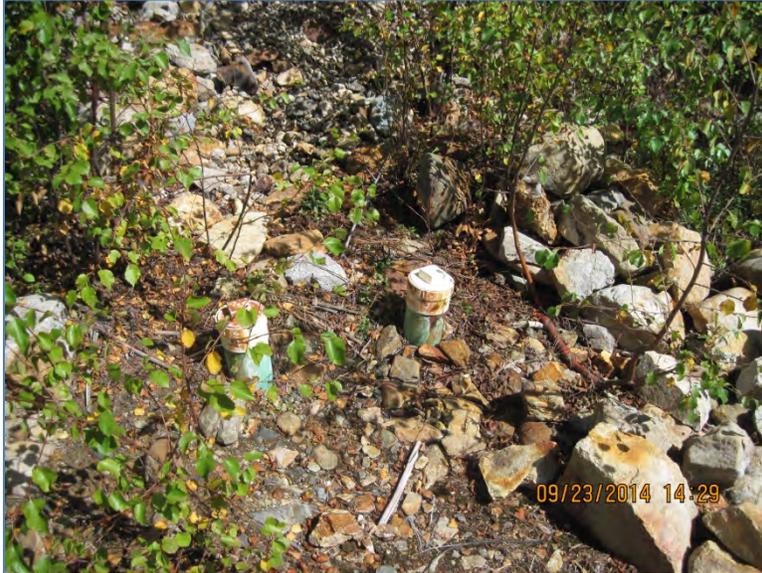
NMED/SWQB Official Photograph Log Photo # 3		
Photographer: Erin S. Trujillo	Date: 09/23/2014	Time: 1429 hours
City/County: East of Questa / Taos County		State: New Mexico
Location: CMI Questa Mine, Spring 13 Seepage Interception System Area, Along north bank of Red River		
Subject: PVC pipes used for maintenance cleanout of Spring 13 Seepage Interception System as described by Permittee on-site representative.

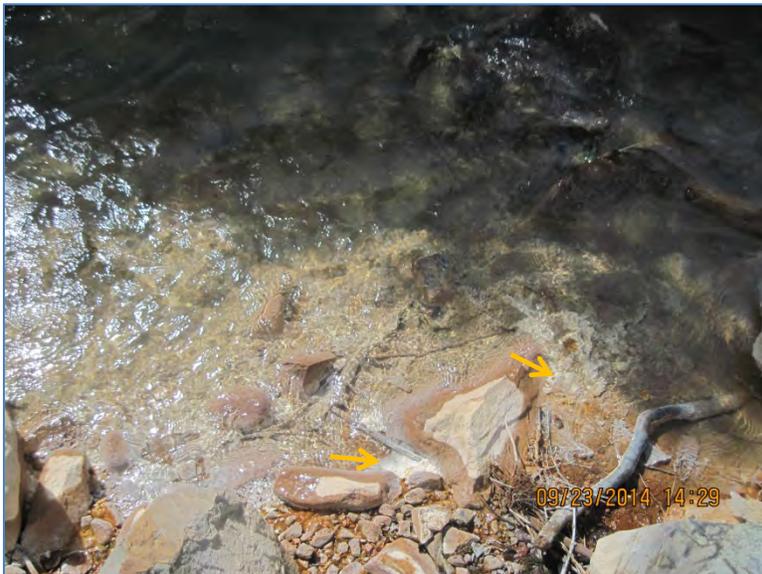
Part II.D of the 2013 Permit states *“This permit prohibits the discharge to the Red River of pollutants traceable to point source mine operations except in trace amounts.”* Visible white (described by Permittee on-site representative to be aluminum hydroxide) and red (rusty in color) slimy deposits, possibly iron bacteria, and algal growth mats were observed along the Red River at and downstream of the Spring 13 interception system during this CEI (see photo #4 and #5). Visible white precipitates in areas of surface water in the floodplain of the Red River at the Spring 39 interception system were observed during this CEI (see photo #2). Further explanation on operation and maintenance of the spring interception systems and ground water well collection systems is discussed below in Section C.

NMED/SWQB Official Photograph Log Photo # 4		
Photographer: Erin S. Trujillo	Date: 09/23/2014	Time: 1429 hours
City/County: East of Questa / Taos County		State: New Mexico
Location: CMI Questa Mine, Adjacent to Spring 13 Seepage Interception System Area, Along bank of Red River		
Subject: Arrows point to examples of visible white precipitate in Red River.

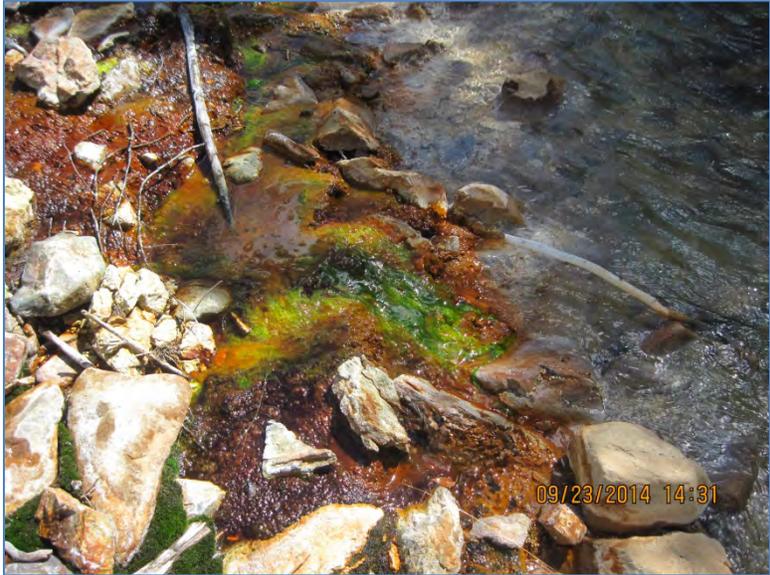
As discussed above in Section A, the aluminum hydroxide and red slimy deposits, possibly iron bacteria with algal growth mats, were observed along the Red River at and downstream of the Spring 13 and Spring 39 interception system during this CEI.

<b>NMED/SWQB          Official Photograph Log          Photo # 5</b>		
Photographer: Erin S. Trujillo	Date: 09/23/2014	Time: 1431 hours
City/County: East of Questa / Taos County		State: New Mexico
Location: CMI Questa Mine, Downstream of Spring 13 Seepage Interception System Area		
Subject: Example of red (rusty in color) slimy deposits, possibly iron bacteria at seep along bank of Red River. Green algal growth mat at seep may be from increased nutrients (nitrogen and phosphorus).

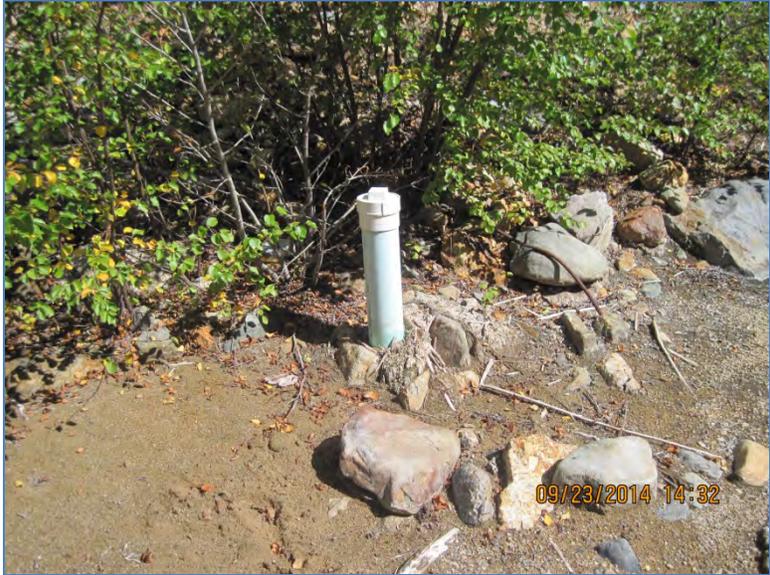
<b>NMED/SWQB          Official Photograph Log          Photo # 6</b>		
Photographer: Erin S. Trujillo	Date: 09/23/2014	Time: 1432 hours
City/County: East of Questa / Taos County		State: New Mexico
Location: CMI Questa Mine, Spring 13 Seepage Interception System Area, Along bank of Red River		
Subject: PVC pipe used for clean out of Spring 13 Seepage Interception System described by Permittee on-site representative.

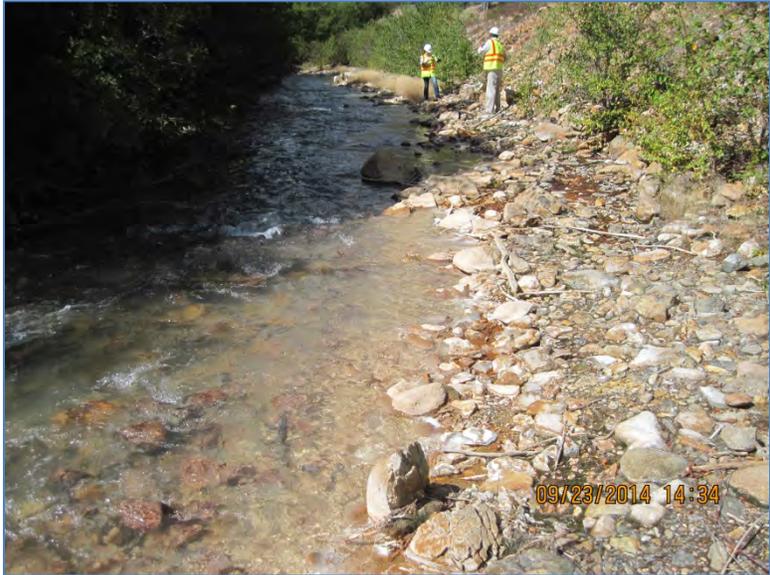
<b>NMED/SWQB          Official Photograph Log          Photo # 7</b>		
Photographer: Erin S. Trujillo	Date: 09/23/2014	Time: 1434 hours
City/County: East of Questa / Taos County		State: New Mexico
Location: CMI Questa Mine, Downstream of Spring 13 Seepage Interception System Area.		
Subject: Looking downstream at Red River

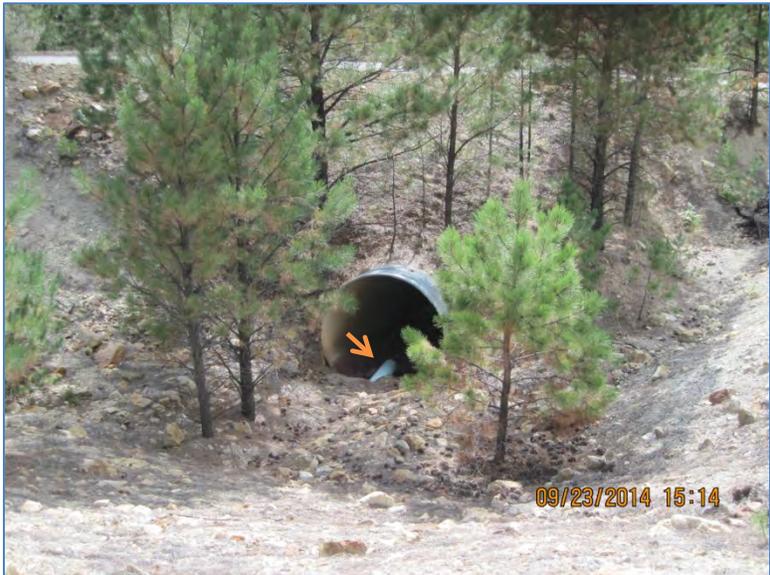
An open pipe was observed at a culvert downgradient of Outfall 004 and associated impoundments (see photo #8). The purpose of the pipe could not be determined and was unknown by Permittee representatives. No discharge from the pipe was observed during the CEI. Inspection of the pipe outlet after a rain event or collection of water in the upgradient impoundments is needed to confirm that there is no mine discharge. The Permittee should cap or remove the pipe.

<b>NMED/SWQB          Official Photograph Log          Photo # 8</b>		
Photographer: Erin S. Trujillo	Date: 09/23/2014	Time: 1514 hours
City/County: East of Questa / Taos County		State: New Mexico
Location: CMI Questa Mine - Downgradient of Monitoring and Measurement Location for Outfall 004		
Subject: Looking south, arrow points to pipe at culvert downgradient of impoundment above Outfall 004. No discharge from pipe was observed during CEI.

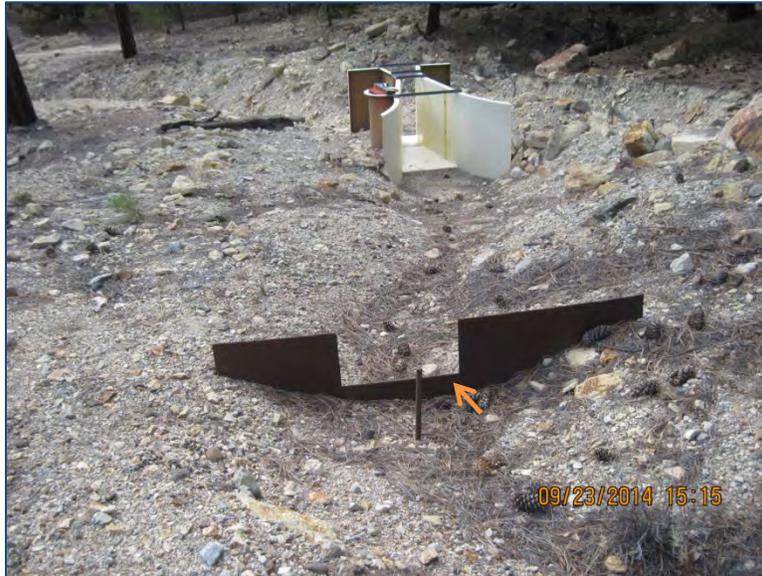
NMED/SWQB  
Official Photograph Log  
Photo # 9

Since there was no discharge at the Outfalls 004 and 005 measurement and monitoring location, it is unknown if the weirs left in place may affect the approach flow into the flumes and possible flow measurements. For example, ISCO Open Channel Flow Measurement Handbook, Sixth Edition, Page 66 states "To assure accurate discharge measurement, the approach flow conditions should be considered" and "large rocks and other debris in the flow may cause problems."

Subject: Looking south-southeast, arrow points to weir in the shallow channel upgradient of flume in background of photo at monitoring and measurement location for Outfall 004.

CMI can contact USEPA Region 6 Permit Section to discuss if a flow measurement type of estimate, instead of weirs,—not subject to accuracy requirements of Part III.C.6 of the permit—would be appropriate at Outfalls 004 and 005.

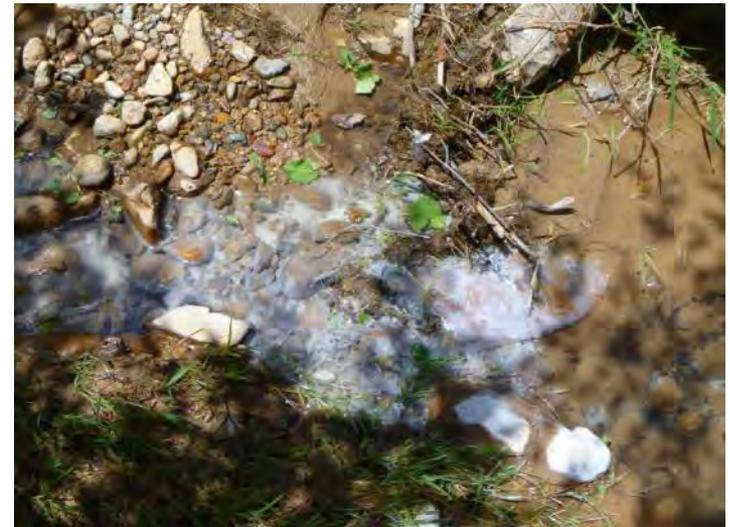
Photo 4. Downstream of Spring 39 – Note milky discharge

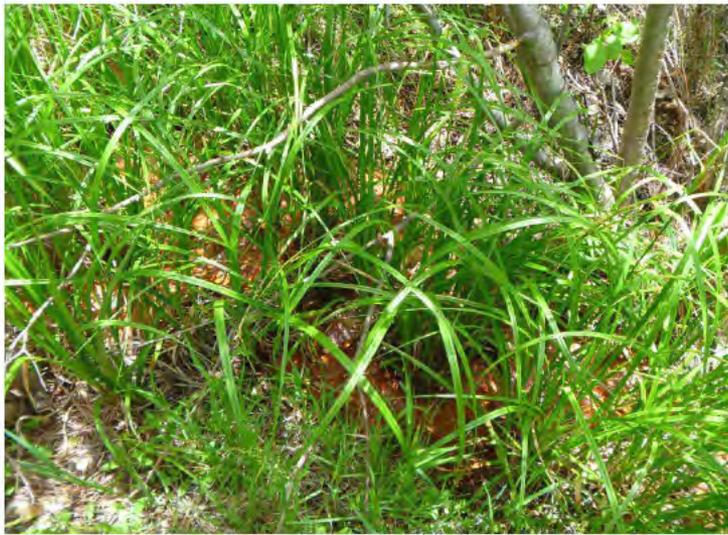
Photo 13. Downstream of Spring 13 – narrow channel with iron staining

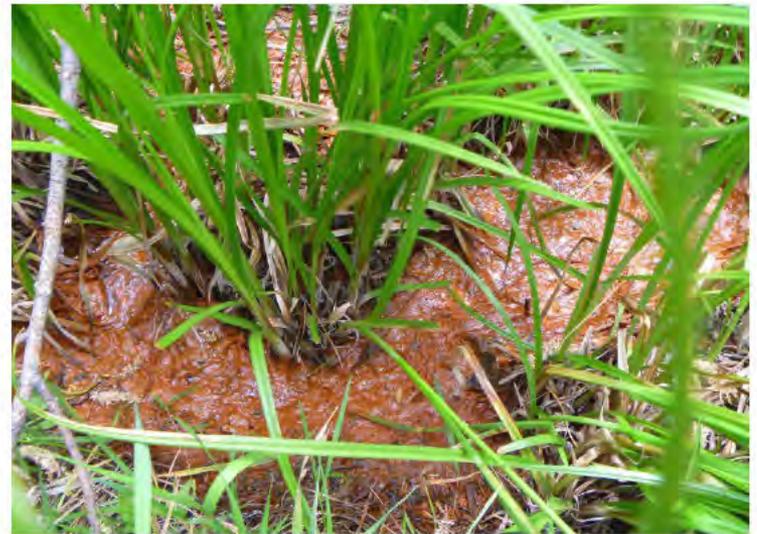
Photo 14. Downstream of Spring 13 – narrow channel with iron staining

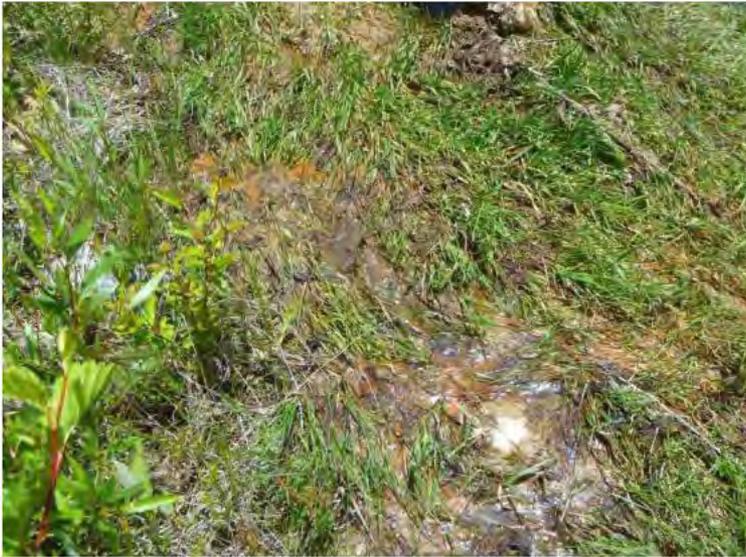
Photo 23. Upstream of Spring 13 – some iron staining on river bank

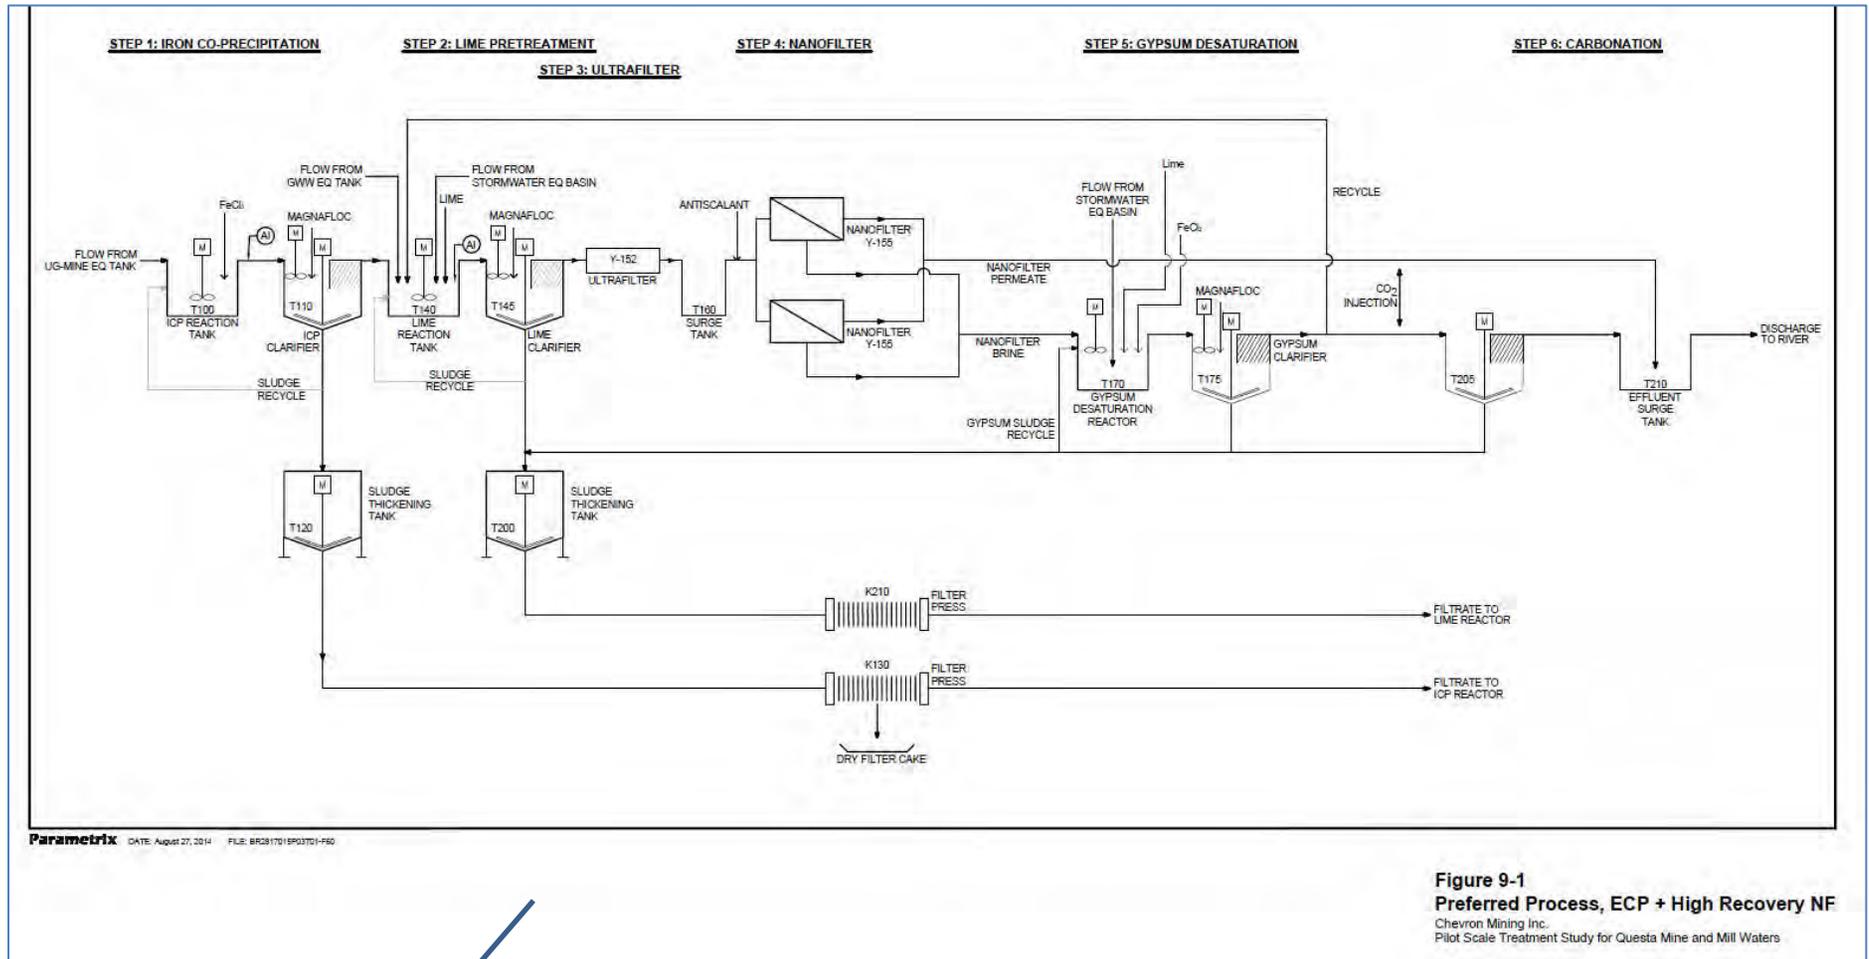
Figure 9-1  
Preferred Process, ECP + High Recovery NF  
Chevron Mining Inc.  
Pilot Scale Treatment Study for Questa Mine and Mill Waters

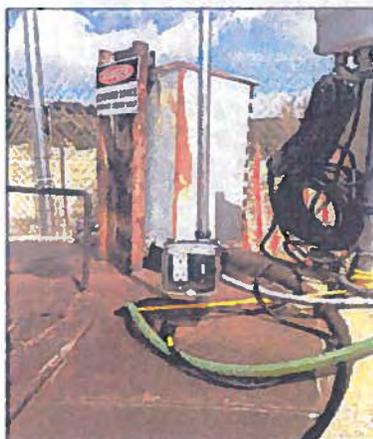
### ***Section 2.3 Power Source***

Outfall 002 is equipped with a submerged pump that is used to bring the sample up from the outfall, which is situated within a confined space. The pump has a cord that is plugged in, which then activates the pump.

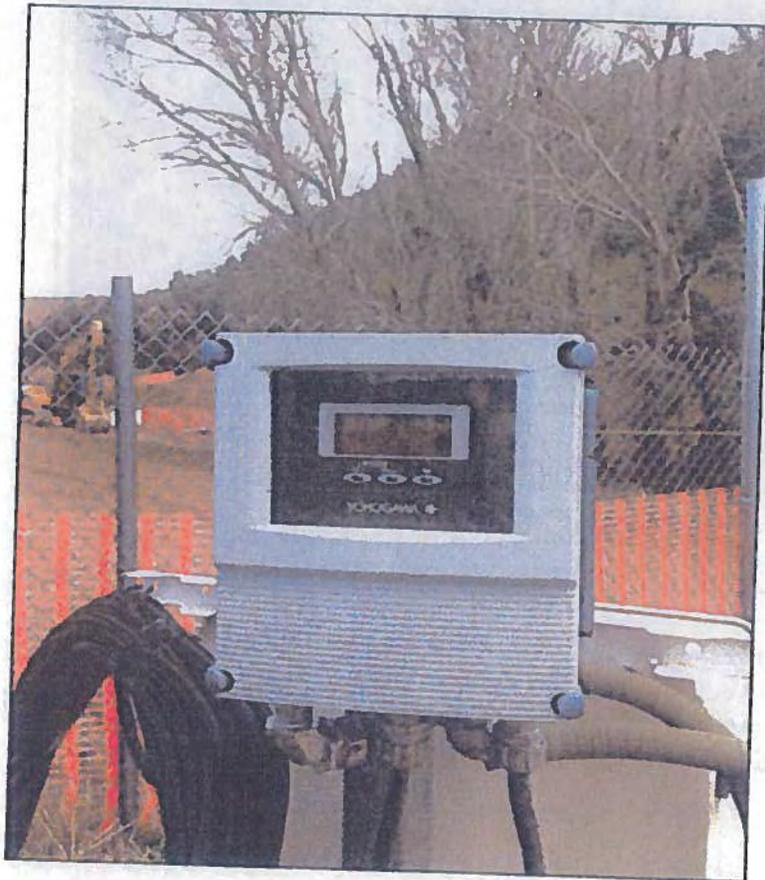
1. Collect the GPM from this meter to determine the volume required. Example: (175GPM x Factor = the volume in Liters) (175 GPM x 16= 2800 ML which is almost 3 liters.)
2. A graduated cylinder is used to measure the exact volume.
3. The same calculation is used each time and factors in the fluctuation of the GPM changing constantly which is taken into account for the calculation.
4. The GPM is taken at the Yokogawa flow display which is pictured below.

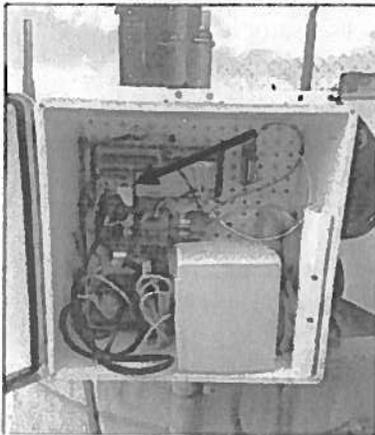
1. Complete and review JSA
2. Before going to location take equipment:
  - laptop
  - down loading cable
  - Outfall 002 keys.
3. Open Control Panel at Outfall 002.
4. Plug downloading cable into designated port.
  - o Refer to picture below.
