Re: Village of Cloudcroft WWTP, Minor, Individual Permit; SIC 4952; NPDES Compliance Evaluation Inspection; NM0023370; March 11, 2014

NPDES Compliance Inspection Report

**Village of Cloudcroft WWTP
NPDES Permit No. NM0023370
Compliance Evaluation Inspection
March 11, 2014**

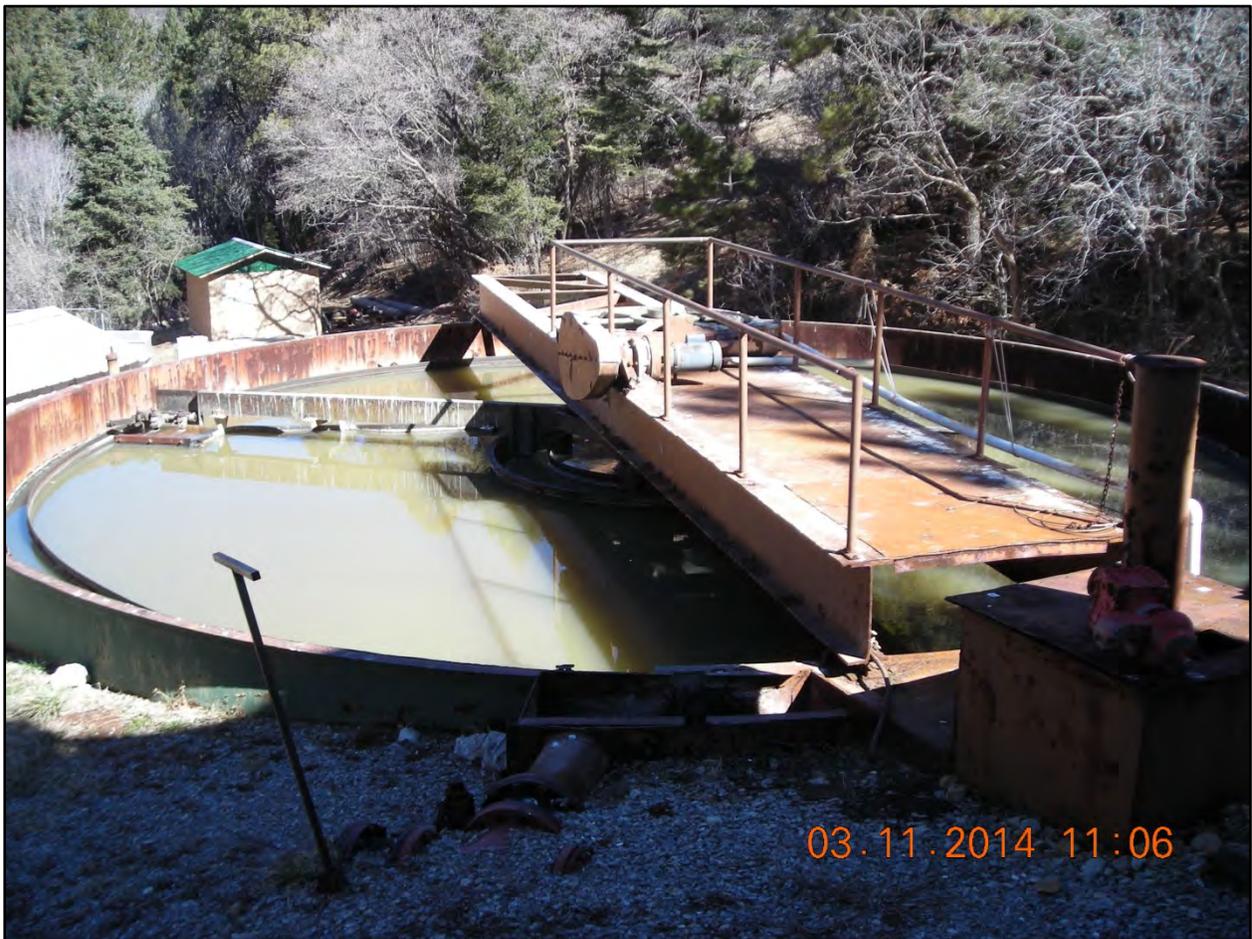
**NMED/SWQB
Official Photograph Log
Photo # 1**

A clarigester, being a modernized Imhoff tank, consists of two tank layers that incorporate a primary clarifier and an anaerobic digester. The collector at the bottom of the first chamber (serving as the primary clarifier) directs the settled materials to the lower chamber (serving as the digester). As digestion occurs, the gas bubbles rise to the surface and the clarigester is designed to keep the solids in the lower chamber. The center scraper located at the bottom of the chamber removes the waste activated solids from the chamber and directs it to the sludge pit. This unit appeared to be operating well at the time of the inspection. Repairs to the influent pipe to this unit had been performed (to avoid allowing infiltration) since the last EPA inspection.

Photographer: Sarah Holcomb	Date: 3-11-2014	Time: 1106 hours
City/County: Cloudcroft, Otero County		
Location: Village of Cloudcroft WWTP		
Subject: The facility's clarigester, which was built in the 1960s. Note the repair to the influent pipe located at the bottom of the photo next to the t-pipe.

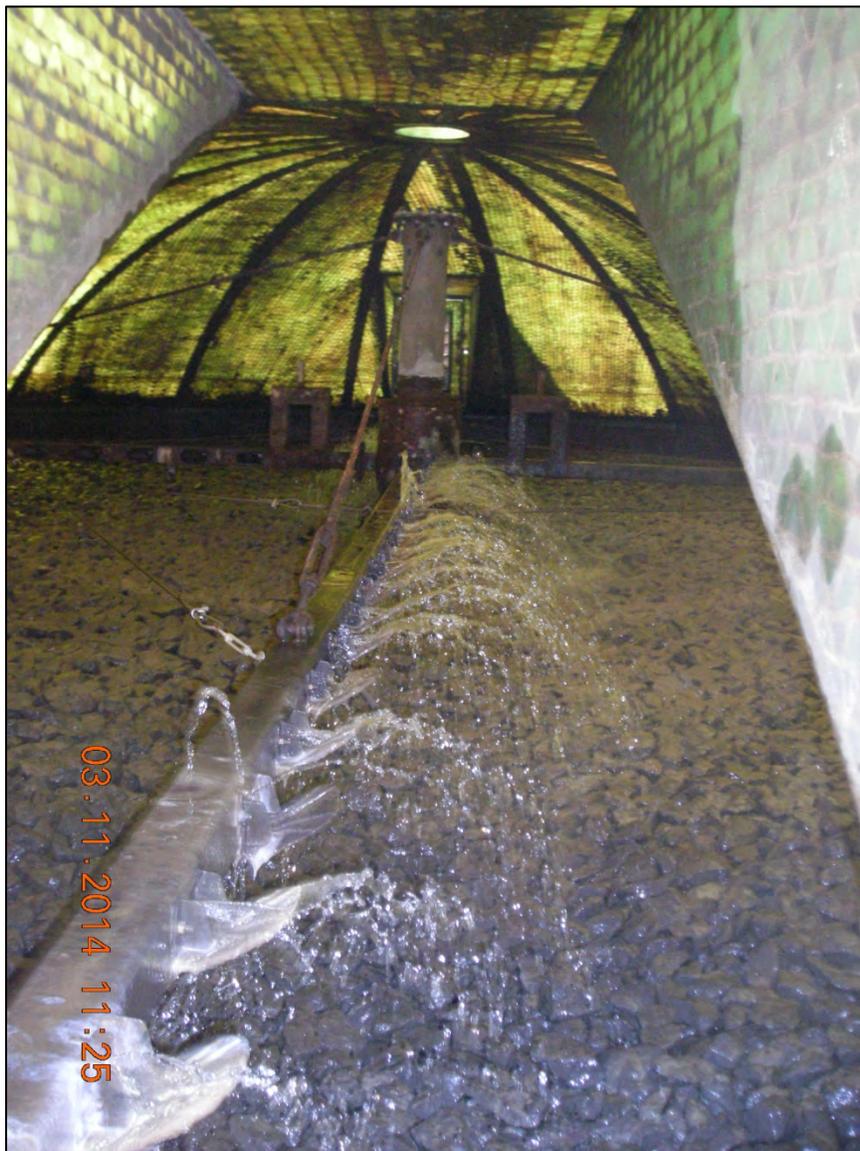
NMED/SWQB
Official Photograph Log
Photo # 2

The trickling filter located at this facility is cylindrical and uses a natural stone media. The zoogical film present on the media appeared to be healthy although there was a slight odor. Only two of the four available distribution arms were being utilized, and there is a passive air circulation system. The facility operator indicated that the wastewater is currently being recirculated through this unit. Increasing the recirculation may aid in decreasing odors from this unit, as well as providing more uniform sloughing of the media, which would also assist the settling process in the secondary clarifier.

Photographer: Sarah Holcomb	Date: 3-11-2014	Time: 1125 hours
City/County: Cloudcroft, Otero County		
Location: Village of Cloudcroft WWTP		
Subject: Interior of the facility's trickling filter. Only two distribution arms were functioning at the time of this inspection.

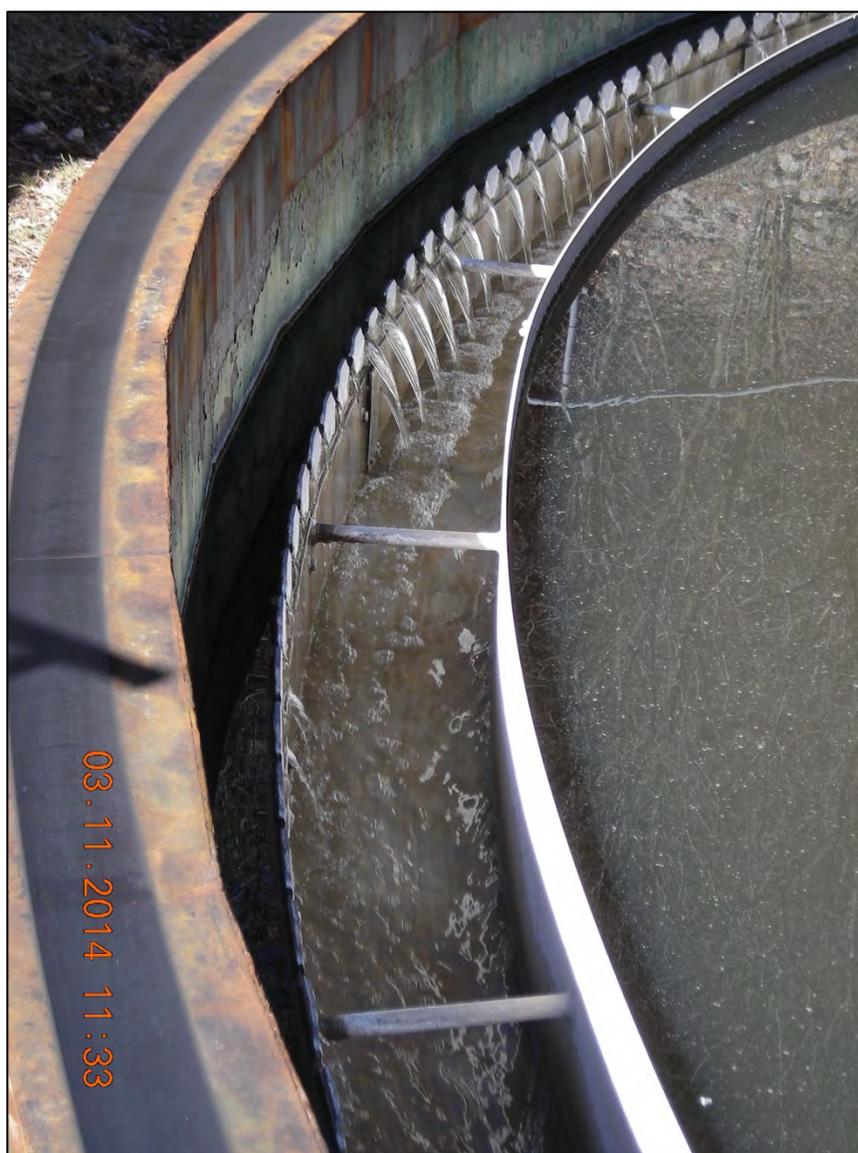
**NMED/SWQB
Official Photograph Log
Photo # 3**

The secondary clarifier was a 9 foot deep unit and at the time of the inspection contained a sludge blanket of approximately 18 inches. Solids were present in the clarifier and did not appear to be settling well. Pin floc or small particulates were floating around the entire unit. The clarifier was also experiencing short circuiting in numerous areas around the clarifier.

Photographer: Sarah Holcomb	Date: 3-11-2014	Time: 1133 hours
City/County: Cloudcroft, Otero County		
Location: Village of Cloudcroft WWTP		
Subject: The facility welded a ring at the edge of the secondary clarifier to prevent further concrete spalling. There was some short circuiting occurring at the time of this inspection.

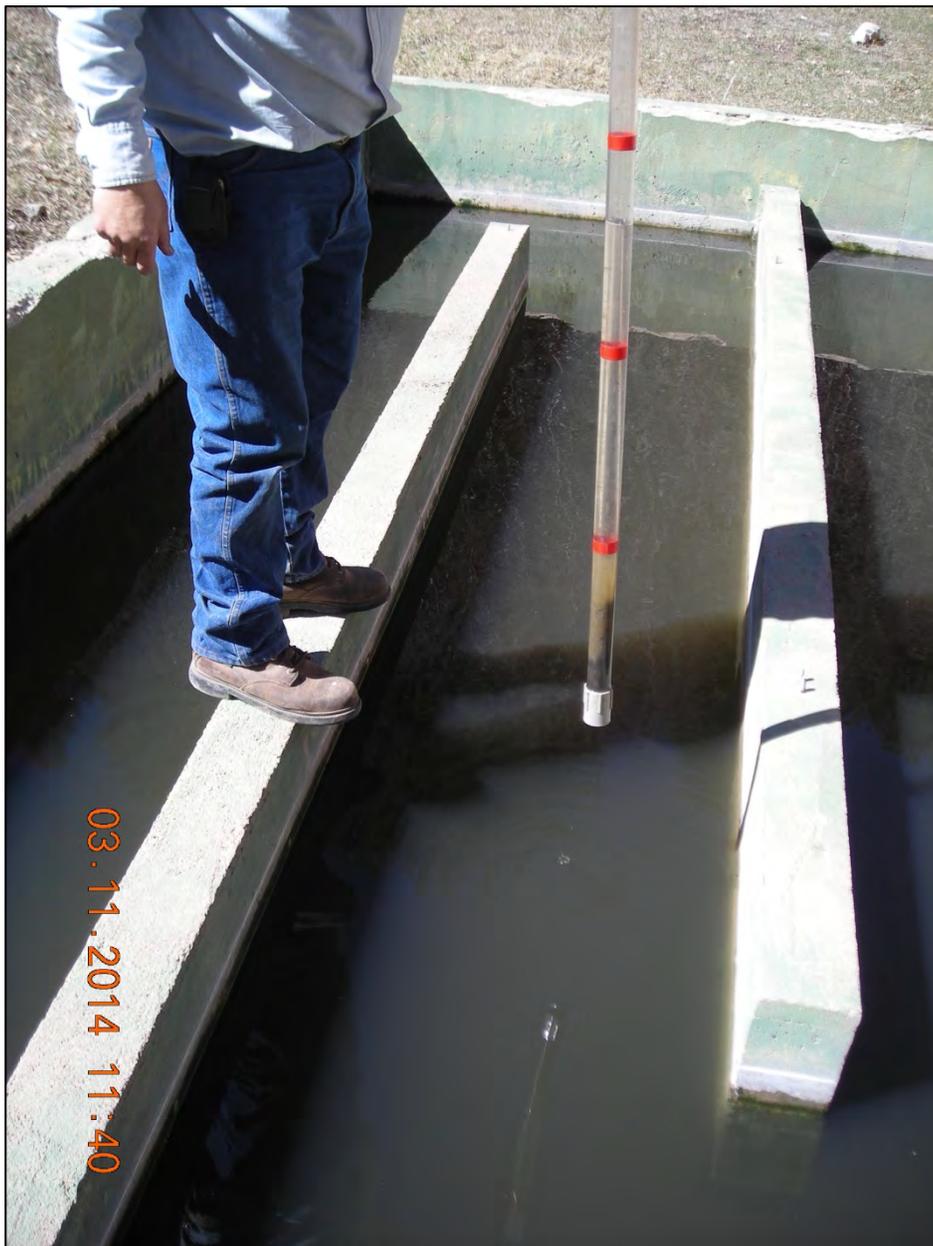
**NMED/SWQB
Official Photograph Log
Photo # 4**

The serpentine chlorine contact chamber contained approximately 10 inches of sludge at the bottom of the chamber. There should not be sludge in this particular unit.

Photographer: Sarah Holcomb	Date: 3-11-2014	Time: 1140 hours
City/County: Cloudcroft, Otero County		
Location: Village of Cloudcroft WWTP		
Subject: There was approximately 10 inches of sludge in the facility's serpentine chlorine contact chamber.

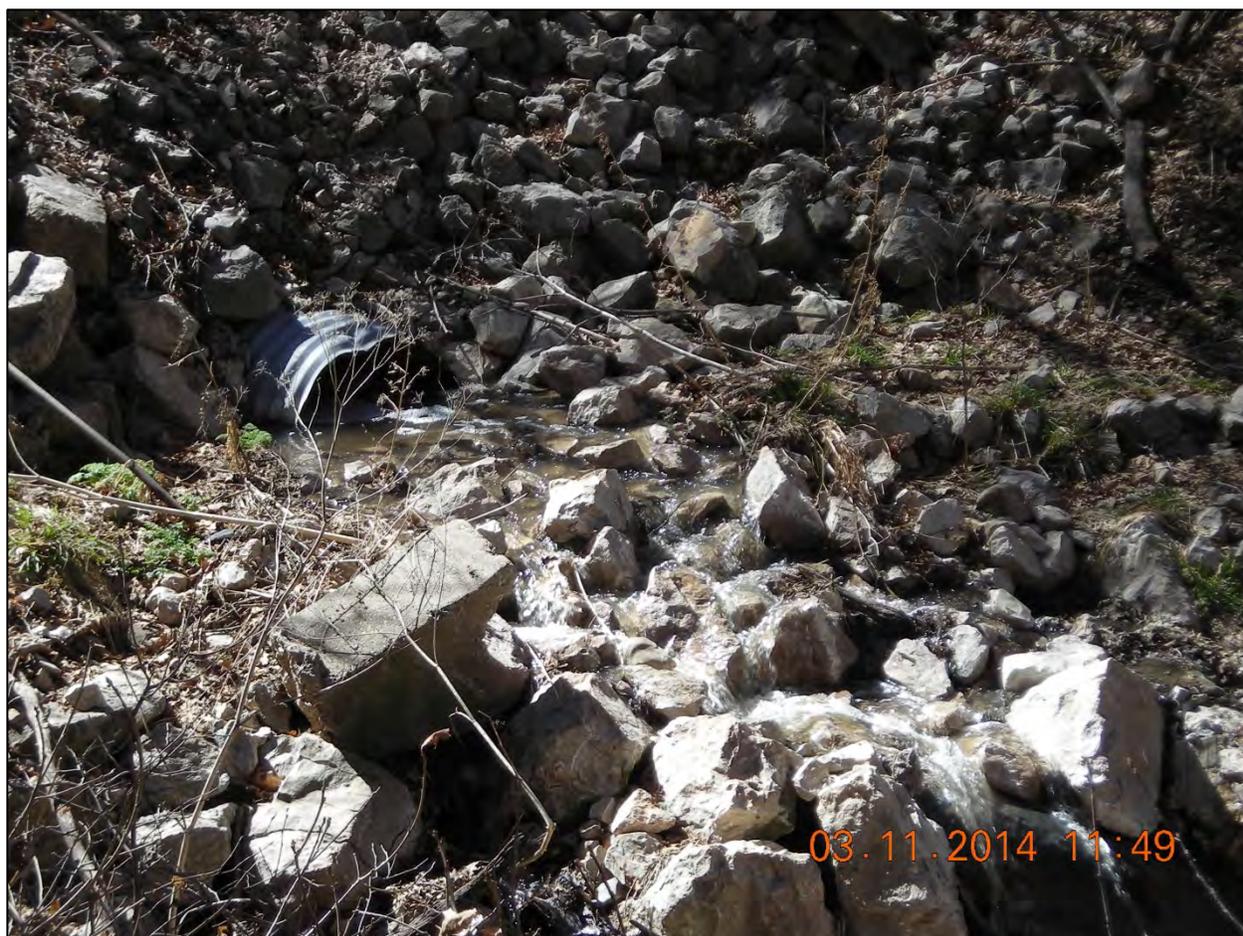
NMED/SWQB
Official Photograph Log
Photo # 5

Photographer: Sarah Holcomb	Date: 3-11-2014	Time: 1149 hours
City/County: Cloudcroft, Otero County		
Location: Village of Cloudcroft WWTP		
Subject: Outfall from the facility into Mexican Canyon.
