**Re: Village of Fort Sumner Wastewater Treatment Plant; Minor Municipal Permit; SIC 4952;
NPDES Compliance Evaluation Inspection; NM0023477; March 17, 2016**

NPDES Compliance Inspection Report

Village of Fort Sumner
Wastewater Treatment Plant
Compliance Evaluation Inspection
NPDES Permit Number NM0023477
17 March 2016
Page 1 of 10

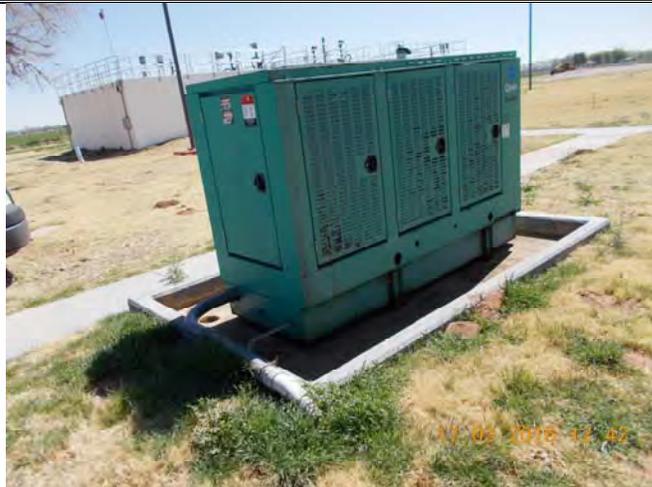
NMED/SWQB
Official Photograph Log
Photo # 3

Subject: Backup diesel generator exercised weekly and ready for use if an electrical failure occurs at the facility.

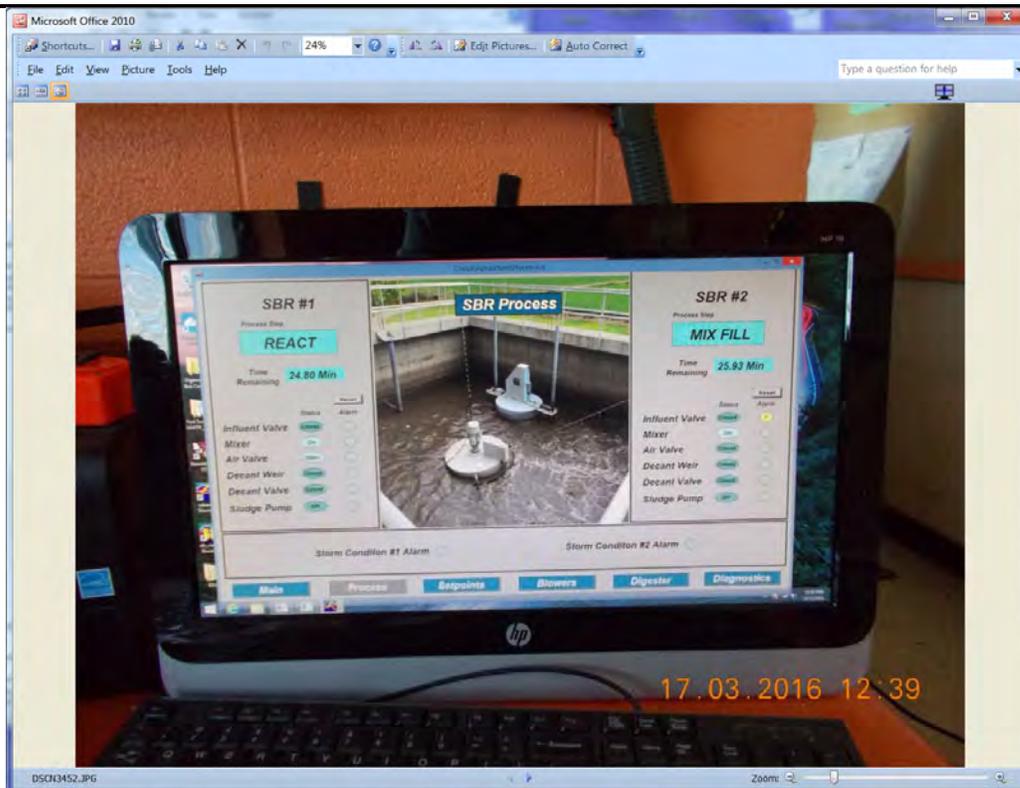
NMED/SWQB
Official Photograph Log
Photo # 4 & 5

Subject: SCADA system monitors plant operations.

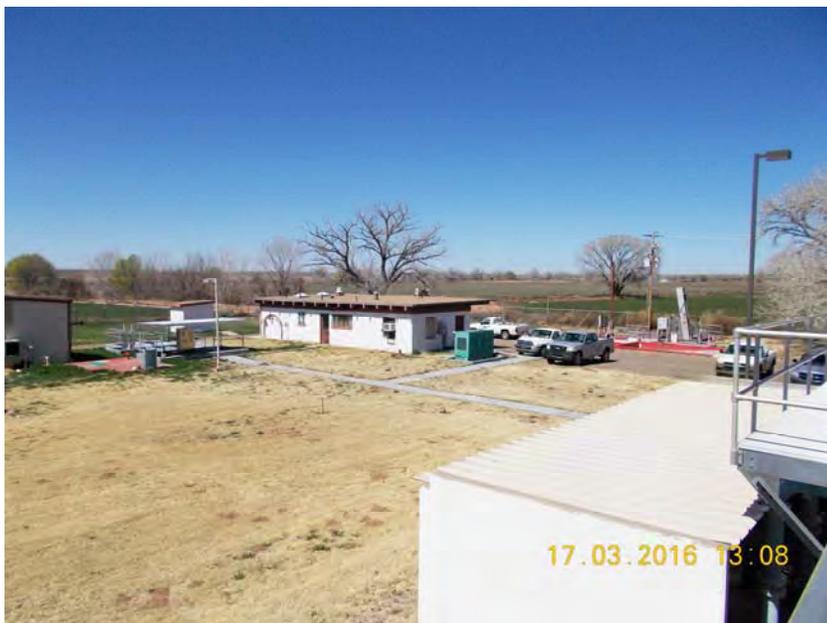
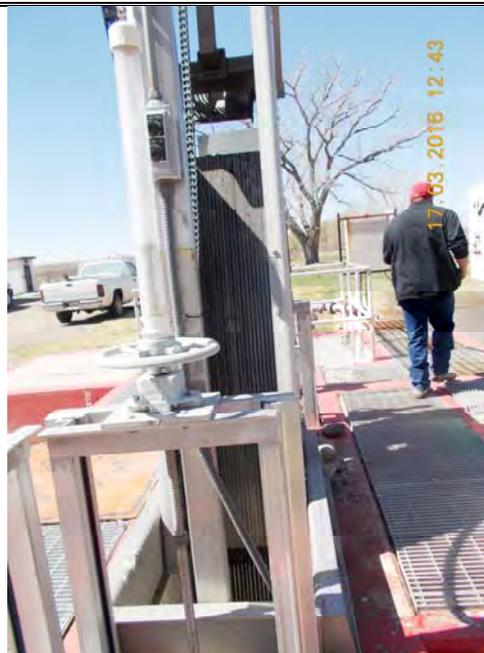
NMED/SWQB
Official Photograph Log
Photo #6

Subject: Headworks to the center right with the mechanical bar screen. To the center is main building and to the left is the UV disinfection and chlorine contact chamber.

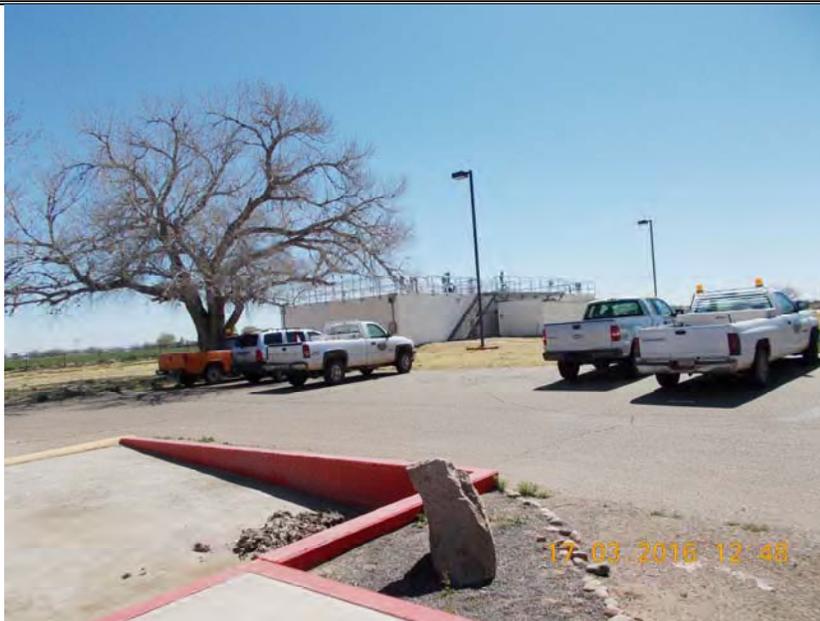
NMED/SWQB
Official Photograph Log
Photo # 7

Subject: Influent overflow area to the lower left of photo and RBCs to the top center.

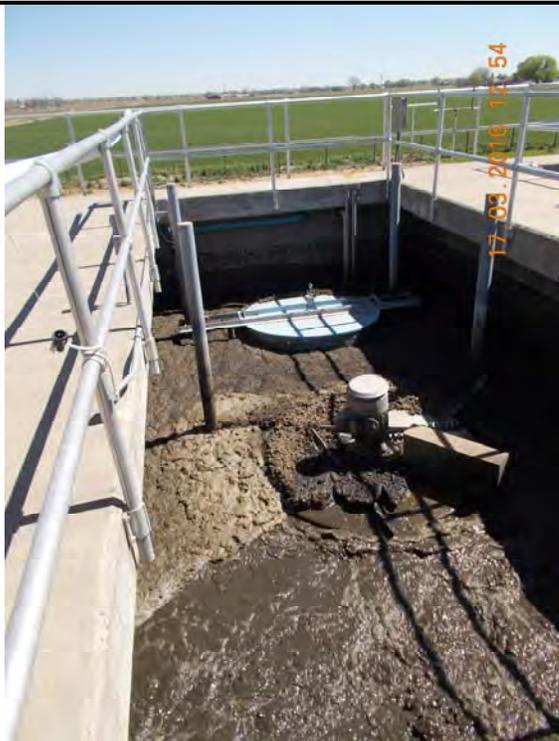
NMED/SWQB
Official Photograph Log
Photo # 8

2. The aging sewer system not being maintained. The collection system is a combination of old clay pipes and old metal pipes. The system has not been upgraded and a failure in the collection system occurred in early 2016. The exact date was not recorded nor provided to inspectors by the permittee, however the system failure was evident as overflows at the headworks of the WWTP which effected the operations in the SBR units.

Subject: RBC aerator in the mixing phase – note the very dark brown/black color of the wastewater being treated as a result of a toxic load from the collection system entering the basin a few weeks earlier.

3. Sanitary sewer overflows have occurred though not reported.
4. The sanitary sewers system has not been surveyed to evaluate the full condition of the pipes throughout. It is advisable that the permittee establish a maintenance schedule and survey schedule to evaluate the condition of the entire system to avoid the type of catastrophic overload that occurred at the WWTP in early 2016.

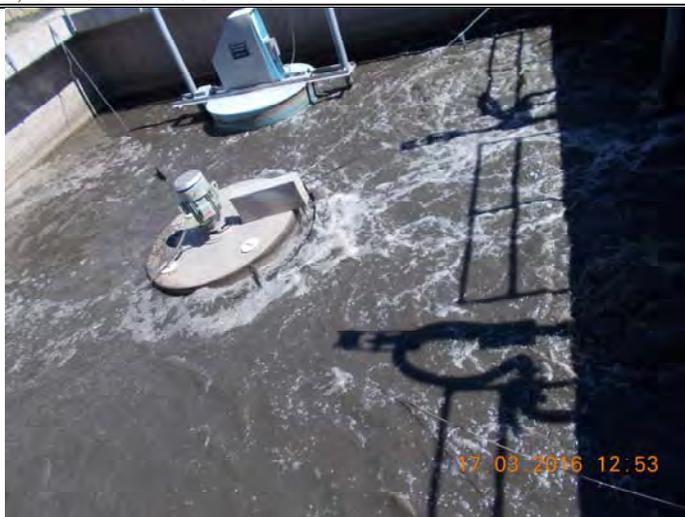
NMED/SWQB
Official Photograph Log
Photo # 9

Subject: SBR in the Aeration phase. Again, not the blackish color of the basin water.

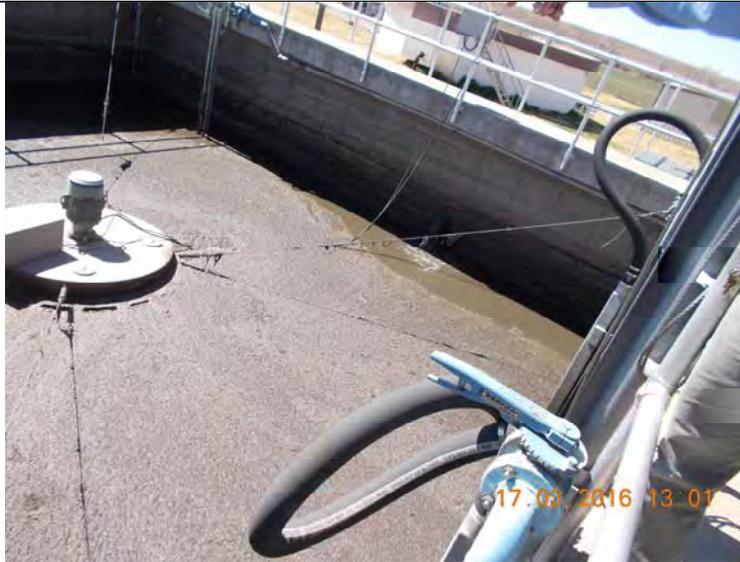
NMED/SWQB
Official Photograph Log
Photo # 10

Subject: SBR in settling phase.

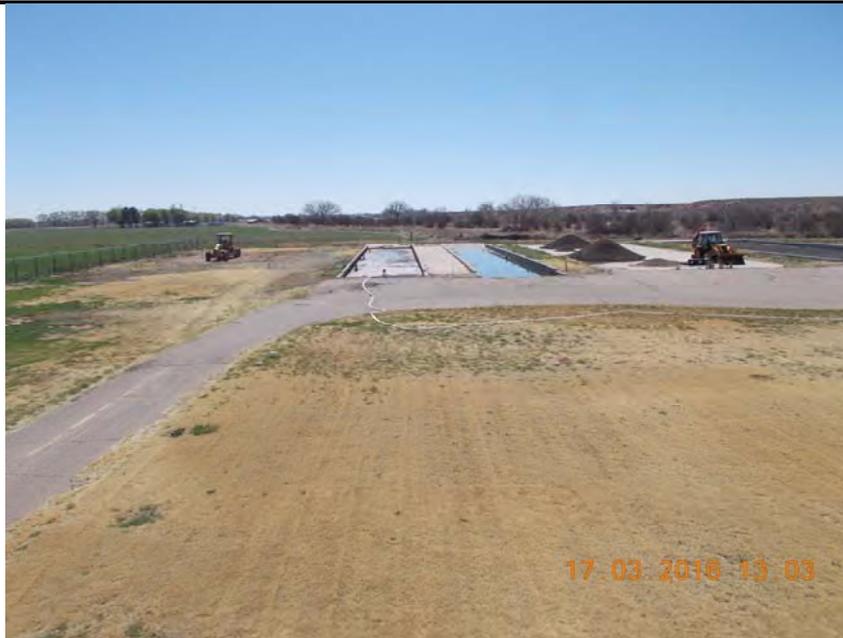
NMED/SWQB
Official Photograph Log
Photo # 11

Dried sludge is moved to another cement pad, windrowed and allowed to sit on site. Previously sludge was taken to the De Baca County Landfill for final disposal. According to operators, solids have not been tested nor transported to the landfill for more than 5 years. Operators and town administrators are exploring alternative land application sites for final disposal.

Subject: The cement lined sludge drying beds are maintained, however the sludge piles have been stored on site for more than 5 years. Note the white hose on the ground and filling the bed on the left – The solids being wasted are from the EQ basin, otherwise known as an old Schreiber treatment system, left over from the past WWTP.

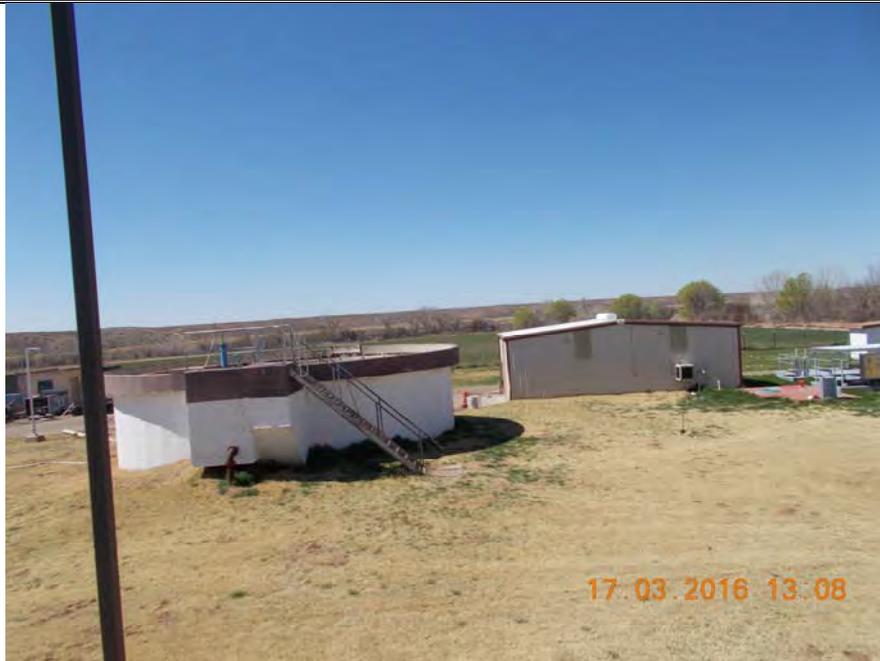
NMED/SWQB
Official Photograph Log
Photo #12

Subject: The EQ basin, otherwise known as an old Schreiber treatment system, left over from the past WWTP, follows the SBRs and is before the UV disinfection system.

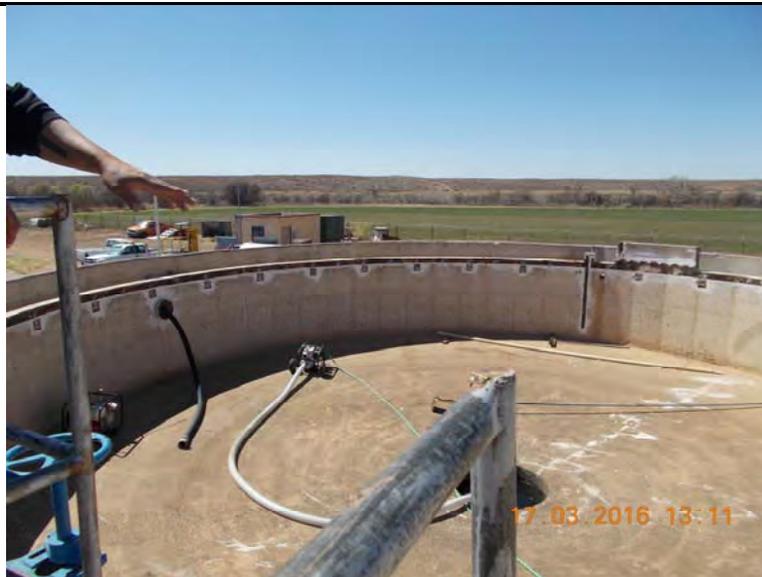
NMED/SWQB
Official Photograph Log
Photo # 13

Solids are also wasted from the old Schreiber system directly to the sludge drying beds. A sump pump with hose attached is used to move the wasted solids (See attached photo).

Subject: A closer view, of the EQ basin, otherwise known as an old Schreiber treatment system, left over from the past WWTP, follows the SBRs and is before the UV disinfection system. The sump pump and white hose are being used to waste solids.

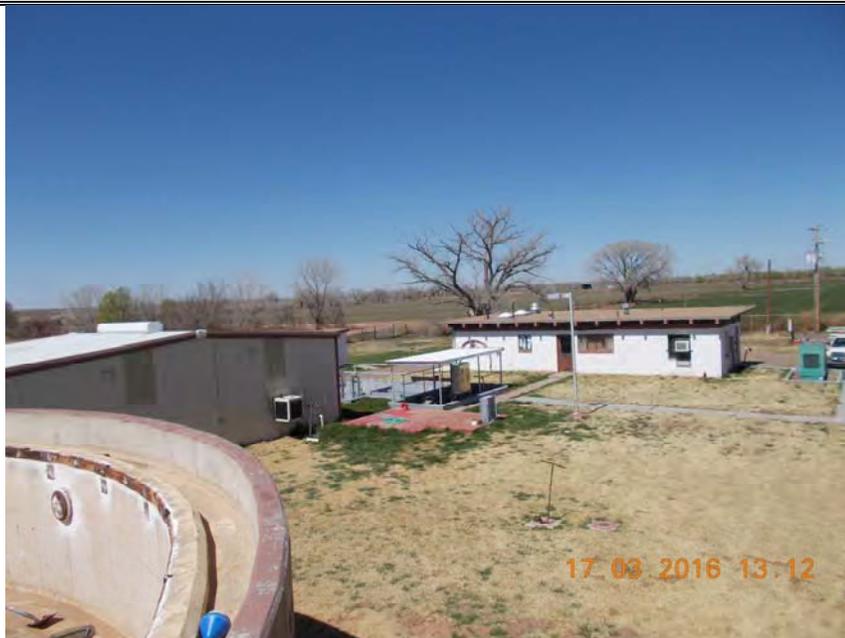
NMED/SWQB
Official Photograph Log
Photo # 14

Subject: The UV system as seen from the EQ basin.

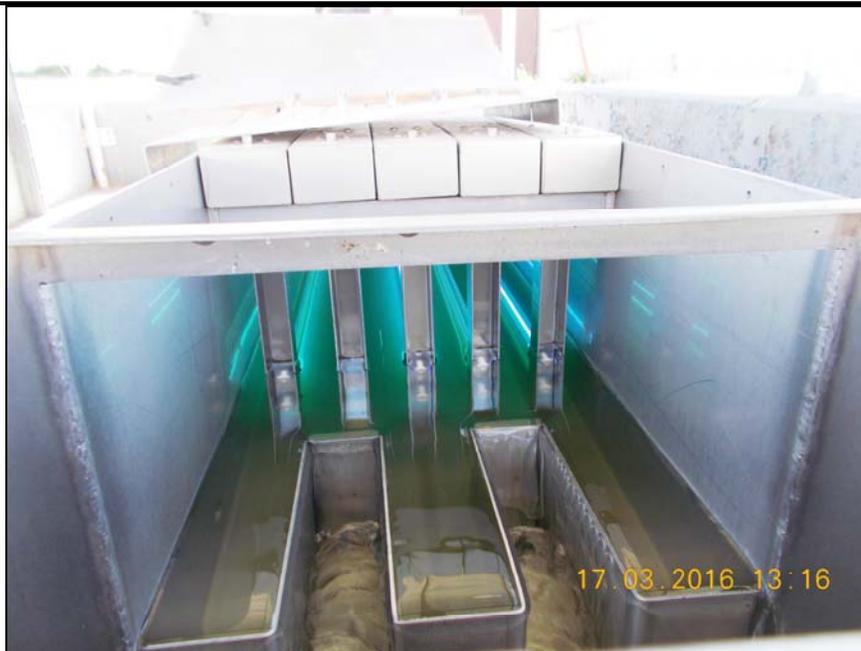
NMED/SWQB
Official Photograph Log
Photo # 15

2. UV lights appeared to be too dim and there was no record of maintenance and/or replacement of the bulbs. There was no apparent buildup of algae in the UV chamber, nor on the bulbs.

Subject: The UV lights, appear to be dim and the water somewhat cloudy.

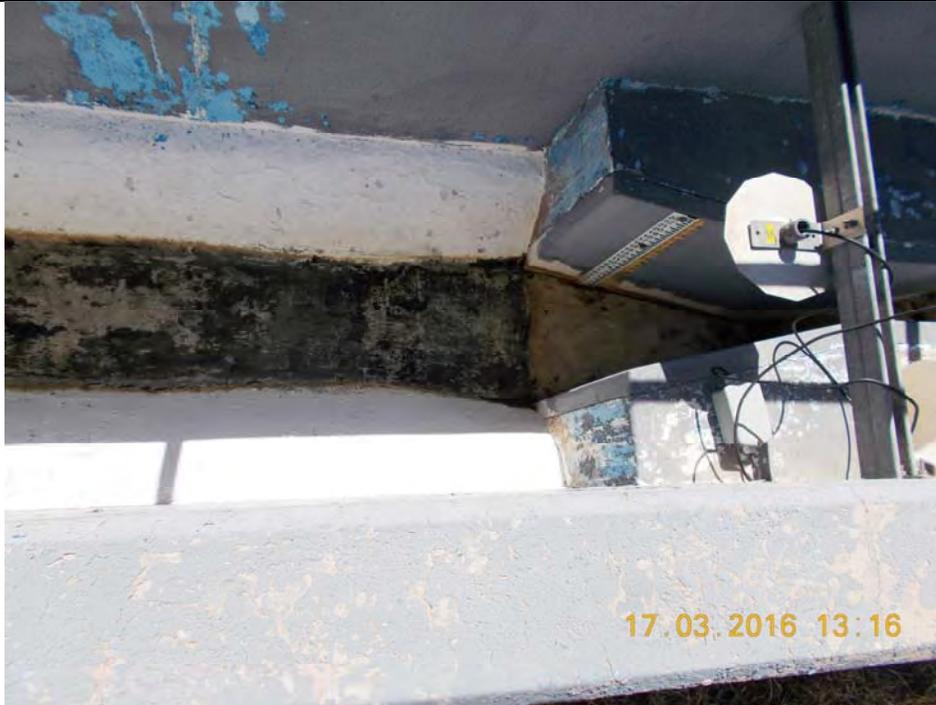
NMED/SWQB
Official Photograph Log
Photo # 16

Subject: Effluent Parshall Flume with staff gauge and mechanical flow meter.

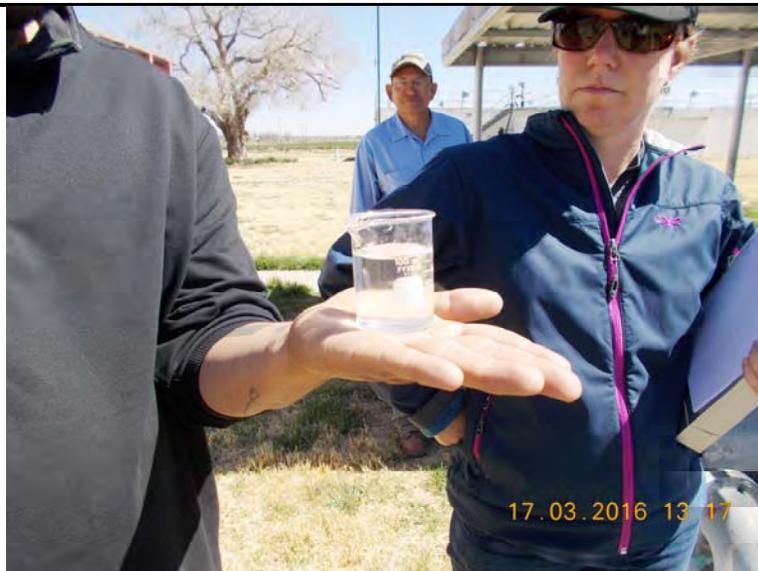
NMED/SWQB
Official Photograph Log
Photo # 17

Subject: Though effluent appeared cloudy in the UV channel, it was fairly clear in this view.

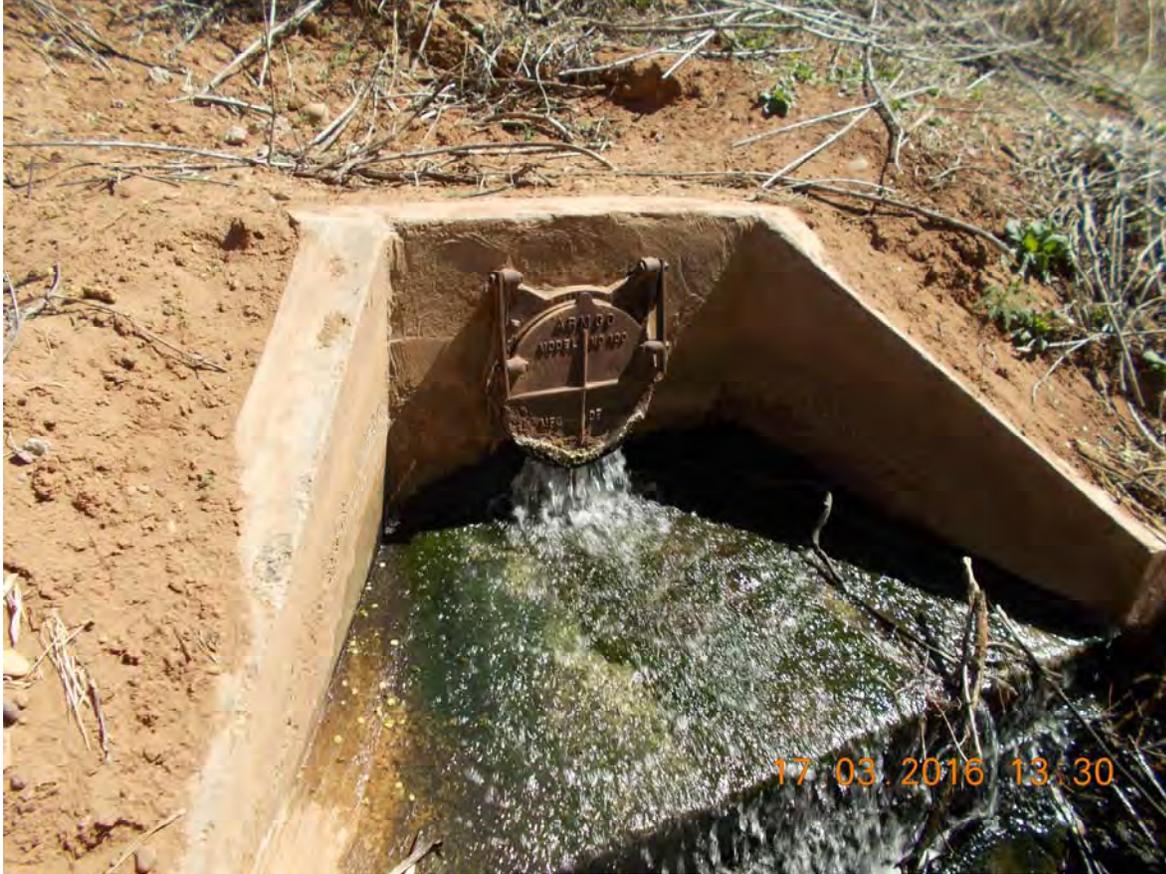
Subject: Outfall pipe to the Rio Grande.
