Re: Town of Taos Waste Water Treatment Plant; Major; Municipal; SIC 4952; NPDES Compliance Evaluation Inspection; NPDES Permit NM0024066; April 10, 2014

NPDES Compliance Inspection Report

Town of Taos Wastewater Treatment Plant
Compliance Evaluation Inspection
NPDES Permit Number NM0024066
April 10, 2014
Page 1 of 7

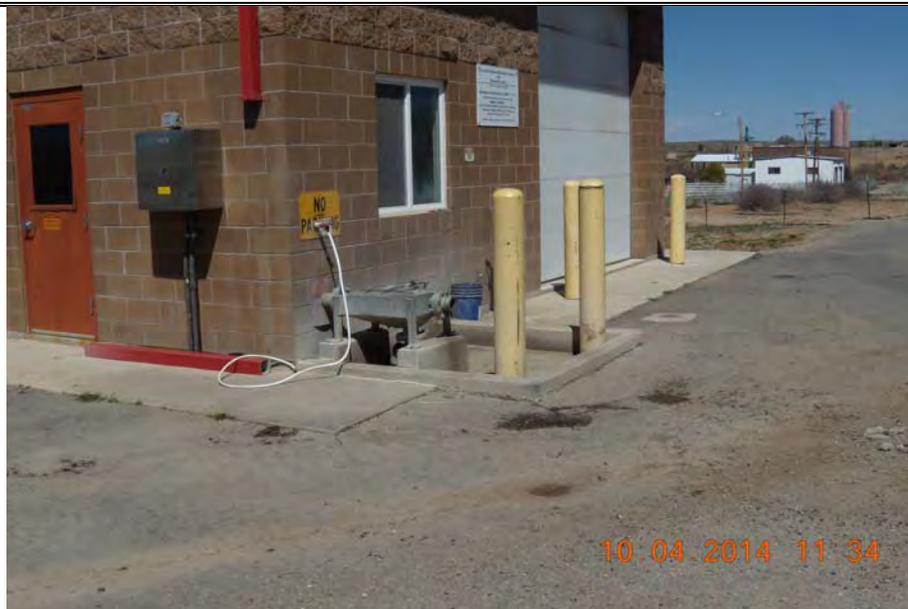
Subject: Septage Receiving Station. The area is not bermed to contain run off. A log in records all haulers who use the station.

2. Internal overflow from basins – failure of power back up system to operate properly and to send a call out notification.
3. Septage Receiving Station: area is not graded to prevent run off in the event of an accidental spill. Containment berms should be installed around this location and grading should be considered to prevent track out onto the public road.

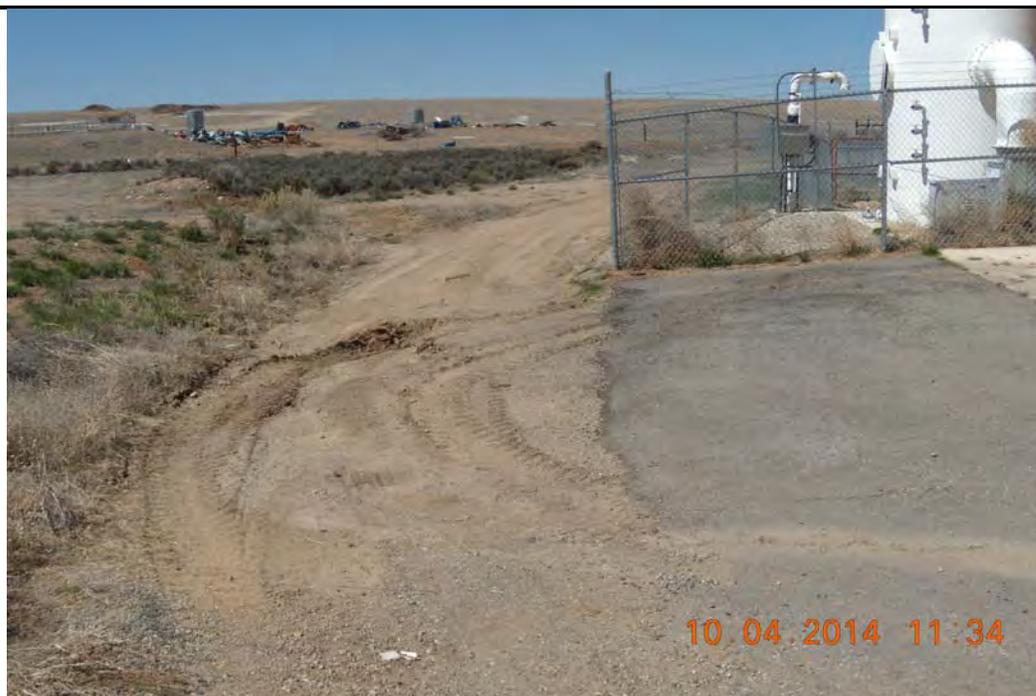
NMED/SWQB
Official Photograph Log
Photo # 2

Subject: Septage Receiving Station. The area is not bermed to contain run off.

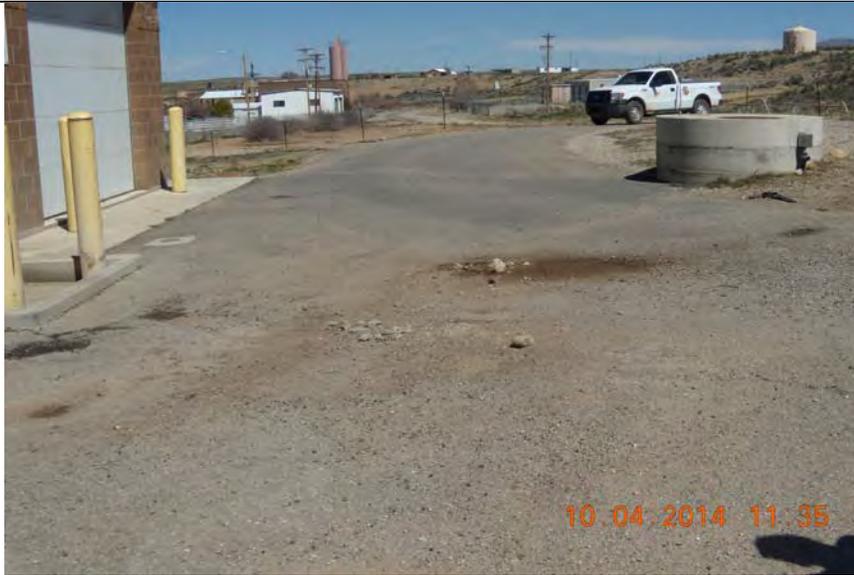
NMED/SWQB
Official Photograph Log
Photo #3

Subject: Septage Receiving Station. The area is not bermed to contain run off.

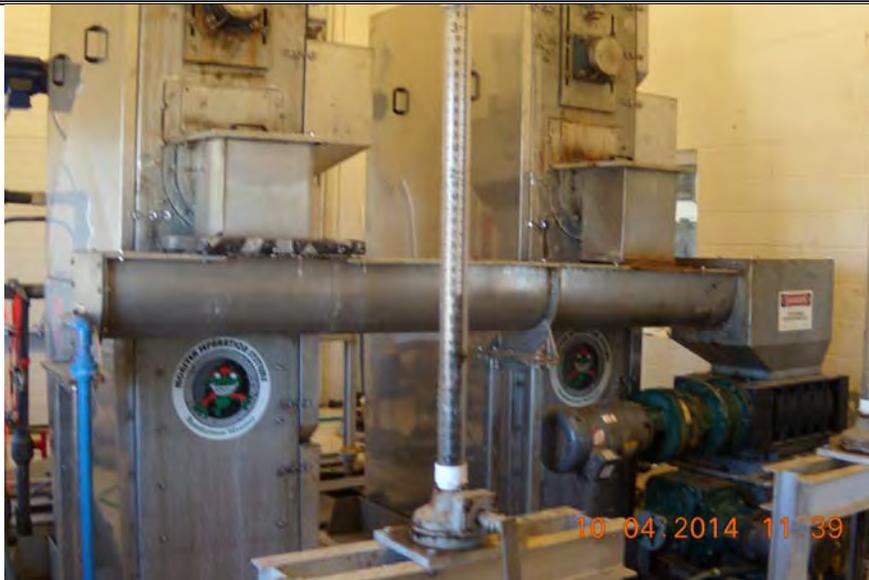
NMED/SWQB
Official Photograph Log
Photo #4

Subject: Headworks – parallel solids and grit removal channels. Both channels are mechanical without a manual back up. As a design, this could be problematic if there were a power failure and the generators failed to start.

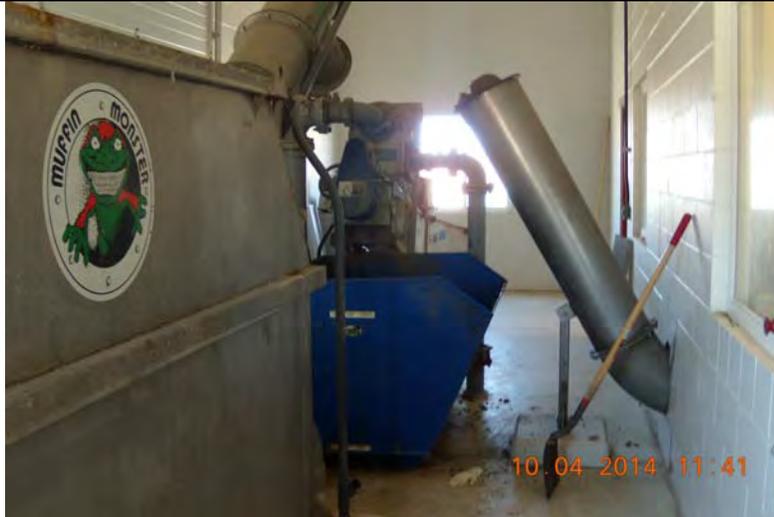
NMED/SWQB
Official Photograph Log
Photo # 5

Subject: Solids removal at the headworks to a dumpster. The solids are sent to a landfill after passing the paint filter test for liquid content.

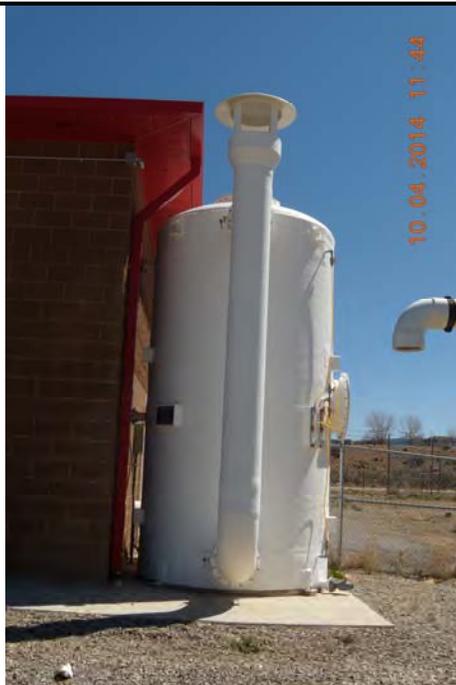
NMED/SWQB
Official Photograph Log
Photo #6

Subject: Influent biological air scrubber helps reduce odors. Residential development has been built up around the WWTP since it was built several decades ago.

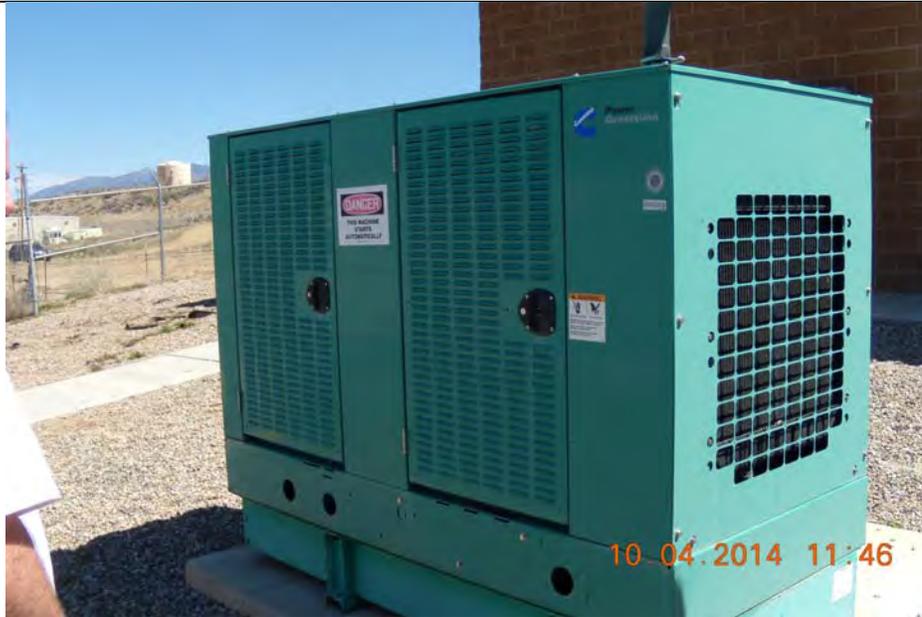
NMED/SWQB
Official Photograph Log
Photo # 7

Subject: Backup generator for the headworks – one of two backups for the treatment plant. The generator is exercised weekly.

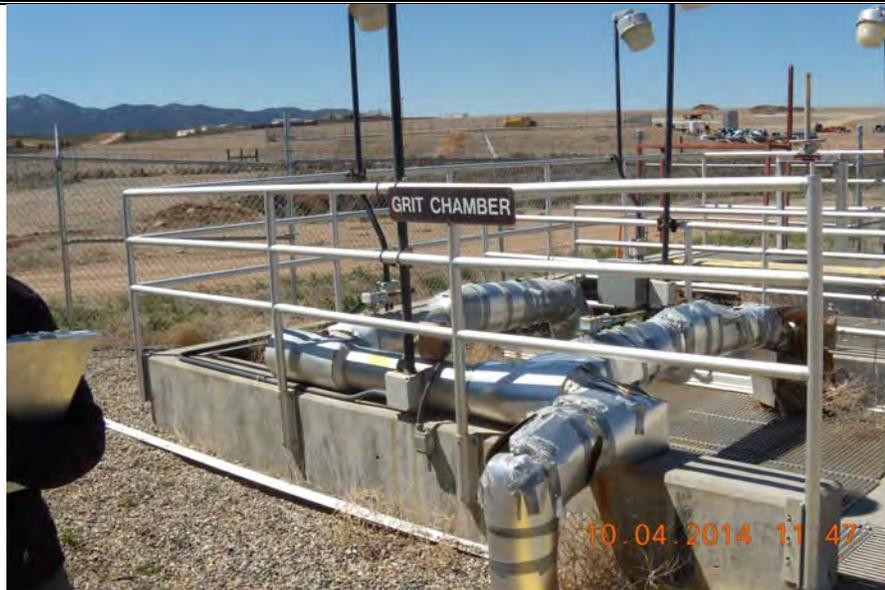
NMED/SWQB
Official Photograph Log
Photo # 8

5. ALL NEEDED TREATMENT UNITS IN SERVICE. Noted is the discontinued use of blowers in the aerated grit chamber.

Subject: The aerated grit removal system is part of the old treatment system. The chambers are still in place but the blowers that provide air for grit removal are out of service. According to facility operators, the new headworks are more effective at grit removal than the previous system and the aerators are no longer necessary for this chamber.

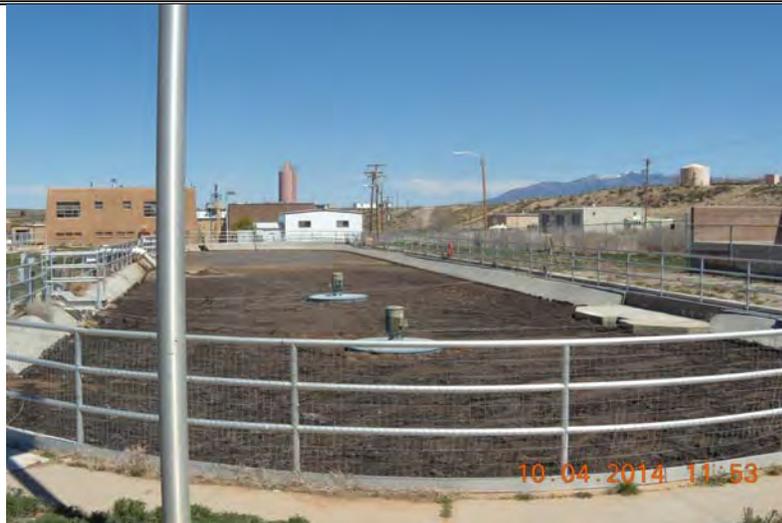
NMED/SWQB
Official Photograph Log
Photo # 9

Subject: West Aeration Basin is now set up with an aerobic and anaerobic section. However the plumbing of the basin is not designed to move the same water through both phases, instead the two sides are mixed together as the water is sent to the Membrane Bio Reactor treatment phase. It is possible that lower levels of Total Nitrogen could be achieved all the wastewater was sent through both phases.

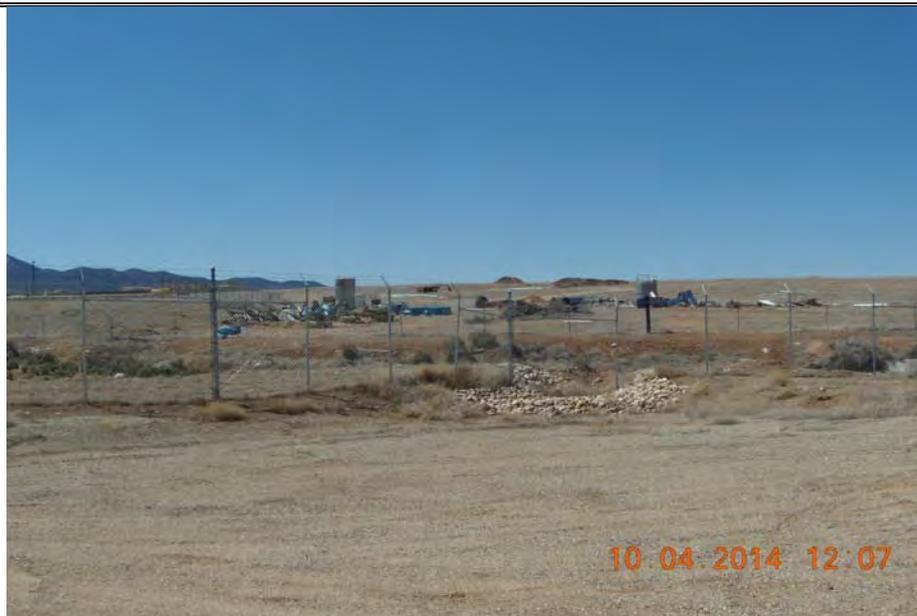
NMED/SWQB
Official Photograph Log
Photo # 10

Subject: In the distance of this photo is the composting location. When the new WWTP was built the intention was to compost 100% of the solids produced at the facility. This effort has been abandoned in part due to citizen complaints about odors. The solids are now sent to the Rio Ranch Landfill, as was done in the past.

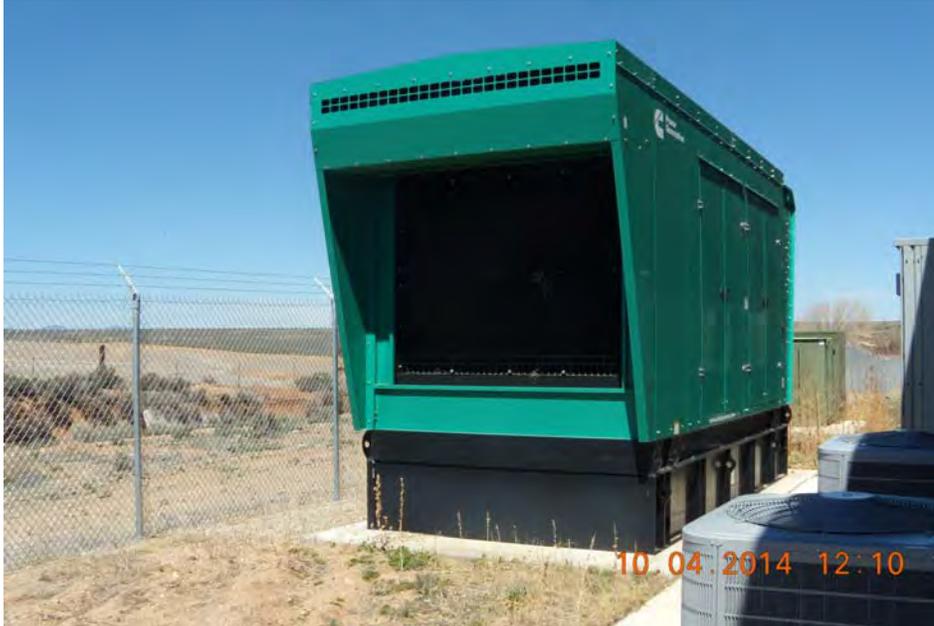
NMED/SWQB
Official Photograph Log
Photo # 11

Subject: Second Back Up Generator for the Membrane Bio Reactor (MBR) portion of the treatment works. This is exercised weekly.

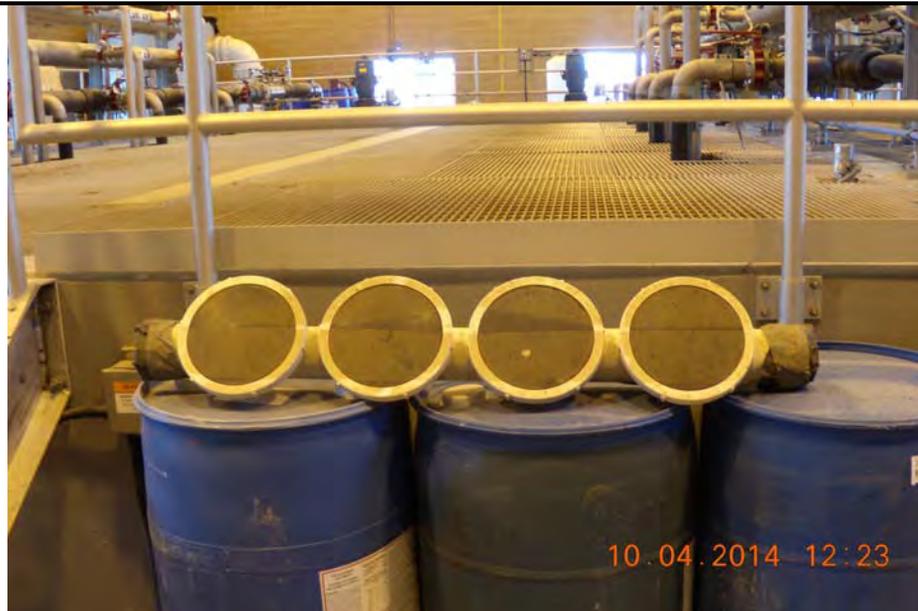
NMED/SWQB
Official Photograph Log
Photo # 12

Subject: Fine bubble diffusers for the MBR.

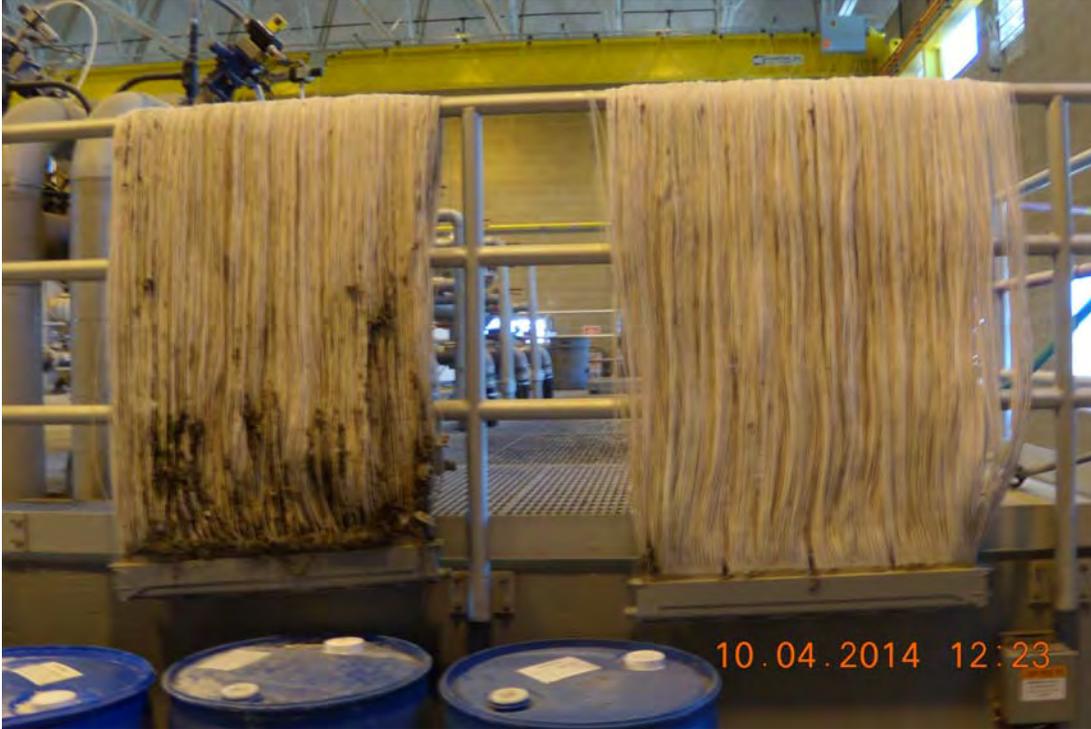
NMED/SWQB
Official Photograph Log
Photo # 13

Subject: Membranes for the MBR system.

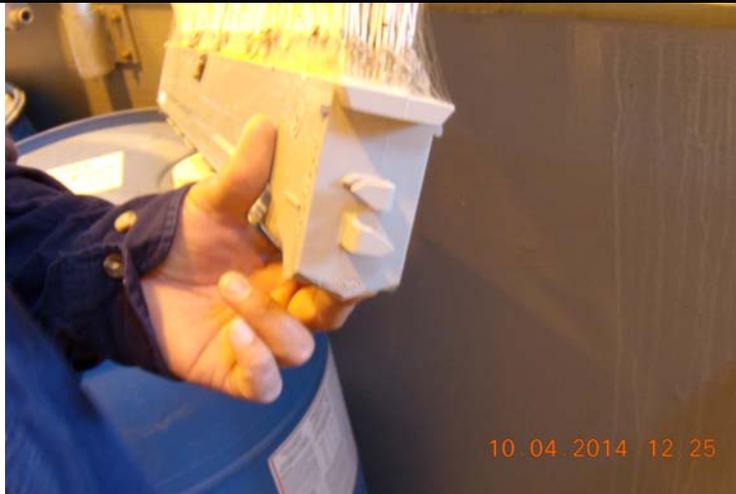
NMED/SWQB
Official Photograph Log
Photo # 14

Subject: Several of the Membrane units have failed because of broken clamps.

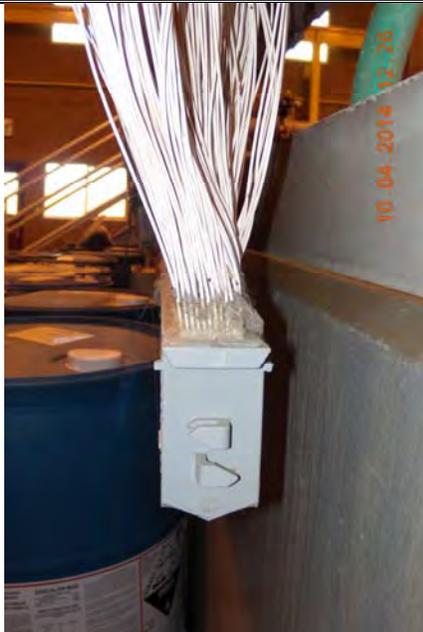
NMED/SWQB
Official Photograph Log
Photo # 15

Subject: Several of the Membrane units have failed because of broken clamps.

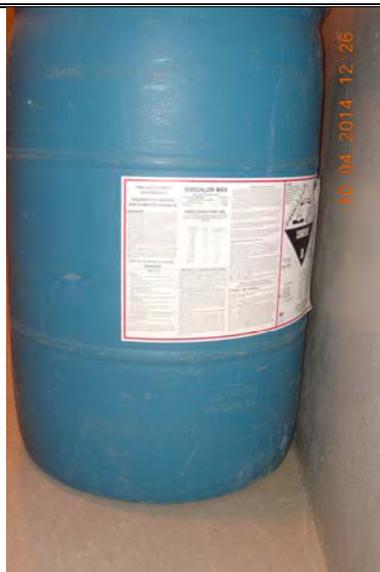
NMED/SWQB
Official Photograph Log
Photo # 16

Subject: Chemicals (Sodium Hypochlorite) stored on site. There was no evidence of spillage at the time of the inspection. Though storage drums should be kept in a bermed and contained area.

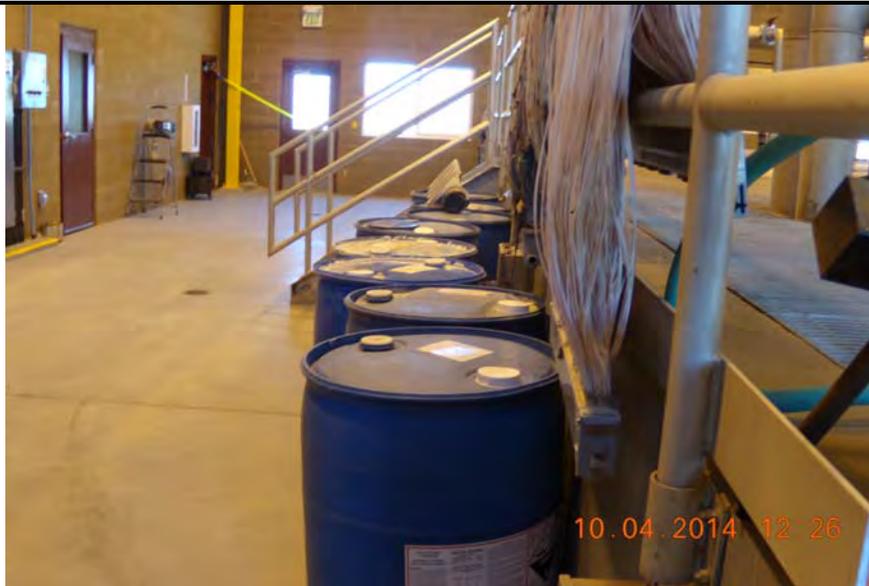
NMED/SWQB
Official Photograph Log
Photo # 17

Subject: Chemicals (Sodium Hypochlorite) stored on site. There was no evidence of spillage at the time of the inspection. Though storage drums should be kept in a bermed and contained area.

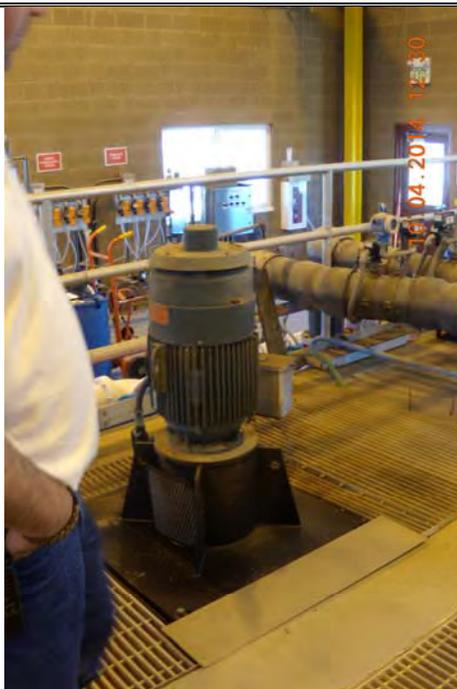
NMED/SWQB
Official Photograph Log
Photo # 18

Subject: MBR Mixer

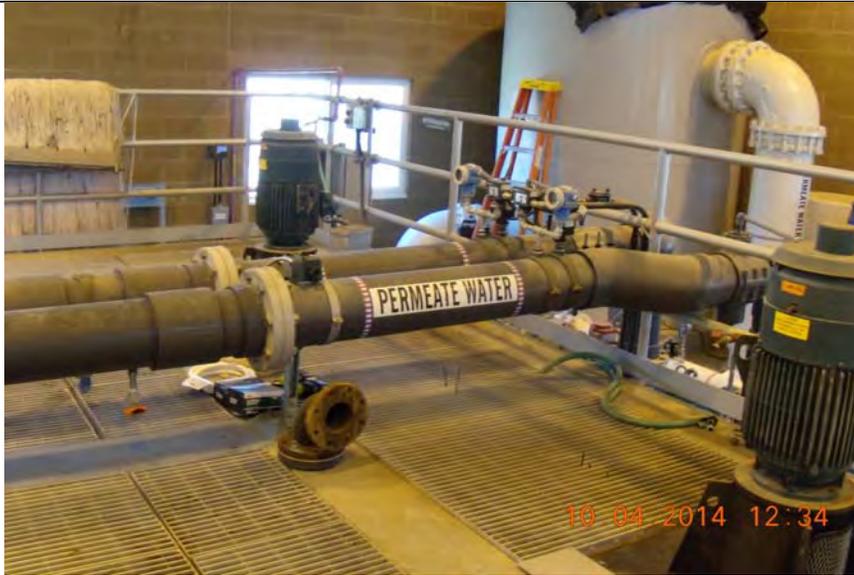
NMED/SWQB
Official Photograph Log
Photo # 19

Subject: Permeate Water – part of the membrane backwash cleaning system. Treated water sent

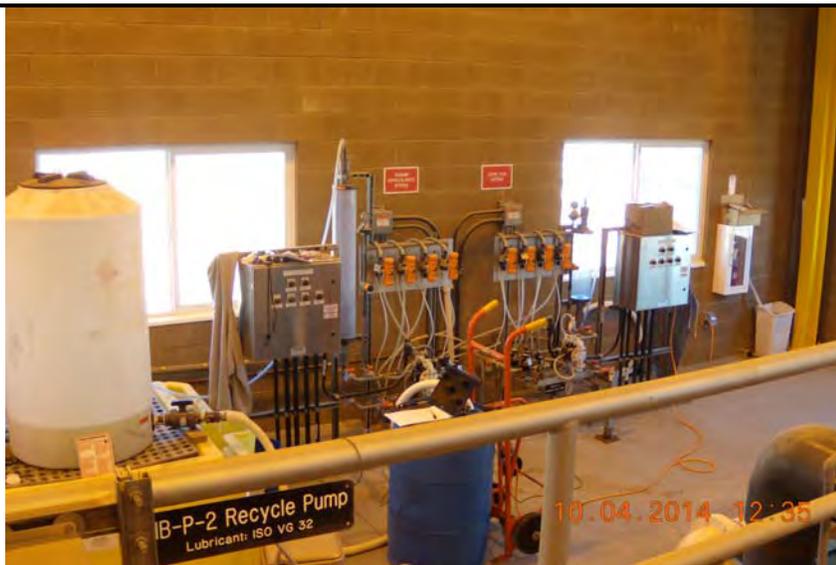
NMED/SWQB
Official Photograph Log
Photo # 20

Subject: Sodium Hypochlorite and Citric Acid dosing system for MBR

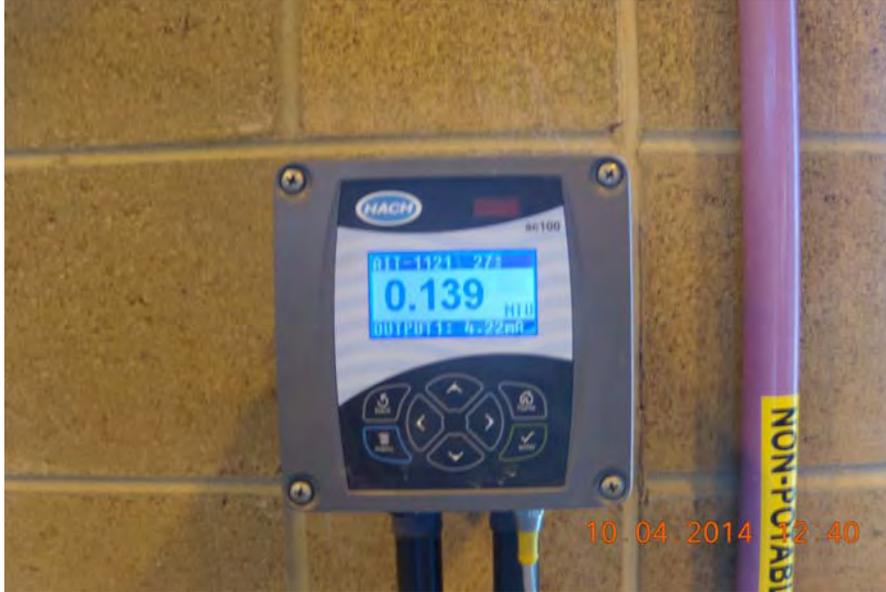
NMED/SWQB
Official Photograph Log
Photo # 21

Subject: Output Turbidity meter measured in NTUs.

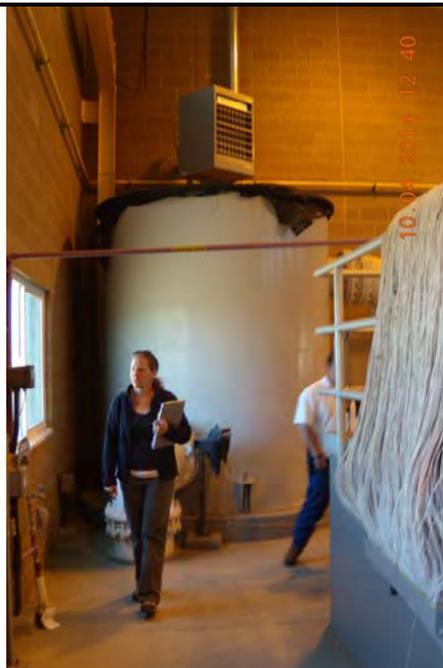
NMED/SWQB
Official Photograph Log
Photo # 22

Subject: Bulk Tank – buffer for back pulse through the MBR system for flushing and cleaning of the filters.

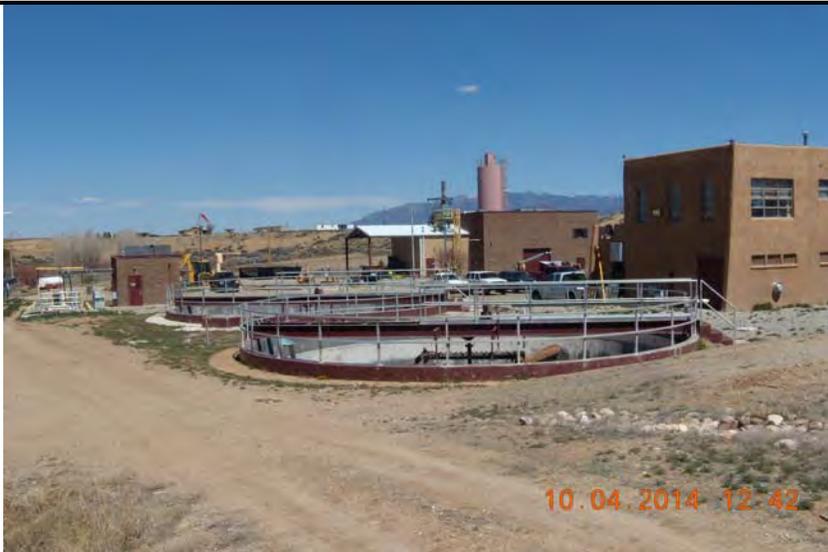
NMED/SWQB
Official Photograph Log
Photo # 23

Subject: Decommissioned secondary clarifiers. Because these units collect and contain standing rain water and precipitation, it is possible during warmer seasons they could become breeding grounds for mosquitoes, if not attended to.

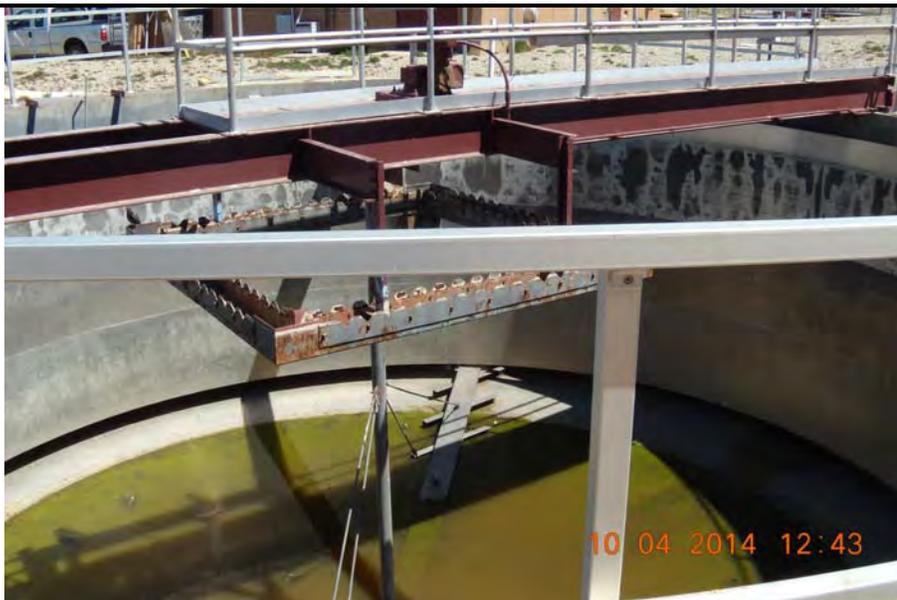
NMED/SWQB
Official Photograph Log
Photo # 24

Subject: Decommissioned secondary clarifiers. Because these units collect and contain standing rain water and precipitation, it is possible during warmer seasons they could become breeding grounds for mosquitoes, if not attended to.

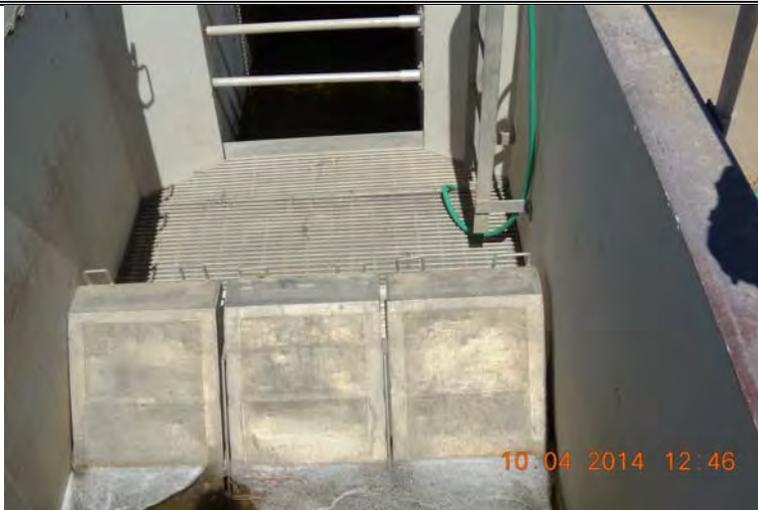
NMED/SWQB
Official Photograph Log
Photo # 25

Subject: Screens before the Ultraviolet Disinfection System.

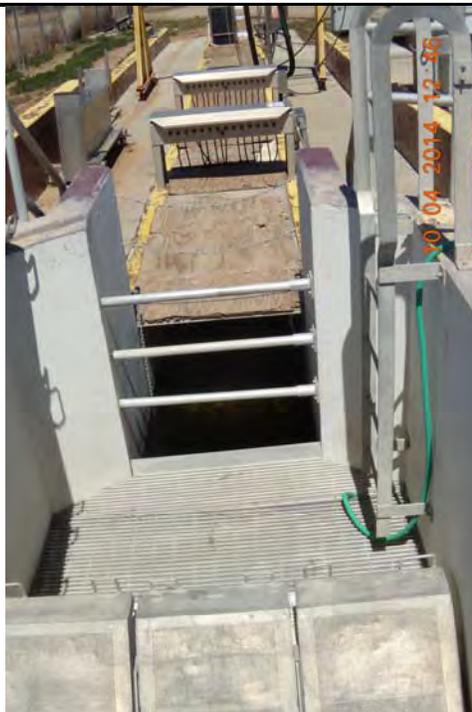
NMED/SWQB
Official Photograph Log
Photo # 26

Subject: Ultra Violet Disinfection System, light banks are covered by plywood for protection and to reduce the amount of sunlight in the channel. Lights are cleaned semiannually. At this time of year, excessive algae growth was not observed. However, in past inspections it was noted that more frequent cleaning may be necessary due to the large amount of algae growing in the channel during warmer months. At the time of the past inspection, the channels were also covered with plywood for protection.

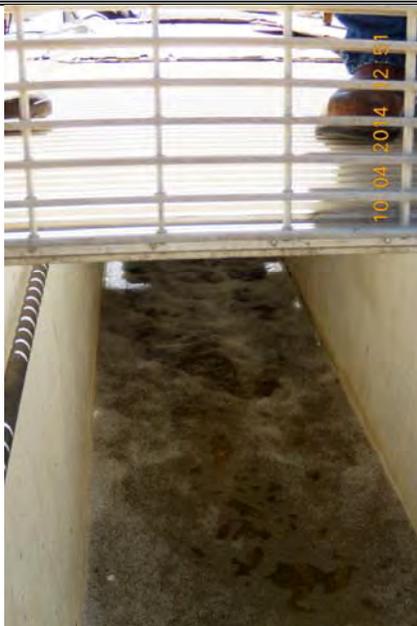
NMED/SWQB
Official Photograph Log
Photo # 27

Subject: Effluent Channel

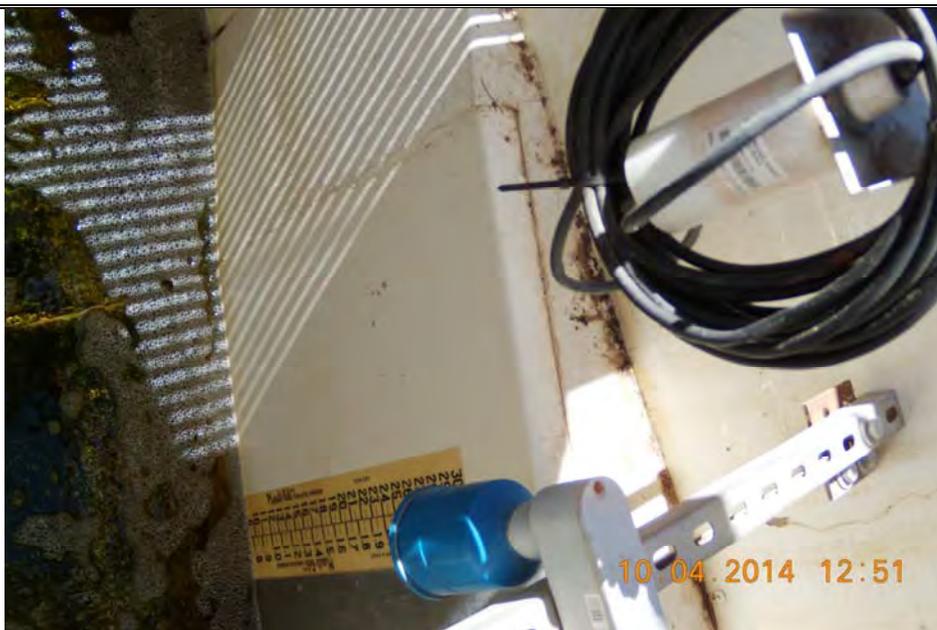
NMED/SWQB
Official Photograph Log
Photo # 28

Subject: Effluent Flow meter and staff gauge.

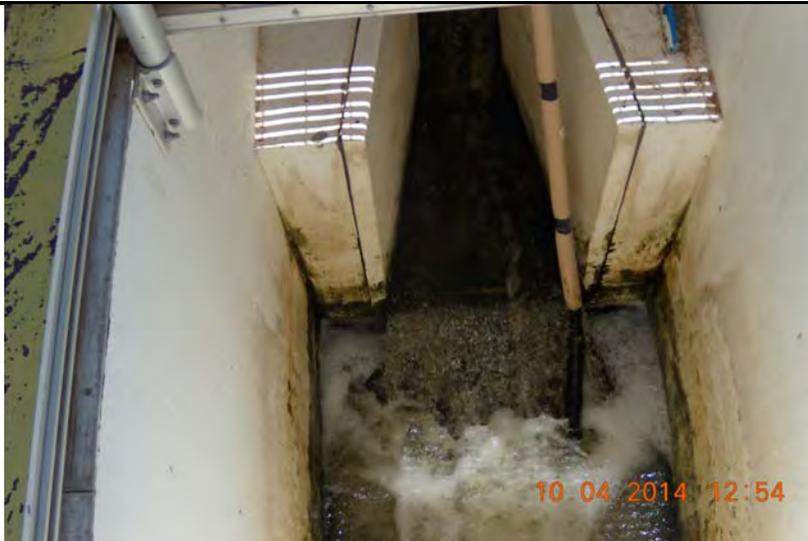
NMED/SWQB
Official Photograph Log
Photo # 30

Subject: Effluent channel past the Parshall Flume and effluent flow meter. The effluent was clear and free of floating solids.

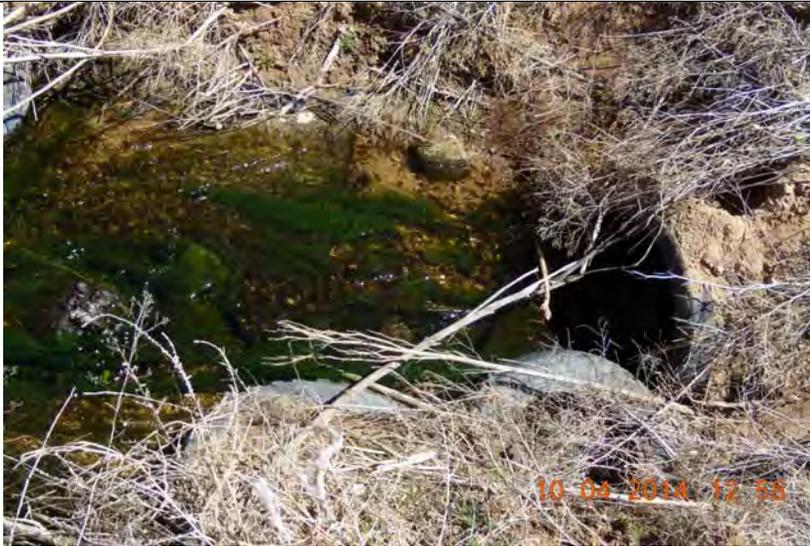
NMED/SWQB
Official Photograph Log
Photo # 31

Subject: Outfall pipe to ditch. Note the algae growth along the ditch bottom, indicating the presence of plant nutrients.

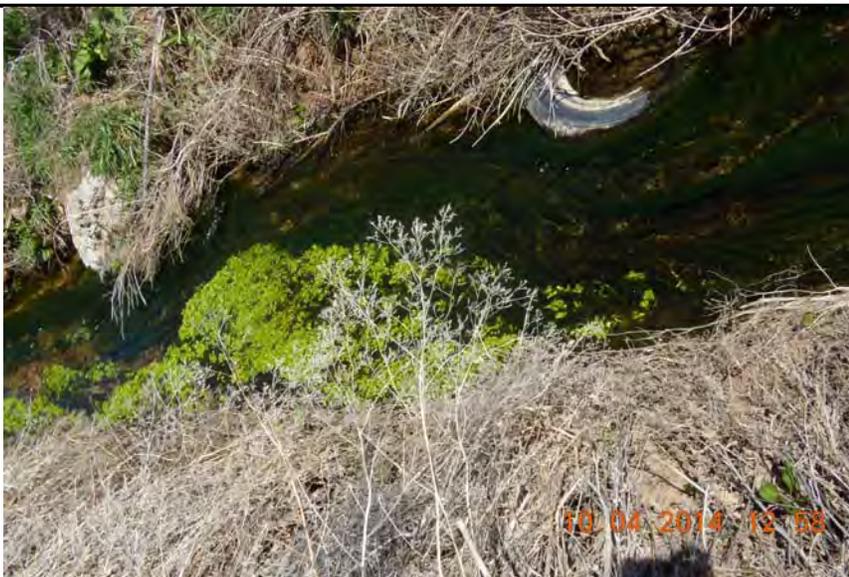
NMED/SWQB
Official Photograph Log
Photo # 32

Subject: Outfall ditch has duck weed and algae growing directly below the pipe.

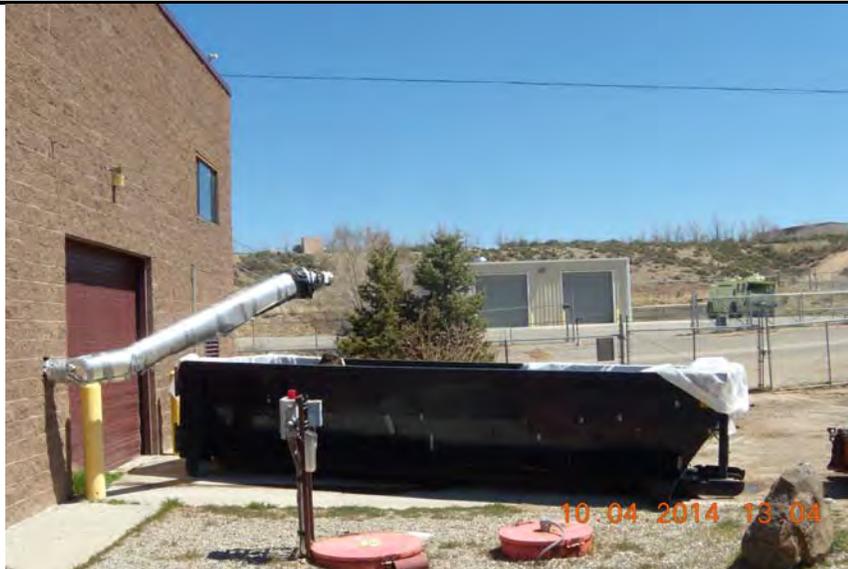
NMED/SWQB
Official Photograph Log
Photo # 33

Subject: Sludge after belt press is put in a roll off dumpster then hauled to the Rio Rancho Landfill. The dumpster is not covered. If there is a rain or snow event, added liquids would cause failure of the paint filter test.

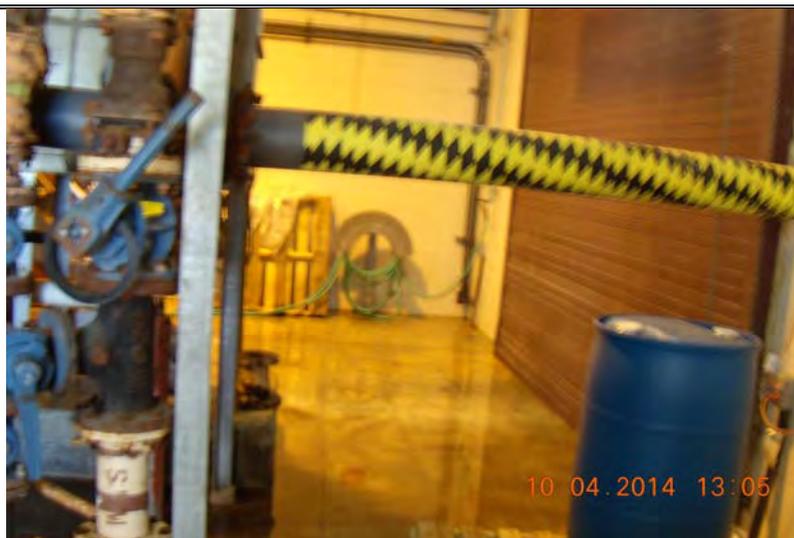
NMED/SWQB
Official Photograph Log
Photo # 34

Subject: Polymer feed to the solids going through the belt filter press was not mixed correctly the day of the inspection and spilled throughout the building, as seen by the wet shiny floor in the photo.

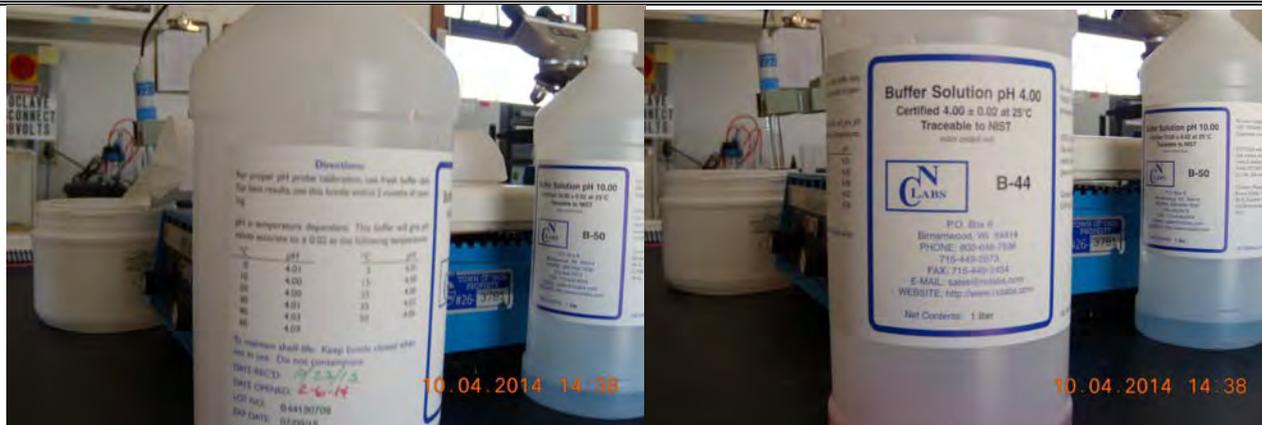
**NMED/SWQB
Official Photograph Log
Photo # 35 and 36**

Photographer: B. Cooney	Date: April 10, 2014	Time: 14:38
City/County: Town of Taos / Taos		State: New Mexico
Location: Town of Taos Wastewater Treatment Plant		
Subject: Laboratory pH buffers were labeled and stored correctly.

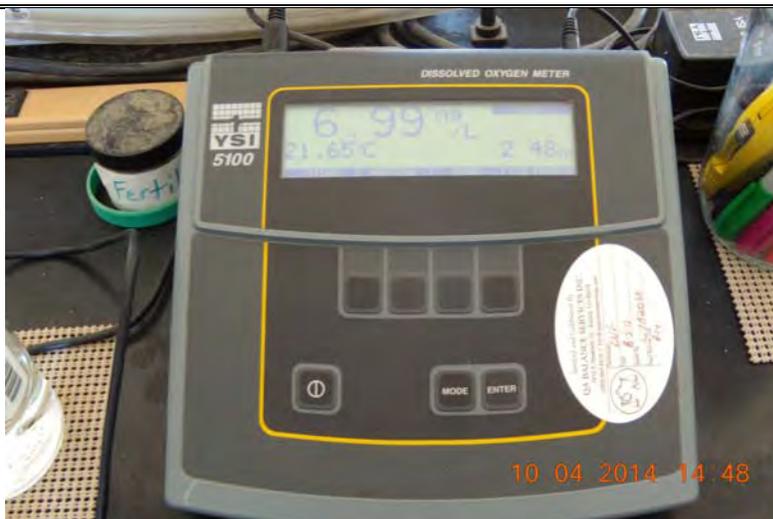
**NMED/SWQB
Official Photograph Log
Photo # 37**

Photographer: B. Cooney	Date: April 10, 2014	Time: 14:48
City/County: Town of Taos / Taos		State: New Mexico
Location: Town of Taos Wastewater Treatment Plant		
Subject: Laboratory Dissolved Oxygen Meter: Laboratory analytical equipment is calibrated and maintained. This meter was last checked for accuracy by an outside contractor August 2013.

The laboratory incubator is very old and it was suspected to have variable temperatures during the incubation cycle for BOD. This piece of equipment should be replaced.
