NEW MEXICO
ENVIRONMENT DEPARTMENT

Surface Water Quality Bureau

Re: Minor Municipal, SIC 4952, NPDES Compliance Evaluation Inspection, Abiquiu MDWCA, NM0024830, April 28, 2011

Official Photograph Log

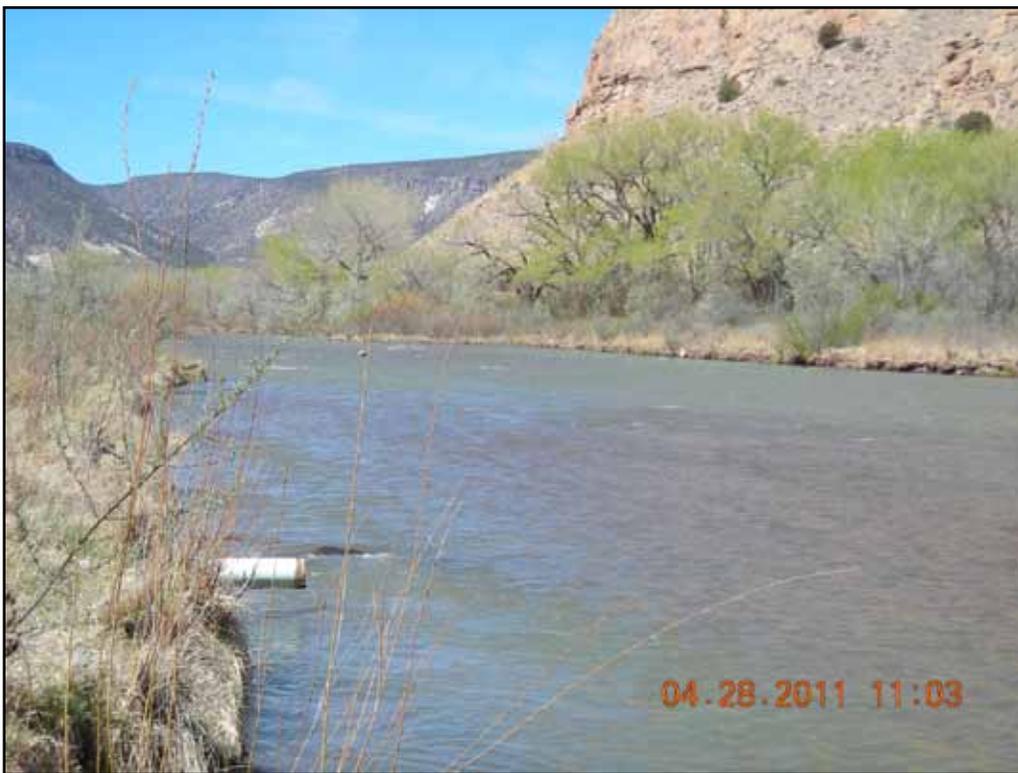
Photo # 1

Photographer: Sarah Holcomb	Date: 4-28-2011	Time: 1103 hours
City/County: Abiquiu/Rio Arriba County		
Location: Abiquiu WWTP		
Subject: Effluent pipe discharging into the Rio Chama.
