RE: Minor Municipal, SIC 4952, NPDES Compliance Evaluation Inspection, Abiquiu Wastewater Treatment Plant, NM0024830, February 27, 2013

ABIQUIU WASTEWATER TREATMENT PLANT

Abiquiu (Village of) Wastewater Treatment Plant
NPDES Permit No. NM0024830
Compliance Evaluation Inspection
Inspection Date: February 27, 2013

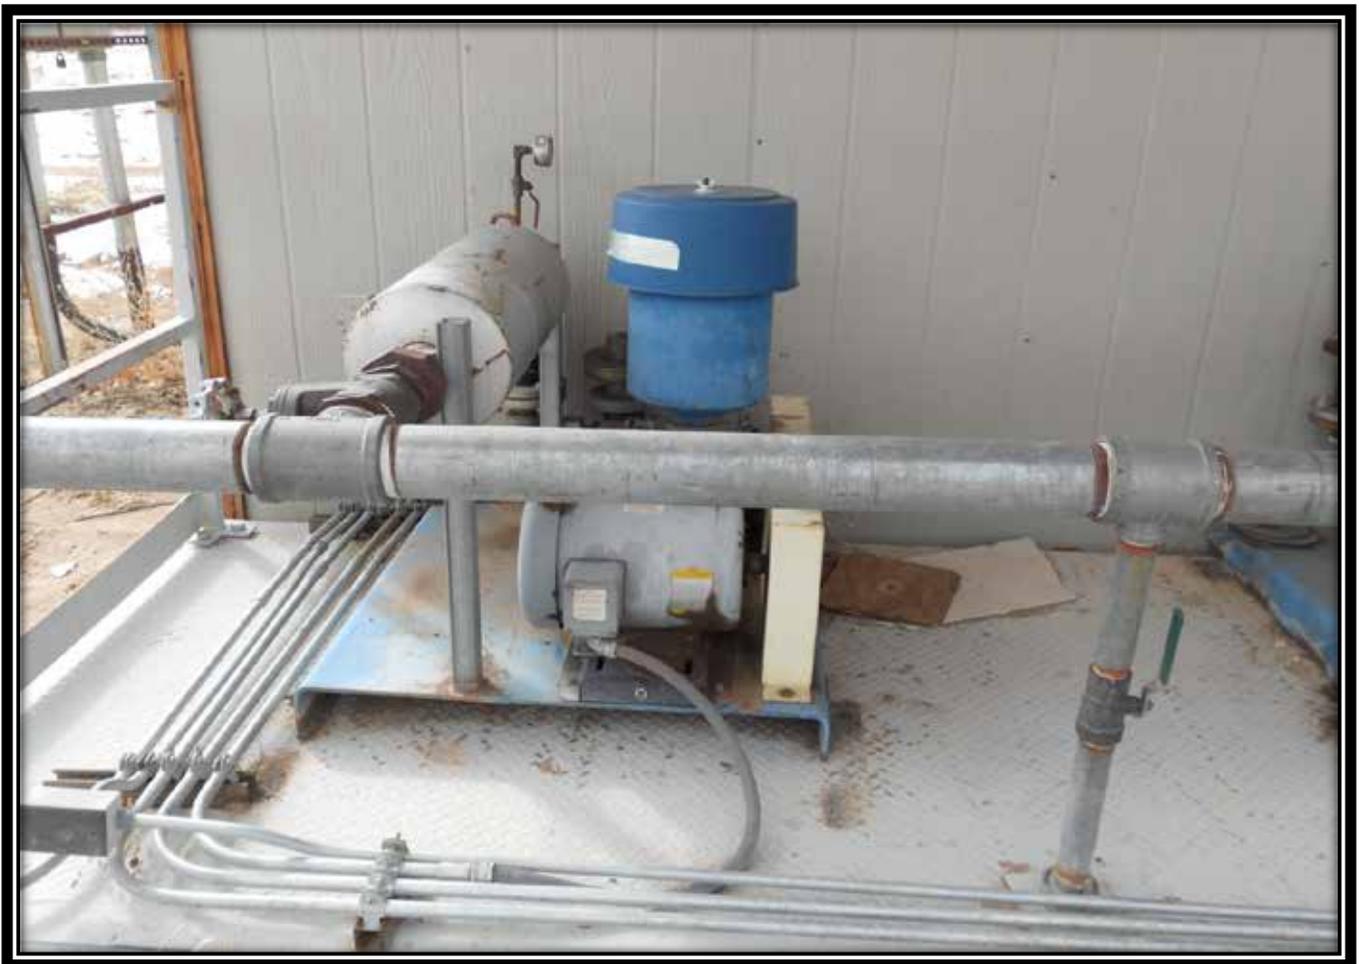
NMED/SWQB
Official Photograph Log
Photo # 1

Photographer: Sandra Gabaldón	Date: 02-27-2013	Time: 1103 Hours
City/County: Abiquiu / Rio Arriba		State: New Mexico
Location: Abiquiu Wastewater Treatment Facility		
Subject: One of two blowers that provide aeration to the activated sludge package plant

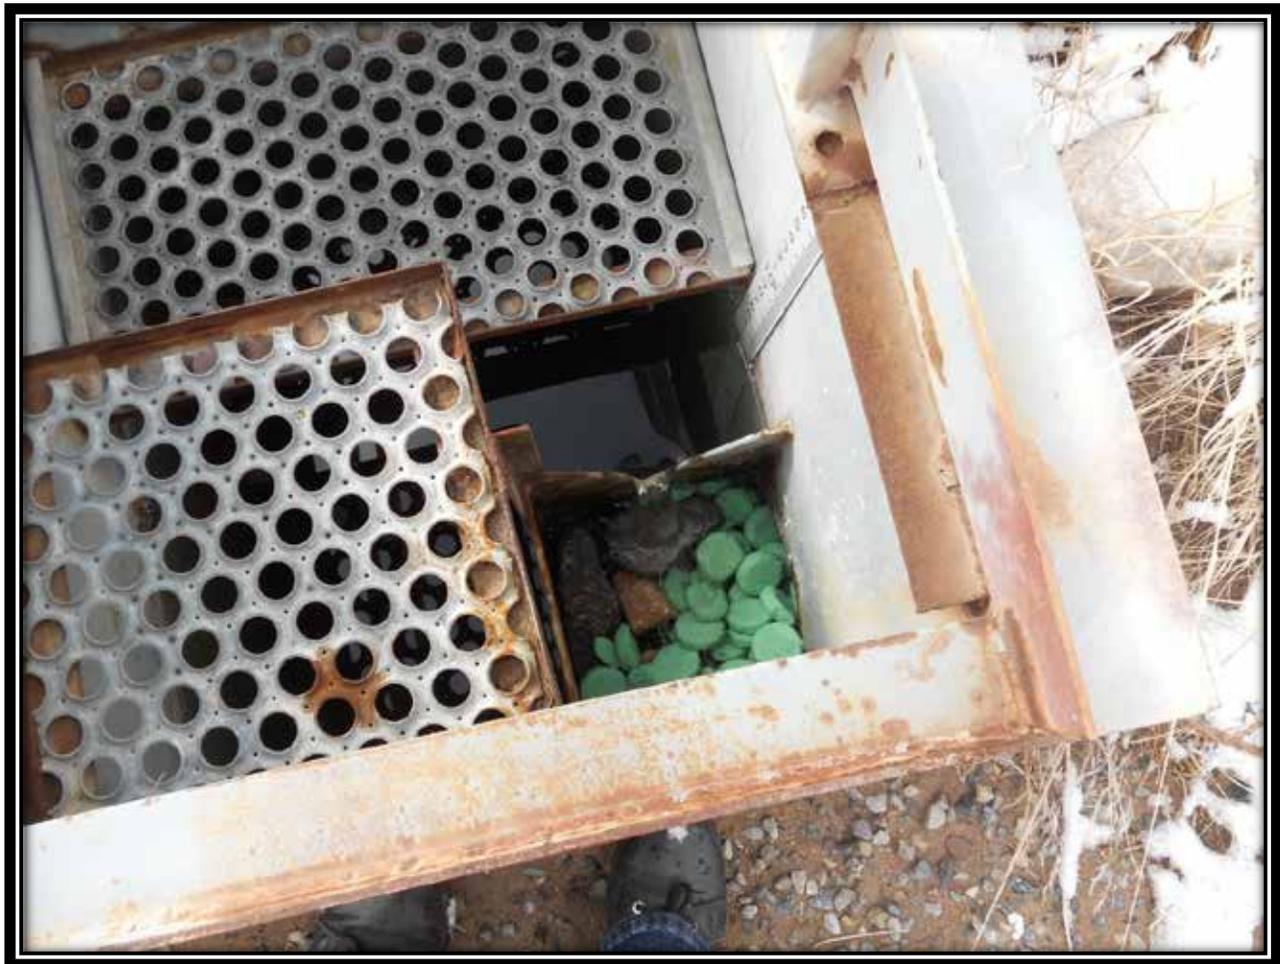
NMED/SWQB
Official Photograph Log
Photo # 2

Photographer: Sandra Gabaldón	Date: 02-27-2013	Time: 1103 Hours
City/County: Abiquiu / Rio Arriba		State: New Mexico
Location: Abiquiu Wastewater Treatment Facility		
Subject: V-notch weir at end of chlorine contact chamber with sodium bisulfate tablets added for dechlorination.

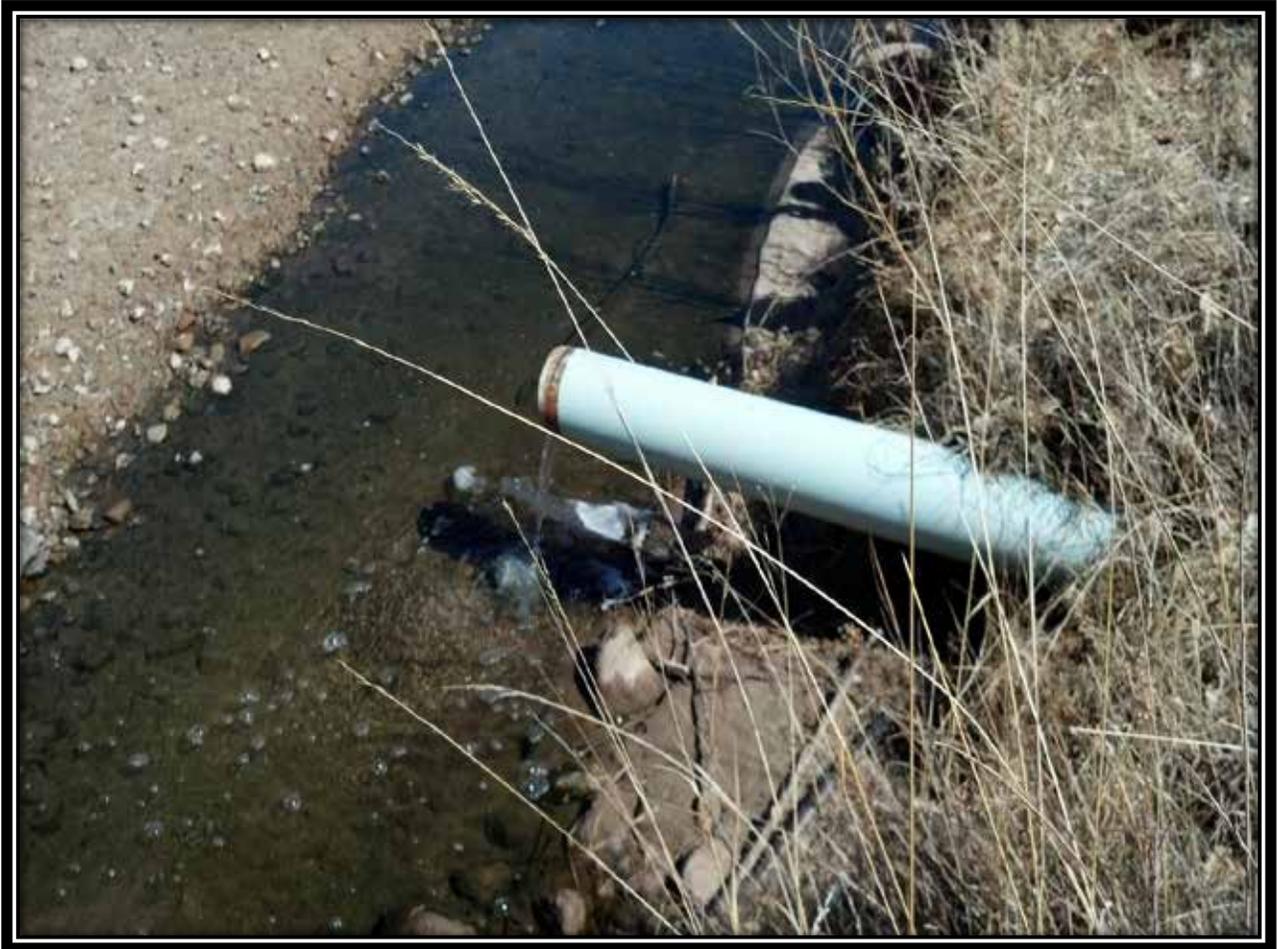
NMED/SWQB
Official Photograph Log
Photo #3

Photographer: Bruce Yurdin	Date: 02-27-2013	Time: 1126 Hours
City/County: Abiquiu / Rio Arriba		State: New Mexico
Location: Abiquiu Wastewater Treatment Facility		
Subject: Discharge into Rio Chama in Segment 20.6.4.116 NMAC. Slight foaming noted. No odor.
