Re: Abiquiu Wastewater Treatment Plant; Minor; Munciple Individual Permit; SIC 4952; Compliance Evaluation Inspection; NPDES Permit NM0024830; December 30, 2014

ABIQUIU WASTEWATER TREATMENT PLANT

PERMIT NO: NM0024830

Abiquiu (Village of) Wastewater Treatment Plant
NPDES Permit No. NM0024830
Compliance Evaluation Inspection
Inspection Date: December 30, 2014

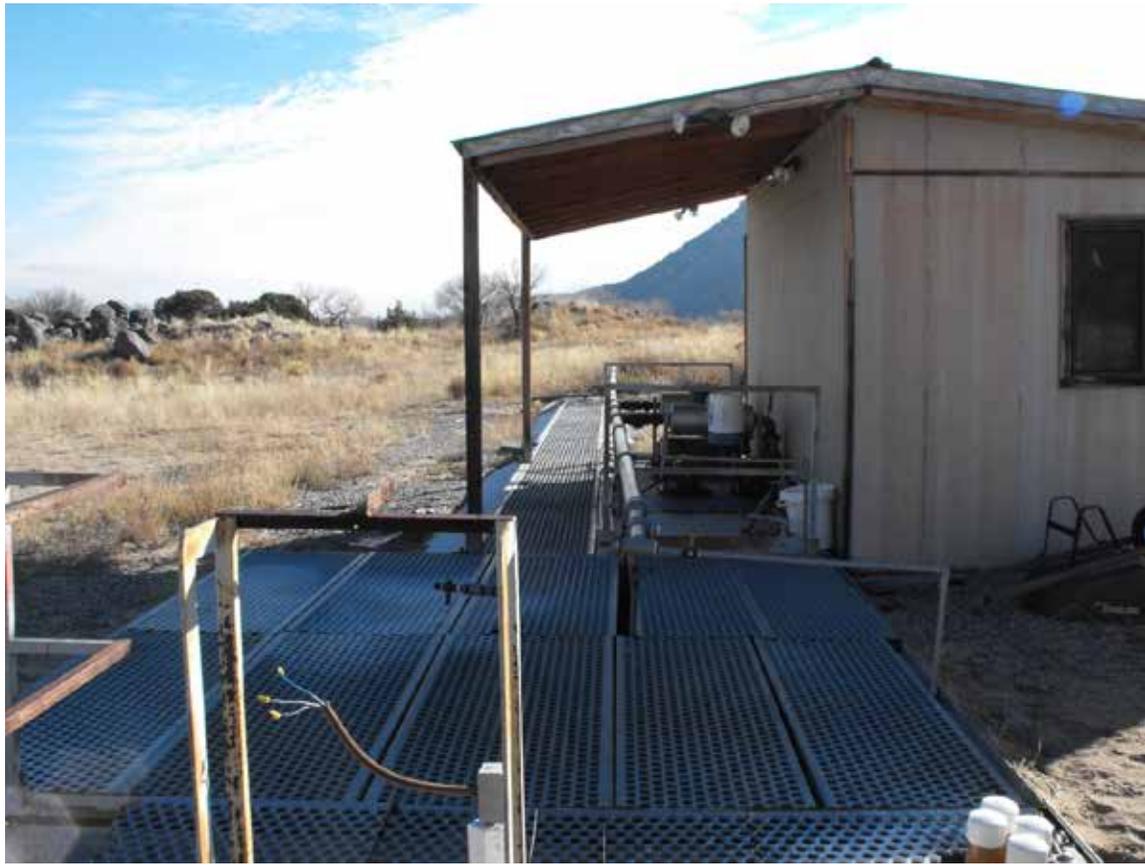
**NMED/SWQB
Official Photograph Log
Photo # 1**

Photographer: Daniel Valenta	Date: 12/30/2014	Time: 1025 Hours
City/County: Abiquiu / Rio Arriba		State: New Mexico
Location: Abiquiu Wastewater Treatment Facility		
Subject: Overview of Abiquiu Wastewater Package Plant

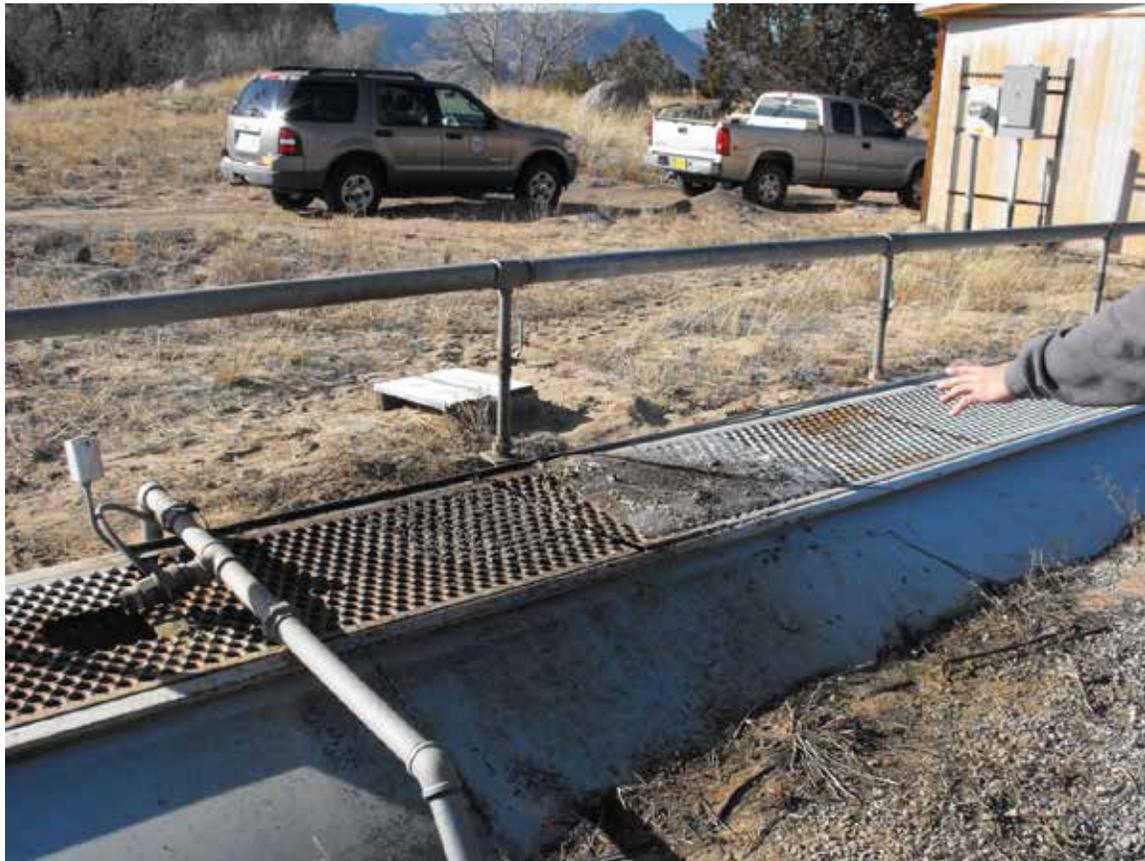
**NMED/SWQB
Official Photograph Log
Photo # 2**

On the day of the compliance evaluation inspection, it appeared that the wastewater treatment plant had a sanitary sewer overflow (SSO) occur at the headworks. The permittee has not reported any overflows as required by the permit. (Please see attached pictures).

Photographer: Daniel Valenta	Date: 12/30/2014	Time: 1030 hours
City/County: Abiquiu / Rio Arriba		State: New Mexico
Location: Abiquiu Wastewater Treatment Facility		
Subject: Apparent SSO at headworks.

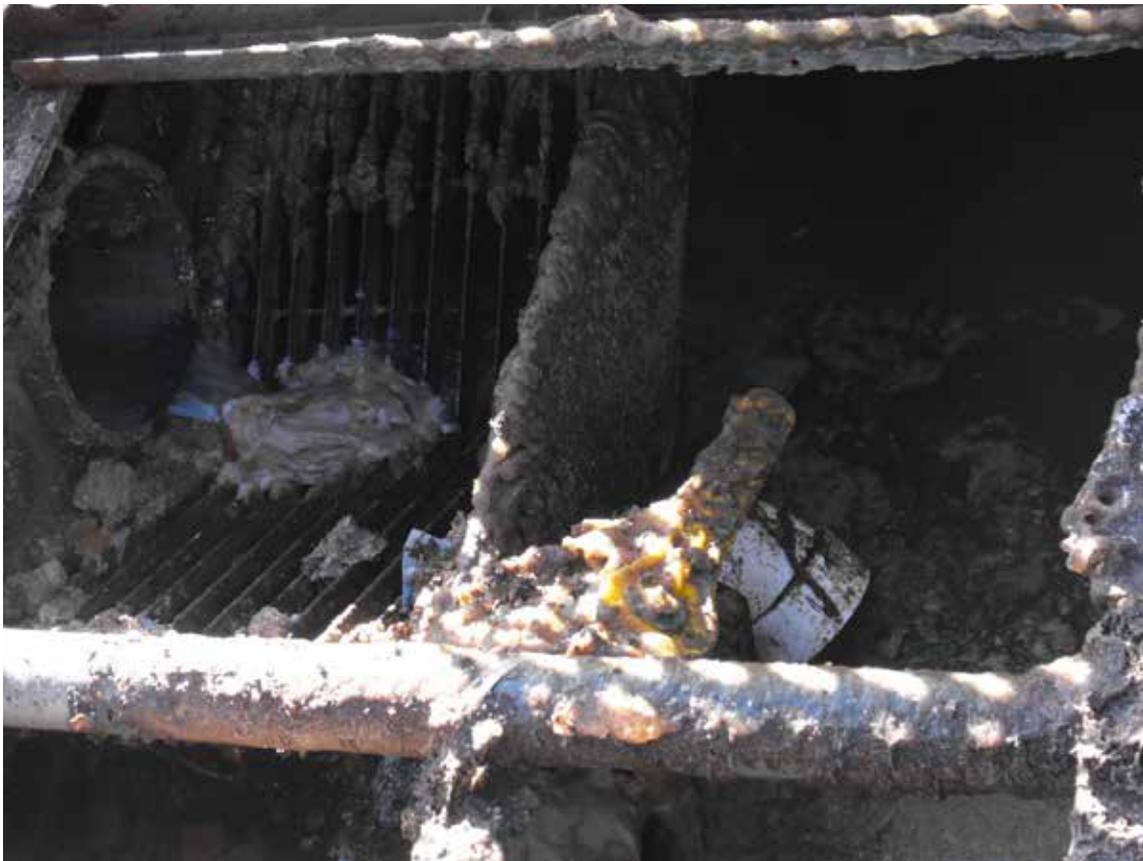
**NMED/SWQB
Official Photograph Log
Photo #3**

Photographer: Daniel Valenta	Date: 12/30/2014	Time: 1031 Hours
City/County: Abiquiu / Rio Arriba		State: New Mexico
Location: Abiquiu Wastewater Treatment Facility		
Subject: Close up view of influent pipe and barscreen.

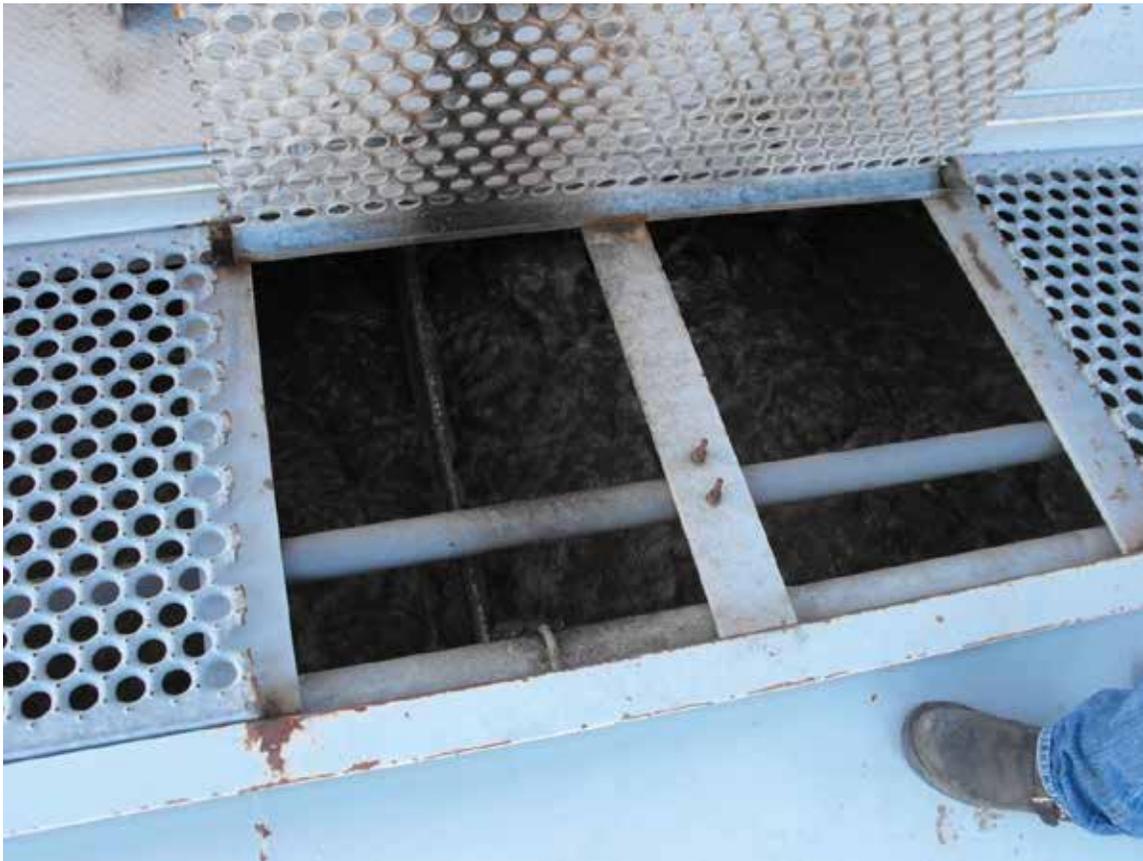
**NMED/SWQB
Official Photograph Log
Photo #4**

The aeration basin is approximately 12 feet deep. The return activated sludge (RAS) in the aeration basin should be no more than one-fourth to one-third of the depth of the basin (three to four feet). There appeared to be approximately 7-8 feet of RAS in the basin. This is a strong indication that the RAS (return activated sludge) pumping rate should be increased to prevent denitrification from occurring.

Photographer: Daniel Valenta	Date: 12/30/2014	Time: 1045 Hours
City/County: Abiquiu / Rio Arriba		State: New Mexico
Location: Abiquiu Wastewater Treatment Facility		
Subject: Aeration basin – Coloration is a deep brown color indicating wasting needs to be done.

The sludge beds have not been used for a number of years. The facility is in desperate need of sludge disposal. Currently, the facility has a sludge blanket that is inhibitive of clarification of the effluent. In order to get appropriate effluent, the permittee needs to remove old sludge. The operator stated that he has had a septic hauler come in and remove sludge, but Mr. Lopez, the President of the Co-op felt that this was too expensive (approximately \$400.00). It would be beneficial for the facility to have operational sludge beds that drain back into the headworks to alleviate the sludge within the system.

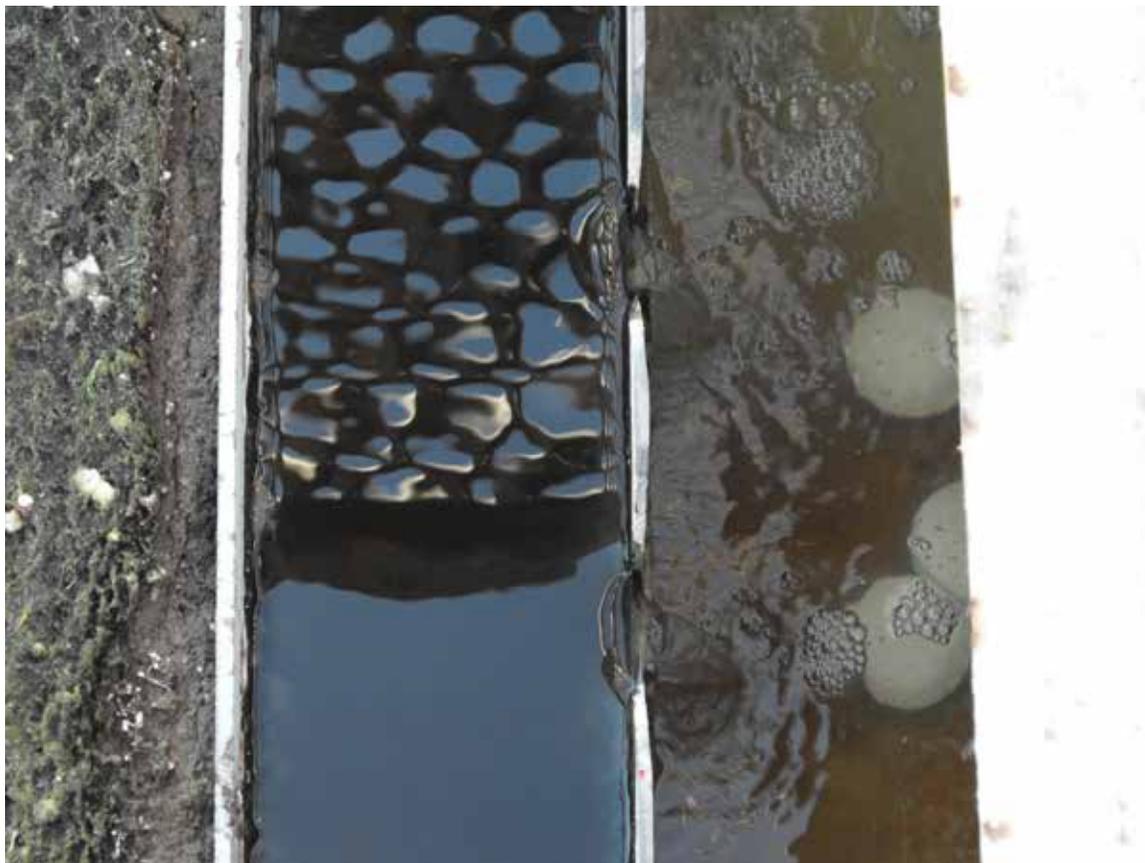
**NMED/SWQB
Official Photograph Log
Photo #5**

Photographer: Daniel Valenta	Date: 12/30/2014	Time: 1039 Hours
City/County: Abiquiu / Rio Arriba		State: New Mexico
Location: Abiquiu Wastewater Treatment Facility		
Subject: Clarifier with chlorination tablets in the channel (May be placed in this area to add detention time).

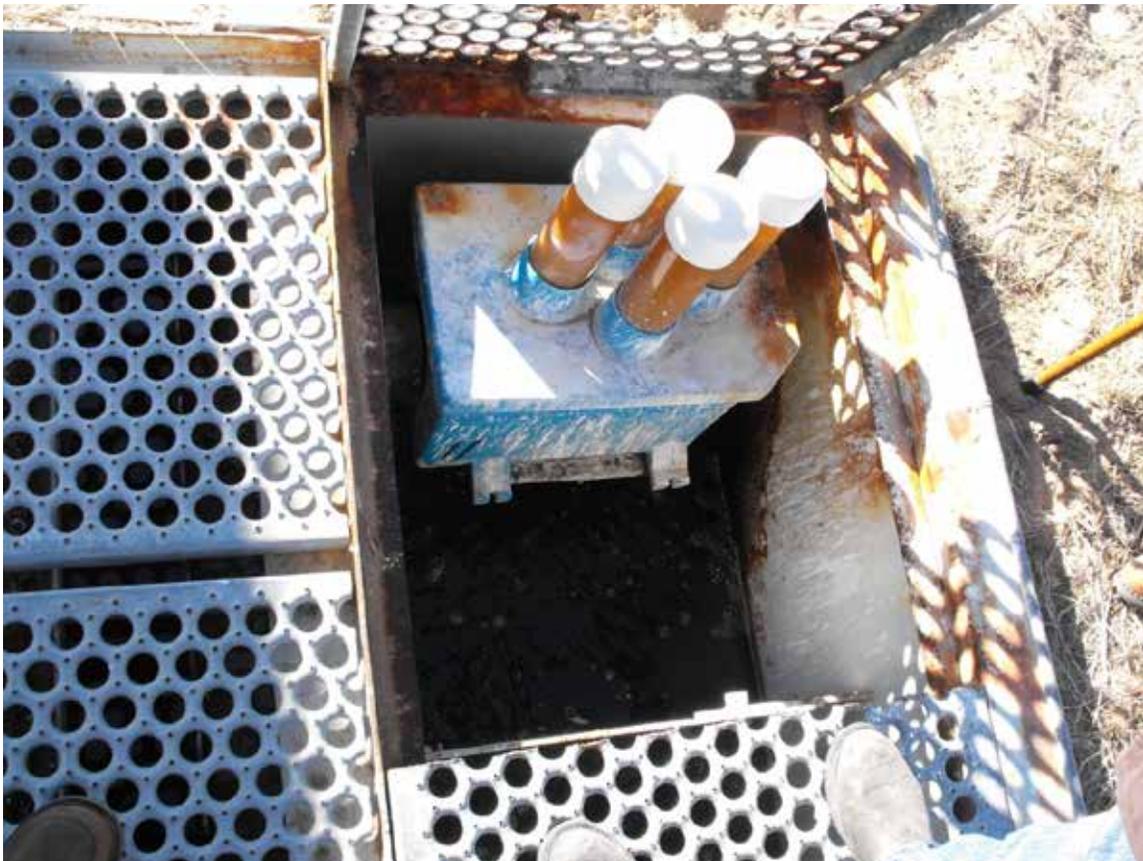
**NMED/SWQB
Official Photograph Log
Photo #6**

The chlorine contact chamber consists of metal baffles with staggered slots that extend the base of the unit that serve to increase the detention time of effluent. After passing through the final slot, the effluent flows over a V-notch weir and into a smaller basin which is a basket filled with de-chlorination tablets.

Photographer: Daniel Valenta	Date: 12/30/2014	Time: 1040 Hours
City/County: Abiquiu / Rio Arriba		State: New Mexico
Location: Abiquiu Wastewater Treatment Facility		
Subject: Chlorine contact chamber.

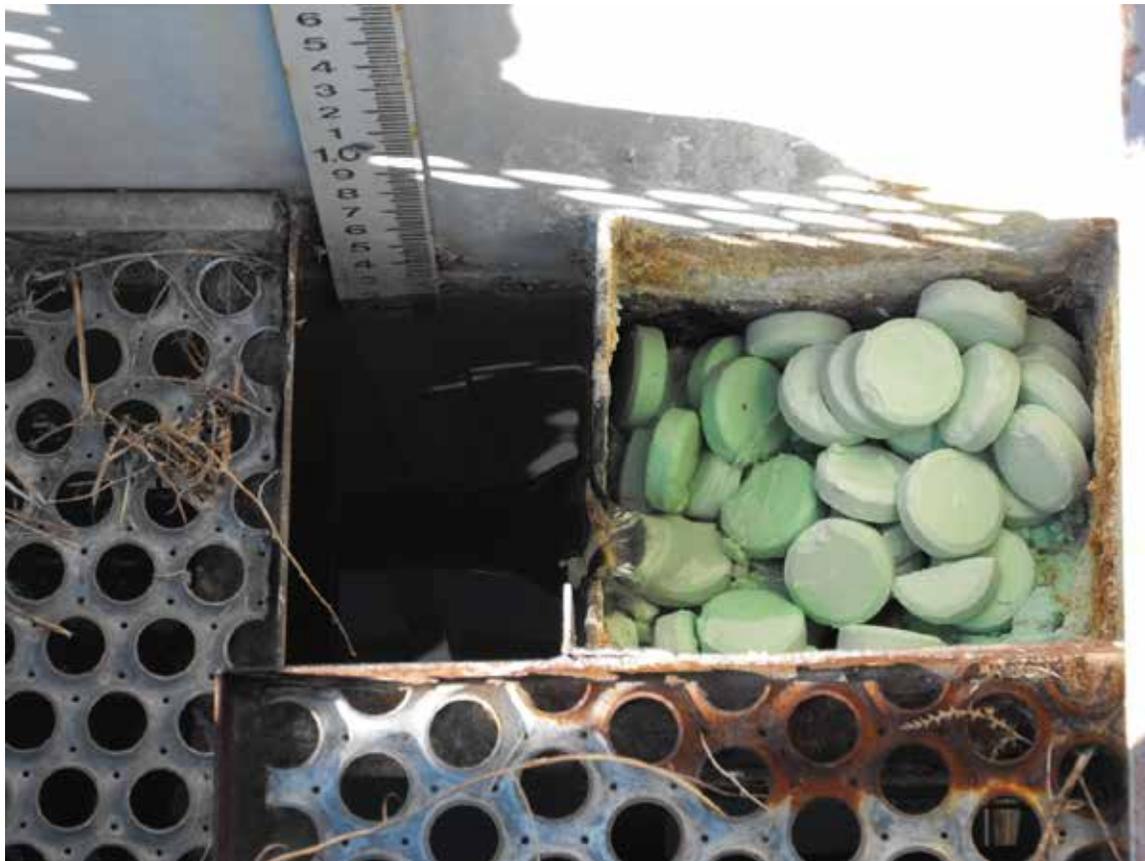
**NMED/SWQB
Official Photograph Log
Photo #7**

The Abiquiu Wastewater Treatment Plant has a 60° V-notch weir. The V-notch weir is placed too close to the staff gauge to get an accurate reading. The V-notch is also thicker than recommended and is not “sharp”.

Photographer: Daniel Valenta	Date: 12/30/2014	Time: 1042 Hours
City/County: Abiquiu / Rio Arriba		State: New Mexico
Location: Abiquiu Wastewater Treatment Facility		
Subject: Staff gage, V-notch weir and de-chlorination box.

It is suggested that the Permittee review the requirements of installation and maintenance, as some corrections need to be made.

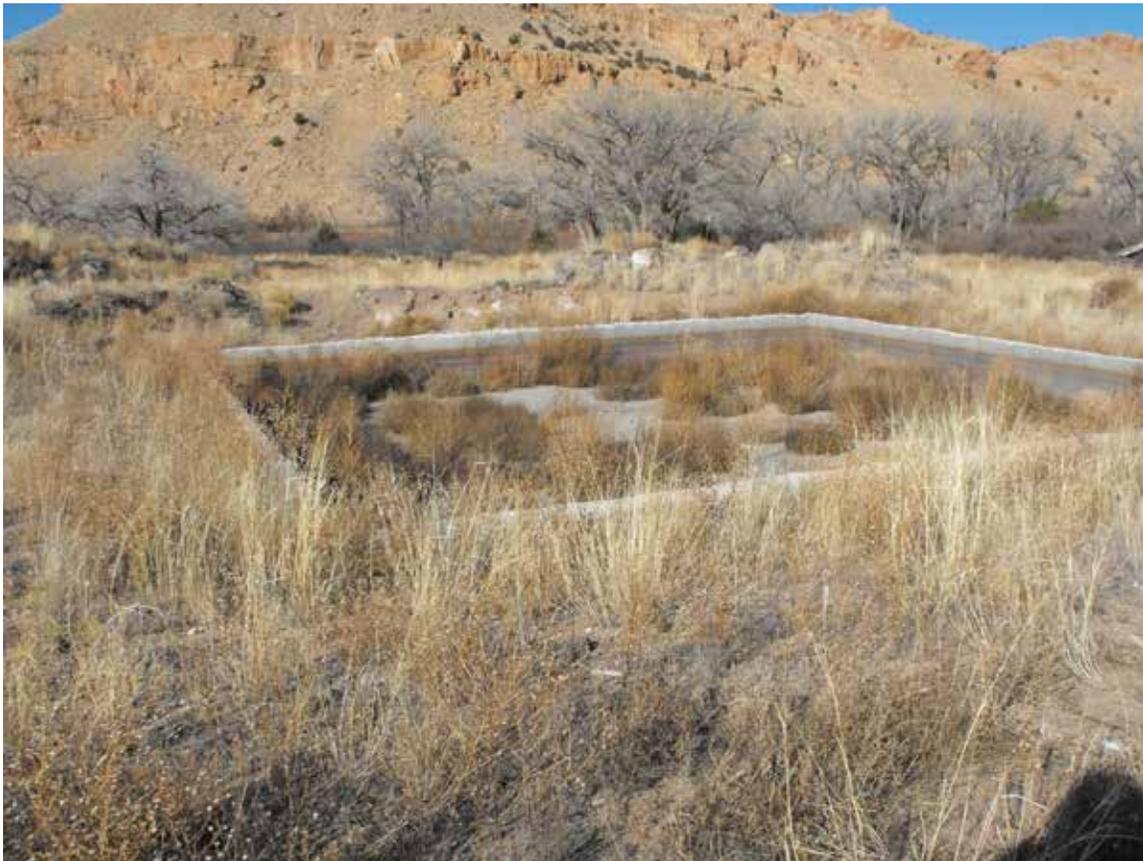
**NMED/SWQB
Official Photograph Log
Photo #8**

The sand filter needs to have the sand replaced with new sand in order to provide the filtering needed. There are weeds growing inside the sand filter as well. The weeds need to be removed.

Photographer: Daniel Valenta	Date: 12/30/2014	Time: 1048 Hours
City/County: Abiquiu / Rio Arriba		State: New Mexico
Location: Abiquiu Wastewater Treatment Facility		
Subject: Sand Filter.

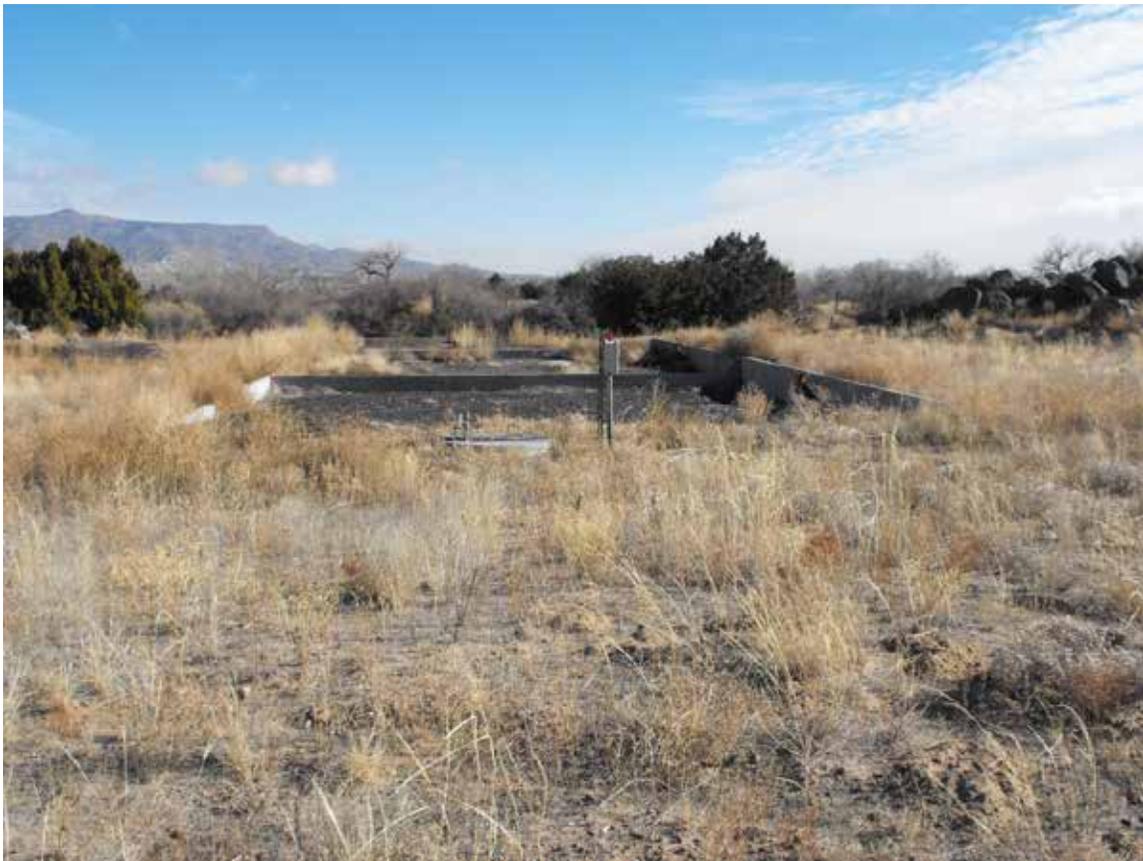
**NMED/SWQB
Official Photograph Log
Photo #9**

Photographer: Daniel Valenta	Date: 12/30/2014	Time: 1048 Hours
City/County: Abiquiu / Rio Arriba		State: New Mexico
Location: Abiquiu Wastewater Treatment Facility		
Subject: Sludge Drying Beds.

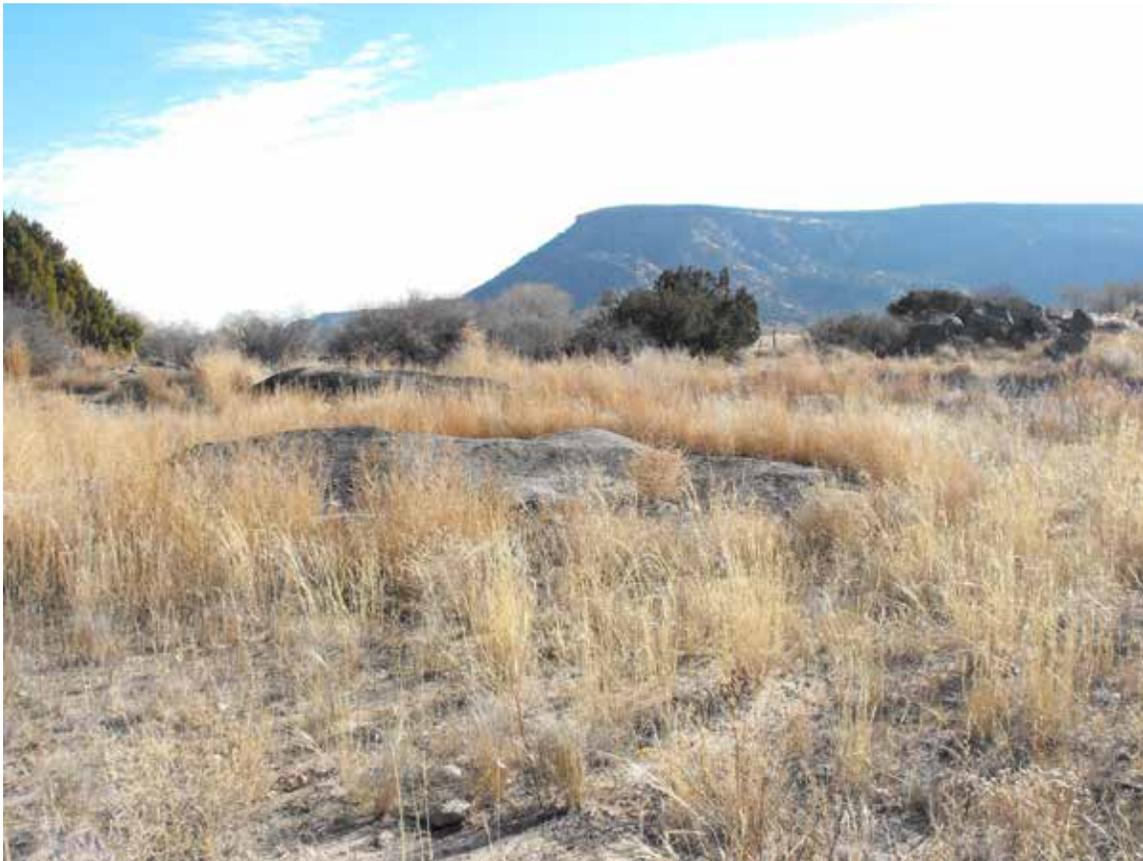
**NMED/SWQB
Official Photograph Log
Photo #10**

On the day of this inspection, it was noted that there were various piles of old sludge (appears to be older than two years) placed above bare ground with no secondary containment.

This facility has failed to follow general requirements, analyses, management practices, and operational standards for their sludge disposal.

Photographer: Daniel Valenta	Date: 12/30/2014	Time: 1050 Hours
City/County: Abiquiu / Rio Arriba		State: New Mexico
Location: Abiquiu Wastewater Treatment Facility		
Subject: Sludge – placed on bare ground.

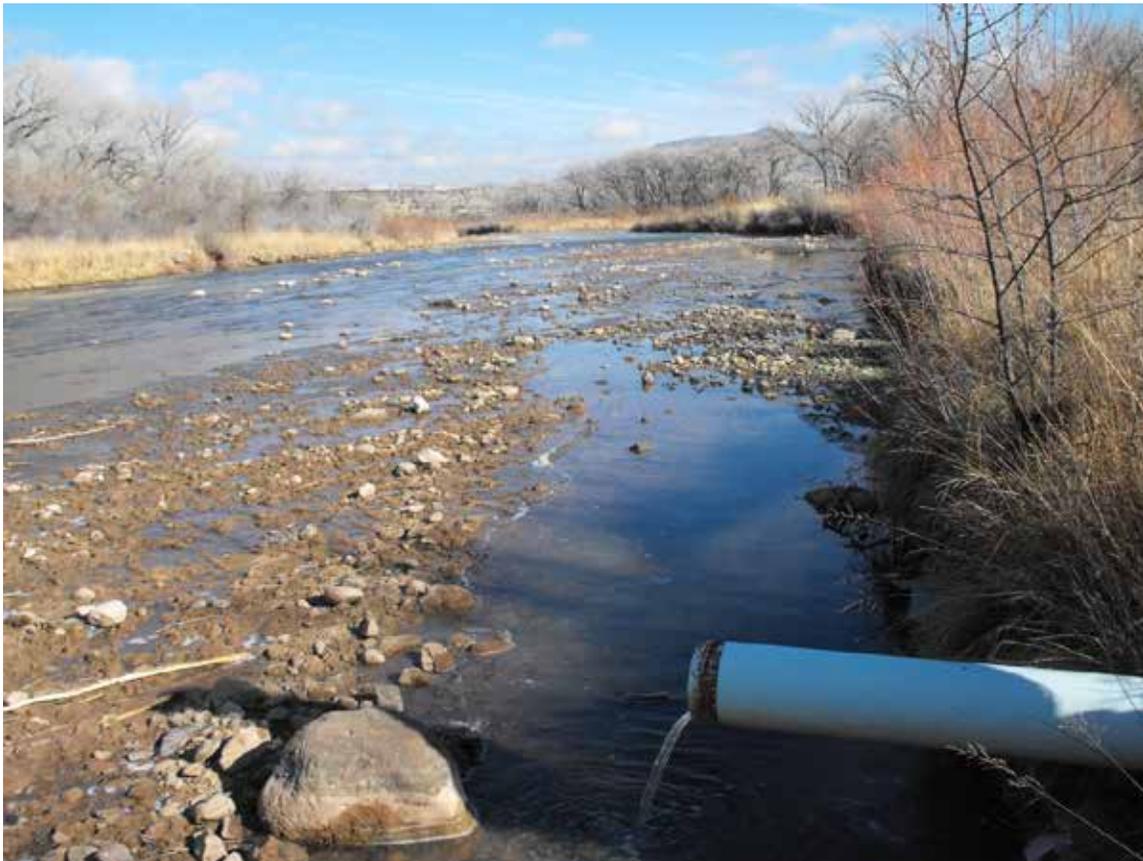
**NMED/SWQB
Official Photograph Log
Photo #11**

Photographer: Daniel Valenta	Date: 12/30/2014	Time: 1103 Hours
City/County: Abiquiu / Rio Arriba		State: New Mexico
Location: Abiquiu Wastewater Treatment Facility		
Subject: Discharge pipe at Rio Chama.

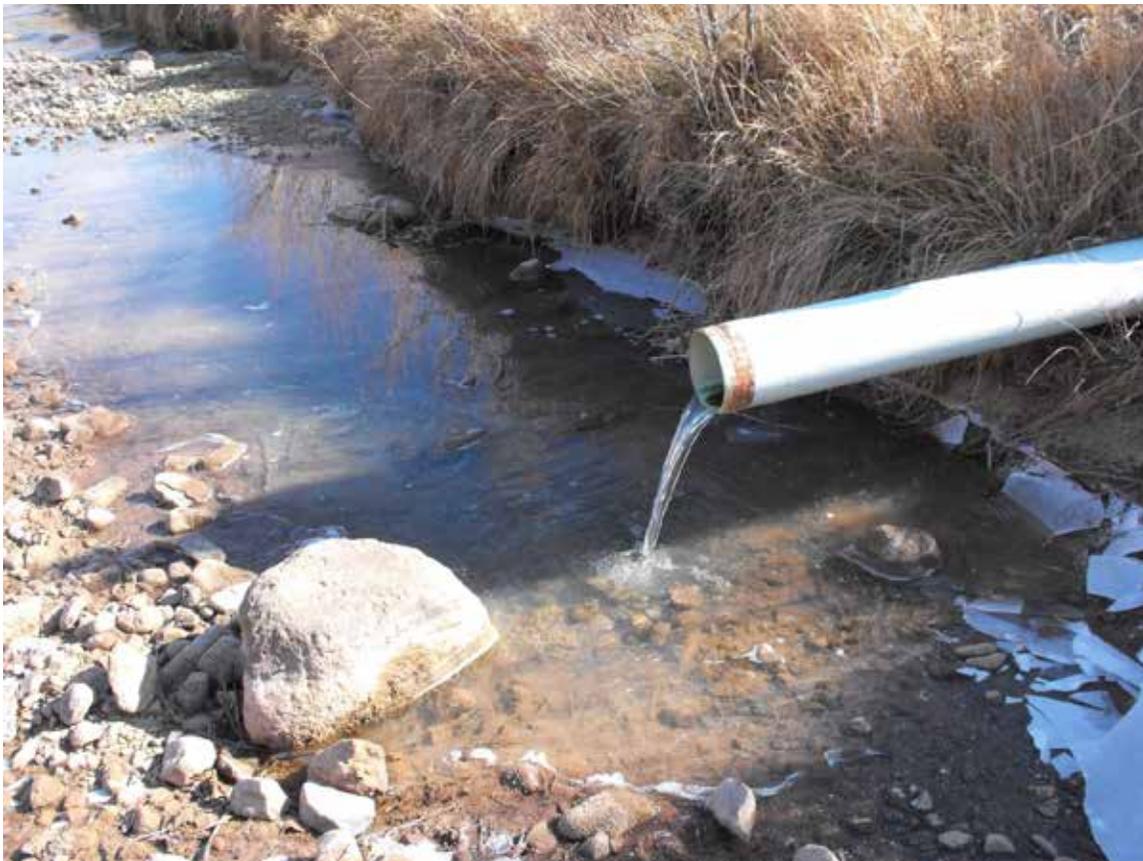
**NMED/SWQB
Official Photograph Log
Photo #12**

Photographer: Daniel Valenta	Date: 12/30/2014	Time: 1103 Hours
City/County: Abiquiu / Rio Arriba		State: New Mexico
Location: Abiquiu Wastewater Treatment Facility		
Subject: Effluent discharge into Rio Chama. Appears cloudy.

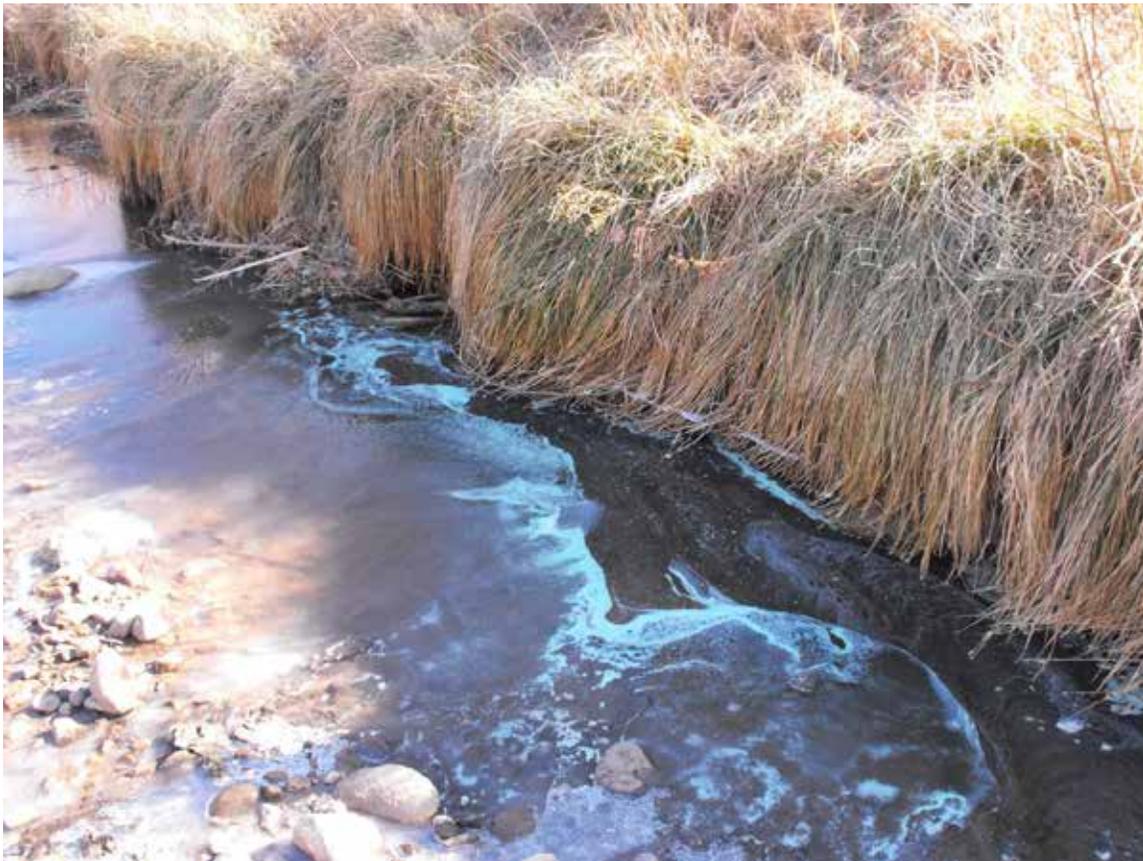
**NMED/SWQB
Official Photograph Log
Photo #13**

Photographer: Daniel Valenta	Date: 12/30/2014	Time: 1106 Hours
City/County: Abiquiu / Rio Arriba		State: New Mexico
Location: Abiquiu Wastewater Treatment Facility		
Subject: Downstream from effluent pipe. Noticeable floatable solids.
