**NEW MEXICO
ENVIRONMENT DEPARTMENT**

Re: Minor Municipal; SIC 4952; Compliance Evaluation Inspection; Village of Cuba
Wastewater Treatment Plant; NPDES Permit No. NM0024848; February 6, 2015

NPDES Compliance Inspection Report

On February 6, 2015 a Compliance Evaluation Inspection (CEI) was conducted at the Village of Cuba Wastewater Treatment Plant (WWTP) by Barbara Cooney of the State of New Mexico Environment Department (NMED), Surface Water Quality Bureau (SWQB). The inspection was conducted by NMED for the US Environmental Protection Agency (USEPA), Region VI, under the National Pollutant Discharge Elimination System (NPDES) permit program, in accordance with the Federal Clean Water Act. These inspections are conducted under contract with the USEPA and are used by USEPA to evaluate compliance with the NPDES permit program. This inspection report is based on information supplied by the representatives (the permittee), observations made by the NMED inspectors, reports and records kept by the permittee and/or NMED.

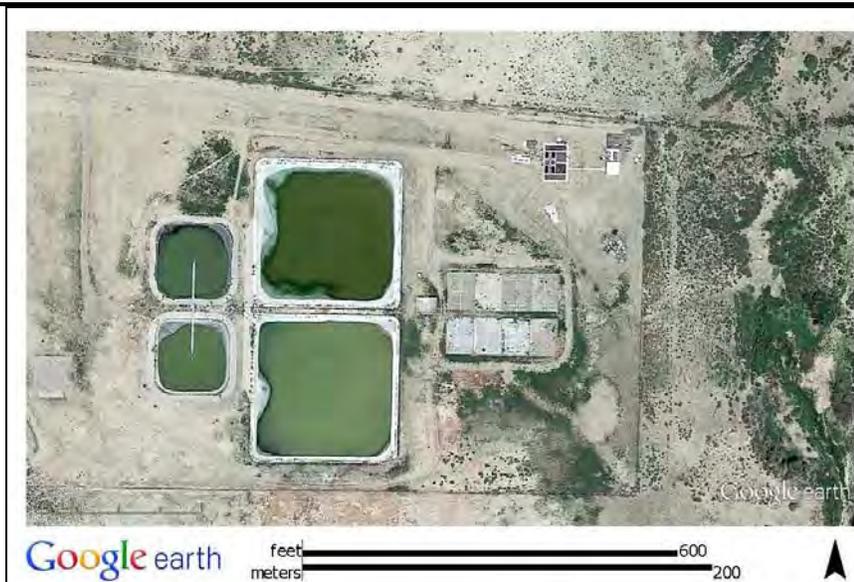
NMED/SWQB
Official Photograph Log
Photo # 2

Subject: Aerial view of the new Aero-Mod treatment system, the old aerated lagoons, holding ponds and sand filters.

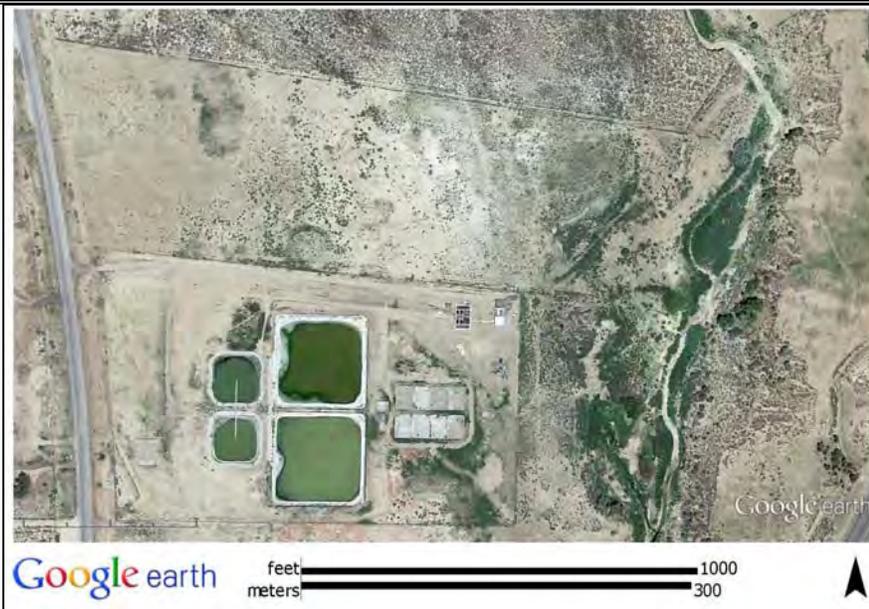
NMED/SWQB
Official Photograph Log
Photo #3

Subject: Aerial view of the treatment plant. Additionally 17.6 acres of land directly north of the facility is now owned by the Village of Cuba and will be used for the surface – agricultural land application for the reuse water from the treatment plant during the warm months of April through October . The distribution lines and solids handling has not yet been constructed.

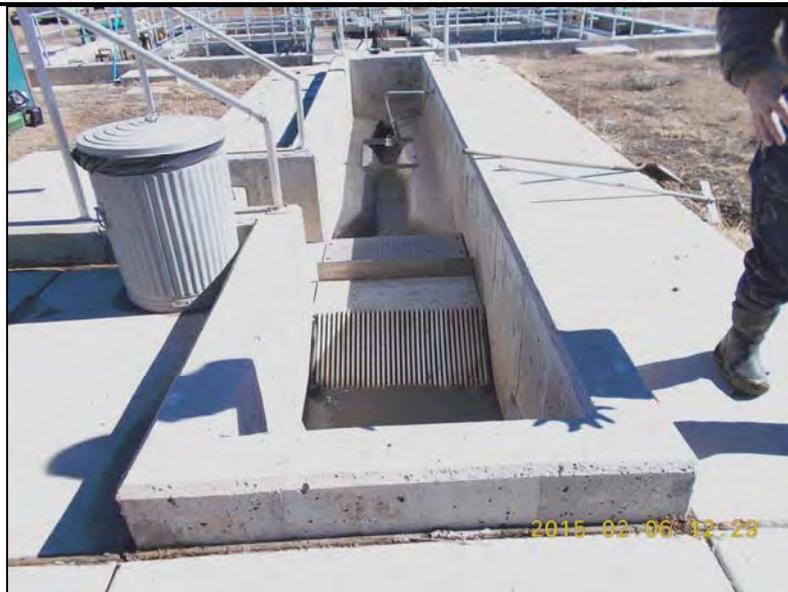
NMED/SWQB
Official Photograph Log
Photo #4

Subject: Influent bar screen. Not grit removal system. Large solids are hand raked from the screen, placed in the trash can and disposed of at the county landfill.

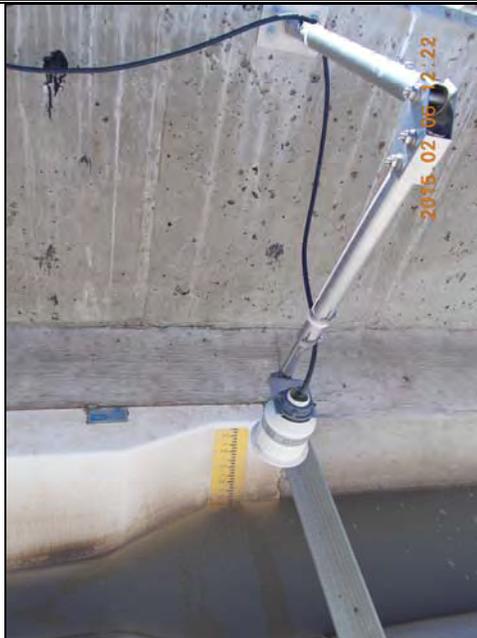
NMED/SWQB
Official Photograph Log
Photo # 5

Subject: Influent flow measurement – staff gauge at the Parshall flume. The ultrasonic sensor was out of service at the time of the inspection.

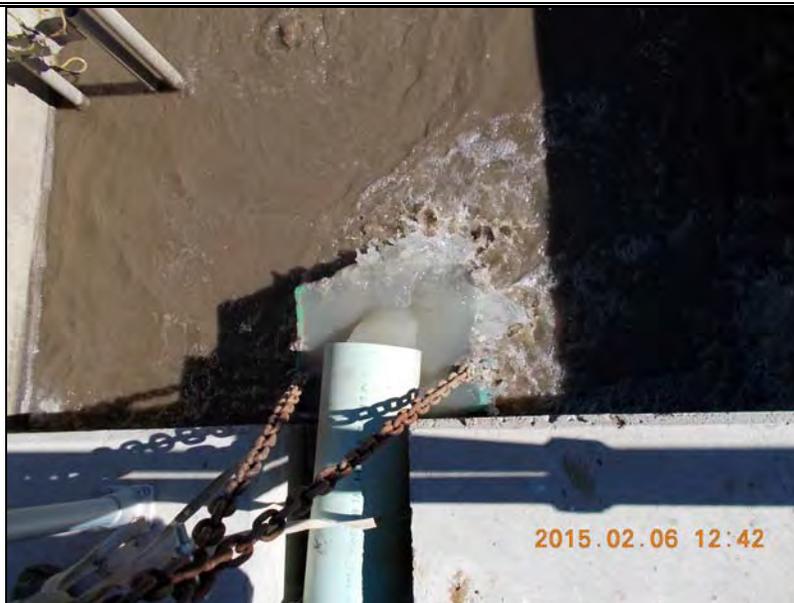
NMED/SWQB
Official Photograph Log
Photo # 6

Subject: Influent wastewater – following the bar screen and flow measurement, enters the pre-activation basin. Operators have install a plastic milk carton crate to capture additional large solids that are not removed by the bar screen. Without a grit removal system fine grit and solids are entering the secondary processes and have the potential to interfere with treatment works such as aerators, pumps and filters.

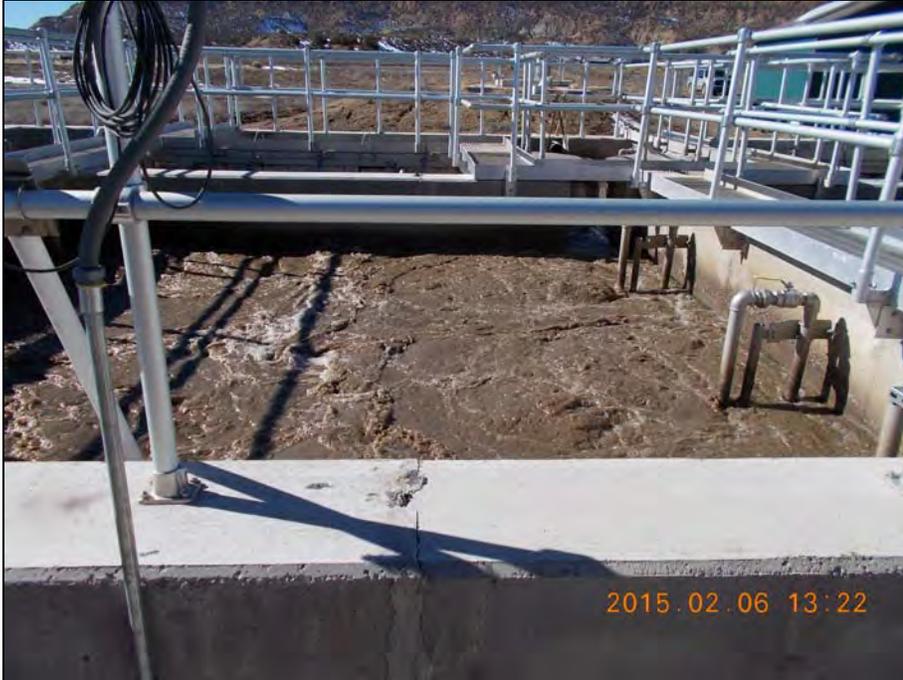
NMED/SWQB
Official Photograph Log
Photo # 7

Subject: Activation basin during the aeration phase. Fine bubble diffusers near the bottom of the basin effectively aerate and act as mixers in the basin.

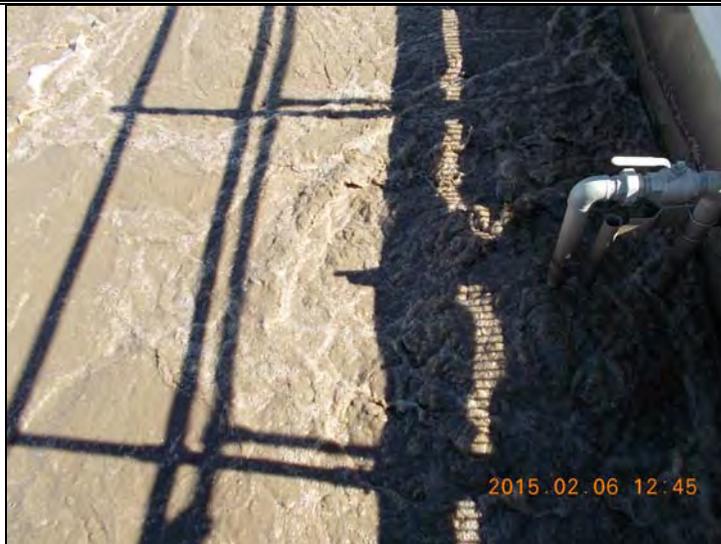
NMED/SWQB
Official Photograph Log
Photo # 8

Subject: Another view of the activation basin. The Mixed Liquor Suspended Solids (MLSS) in the basin according to operators is being maintained near 6000 mg/L during the winter months, when microbial activity is low. However there is indication in the basin of older solids and increased wasting may be necessary.

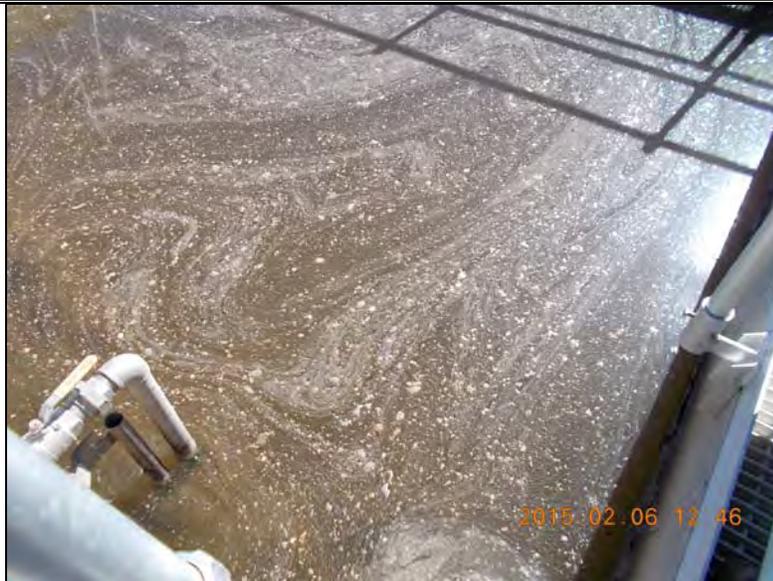
NMED/SWQB
Official Photograph Log
Photo # 9

Subject: Activation basin during the resting phase where blower are turned off and no aeration takes place. Floating solids indicate grease and older solids in the basin.

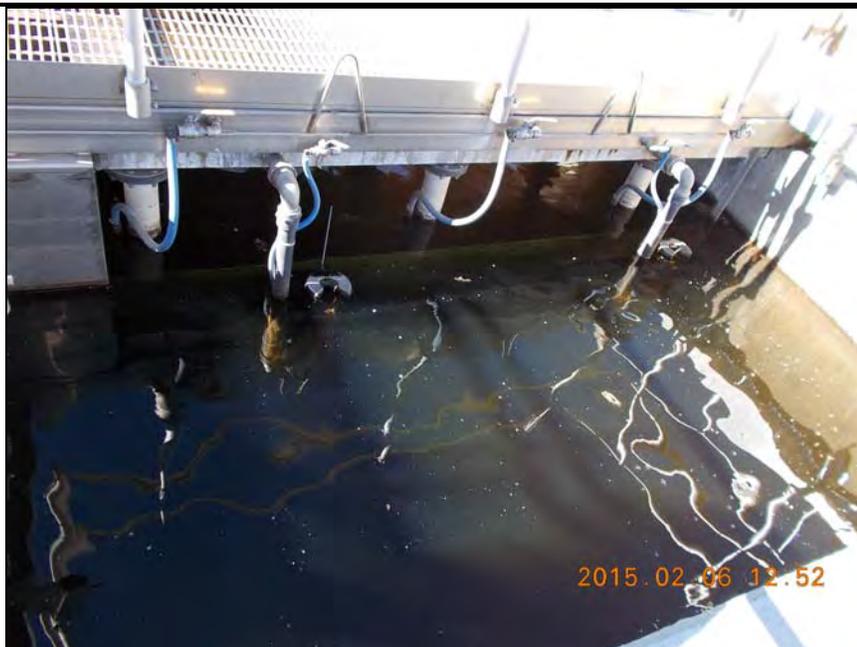
NMED/SWQB
Official Photograph Log
Photo # 10

Subject: Secondary Clarifier, floating solids are noted exiting the basin. Water from this basin goes to Ultraviolet disinfection then to the outfall.

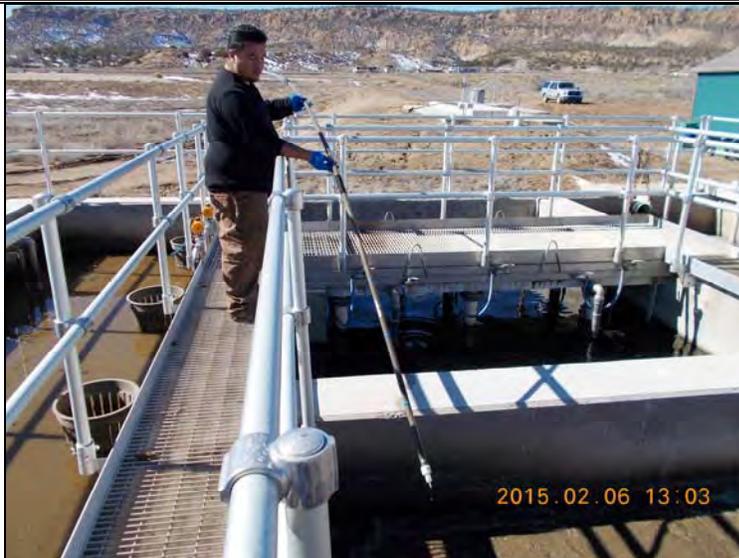
NMED/SWQB
Official Photograph Log
Photo # 11

Subject: Sludge blanket in the secondary clarifier before wasting is between 7 and 8 feet with a diffuse layer above. The basins are 25 feet deep.

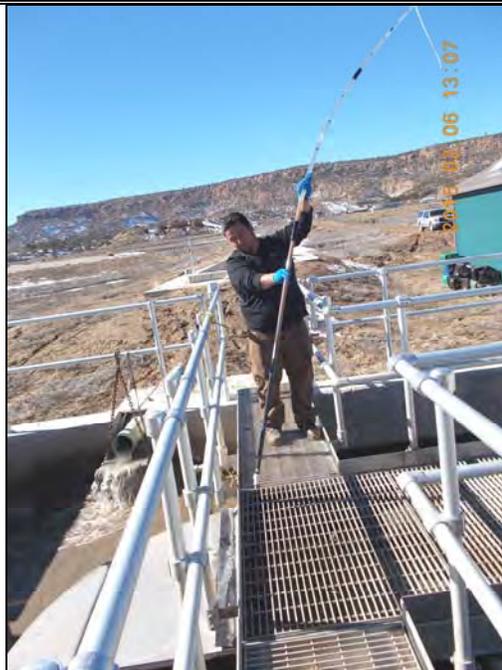
NMED/SWQB
Official Photograph Log
Photo #12

Subject: The sludge blanket in the secondary clarifiers after solids wasting are 4 -5 feet with a diffuse layer above.

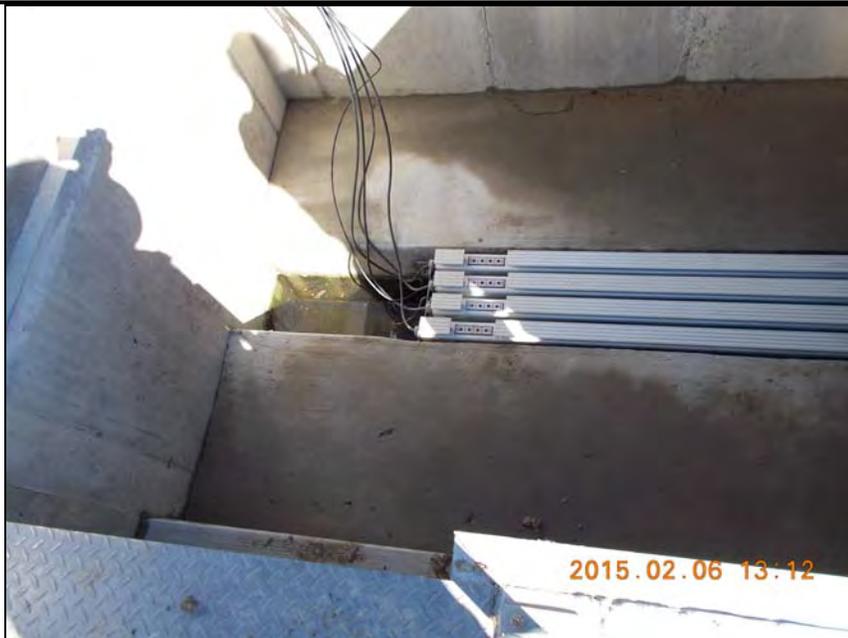
NMED/SWQB
Official Photograph Log
Photo # 14

Subject: Ultraviolet Disinfection system – 4 banks of lights. Operators clean the lights weekly. A slight amount of floating solids are noted in the chamber.

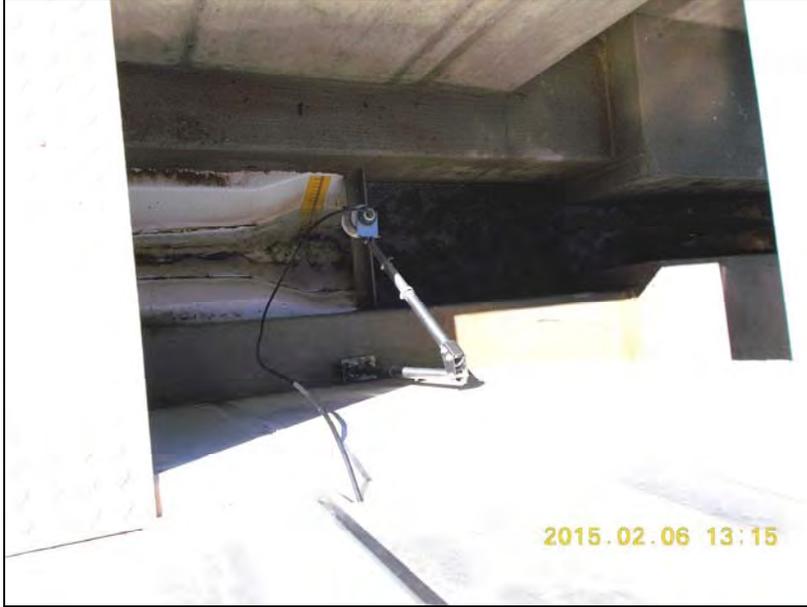
NMED/SWQB
Official Photograph Log
Photo # 15

Subject: Effluent Parshall Flume Flow Meter and staff gauge.

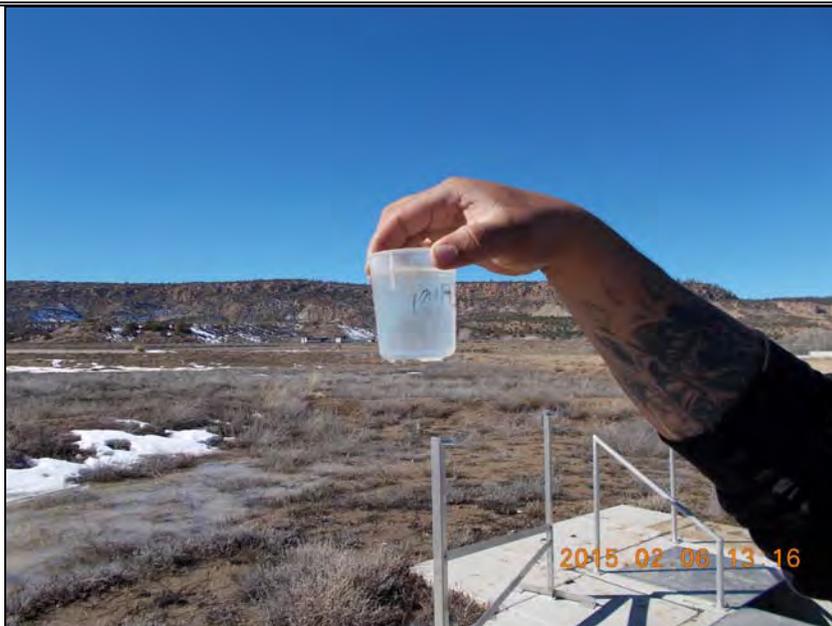
NMED/SWQB
Official Photograph Log
Photo # 16

Subject: Final effluent is clear.

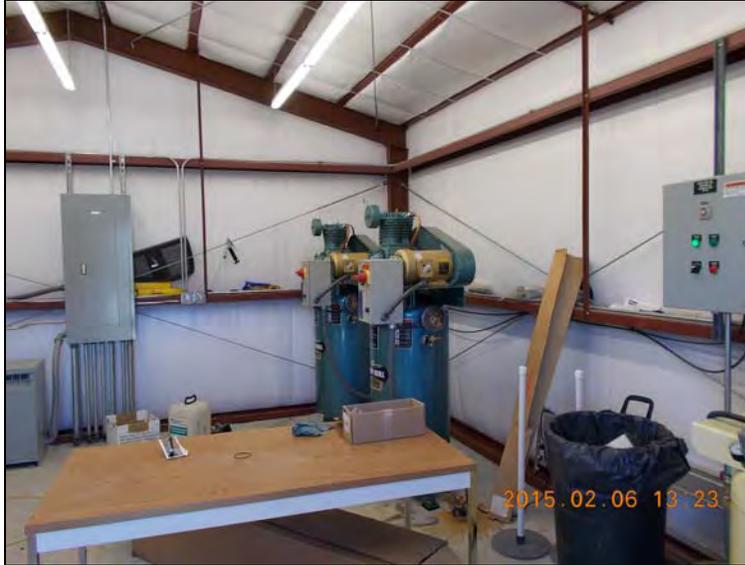
NMED/SWQB
Official Photograph Log
Photo # 17

Subject: Blowers and control room. The blowers are used in alternate cycle rotation.

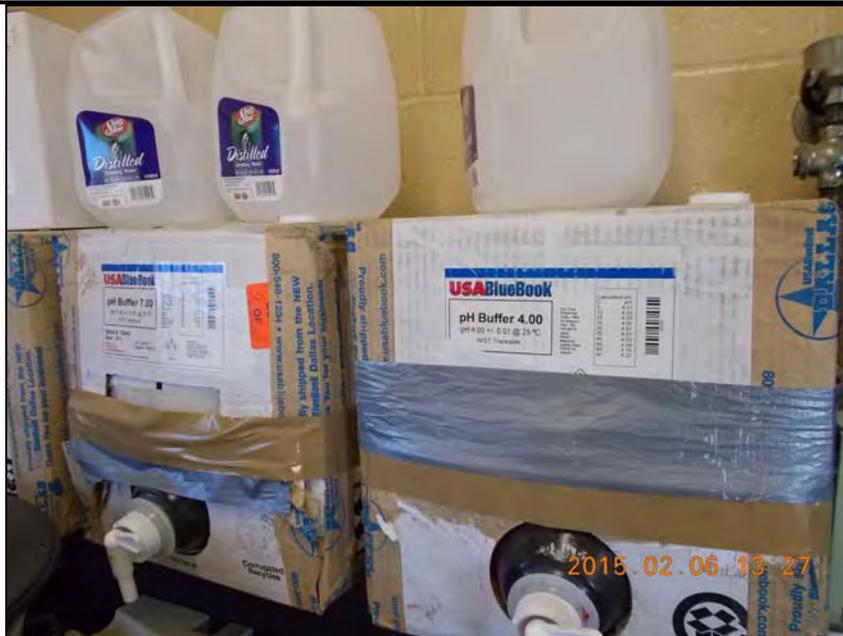
NMED/SWQB
Official Photograph Log
Photo # 20

Subject: The pH buffer. The dates the boxes were opened should be hand written and initialed on the containers.
