Re: Town of Red River WWTP, Minor, Individual Permit; SIC 4952; NPDES Compliance Evaluation Inspection; NM0024899; June 30, 2016

NPDES Compliance Inspection Report

**Compliance Evaluation Inspection
Red River Wastewater Treatment Plant
Permit #: NM0024899
June 30, 2016**

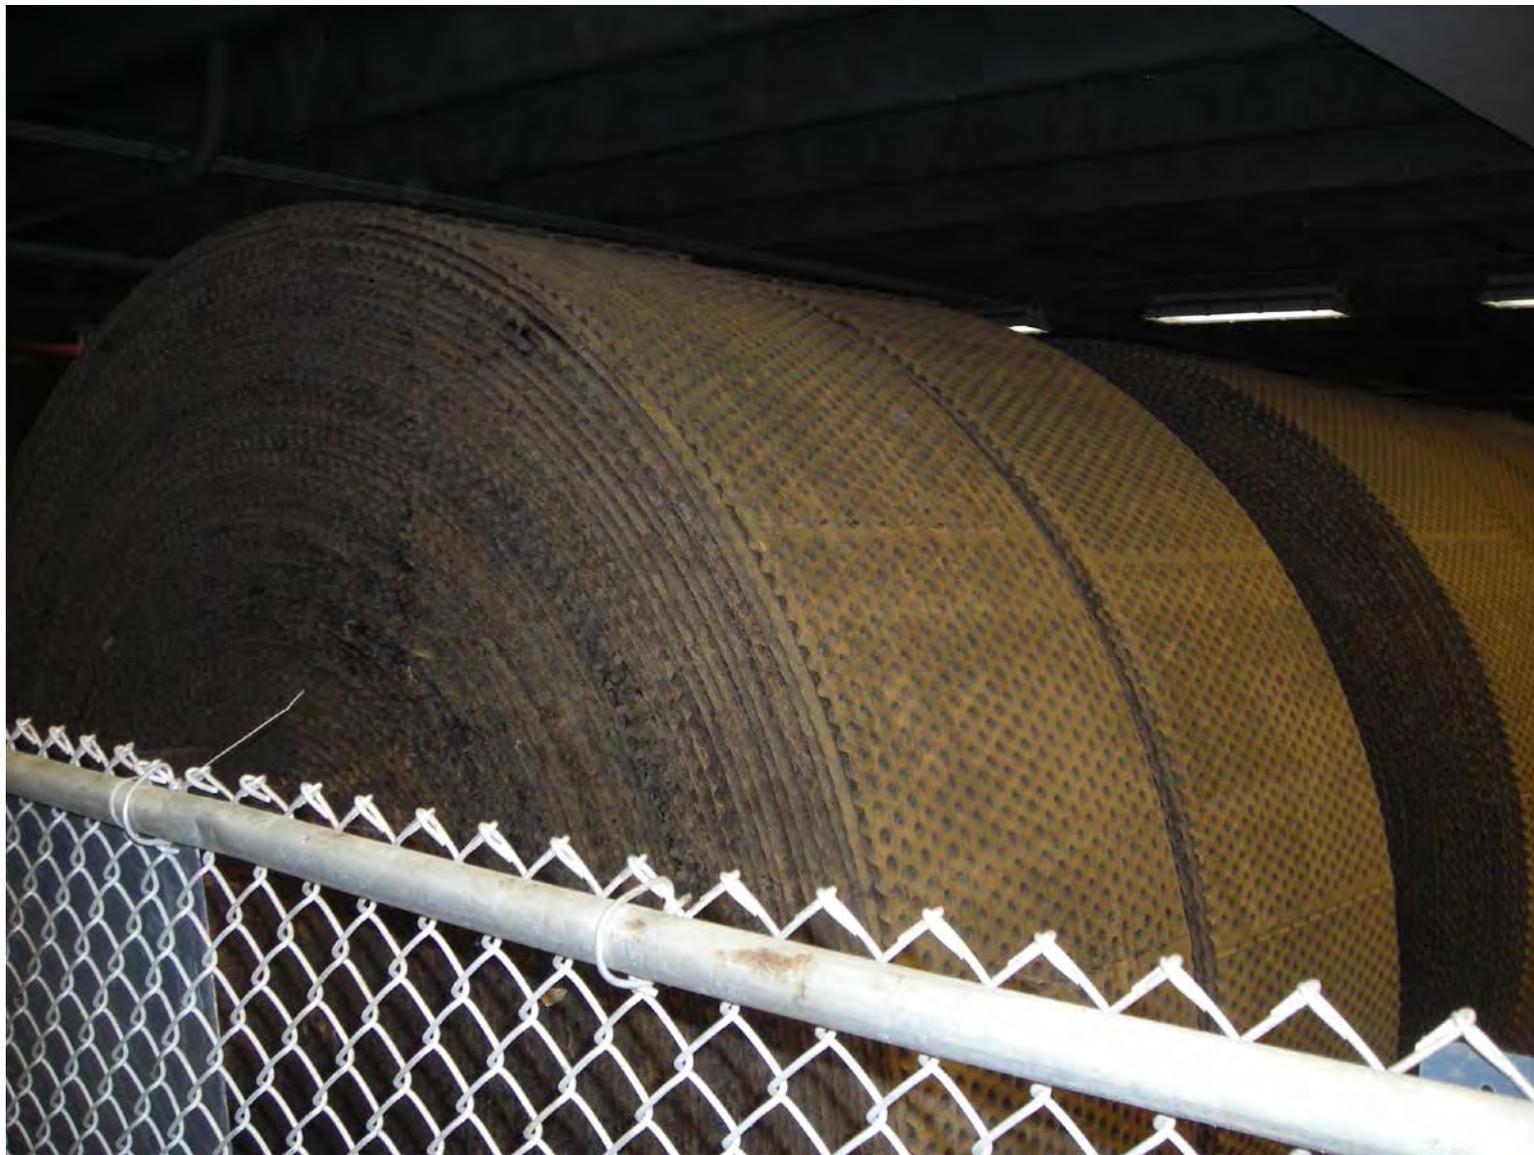
NMED/SWQB
Official Photograph Log
Photo # 1

Photographer: Sarah Holcomb	Date: 6-30-2016	Time: 0945 hours
City/County: Near Red River, Taos County		
Location: Red River Waste Water Treatment Plant		
Subject: RBC train #2 – note the missing cassettes (one at the end on the left side of the photo and the other toward the right side of the photo.)

The second bank of rotating biological contactors (RBCs) was down at the time of this inspection. Three cassettes were missing from the bank as well. The facility's operation and maintenance manual states that each bank of RBCs is capable of handling approximately 0.3 mgd flow, and the facility's current influent flow at the time of this inspection was approximately 0.689 mgd, with two banks of RBCs online. Because RBCs take a while to generate the appropriate biomass to be able to adequately treat wastewater, some consideration should be given to fluctuations in influent flow/plant capacity. Red River is a small town that experiences high fluctuations in flow due to incoming populations during the summer and holidays. The facility should consider developing SOPs that detail the amount of time it takes to bring an RBC online in order to have it available during high flow/high demand periods. It may take several weeks to bring the new train completely online with enough biological media to effectively treat the wastewater. Over the past two years, there have been exceedances of the lower pH limit, and one daily maximum limit for E. coli.

Previous inspection reports have detailed that the RBCs in use at this facility are out of date (original to the plant, which was constructed in 1983), and thus spare parts are not able to be obtained when there is a breakdown. In the past, the facility has obtained replacement parts from other plants that have upgraded to newer technology. During this inspection, Mr. Church indicated that the Town has completed a preliminary engineering review (PER) as of July 2014, and as part of that review intends to replace the current RBCs with a newer RBC technology. The PER indicates that the new media will have a higher surface area. The existing Type 1 media, which is discontinued, will be replaced with Type 2 media, which consists of individual wedge shaped sheets of high molecular polyethylene. According to permittee representatives, this media would be easier to change out if there are issues that require repair. The Town just passed a general obligation bond which can be used for water or wastewater repairs. Permittee representatives indicated that the company "RBC Services" will be doing the work and replacement of the RBCs may occur in phases in order to avoid interrupting treatment capability.

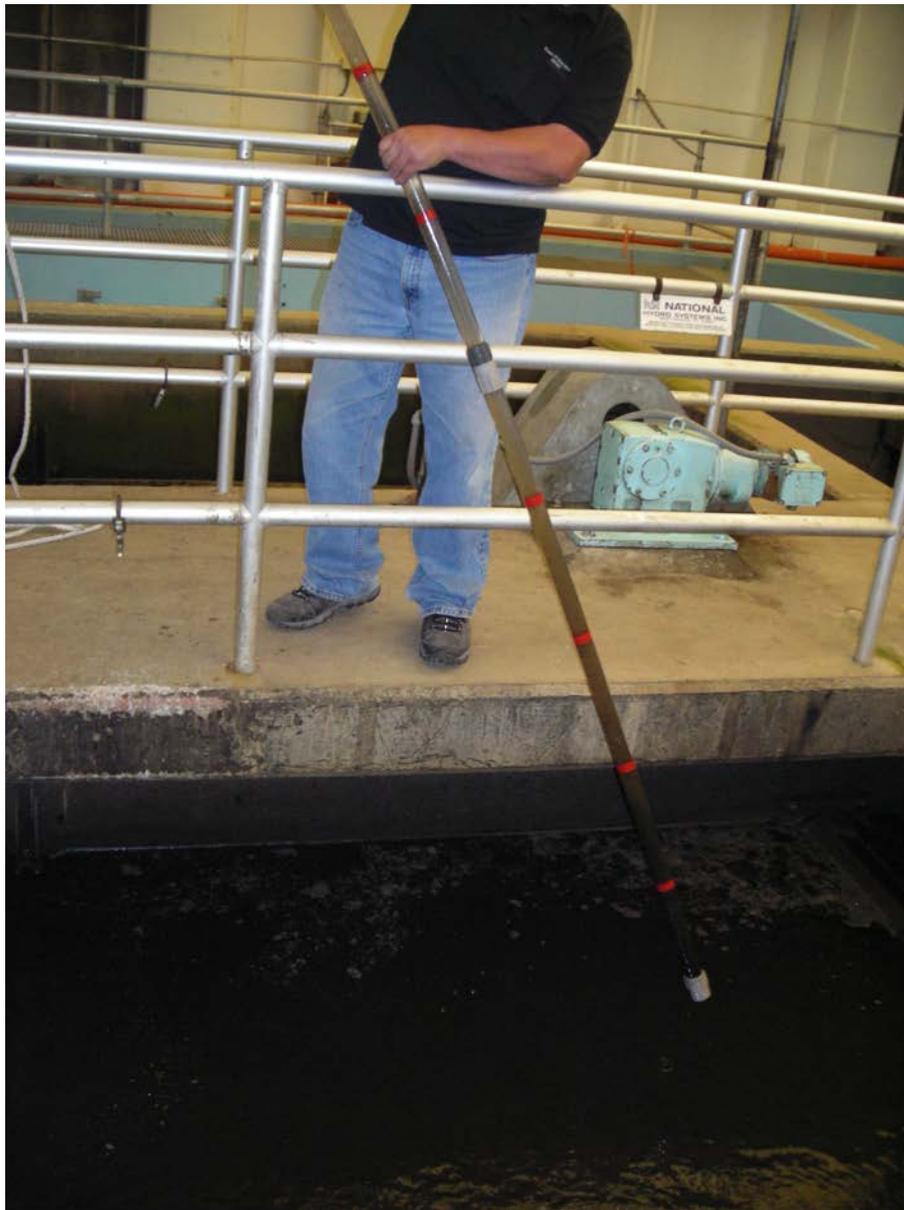
NMED/SWQB
Official Photograph Log
Photo # 2

Photographer: Sarah Holcomb	Date: 6-30-2016	Time: 0951 hours
City/County: Near Red River, Taos County		
Location: Red River Waste Water Treatment Plant		
Subject: Sludge judge taken from the scum pit prior to the rectangular clarifiers. There was about 2 feet of sludge in the 11 ft basin.

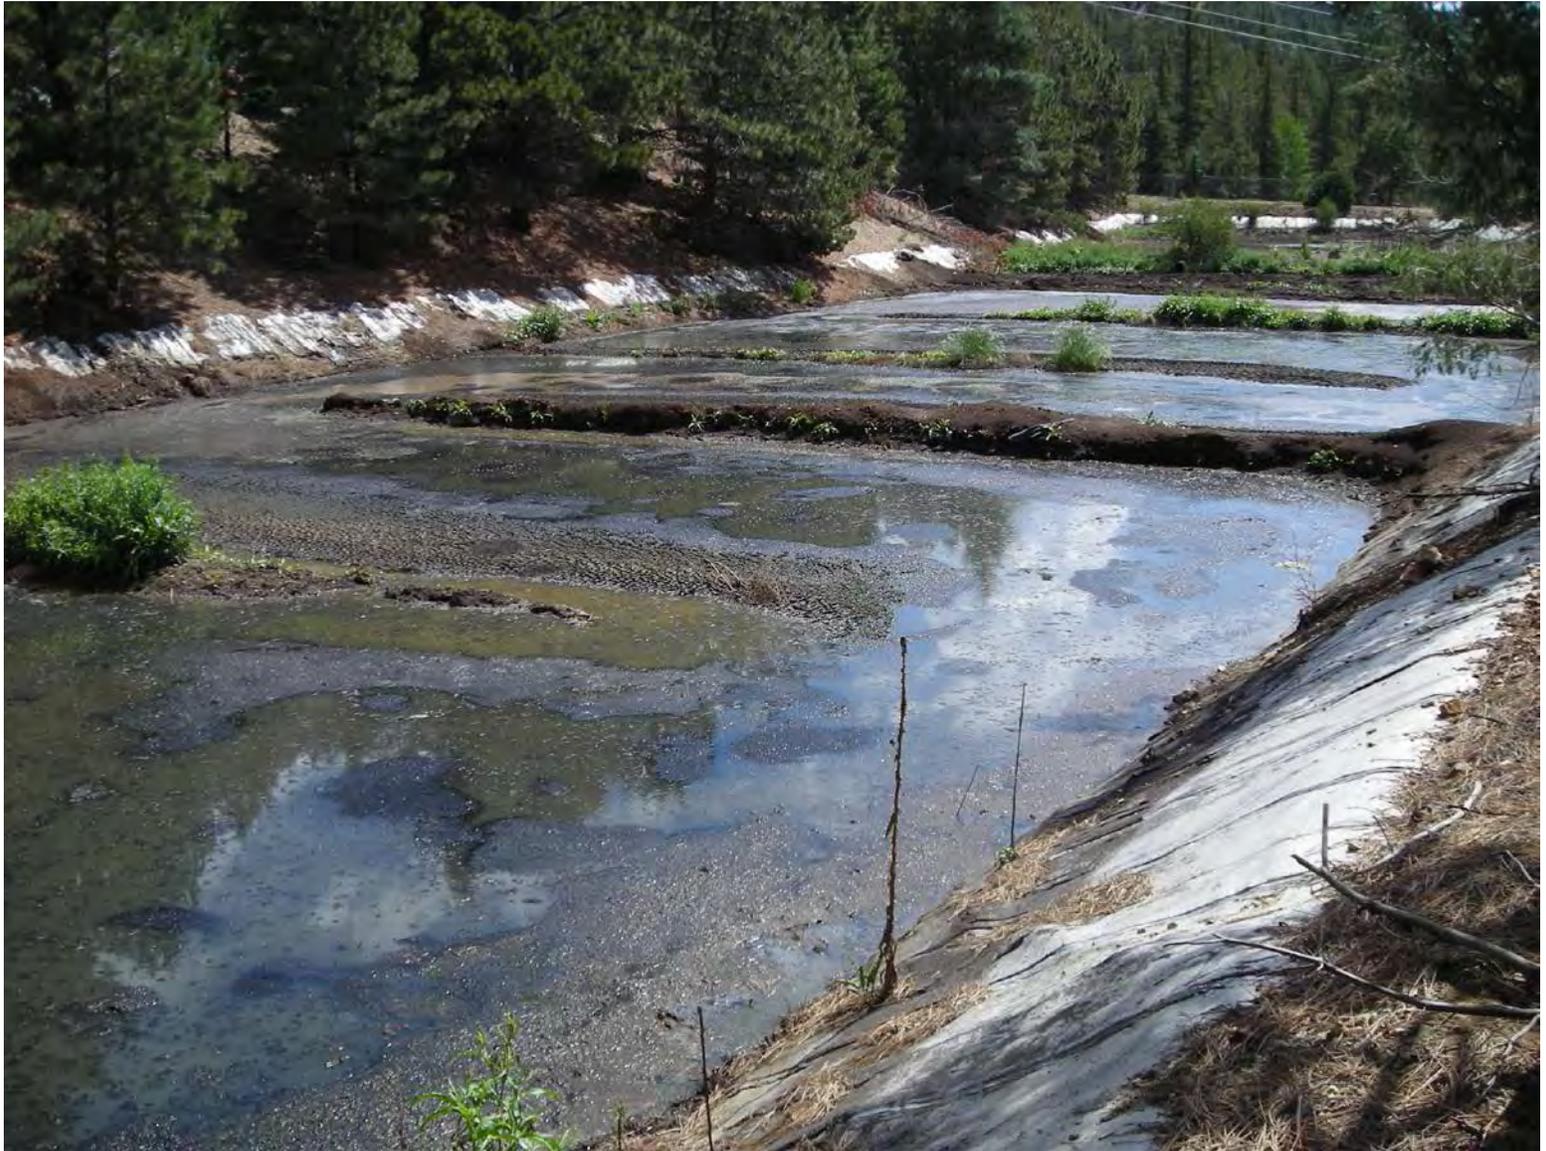
NMED/SWQB
Official Photograph Log
Photo # 3

Photographer: Sarah Holcomb	Date: 6-30-2016	Time: 1043 hours
City/County: Near Red River, Taos County		
Location: Red River Waste Water Treatment Plant		
Subject: Sludge lagoons. There was a heavy rain the day before the inspection.

As noted in past inspection reports, the sludge drying beds are cracked and leaking. The sludge lagoons are located on Forest Service property. Permittee representatives indicated that they will be installing groundwater monitoring wells in the near

future. This methodology of sludge treatment is not effective for this microclimate. During the winter, the beds freeze and it is not possible to treat the solids effectively, and during the summer, the lagoons are open and exposed to monsoon rains. It takes a long period of time to sufficiently dry out the solids in order to remove them from the drying beds. At the time of this inspection, permittee representatives indicated that the most recent solids removal effort occurred a year and a half ago, and the material was disposed by composting with wood chips and giving the compost away. Permittee representatives also indicated that work has progressed with the Forest Service and an agreement has been made based on the Small Tract Act. This land acquisition by the Town will allow the facility to evaluate plans to put in more effective sludge treatment options, such as a belt press – if all goes as planned, the Town would own land from where the sludge beds/lagoons are currently located all the way down to the highway.

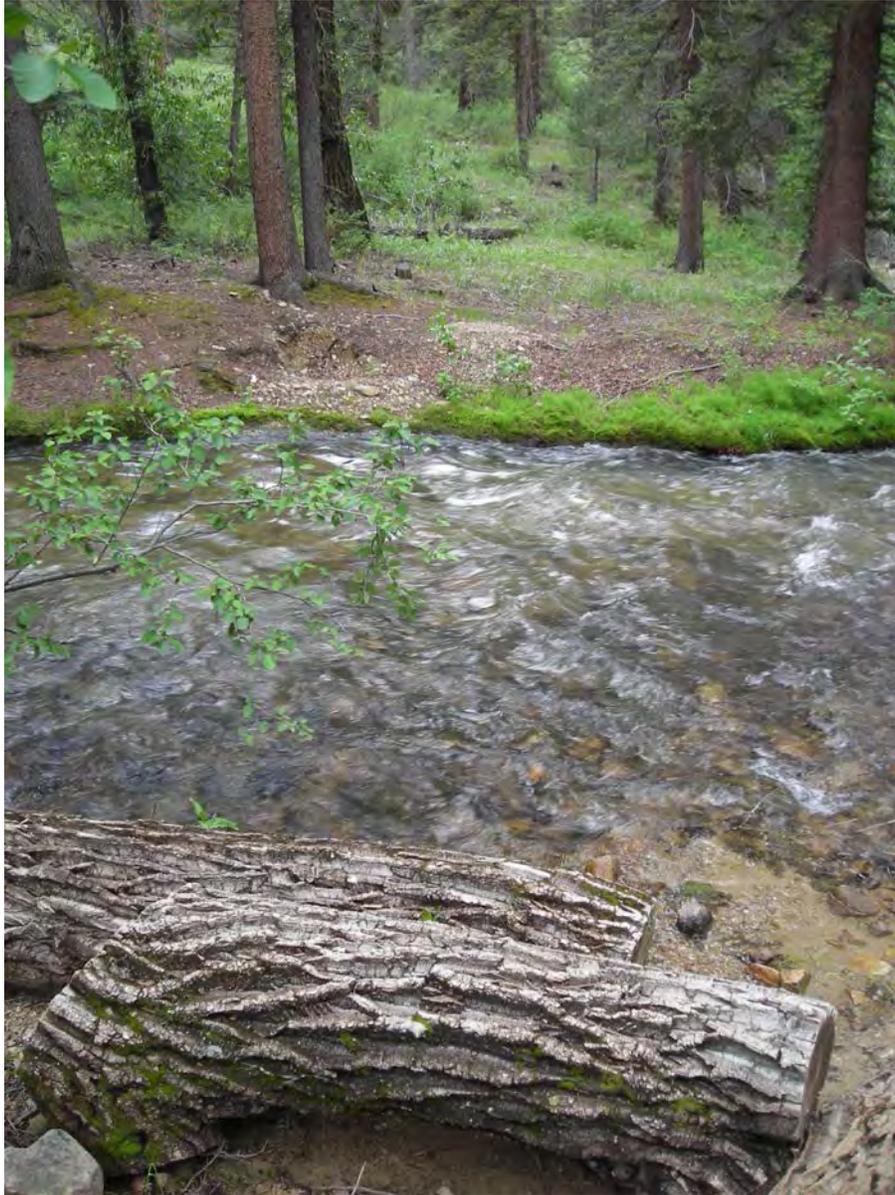
NMED/SWQB
Official Photograph Log
Photo # 4

Photographer: Sarah Holcomb	Date: 6-30-2016	Time: 1155 hours
City/County: Near Red River, Taos County		
Location: Red River Waste Water Treatment Plant		
Subject: Outfall 001. The excavated area on the far side of the Red River is the effluent cleanout.
