RE: Minor Municipal, SIC 4952, NPDES Compliance Evaluation Inspection, Santa Rosa
Wastewater Treatment Plant (WWTP), NPDES Permit No. NM0024988, July 23, 2015

NPDES Compliance Inspection Report

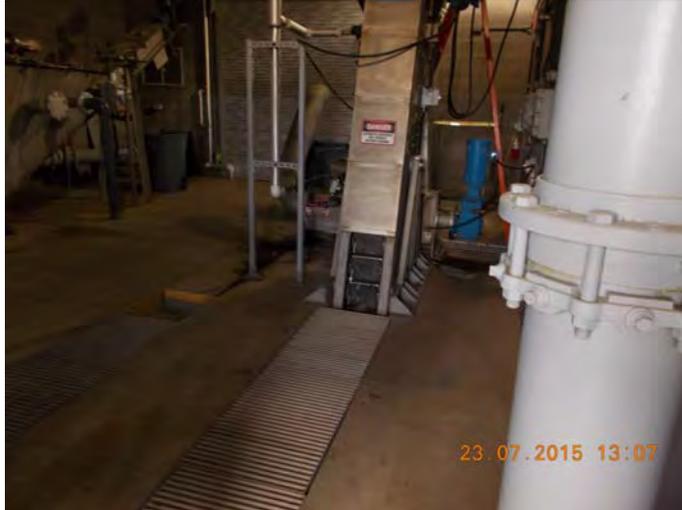
NMED/SWQB
Official Photograph Log
Photo # 1

Subject: Influent automatic bar screen with a grinder unit to remove large solids from entering the treatment works.

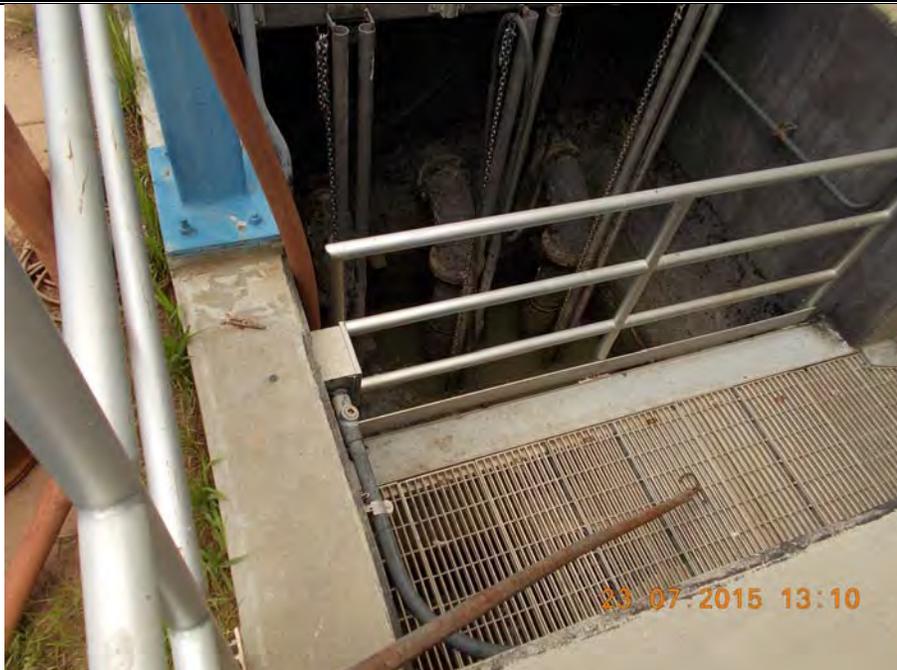
NMED/SWQB
Official Photograph Log
Photo # 2

Subject: Lift station at head works of WWTP with 3 Flygt pumps, activated by floats that detect the height of the water level.

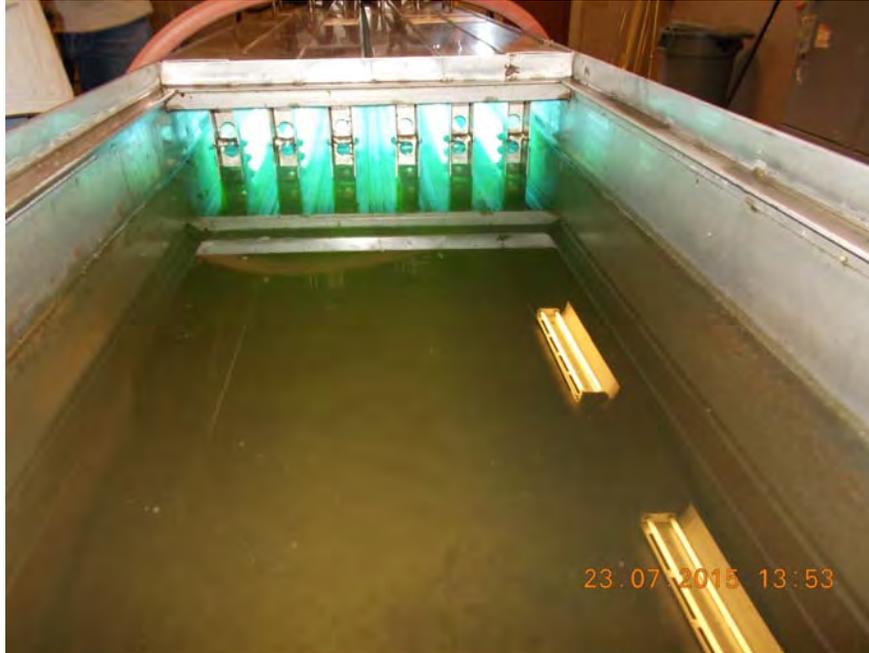
NMED/SWQB
Official Photograph Log
Photo # 3

Subject: Ultra Violet (UV) disinfection system, two trains are run parallel. This photo is of one of the two trains. There were solids present in the basin. Solids should settle in the secondary clarifier and be wasted before reaching the UV system.

3. The UV treatment units had algae growth on the lights and the sides, A fine layer of solids were settling in the bottom of the channel. Operators said the channels and lights were cleaned weekly and the only reason they were not cleaned on this day, was because the inspector was taking them away from their normally scheduled tasks. It is advisable that these units be cleaned more frequently due to the ammount of interference to the light transmittance by the algae and solids. At the time of the inspection the light

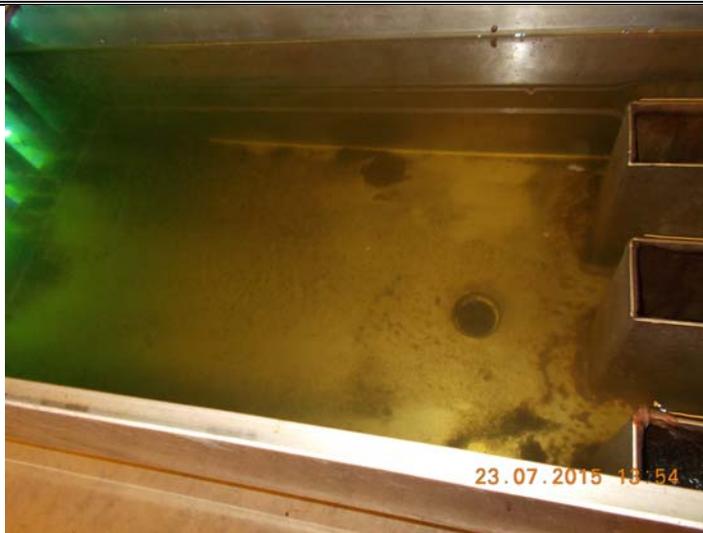
NMED/SWQB
Official Photograph Log
Photo # 4

Subject: Another view of the Ultra Violet (UV) disinfection system, two trains are run parallel. This photo is of one of the two trains. There were solids present in the basin. Solids should settle in the secondary clarifier and be wasted before reaching the UV system.

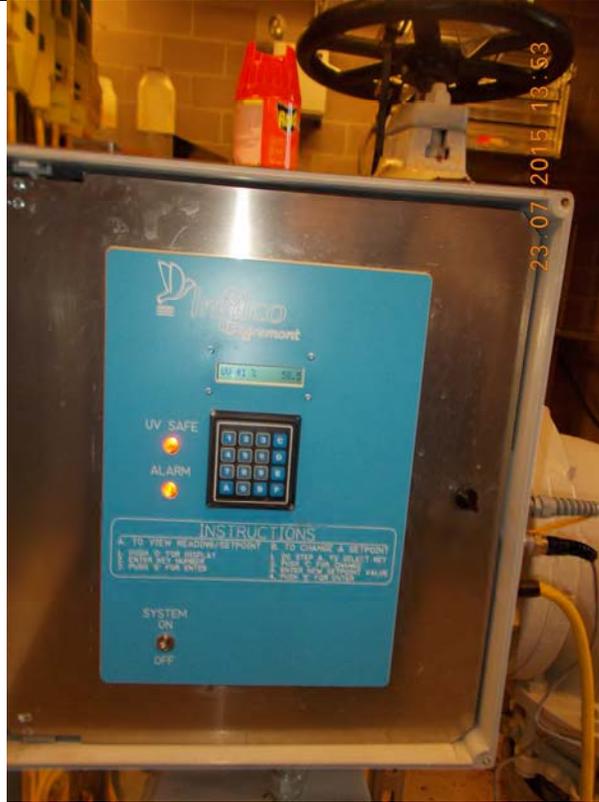
NMED/SWQB
Official Photograph Log
Photo # 5

Subject: Light transmittance in the Ultra Violet Disinfection Chamber is 58.5%. The water was slightly turbid in the chamber and at the discharge.

transmittance was 58%. According to the design engineer, Mr. Ed Dubois the UV light should be functional with even as low as 55% depending on flow rate. However, the E. coli bacterial exceedences indicate that disinfection has not always been adequately achieved.

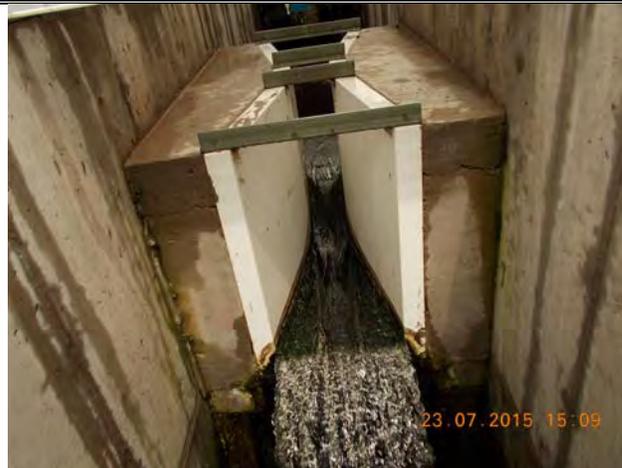
NMED/SWQB
Official Photograph Log
Photo # 6

Subject: Flow Measurement at the Parshall Flume w/ Staff Gauge and Ultrasonic Flow Meter. The flow is free of turbulence and is a good representation of laminar flow.

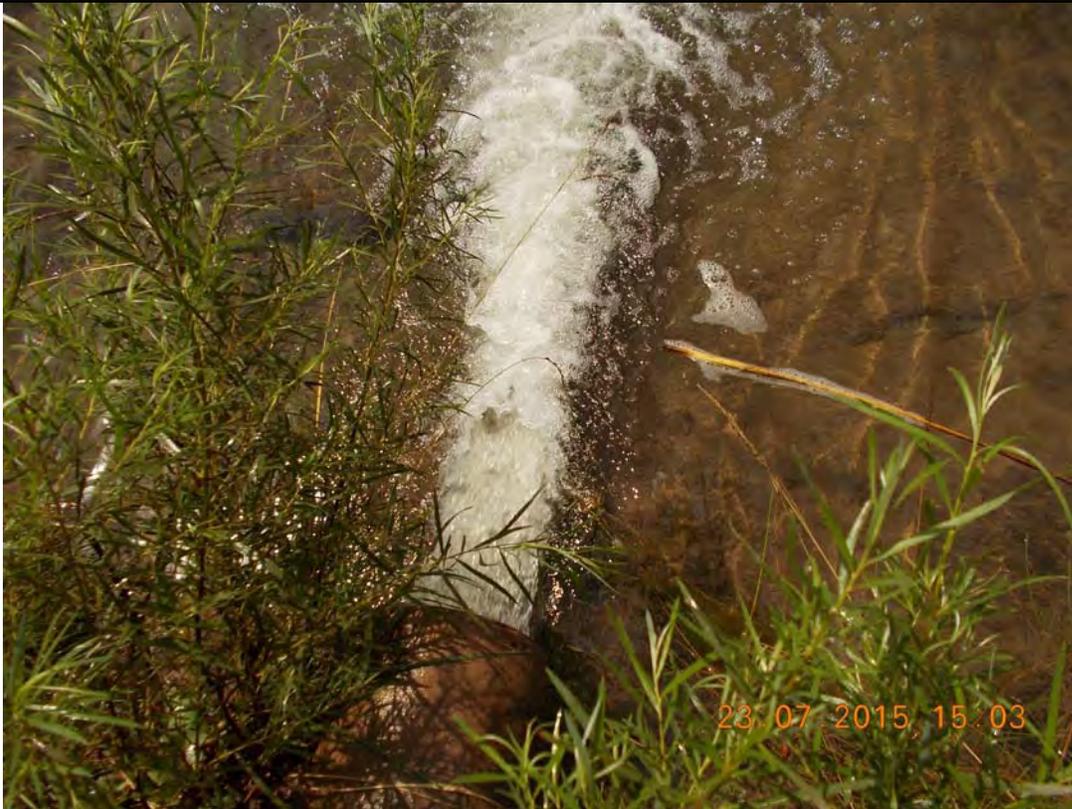
NMED/SWQB
Official Photograph Log
Photo # 7

Subject: WWTP outfall pipe to El Rito Creek. Effluent is free of floating solids.
