Re: Sandia Peak Tramway, Minor, Individual Permit; SIC 4952; NPDES Compliance Evaluation Inspection; NM0027863; April 30, 2014

NPDES Compliance Inspection Report

Sandia Peak Tramway Company WWTP
NPDES Permit No. NM0027863
Compliance Evaluation Inspection
April 30, 2014

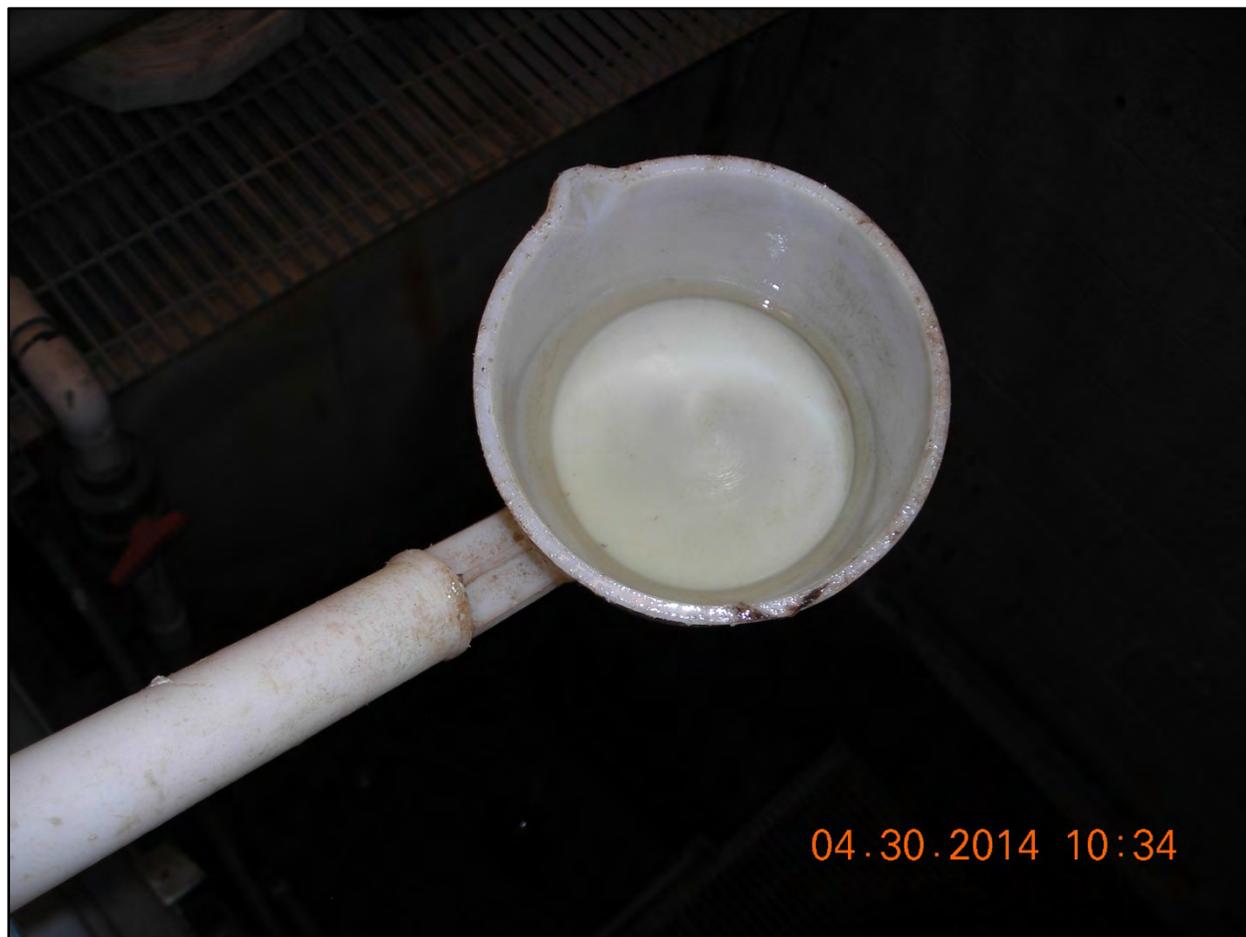
Photo # 1

Photographer: Sarah Holcomb	Date: 4-30-2014	Time: 1034 hours
City/County: Albuquerque, Bernalillo County		
Location: Sandia Peak WWTP at the Sandia Crest.		
Subject: Effluent pulled from the discharge basin. This picture is included since the outfall cannot be observed.
