**RE: Major Municipal, SIC 4952, NPDES Compliance Evaluation Inspection, Rio Rancho  
Wastewater Treatment Plant #2, NM0027987, February 11, 2016**

### NPDES Compliance Inspection Report

Compliance Evaluation Inspection  
Rio Rancho # 2  
Wastewater Treatment Plant  
NPDES Permit No. NM0027987  
Date of Inspection: February 11, 2016

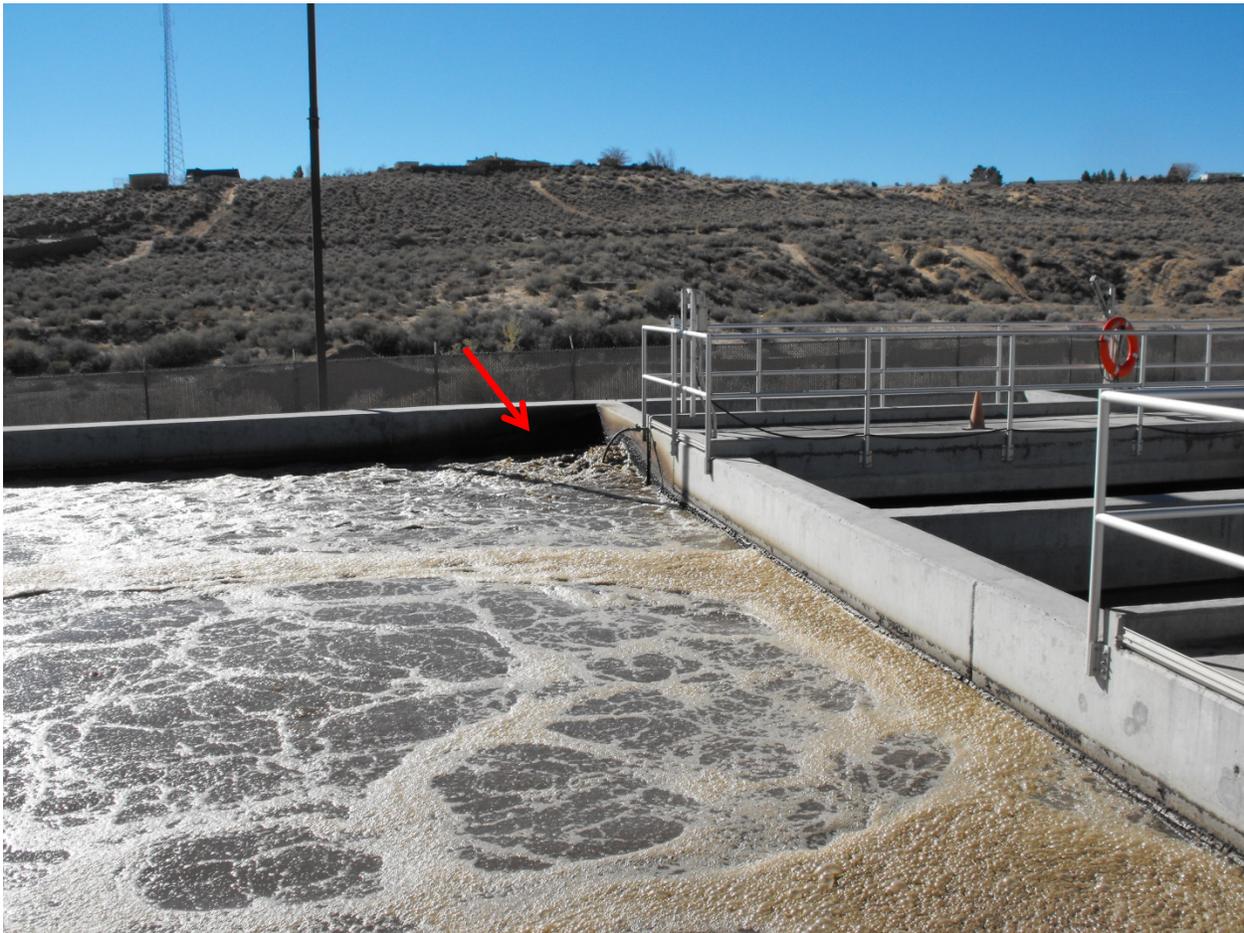
**NMED/SWQB  
Official Photograph Log  
Photo # 1**

In one of the aeration basins there was a broken line that is in need of repair. The broken line is causing disruptive air flow in the basin.

Photographer: Daniel Valenta	Date: February 11, 2016	Time: 1035 Hours
City/County: City of Rio Rancho / Sandoval County		State: New Mexico
Location: City of Rio Rancho Wastewater Treatment Plant #2		
Subject: Aeration Basin – Broken line causing uneven air diffusion

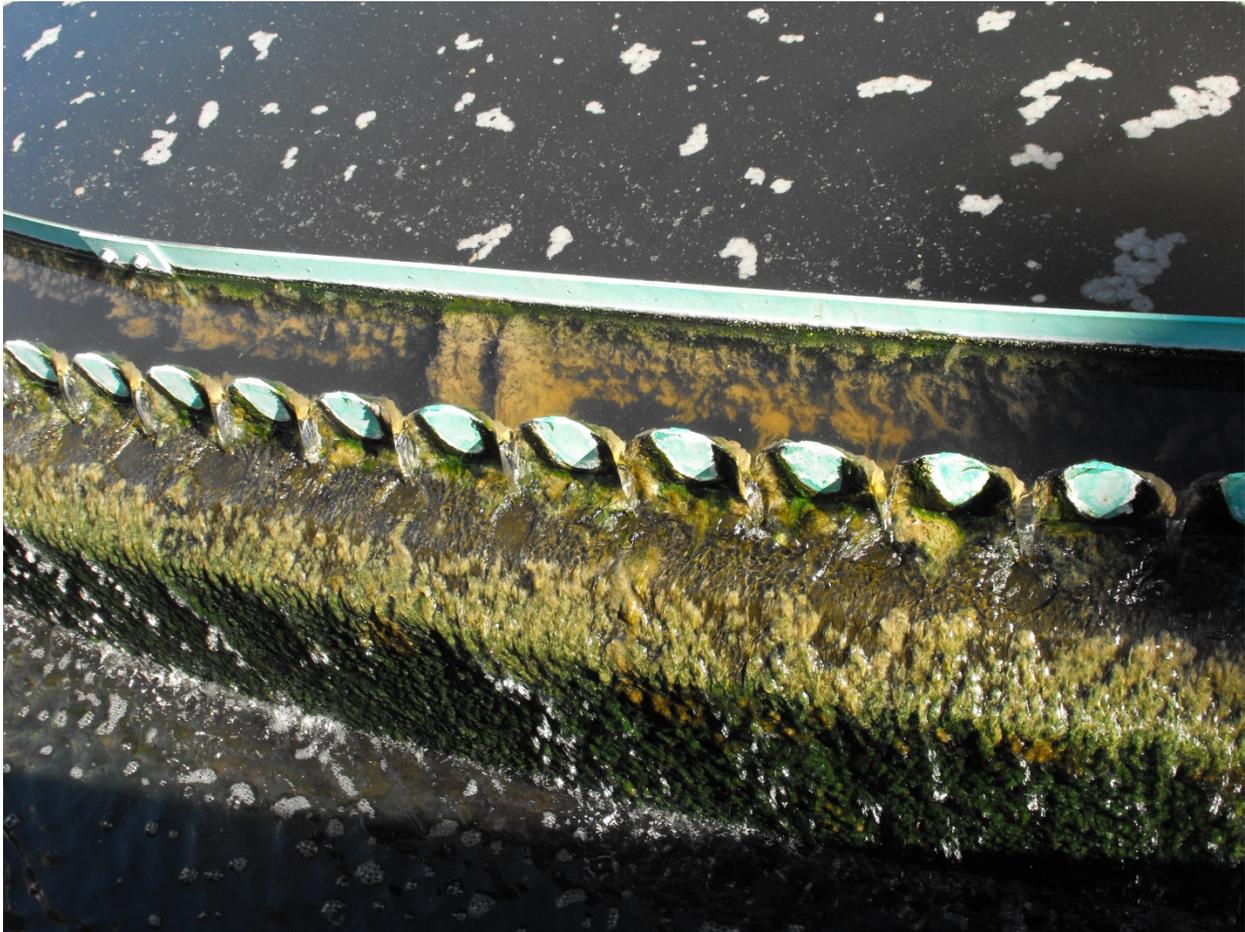
**NMED/SWQB  
Official Photograph Log  
Photo # 2**

The east and west clarifiers in plant 2B were having problems draining through the sump system. Mr. De Lara and his operators were working on this while we were there. Mr. De Lara hopes to have both the east and west clarifiers fixed by Saturday. When we were leaving, conversations with operators suggested that the west clarifier had been fixed but they were still working on the east clarifier.

Photographer: Daniel Valenta	Date: February 11, 2016	Time: 1035 Hours
City/County: City of Rio Rancho / Sandoval County		State: New Mexico
Location: City of Rio Rancho Wastewater Treatment Plant #2		
Subject: Clarifier

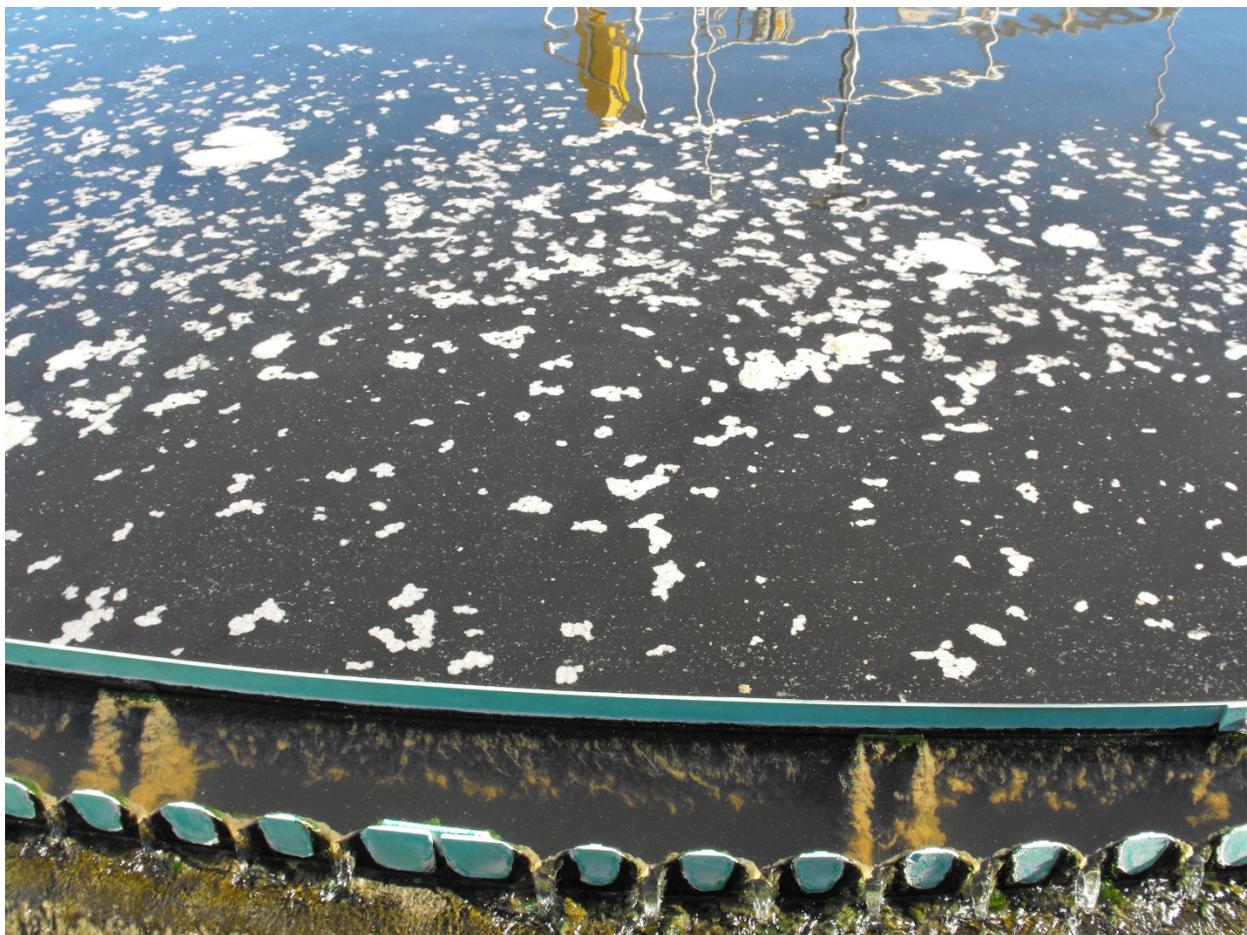
**NMED/SWQB  
Official Photograph Log  
Photo # 3**

Photographer: Daniel Valenta	Date: February 11, 2016	Time: 1037 Hours
City/County: City of Rio Rancho / Sandoval County		State: New Mexico
Location: City of Rio Rancho Wastewater Treatment Plant #2		
Subject: Clarifier

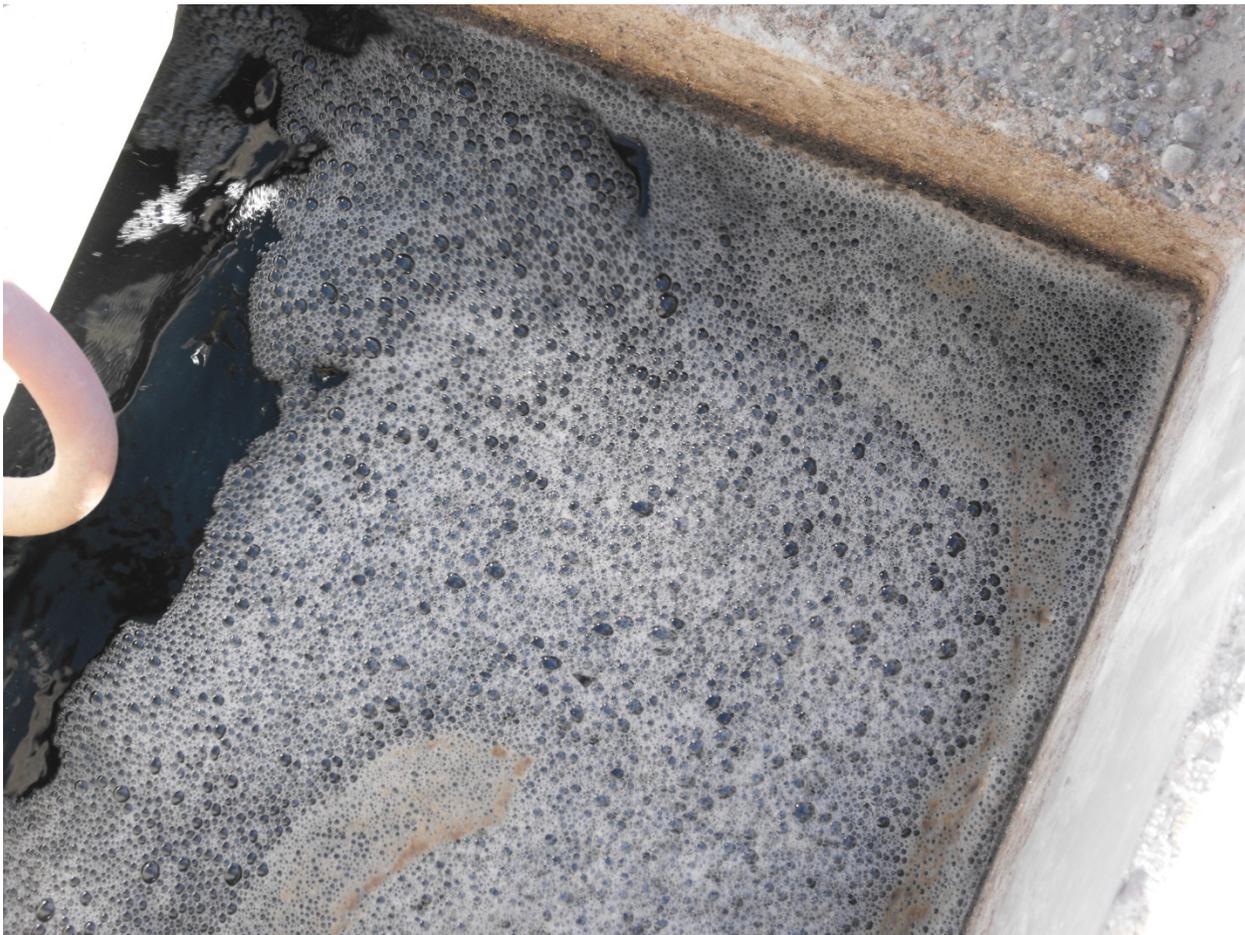
**NMED/SWQB  
Official Photograph Log  
Photo # 4**

The Ultraviolet Light (UV) system had some foaming prior to the effluent entering the treatment unit. Although, this may inhibit the ability for the UV system to kill bacteria, the permittee has had no exceedances for E.coli or for TSS. Mr. De Lara stated that the foam is sprayed down on Saturday during the routine cleaning.

Photographer: Daniel Valenta	Date: February 11, 2016	Time: 1120 Hours
City/County: City of Rio Rancho / Sandoval County		State: New Mexico
Location: City of Rio Rancho Wastewater Treatment Plant #2		
Subject: Ultraviolet channel – foaming prior to entering the UV system
