**Re: Town of Las Vegas Waste Water Treatment Plant; Major; Municipal; SIC 4952; NPDES
Compliance Evaluation Inspection; NPDES Permit NM0028827; June 11, 2014**

NPDES Compliance Inspection Report

City of Las Vegas Wastewater Treatment Plant
Compliance Evaluation Inspection
NPDES Permit Number NM0028827
June 11, 2014
Page 1 of 9

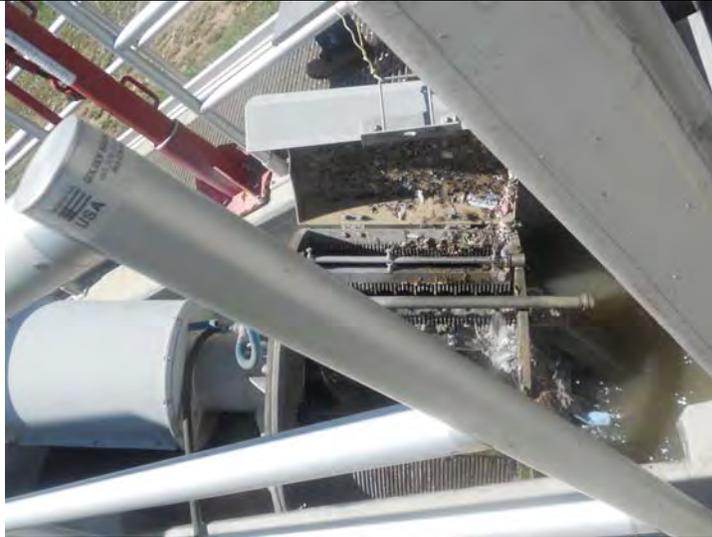
Subject: Headworks Bar Screen

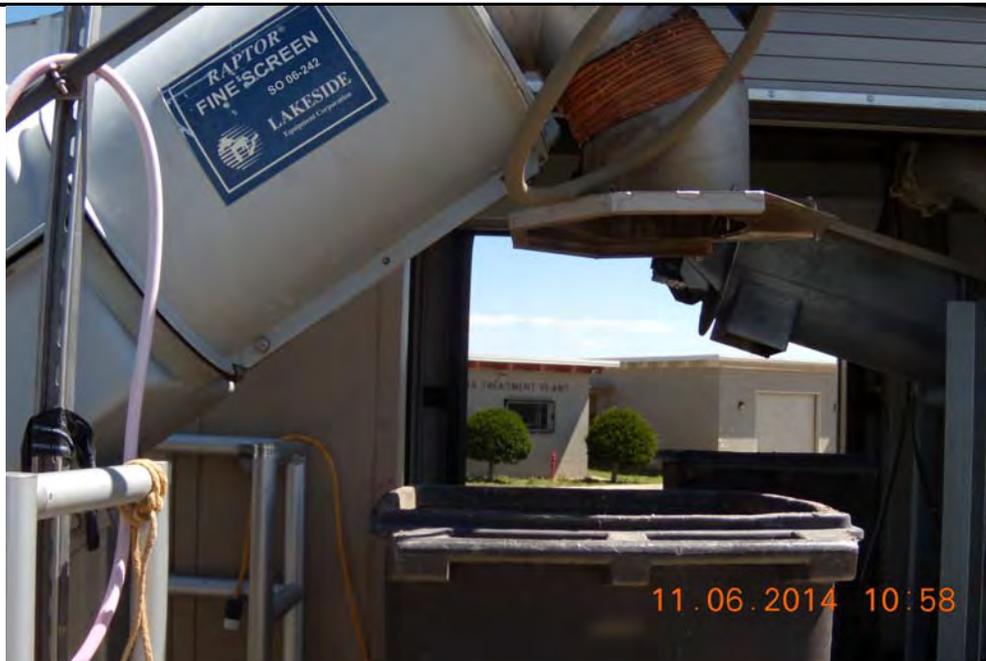
NMED/SWQB
Official Photograph Log
Photo # 2

Subject: Headworks Bar Screen – grit removal system

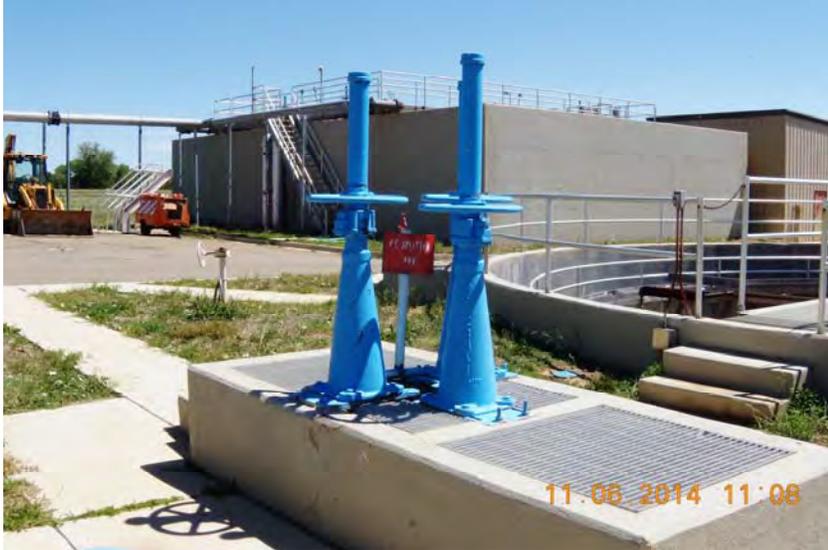
NMED/SWQB
Official Photograph Log
Photo # 3

Subject: Splitter box following headworks

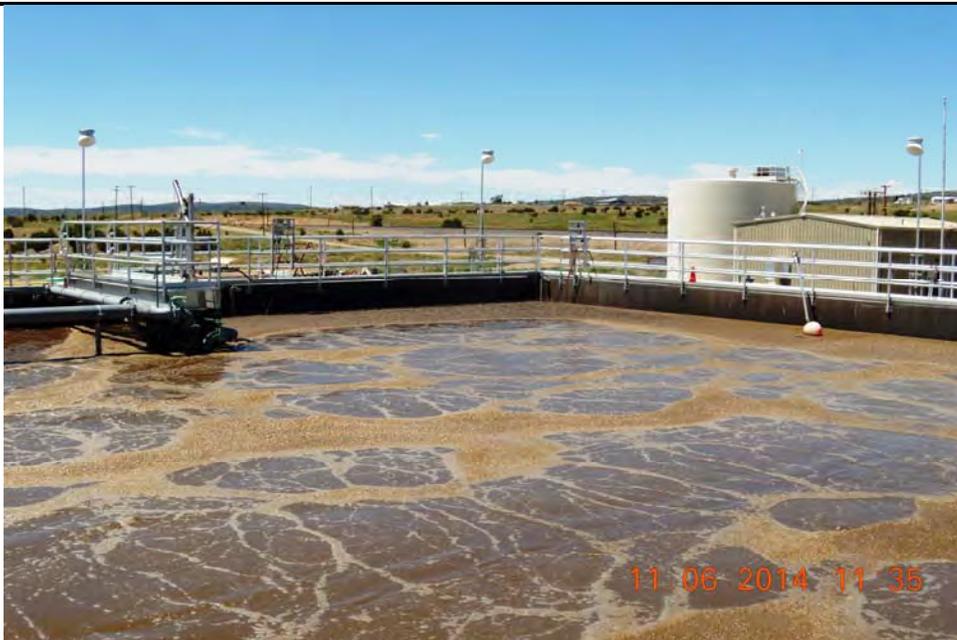
NMED/SWQB
Official Photograph Log
Photo #4

Subject: AB Basin – anoxic zone

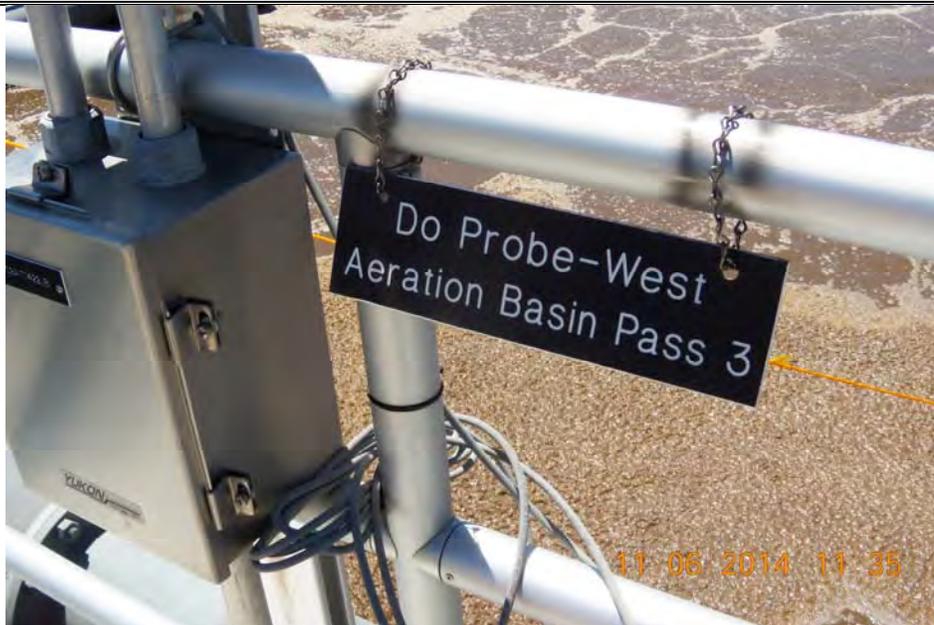
NMED/SWQB
Official Photograph Log
Photo #5

1. The Dissolved Oxygen (DO) meters in the AB basin are not working. A hand DO meter is being used. It is suggested the continuous reading DO meters be replaced and records be maintained of those readings for the purpose of operational controls.

Subject: AB basin – intermediate zone. The Dissolved Oxygen probes were not working in this basin.

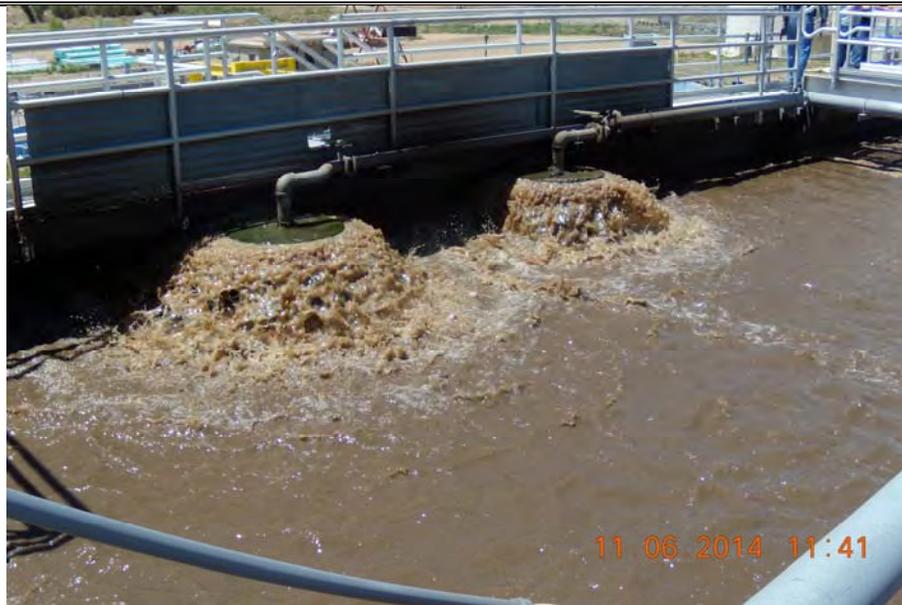
NMED/SWQB
Official Photograph Log
Photo # 6

Subject: AB basin – Returned Activated Sludge

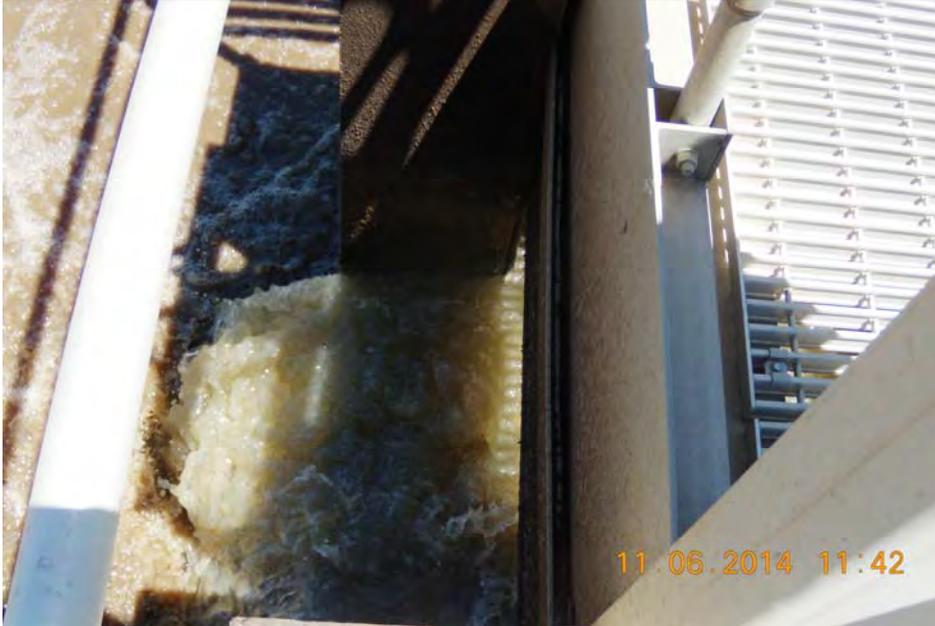
NMED/SWQB
Official Photograph Log
Photo # 7

Subject: Decant from the AB basins going to the Secondary Clarifiers.

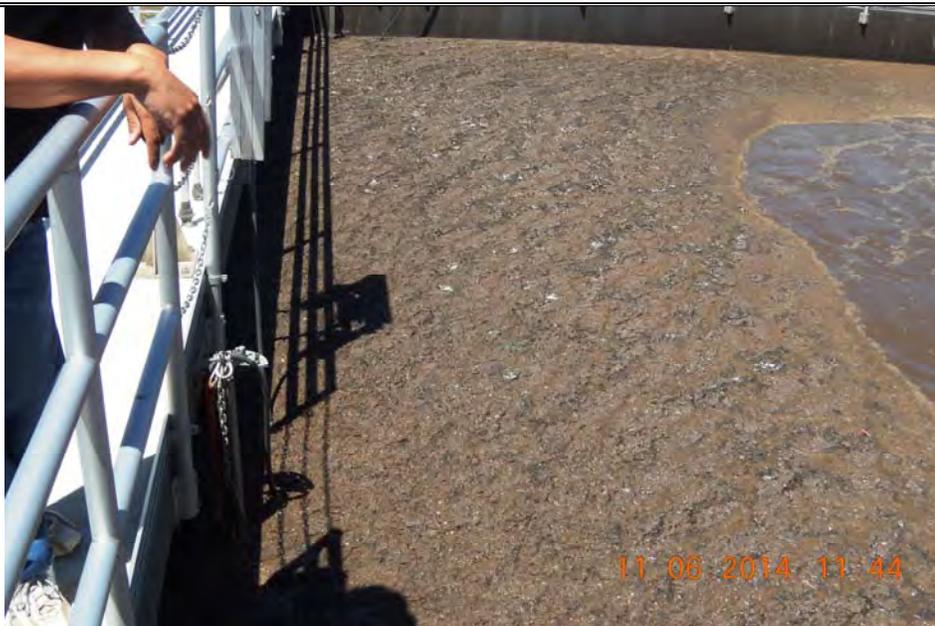
NMED/SWQB
Official Photograph Log
Photo # 8

Subject: Anoxic zone in the AB basin. Note the floating foam and the particulate solids that have made it through the headworks. Some portions of these solids are also making it to the secondary clarifiers.

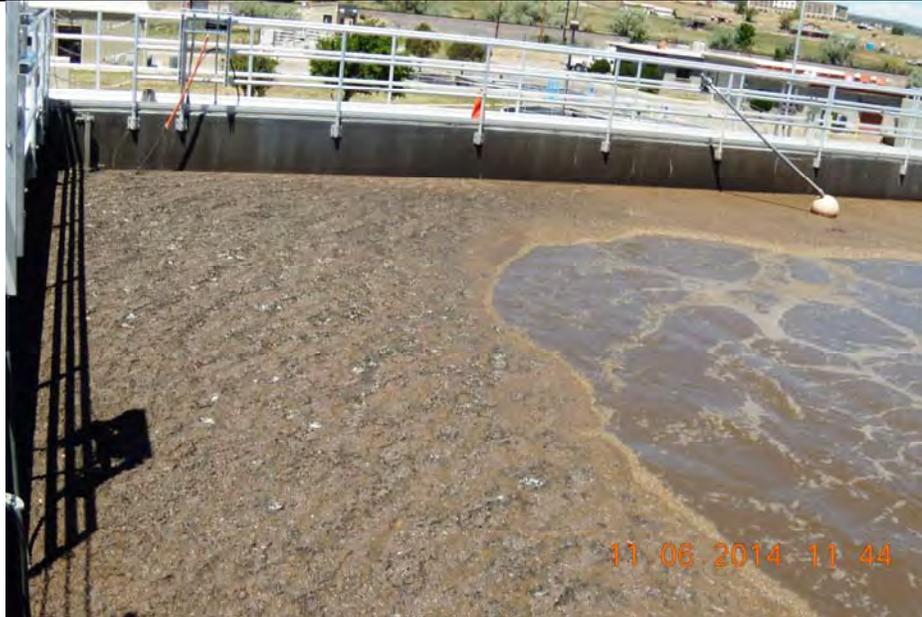
NMED/SWQB
Official Photograph Log
Photo # 9

Subject: Another view of Anoxic zone in the AB basin. Note the floating foam and the particulate solids that have made it through the headworks. Some portions of these solids are also making it to the secondary clarifiers. Note the DO probe. These DO probes should be repaired or replaced.

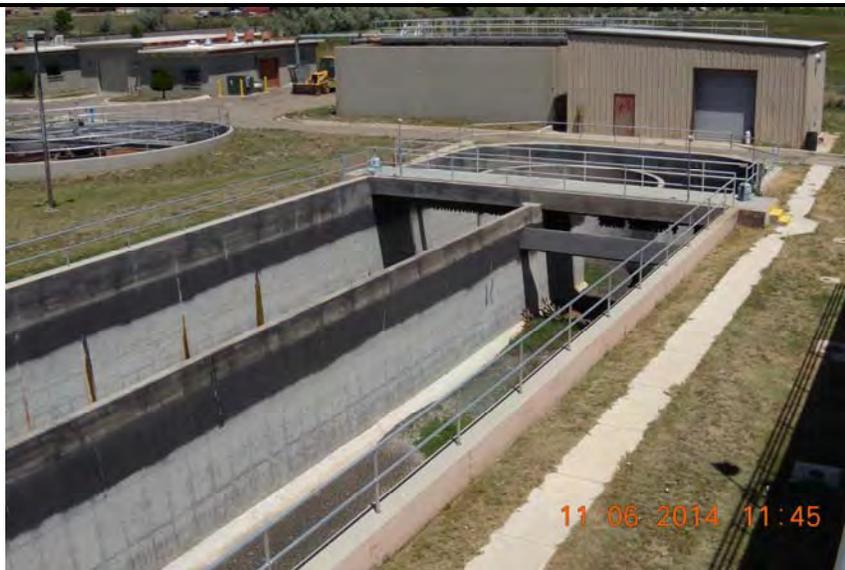
NMED/SWQB
Official Photograph Log
Photo # 10

Subject: The old raceway treatment system that is no longer in use. This system is still plumbed in so that it can be used for excess wastewater in the event of an emergency.

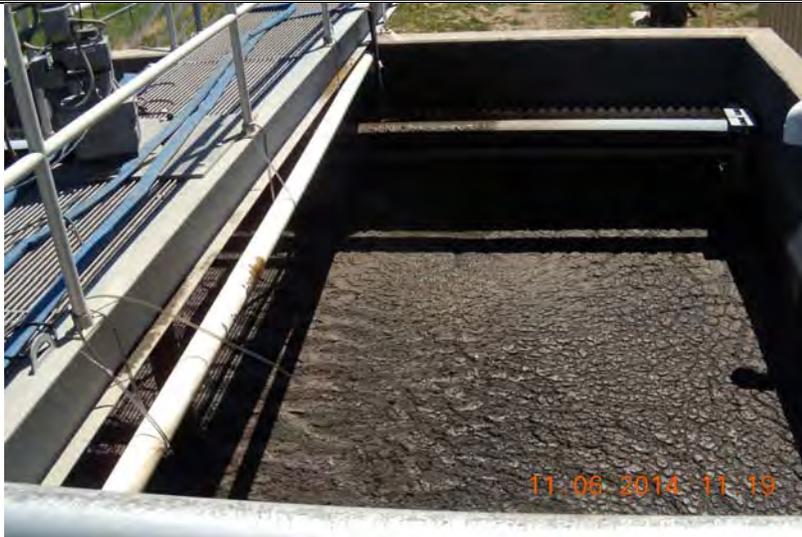
NMED/SWQB
Official Photograph Log
Photo #11

Subject: Sludge Thickener

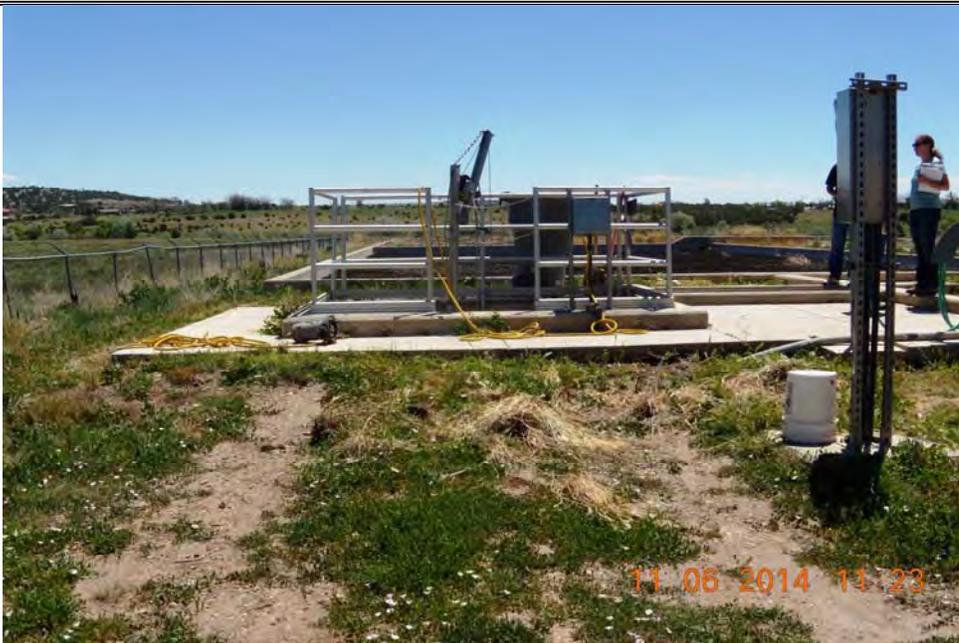
NMED/SWQB
Official Photograph Log
Photo # 12

10. The Septage Receiving Station had signs of splash over and over flows to the ground.
11. Inadequate number of operational and maintenance staff. Several treatment units were not being maintained and/or were off line at the time of the inspection.

Subject: Septage Receiving Station shows signs of over flow and splash out. Better containment for this area to prevent any raw septage from reaching bare ground is suggested.

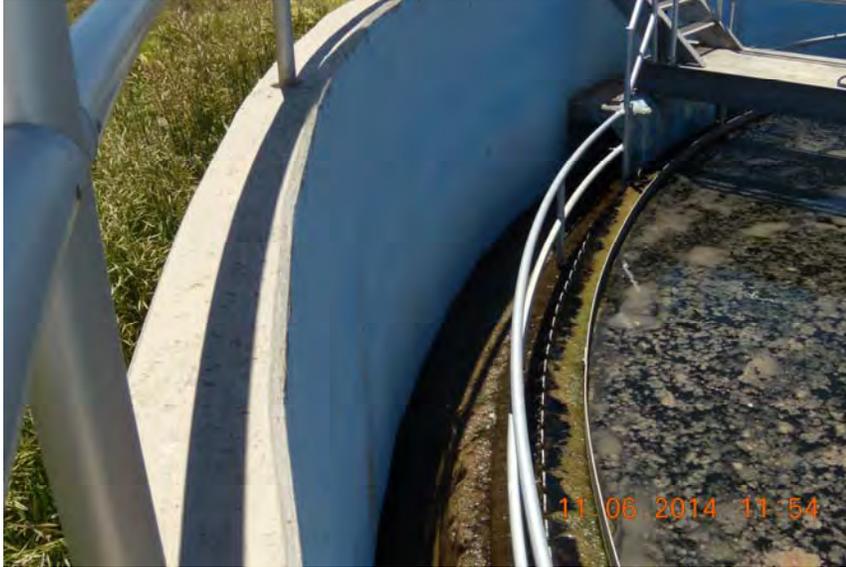
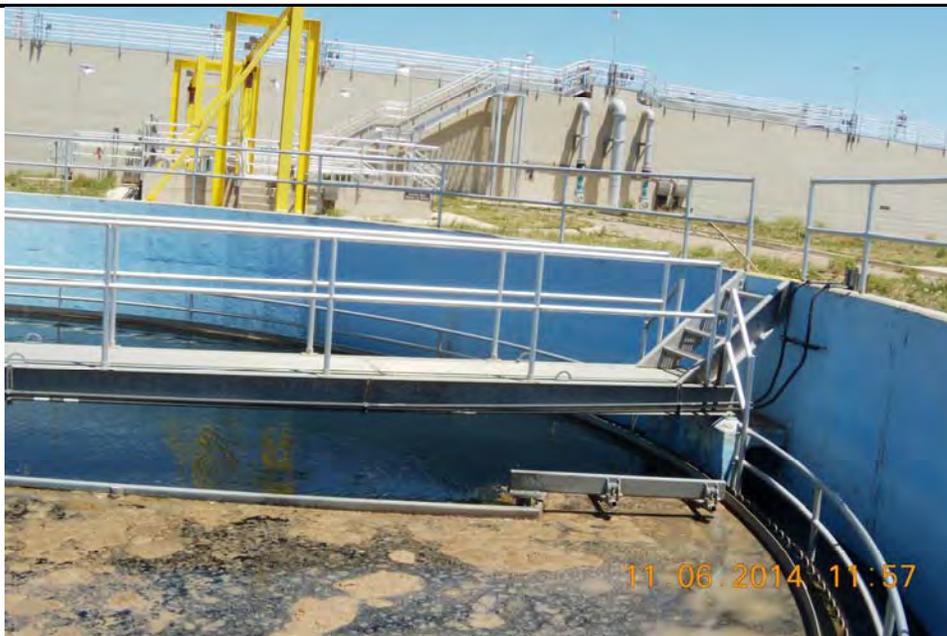
4. Secondary Clarifier – Excessive algae growth was observed on the weirs. According to operators there was training the week of the inspection and no operators were available to do the regular maintenance. According to operators Clarifiers are scheduled to be cleaned Monday of every week.

5. Secondary Clarifiers – The weirs were observed to be uneven around the basin. Short circuiting was observed.
6. The micro filters before the UV disinfection system were off line for cleaning. The design included only one train so there are no back up when the filters are being cleaned.

Subject: Secondary Clarifiers – weirs have heavy algae growth, floating solids in the basin that are being scraped off into the scum trough, and weirs were uneven.

Subject: Subject: Secondary Clarifiers – weirs have heavy algae growth, floating solids in the basin that are being scraped off into the scum trough, and weirs were uneven.

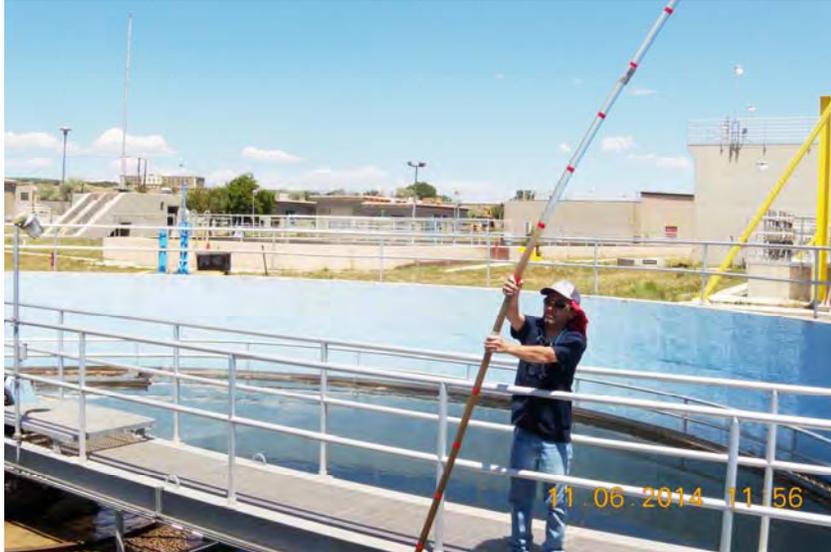
NMED/SWQB
Official Photograph Log
Photo # 15

8. Some turbidity and floating solids were observed in the effluent. This can be a result of the secondary clarifiers and the high sludge blanket maintained in combination with the micro filters being off line.

Subject: Secondary Clarifiers – sludge judge showed 3- 4 foot sludge blanket with several feet of dispersed solids above.

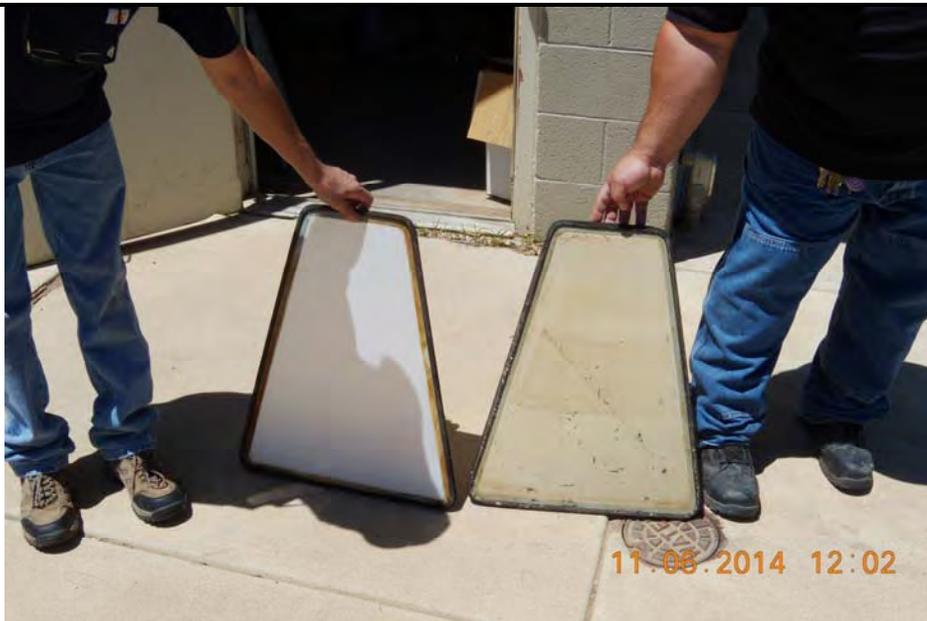
NMED/SWQB
Official Photograph Log
Photo # 16

Subject: Micro filters prior to disinfection. The filter on the right was going to be cleaned. The filter on the left is new.

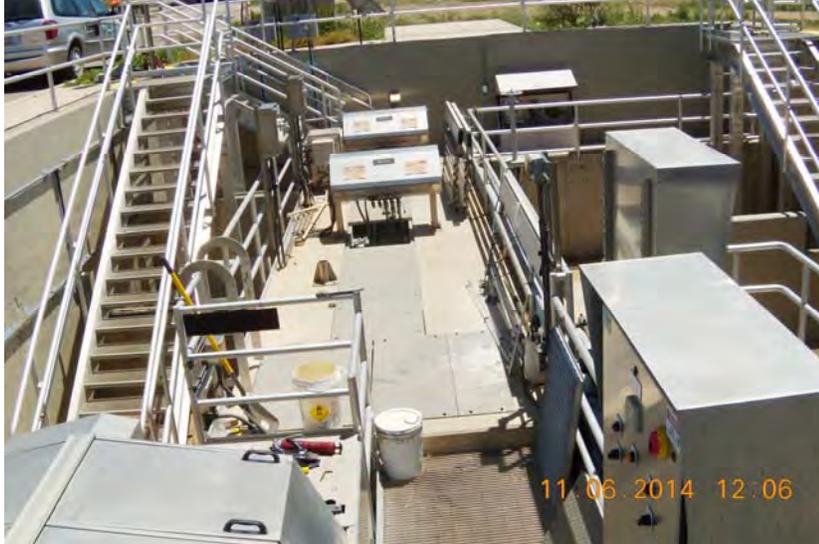
NMED/SWQB
Official Photograph Log
Photo # 17

Subject: Ultraviolet Disinfection Channel with two banks of lights.

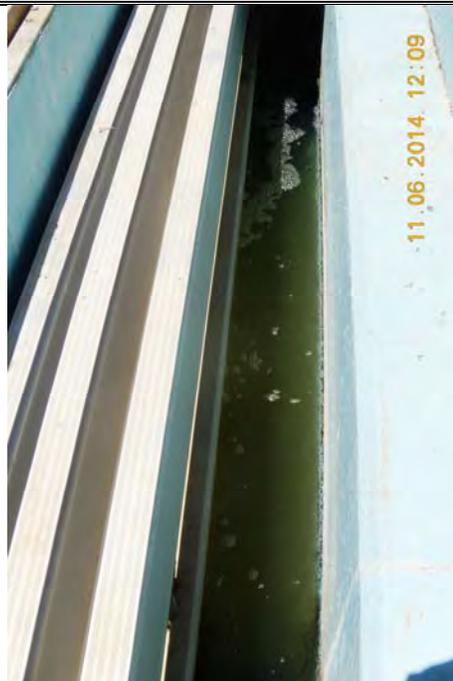
NMED/SWQB
Official Photograph Log
Photo # 18

7. Ultra Violet disinfection system. There were several UV bulbs pulled out for cleaning and were broken on the side of the basin. Cleaning is done by hand with an acid wash. There was some turbidity and some floating solids observed in the UV basin. This can reduce the efficacy of the disinfection.

Subject: Ultraviolet Disinfection Channel – the water in the channel was turbid and had floating solids.

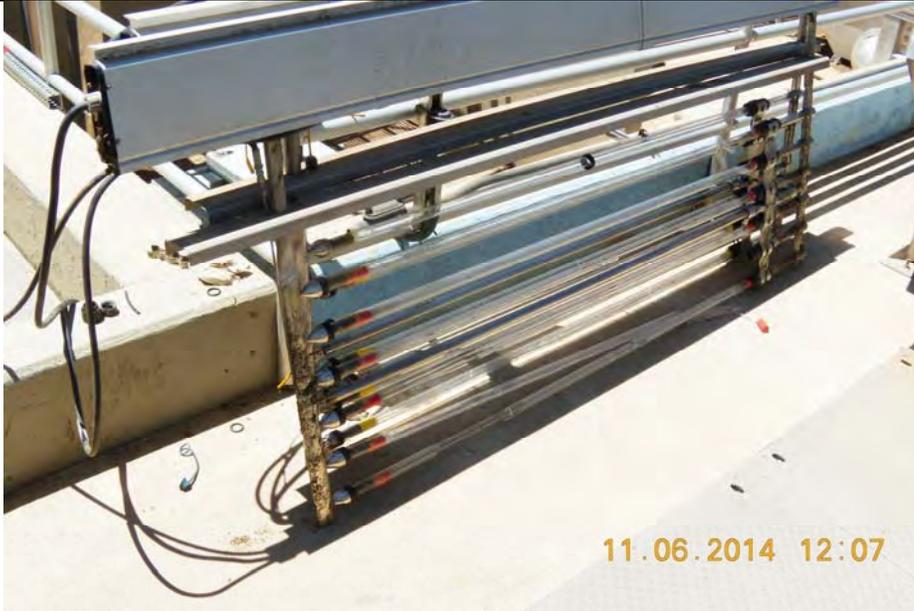
NMED/SWQB
Official Photograph Log
Photo # 19

Subject: Ultraviolet lights – one bank taken out for cleaning and repair. The lights are very fragile, some of the bulbs were broken when they were pulled up for maintenance.

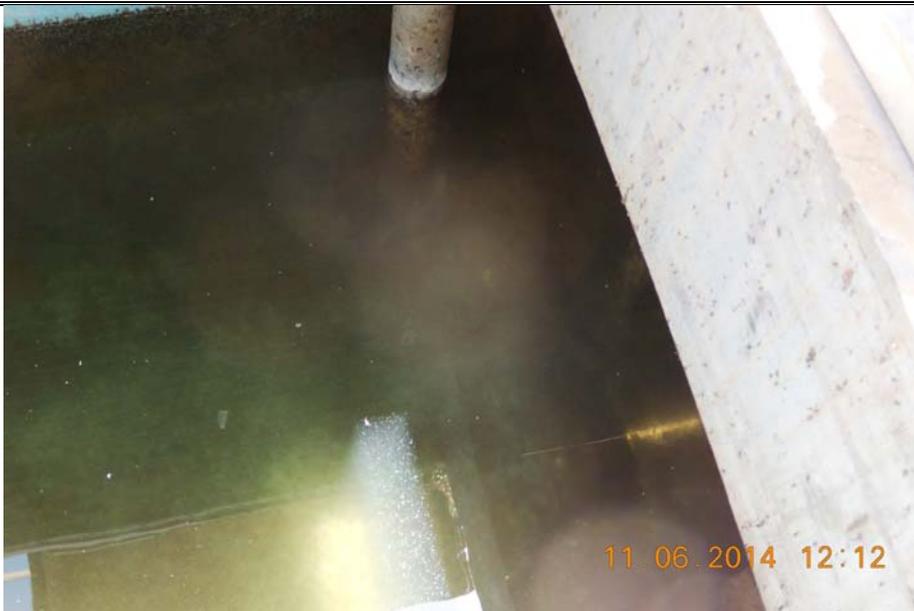
NMED/SWQB
Official Photograph Log
Photo # 20

1. The water exiting the WWTP at the time of the inspection was turbid and floating solids were observed.
2. A review of the discharge monitoring reports indicates that effluent exceedences have occurred for:
 Total Aluminum: December 2013, November 2013, September 2013,
 E. coli Bacteria: September 2013

Subject: Effluent –floating solids and turbidity was noted.

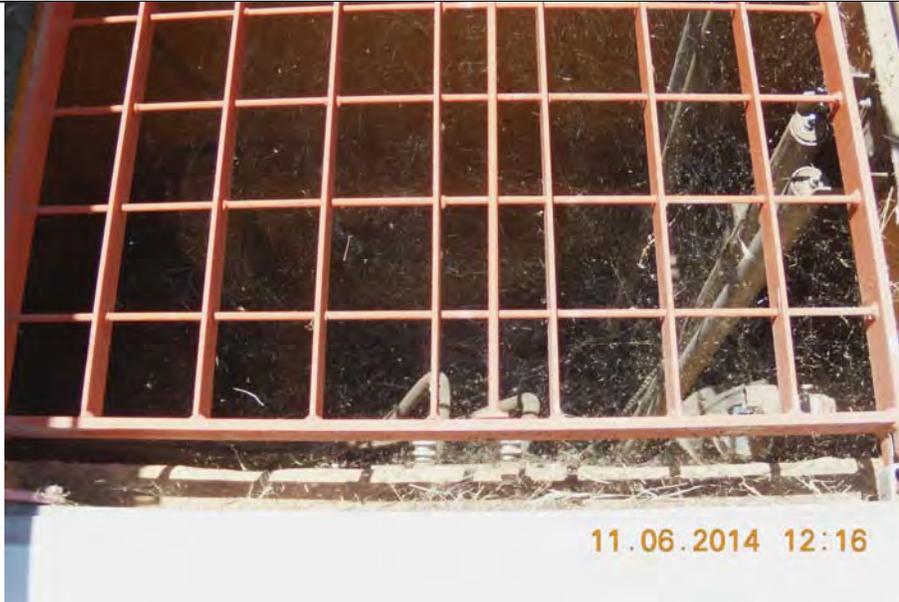
NMED/SWQB
Official Photograph Log
Photo # 21

Subject: Effluent flow meter and staff gauge is inaccessible.
