**Re: City of Las Vegas Wastewater Treatment Facility; Major; Municipal Individual Permit; SIC 4952; Compliance Evaluation Inspection; NPDES Permit NM0028827; November 5, 2015**

### NPDES Compliance Inspection Report

**City of Las Vegas Wastewater Treatment Facility**  
**NPDES Permit No. NM0028827**  
**Compliance Evaluation Inspection**  
**Inspection Date: November 5, 2015**

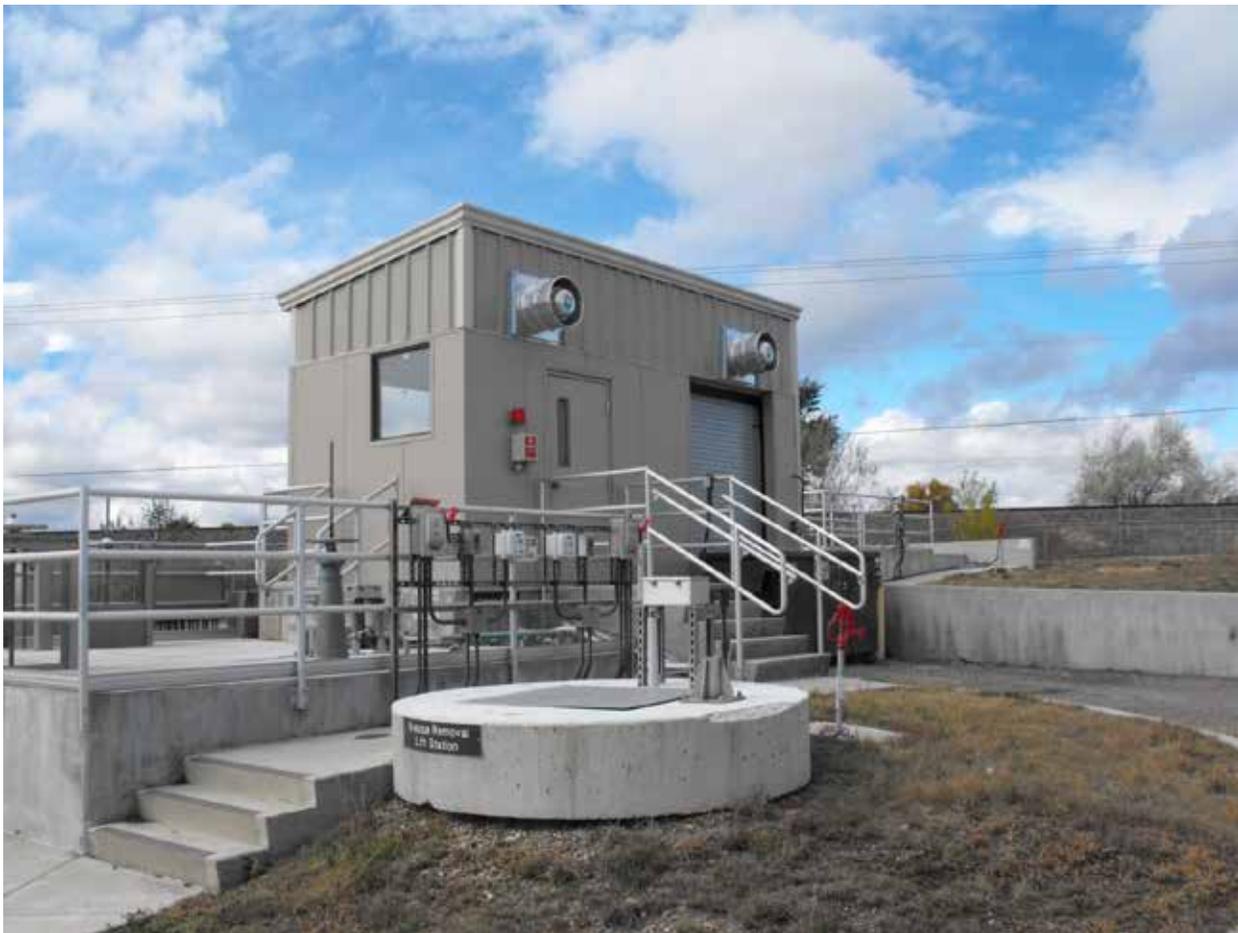
**NMED/SWQB  
Official Photograph Log  
Photo # 1**

Photographer: Daniel Valenta	Date: November 5, 2015	Time: 0943 Hours
City/County: Las Vegas / San Miguel		State: New Mexico
Location: City of Las Vegas Wastewater Treatment Facility		
Subject: Headworks

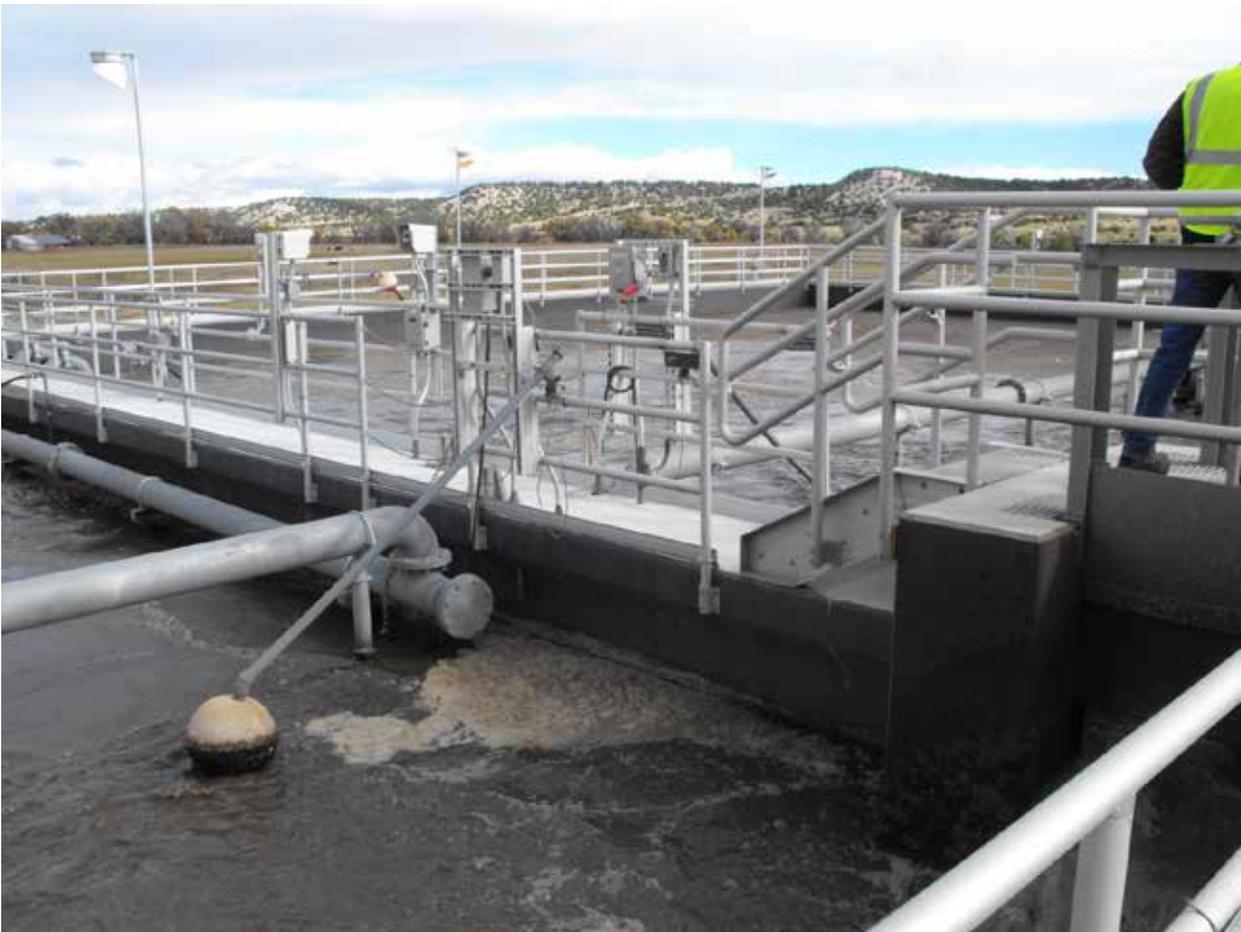
**NMED/SWQB  
Official Photograph Log  
Photo # 2**

Photographer: Daniel Valenta	Date: November 5, 2015	Time: 0954 Hours
City/County: Las Vegas / San Miguel		State: New Mexico
Location: City of Las Vegas Wastewater Treatment Facility		
Subject: One of two aeration basins (note the grease accumulation)

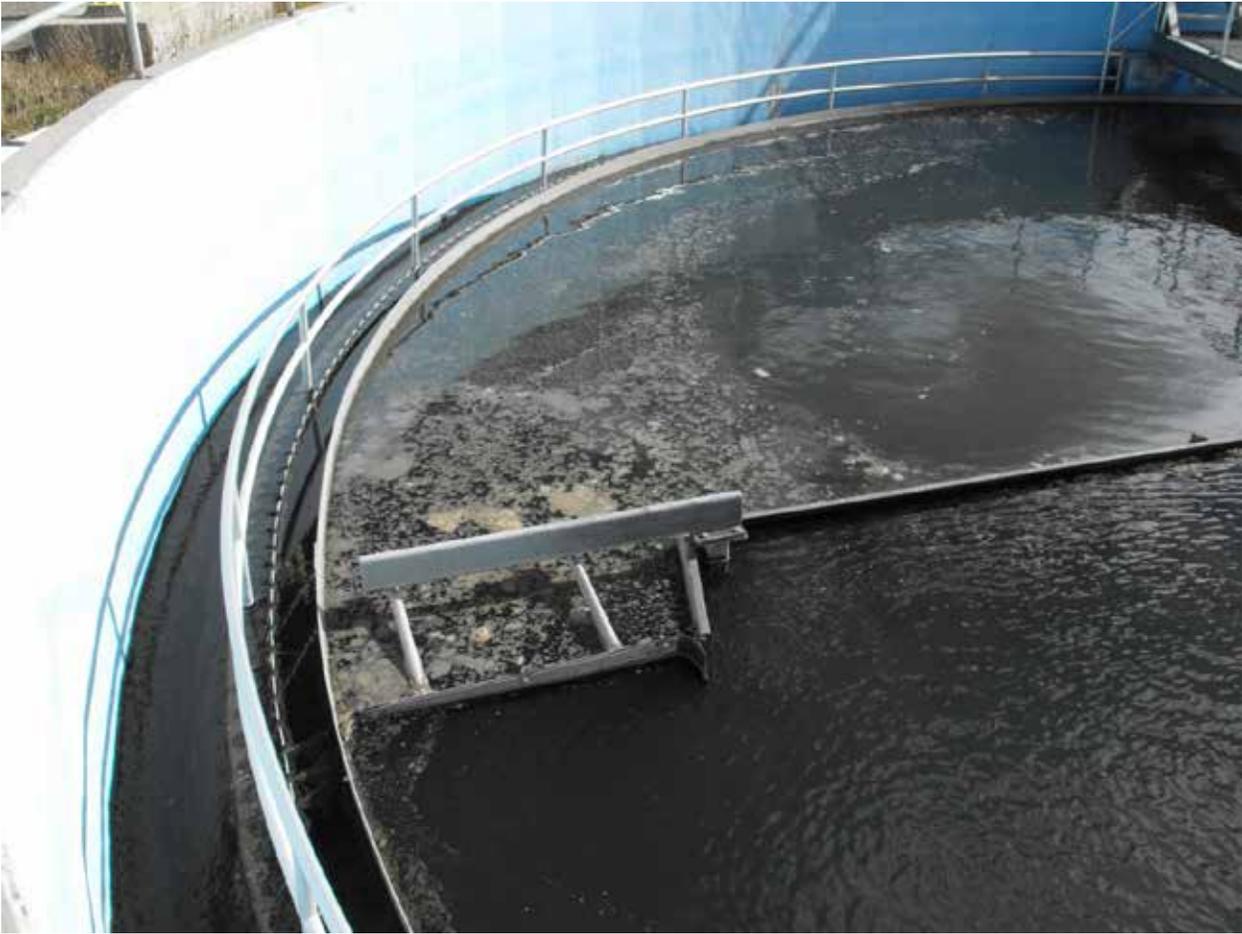
**NMED/SWQB  
Official Photograph Log  
Photo # 3**

The facility has a considerable amount of sludge in their secondary clarifiers. The clarifiers should have approximately 1/3 the depth of the clarifier. It is apparent that the sludge has been in the clarifiers for some time because of the ashen appearance of the surface.

The secondary clarifiers also show short circuiting. It may be beneficial if the weirs are leveled.

Photographer: Daniel Valenta	Date: November 5, 2015	Time: 1004 Hours
City/County: Las Vegas / San Miguel		State: New Mexico
Location: City of Las Vegas Wastewater Treatment Facility		
Subject: One of two secondary clarifiers

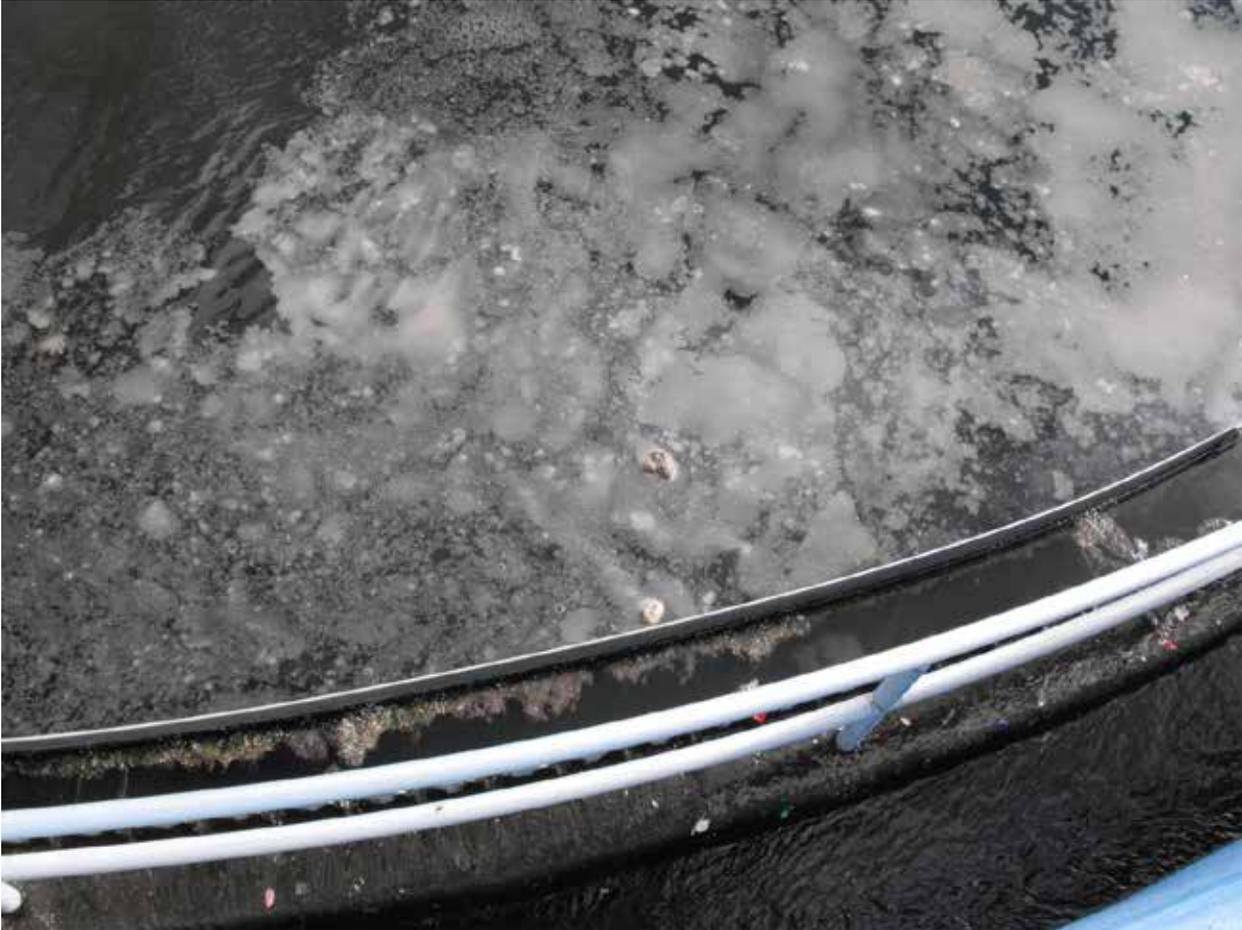
**NMED/SWQB  
Official Photograph Log  
Photo # 4**

Photographer: Daniel Valenta	Date: November 5, 2015	Time: 1006 Hours
City/County: Las Vegas / San Miguel		State: New Mexico
Location: City of Las Vegas Wastewater Treatment Facility		
Subject: One of two secondary clarifiers - solids rising and inorganic particulate.

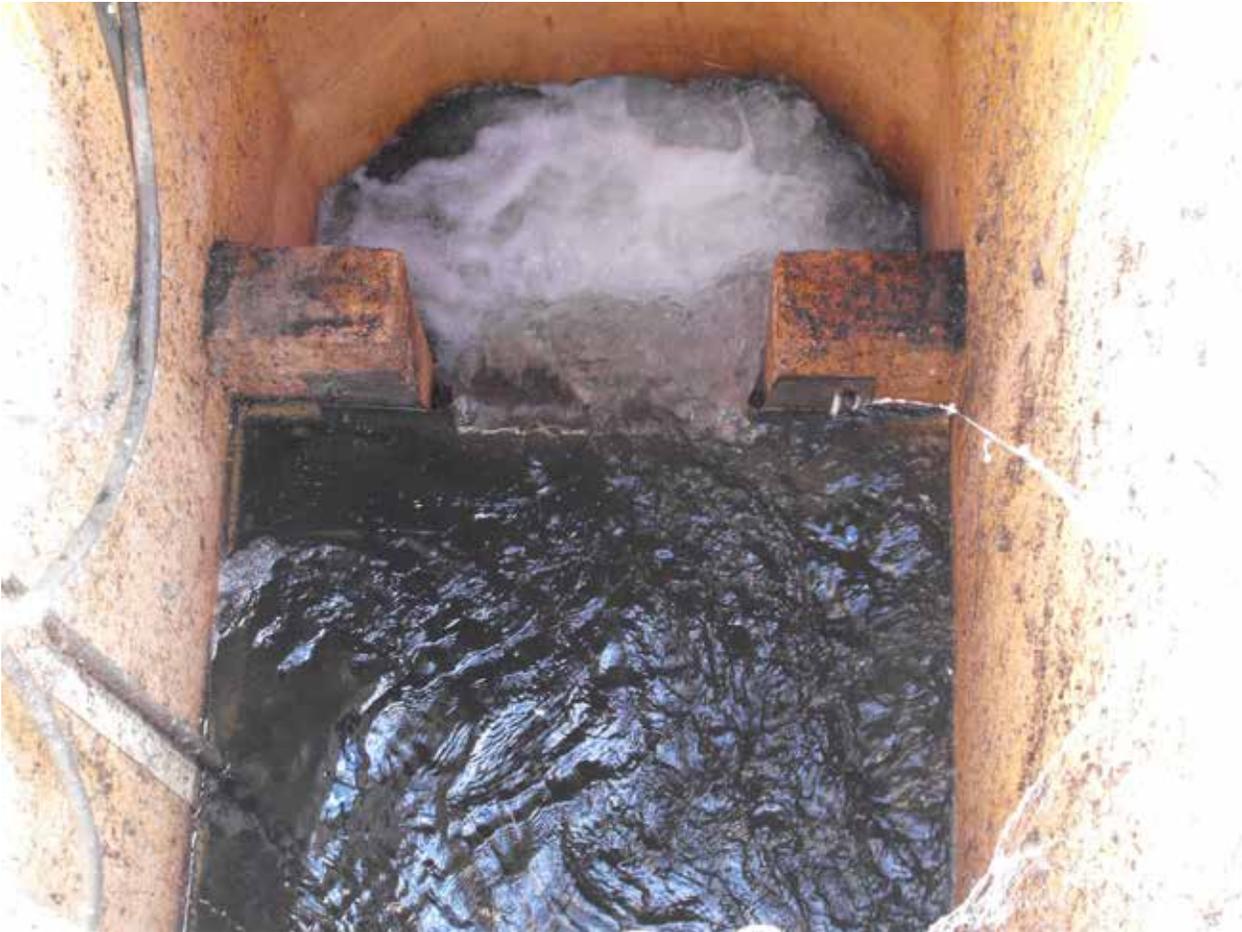
**NMED/SWQB  
Official Photograph Log  
Photo # 5**

The flow entering the weir is turbid and this also attributes to an error in flow readings.

Photographer: Daniel Valenta	Date: November 5, 2015	Time: 1021 Hours
City/County: Las Vegas / San Miguel		State: New Mexico
Location: City of Las Vegas Wastewater Treatment Facility		
Subject: 2' Cipoletti Weir – the flow entering the weir is turbulent.

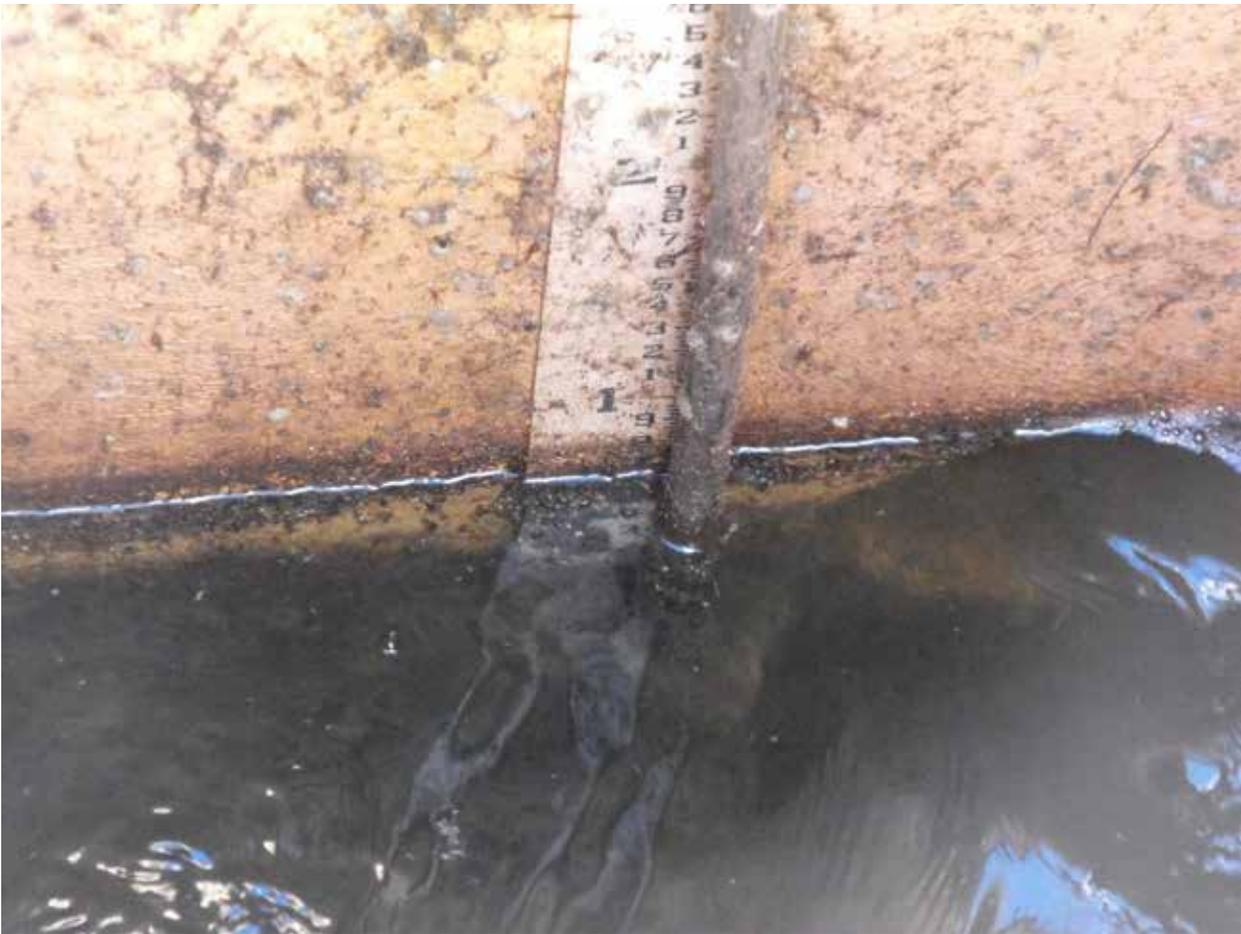
**NMED/SWQB  
Official Photograph Log  
Photo # 6**

The staff gage is also rusted and worn and should be replaced so that the numbers are easier to decipher.

Photographer: Daniel Valenta	Date: November 5, 2015	Time: 1021 Hours
City/County: Las Vegas / San Miguel		State: New Mexico
Location: City of Las Vegas Wastewater Treatment Facility		
Subject: Staff gage – needs to be replaced.
