Re: **Minor Non-Municipal; SIC 4952; NPDES Compliance Evaluation Inspection; Harper Valley Homeowners Association; NM0029025; May 19, 2016**

**Harper Valley Homeowners Association
Compliance Evaluation Inspection
NPDES Permit No. NM0029025
May 19, 2016**

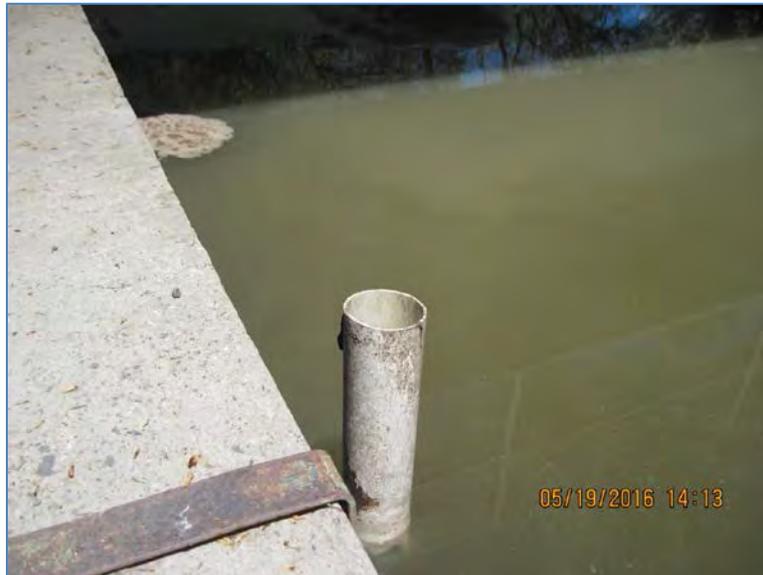
- Larger solids were not screened at the influent pipe that enters the aeration basin. Screening is important to prevent mechanical problems in the plant and effluent exceedances for TSS.

NMED/SWQB Official Photograph Log Photo # 1		
Photographer: Erin S. Trujillo	Date: 05/19/2016	Time: 1413 hours
City/County: Harper Valley Home Owners Association / San Juan County		State: New Mexico
Location: Harper Valley Home Owners Association, NPDES Permit #NM0029025		
Subject: Unscreened influent pipe in aeration basin.

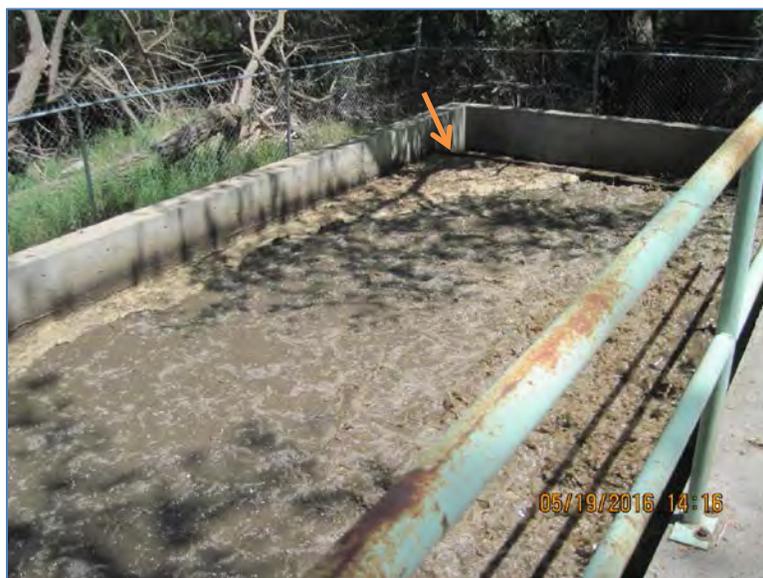
trough basin then flows to the clarifier. When the aerator was operating, wastewater surged above the barrier between the aeration basin and trough carrying floating solids and brownish foam. The rectangular clarifier is equipped with a traveling bridge that can be operated manually to skim off foam, scum, and other floatable material into the clarifier trough. Return Activated Sludge (RAS) from the clarifier is routed back to the aeration basin or enters an aerated digester as waste activated sludge (WAS). After the clarifier, flow continues to a serpentine chlorine contact chamber. Calcium hypochlorite granules mixed in solution and stored in a drum is fed by a tube to the contact chamber for disinfection. Flow then passes through a pipe fitted with distribution tubes with sodium sulfite tablets for de-chlorination. After the de-chlorination unit, effluent enters an approximate 4-foot V-notch weir box. Flow measurements and effluent samples are taken at the weir box. A volume and timed method is used for flow measurements. The number of seconds to fill the container is recorded on the daily log. Effluent then flows through an enclosed six inch diameter pipe to an open channel then to the San Juan River located approximately 150 feet south of the plant.

NMED/SWQB Official Photograph Log Photo # 2		
Photographer: Erin S. Trujillo	Date: 05/19/2016	Time: 1416 hours
City/County: Harper Valley Home Owners Association / San Juan County		State: New Mexico
Location: Harper Valley Home Owners Association, WWTP, NPDES Permit #NM0029025		
Subject: Aeration basin was resting upon arrival. Mr. Hathaway briefly started the aeration cycle in the basin to show how it operated. Arrow points to brown foam collected in southeast corner of the basin at the top of the barrier. Level of wastewater and foam was observed higher than the barrier during aeration.

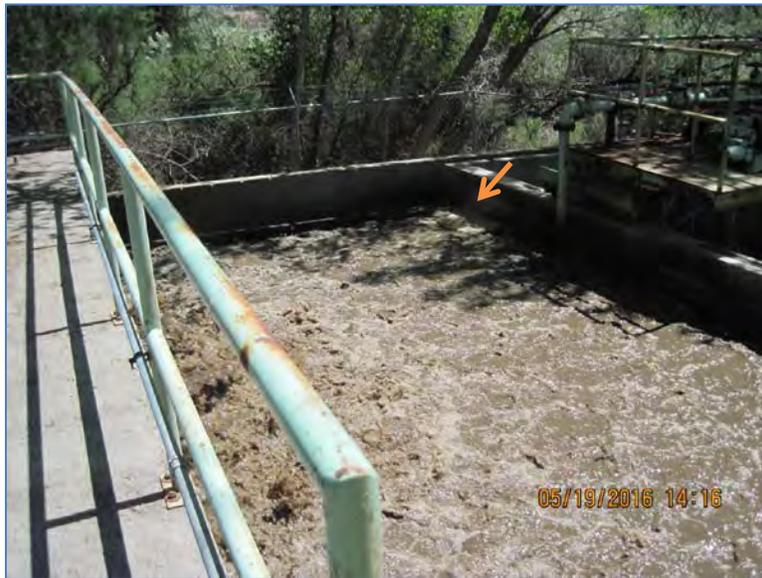
NMED/SWQB Official Photograph Log Photo # 3		
Photographer: Erin S. Trujillo	Date: 05/19/2016	Time: 1416 hours
City/County: Harper Valley Home Owners Association / San Juan County		State: New Mexico
Location: Harper Valley Home Owners Association, NPDES Permit #NM0029025		
Subject: Arrow points to brown foam in the southwest corner of the basin during aeration. Except for the foam, level of wastewater and foam did not rise above the barrier.

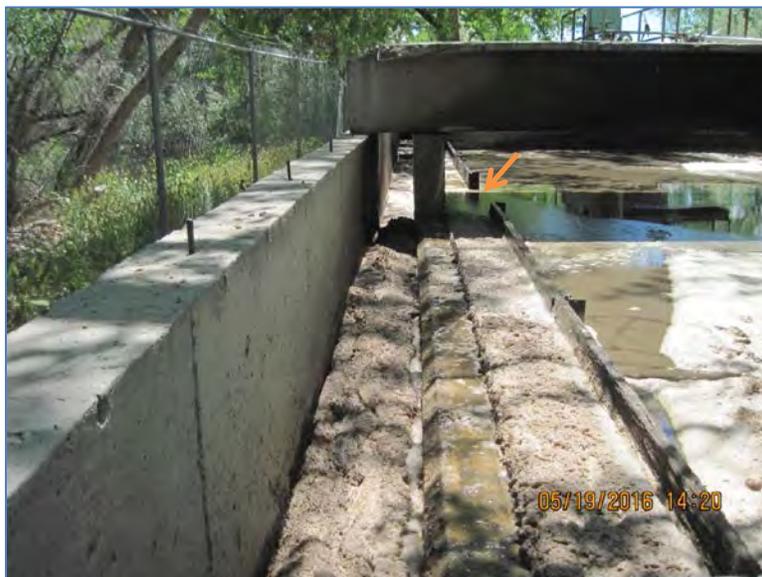
NMED/SWQB Official Photograph Log Photo # 4		
Photographer: Erin S. Trujillo	Date: 05/19/2016	Time: 1420 hours
City/County: Harper Valley Home Owners Association / San Juan County		State: New Mexico
Location: Harper Valley Home Owners Association, NPDES Permit #NM0029025		
Subject: Photo was taken when the aeration was off. Brown foam and solids exist in both channels of the basin. Arrow points to opening in the barriers where flow from the aeration basin enters the inner channel.

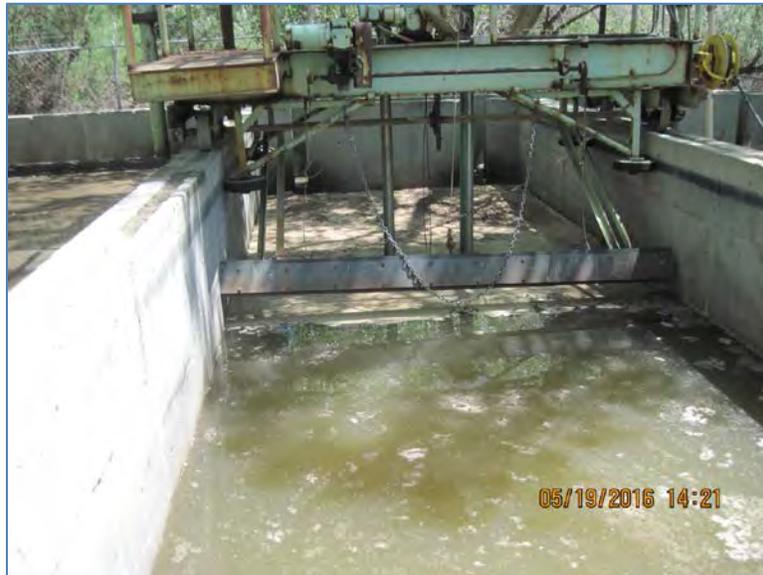
NMED/SWQB Official Photograph Log Photo # 5		
Photographer: Erin S. Trujillo	Date: 05/19/2016	Time: 1421 hours
City/County: Harper Valley Home Owners Association / San Juan County		State: New Mexico
Location: Harper Valley Home Owners Association, NPDES Permit #NM0029025		
Subject: Traveling bridge skimmer in clarifier

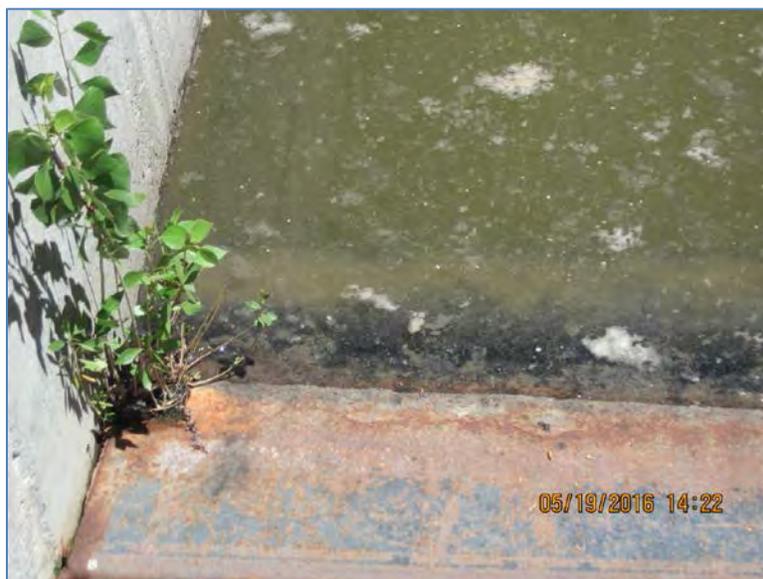
- Lift station was in an unprotected or unrestricted area (e.g., area was not fenced).
- Plant has concrete cracks, and metal fixtures show signs of rust corrosion and pitting.

NMED/SWQB Official Photograph Log Photo # 6		
Photographer: Erin S. Trujillo	Date: 05/19/2016	Time: 1420 hours
City/County: Harper Valley Home Owners Association / San Juan County		State: New Mexico
Location: Harper Valley Home Owners Association, NPDES Permit #NM0029025		
Subject: Floating solids, metal corrosion, and vegetation growing in clarifier.

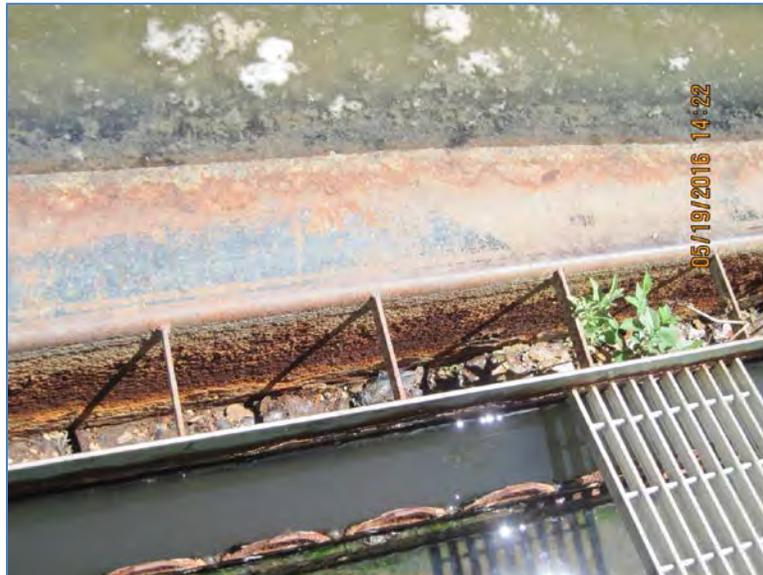
NMED/SWQB Official Photograph Log Photo # 7		
Photographer: Erin S. Trujillo	Date: 05/19/2016	Time: 1422 hours
City/County: Harper Valley Home Owners Association / San Juan County		State: New Mexico
Location: Harper Valley Home Owners Association, NPDES Permit #NM0029025		
Subject: Metal corrosion of troughs and weir teeth, and algal growth in Clarifier. Vegetation, leaf litter and dead bird was in clarifier trough.

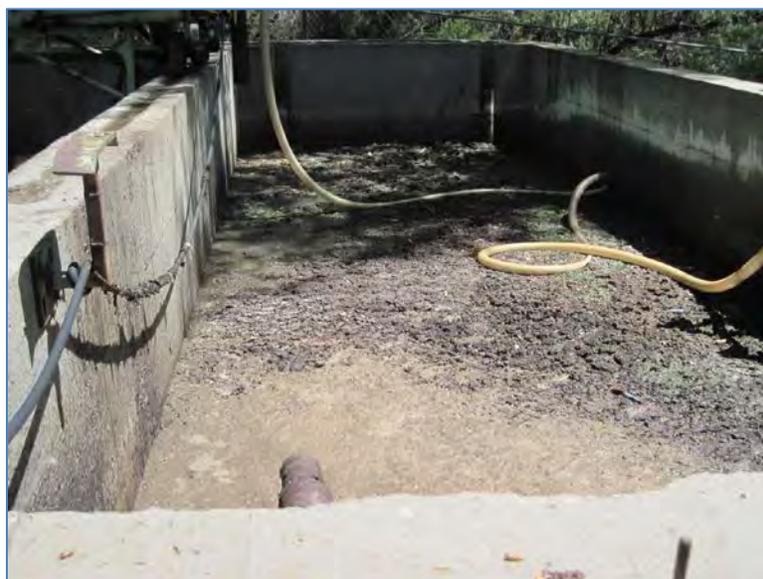
NMED/SWQB Official Photograph Log Photo # 8		
Photographer: Erin S. Trujillo	Date: 05/19/2016	Time: 1423 hours
City/County: Harper Valley Home Owners Association / San Juan County		State: New Mexico
Location: Harper Valley Home Owners Association, NPDES Permit #NM0029025		
Subject: Sludge digester. Algal growth on surface of WAS.

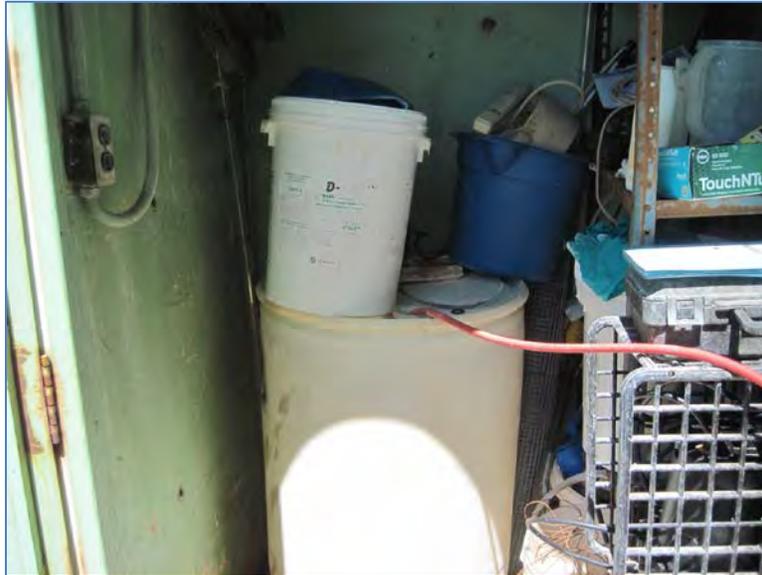
NMED/SWQB Official Photograph Log Photo # 9		
Photographer: Erin S. Trujillo	Date: 05/19/2016	Time: 1427 hours
City/County: Harper Valley Home Owners Association / San Juan County		State: New Mexico
Location: Harper Valley Home Owners Association, NPDES Permit #NM0029025		
Subject: Storage shed at plant with chlorination drum and feed hose.

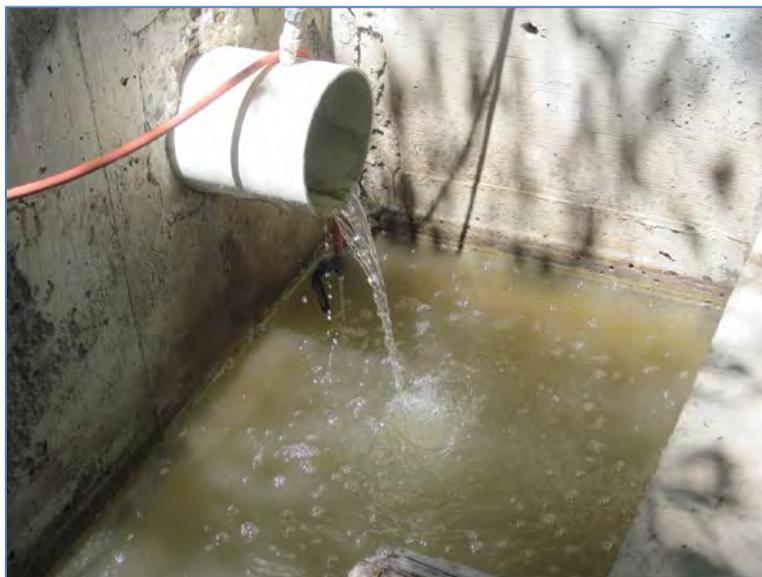
- Solids management and chlorination dosage procedures are not sufficient based on effluent permit limit exceedances for BOD, TSS and E.coli bacteria.
- Removal of solids and cleaning of the chlorine contact chamber appears needed. Water in the chlorine contact chamber appeared cloudy. The bottom of the chamber could not be observed to ensure that there were no accumulated solids in the chamber.

NMED/SWQB Official Photograph Log Photo # 10		
Photographer: Erin S. Trujillo	Date: 05/19/2016	Time: 1428 hours
City/County: Harper Valley Home Owners Association / San Juan County		State: New Mexico
Location: Harper Valley Home Owners Association, NPDES Permit #NM0029025		
Subject: Chlorination feed and flow into chlorination chamber. Flow was slightly turbid. Bottom of chamber could not be observed.

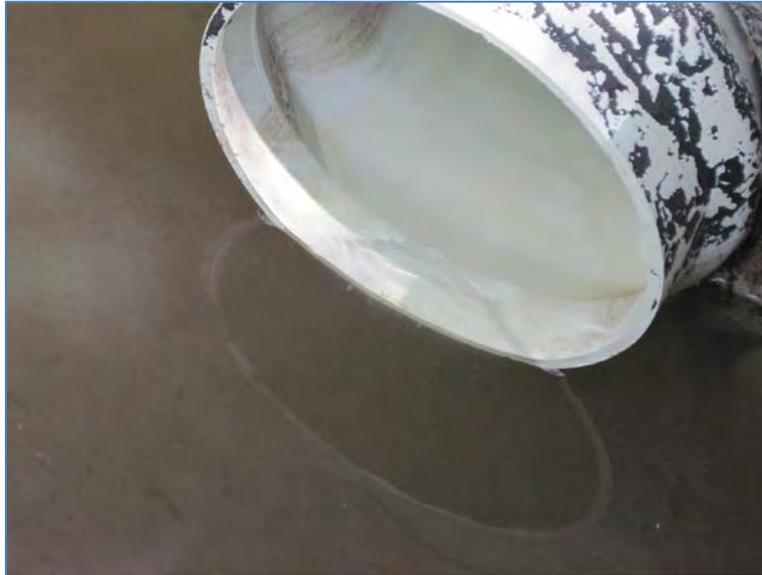
NMED/SWQB Official Photograph Log Photo # 11		
Photographer: Erin S. Trujillo	Date: 05/19/2016	Time: 1429 hours
City/County: Harper Valley Home Owners Association / San Juan County		State: New Mexico
Location: Harper Valley Home Owners Association, NPDES Permit #NM0029025		
Subject: Flow in pipe before de-chlorination shown in next photo.

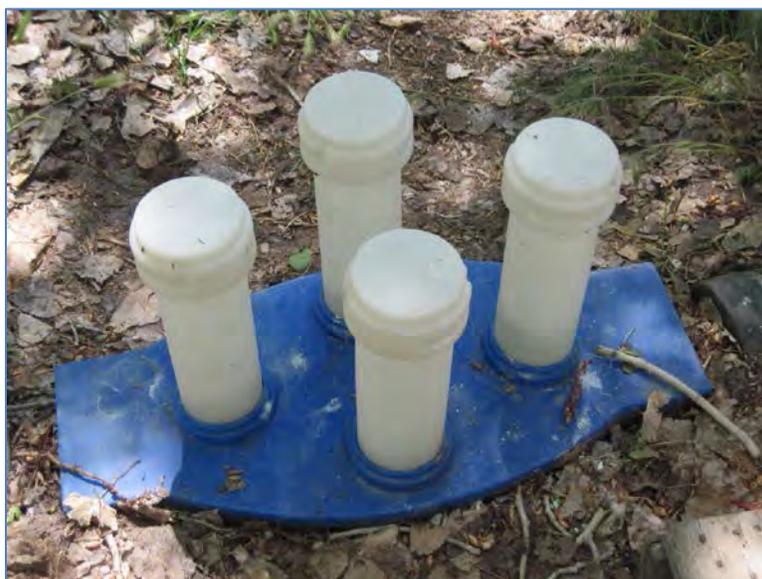
NMED/SWQB Official Photograph Log Photo # 12		
Photographer: Erin S. Trujillo	Date: 05/19/2016	Time: 1430 hours
City/County: Harper Valley Home Owners Association / San Juan County		State: New Mexico
Location: Harper Valley Home Owners Association, NPDES Permit #NM0029025		
Subject: De-chlorination tablet risers

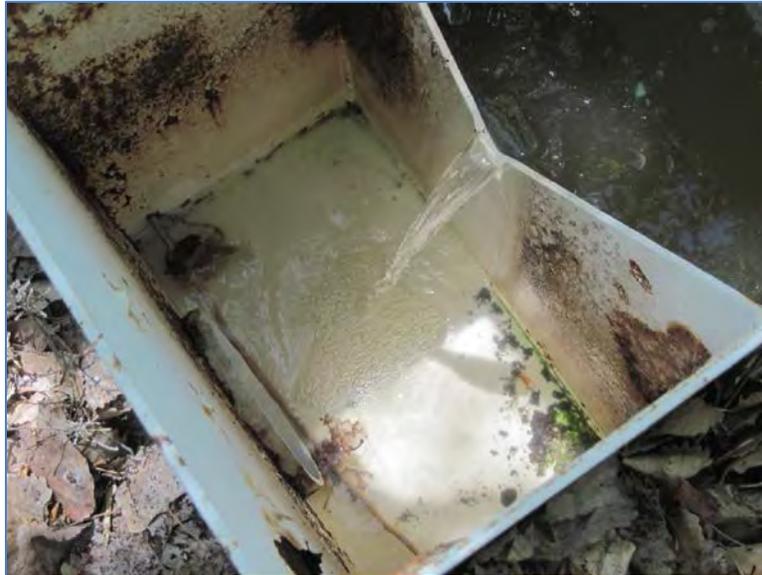
NMED/SWQB Official Photograph Log Photo # 13		
Photographer: Erin S. Trujillo	Date: 05/19/2016	Time: 1432 hours
City/County: Harper Valley Home Owners Association / San Juan County		State: New Mexico
Location: Harper Valley Home Owners Association, NPDES Permit #NM0029025		
Subject: Effluent at weir box

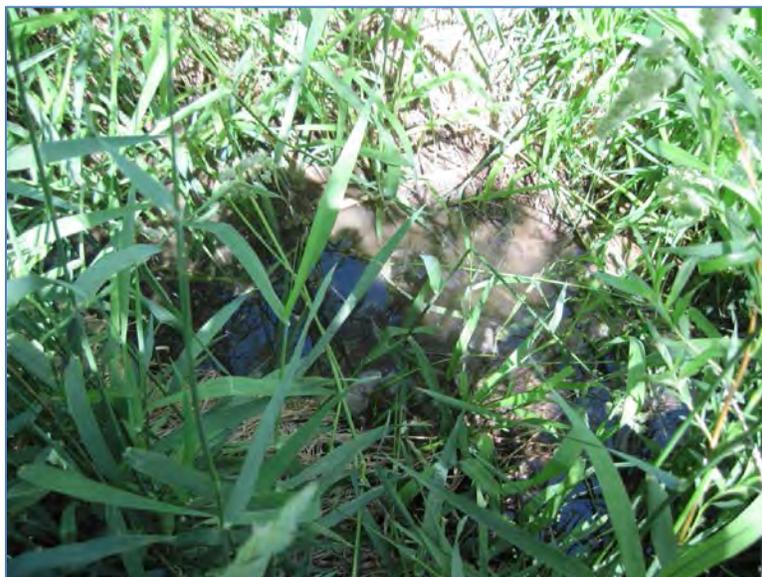
NMED/SWQB Official Photograph Log Photo # 14		
Photographer: Erin S. Trujillo	Date: 05/19/2016	Time: 1434 hours
City/County: Harper Valley Home Owners Association / San Juan County		State: New Mexico
Location: Harper Valley Home Owners Association, NPDES Permit #NM0029025		
Subject: Effluent channel downstream of effluent pipe.

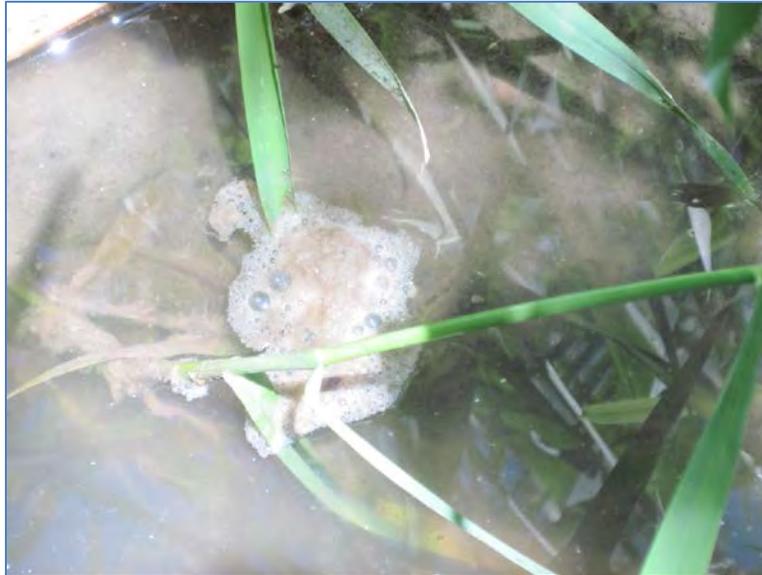
- Floating solids were observed in the channel before entering San Juan River. Due to the high water levels of the river, there was turbid backflow into the channel.
- **Revised** DMRs submitted to USEPA with copy to NMED need to correctly report data, effluent exceedances and excursions.

NMED/SWQB Official Photograph Log Photo # 15		
Photographer: Erin S. Trujillo	Date: 05/19/2016	Time: 1434 hours
City/County: Harper Valley Home Owners Association / San Juan County		State: New Mexico
Location: Harper Valley Home Owners Association, NPDES Permit #NM0029025		
Subject: Floating solids and foam observed at location shown in previous photo.

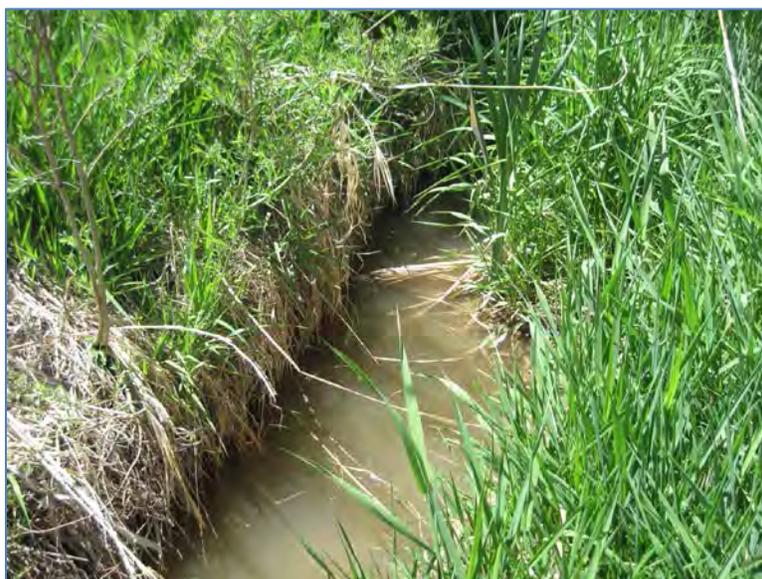
NMED/SWQB Official Photograph Log Photo # 16		
Photographer: Erin S. Trujillo	Date: 05/19/2016	Time: 1436 hours
City/County: Harper Valley Home Owners Association / San Juan County		State: New Mexico
Location: Harper Valley Home Owners Association, NPDES Permit #NM0029025		
Subject: Channel that leads to San Juan River.

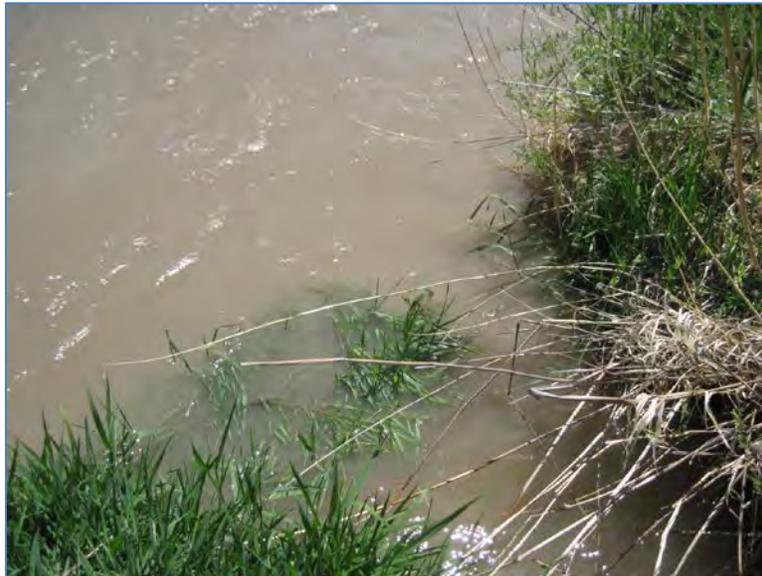
NMED/SWQB Official Photograph Log Photo # 18		
Photographer: Erin S. Trujillo	Date: 05/19/2016	Time: 1436 hours
City/County: Harper Valley Home Owners Association / San Juan County		State: New Mexico
Location: Harper Valley Home Owners Association, NPDES Permit #NM0029025		
Subject: Looking downstream from right bank at San Juan River

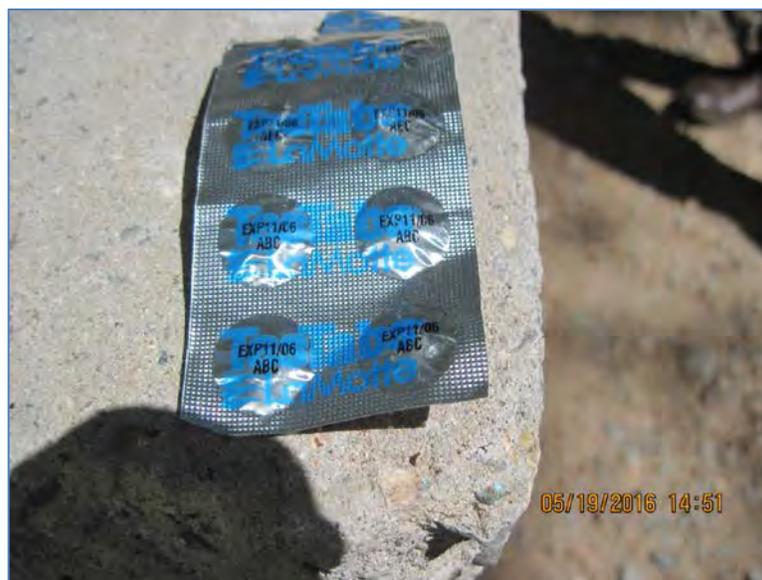
- TRC monitoring records, in this case zero (0) reporting results on daily logs, did not include times of sampling and times of analysis to verify holding times. Instrument reagents observed on site were expired. Procedures, calibration, approved methods, were not documented to verify that pH monitoring met the conditions of the Permit.

NMED/SWQB Official Photograph Log Photo # 20		
Photographer: Erin S. Trujillo	Date: 05/19/2016	Time: 1451 hours
City/County: Harper Valley Home Owners Association / San Juan County		State: New Mexico
Location: Harper Valley Home Owners Association, NPDES Permit #NM0029025		
Subject: On-site reagents for LaMotte Chlorine DPD were expired (printing on package reads "Exp 11/06").

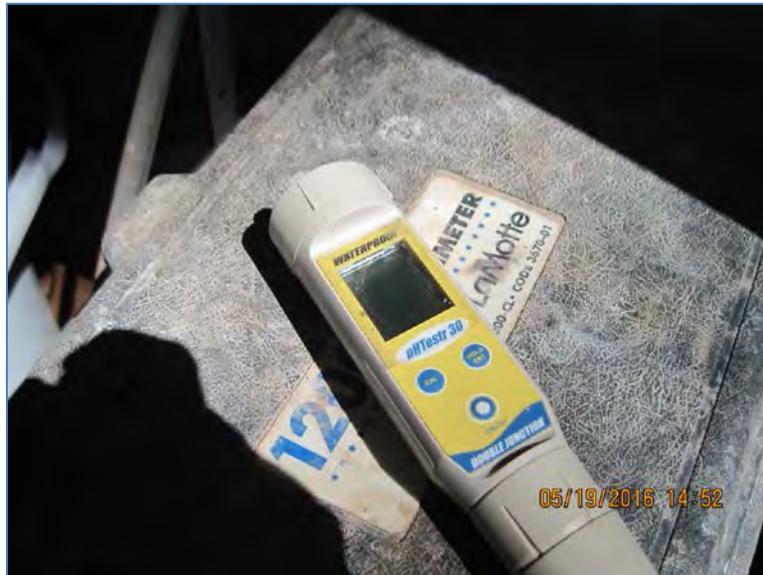
NMED/SWQB Official Photograph Log Photo # 21		
Photographer: Erin S. Trujillo	Date: 05/19/2016	Time: 1452 hours
City/County: Harper Valley Home Owners Association / San Juan County		State: New Mexico
Location: Harper Valley Home Owners Association, NPDES Permit #NM0029025		
Subject: On-site pH tester

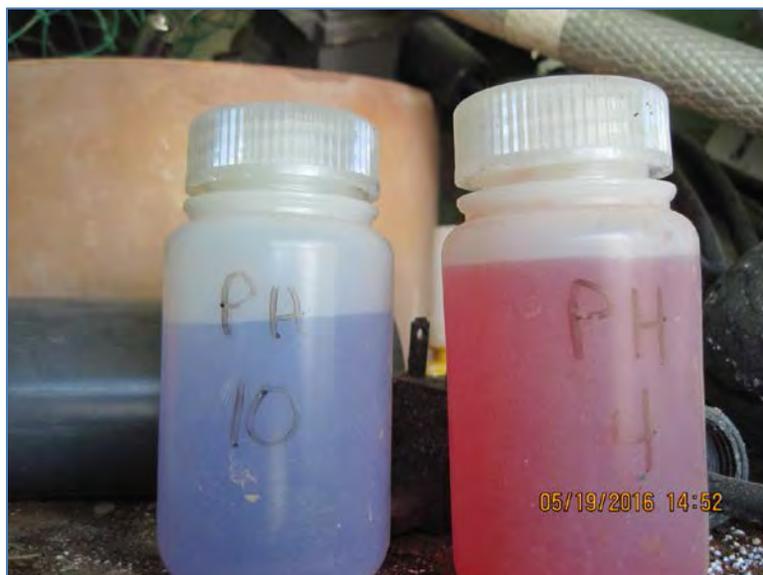
- Recordkeeping for pH monitoring (benchsheets) were not provided. Procedures, calibration, instrument standardization using buffers, buffer expiration dates, approved methods, holding times and frequency of analysis were not documented to verify that pH monitoring met the conditions of the Permit.

NMED/SWQB Official Photograph Log Photo # 22		
Photographer: Erin S. Trujillo	Date: 05/19/2016	Time: 1452 hours
City/County: Harper Valley Home Owners Association / San Juan County		State: New Mexico
Location: Harper Valley Home Owners Association, NPDES Permit #NM0029025		
Subject: Two pH buffers (labeled 10 and 4) were observed. There were no dates as to when the buffers were mixed and/or would expire.
