**Re: Central Consolidated School District, Wastewater Treatment Plant, Minor Non-Municipal;
SIC 4952; NPDES Compliance Evaluation Inspection; NM0029319; May 19, 2016**

NPDES Compliance Inspection Report

Central Consolidated School District No. 22 / Kirtland Schools
Compliance Evaluation Inspection
NPDES Permit No. NM0029319
May 19, 2016

Further Explanations

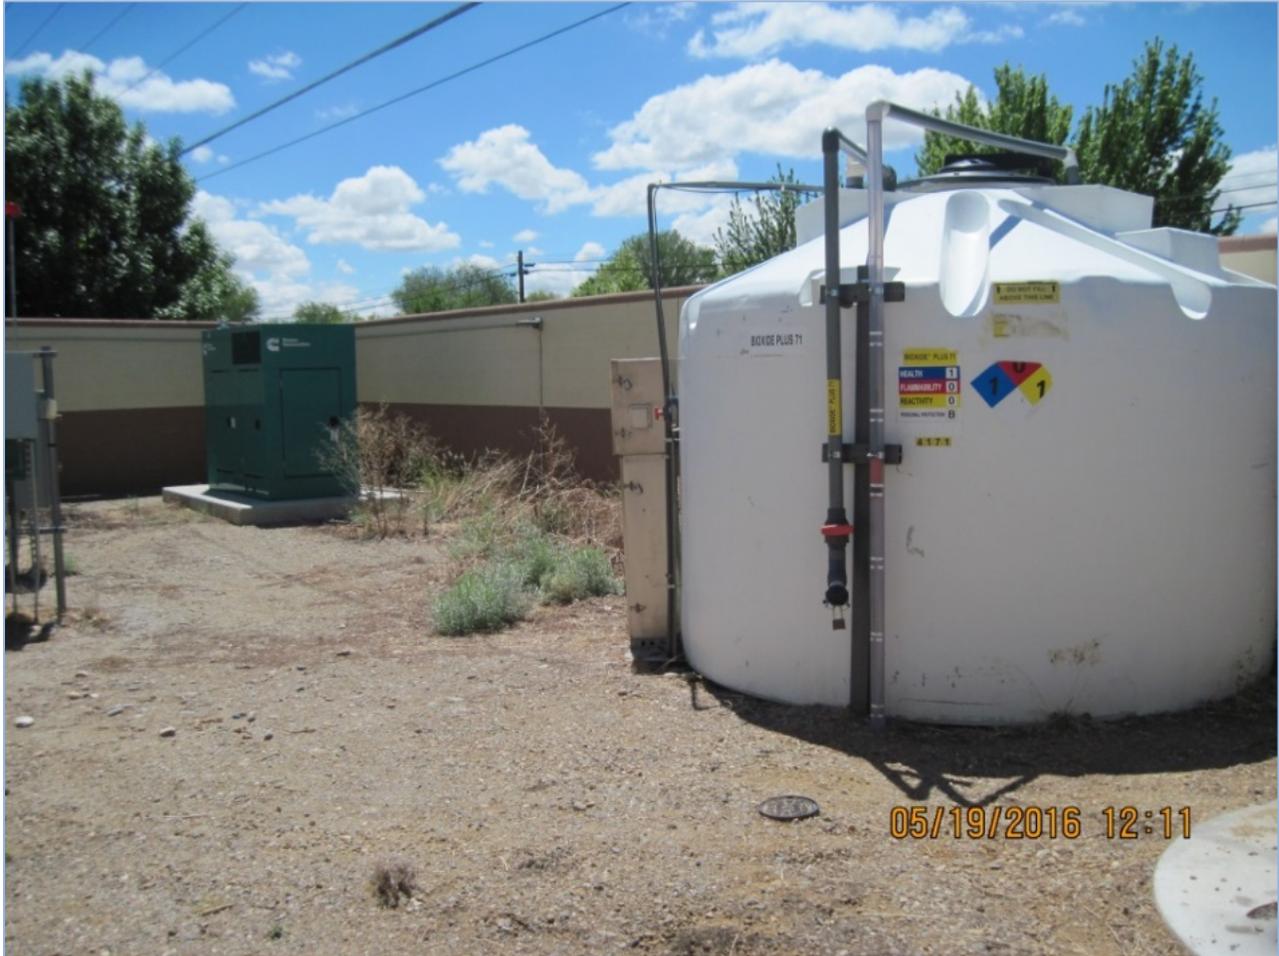
**NMED/SWQB
Official Photograph Log
Photo # 1**

Photographer: Erin S. Trujillo	Date: 05/19/2016	Time: 1211 hours
City/County: Kirtland / San Juan County	State: New Mexico	
Location: Central Consolidated School District / Kirtland Schools, Lift Station Area		
Subject: Diesel generator and Bioxide Plus 71 above-ground storage tank in school's lift station area.

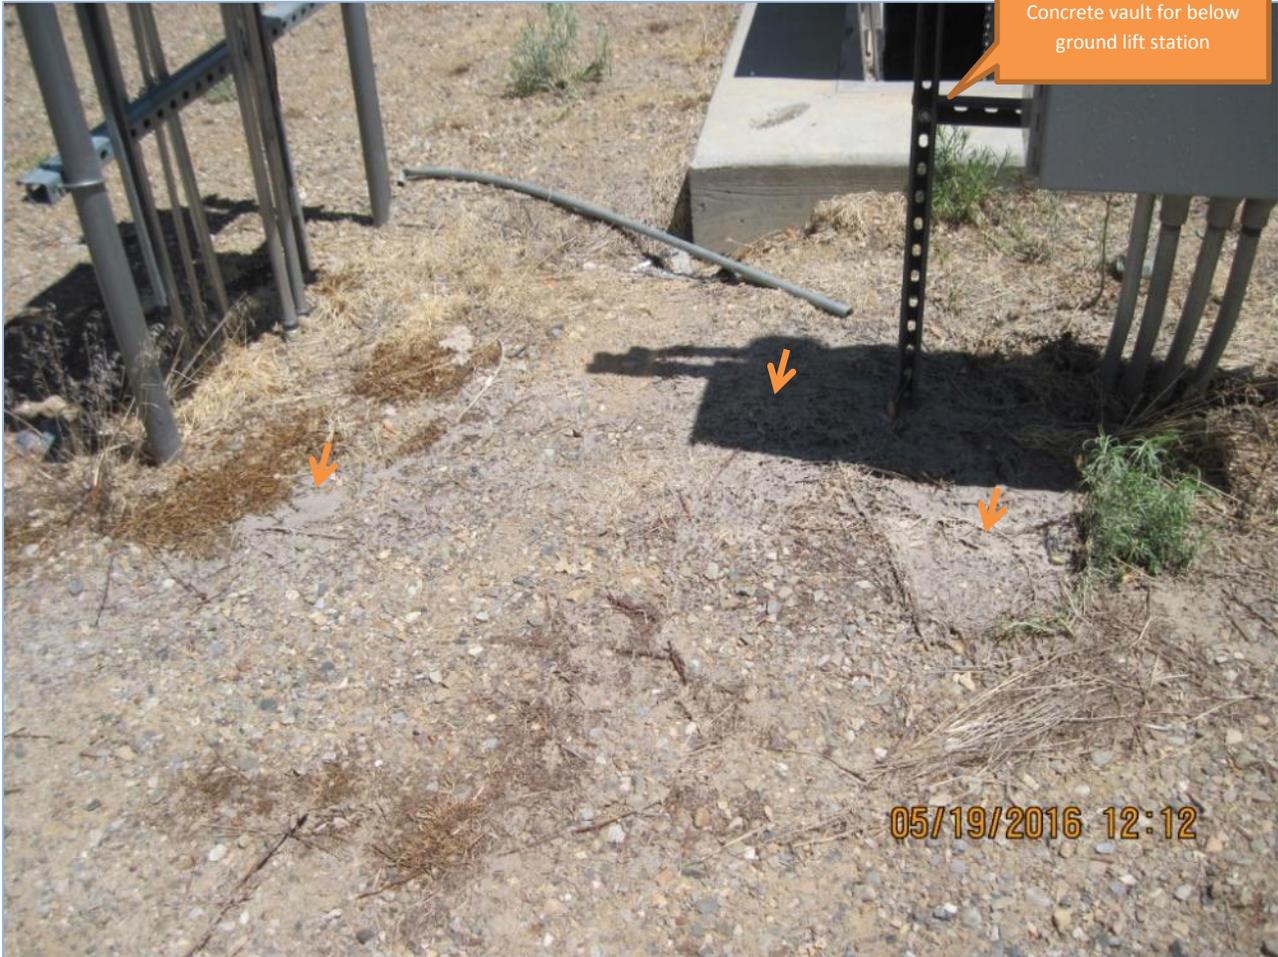
- Dried sewage was observed on the ground in the lift station area. This is a **Repeat Finding**.

Additional Notes: The 2012 CEI report states “Numerous overflows from the lift station in front of the junior high school have occurred. These failures have resulted in raw sewage flowing across the road, into a storm drain, to a holding pond, past houses and a residential area and potentially to the San Juan River. No preventive measures have been taken to stop future overflows. Debris on the ground near the lift station shows dried sewage solids.” Based on the amount observed during this CEI and information from the on-site Permittee representatives, the sewage appeared to be from a spill during work to remove air from the system and not from a back up, high level or electrical outage causing an overflow at the lift station.

NMED/SWQB Official Photograph Log Photo # 2		
Photographer: Erin S. Trujillo	Date: 05/19/2016	Time: 1212 hours
City/County: Kirtland / San Juan County	State: New Mexico	
Location: Central Consolidated School District / Kirtland Schools, Lift Station Area		
Subject: Arrows point to examples of light gray dried raw sewage on ground and on vegetation at lift station.

Additional Information: Examples for control measures may include, but are not limited to, constructed or temporary inlet berms, wattles, spill kits, etc.). Also, written standard operating procedures should include updated contacts and procedures for spill or overflow clean up, notifications and reporting (e.g., VWSD, local residents, irrigation districts, state and/or federal agencies).

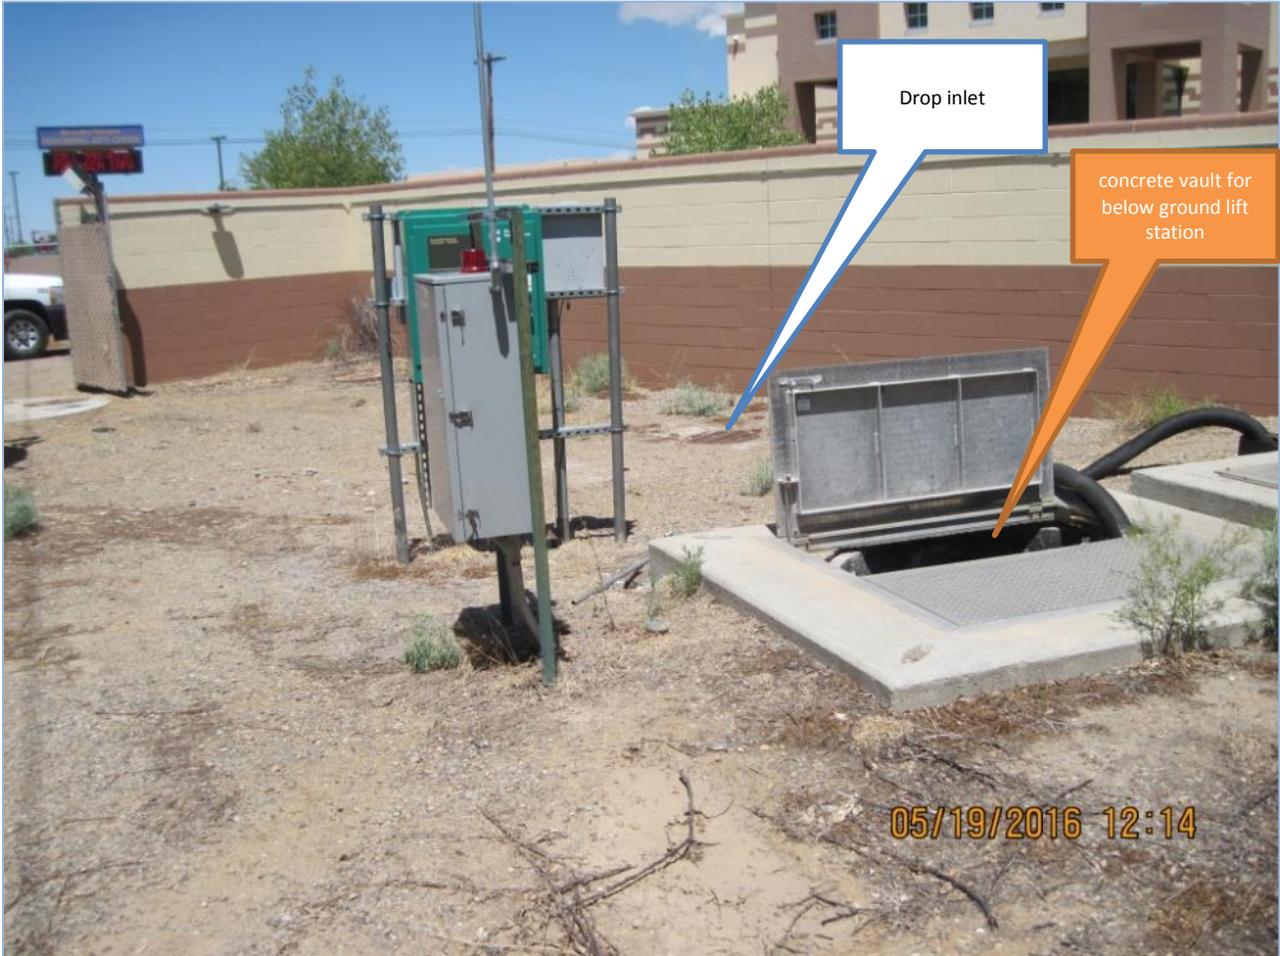
- No control measures were observed in the lift station area to prevent or minimize potential pollutants from chemical storage spills, raw sewage spills, or overflows from entering the storm water drop inlet and off-site surface waters.

NMED/SWQB Official Photograph Log Photo # 3		
Photographer: Erin S. Trujillo	Date: 05/19/2016	Time: 1214 hours
City/County: Kirtland / San Juan County	State: New Mexico	
Location: Central Consolidated School District / Kirtland Schools, Lift Station Area		
Subject: Storm water drop inlet in lift station area.

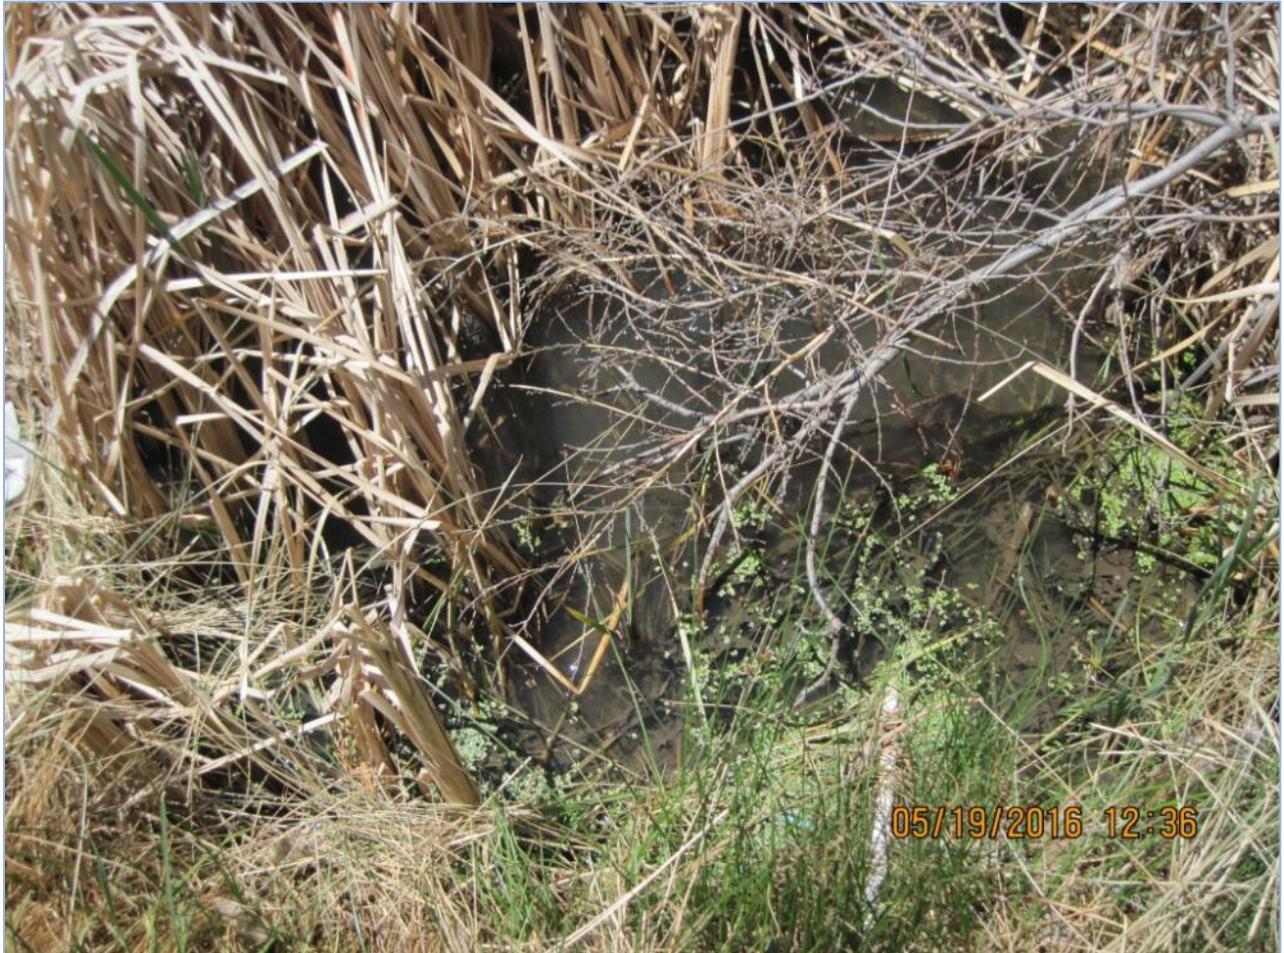
NMED/SWQB
Official Photograph Log
Photo # 4

Photographer: Erin S. Trujillo	Date: 05/19/2016	Time: 1236 hours
City/County: Kirtland / San Juan County	State: New Mexico	
Location: Central Consolidated School District / Kirtland Schools, South of CR 6100		
Subject: Drop inlet shown in previous photo is connected to a pipe with an outlet according to on-site permittee representatives. Photo is of water at outlet of pipe south of schools and associated facilities.

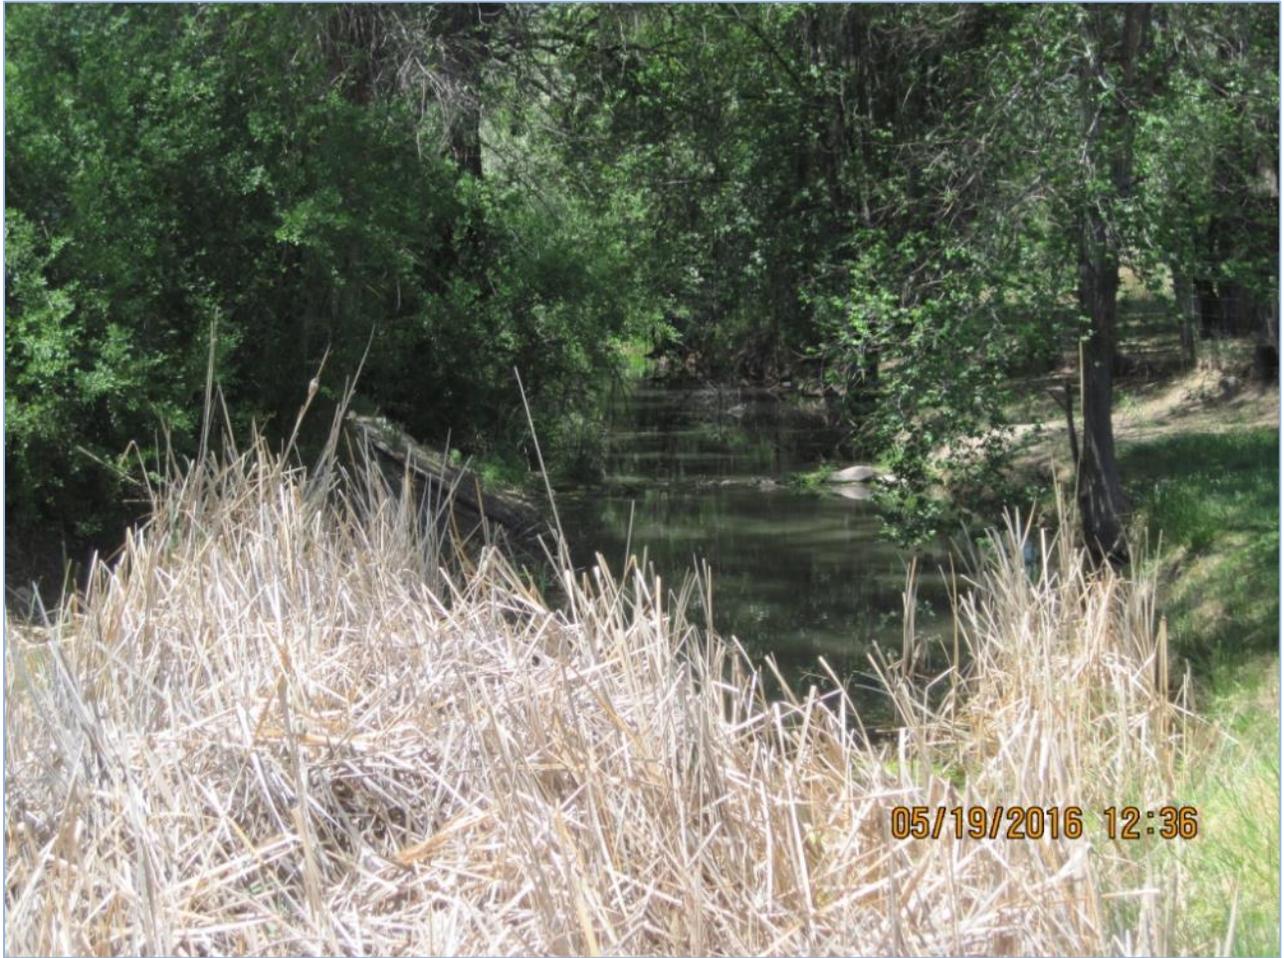
NMED/SWQB
Official Photograph Log
Photo # 5

Photographer: Erin S. Trujillo	Date: 05/19/2016	Time: 1236 hours
City/County: Kirtland / San Juan County	State: New Mexico	
Location: Central Consolidated School District / Kirtland Schools, Lift Station Area		
Subject: Flow from previous photo continues to ditch and pond in residential area.

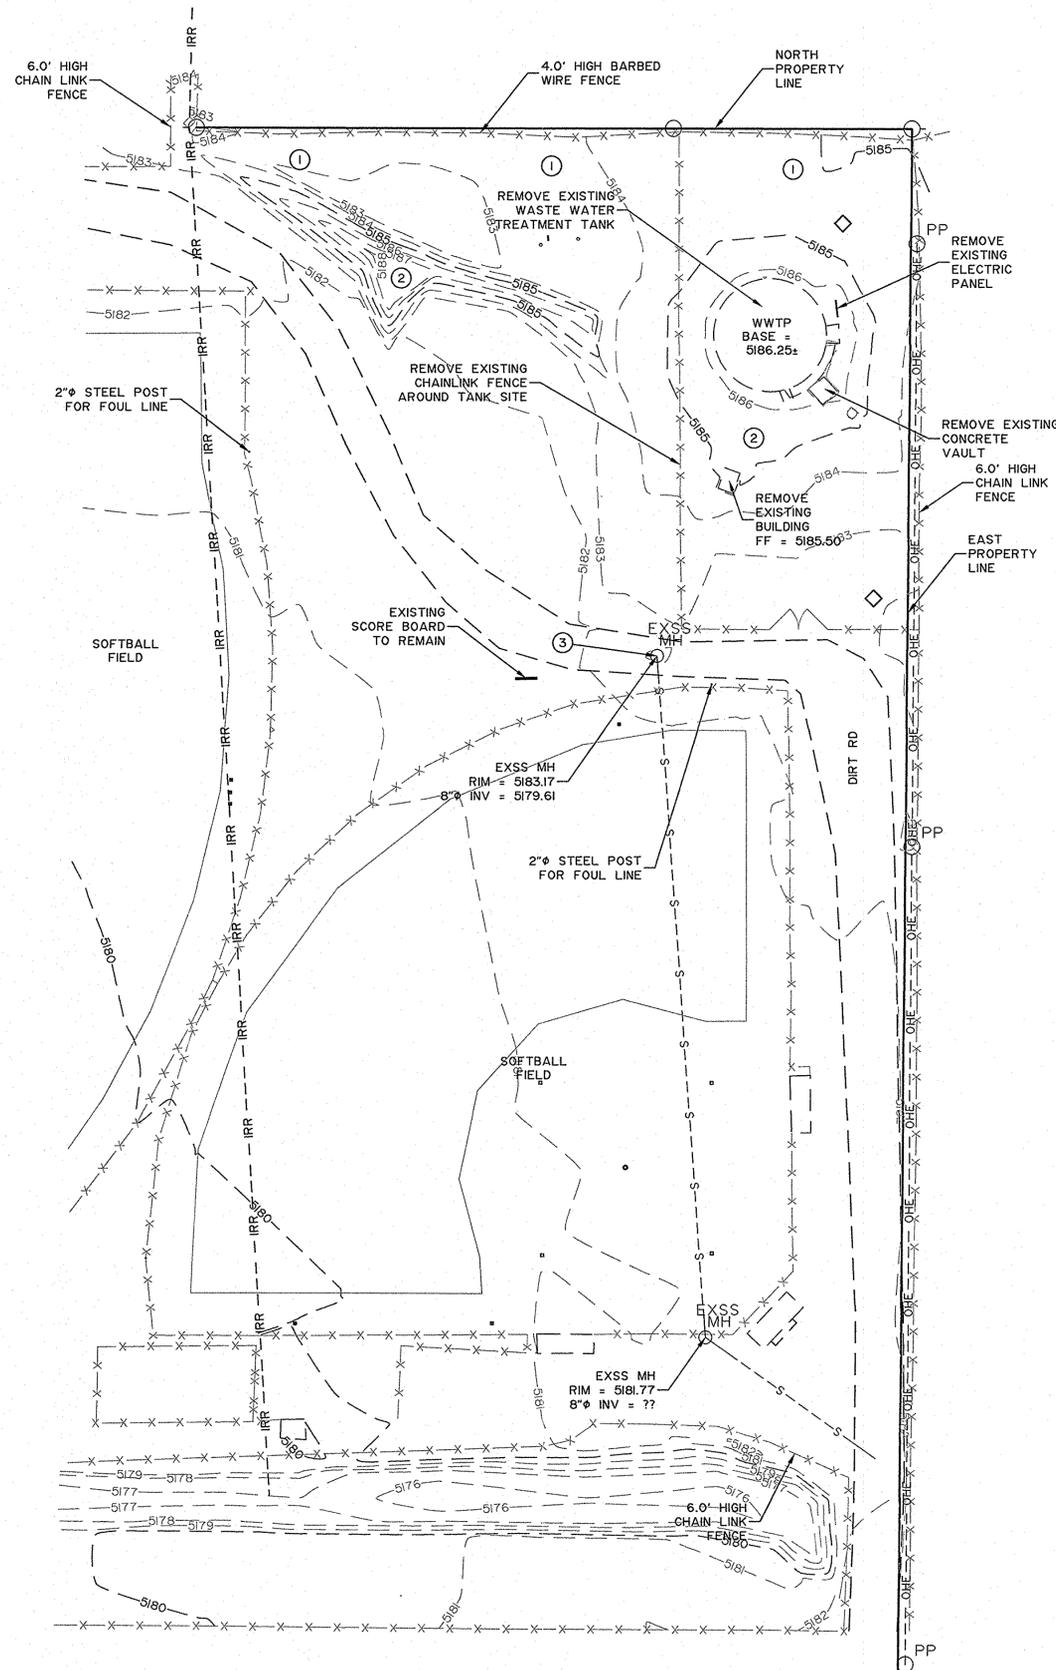
DEMOLITION PLAN CENTRAL CONSOLIDATED SCHOOL KIRTLAND HIGH SCHOOL
 WASTE WATER TREATMENT PLANT
 KIRTLAND, NEW MEXICO

- DEMOLITION NOTES:**
- ① REMOVE ALL TREES, BUSHES AND VEGETATION IN AREA FROM NORTH PROPERTY LINE TO THE FENCE LINES AT THE SOFTBALL FIELDS AND EAST FROM THE SOFTBALL FIELDS FENCE LINES TO THE EAST PROPERTY LINE.
 - ② REGRADE AREA BACK TO ORIGINAL GRADE.
 - ③ CAP INLET PIPE AT MANHOLE - INSTALL CAP ON PIPE AND PLUG WITH CONCRETE.
