NEW MEXICO
ENVIRONMENT DEPARTMENT

RE: Minor-Municipal; SIC 4952; NPDES Compliance Evaluation Inspection; Anthony Water and Sanitation District Waste Water Treatment Plant; NM0029629; July 18, 2013

NPDES Compliance Inspection Report

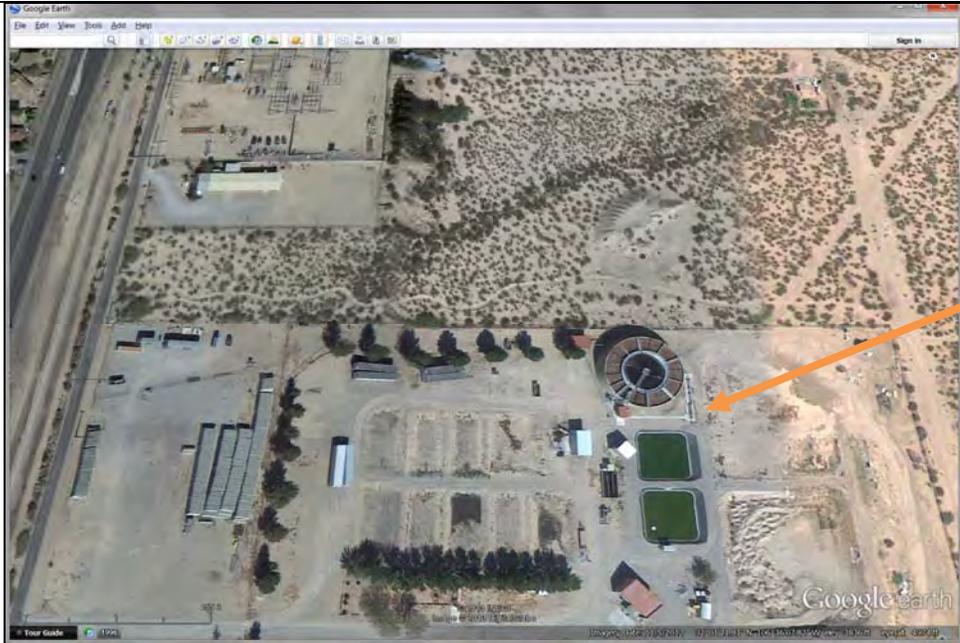
**NMED/SWQB
Official Photograph Log
Photo # 1**

Photographer: B. Cooney	Date: 18 July 2013	Time: Unknown
City/County: Anthony / Dona Ana		State: New Mexico
Location: Anthony WWTP		
Subject: Google Earth Aerial View of Anthony WWTP

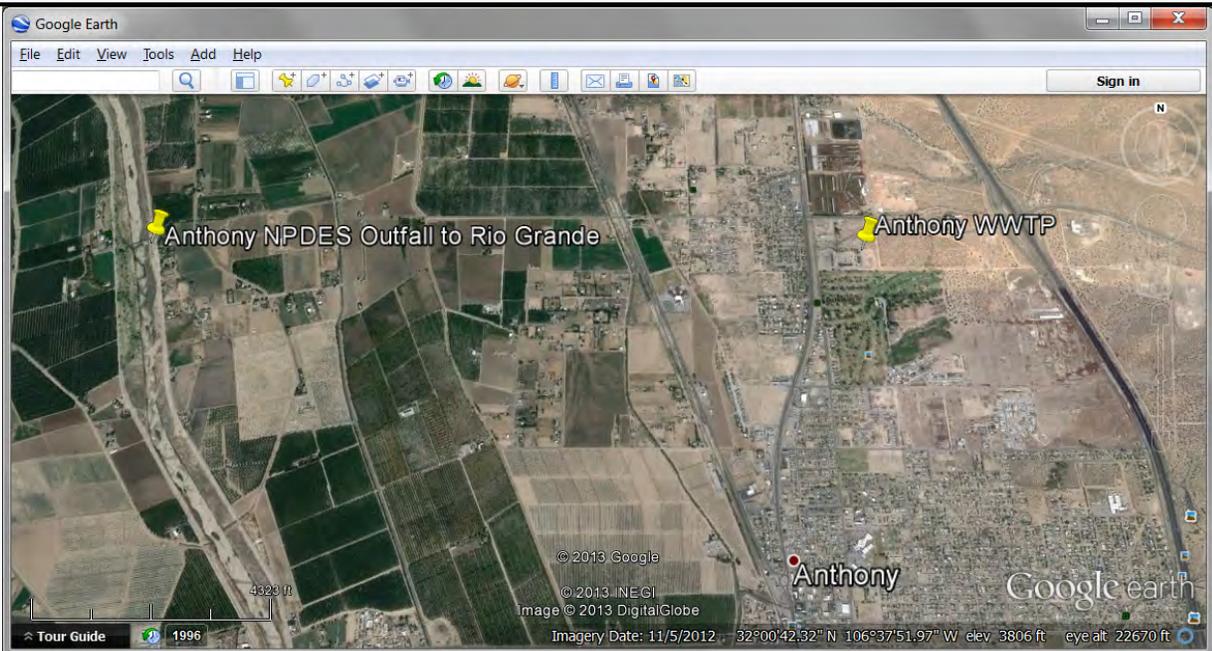
**NMED/SWQB
Official Photograph Log
Photo # 2**

Photographer: : B. Cooney	Date: 18 July 2013	Time: Unkn own
City/County: Anthony / Dona Ana		State: New Mexico
Location: Anthony WWTP		
Subject: Google Earth Aerial View of Anthony WWTP and the Discharge Location at the Rio Grande River aprox. 2 miles away.

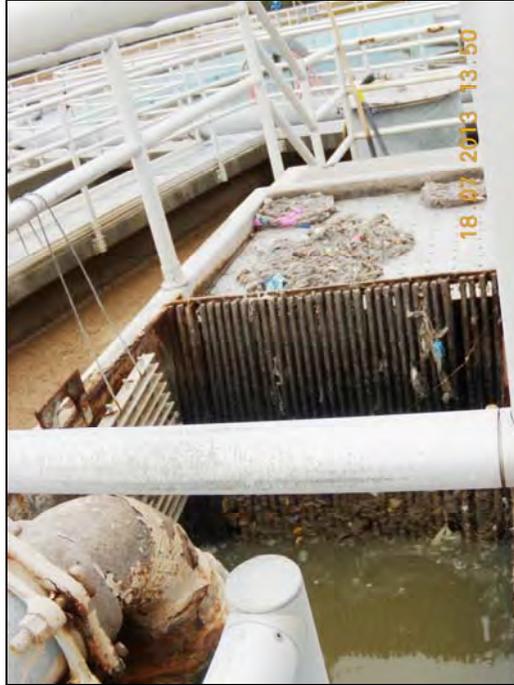
NMED/SWQB
Official Photograph Log
Photo #3

Subject: influent bar screen. Cleaned manually by operators. The solids are placed in a dumpster and disposed of at a landfill. – No paint filter tests were being done.

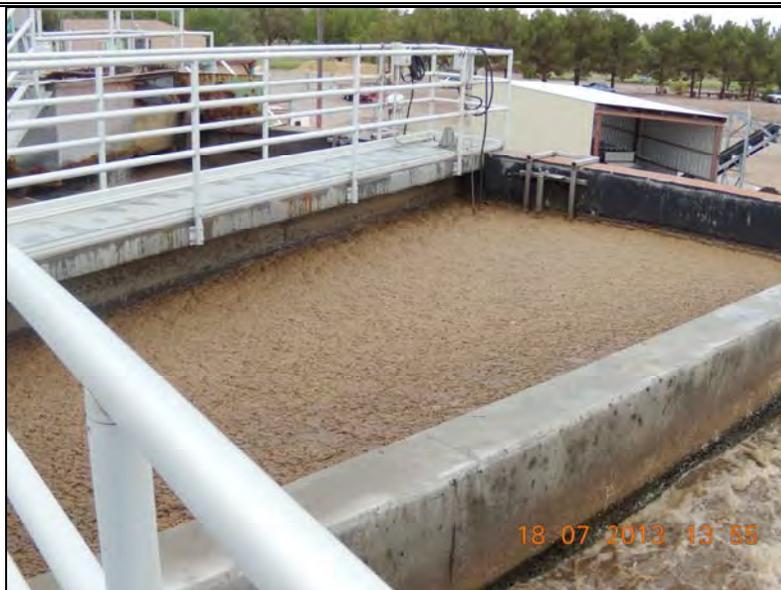
NMED/SWQB
Official Photograph Log
Photo # 4

Subject: Anoxic basin next to an aerated basin.

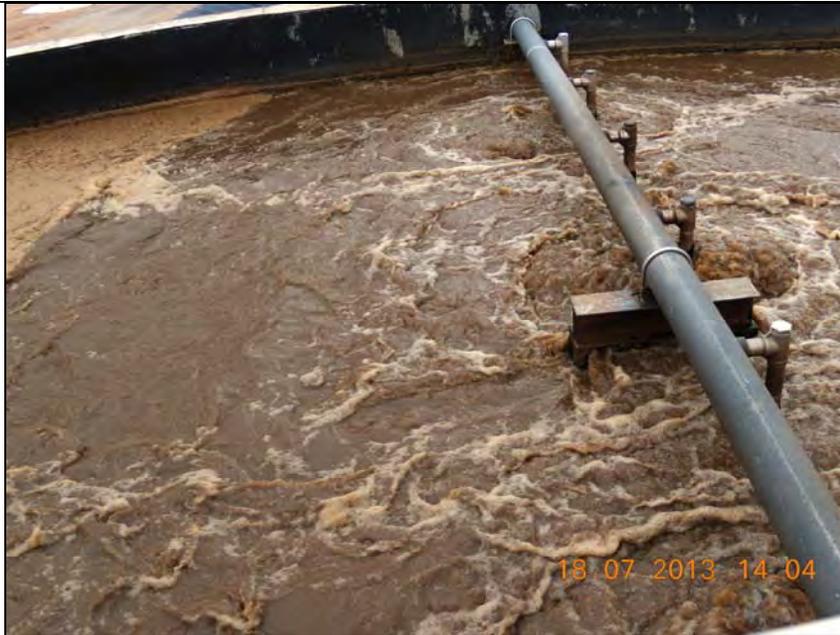
NMED/SWQB
Official Photograph Log
Photo # 5

Subject: Aeration basin. The air distribution is uneven.

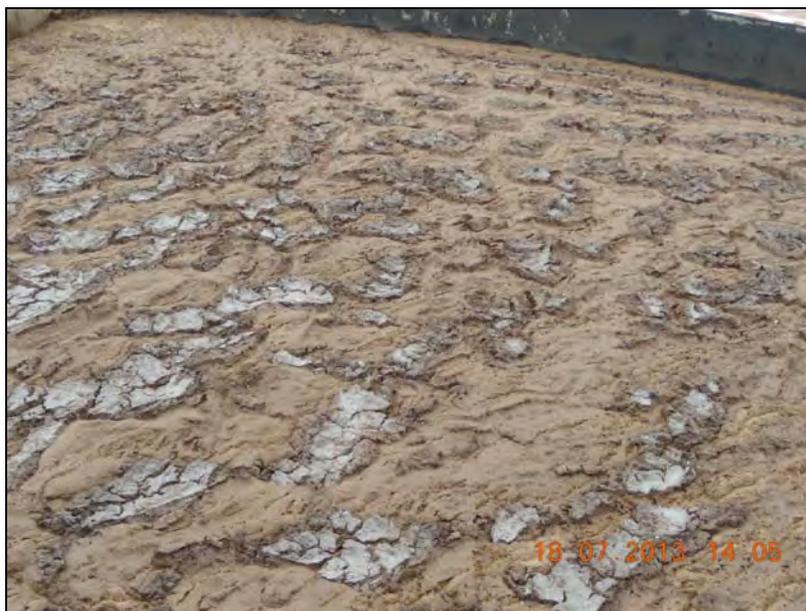
NMED/SWQB
Official Photograph Log
Photo # 6

4. The DO concentration in the aeration basins is too low and likely caused by an overload of solids.
5. There was excess foam in the anoxic zones and some foam accumulation in the aeration basins.

Subject: anoxic basin – large amounts of foam accumulation is present.

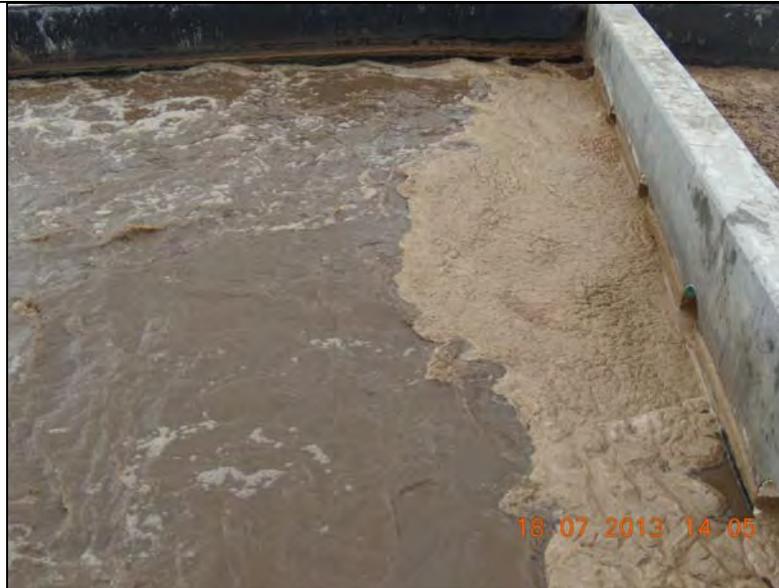
NMED/SWQB
Official Photograph Log
Photo # 7

Subject: Aeration Basin – some foam accumulation

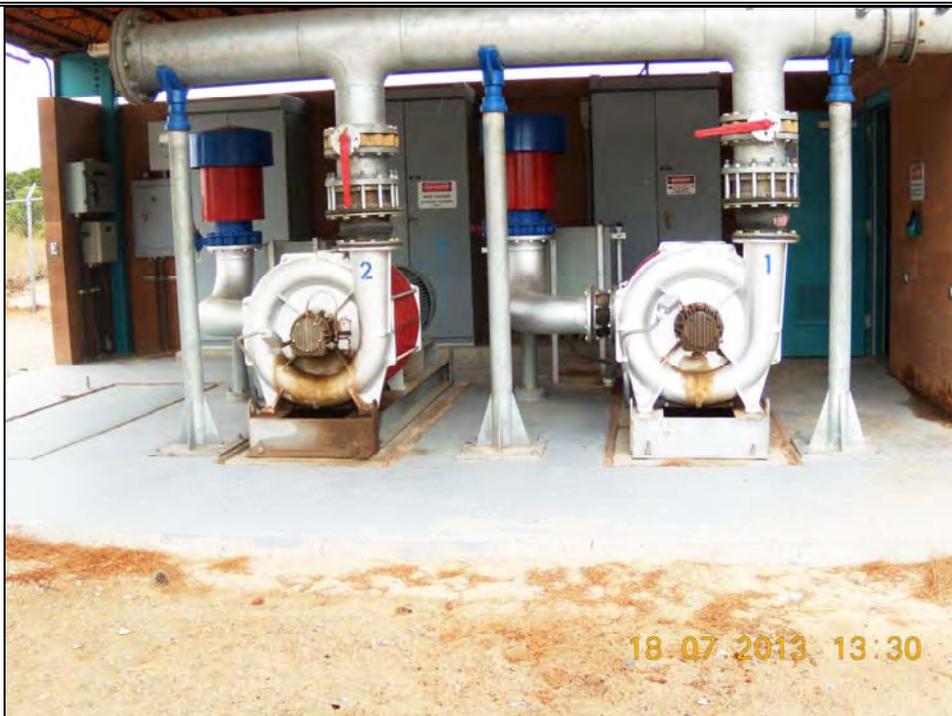
NMED/SWQB
Official Photograph Log
Photo # 8

Subject: Air Blowers - one unit was running at the time of the inspection. These units showed some signs of aging and some oil leakage.

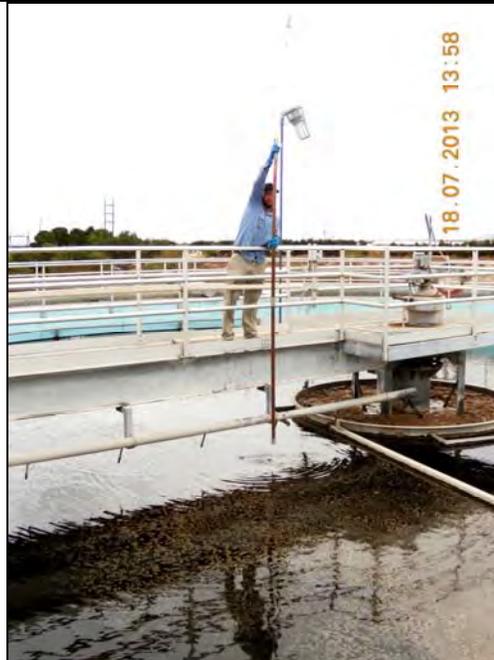
NMED/SWQB
Official Photograph Log
Photo # 9

7. The sludge blanket in the secondary clarifier was 10 feet and should be maintained at between 2 and 3 feet. Floating solids were also found in the clarifer.

Subject: Secondary Clarifier sludge test. There was nine to ten feet of a solids blanket in the basin. Solids wasting rates need to be increased. The solids were aging and some floating solids were observed. An optimal solids blanket would be two to three feet in this basin.

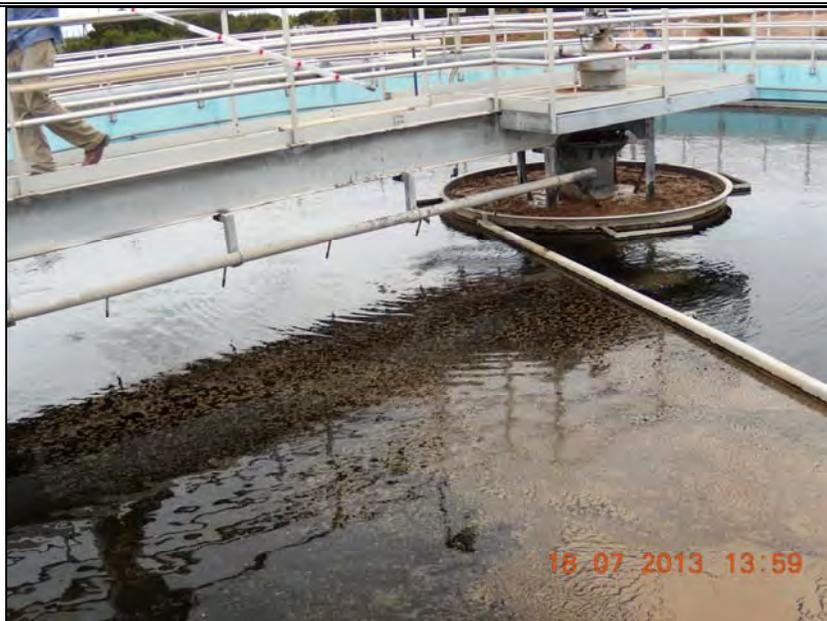
NMED/SWQB
Official Photograph Log
Photo # 10

Subject: Secondary Clarifier – large amounts of floating solids in the basin.

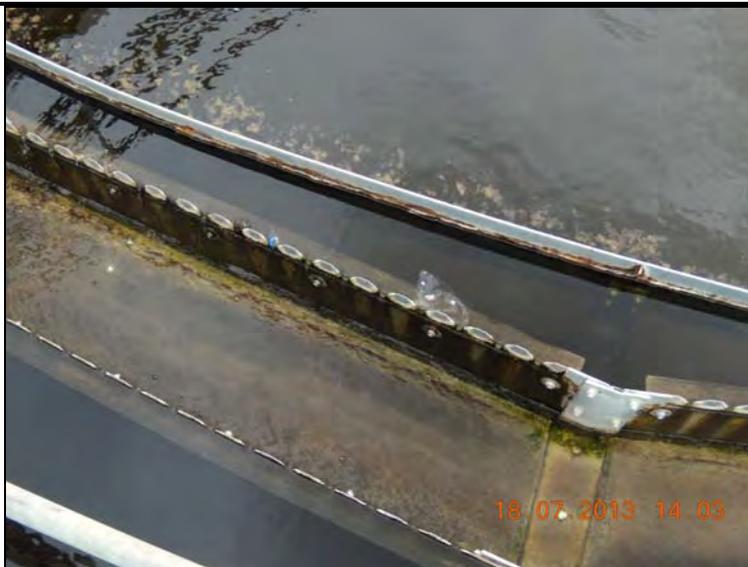
NMED/SWQB
Official Photograph Log
Photo # 11

8. Some uneven flow and short circuiting was observed in the secondary clarifiers. This is likely the result of the units settling into the ground over the years. However the weirs were free of excessive algae build up.

Subject: Secondary Clarifier Weirs- uneven flow and short circuiting was observed. Also noted were floating solids getting past the weirs. The weirs were largely clear of accumulated algae growth.

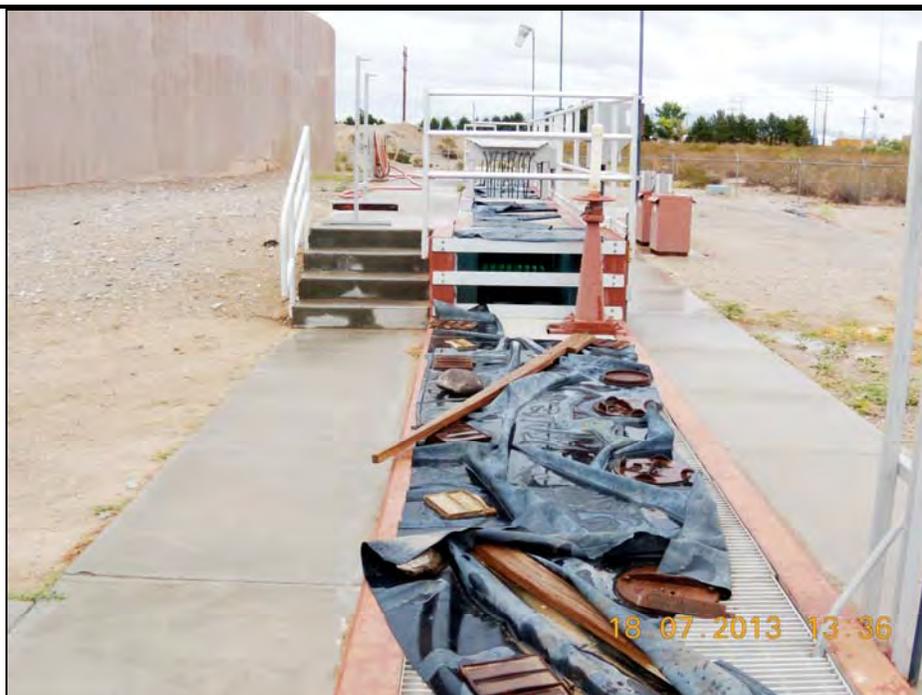
NMED/SWQB
Official Photograph Log
Photo # 12

Subject: Effluent Channel and UV disinfection treatment units. The channel is covered with tarps to reduce the sunlight in the chamber that causes algae accumulation and growth.

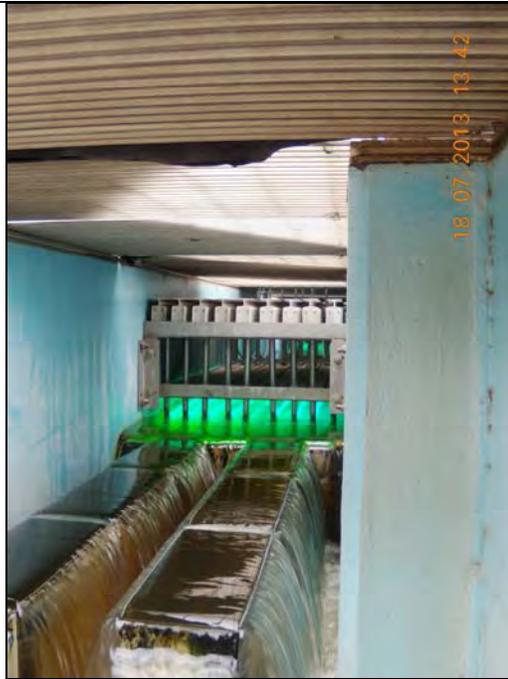
NMED/SWQB
Official Photograph Log
Photo # 13

Subject: Ultra Violet (UV) disinfection units. The bulbs appeared to be free of algae accumulation.

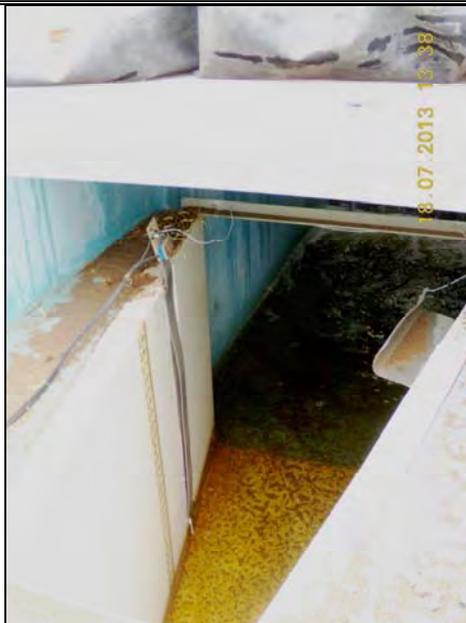
NMED/SWQB
Official Photograph Log
Photo # 14

Subject: Effluent staff gauge and pressure sensor for flow measurement at the Parshall Flume.

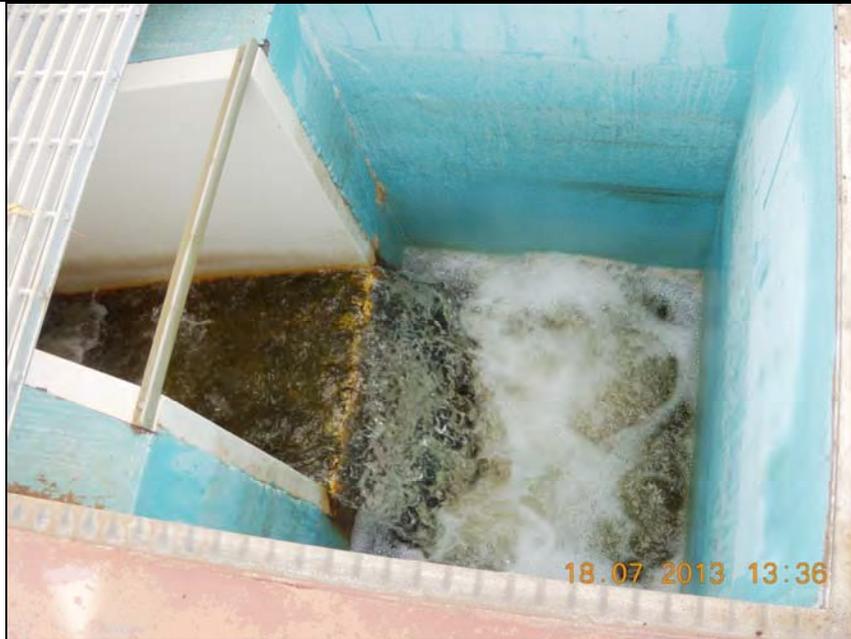
NMED/SWQB
Official Photograph Log
Photo # 15

Subject: Effluent past the UV disinfection. The color of the effluent was slightly greenish. Some turbidity and some floating solids were noted. – Additional screens could be located before the UV chamber to catch large floating solids that make it past the other treatment works.

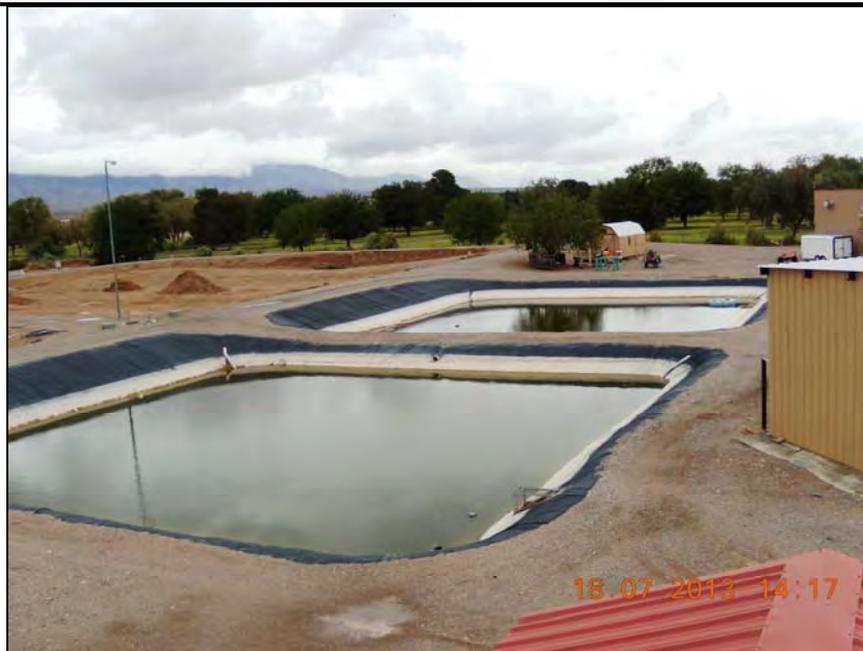
NMED/SWQB
Official Photograph Log
Photo # 16

Subject: Holding ponds for treated effluent before it is sent to reuse.

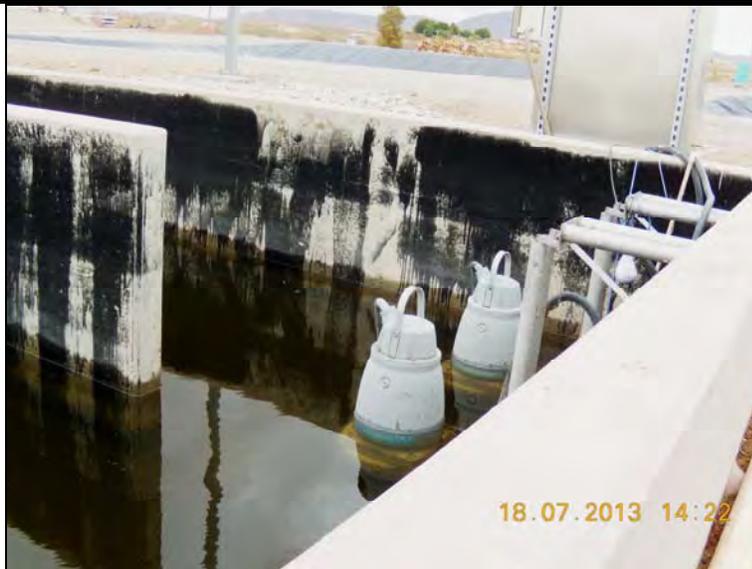
NMED/SWQB
Official Photograph Log
Photo # 17

Subject: Old chlorine contact chamber no longer in use because of UV disinfection. These basins hold the effluent water that backs up in the pipes when the river water level is higher than the effluent pipes.

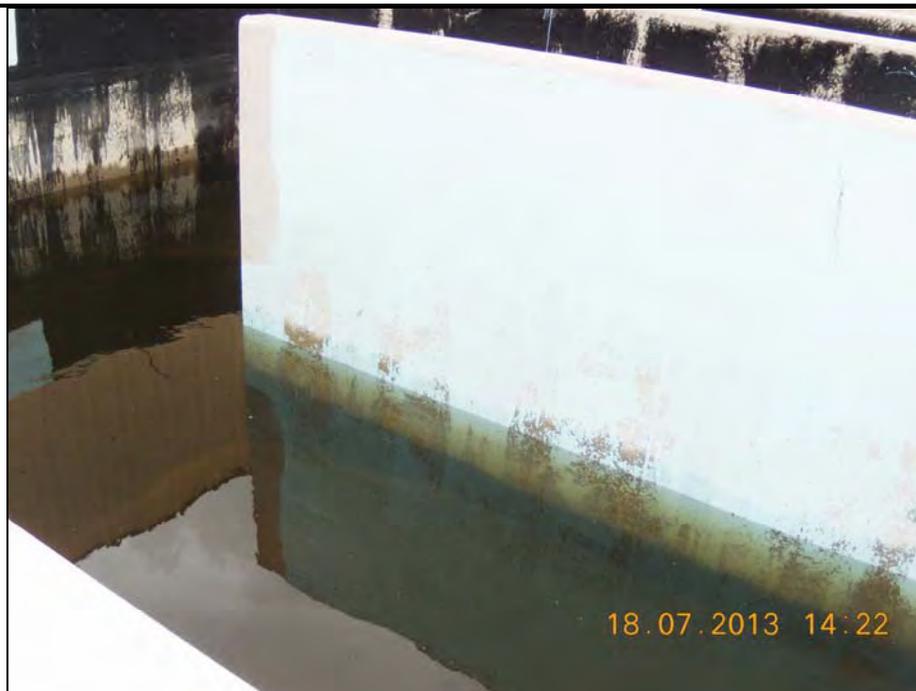
NMED/SWQB
Official Photograph Log
Photo # 18

Subject: Old chlorine contact chamber no longer in use because of UV disinfection. These basins hold the effluent water that backs up in the pipes when the river water level is higher than the effluent pipes.

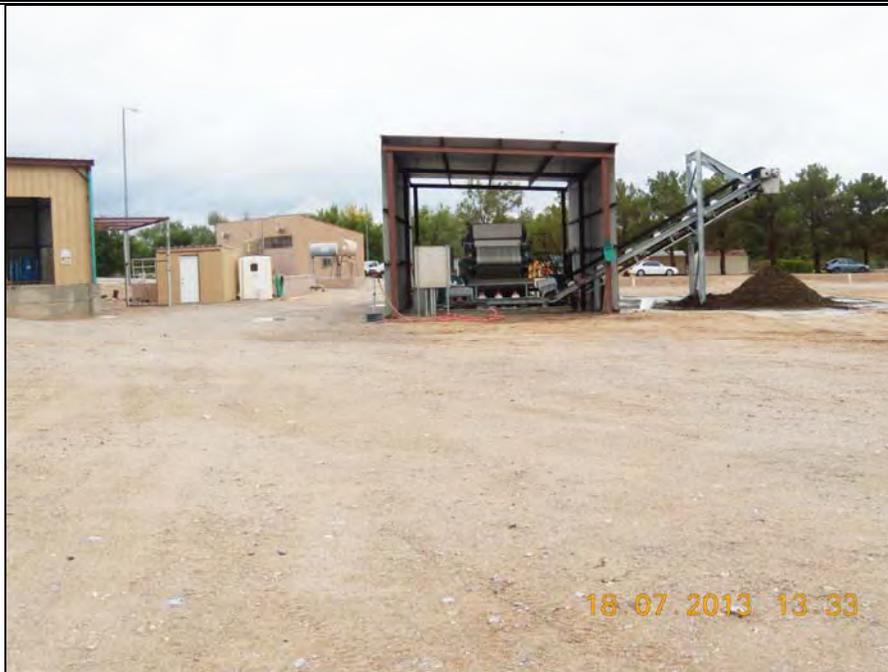
NMED/SWQB
Official Photograph Log
Photo # 19

Subject: Sludge Belt Press – and concrete pad where it is dropped. – Bins should be placed under the belt press to capture the processed solids.

9. The sludge belt press dropped solid onto a concrete pad. These solids should be deposited directly into a hauling container. The concrete pad was not bermed and there was evidence of solids track out and runoff from the pad.
10. The piping for the air diffusers in the aeration basins was showing signs of rusting and deterioration.
11. There were not back up parts on site for the blowers or other equipment.
12. A mixer in the digester was not working at the time of the inspection.
13. The sludge drying bed liners are old and falling apart.
14. The backup power generator was out of service at the time of the inspection.
15. The alarm system for the WWTP was not working at the time of the inspection.

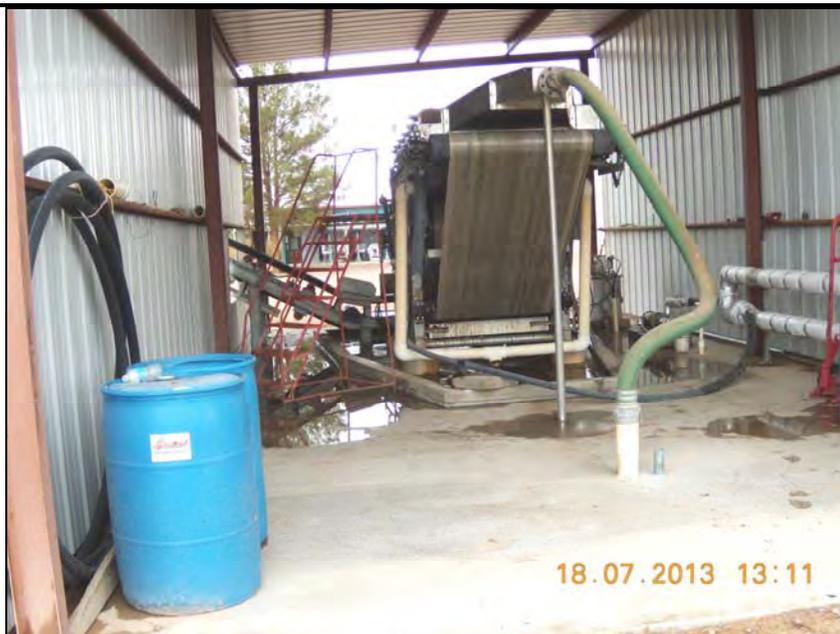
NMED/SWQB
Official Photograph Log
Photo # 20

Subject: Sludge Belt Press down from operation at the time of the inspection.

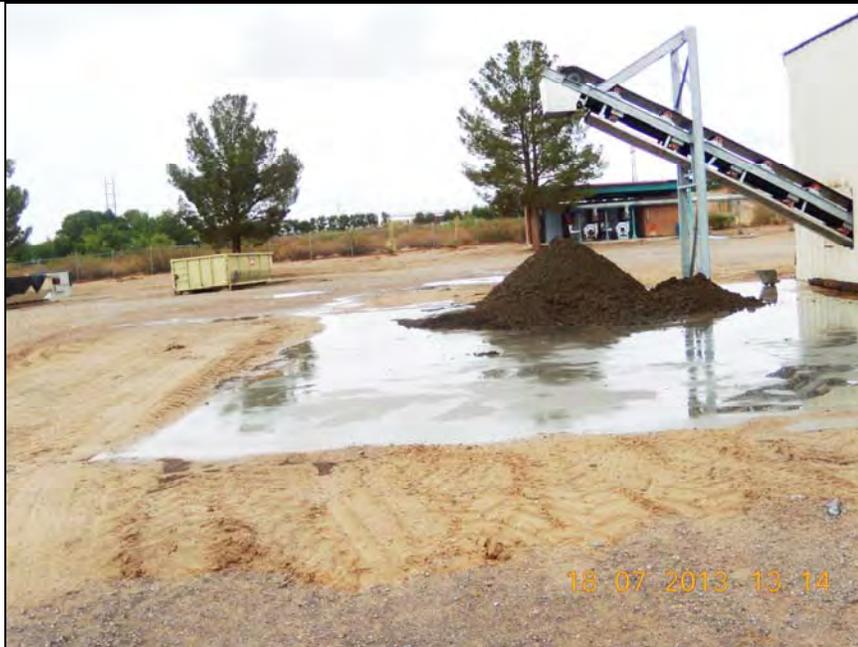
NMED/SWQB
Official Photograph Log
Photo # 21

Subject: Sludge belt press deposits solids onto a concrete pad. The solids are eventually scooped up with a backhoe and deposited in transport bins (see one in background of photo). The concrete pad has no berm. Run off and track out is visible.

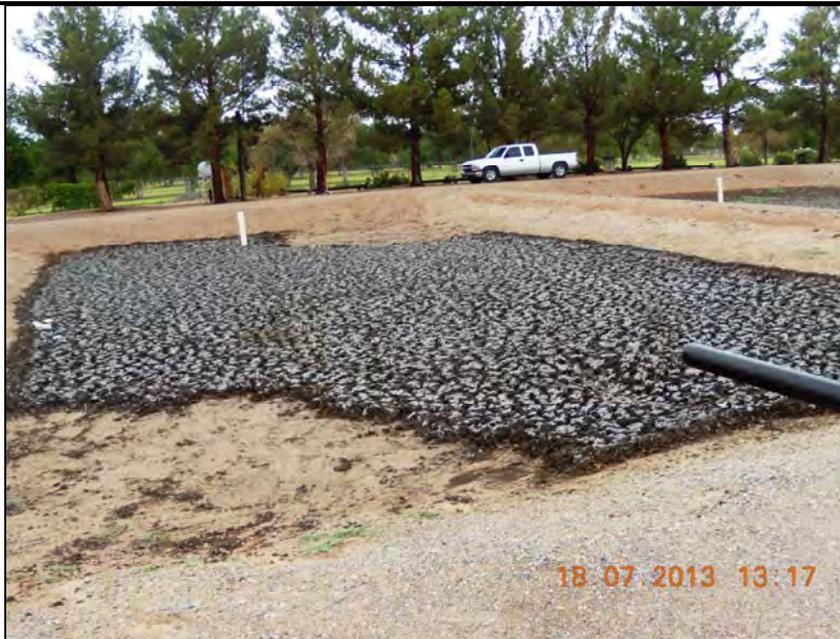
NMED/SWQB
Official Photograph Log
Photo # 22

1. Testing and analysis of sewage sludge is not being sent to NMED - Surface Water Quality Bureau and therefore appears to not be done.
2. Solids are not being wasted at an adequate rate from this facility to optimize the operations of the treatment units and to maintain the quality of the effluent.
3. Solids coming off the belt press land on an unbermed concrete area. A backhoe then moves the sludge to the transport container. There is not a berm in place. Run off and track out is occurring from this area.
4. The sludge drying beds have liners that are breaking down and leaking.

Subject: Sludge Drying Bed – one of six. These beds are used as a backup. The plastic lining of the beds is deteriorated and likely very permeable.

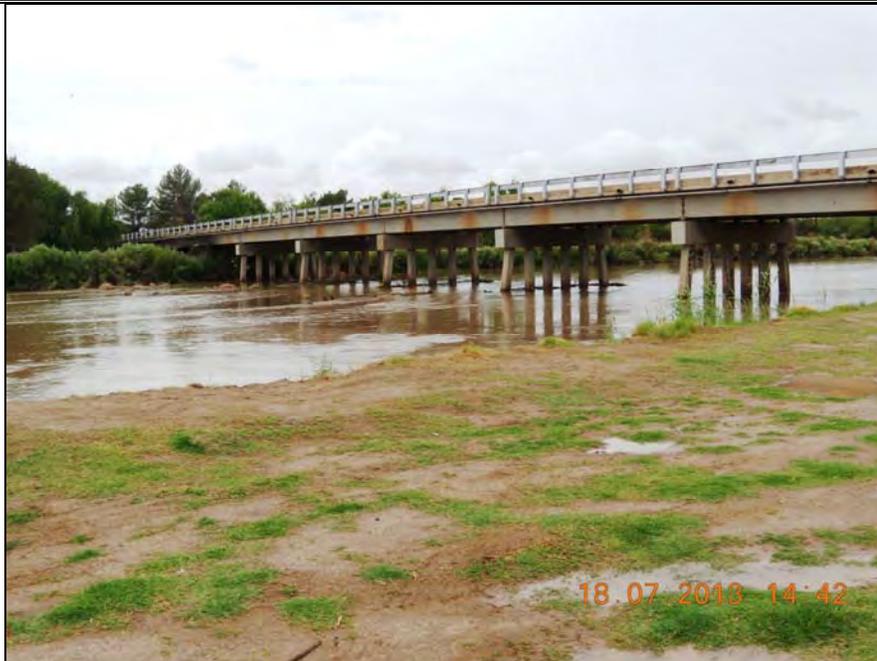
NMED/SWQB
Official Photograph Log
Photo # 23

Subject: Discharge Location at the Rio Grande is approx. 2 miles from the WWTP.

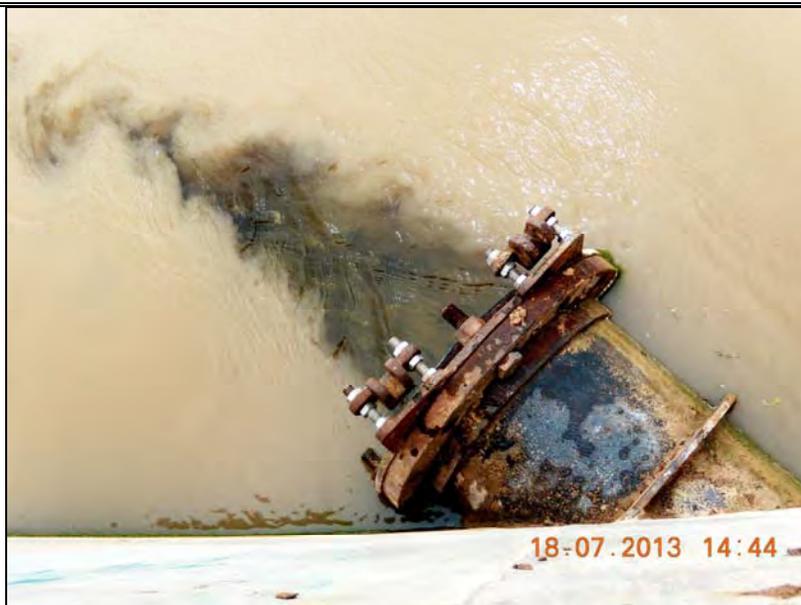
NMED/SWQB
Official Photograph Log
Photo # 24

Subject: Effluent pipe to the Rio Grande- The effluent mixing with the River. The Rio Grande is the typical turbid sandy color found during rain storms. The effluent water is greenish and less turbid than the river.

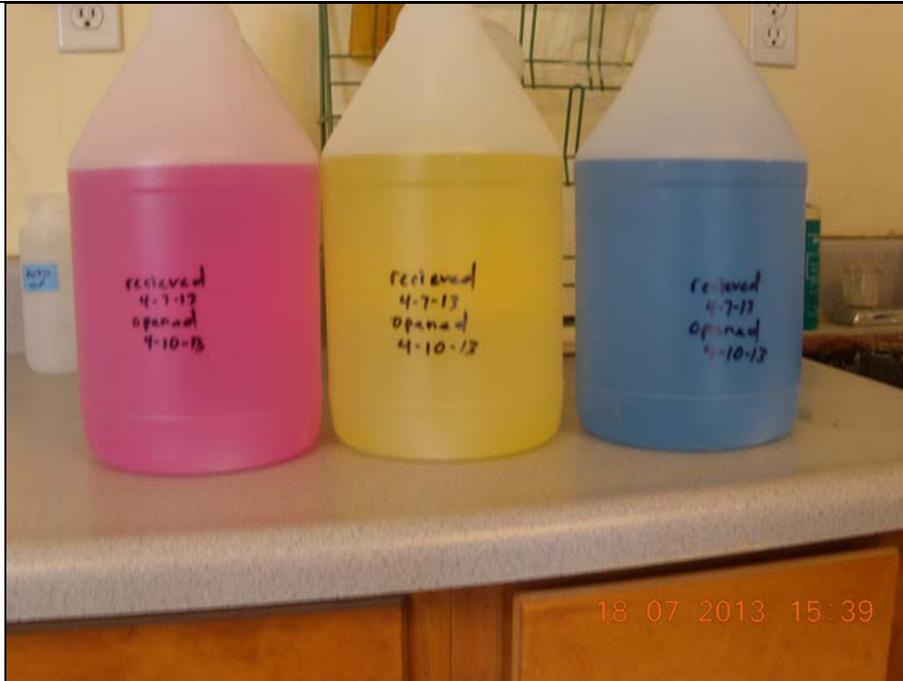
NMED/SWQB
Official Photograph Log
Photo # 25

Subject: pH Buffers – labeled and dated.
