**RE: Minor-Municipal; SIC 4952; NPDES Compliance Evaluation Inspection; Anthony Water and Sanitation District Waste Water Treatment Plant; NM0029629; November 17, 2015**

### NPDES Compliance Inspection Report

On November 17, 2015 a Compliance Evaluation Inspection (CEI) was conducted at the Anthony Water and Sanitation District Wastewater Treatment Plant (WWTP) by Barbara Cooney of the State of New Mexico Environment Department (NMED), Surface Water Quality Bureau (SWQB). The inspection was conducted by NMED for the US Environmental Protection Agency (USEPA), Region VI, under the National Pollutant Discharge Elimination System (NPDES) permit program, in accordance with the Federal Clean Water Act. These inspections are conducted under contract with the USEPA and are used by USEPA to evaluate compliance with the NPDES permit program. This inspection report is based on information supplied by the Anthony Water and Sanitation District representatives (the permittee), observations made by the NMED inspectors, reports and records kept by the permittee and/or NMED.

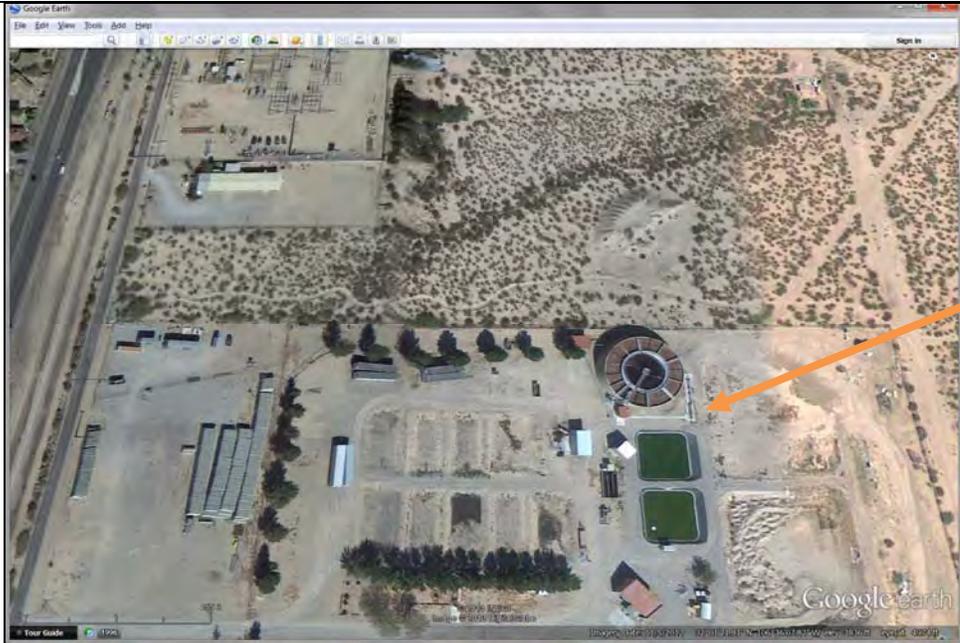
**NMED/SWQB  
Official Photograph Log  
Photo # 1**

Photographer: B. Cooney	Date: Unknown	Time: Unknown
City/County: Anthony / Dona Ana		State: New Mexico
Location: Anthony WWTP		
Subject: Google Earth Aerial View of Anthony WWTP

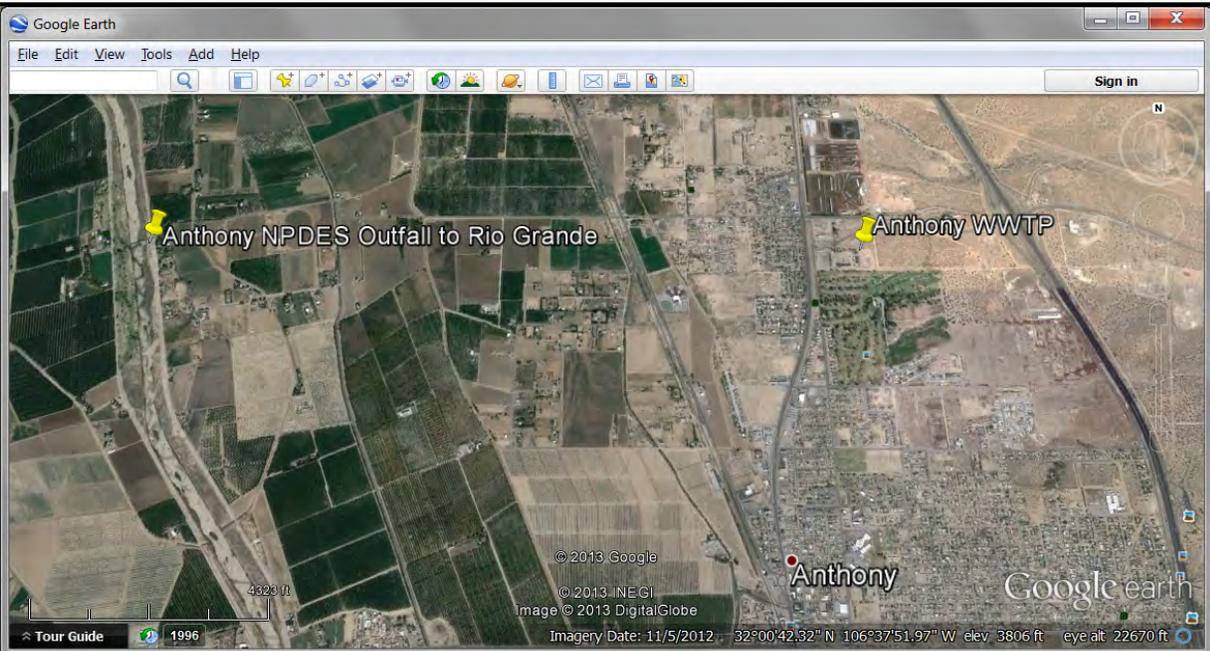
**NMED/SWQB  
Official Photograph Log  
Photo # 2**

Photographer: : B. Cooney	Date: Unknown	Time: Unkn own
City/County: Anthony / Dona Ana		State: New Mexico
Location: Anthony WWTP		
Subject: Google Earth Aerial View of Anthony WWTP and the Discharge Location at the Rio Grande River aprox. 2 miles away.

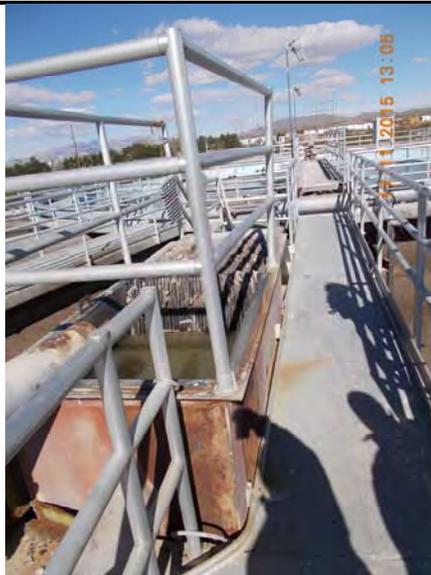
NMED/SWQB  
Official Photograph Log  
Photo #3

Subject: A screw pump lifts raw sewage to the above ground treatment units. The entrance works include a manual bar screen seen below. Scraping are put in a hopper and disposed of at the Camino Real Landfill.

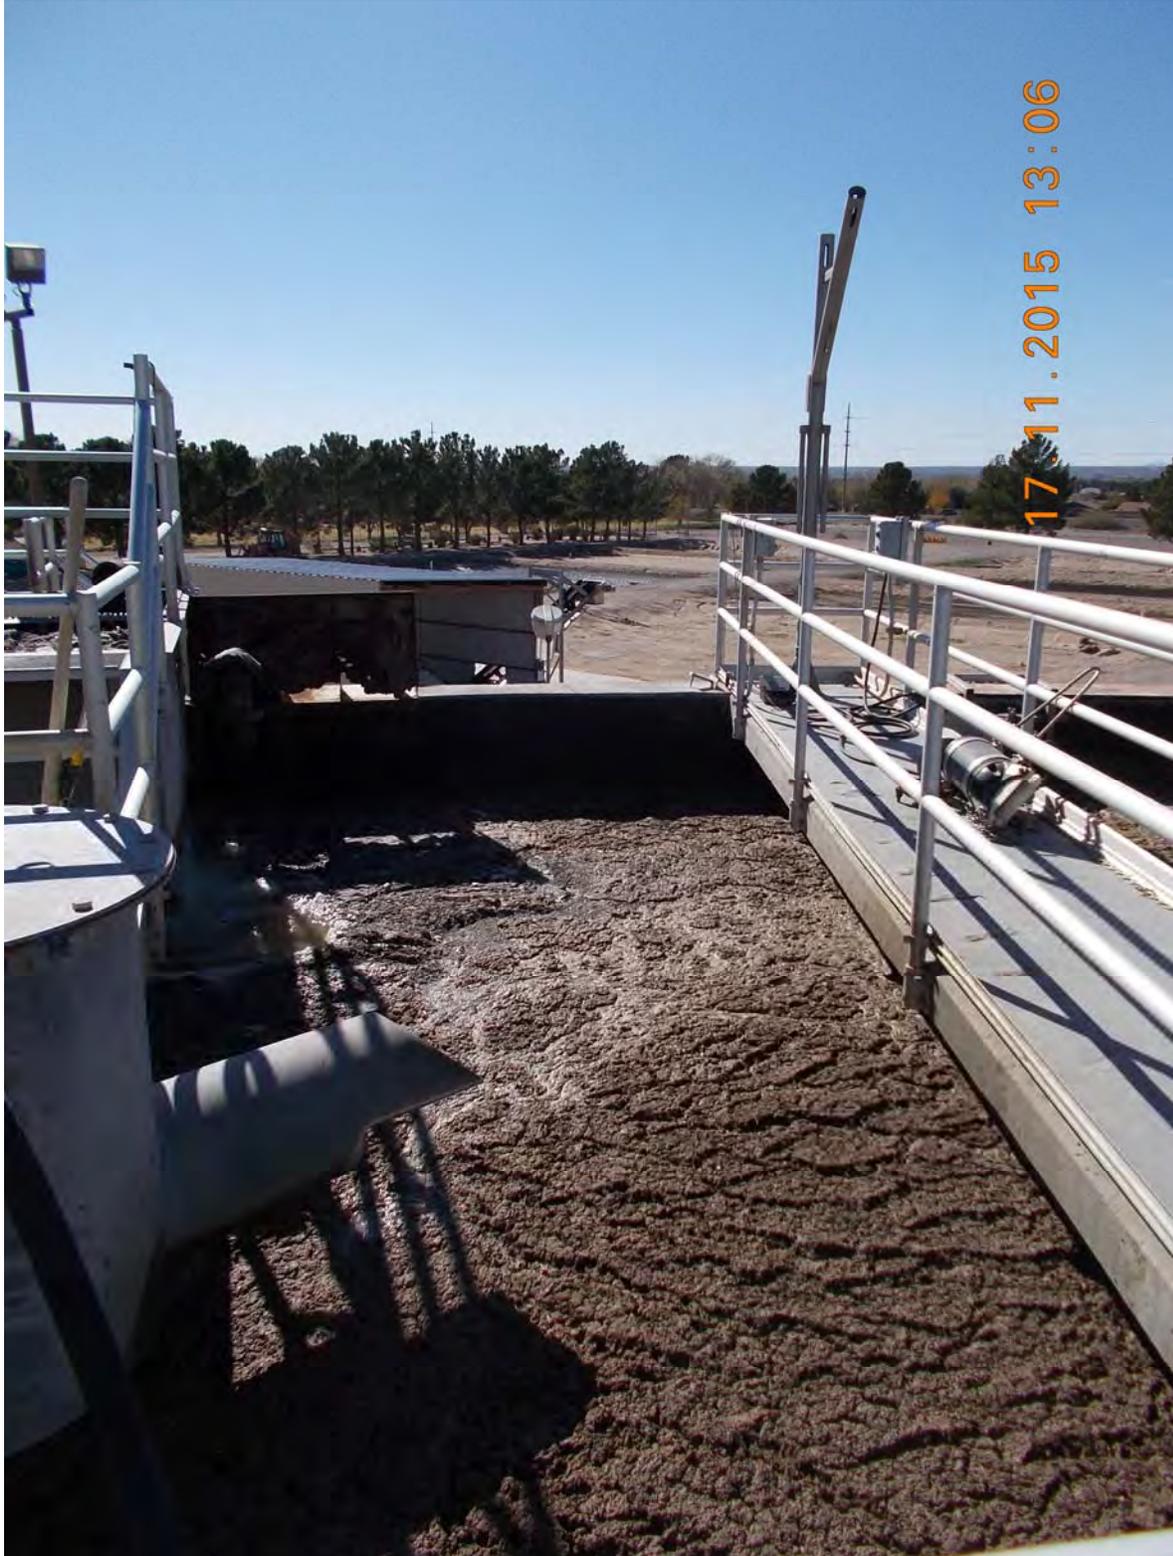
NMED/SWQB  
Official Photograph Log  
Photo # 5

Subject: An anoxic basin in the settling phase. Foam and solids were observed on the surface. However the solids did not appear to be exceptionally old. There was no indication of spillage or overflow from the basin. There is no mechanism for removal of floating solids in the basin.

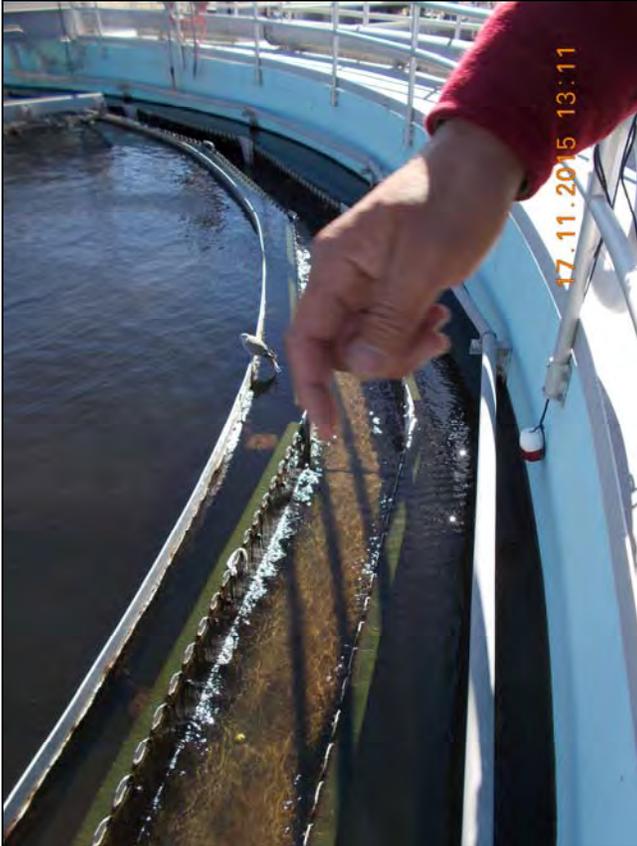
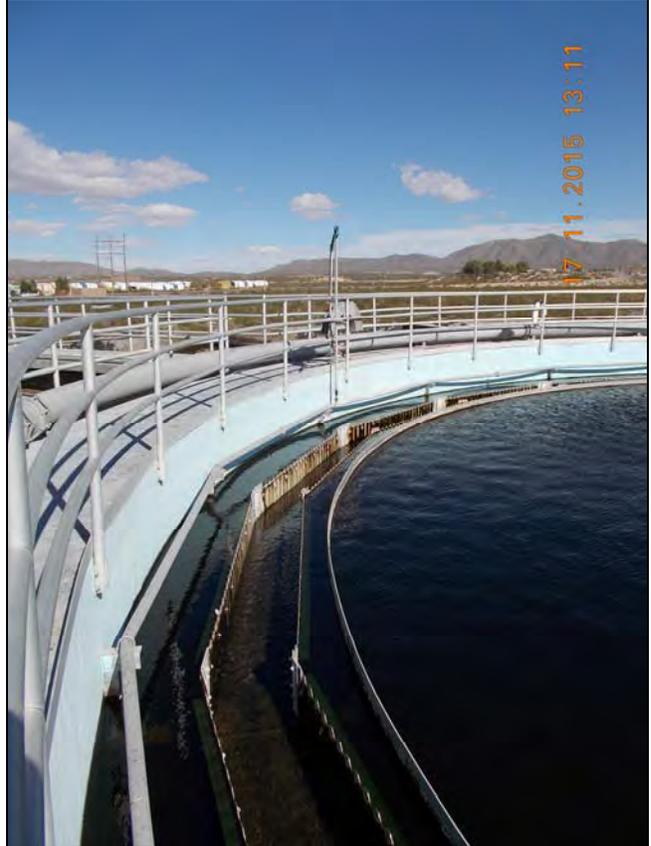
NMED/SWQB  
Official Photograph Log  
Photo # 6 & 7

Subject: The central part of the treatment "doughnut" is the secondary clarifier. The day of the inspection was a very windy so the effects may have been exaggerated; however, the weirs appeared to not be level throughout the basin. The operator indicated that even on days without wind, decant flow was high over the weirs in some parts of the basin than others. The weirs were generally clean and free of debris. Some amounts of larger solids appear to have been caught. The sludge blanket was 1 to 2 feet in the basin, indicating frequent wasting of solids.

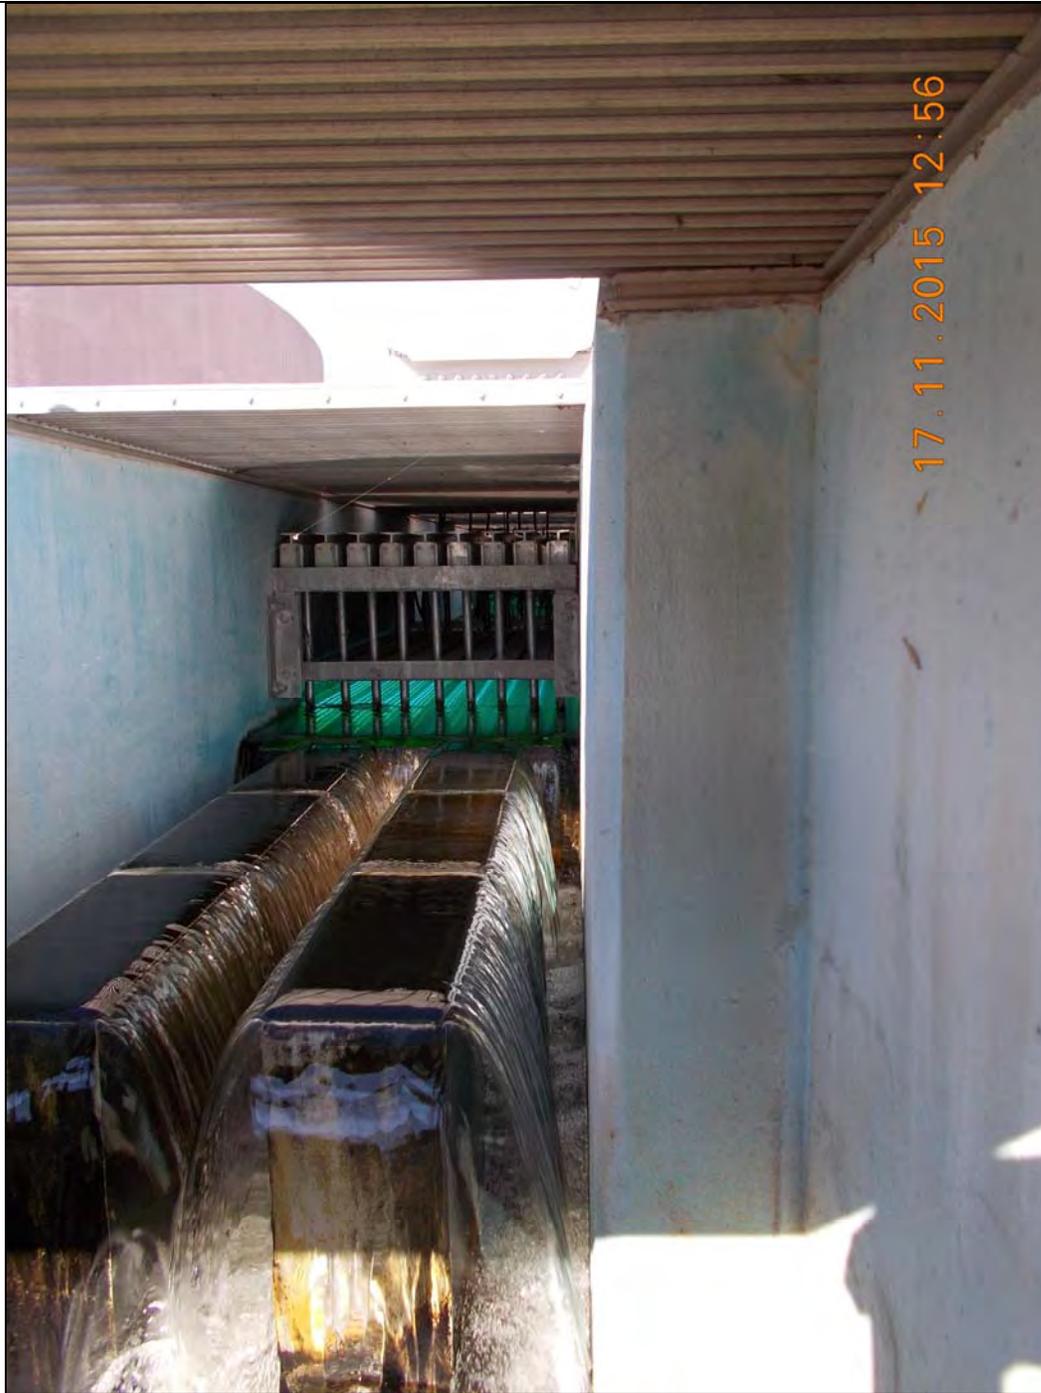
NMED/SWQB  
Official Photograph Log  
Photo # 8

Subject: Ultra Violet Disinfection Lights and effluent weirs. At the time of inspection all bulbs were operating. Effluent was clear.

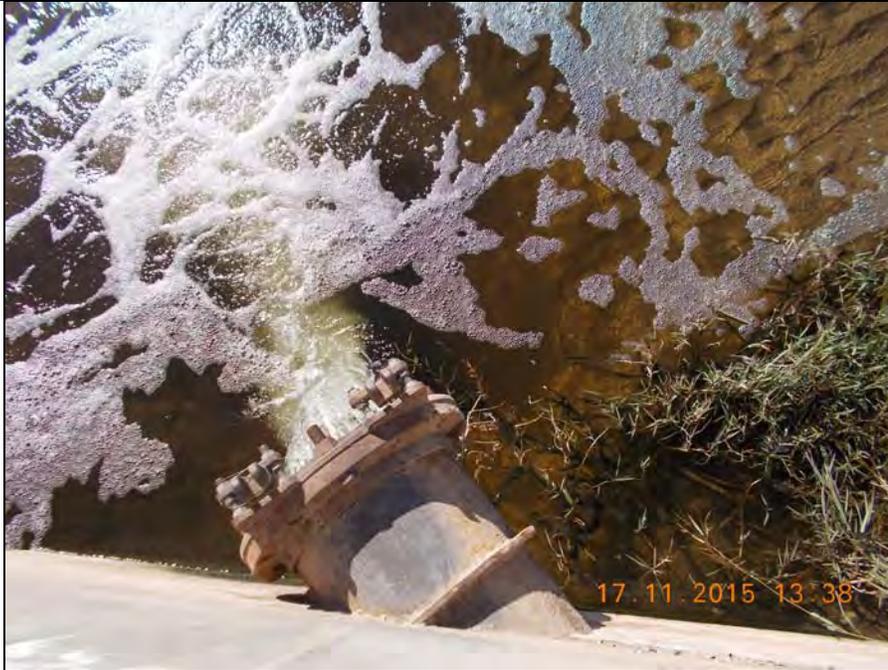
NMED/SWQB  
Official Photograph Log  
Photo # 9

Subject: Effluent pipe at the Rio Grande. The treated discharge was clear and free of floating solids. Small fish or minnows were swimming in the outfall water.

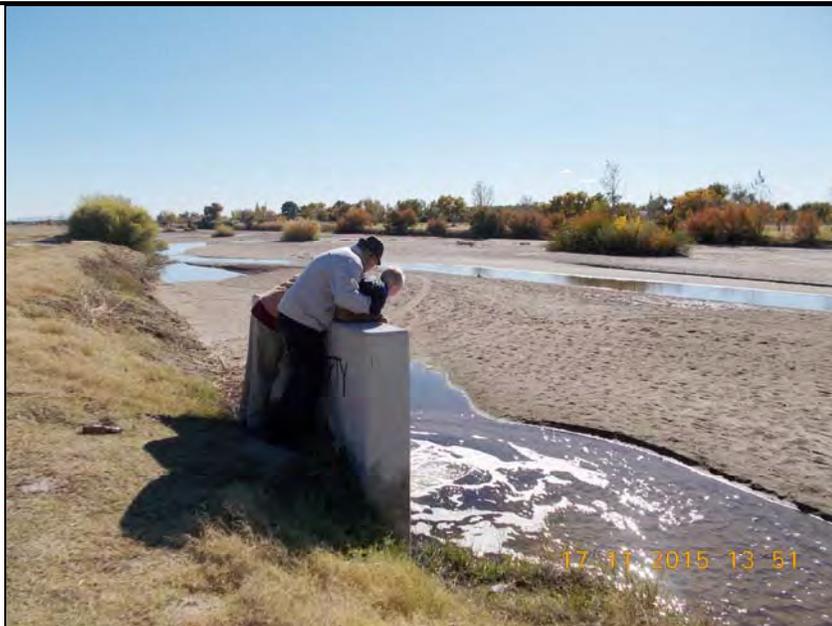
NMED/SWQB  
Official Photograph Log  
Photo # 10

Subject: Effluent pipe at the river, a gentleman and his grandson watching the water and minnows at the outfall.

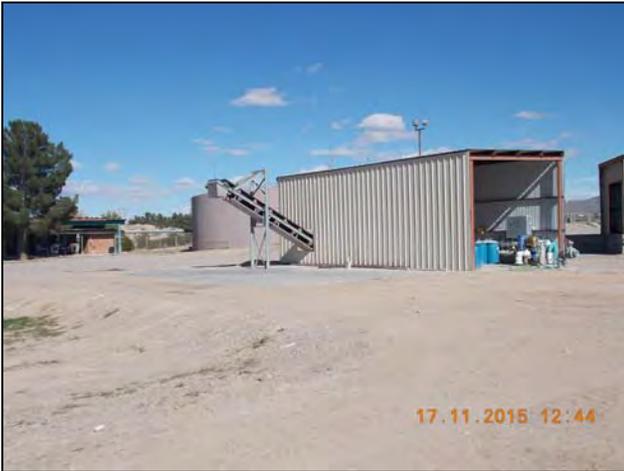
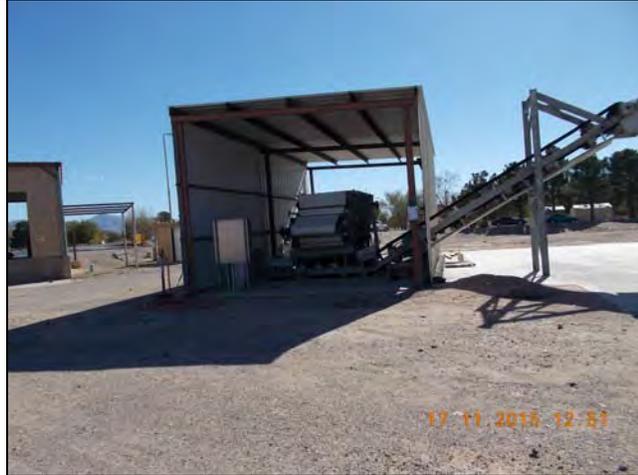
NMED/SWQB  
Official Photograph Log  
Photo # 11 & 12

1. Operators have increased solids wasting from the time of the previous inspection. This has had a positive effect on overall plant performance.
2. A mixer in an anoxic basin was out of order. The sludge belt press was out of order at the time of the inspection.
3. A blower was out of order at the time of the inspection.
4. Some uneven flow and short circuiting was observed in the secondary clarifiers. This is likely the result of the units settling into the ground over the years. However the weirs were free of excessive algae build up and were being cleaned regularly.
5. The piping for the air diffusers in the aeration basins was showing signs of rusting and deterioration.
6. There were not any back up parts on site for the blowers or other equipment.
7. The sludge drying bed liners are old and falling apart.

Subject: Sludge processing. Belt press and conveyor belt sends solids to a dump truck that hauls solids to the Camino Real Landfill for final disposal. At the time of the inspection the belt press was out of operation while the permittee was waiting for spare parts.

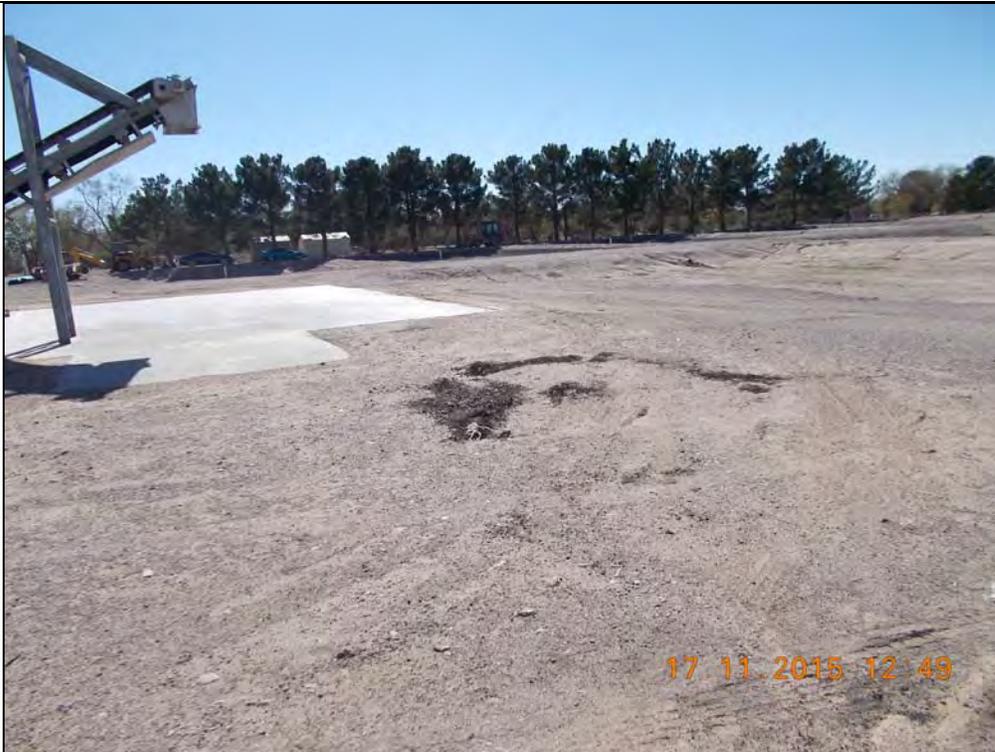
NMED/SWQB  
Official Photograph Log  
Photo # 13

1. DMRs have not been submitted for sludge. Records were not provided for solids testing. This is the reason for the Unsatisfactory rating.
2. Solids coming off the belt press land on an unbermed concrete area. Run off and track out is occurring from this area. Solids were observed on bare ground.
3. The sludge drying beds have liners that are breaking down and could potentially be leaking into groundwater.

Subject: Sludge processing area is not bermed and some dried solids were observed on the ground.

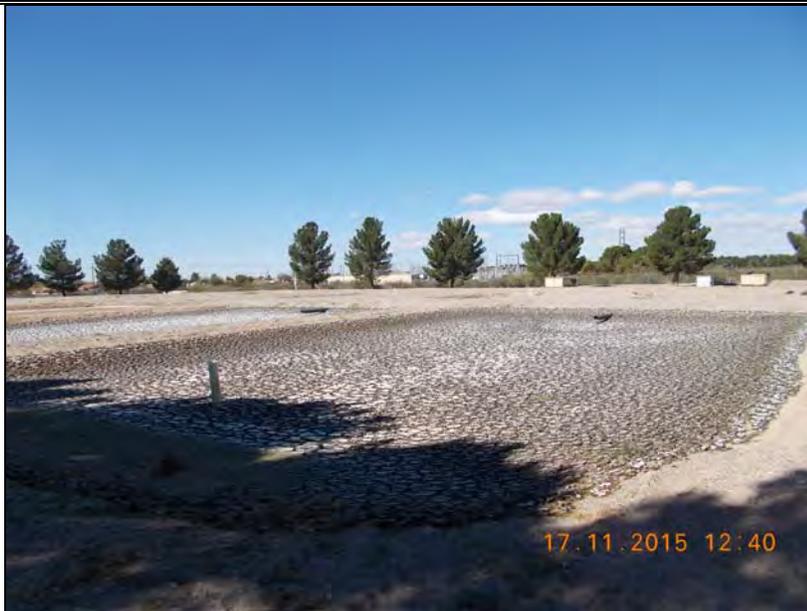
NMED/SWQB  
Official Photograph Log  
Photo # 14

Subject: Solids handling, when the belt press is out of operation the lined drying beds hold wasted solids. The facility has a NMED Ground Water Discharge Permit.

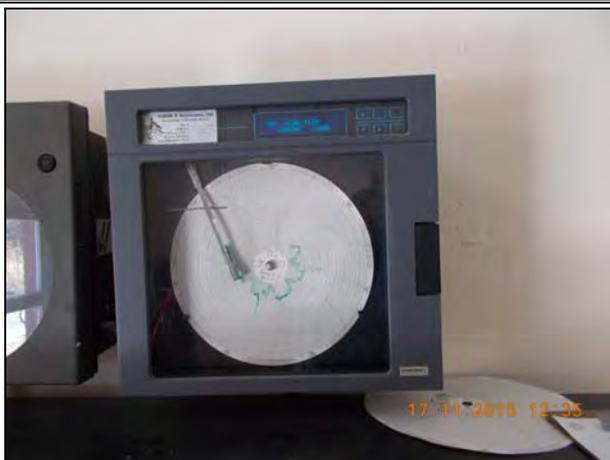
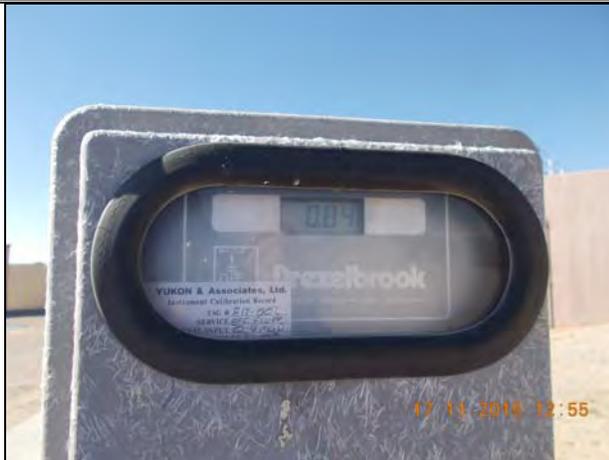
NMED/SWQB  
Official Photograph Log  
Photo # 15 & 16

Subject: Influent Flow meter, recording daily flows. Drexelbrook Ultrasonic Effluent flow meter .

1. The calibration record from the contractor Yukon & Associates show it was last checked September 17, 2014. This should be done yearly. In addition Operators should periodically through the year check the Drexelbrook electronic sensor against the Parshall Flume staff gauge.

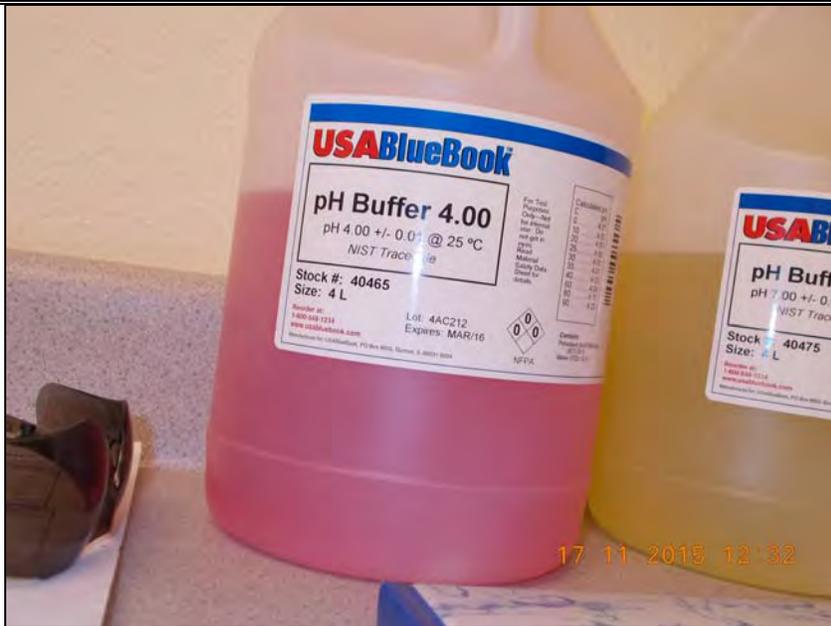
NMED/SWQB  
Official Photograph Log  
Photo # 17

Subject: pH buffers were stored correctly and within the manufactures expiration date. Operators should also write on the bottles the date it was opened.

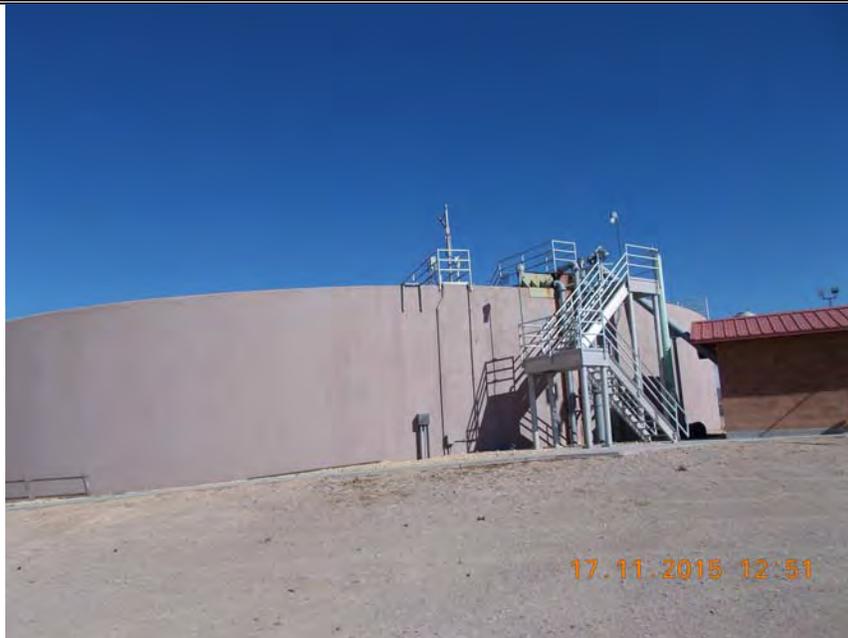
NMED/SWQB  
Official Photograph Log  
Photo # 18

Subject: The activated sludge treatment units are above ground. The ground water table in the area is near the surface, less than 20 feet deep.

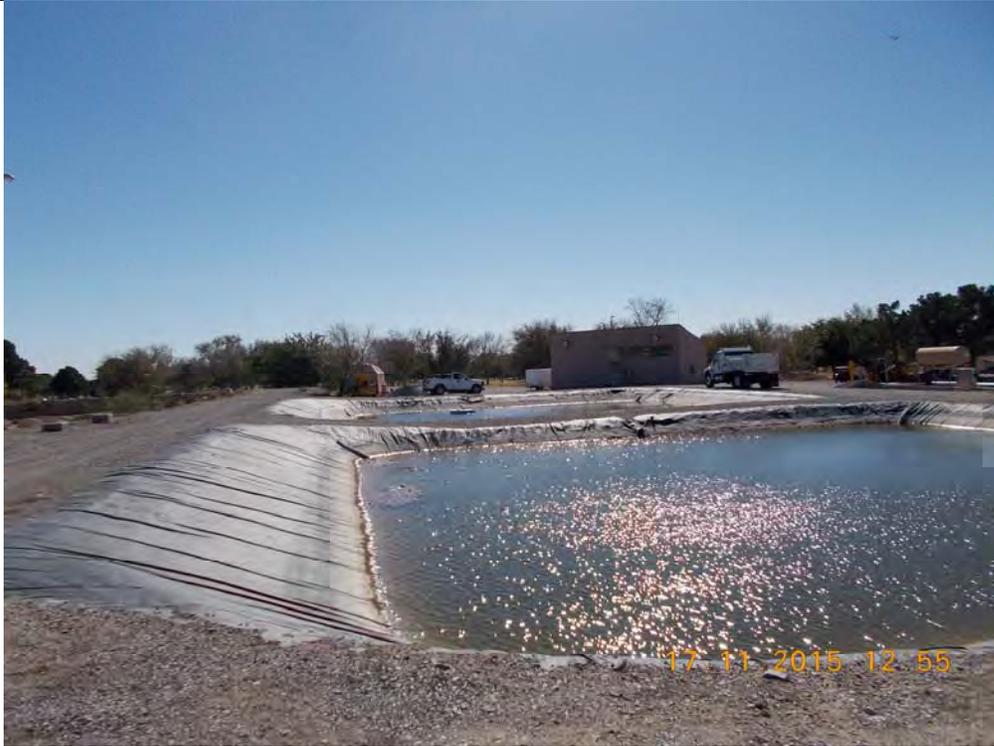
NMED/SWQB  
Official Photograph Log  
Photo # 19

Subject: The facility has storage lagoons that are not used in the treatment process. The lagoons remain in place. According to operators contain rain water and runoff.
