**Re: Raton Water Treatment Plant; Minor Non-Municipal; SIC 4941; NPDES Compliance
Evaluation Inspection; NM0029891; August 26, 2015**

NPDES Compliance Inspection Report

Raton Water Treatment Plant
NPDES Permit NM0029891
August 26, 2015

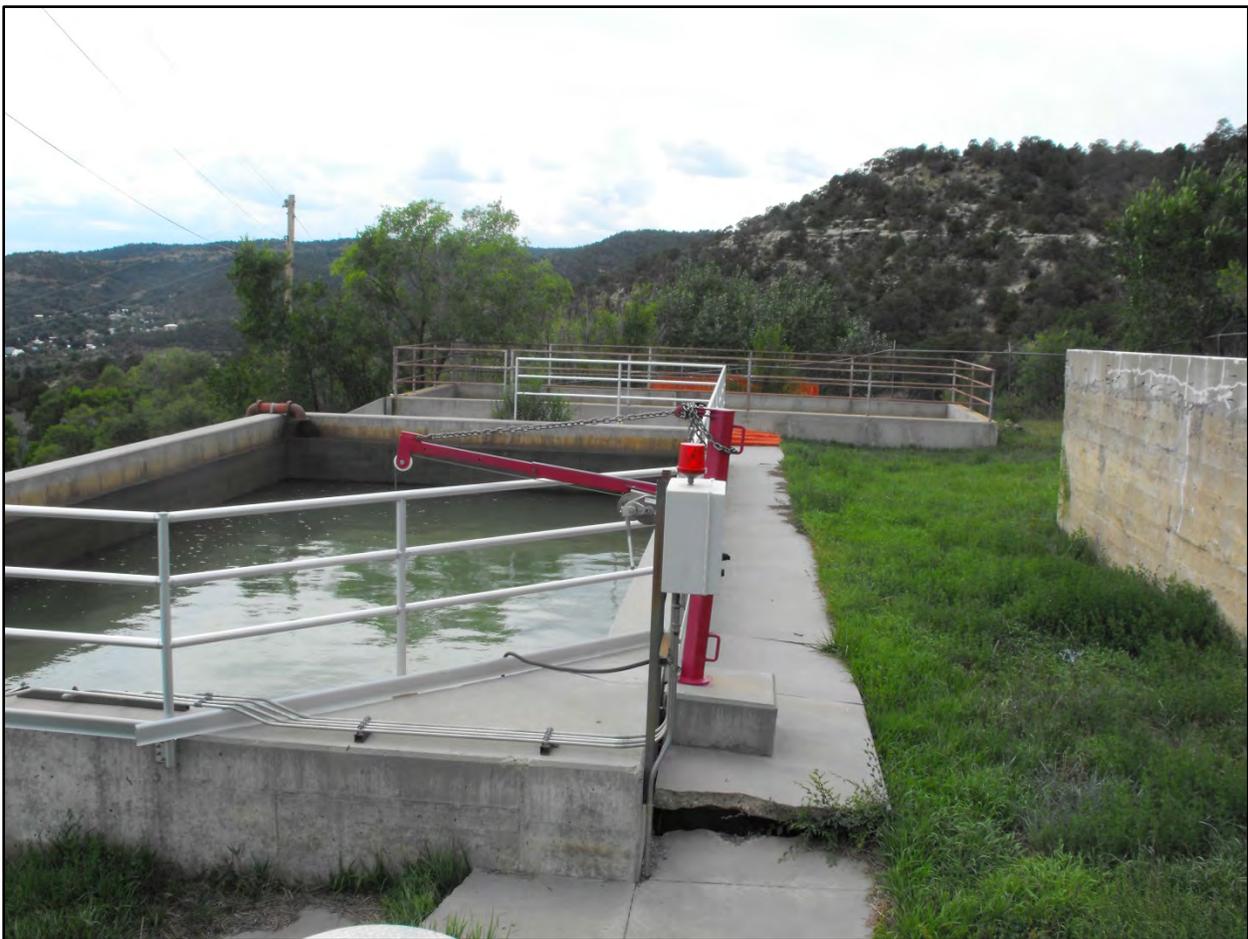
Photo # 1

Photographer: Daniel Valenta	Date: 8/26/2015	Time: 1441 hours
City/County: Raton/Colfax County		
Location: Raton Water Treatment Plant, facing southwest.		
Subject: Back flush settling basins, note terrain. Facility is located above the city.

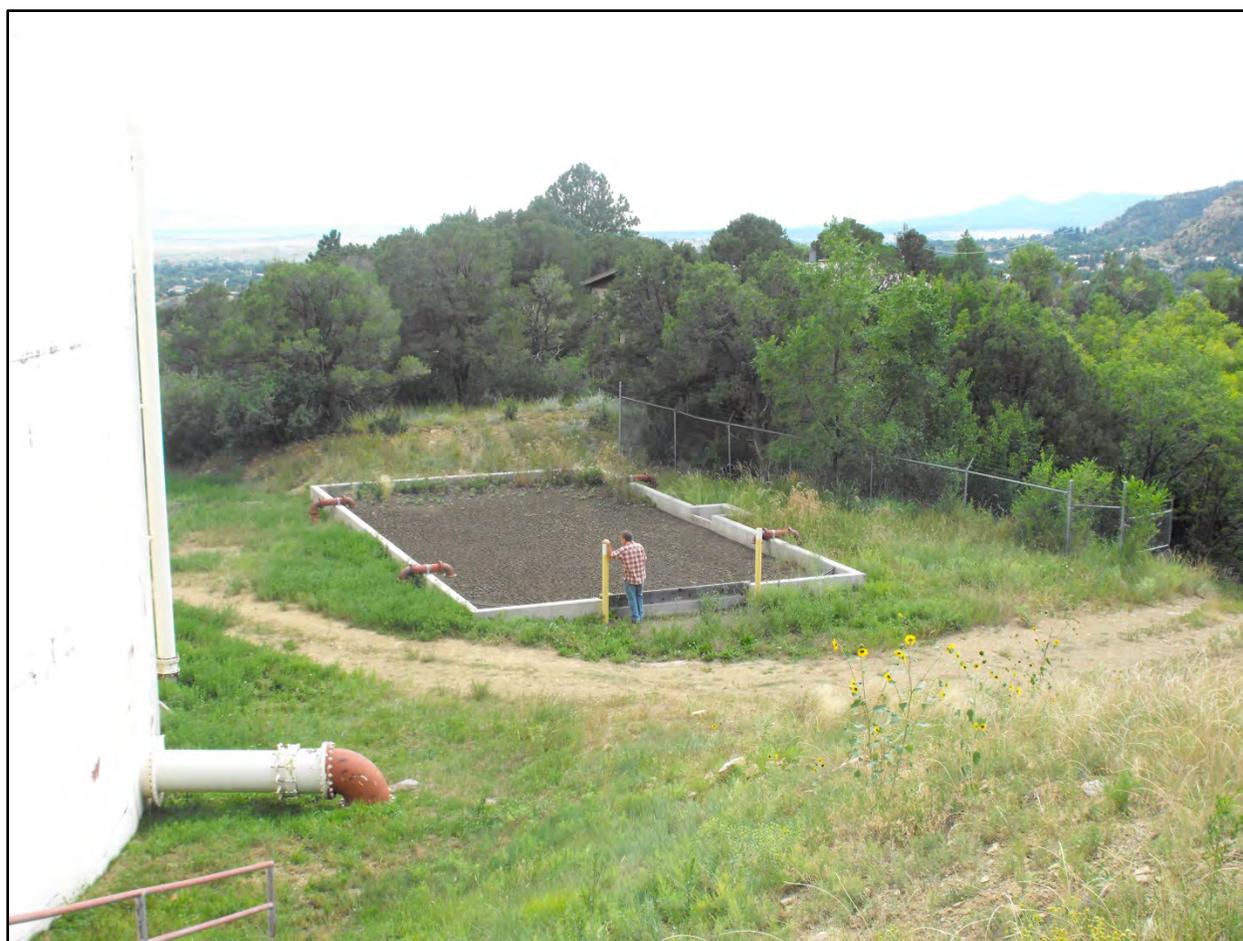
Photo # 2

Photographer: Daniel Valenta	Date: 8/26/2015	Time: 1442 hours
City/County: Raton/Colfax County		
Location: Raton Water Treatment Plant, looking southwest.		
Subject: Drying bed when solids build up in settling basins.

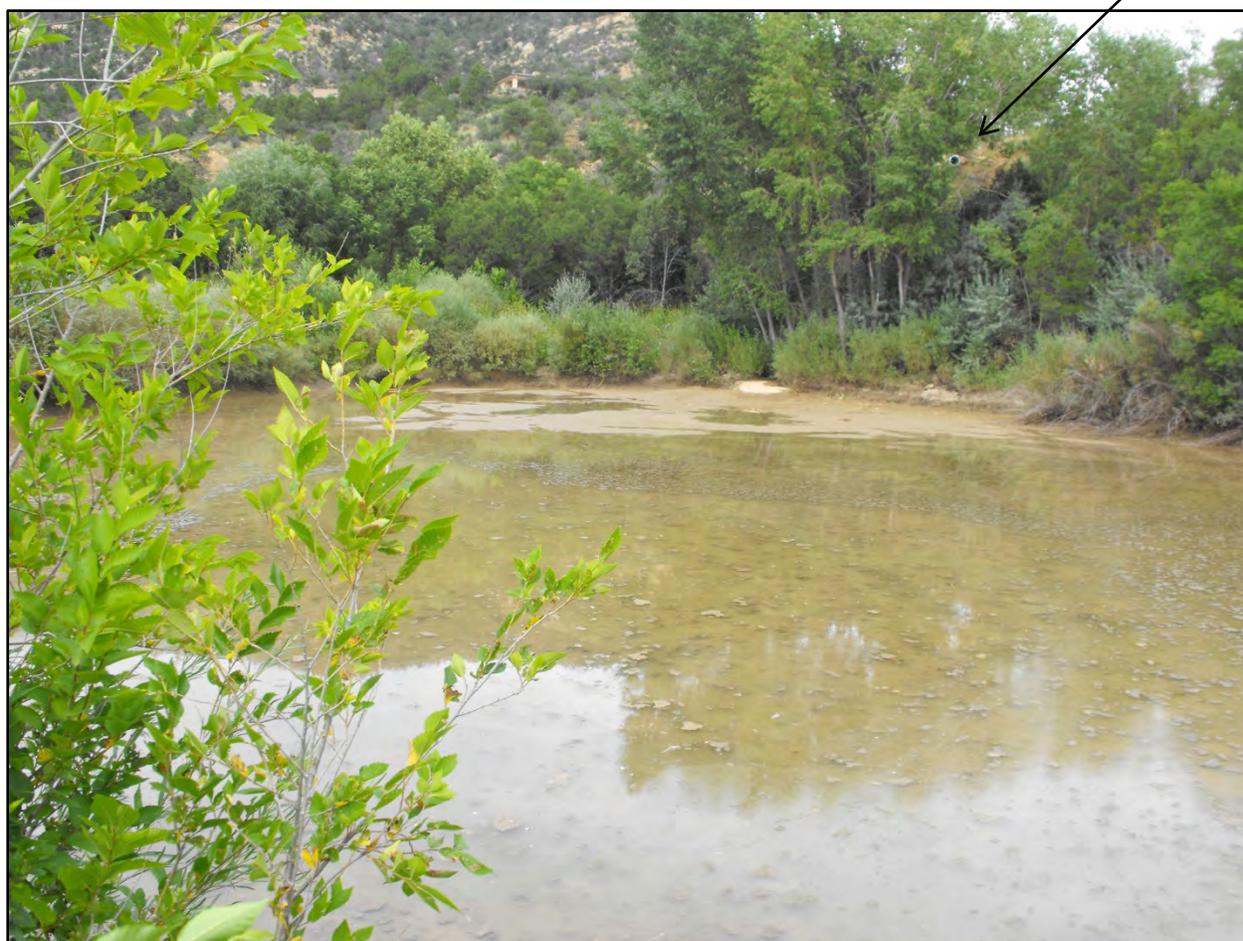
Photo # 3

Photographer: Daniel Valenta	Date: 8/26/2015	Time: 1446 hours
City/County: Raton/Colfax County		
Location: Raton Water Treatment Plant, looking northwest.		
Subject: Pond below facility. Arrow points to discharge pipe from the plant to the pond if needed.

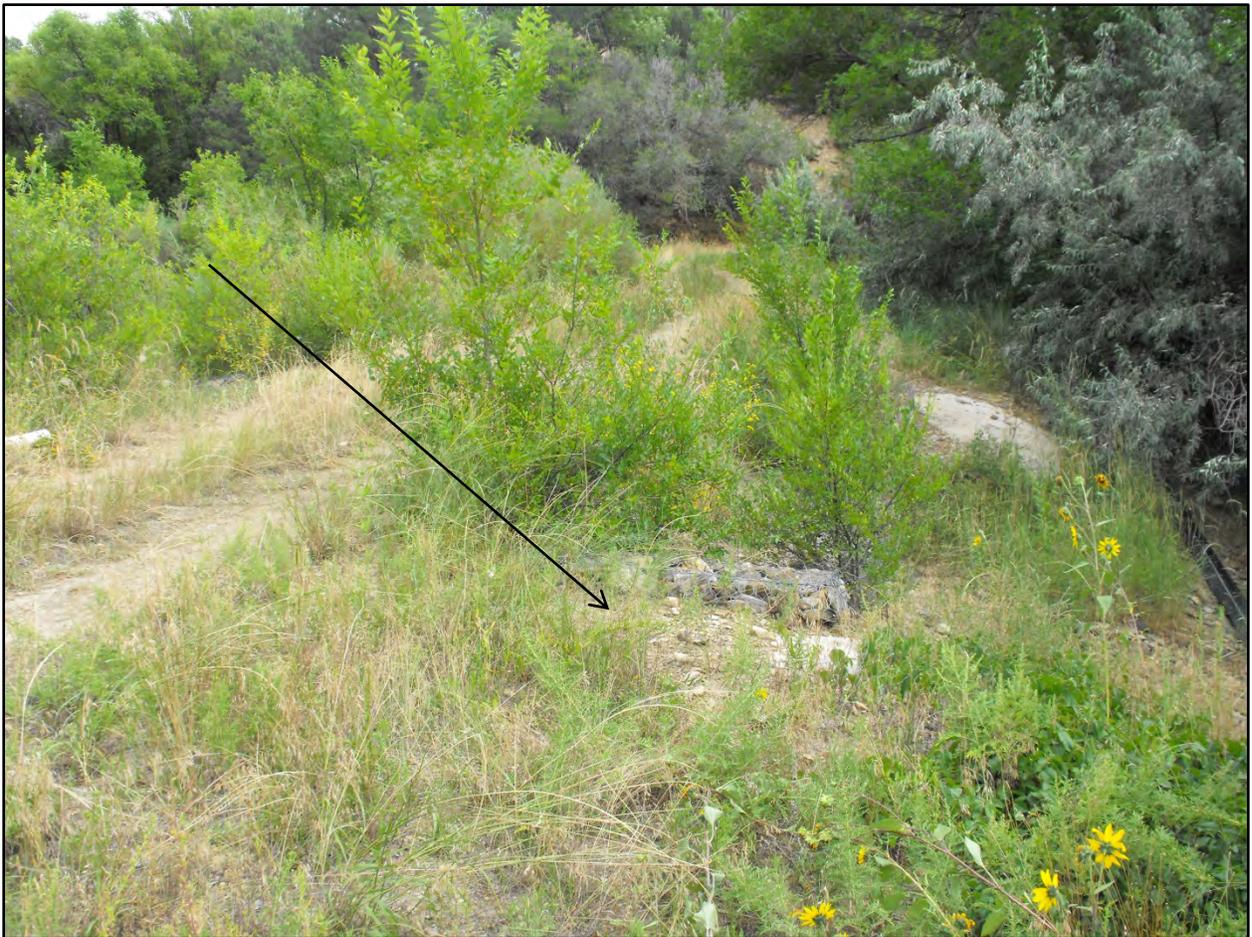
Photo # 4

During the treatment process if needed water can be diverted into a holding pond below the plant. Water from this pond can be pumped back up to the holding tanks after the waste has settled. If the pond were to overflow it would breach on the west side. This is where the discharge flow would be sampled and flow rates estimated. See attached photos. The slopes of the pond have been enforced with rip rap to prevent down cutting of the banks and a total collapse of the retention bank.

Photographer: Daniel Valenta	Date: 8/26/2015	Time: 1447 hours
City/County: Raton/Colfax County		
Location: Raton Water Treatment Plant, looking north.		
Subject: Pond spillway below facility. Discharge would occur here if pond overflowed.
