Re: Minor Non Municipal Inspection, SIC 0921, New Mexico Department of Game and Fish, Seven Springs Trout Hatchery, NPDES Compliance Evaluation Inspection, NM0030112, August 6, 2015

NPDES Compliance Inspection Report

**Compliance Evaluation Inspection
NMDGF Seven Springs Trout Hatchery
NPDES Permit NM0030112
August 6, 2015**

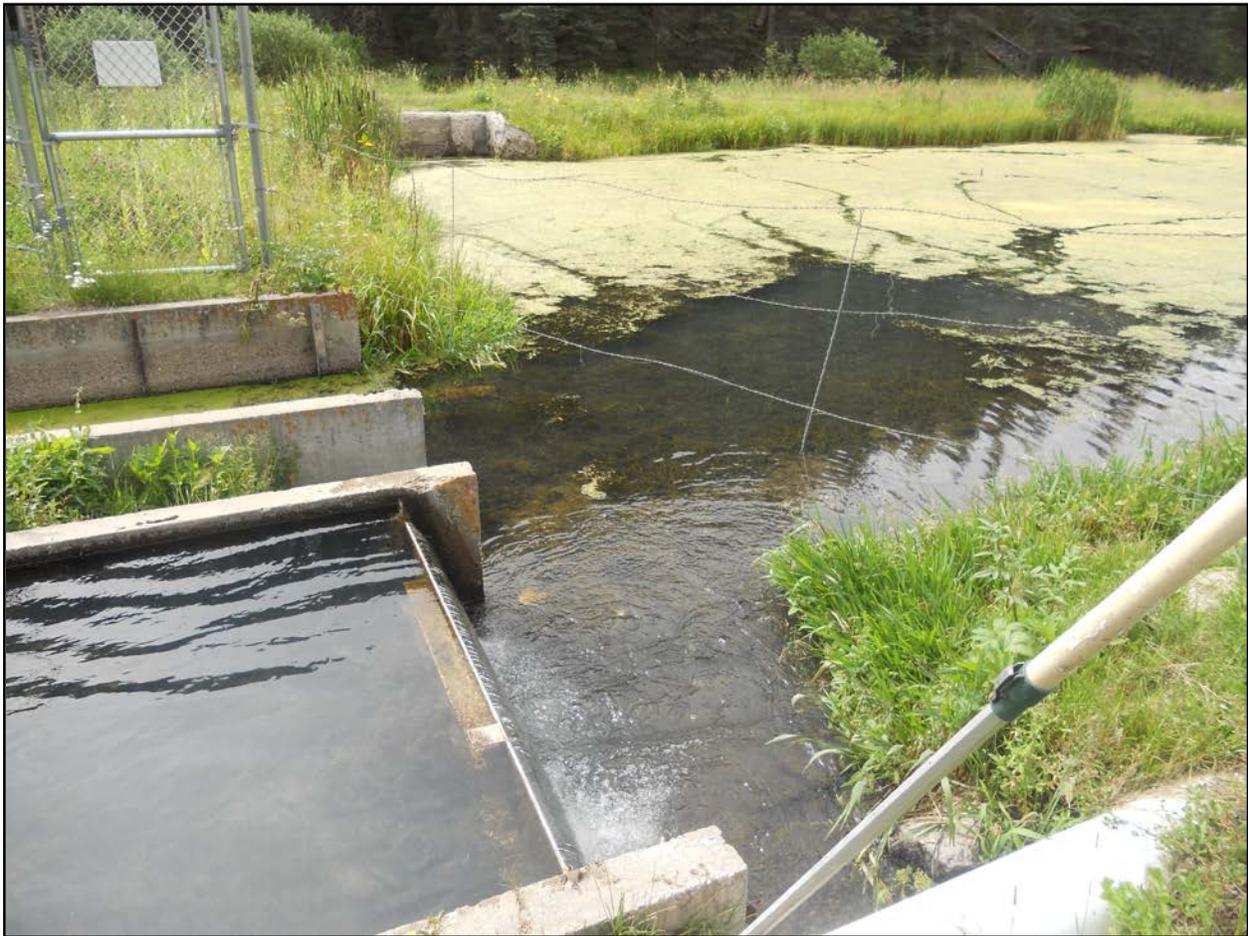
Photo # 1

Photographer: Sarah Holcomb	Date: 8-6-2015	Time: 1020 hours
City/County: Sandoval County		
Location: Seven Springs Fish Hatchery		
Subject: Outfall 001 to the kids' fishing pond. Note the amount of algae.

Although there is not a permit requirement to control algae, the inspector noted that there was excessive algae in both the settling pond leading to Outfall 002, and in the kids' pond receiving the discharge from Outfall 001. However, there did not appear to be an effect on the Rio Cebolla, as shown in Photo #4 in this report.

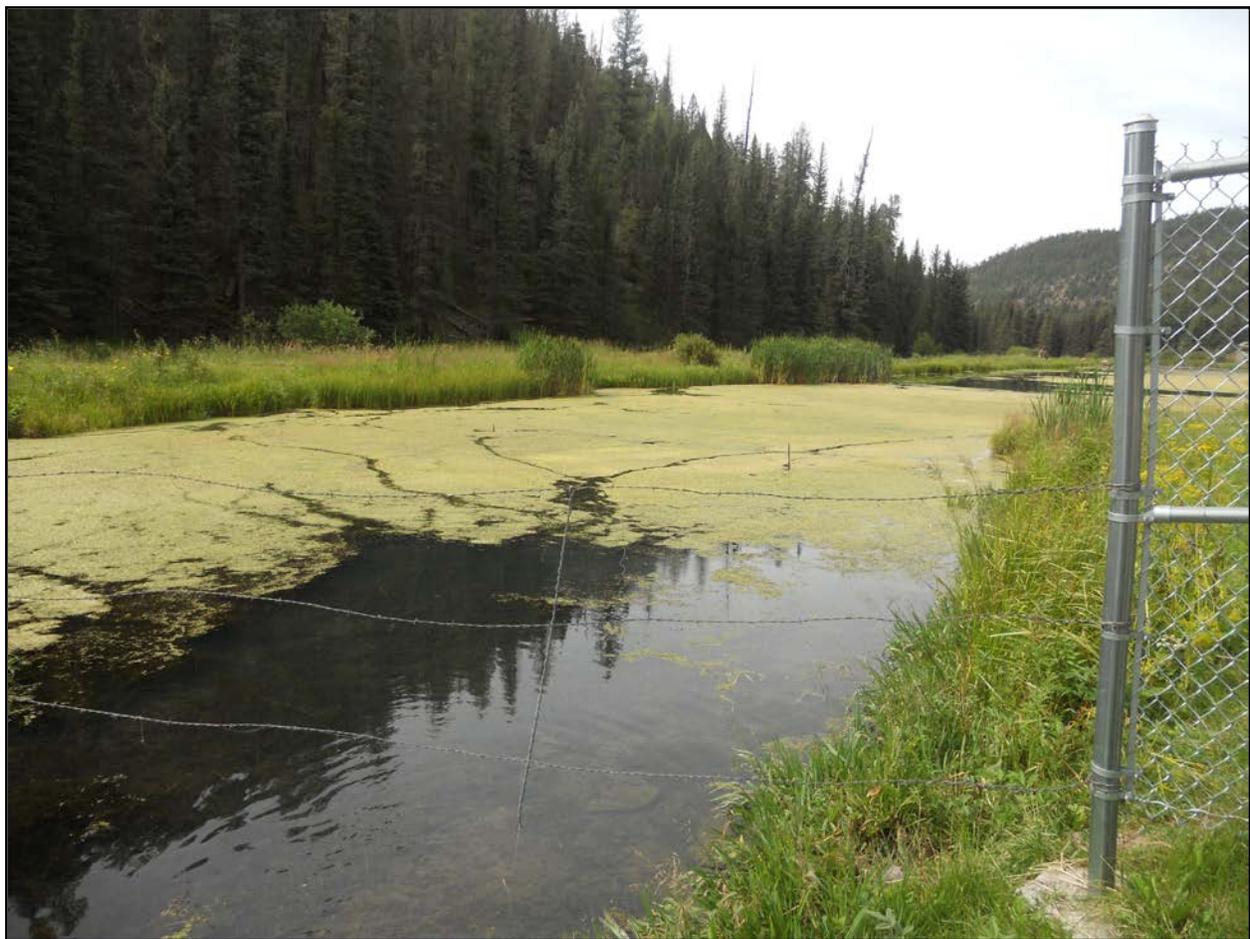
Photo # 2

Photographer: Sarah Holcomb	Date: 8-6-2015	Time: 1020 hours
City/County: Sandoval County		
Location: Seven Springs Fish Hatchery		
Subject: Overview of the kids' fishing pond. Note the amount of algae.

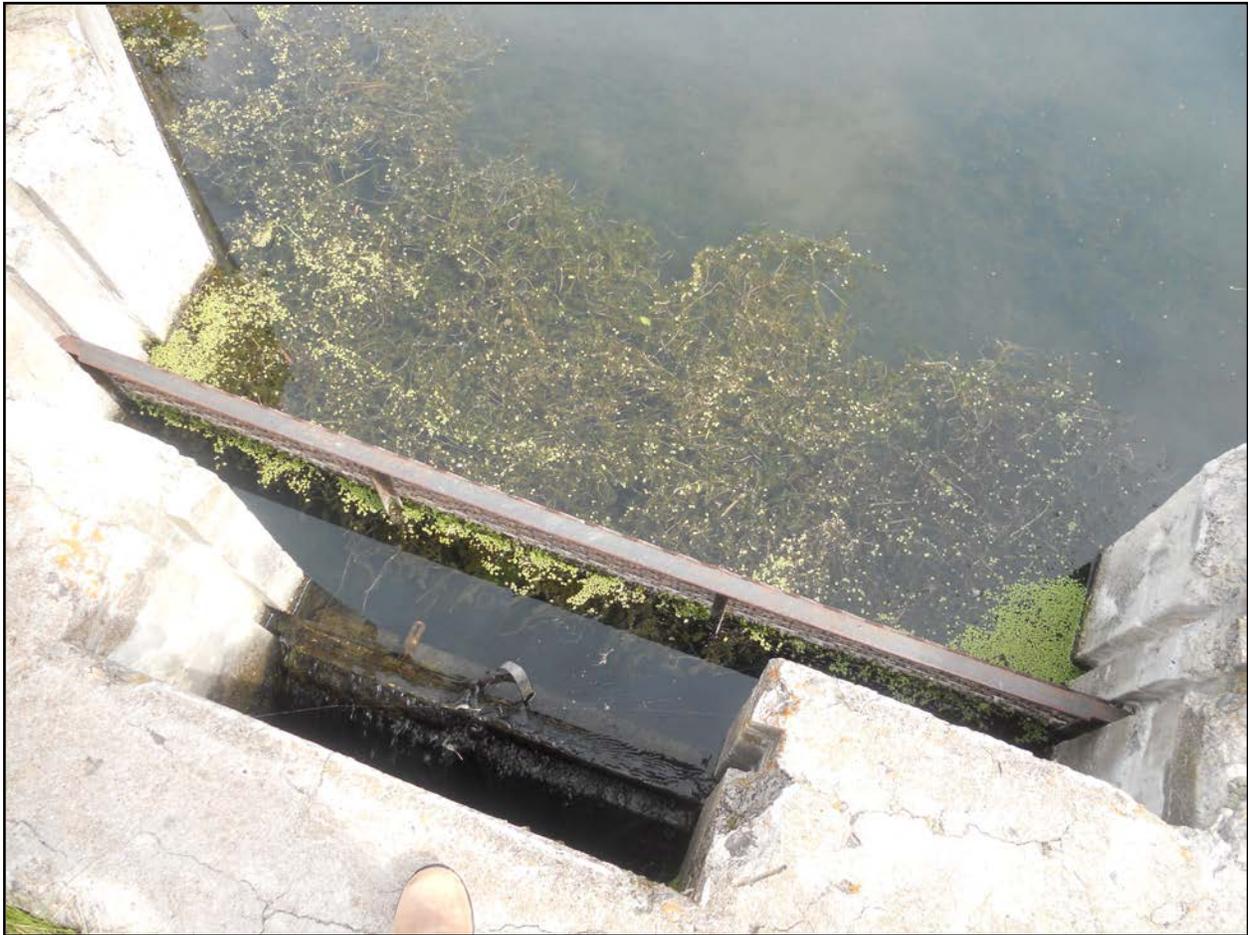
Photo # 3

Photographer: Sarah Holcomb	Date: 8-6-2015	Time: 1023 hours
City/County: Sandoval County		
Location: Seven Springs Fish Hatchery		
Subject: Outfall 002

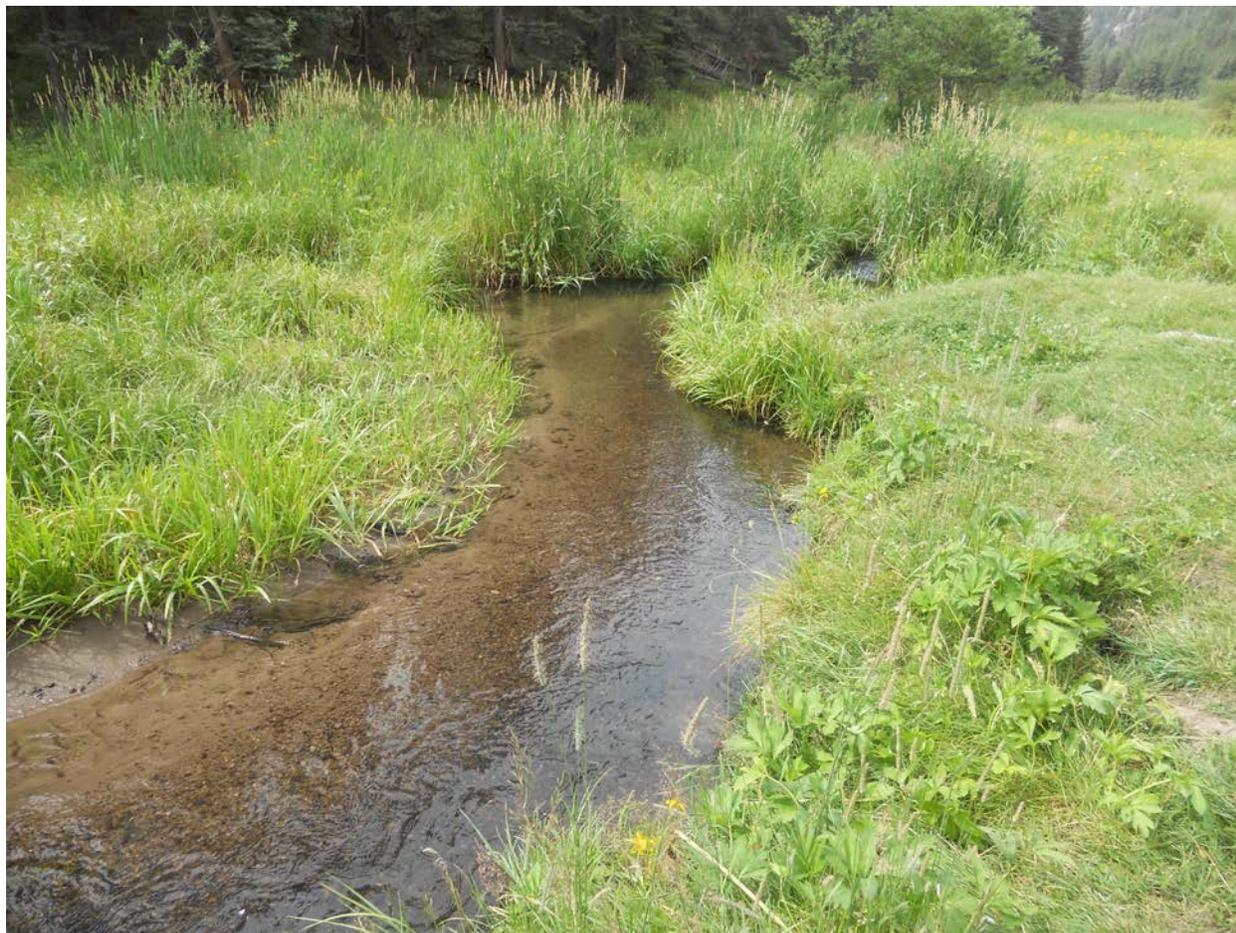
Photo # 4

Photographer: Sarah Holcomb	Date: 8-6-2015	Time: 1025 hours
City/County: Sandoval County		
Location: Seven Springs Fish Hatchery		
Subject: Rio Cebolla downstream of Outfall 002.
