Re: New Mexico Department of Game and Fish, Lisboa Springs Hatchery; Major; Individual Permit; SIC 0921; NPDES Compliance Evaluation Inspection; NM0030121; January 22, 2014

**NMDGF Lisboa Springs State Trout Hatchery
Compliance Evaluation Inspection
NPDES Permit No. NM0030121
January 22, 2014**

Further Explanations

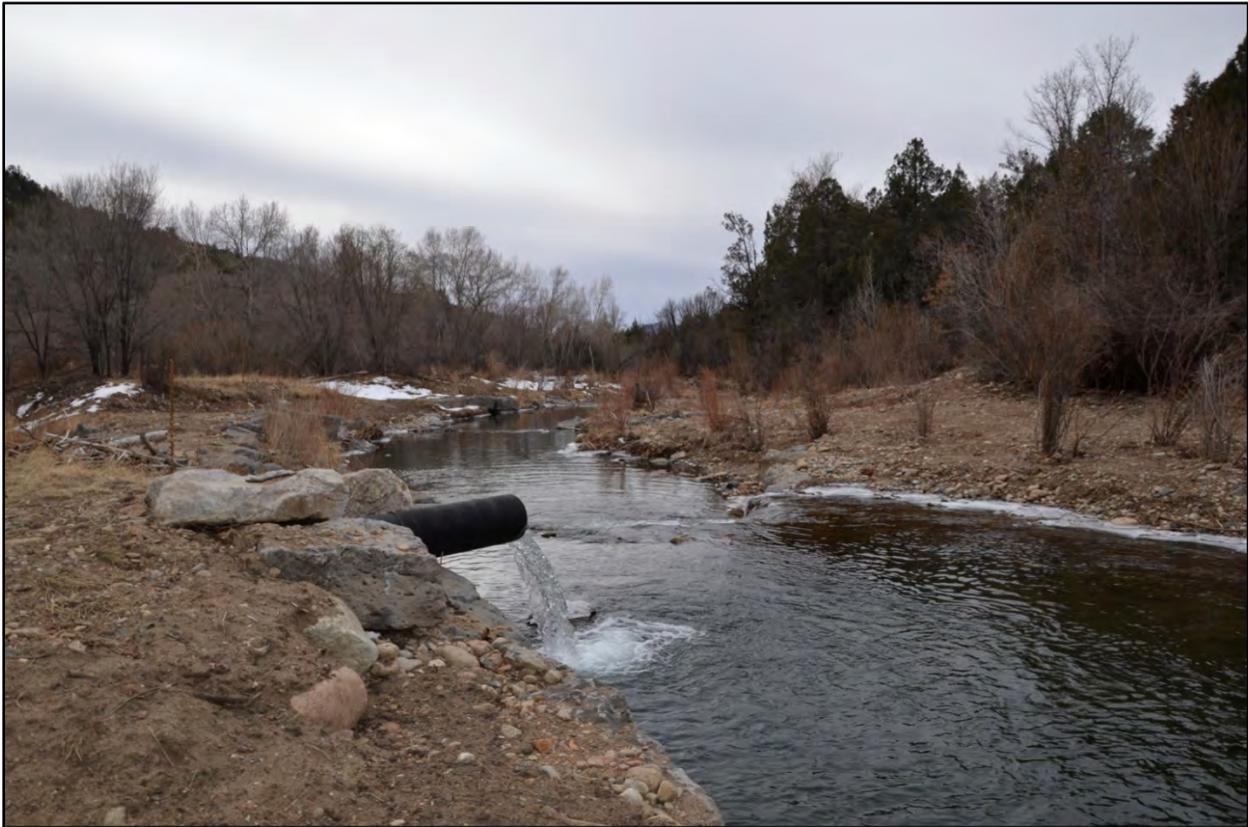
NMED/SWQB
Official Photograph Log
Photo # 1

Photographer: Sarah Holcomb	Date: 1-22-2014	Time: 1035 hours
City/County: Near Pecos, San Miguel County		
Location: NMDGF Lisboa Springs State Hatchery.		
Subject: Outfall 002 discharge to the Pecos River.
