**Re: New Mexico Department of Game and Fish, Lisboa Springs Hatchery; Major; Individual Permit; SIC 0921; NPDES Compliance Evaluation Inspection; NM0030121; June 27, 2016**

### NPDES Compliance Inspection Report

**NMDGF Lisboa Springs State Trout Hatchery  
Compliance Evaluation Inspection  
NPDES Permit No. NM0030121  
June 27, 2016**

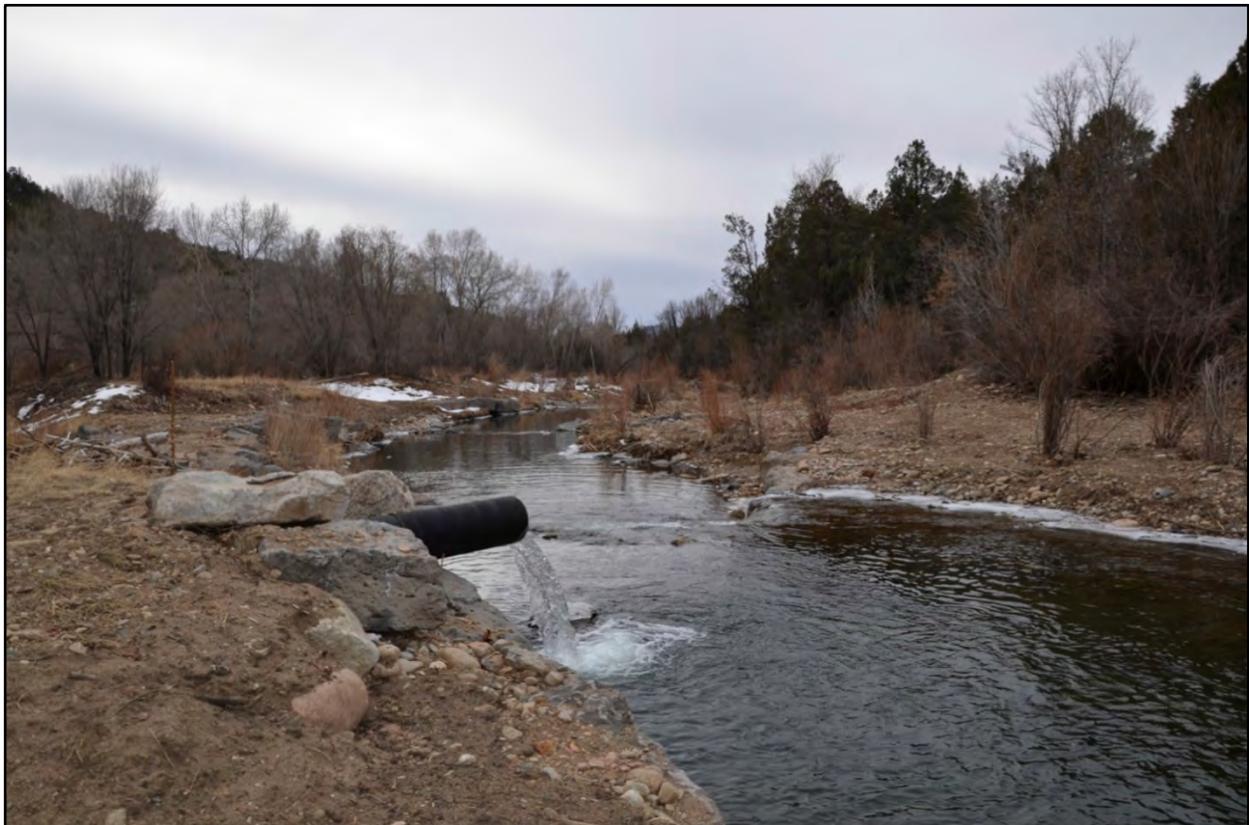
**NMED/SWQB**  
**Official Photograph Log**  
Photo # 1

Photographer: Sarah Holcomb	Date: 1-22-2014	Time: 1035 hours
City/County: Near Pecos, San Miguel County		
Location: NMDGF Lisboa Springs State Hatchery.		
Subject: Outfall 002 discharge to the Pecos River. Note scouring from 2013 floods in comparison to photo #2.

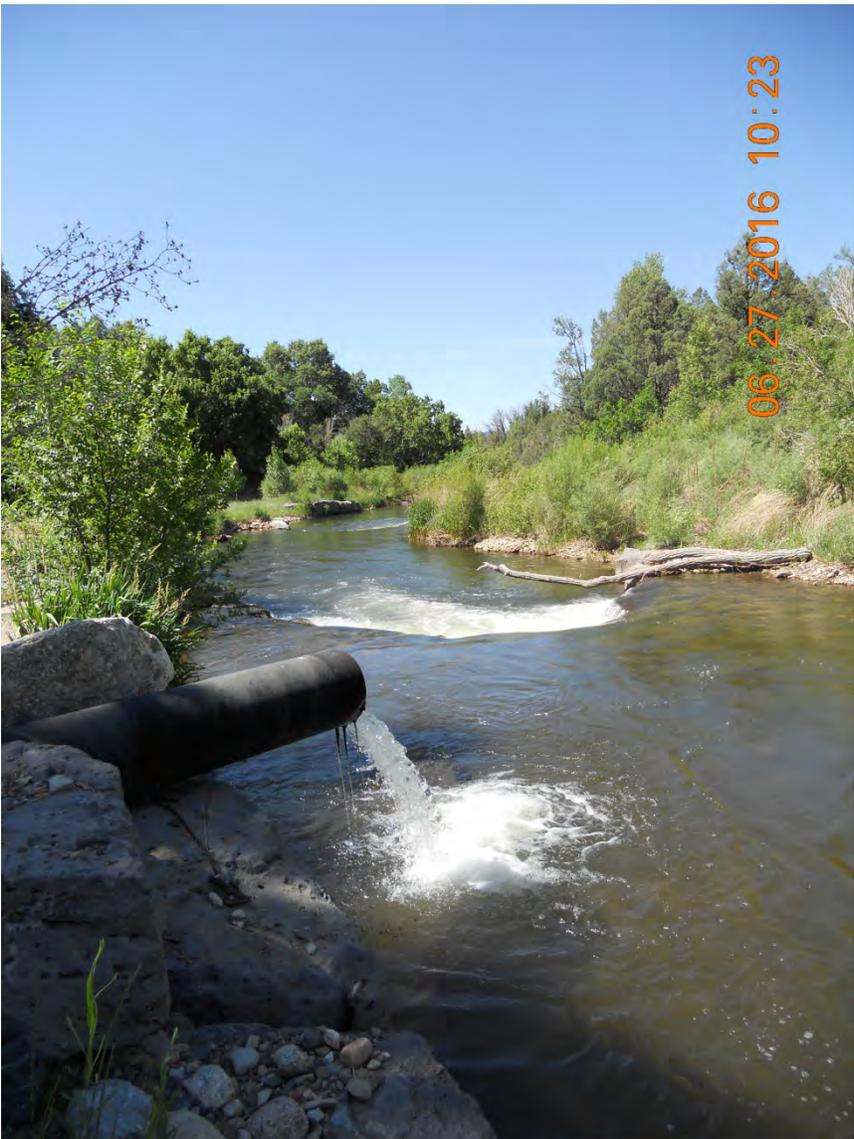
**NMED/SWQB**  
**Official Photograph Log**  
Photo # 2

Photographer: Sarah Holcomb	Date: 6-27-2016	Time: 1023 hours
City/County: Near Pecos, San Miguel County		
Location: NMDGF Lisboa Springs State Hatchery.		
Subject: Outfall 002 discharge to the Pecos River.

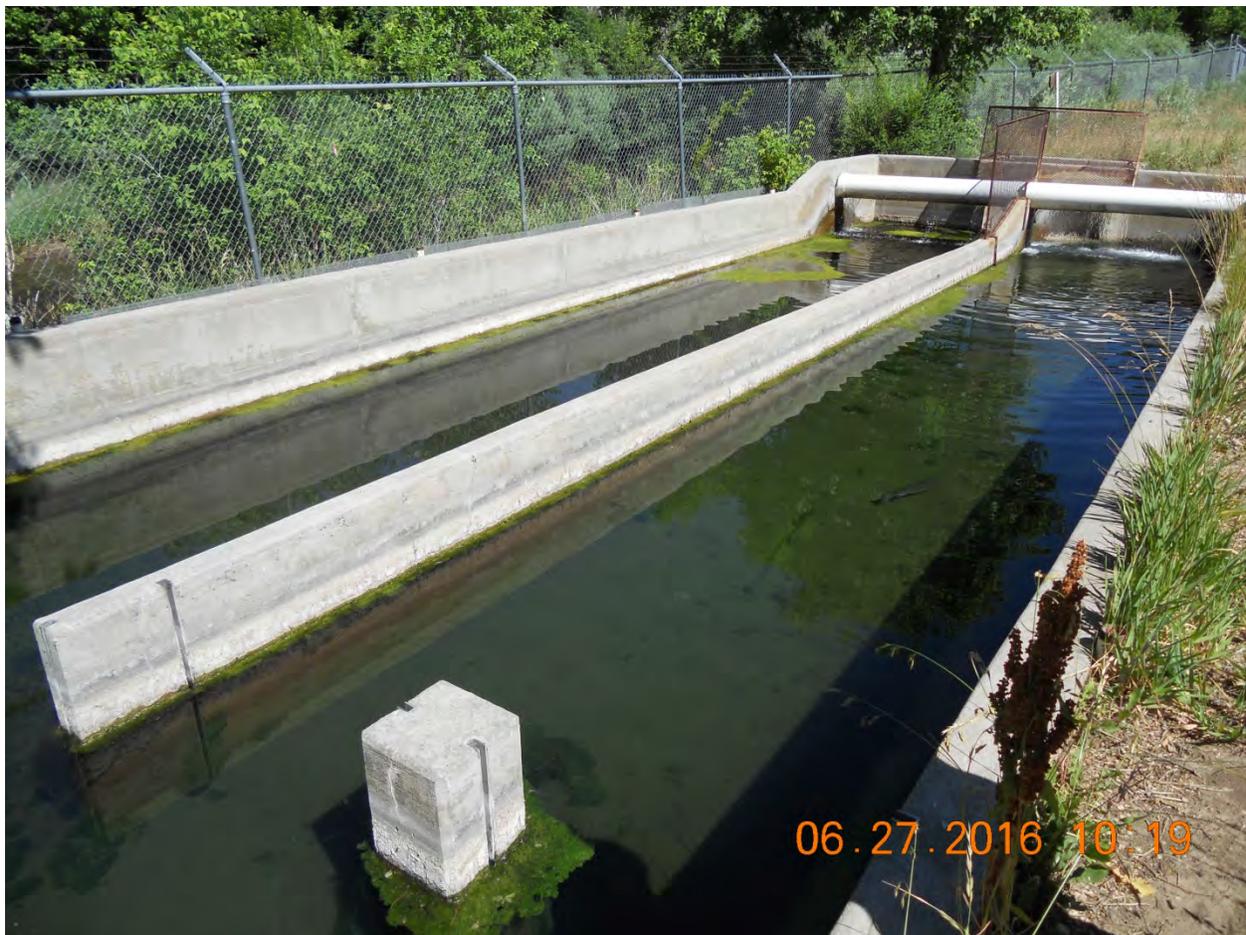
**NMED/SWQB**  
**Official Photograph Log**  
Photo # 3

During the site tour of the facility, the inspector noted that the kettles just prior to discharge at Outfall 002 had accumulated a large amount of algae. From reviewing the facility's NetDMR submissions, the algae do not appear to be affecting the TSS levels at the outfall, but the inspector noted that the kettles should be cleaned to prevent elevated TSS levels in the effluent. Permittee representatives indicated that this action is planned for FY2017.

Photographer: Sarah Holcomb	Date: 6-27-2016	Time: 1019 hours
City/County: Near Pecos, San Miguel County		
Location: NMDGF Lisboa Springs State Hatchery.		
Subject: Kettles/settling basins prior to Outfall 002. Large amounts of algae accumulation noted although it does not appear to be affecting TSS in discharge.
