**Re: New Mexico Department of Game & Fish / Red River State Trout Hatchery; Minor;
Individual Permit; SIC 0921; NPDES Compliance Evaluation Inspection; NPDES #
NM0030147; January 8, 2014**

**Compliance Evaluation Inspection
Red River State Fish Hatchery
NPDES Permit #NM0030147, January 8, 2014**

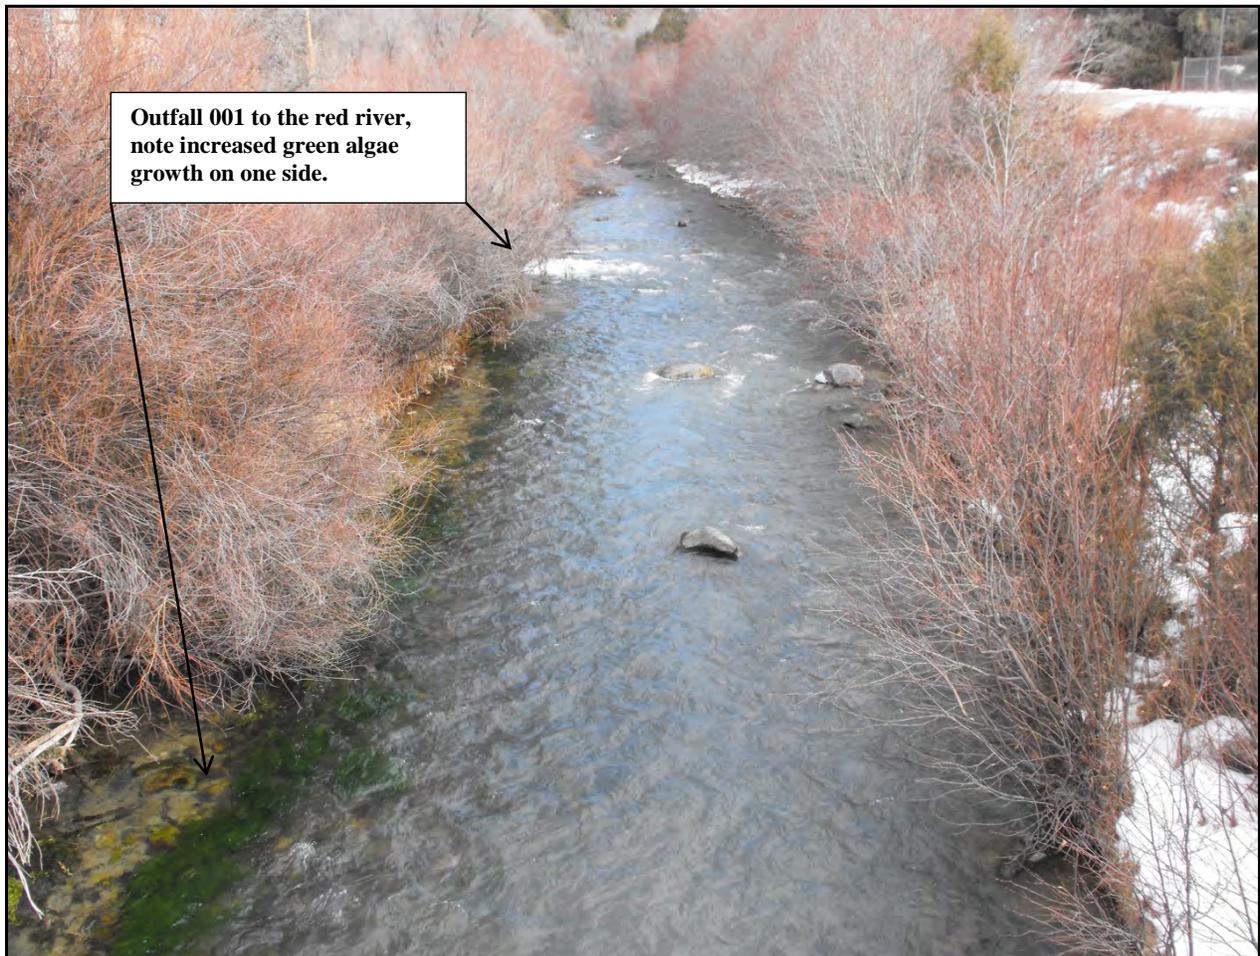
Photo # 1

Photographer: Daniel Valenta	Date: 1/8/2014	Time: 1241 hours
City/County: Near Questa / Taos County		
Location: Red River State Trout Hatchery approximately 3.5 miles southwest of Questa, New Mexico in Taos County, New Mexico.		
Subject: While observing the river it appeared green algae growth greatly increased below 001 outfall, no increased growth was observed upstream of the outfall.

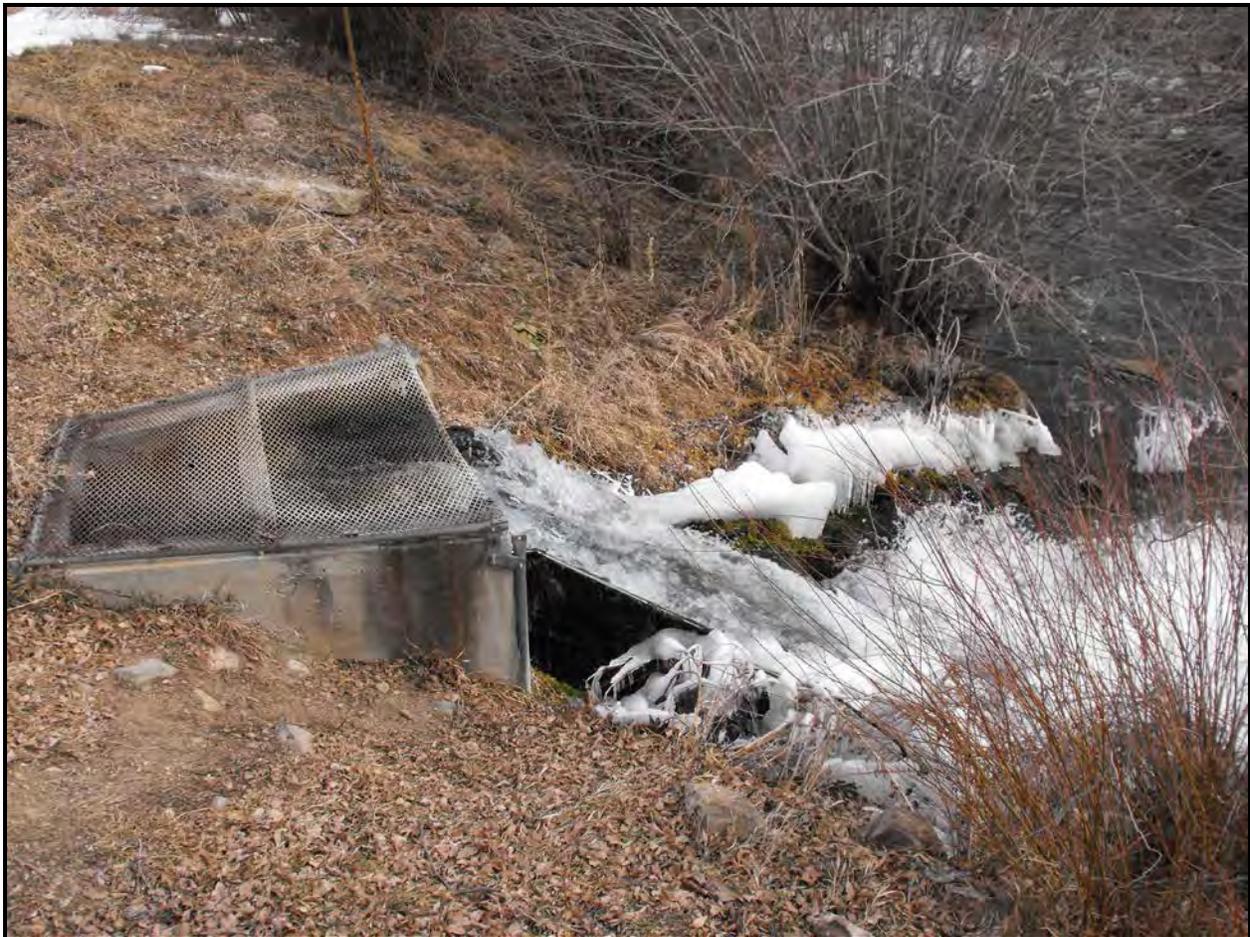
Photo # 2

Flow entering the weir at Outfalls 001 was not well distributed across the channel and was not free of turbulence, (see photo 2). The flow measurement device at Outfall 001 did not appear adequate to handle expected range of flow rates and/or to allow smooth water flow.

Photographer: Daniel Valenta	Date: 1/8/2014	Time: 1242 hours
City/County: Near Questa / Taos County		
Location: Red River State Trout Hatchery approximately 3.5 miles southwest of Questa, New Mexico in Taos County, New Mexico.		
Subject: Outfall 001, majority of discharge volume discharges here.

At the time of the inspection on January 8, 2014, the materials required to make the necessary modifications and/or repairs to the weirs in order to obtain accurate flow measurements, as noted in the CEI report, had been procured and were onsite. The needed modifications to the weirs at outfalls 002 and 003 have been completed following the inspection and are currently being performed by hatchery staff at outfall 001.

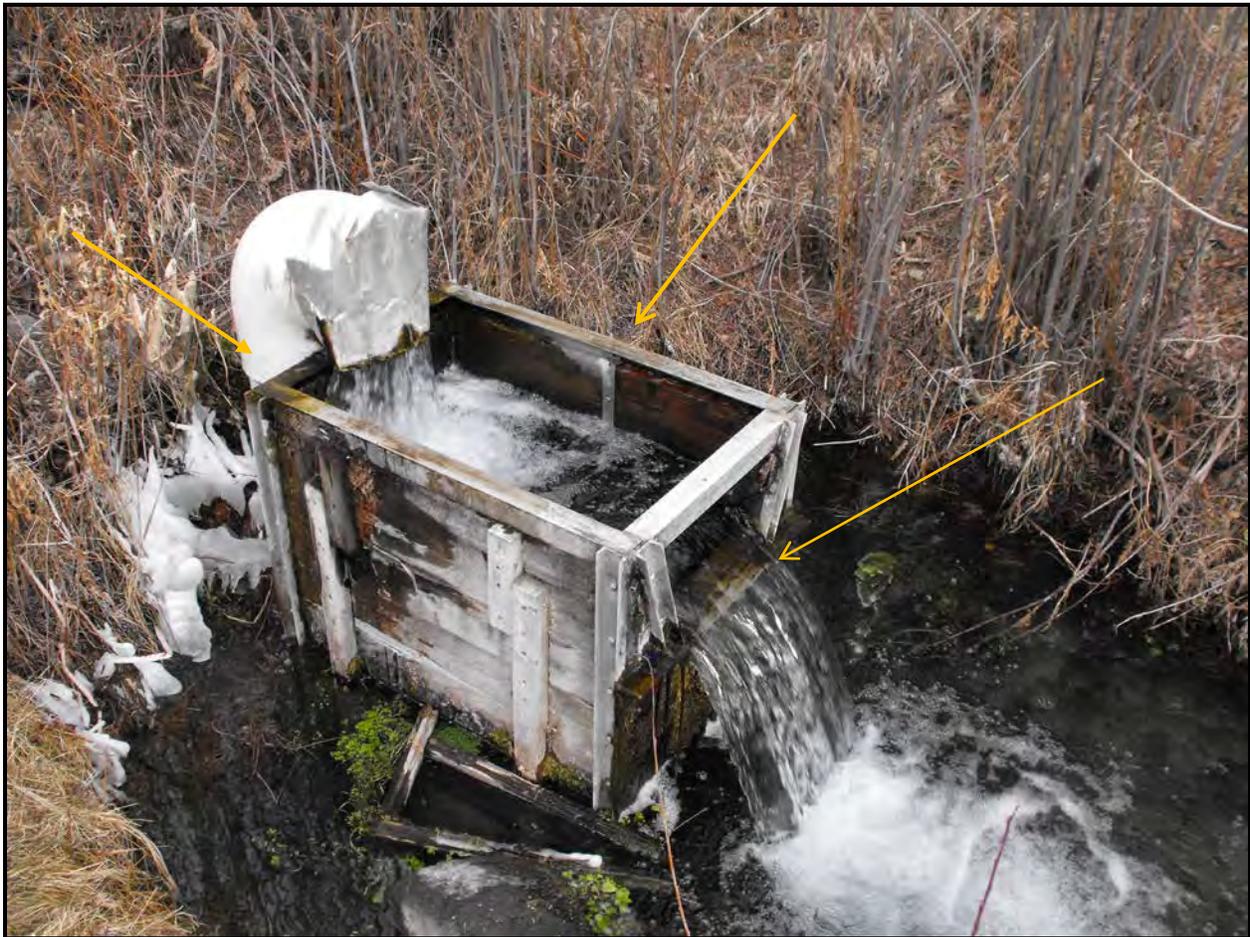
Photo # 3

Facility weir crests were square edged approximately 1.5 inches wide. The Permittee did not have documentation on-site that the standard head to discharge calculations from the USFWS manual would apply to the wider crest width. Isco Open Channel Flow Measurement Handbook, Sixth Edition, Chapter 3 Weirs, Figure 3-2 also show a sharp-crested weir width of approximately 1/8 inch. The above-referenced Isco Handbook states, *"To ensure accurate discharge measurement, there are certain general weir design requirements that apply to all types: ...The weir should consist of a thin plate 1/8 to 1/4 inch thick..."* Isco Handbook states, *"The details of a particular installation may justify a deviation from these recommendations, based on sound engineering judgment."*

The drain line pipe from the show ponds was leaking where it entered the constructed channel at Outfall 002. A portion of the flow did not enter the weir to be measured. The flow around the constructed channel could affect the integrity of the bank at the base of the constructed box and cause settling. Calibration checks, in this case horizontal and vertical surface levels or checks for settling, including the measuring scales, had not been conducted at Outfalls 001, 002 and 003 since installation.

Photographer: Daniel Valenta	Date: 1/8/2014	Time: 1253 hours
City/County: Near Questa / Taos County		
Location: Red River State Trout Hatchery approximately 3.5 miles southwest of Questa, New Mexico in Taos County, New Mexico.		
Subject: Outfall 002, note weir edge improperly designed and some flow is leaking before entering the box.

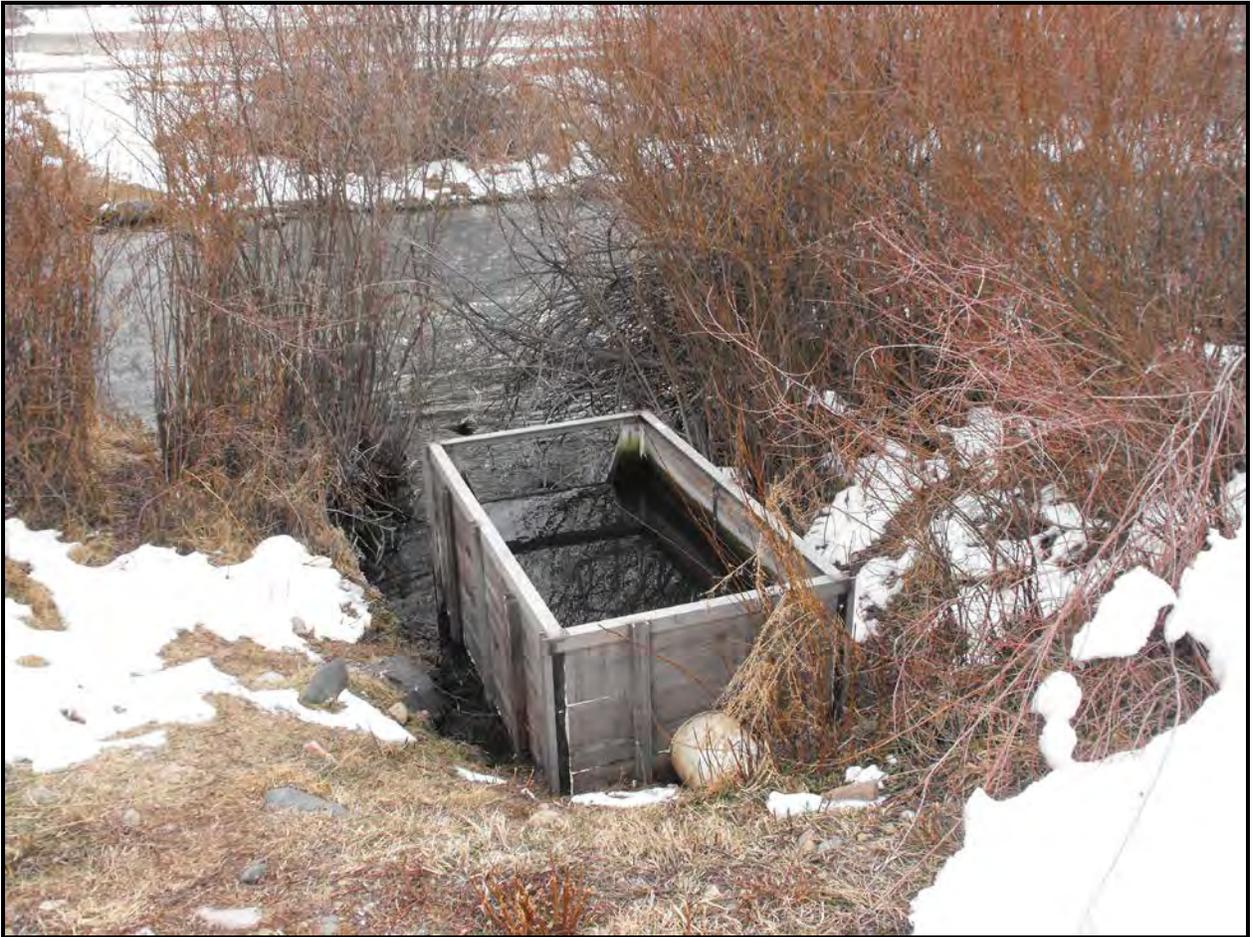
Photo # 4

Photographer: Daniel Valenta	Date: 1/8/2014	Time: 1300 hours
City/County: Near Questa / Taos County		
Location: Red River State Trout Hatchery approximately 3.5 miles southwest of Questa, New Mexico in Taos County, New Mexico.		
Subject: Outfall 003, discharge from settling ponds.

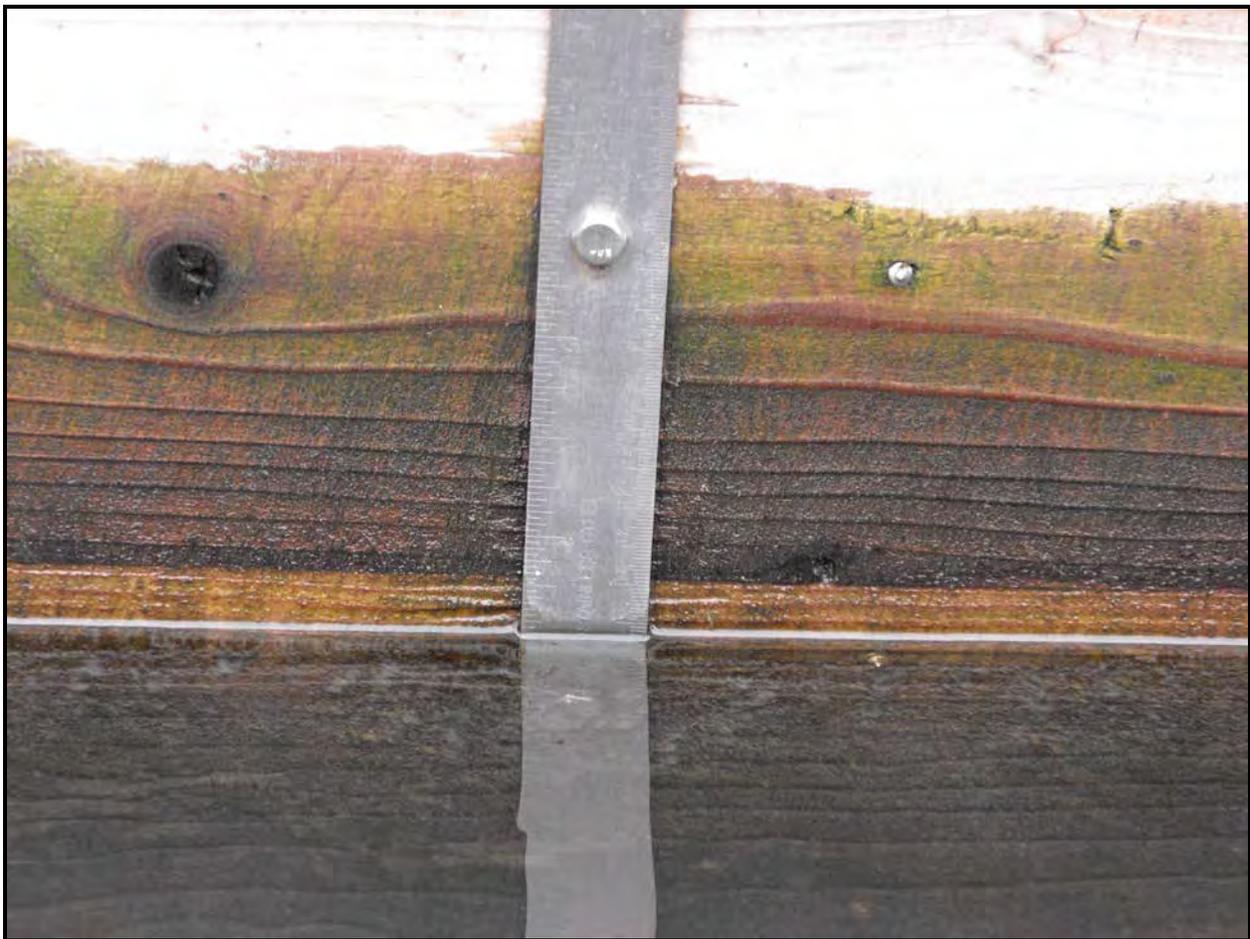
Photo # 5

Photographer: Daniel Valenta	Date: 1/8/2014	Time: 1253 hours
City/County: Near Questa / Taos County		
Location: Red River State Trout Hatchery approximately 3.5 miles southwest of Questa, New Mexico in Taos County, New Mexico.		
Subject: Outfall 003, type of staff gage used at all outfalls. Even at very close range with no flow reading the weathered scale is extremely difficult.
