Re: New Mexico Department of Game and Fish/Red River State Trout Hatchery; Minor; Individual Permit; SIC 0921; NPDES Compliance Evaluation Inspection; NPDES #NM0030147; June 30, 2016

NPDES Compliance Inspection Report

**Compliance Evaluation Inspection
Red River State Fish Hatchery
NPDES Permit #NM0030147
June 30, 2016**

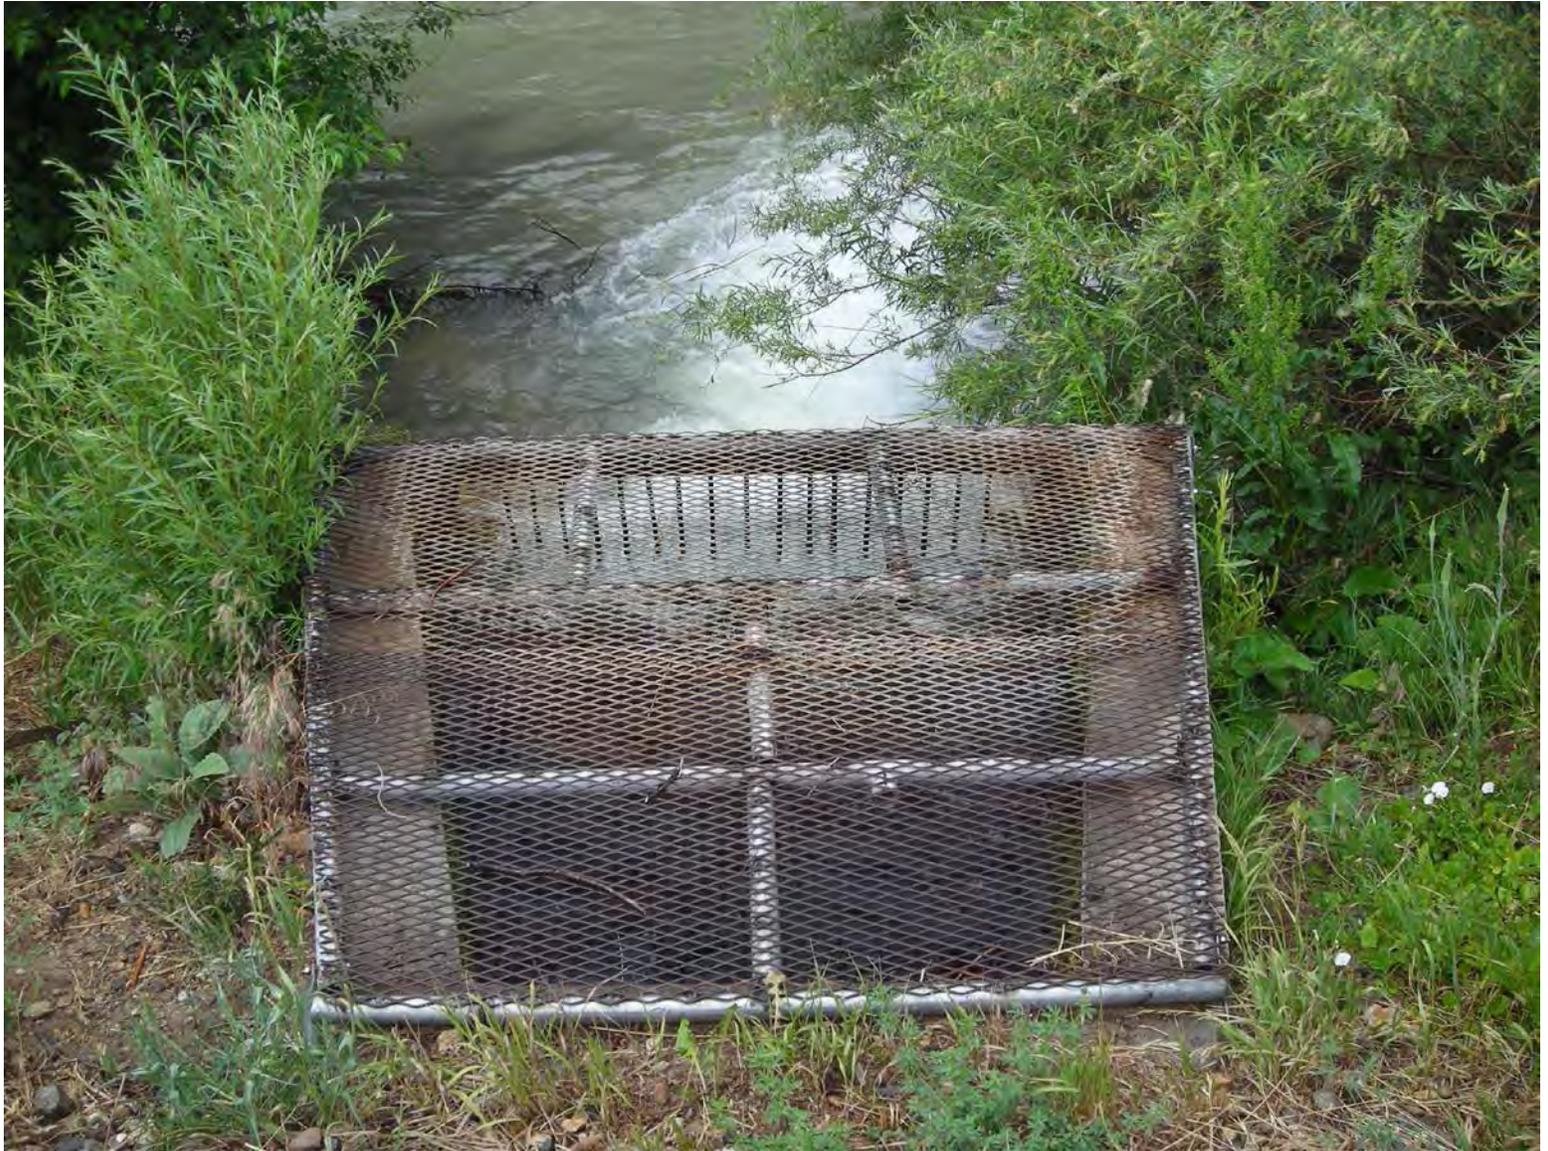
Photo # 1

Photographer: Sarah Holcomb	Date: 6-30-2016	Time: 1335 hours
City/County: Near Questa, Taos County		
Location: Red River State Trout Hatchery		
Subject: Outfall 001

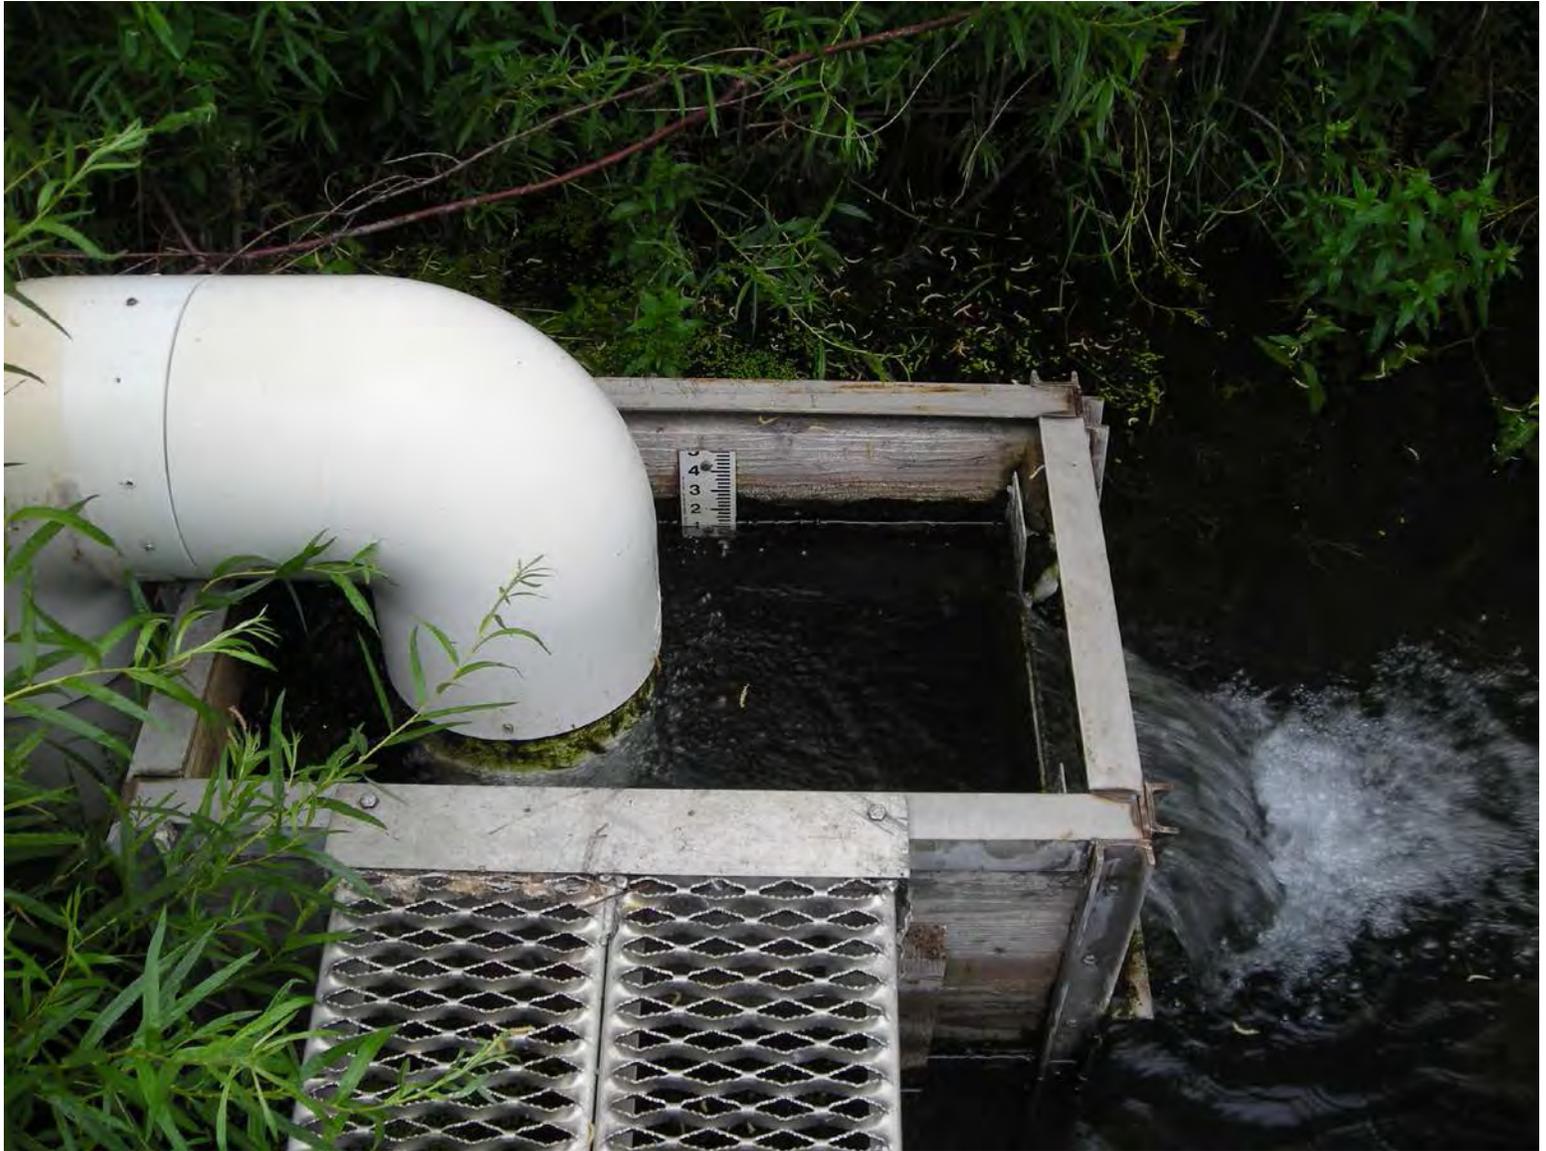
Photo # 2

Photographer: Sarah Holcomb	Date: 6-30-2016	Time: 1337 hours
City/County: Near Questa, Taos County		
Location: Red River State Trout Hatchery		
Subject: Outfall 002

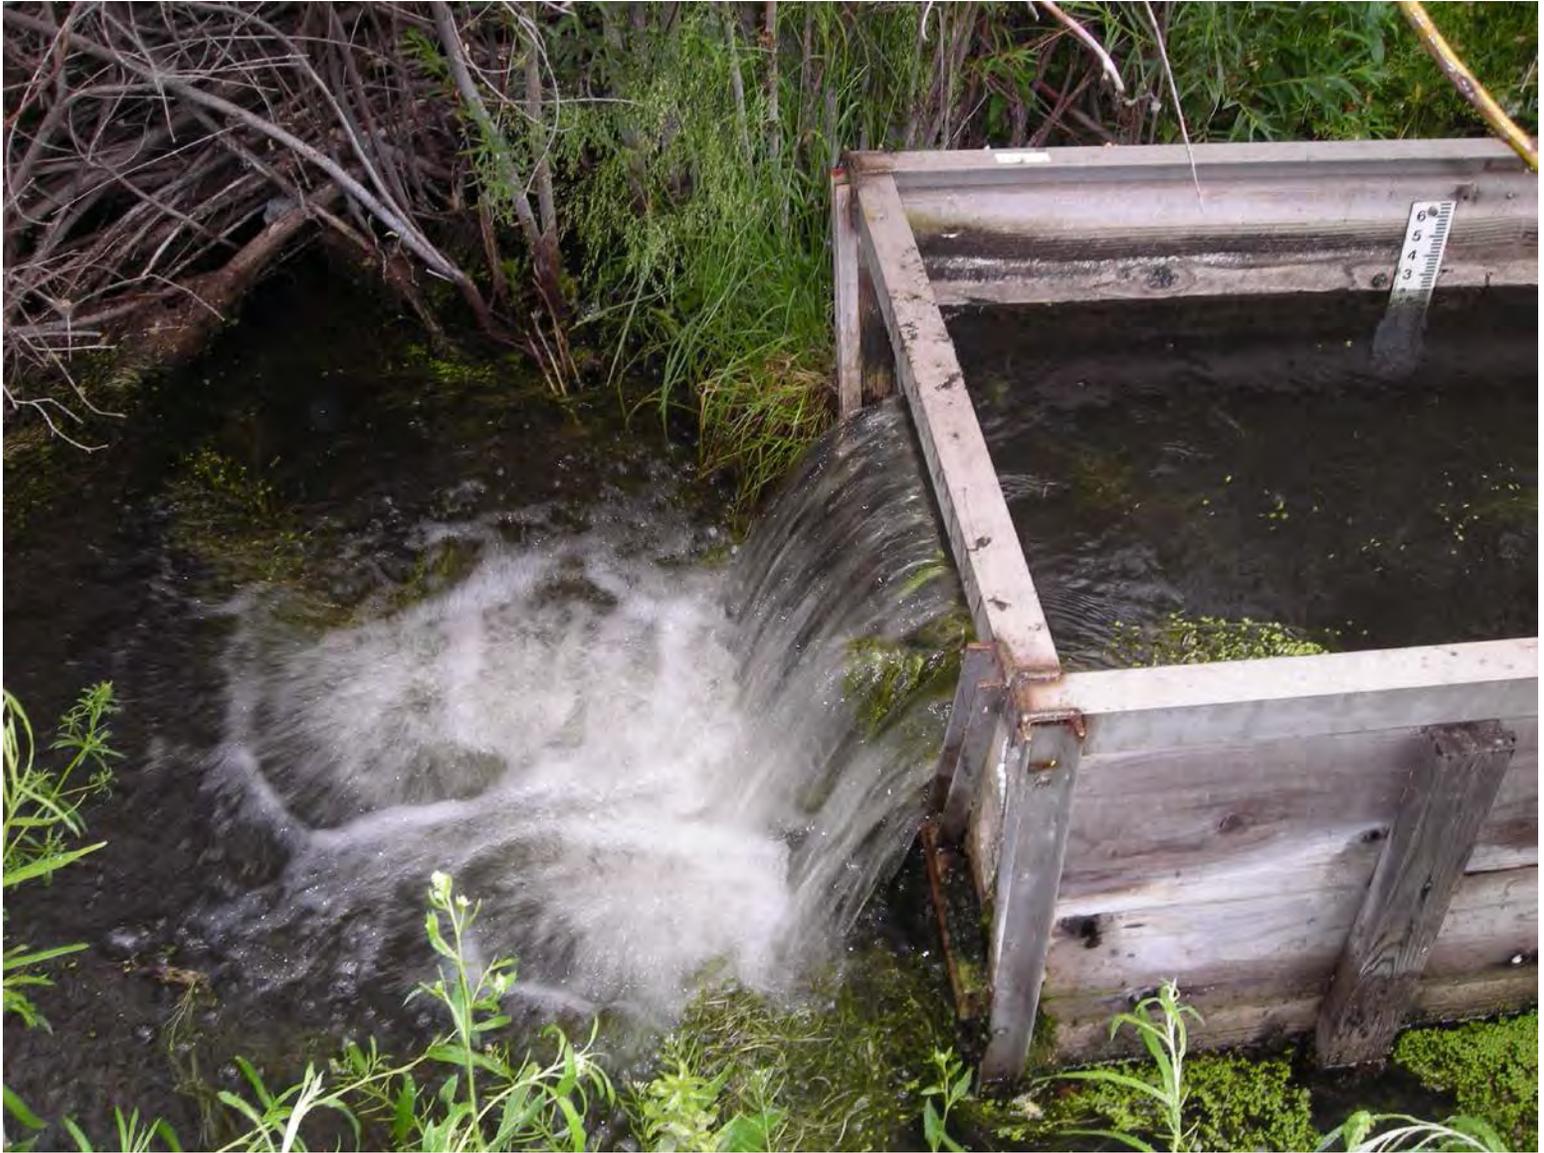
Photo # 3

Photographer: Sarah Holcomb	Date: 6-30-2016	Time: 1339 hours
City/County: Near Questa, Taos County		
Location: Red River State Trout Hatchery		
Subject: Outfall 003
