Re: Minor Individual Permit; SIC 1221; NPDES Compliance Evaluation Inspection; CMI / Ancho-Gachupin-Bracket Mine; NM0030180; July 22, 2014

NPDES Compliance Inspection Report

Compliance Evaluation Inspection
Chevron Mining, Inc. / Ancho-Gachupin-Bracket (Ancho) Mine
NPDES Permit No. NM0030180
July 22, 2014

Further Explanations

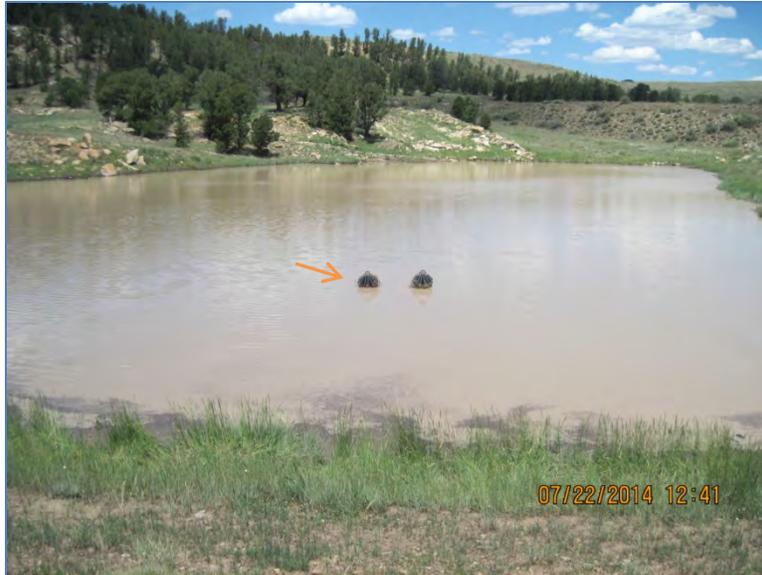
NMED/SWQB Official Photograph Log Photo # 1		
Photographer: Erin S. Trujillo	Date: 07/22/2014	Time: 1241 hours
City/County: Approximately 33 miles West of Raton / Colfax County		State: New Mexico
Location: Chevron Mining, Inc. / Ancho-Gachupin-Bracket (Ancho) Mine		
Subject: Pond above Outfall 005. Arrow points to trash rack inlets to pipe at Outfall 005. Water level is near top of inlets.

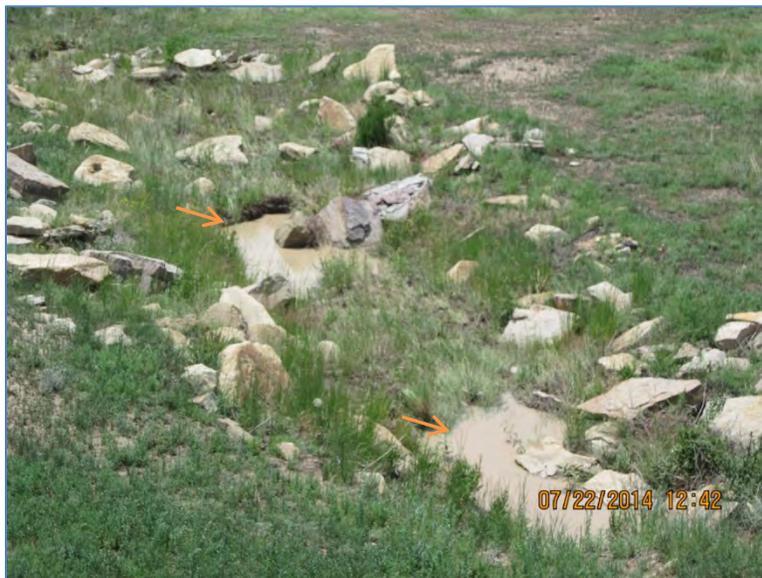
RECEIVING WATER OBSERVATIONS **Seepage below rock check dam at Outfall 034 is within Brackett Canyon. Water in channel below Outfall 005 was turbid.**

NMED/SWQB Official Photograph Log Photo # 2		
Photographer: Erin S. Trujillo	Date: 07/22/2014	Time: 1242 hours
City/County: Approximately 33 miles West of Raton / Colfax County		State: New Mexico
Location: Chevron Mining, Inc. / Ancho-Gachupin-Bracket (Ancho) Mine		
Subject: Arrows point to water in channel below Outfall 005 which is above Salyers Canyon. Water appeared turbid.

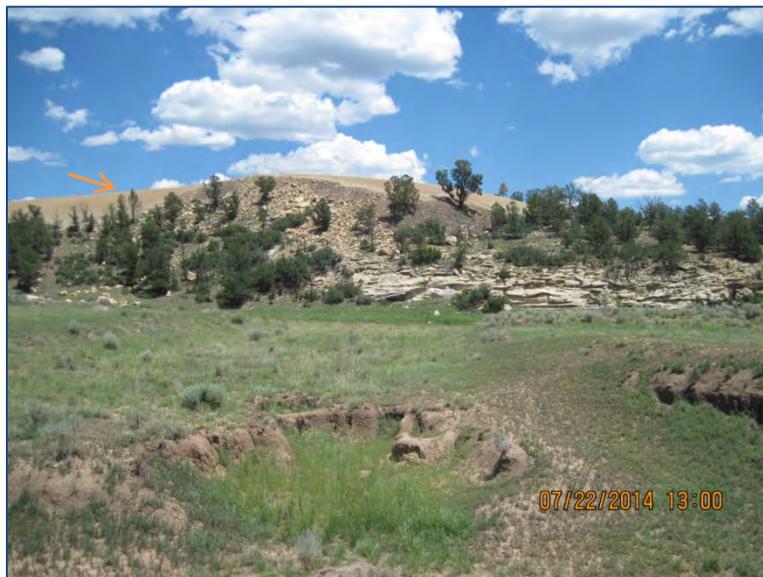
NMED/SWQB Official Photograph Log Photo # 3		
Photographer: Erin S. Trujillo	Date: 07/22/2014	Time: 1300 hours
City/County: Approximately 33 miles West of Raton / Colfax County		State: New Mexico
Location: Chevron Mining, Inc. / Ancho-Gachupin-Bracket (Ancho) Mine		
Subject: Arrow points to status of corrective action to install rock mulch and re-vegetation above Outfall 007. Erosion above Outfall 007 was discussed in Permittee's 2012 3 rd Quarter Reclamation Inspection Report dated October 22, 2012.

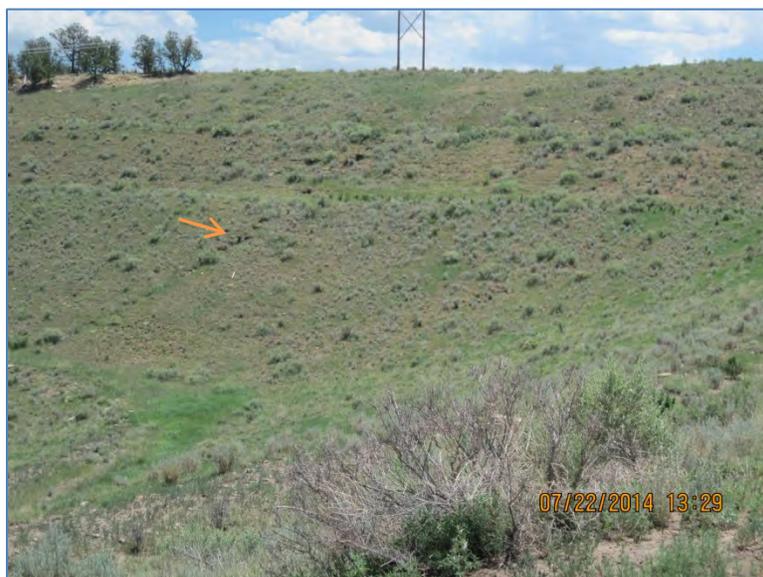
NMED/SWQB Official Photograph Log Photo # 4		
Photographer: Erin S. Trujillo	Date: 07/22/2014	Time: 1329 hours
City/County: Approximately 33 miles West of Raton / Colfax County		State: New Mexico
Location: Chevron Mining, Inc. / Ancho-Gachupin-Bracket (Ancho) Mine		
Subject: Arrow points to linear erosion feature in reclaimed slope above impoundment associated with Outfall 014.

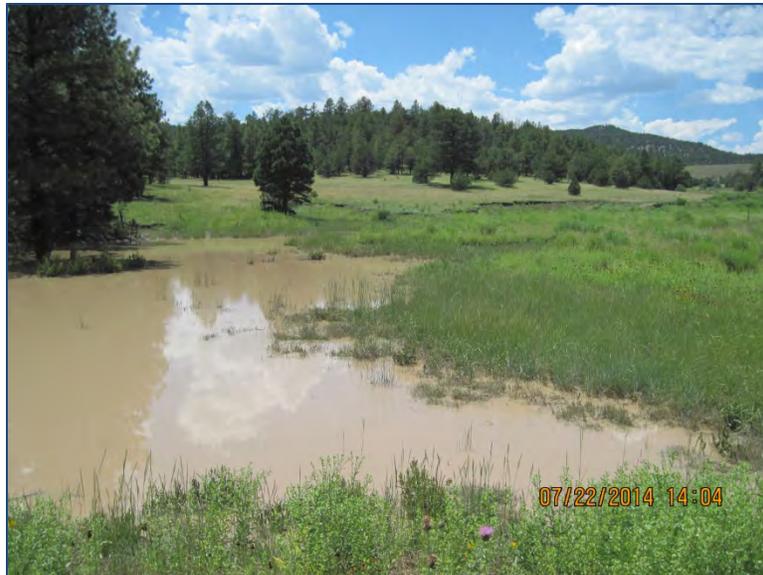
NMED/SWQB Official Photograph Log Photo # 5		
Photographer: Erin S. Trujillo	Date: 07/22/2014	Time: 1404 hours
City/County: Approximately 33 miles West of Raton / Colfax County		State: New Mexico
Location: Chevron Mining, Inc. / Ancho-Gachupin-Bracket (Ancho) Mine		
Subject: Water above rock check dam associated with Outfall 034 in Bracket Canyon.

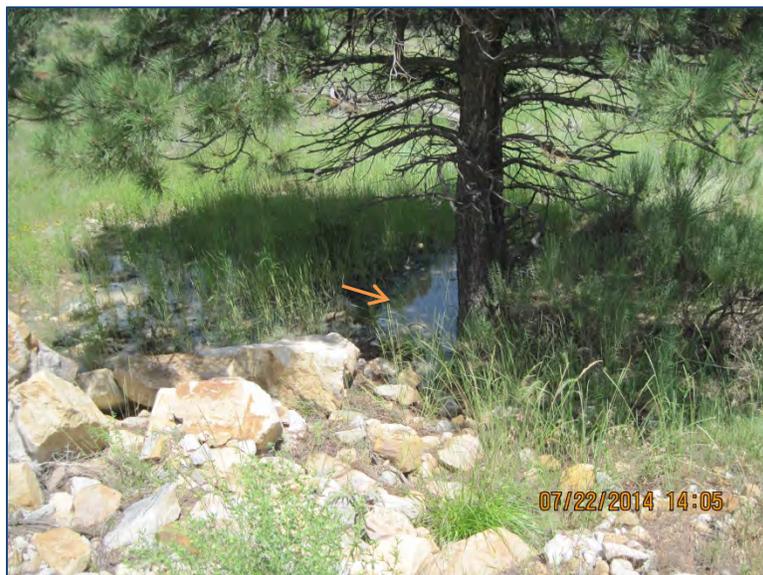
NMED/SWQB Official Photograph Log Photo # 6		
Photographer: Erin S. Trujillo	Date: 07/22/2014	Time: 1405 hours
City/County: Approximately 33 miles West of Raton / Colfax County		State: New Mexico
Location: Chevron Mining, Inc. / Ancho-Gachupin-Bracket (Ancho) Mine		
Subject: Arrow points to example of water below rock check dam associated with Outfall 034. Water appeared to have a substantially lower turbidity compared to water shown in previous photo.
