**Re: Bosque Farms Wastewater Treatment Plant; Minor; Municipal Individual Permit; SIC 4952; Compliance Evaluation Inspection; NPDES Permit NM0030279; February 3, 2015**

### NPDES Compliance Inspection Report

**Village of Bosque Farms**  
**NPDES Permit No. NM0030279**  
**Compliance Evaluation Inspection**  
**DATE OF INSPECTION: February 3, 2015**

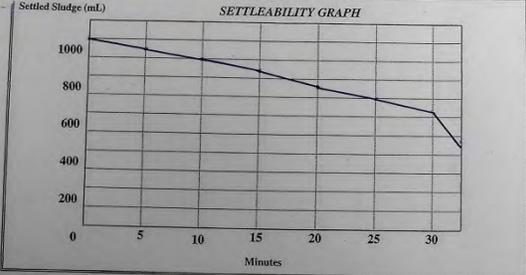
**NMED/SWQB**  
**Official Photograph Log**  
**Photo # 2**

When asked to pull a sludge reading using the sludge judge, it was noted that there was approximately 4.5 feet of sludge and it was not settling well. The permittee provided settleability worksheets and it was noted that the sludge was rather young, which produces a cloudy supernatant. This was noted on their settleometer bench sheets.

Photographer: Daniel Valenta	Date: 02-03-2015	Time: 1020 Hours
City/County: Bosque Farms / Valencia		State: New Mexico
Location: Bosque Farms Wastewater Treatment Plant		
Subject: Settleability Test Bench Sheet.

Notes: *supernatant semi cloudy - oil scum on Top -*  
*no visible solids floating*

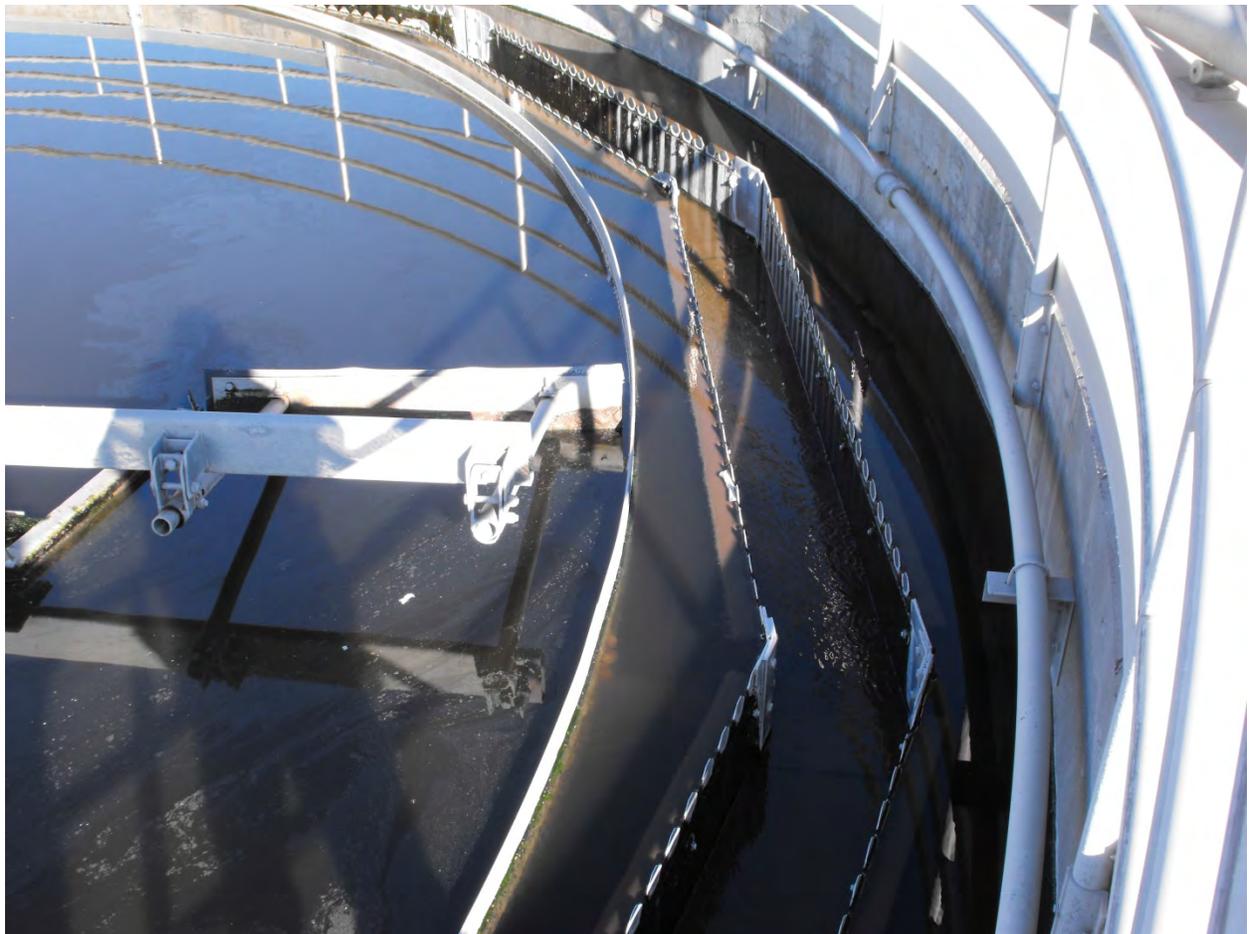
**NMED/SWQB**  
**Official Photograph Log**  
**Photo # 3**

The rubber on the skimmer arm in the clarifier is still in disrepair. This needs to be replaced in order to properly skim the surface of debris. **This is a repeat finding.**

The clarifier had noticeable grease and pin floc on the day of the inspection.

Photographer: Daniel Valenta	Date: 02-03-2015	Time: 0950 Hours
City/County: Bosque Farms / Valencia		State: New Mexico
Location: Bosque Farms Wastewater Treatment Plant		
Subject: Clarifier – Skimmer arm needs rubber to touch ring. Pin floc, grease on surface of clarifier.

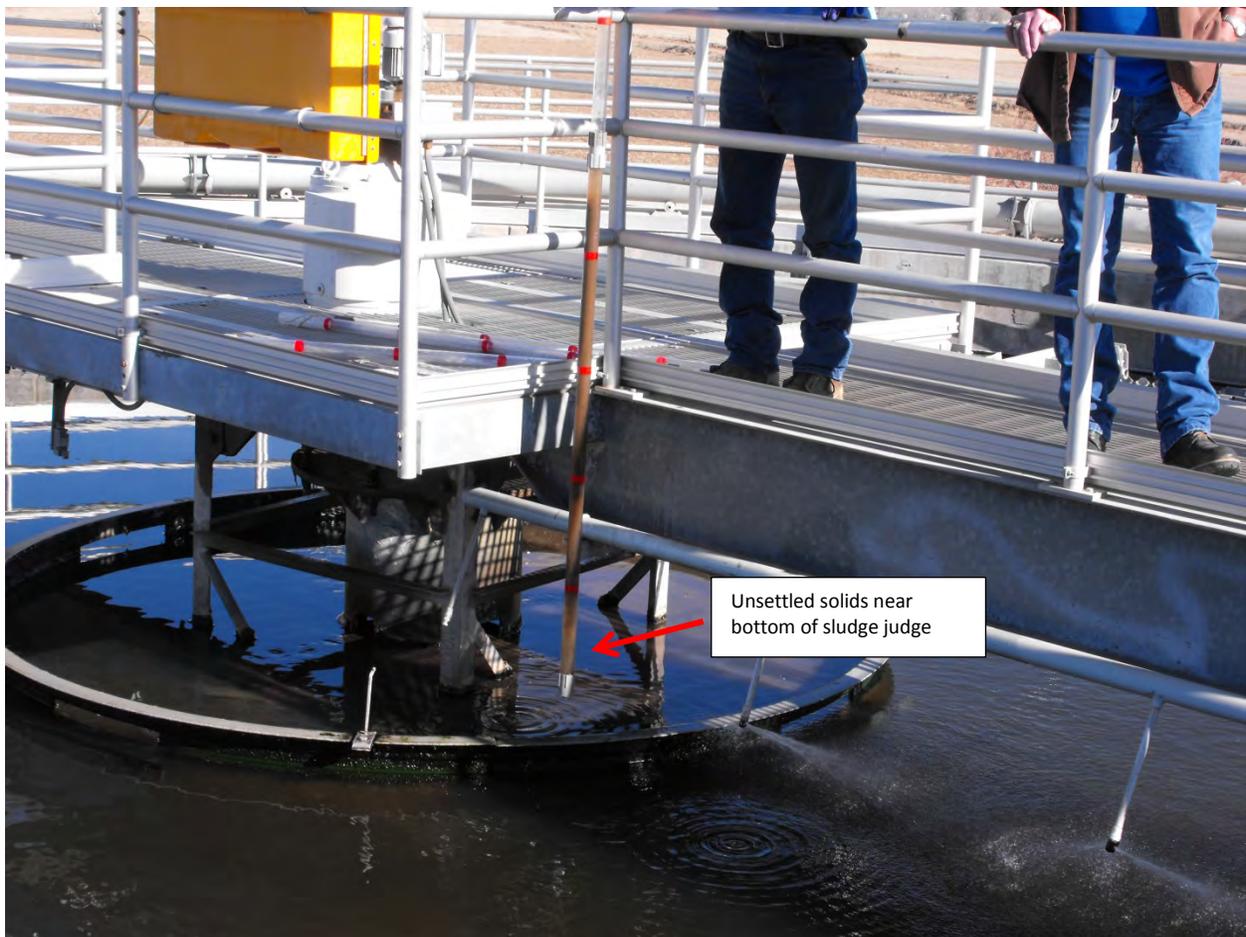
**NMED/SWQB**  
**Official Photograph Log**  
**Photo # 4**

Photographer: Daniel Valenta	Date: 02-03-2015	Time: 1000 Hours
City/County: Bosque Farms / Valencia		State: New Mexico
Location: Bosque Farms WWTP		
Subject: Sludge Judge approximately 4.5 feet.

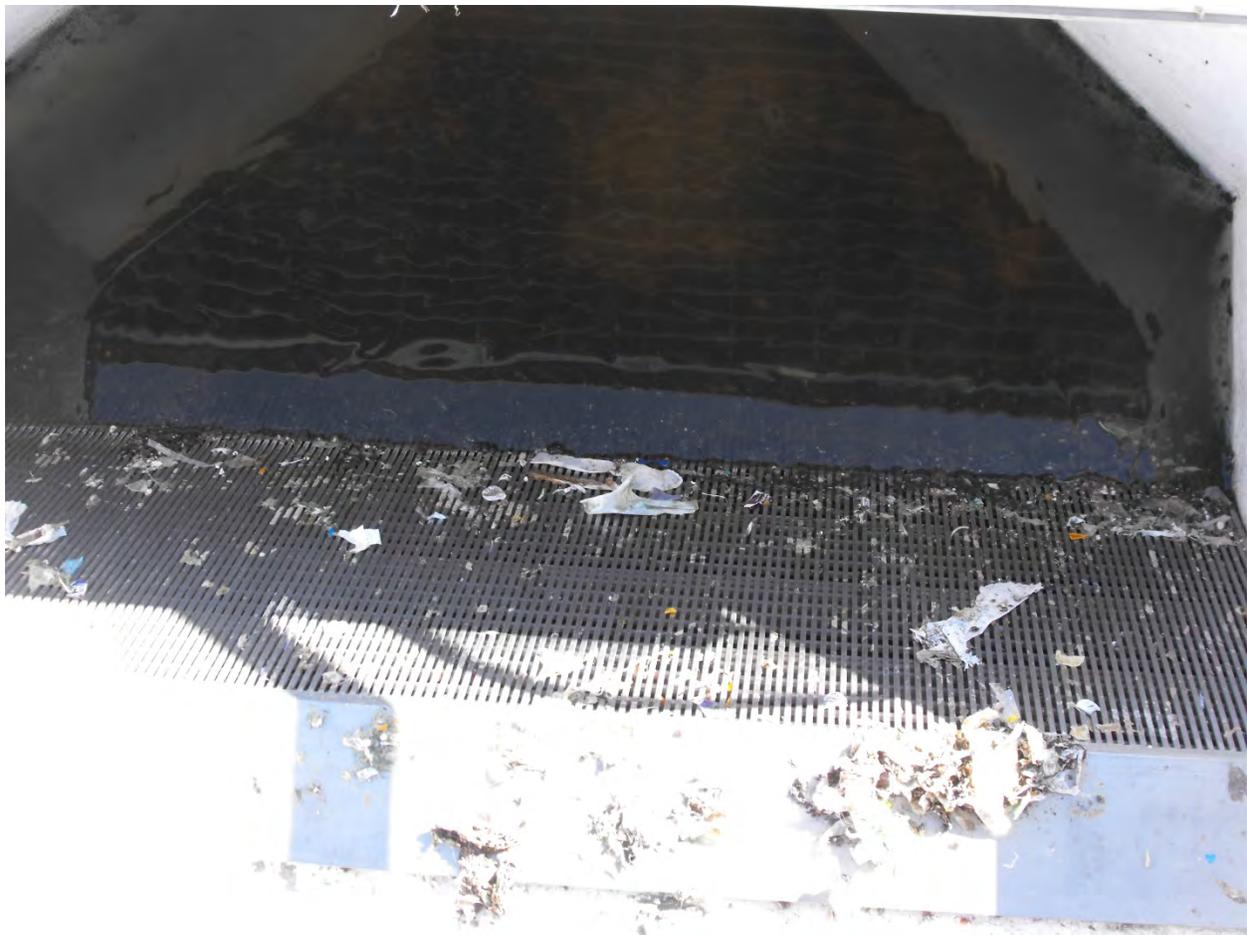
**NMED/SWQB**  
**Official Photograph Log**  
**Photo # 5**

Photographer: Daniel Valenta	Date: 02-03-2015	Time: 1016 Hours
City/County: Bosque Farms / Valencia		State: New Mexico
Location: Bosque Farms Wastewater Treatment Plant		
Subject: Bar screen at entrance of effluent channel

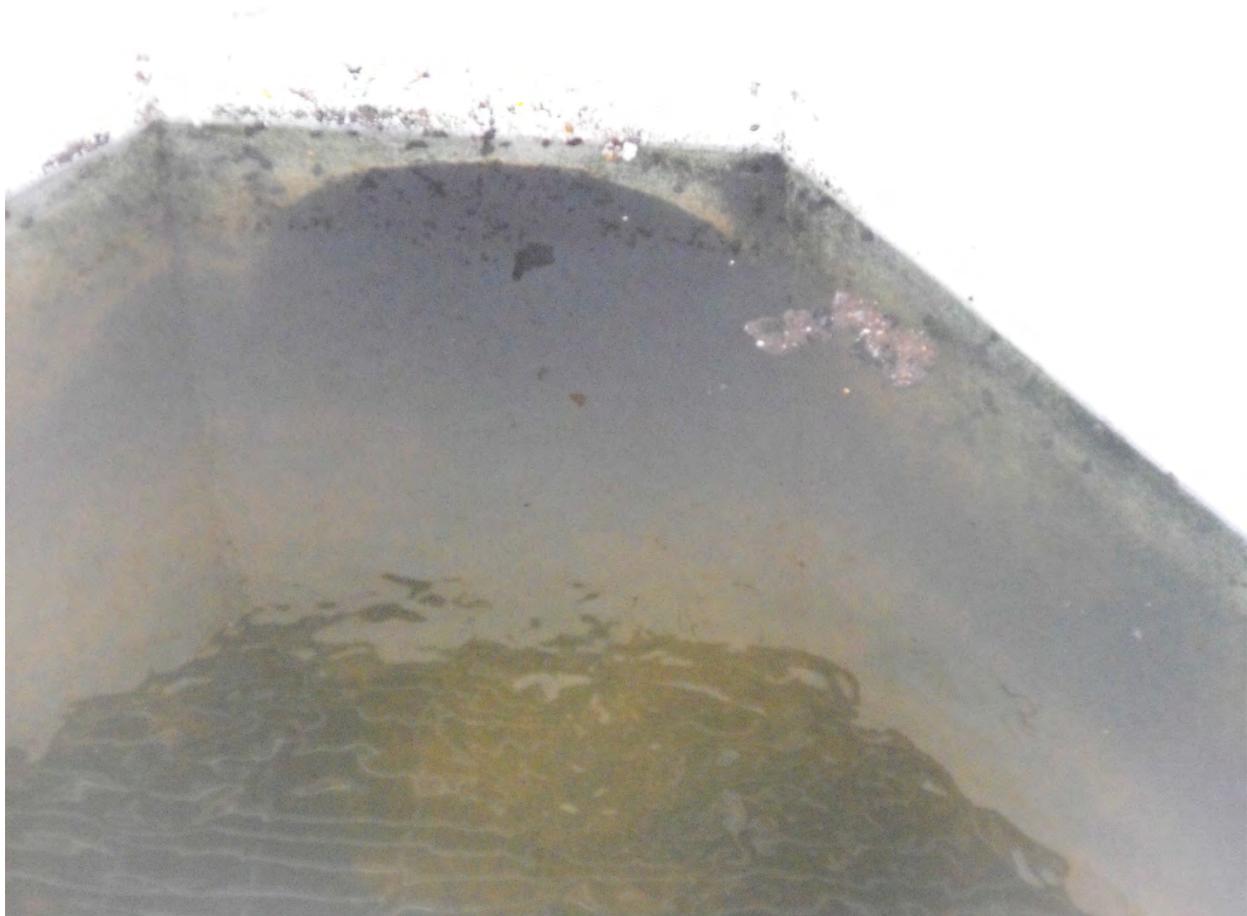
**NMED/SWQB**  
**Official Photograph Log**  
**Photo # 6**

There were noticeable suspended particles entering the UV system. Suspended particles will have a tendency to shield the microorganisms entering the system and protect them from the destructive effects of the UV system, thus, inadequately treating the effluent.

Photographer: Daniel Valenta	Date: 04-11-2013	Time: 1020 Hours
City/County: Bosque Farms / Valencia		State: New Mexico
Location: Bosque Farms Wastewater Treatment Plant		
Subject: Solids in effluent parshall flume

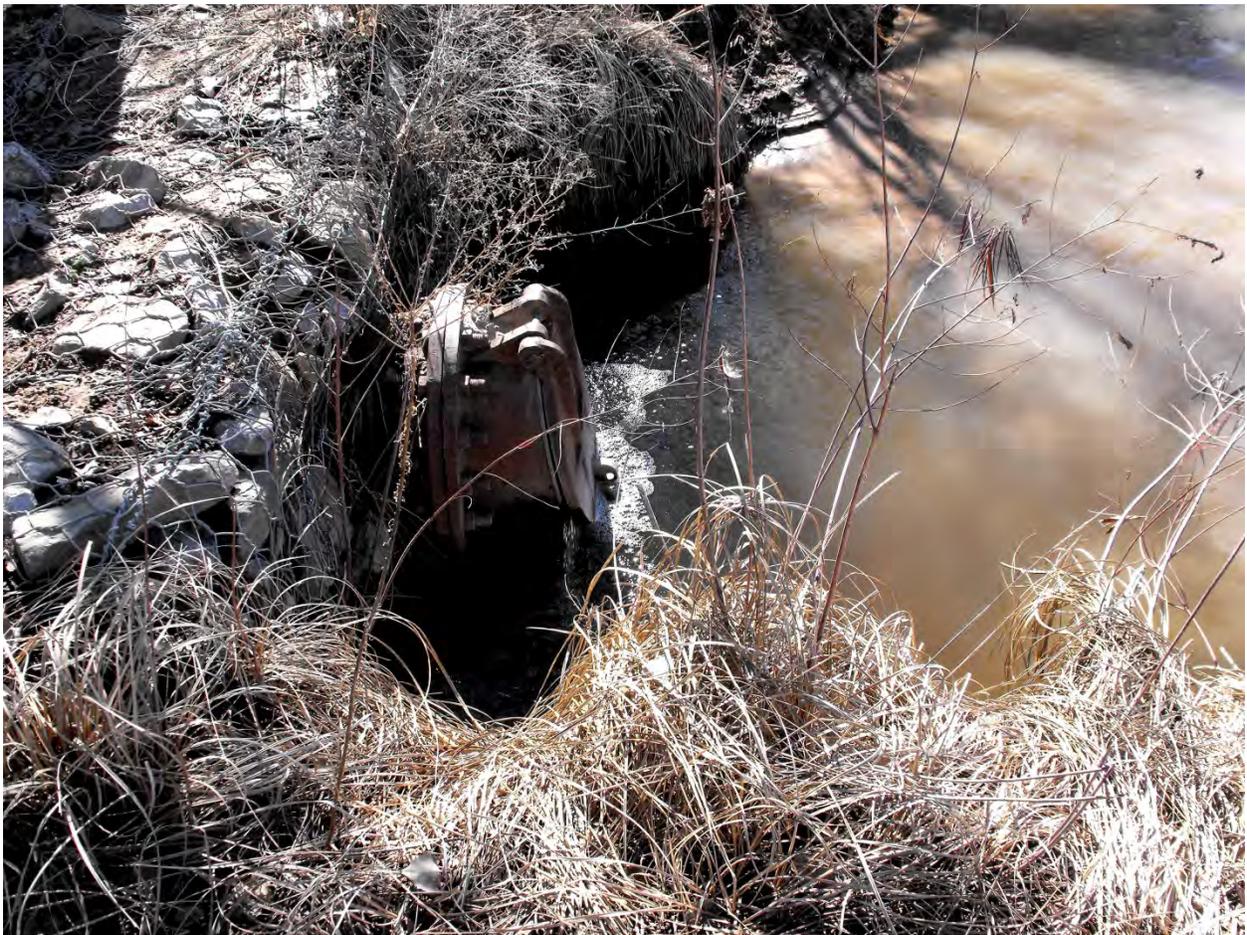
**NMED/SWQB**  
**Official Photograph Log**  
**Photo # 7**

Photographer: Daniel Valenta	Date: 02-03-2014	Time: 1127 Hours
City/County: Bosque Farms / Valencia		State: New Mexico
Location: Bosque Farms Wastewater Treatment Plant		
Subject: Effluent Pipe @ Rio Grande
