**Re: Ranchland Utility Wastewater Treatment Plant; Minor; Individual Permit; SIC 4952;
Compliance Evaluation Inspection; NPDES Permit NM0030368; February 25, 2014**

Compliance Evaluation Inspection
Ranchland Utilities Water Reclamation Facility
NPDES Permit No. NM0030368
February 25, 2014

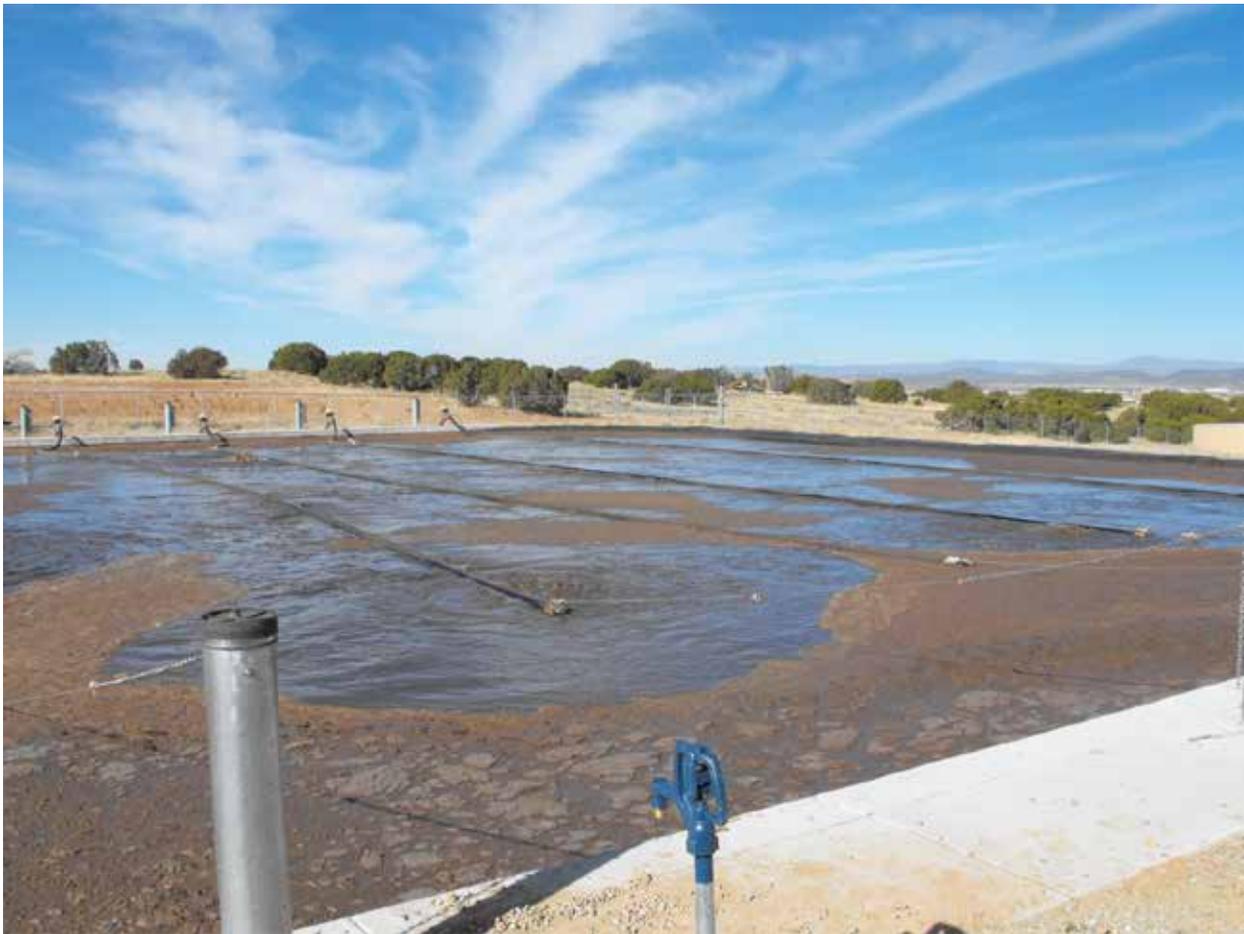
NMED/SWQB
Official Photograph Log
Photo # 1

The biolac system has floating solids as well as noticeable grease. Three of the fine bubble diffusers were malfunctioning.

Photographer: Daniel Valenta	Date: February 25, 2013	Time: 0950 hours
City/County: Santa Fe / Santa Fe		State: New Mexico
Location: Ranchland Utilities		
Subject: Biolac aeration pond.

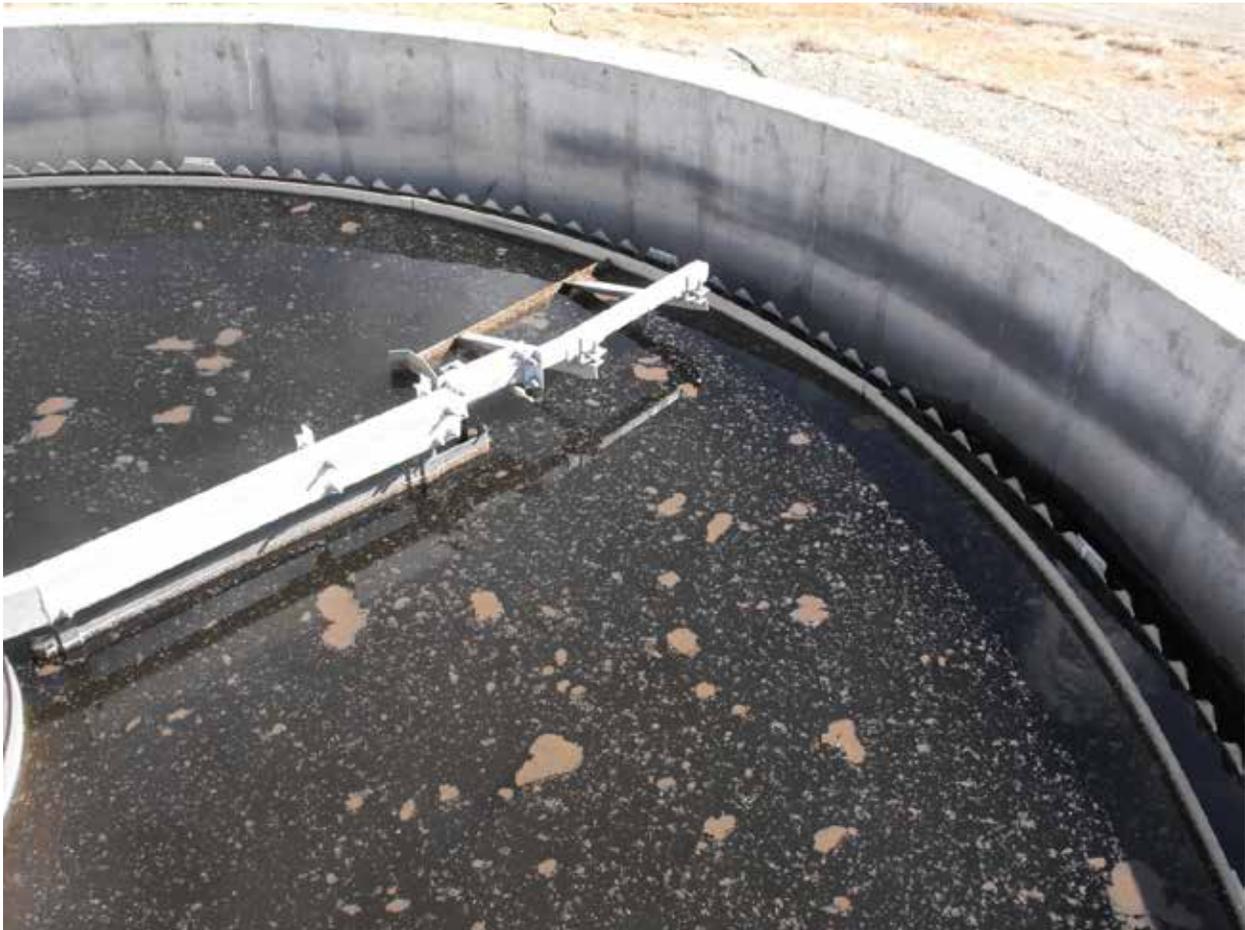
NMED/SWQB
Official Photograph Log
Photo # 2

Photographer: Daniel Valenta	Date: February 25, 2014	Time: 0950 Hours
City/County: Santa Fe / Santa Fe		State: New Mexico
Location: Ranchland Utilities		
Subject: East clarifier
