## NEW MEXICO ENVIRONMENT DEPARTMENT

Re: Minor Municipal; SIC 4952; Compliance Evaluation Inspection; Angel Fire Wastewater Treatment Plant; NPDES Permit No.NM0030503, September 25, 2014

### NPDES Compliance Inspection Report

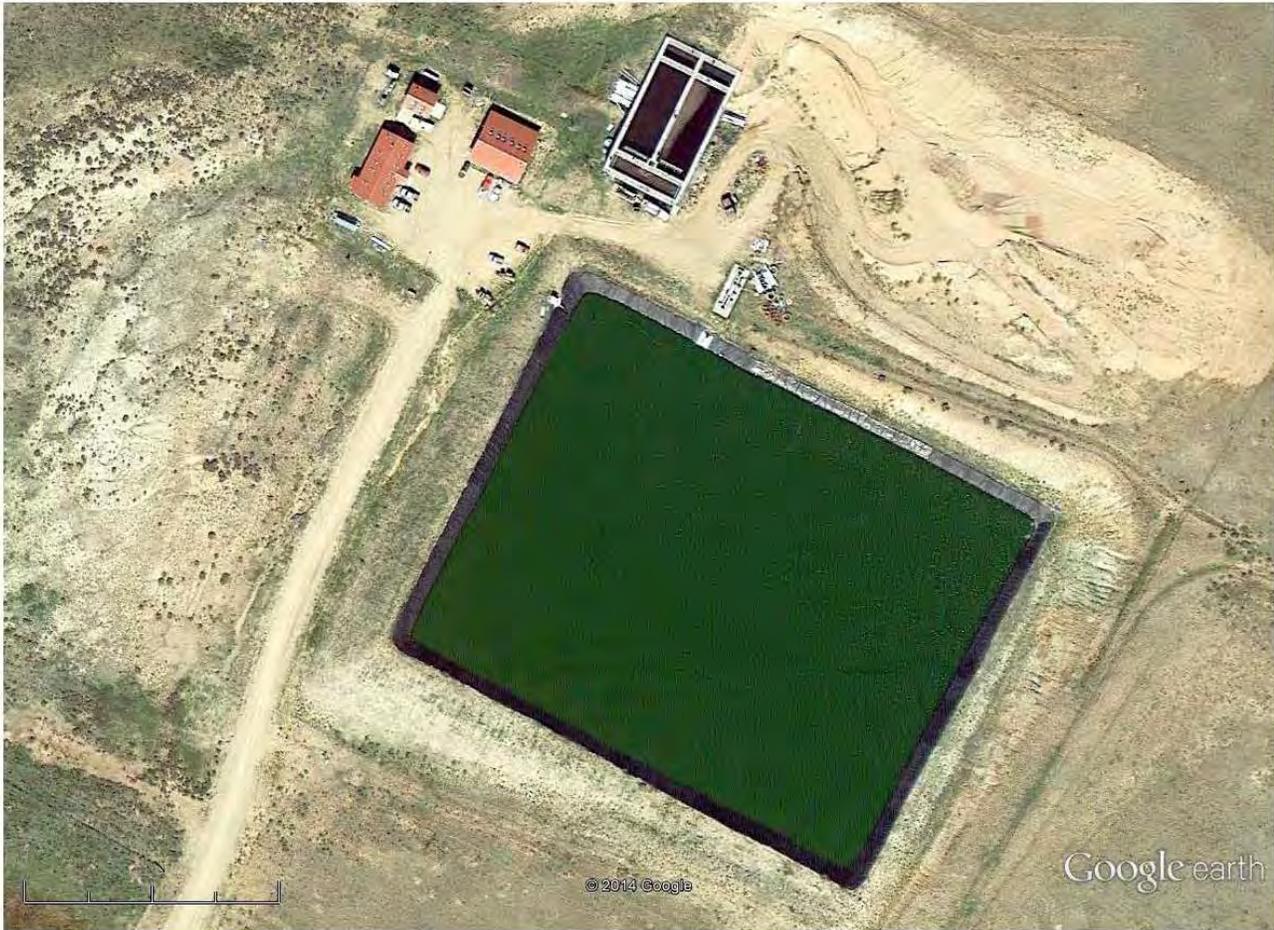
Subject: Angel Fire WWTP Aerial View of the Sequencing Batch Reactors (SBR), Administrative Building, Solids Handling Building and Ultraviolet Treatment Unit.

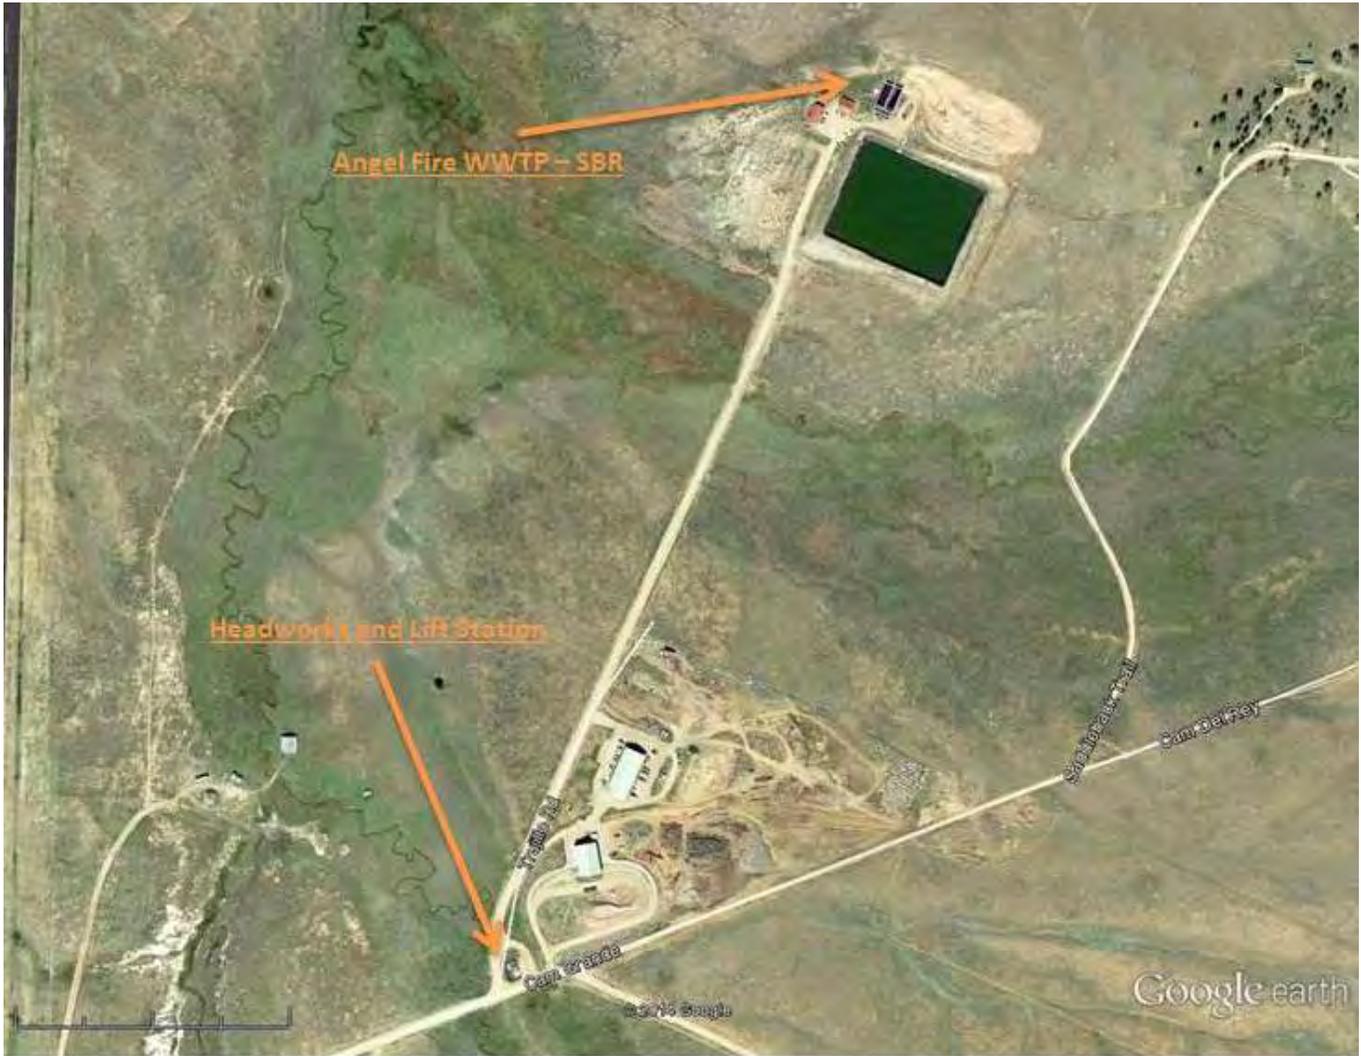
Subject: Influent headworks and lift station are located nearly one half mile away from the main treatment plant. A lift station and forced main line transports the raw sewage from the headworks to the Sequencing Batch Reactors (SBRs).

1. Ultra Violet (UV) disinfection light banks had some bulbs that were either burned out or were not working at full strength.
2. Operators were not able to order replacement parts for the UV unit.
3. The headworks located a half mile away from the SBR has a manual and mechanical bar screen. Some large solids are getting past these units. Operators indicated there are plans to install a "muffin monster" grinder that would break up any solids that interfere with the lift station and following treatment works.

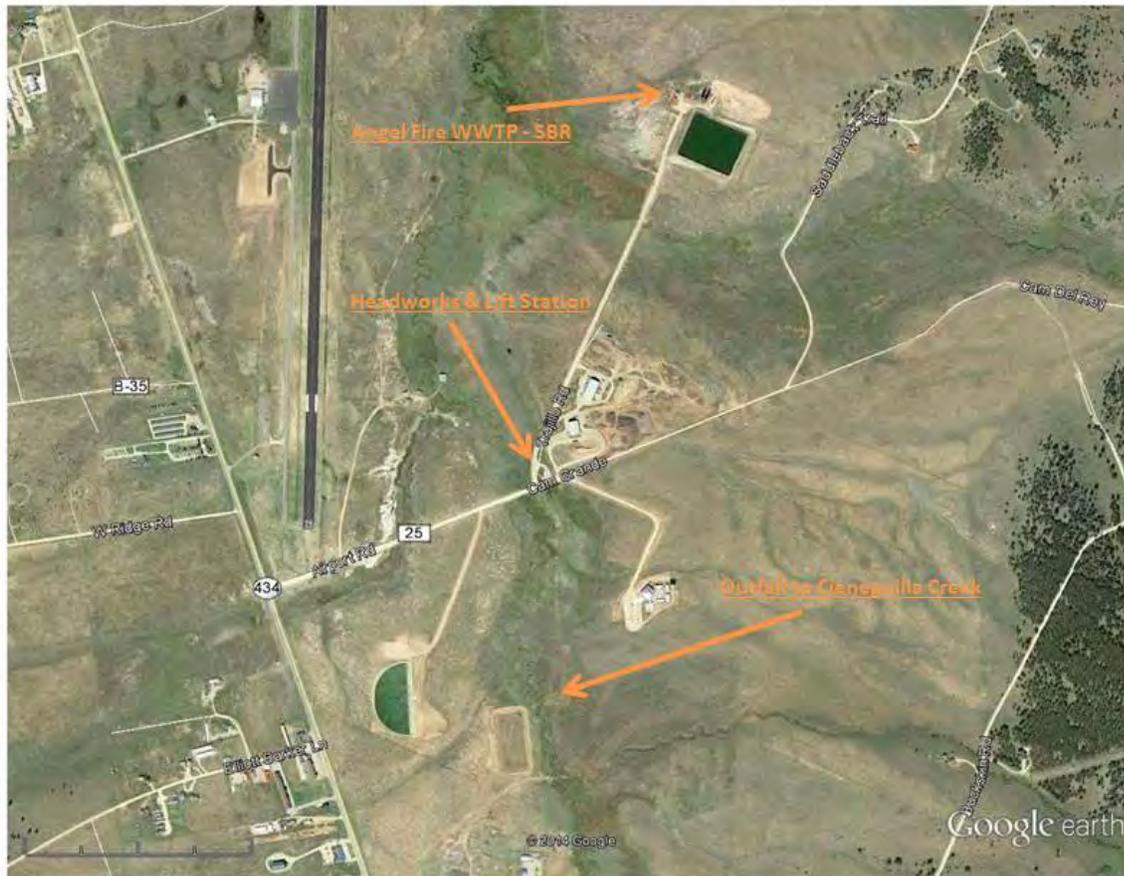
Subject: WWTP SBR and Lagoon; Influent Headworks; Outfall location. The Outfall to Cieneguilla Creek is nearly a mile away from the main treatment plant.

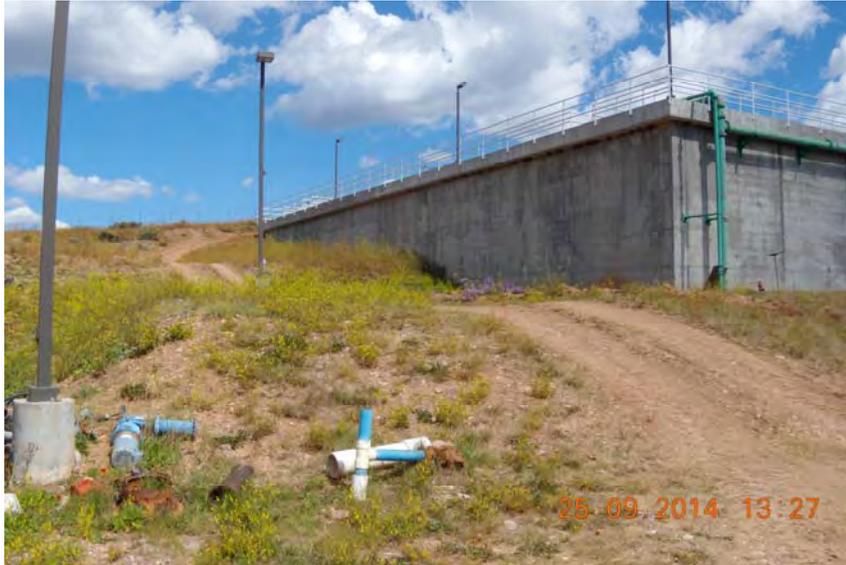
NMED/SWQB  
Official Photograph Log  
Photo # 5

Subject: Above ground SBR treatment system The treatment units and the concrete appeared to be in good condition, maintained and free of concrete cracking and obvious deterioration.

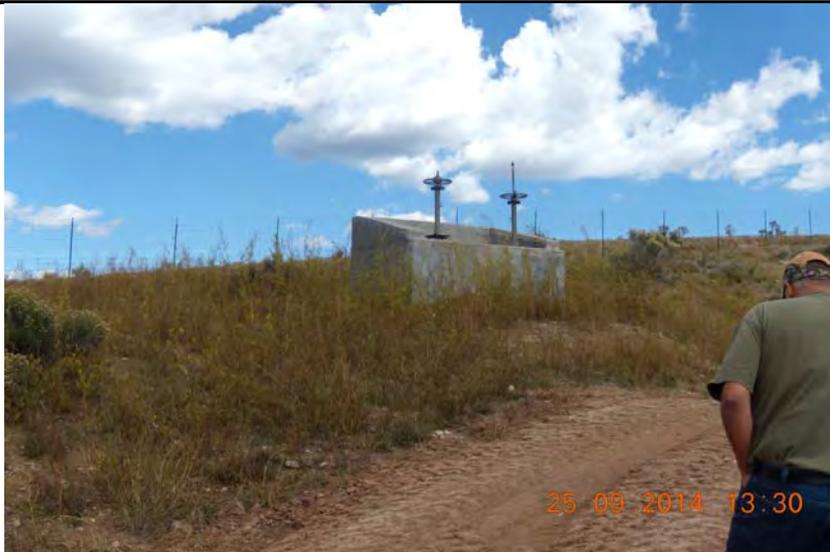
NMED/SWQB  
Official Photograph Log  
Photo # 6

Subject: Splitter box that controls the flow to the SBR basins. The basin can be run in parallel if needed.

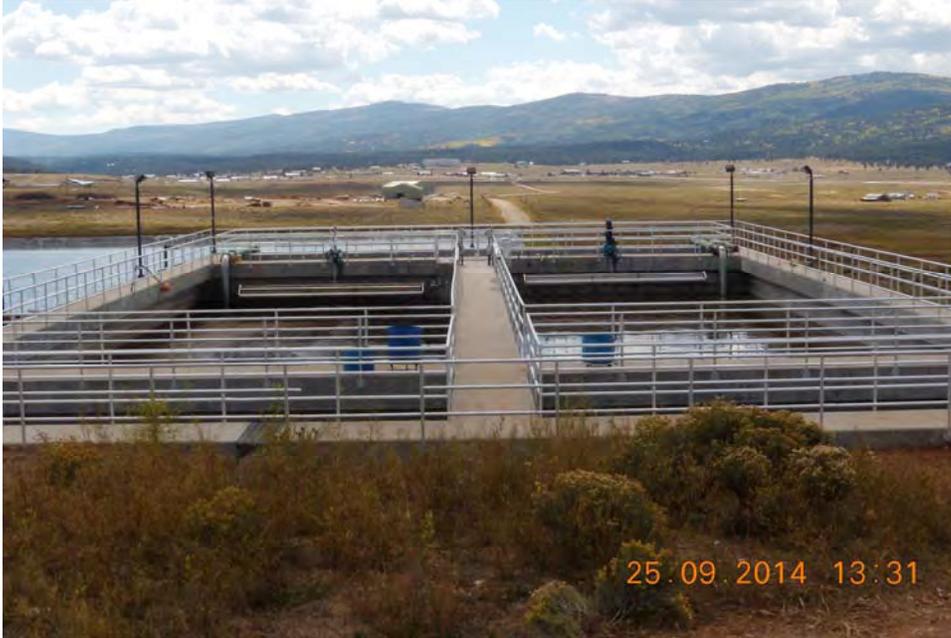
NMED/SWQB  
Official Photograph Log  
Photo # 7

Subject: The Sequencing Batch Reactor System – two trains. One basin was being used for solids and the other for water treatment.

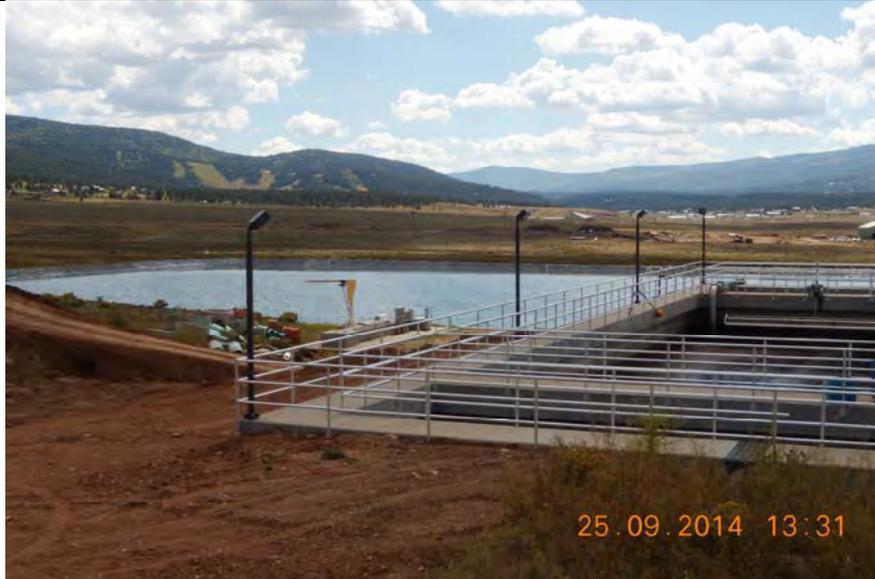
NMED/SWQB  
Official Photograph Log  
Photo # 8

Subject: The Sequencing Batch Reactor System and the reuse holding pond.

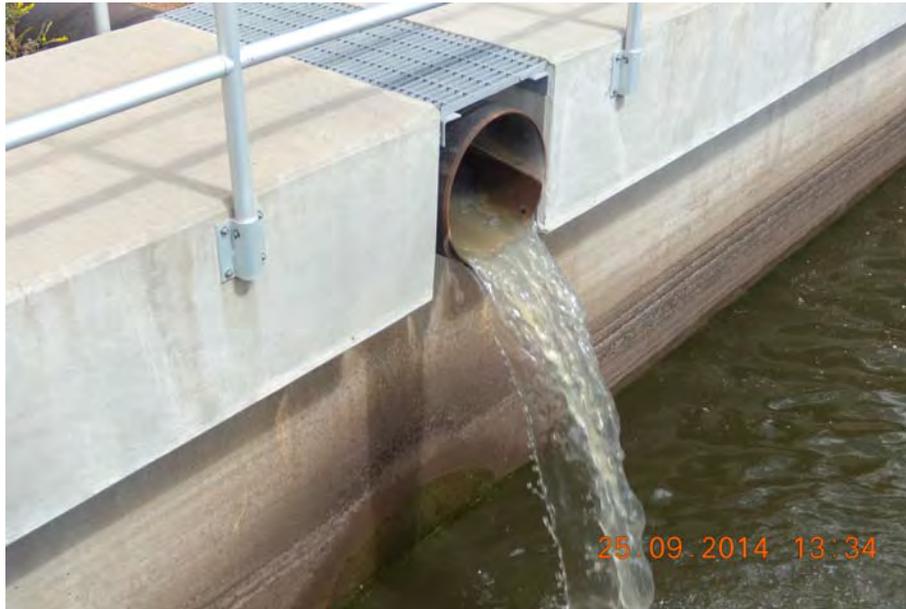
NMED/SWQB  
Official Photograph Log  
Photo # 9

Subject: Influent to the pre-activation basin. Water from this basin can be split to two basins. At the time of the inspection the influent was not being split. Instead, one basin was being used for solids.

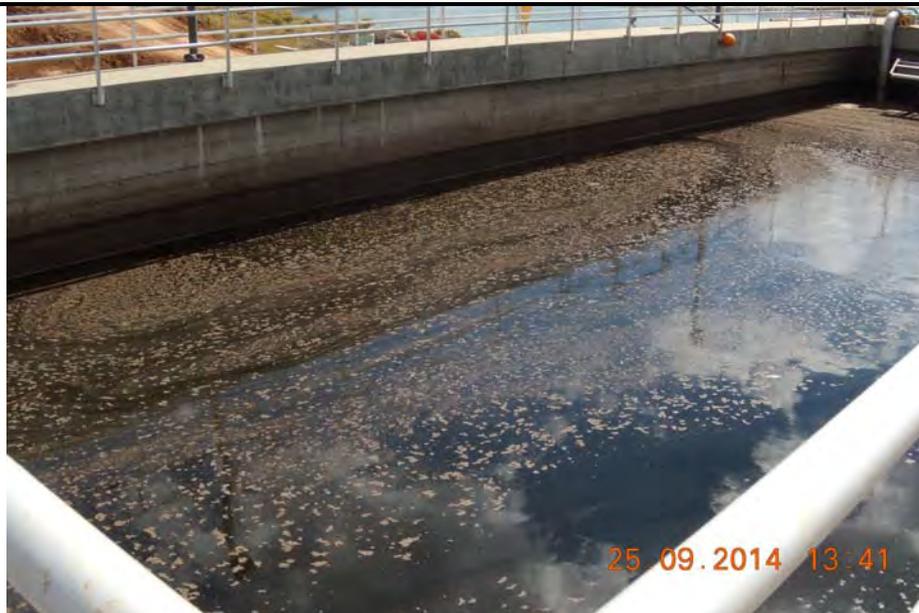
NMED/SWQB  
Official Photograph Log  
Photo # 10

Subject: Solids settling basin. Note some older floating solids in the basin.

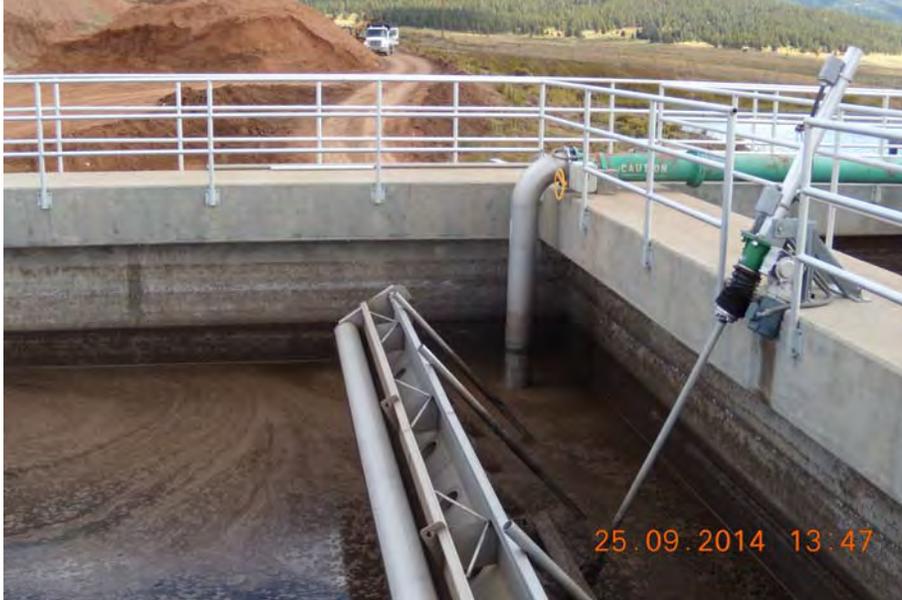
NMED/SWQB  
Official Photograph Log  
Photo # 11

Subject: Decant arm in SBR. Decant is sent to a secondary holding basin that equalize the flow levels being sent through the UV disinfection system.

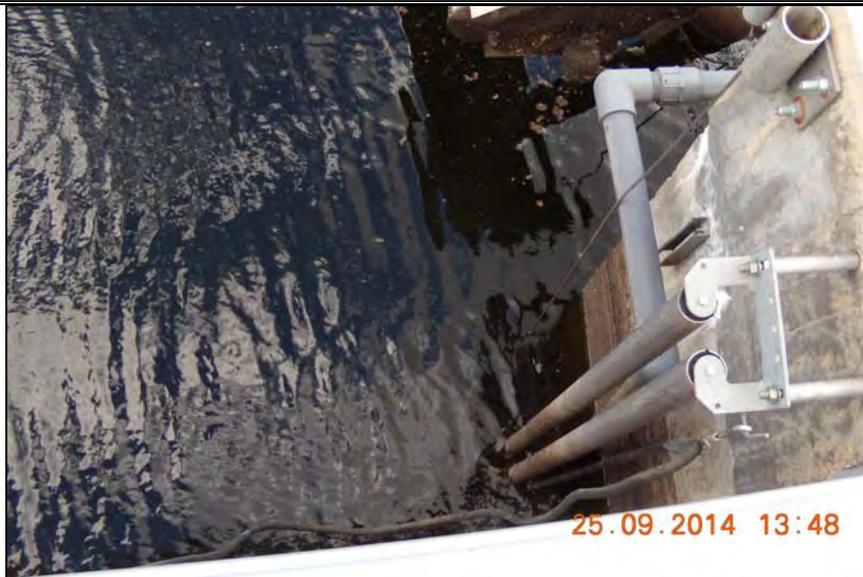
NMED/SWQB  
Official Photograph Log  
Photo # 12

Subject: Secondary basin and pump that send treated wastewater to the Ultraviolet disinfection system. Note that what appears to be floating debris is leaves blown into the open air unit.

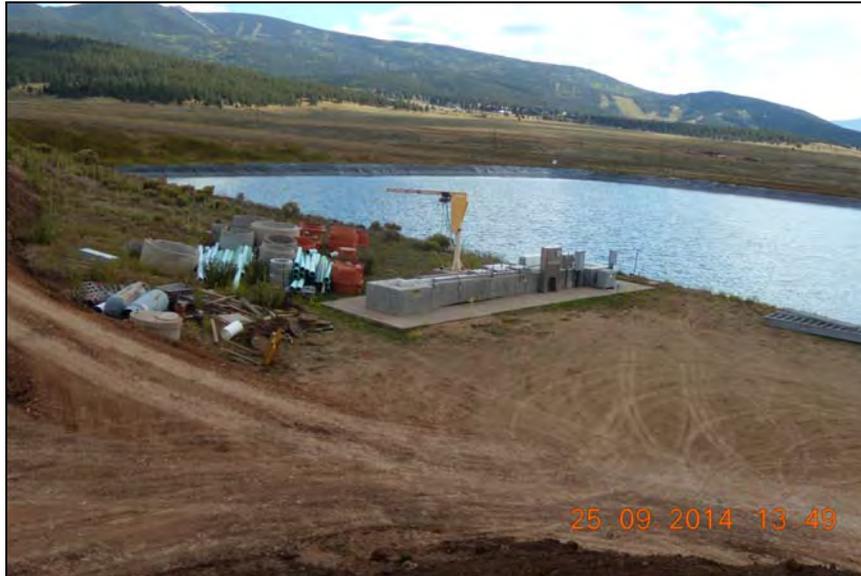
NMED/SWQB  
Official Photograph Log  
Photo # 13

Subject: The Ultraviolet Disinfection unit and the reuse holding pond. In order to do maintenance at the UV system a pulley can crane system are in place.

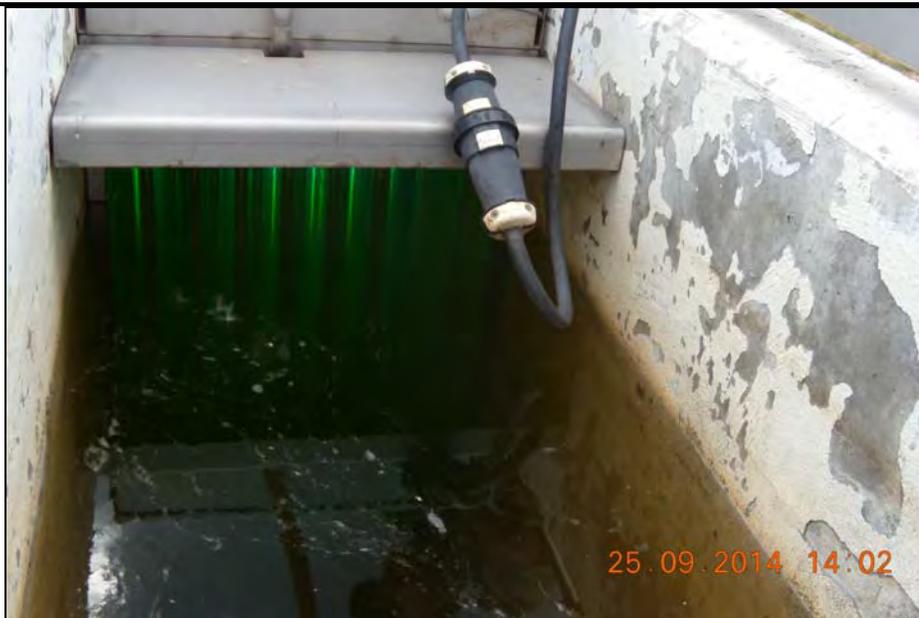
NMED/SWQB  
Official Photograph Log  
Photo # 14

1. A slight amount of floating solids and foam was observed entering the UV chamber.

Subject: Treated water entering the Ultra Violet (UV) disinfection basin. Note a light amount of dispersed foam and slight amount of floating solids in basin.

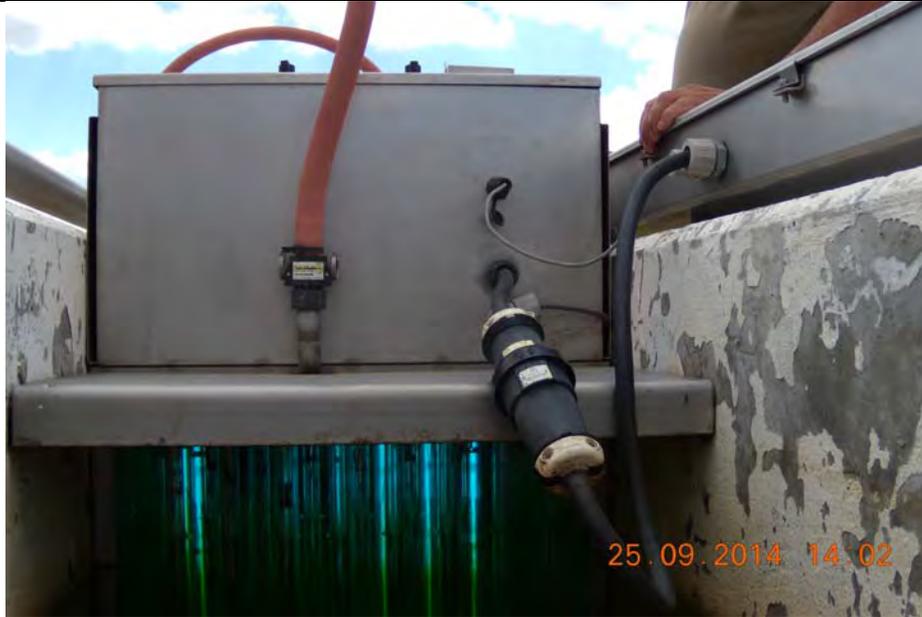
NMED/SWQB  
Official Photograph Log  
Photo # 15

Subject: The Ultra Violet (UV) disinfection lights. Note some of the lights are not operating at full intensity. The lights are cleaned weekly and were free of debris.

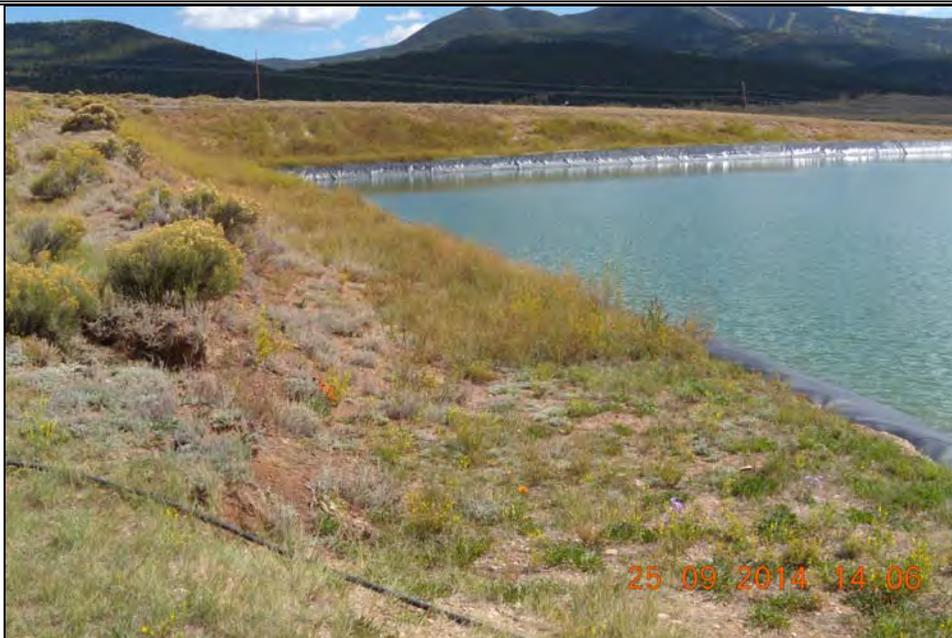
NMED/SWQB  
Official Photograph Log  
Photo # 16

Subject: Effluent holding pond for reuse. Flow measurement for reuse is past the pond location.

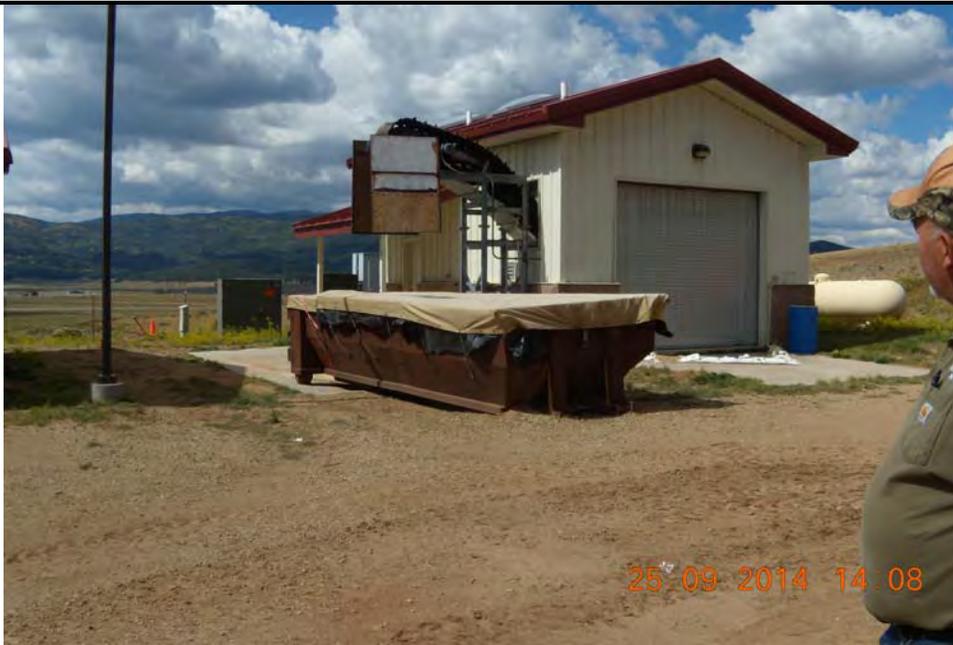
NMED/SWQB  
Official Photograph Log  
Photo # 17

Subject: Solids handling onsite included a dewatering belt press that is plumbed to send the liquids back to the headworks. The solids are deposited in a roll off dumpster that is hauled to the Rio Rancho Landfill for final surface disposal.

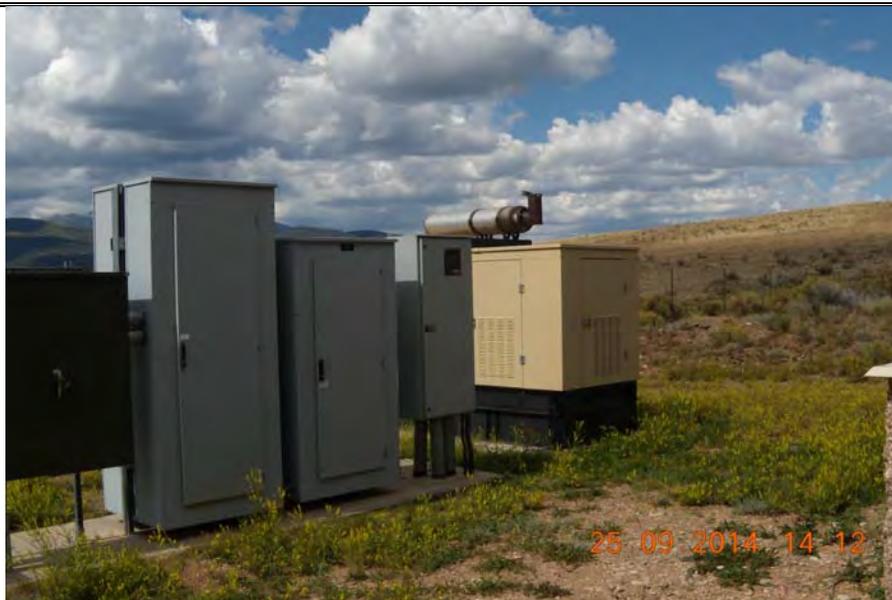
**NMED/SWQB  
Official Photograph Log  
Photo # 18**

Subject: A backup diesel generator is exercised weekly.

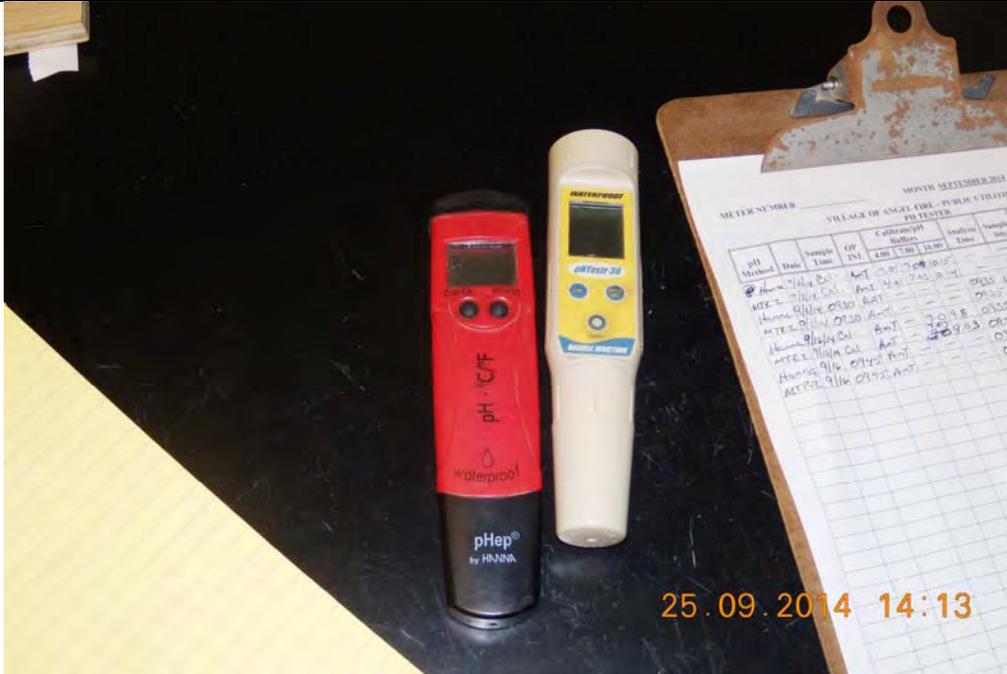
**NMED/SWQB  
Official Photograph Log  
Photo # 19**

Subject: On site pH meter.

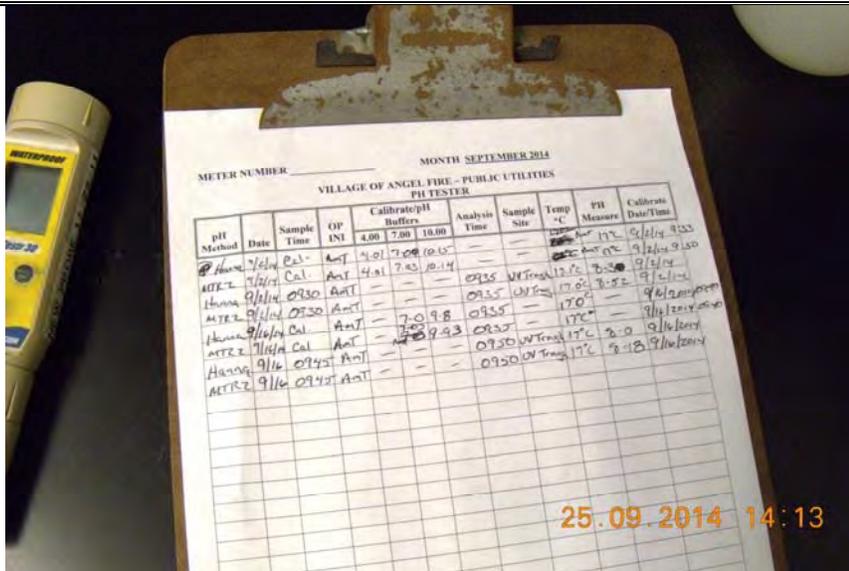
NMED/SWQB  
Official Photograph Log  
Photo # 20

Subject: pH meter bench sheet.

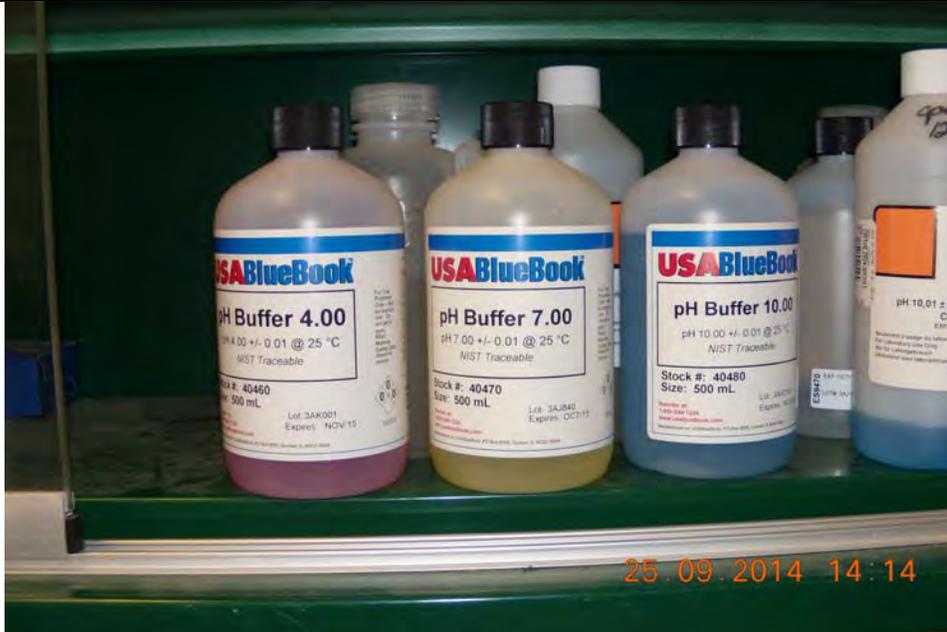
NMED/SWQB  
Official Photograph Log  
Photo # 21

Subject: pH buffers were within the manufacture's expiration date. However bottles did not have a hand written "open date".

1. Reagent bottles for pH did not have the "open date" written on the bottles. The reagents were within the expiration date as listed by the manufacture. As part of a quality control practice, it is recommended that all reagents and standards have the "open date" clearly marked on containers.

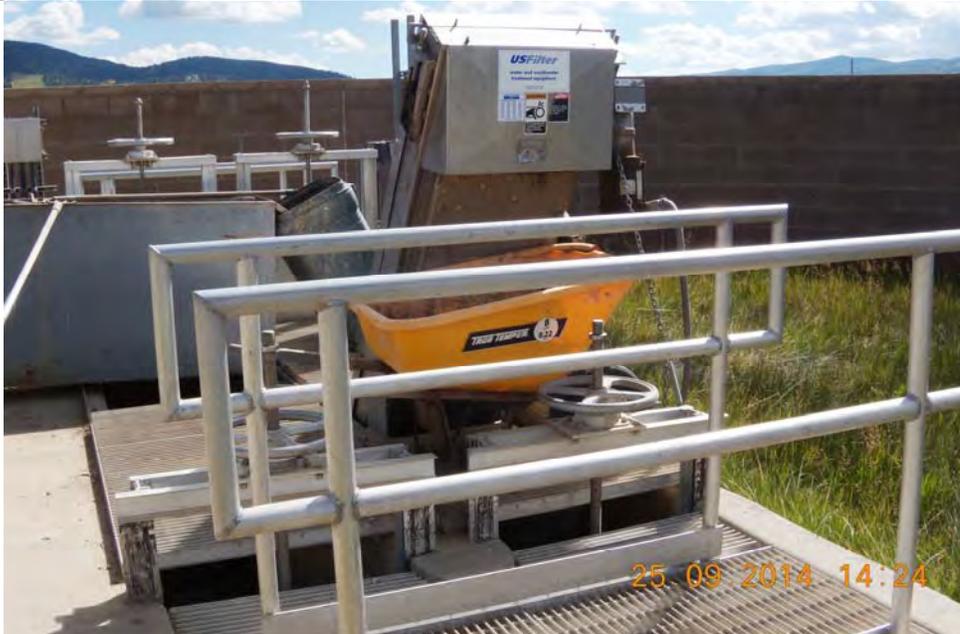
NMED/SWQB  
Official Photograph Log  
Photo # 22

Subject: Headwork grit removal system. Solids are collected and after passing the paint filter test disposed of at a landfill.

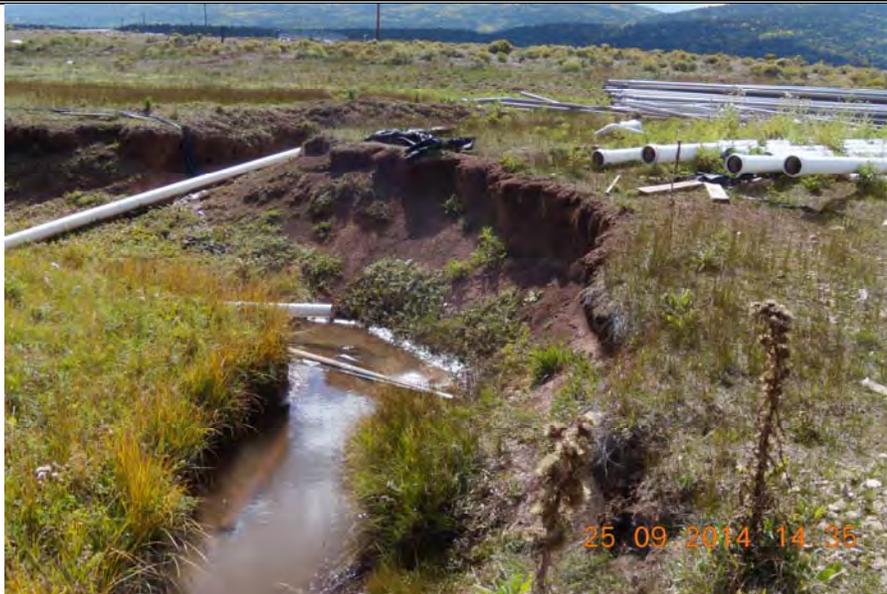
NMED/SWQB  
Official Photograph Log  
Photo # 23

Subject: Cieneguilla Creek approximately 20 feet below the effluent pipe. Effluent discharge location is in the Angel Fire Ski Resort "Bone Yard" a storage area. Note the debris in the stream channel. These items of debris are outside the authority of the Village of Angel Fire. Efforts should be made to remove any debris and to prevent debris and trash from entering the stream channel.

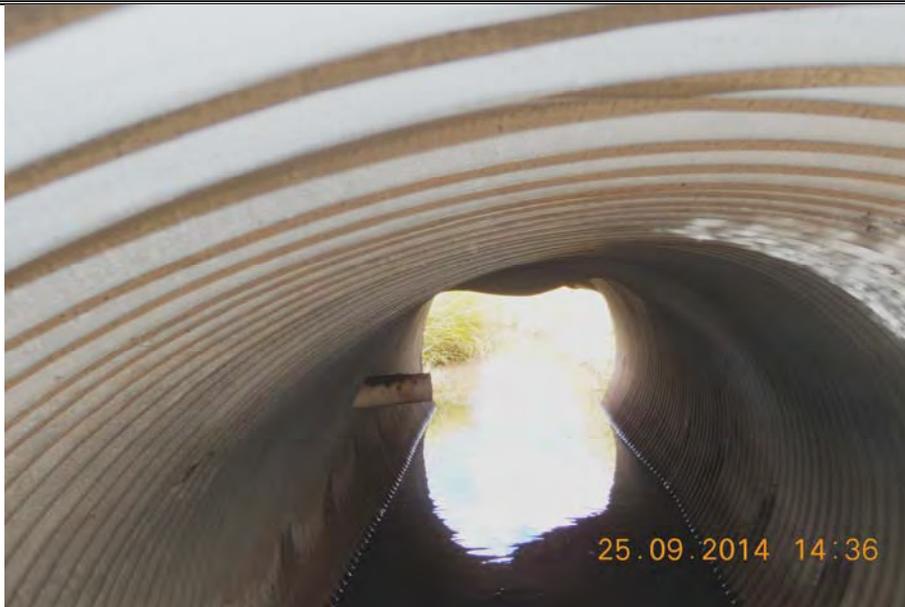
NMED/SWQB  
Official Photograph Log  
Photo # 24

Subject: Effluent pipe is on the left side of this culvert. There was no discharge at the time of the inspection.

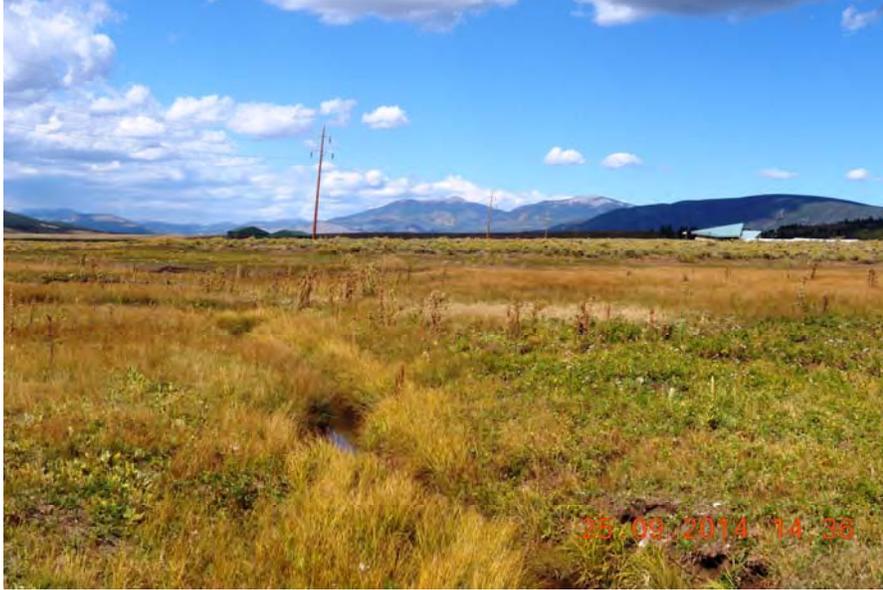
NMED/SWQB  
Official Photograph Log  
Photo # 25

Subject: The Cieneguilla Creek stream channel above the effluent pipe.

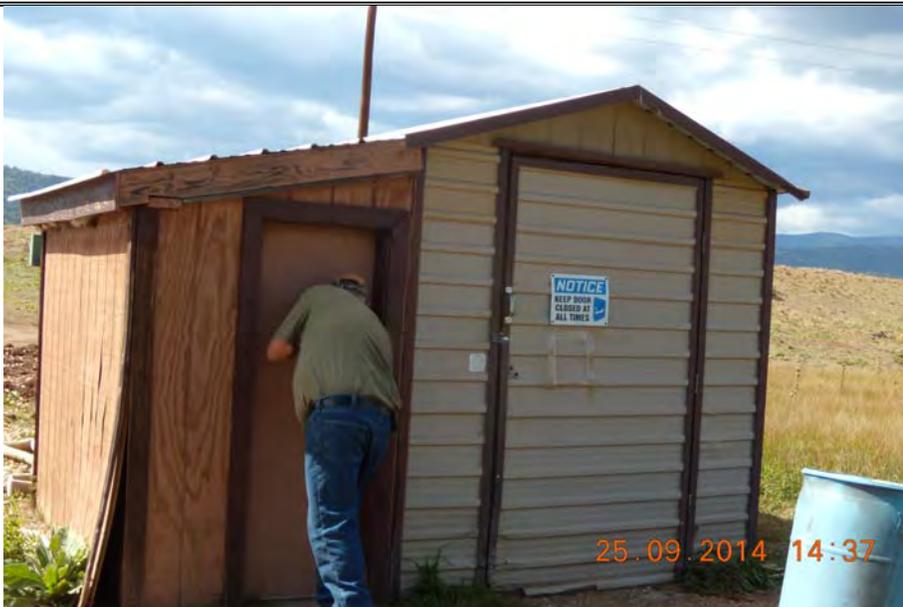
NMED/SWQB  
Official Photograph Log  
Photo # 26

Subject: Building that houses the effluent sampling location and the effluent flow meter.

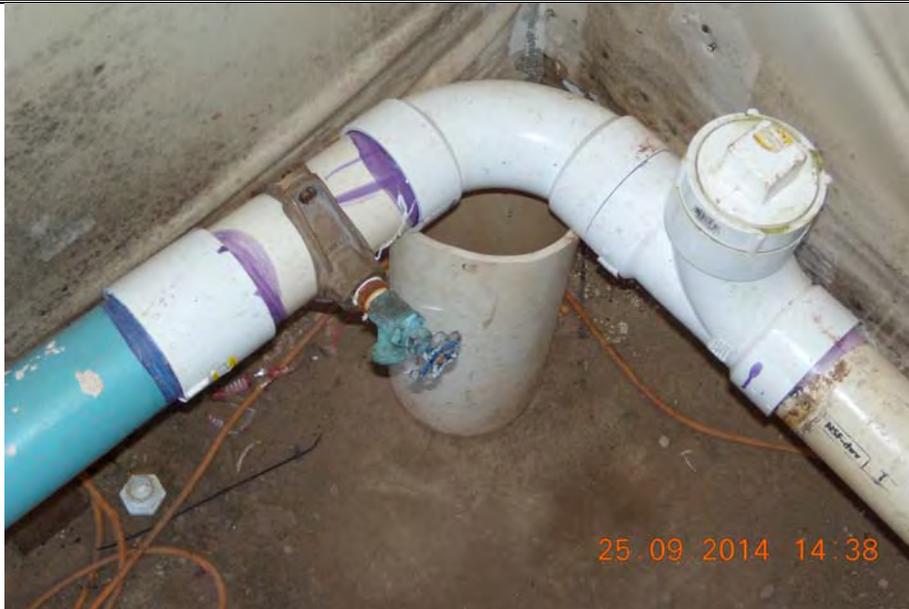
NMED/SWQB  
Official Photograph Log  
Photo # 27

Subject: Effluent sampling port.

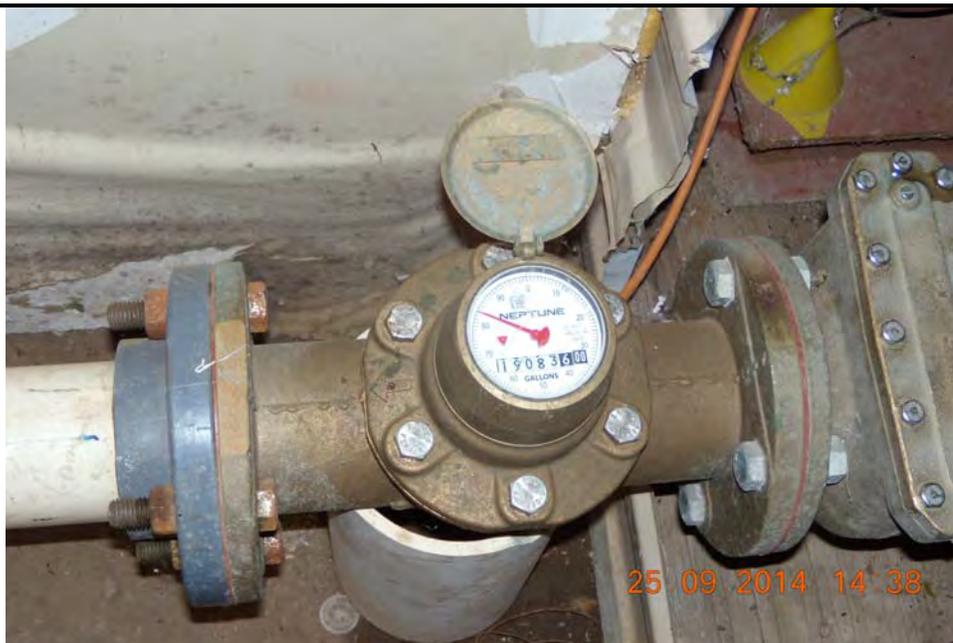
Subject: Effluent flow meter is and inline totalizer.
